**HYDRAULIC MODEL STUDY
ROZA FISH SCREEN, WASHINGTON**

Subject: Model Study for Roza Canal Fish Screen Structure - Yakima
Project Washington

HYDRAULIC MODEL STUDY
ROZA FISH SCREEN, WASHINGTON

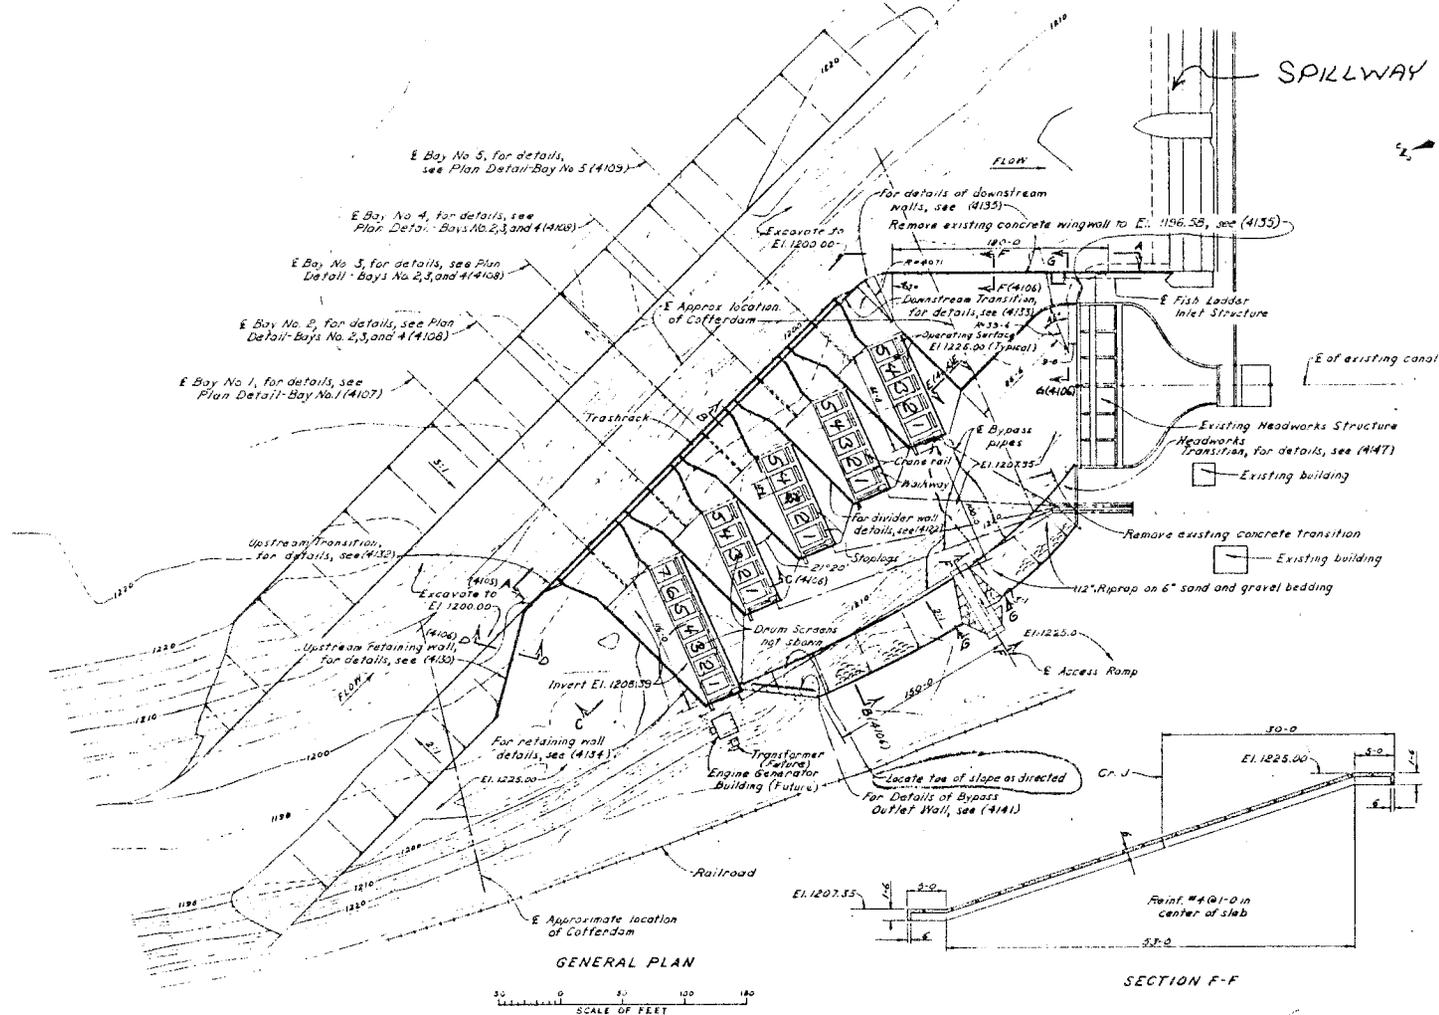
FIGURE 1

GENERAL PLAN OF FISHSCREEN STRUCTURE

The proposed design consisted of a five bay drum screen structure located in the diversion pool at the headworks of the Roza Canal (figure 1). Roza Canal is an irrigation and power canal which receives water diverted from the Yakima River. The maximum canal discharge is 2,200 ft³/s. The structure draws water directly from the diversion pool, which has a limited volume (figure 1) and cannot be considered an infinite reservoir. Depending on operating conditions, pronounced velocities will occur at some locations in the diversion pool. For example, if a larger spill is occurring at the dam and maximum discharges are being diverted, substantial flow bypassing the entrance to the screen structure will result (figure 2). In cases where no or limited spill is occurring, but diversion is high, pronounced passing flow (flow passing the bay entrance) with velocities of 1 to 2 ft/s will occur in front of the first of the five bays (the seven-drum bay). The magnitude of these passing flows would decrease from bay to bay down the structure until, for the last bay, withdrawal would be from a fairly quiet low velocity zone (figure 2). Finally, if no spills are occurring and if limited diversions are being made, velocities in the diversion pool could be quite low and the pool might be considered as a large reservoir.

Initially, the seven-drum first bay of the structure (figure 1) was studied. All tests were run with the screens oriented at an angle of $21^{\circ} 20'$ to the walls of the structure. Likewise, all tests were run with the water surface at elevation 1220.60. The initially proposed design was first operated over the full range of potential operating conditions and resulting flow patterns were visually observed. The seven-drum bay was operated at $560 \text{ ft}^3/\text{s}$ (the maximum discharge) both with passing and straight-in approach flow and both with and without trashracks. In general, for all cases the flow was well directed down the bay. Localized exceptions were noted, in particular across the first half of drum 7 (figure 6) where the offset of the drum screens from the intake caused an eddy zone, along the outside wall of the bay where a low velocity zone occurred, and near the fish bypass intake. To improve the flow across drum 7, the offset was eliminated as much as possible by cutting back the wall to the position shown in figure 7. This resulted in a substantial reduction of the eddy size. It also resulted in an unsymmetrical inlet from the diversion pool, with the portion of the intake to the left (looking in the direction of flow) of the center pier wall being 3 ft wider than the portion to the right.

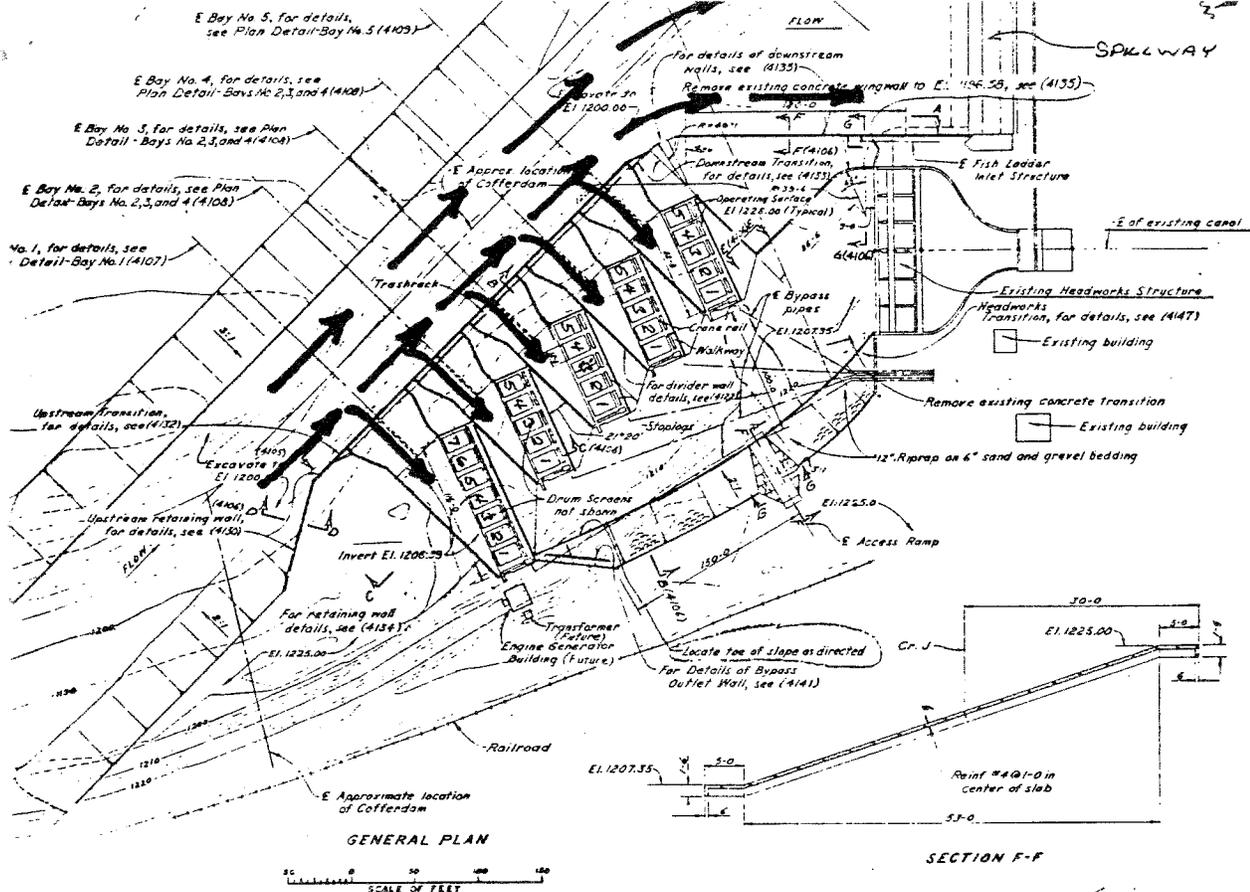
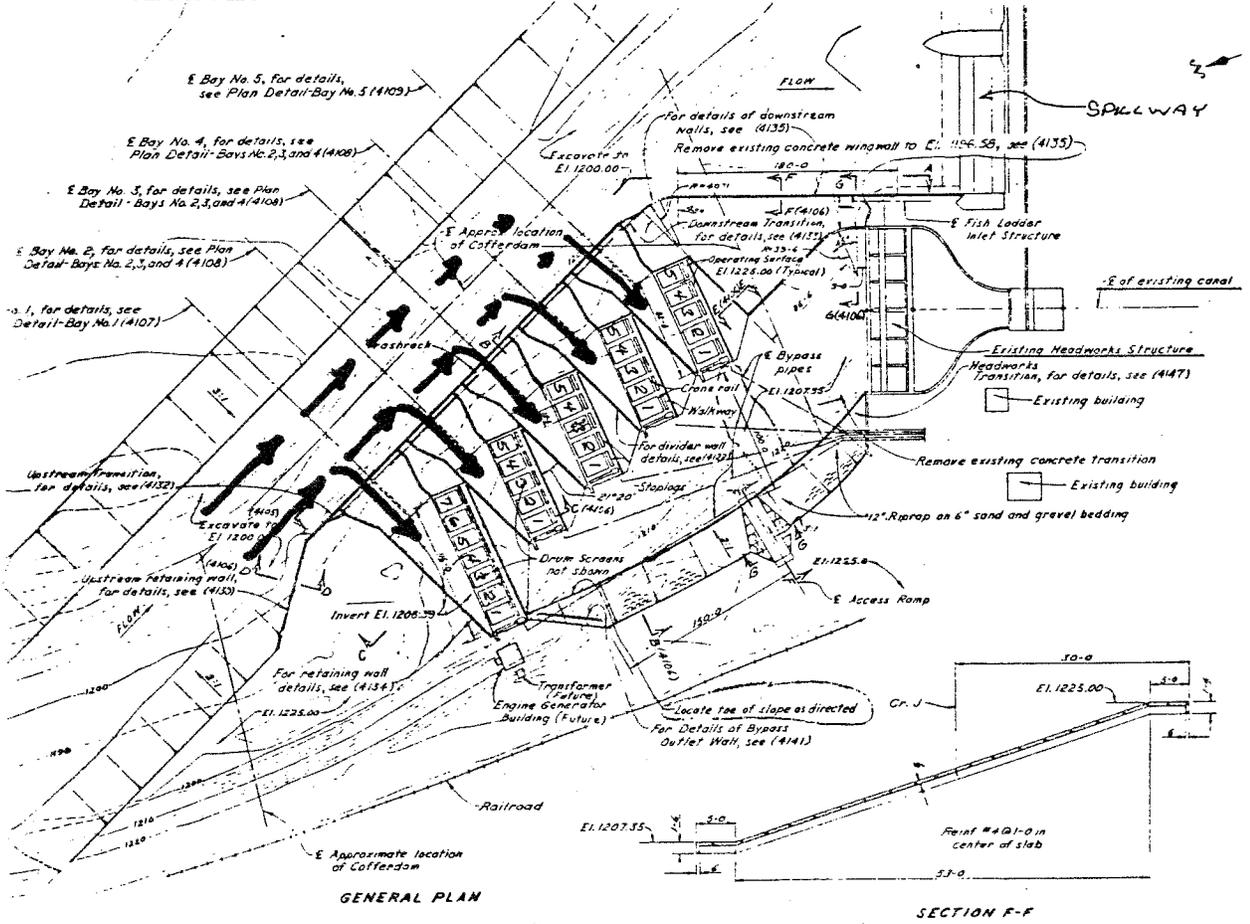
FIGURE 2

APPROXIMATE FLOW PATTERN WITH LARGE SPILLWAY RELEASE

APPROXIMATE FLOW PATTERN WITH NO SPILLWAY RELEASE

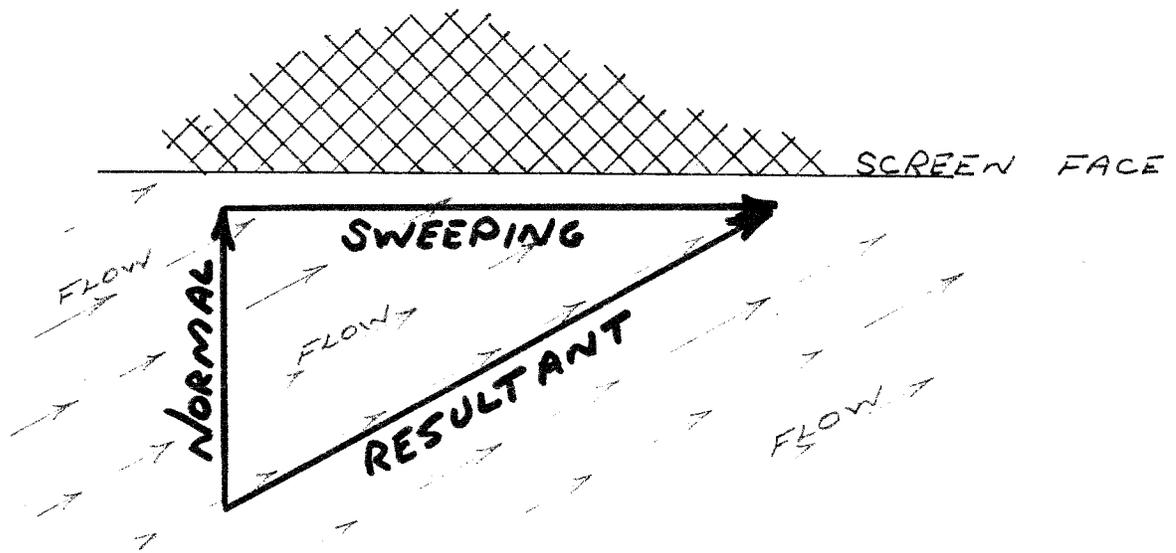
FIGURE 3

DEFINITION OF VELOCITY COMPONENTS

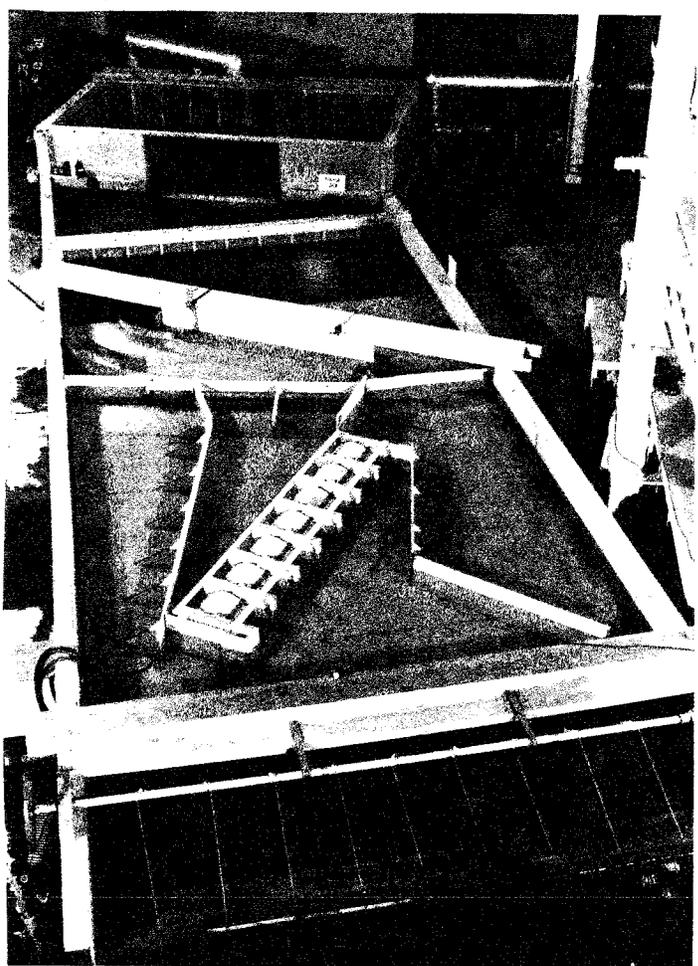
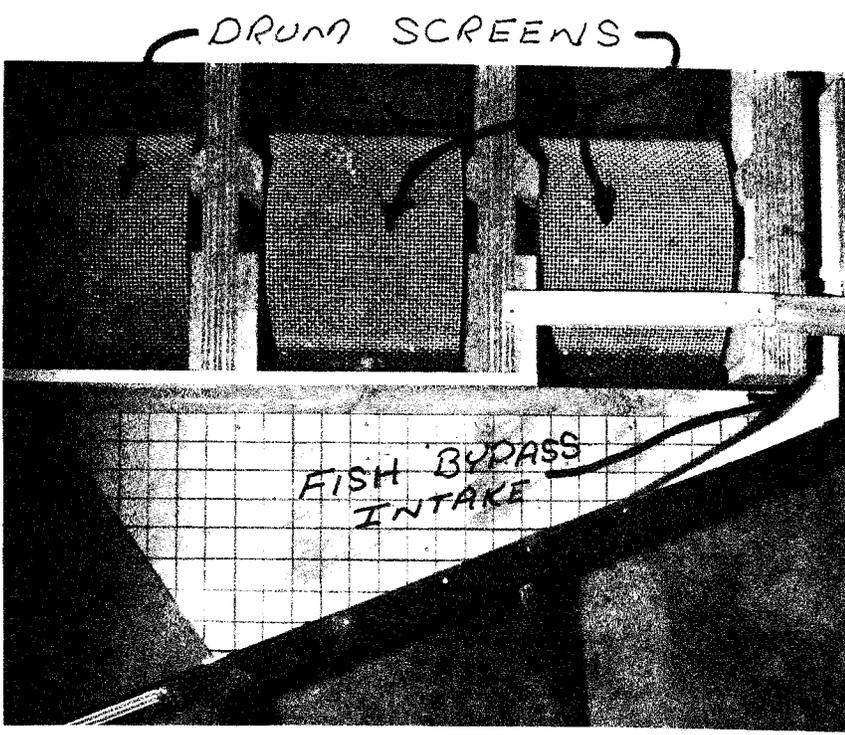
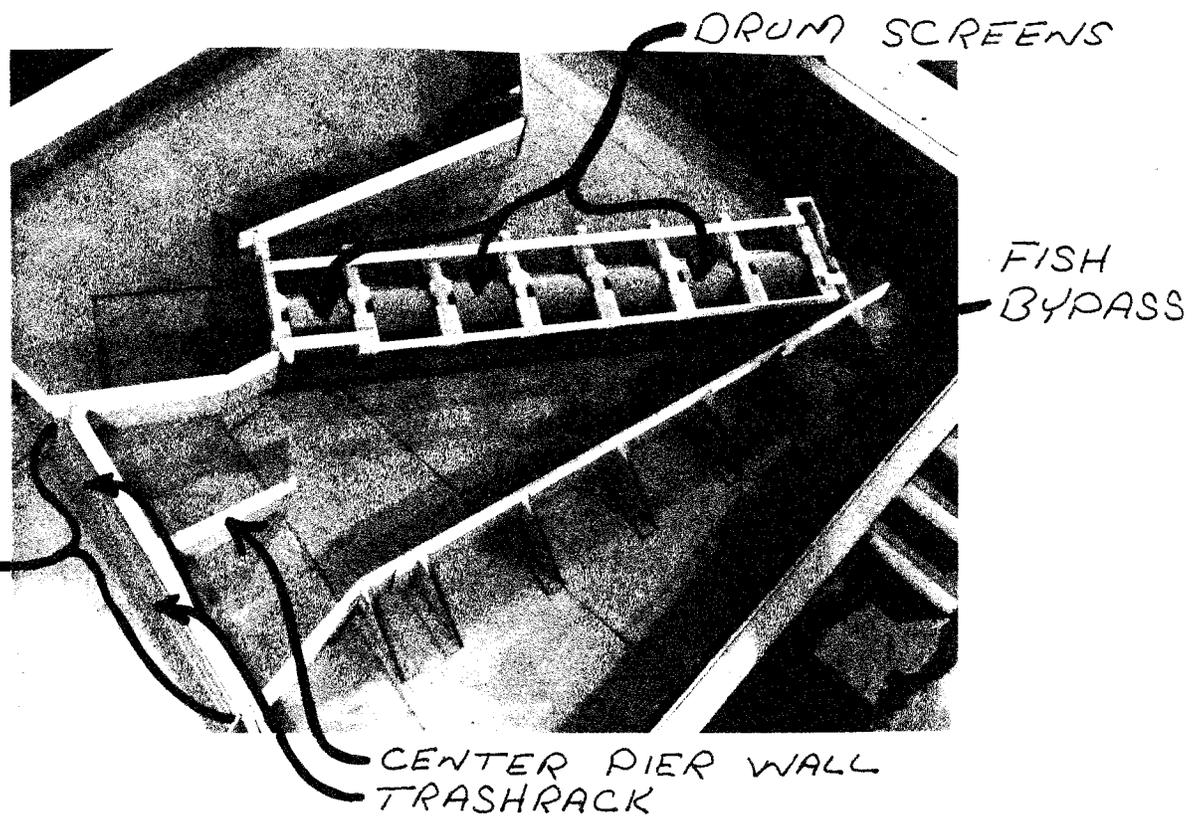
FIGURE 4

1:12 HYDRAULIC MODEL

The Roza fish screen model was a 1 to 12 scale representation of one bay of the five bay structure. The model could be adjusted to include five or seven drum screens, and thus any one of the five bays could be studied. The model also included the trashrack, entrance transition, center pier wall, and fish bypass intake (figure 4).

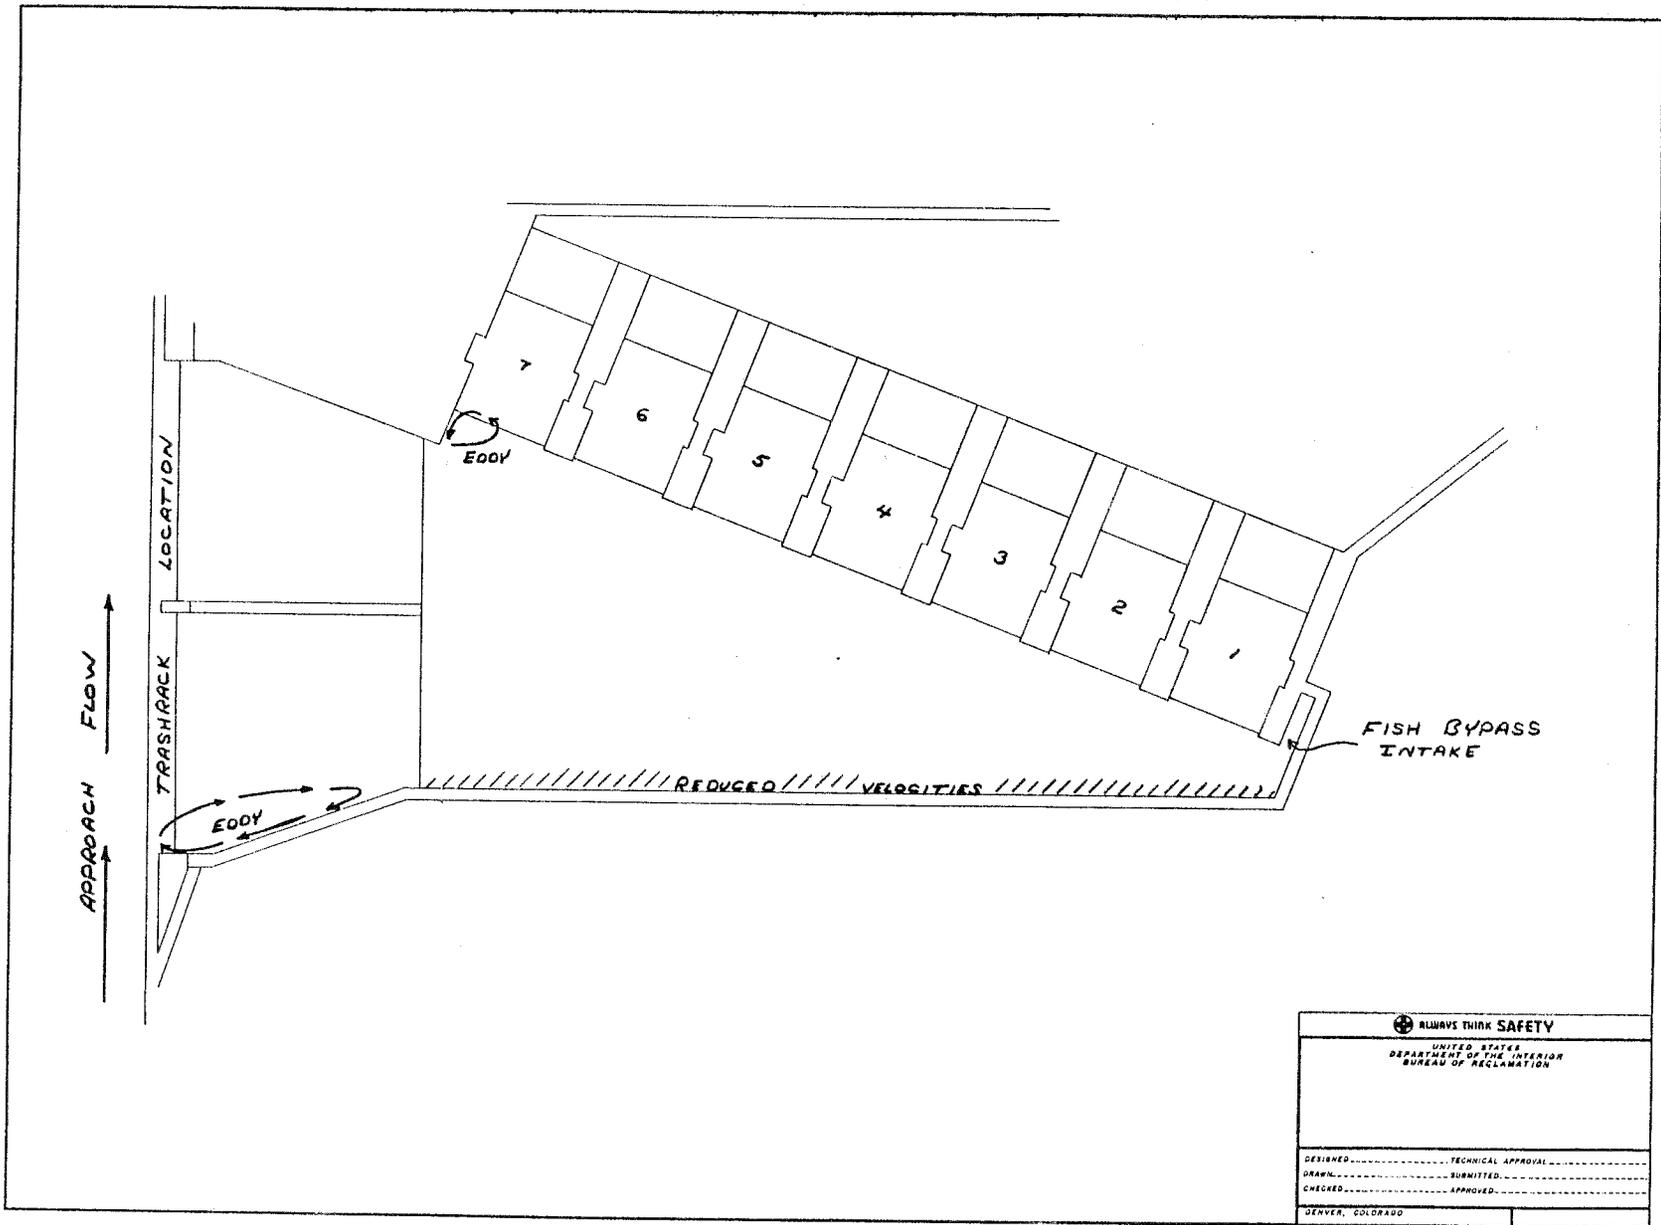
FIGURE 6

INITIALLY OBSERVED FLOW PATTERNS

It was observed that with passing approach flow, velocities along the bay wall opposite the drums, or the outside wall of the bay, were reduced. This resulted from the corner separation (eddy) that occurred at the entrance (figure 6). This was corrected by reducing the width of the intake bay by 3 ft which again made the intake symmetrical and reduced the size of the low velocity zone (figure 7).

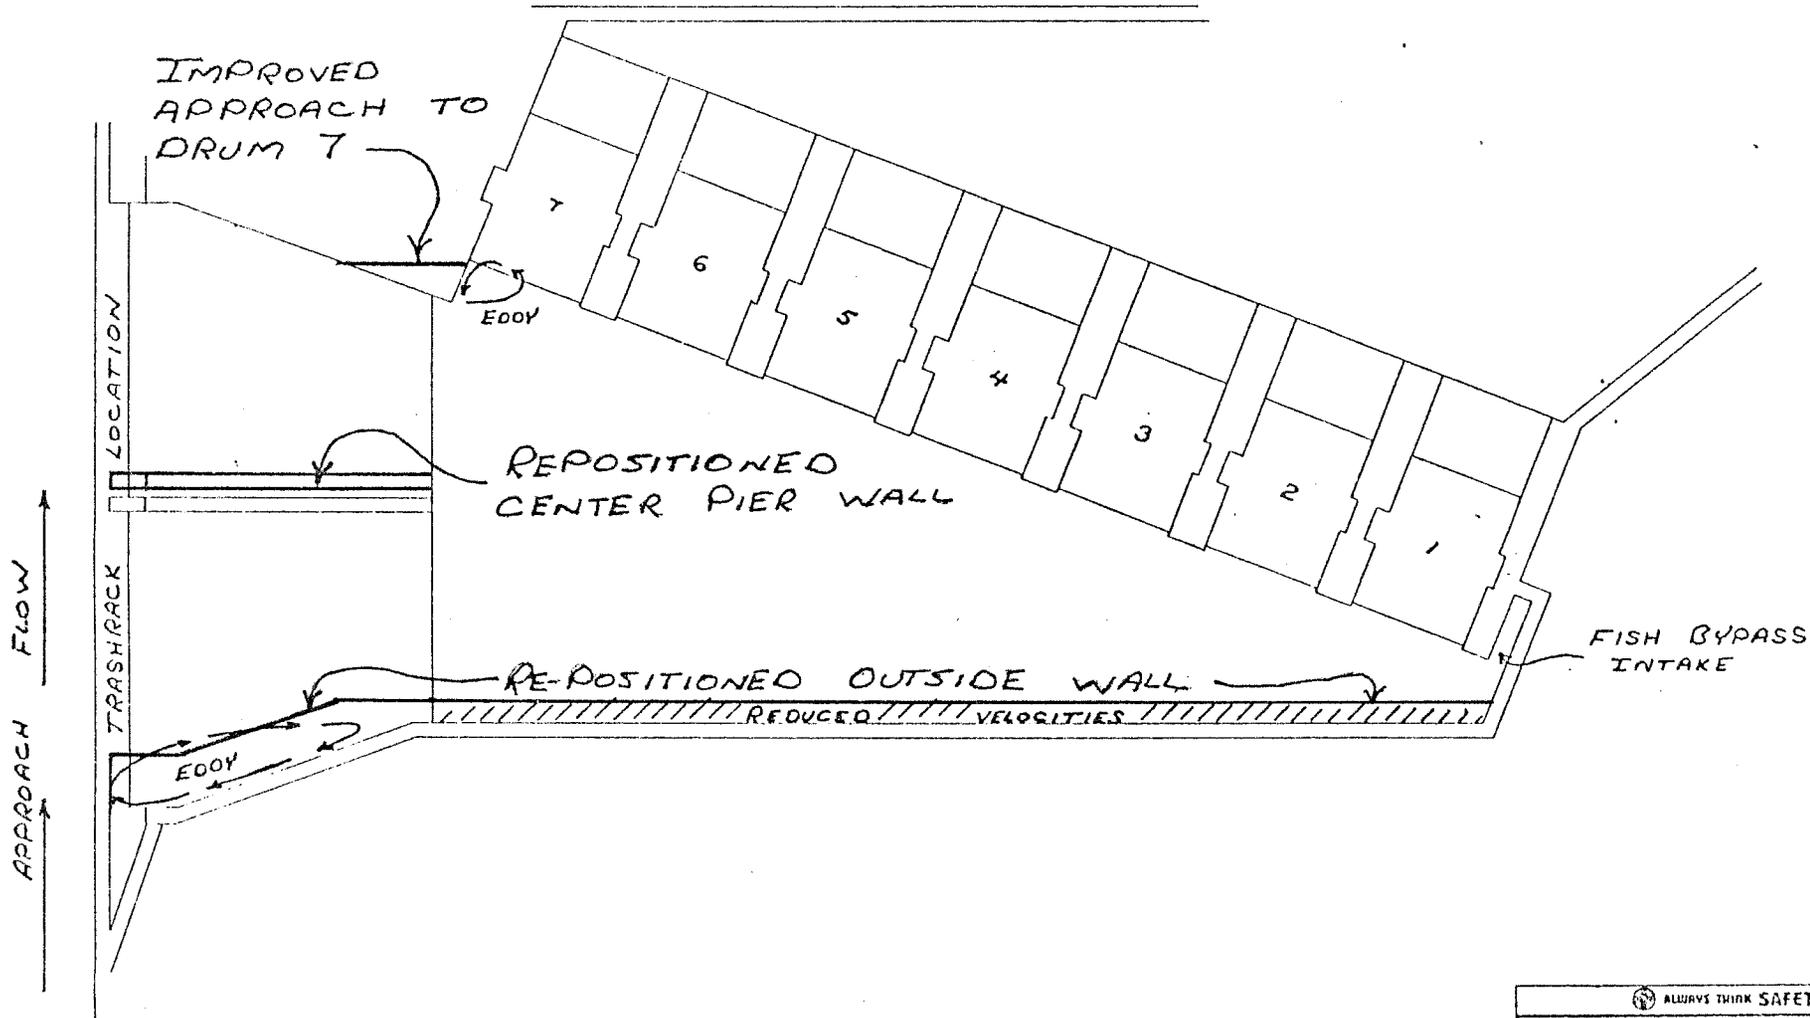
FIGURE 7

MODIFIED BAY GEOMETRY

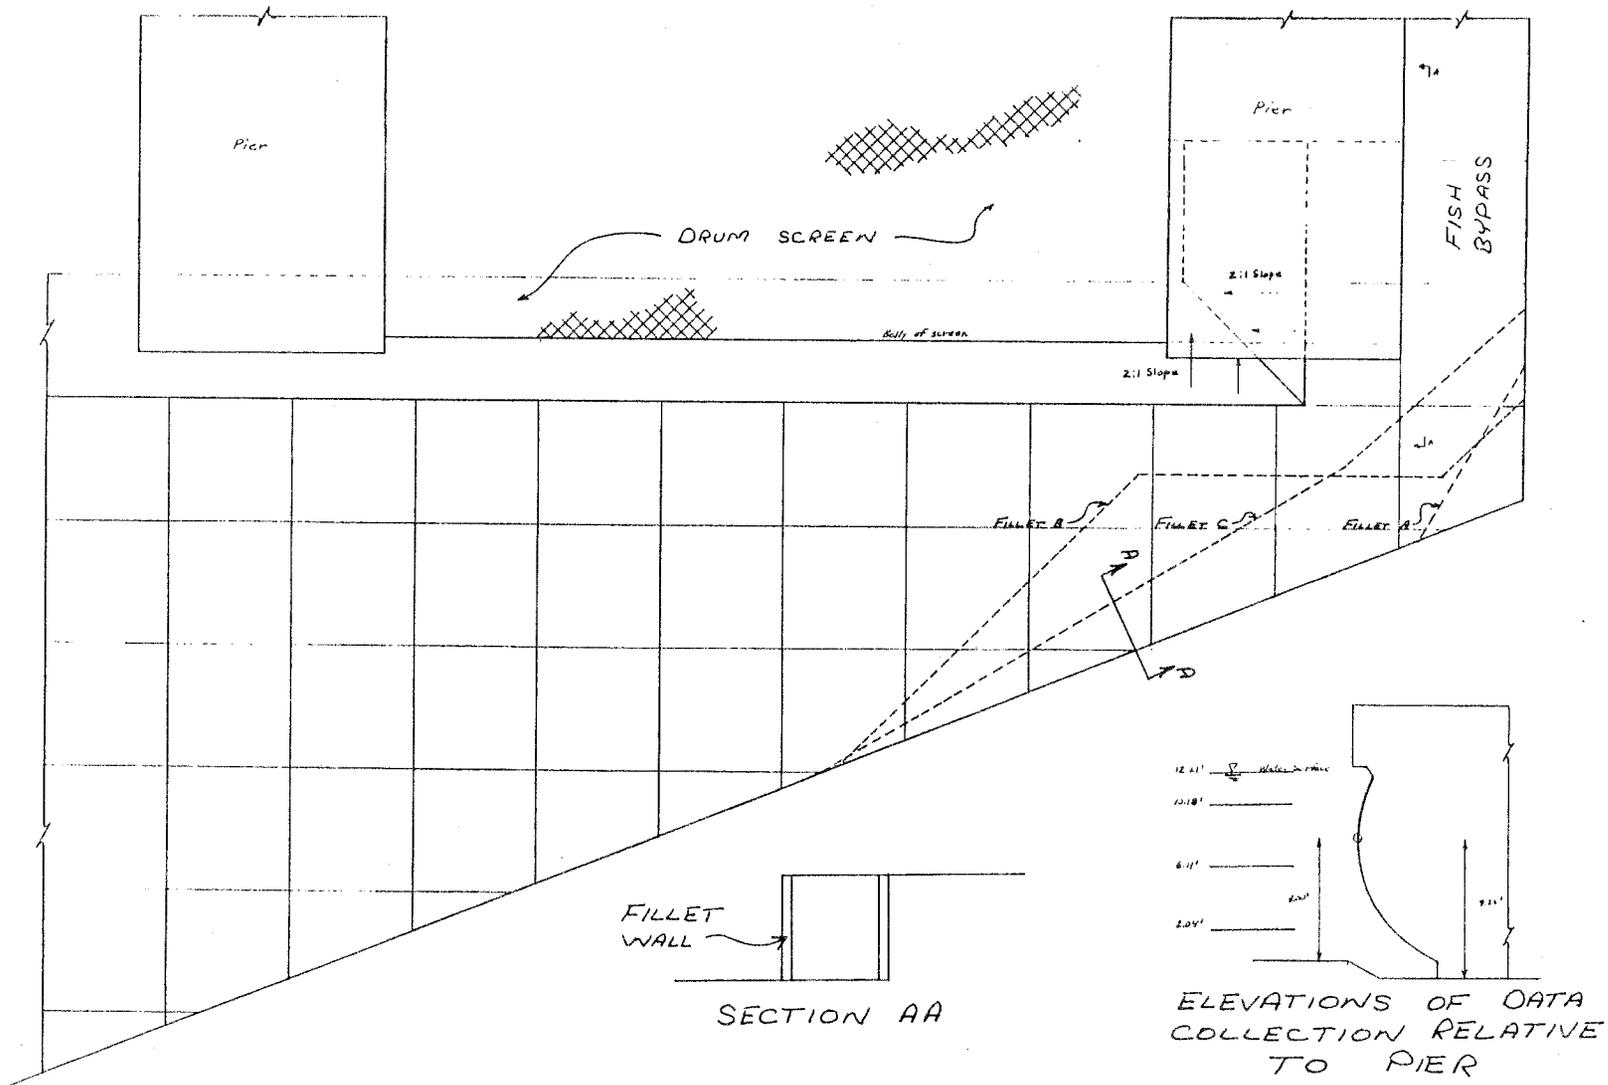
FIGURE 9

ALTERNATIVE BYPASS INTAKE FILLETS

Finally, using the seven-drum bay and with confirmation from the five-drum bay the design of the fish bypass intake was investigated. With the initial design a low velocity zone occurred near the outer wall of the bay opposite the fish bypass intake (figure 8). Three different vertical wall fillet configurations were tested to eliminate this zone and thus to accelerate the flow approaching the bypass intake. The longer concave fillet (figure 9,

fillet C) was found to be the most effective in creating gradual uniform acceleration of the flow with no flow separation or eddy zones. It should be noted that care had to be taken to keep the bypass intake at least 2 ft wide. To install the fillet, required beveling the corner of the pier between drum 1 and the bypass intake (figure 10). Figure 10 also shows a typical observed flow field for this design. These data were taken on the seven-drum bay, with the design diversion discharge, passing approach flow, and no stoplogging. Velocities shown are averages of velocities taken at 17, 50, and 83 percent of total water depth. Note that in general a fairly uniform accelerating flow field has been created (figure 10). Note also that within the bypass intake itself a separation or eddy zone occurs just downstream of the beveled corner. Consideration was given to ways to eliminate this zone. However, it was concluded that due to space limitations a transition of adequate length to eliminate the separation could not be installed.

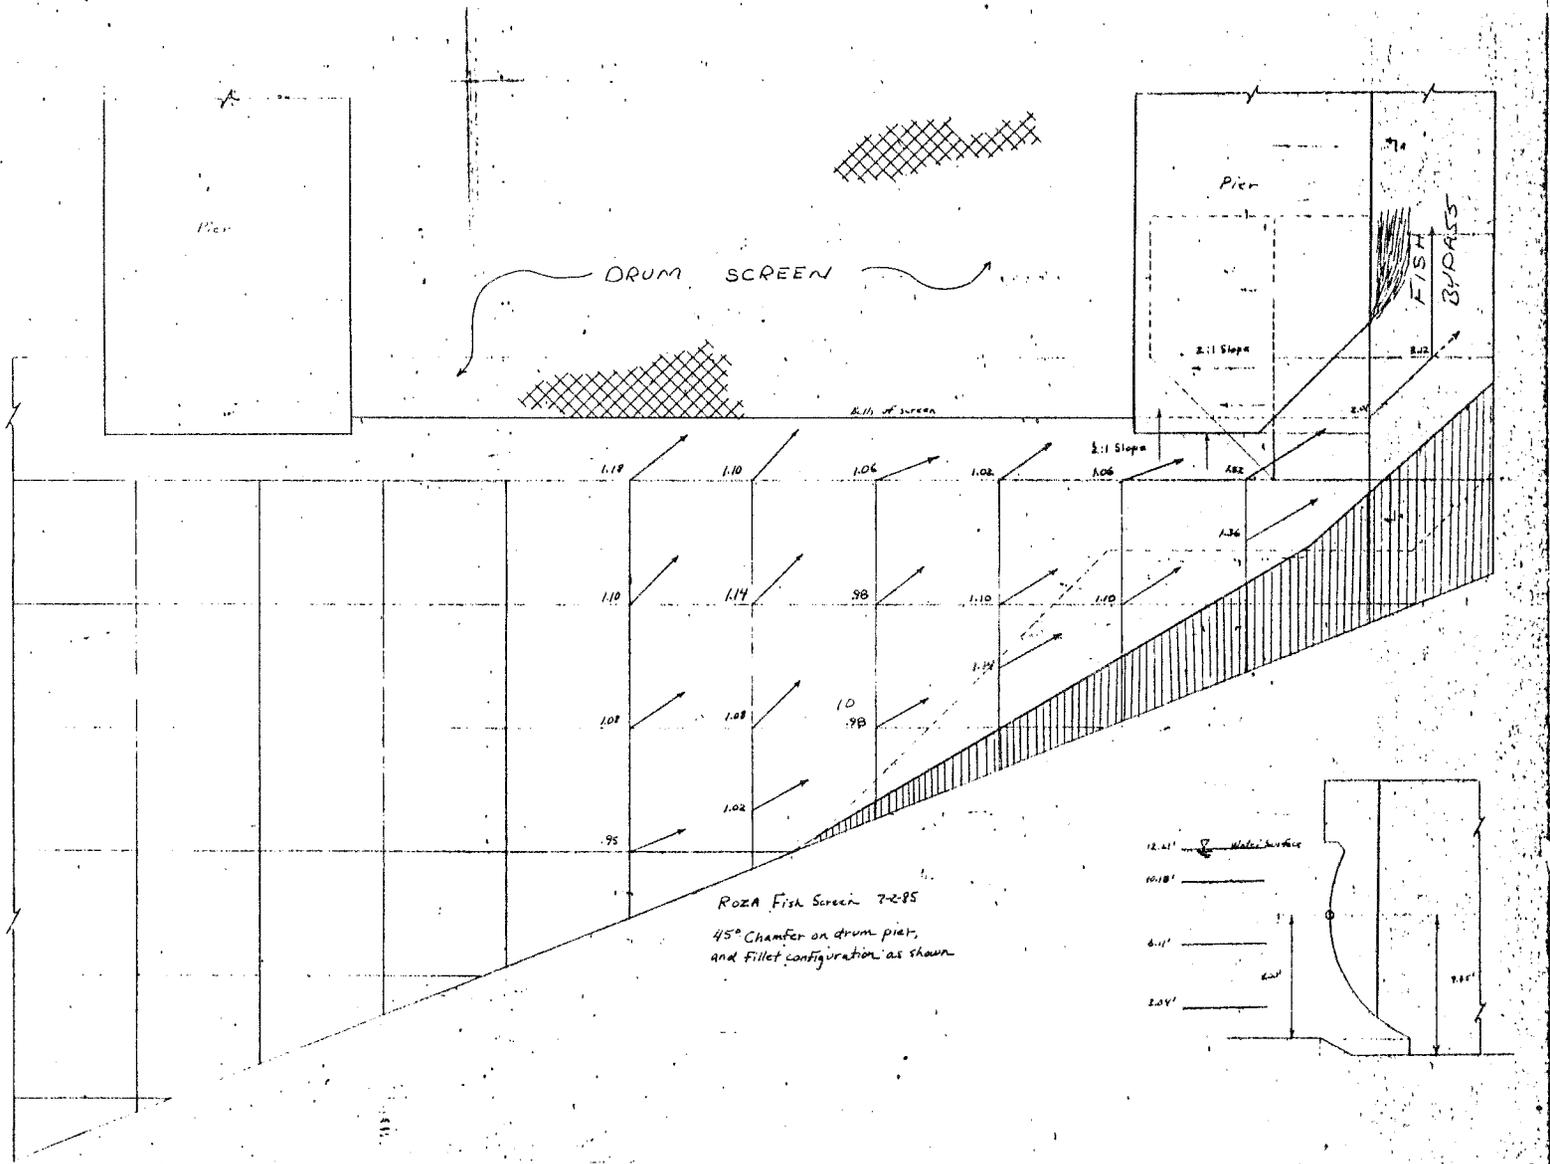
FIGURE 10

RECOMMENDED BYPASS INTAKE FILLET
WITH OBSERVED APPROACH FLOW

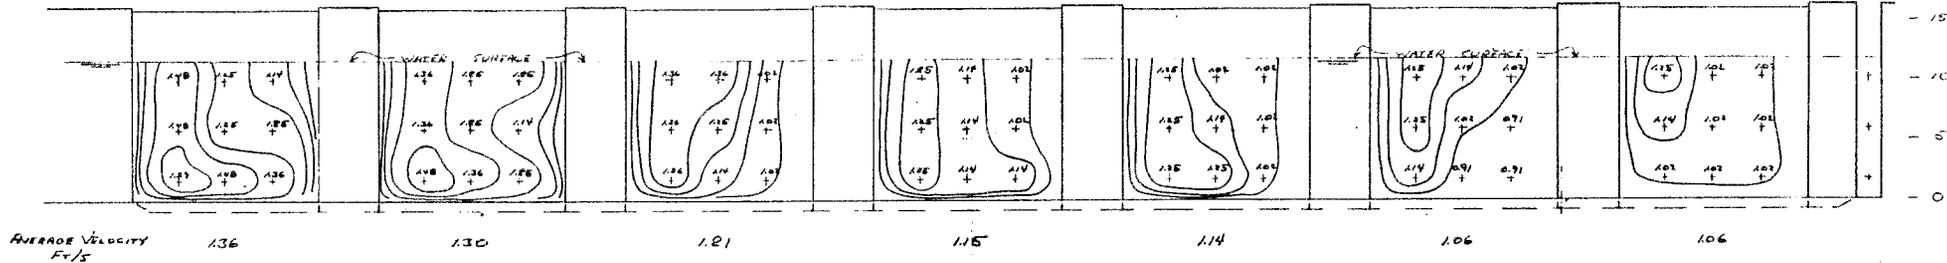
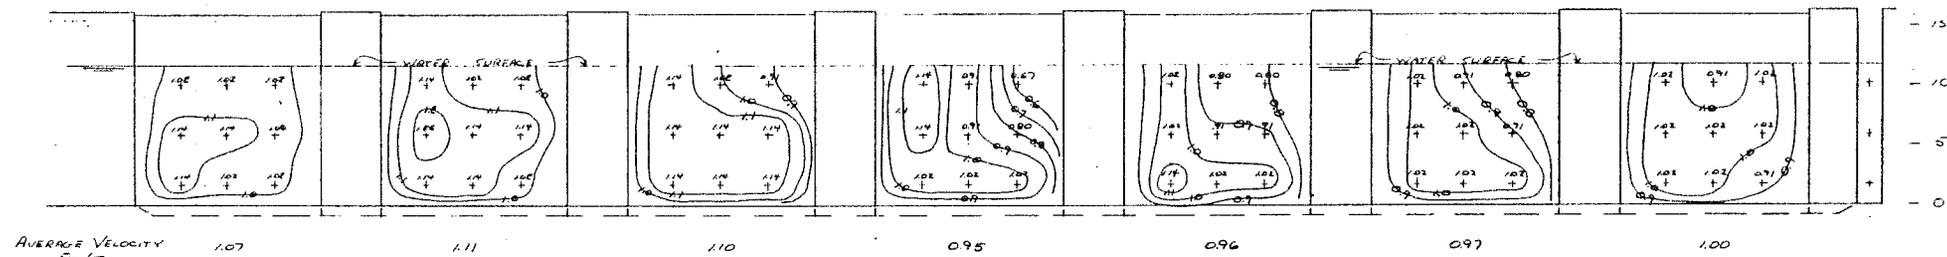
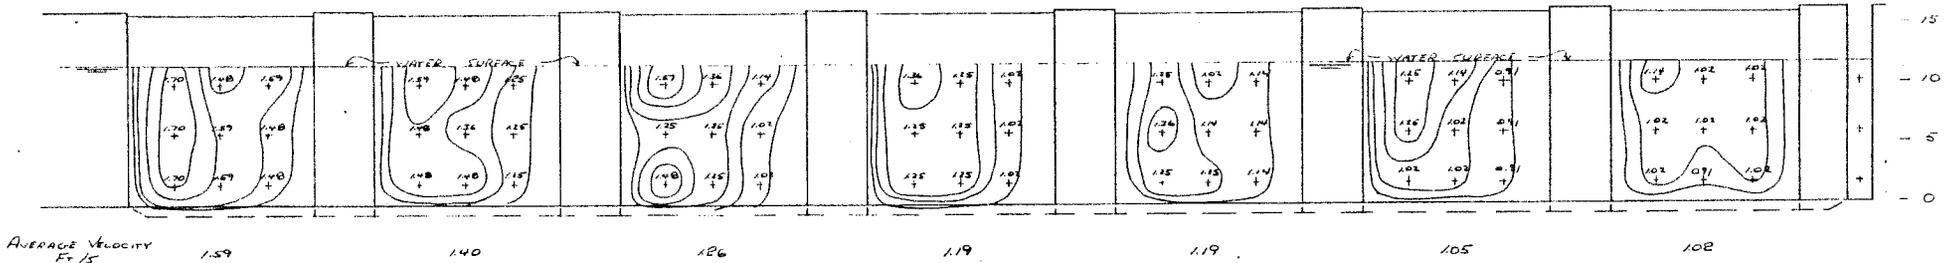
FIGURE 11

DISCHARGE = 560 FT³/S
 PASSING APPROACH FLOW
 WITH TRASHRACKS
 NO STOPLOGS

DISCHARGE = 560 FT³/S
 STRAIGHT IN APPROACH FLOW
 WITH TRASHRACKS
 NO STOPLOGS

DISCHARGE = 560 FT³/S
 PASSING APPROACH FLOW
 NO TRASHRACKS
 NO STOPLOGS

OBSERVED RESULTANT VELOCITY DISTRIBUTION
 SEVEN DRUM BAY - NO STOPLOGS

With the previously mentioned modifications in place, efforts were directed at obtaining detailed evaluations and refinements of flow patterns at the drum screens. Velocity data were taken in a vertical plane 1 ft in front of the drums at approximately 20, 60, and 80 percent of the total water depth. All initial tests were conducted with no stoplogging behind the drums. Observed drum screen flow conditions for the various approach flow conditions tested are shown in figure 11. Note that with passing approach flow and with trashracks in place, average resultant (figure 3) velocities at the drums varied from 1.36 ft/s at drum 7 to 1.06 ft/s at drum 1 (figure 11a). Likewise there tended to be a horizontal velocity gradient across each drum. Vertically, velocities were quite uniform. Corresponding normal velocity components range from 0.39 ft/s at drum 7 to 0.19 ft/s at drum 4 to 0.36 ft/s at drum 1 (table 1). Velocity component ratios ranged from 3.38 at drum 7 to 5.84 at drum 4 to 2.44 at drum 1 (table 1). This component ratio data shows that the angle of flow attack flattens over the middle drums and is sharper at both ends of the structure. Again with passing approach flow, but with the trashracks removed, average resultant velocities at the drum screens varied from 1.59 ft/s at drum 7 to 1.02 ft/s at drum 1 (figure 11c). As with the trashracks in place there were horizontal gradients across each drum with vertical velocity variations tending to be small. As can be seen by comparison of figures 11a and 11c, the model trashracks do have a significant influence on the flow. The trashracks tend to intercept and turn the flow into the bay, reducing separation and flow concentration zones. Performance of the prototype with trashracks should be someplace between these two observed model conditions. It is speculated that the prototype trashracks will have significant influence on flow direction and distribution and that resulting performance will be more like the model with trashracks than the model without.

The seven-drum bay was also observed with straight-in approach flow. This was done with the trashracks in place. However, with straight-in approach flow trashrack influence is negligible. The observed flow distribution is shown in figure 11b. Note that for the maximum discharge average resultant velocities range from 1.07 ft/s at drum 7 to 0.95 ft/s at drum 4 to 1.00 ft/s at drum 1. Thus, with straight-in approach flow, velocities at the drum screens are quite uniform in both the horizontal and vertical. Figures 11a and 11b represent the most likely extremes of drum screen

flow distribution that result due to approach flow variations when no stoplogging or no effort to force a modified distribution is made. Thus, potential distributions range from a marginal condition for which the localized component criteria are satisfied but for which the overall flow pattern yields a deceleration of flow across the drum screens instead of the desired steady or gradually accelerating flow to an acceptable flow pattern which both satisfies local flow criteria as well as desired general flow patterns.

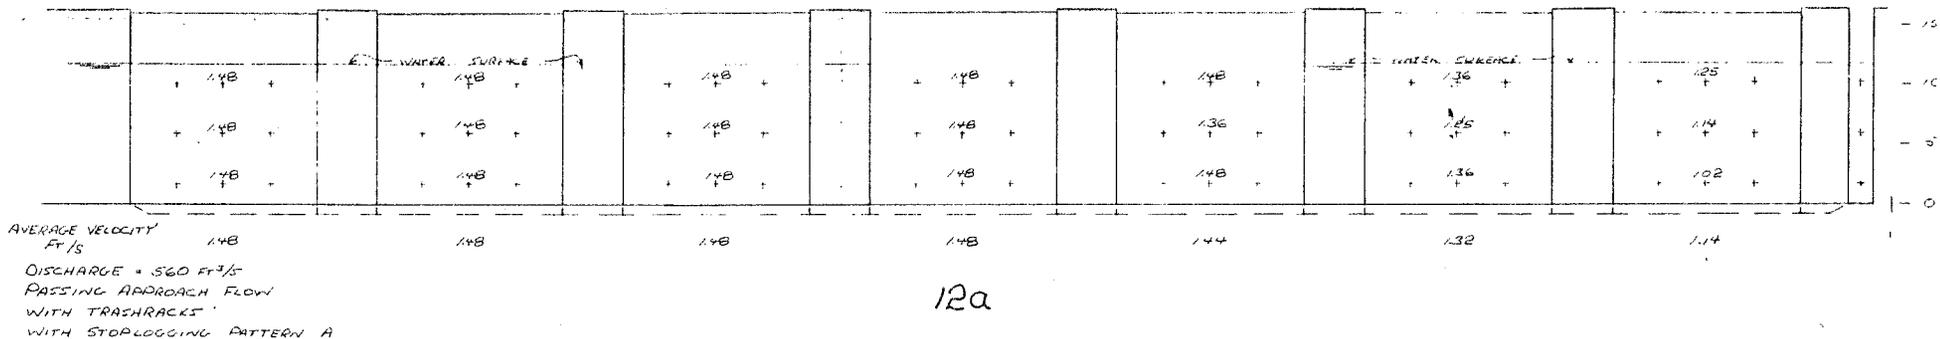
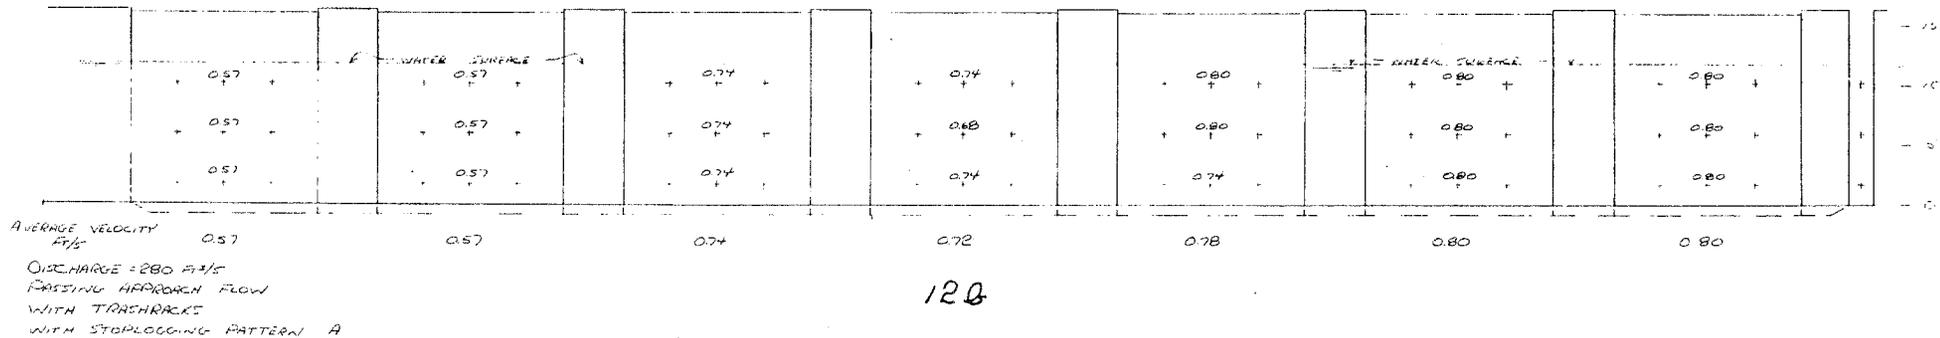
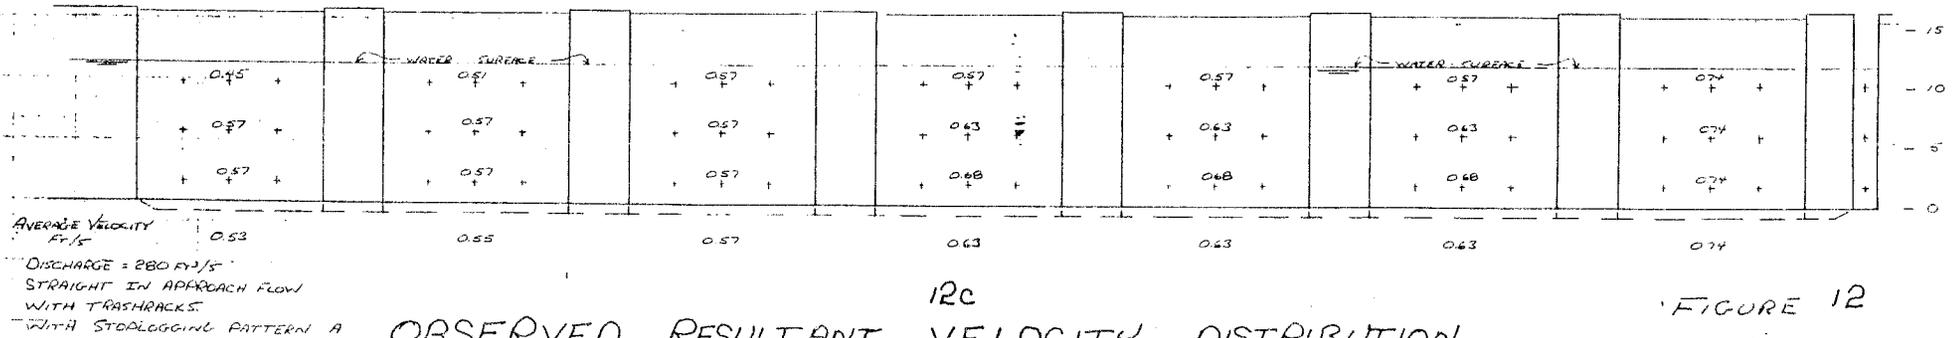
FIGURE 12

OBSERVED RESULTANT VELOCITY DISTRIBUTION
SEVEN DRUM BAY - WITH STOPLOGS

Numerous efforts were made through use of stoplogs placed behind the drums to force improved flow distribution. Numerous stoplogging patterns were tested. All velocity data, with stoplogging, presented in this report are with what was found to be the optimum pattern (pattern A). This arrangement had 80 percent stoplog blockage behind drums 5, 6, and 7; 50 percent stoplog blockage behind drums 3 and 4; and 20 percent stoplog blockage behind drums 1 and 2. The resulting velocity distribution for the maximum discharge with a passing approach flow is shown on figure 12a. Note that average velocities ranged from 1.48 ft/s at drum 7 to 1.14 ft/s at drum 1 and that velocities were extremely constant across drums 7 to 3.

The seven-drum bay was also studied operating with a diversion discharge of 280 ft³/s, 50 ft³/s of which was discharged through the fish bypass. The drum screen velocity distribution with stoplogging and with passing approach flow is shown on figure 12b. The drum screen velocity distribution with stoplogging and with straight-in approach flow is shown on figure 12c. Corresponding normal velocity components and sweeping to normal component ratios are shown in table 1. Note that for both cases the magnitude of the resultant, normal, and sweeping velocities increased as the flow passes from drum 7 to drum 1 and then into the bypass. Velocities are all reduced from the levels observed with the 560 ft³/s discharge. Normal velocity components ranged from 0.09 ft/s to 0.26 ft/s with stoplogging and passing approach flow, and from 0.10 ft/s to 0.27 ft/s with stoplogging and straight-in approach flow. These conditions are all acceptable with respect to the hydraulic criteria and actually represent very desirable flow patterns for guiding fish into the bypass intakes.

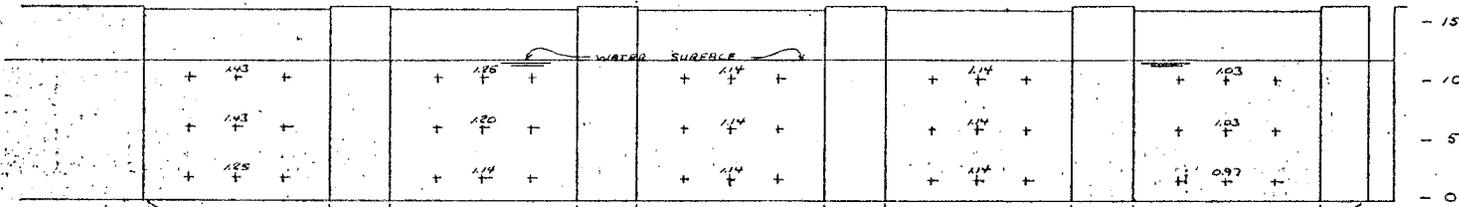
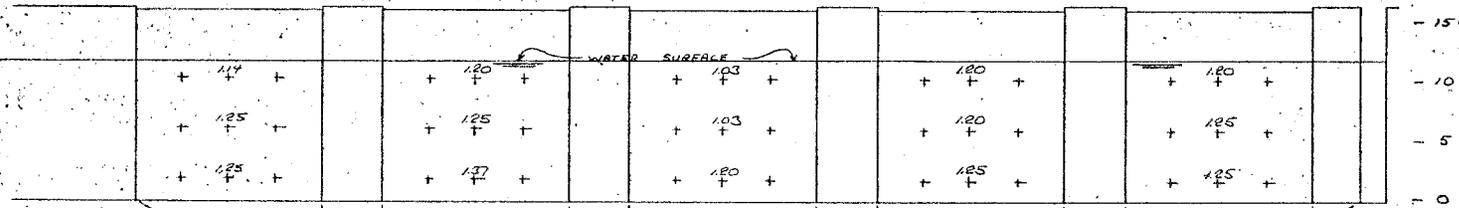
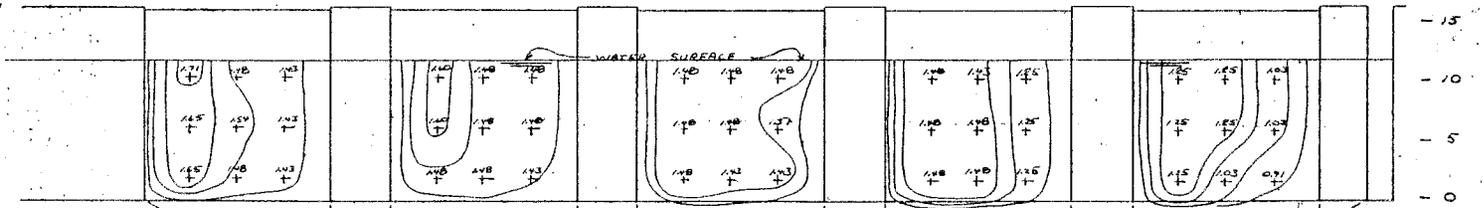
FIGURE 13

DISCHARGE = 415 FT³/S
PASSING APPROACH FLOW
WITH TRASHRACKS
AND STOPLOGGING

DISCHARGE = 415 FT³/S
STRAIGHT IN APPROACH FLOW
WITH TRASHRACKS
AND STOPLOGGING

DISCHARGE = 415 FT³/S
PASSING APPROACH FLOW
WITH TRASHRACKS
WITH STOPLOGGING PATTERN A

OBSERVED RESULTANT VELOCITY DISTRIBUTION - FIVE DRUM BAY

With completion of testing of the seven-drum bay, a five-drum bay was installed in the model. The five-drum bay was tested for similar approach flow, discharge, and stoplogging conditions as the seven-drum bay. With no stoplogging and at the maximum discharge (415 ft³/s including 50 ft³/s bypass discharge) flow patterns were evaluated both with passing and straight-in flow. With passing flow and no stoplogging, resultant velocities ranged from 1.36 ft/s at drum 5 to 1.01 ft/s at drum 1 (figure 13a). Corresponding normal velocity components range from 0.45 ft/s at drum 5 to 0.21 ft/s at drum 4 to 0.39 ft/s at drum 1 (table 1). Likewise, the component ratios ranged from 2.84 at drum 5 to 5.57 at drum 4 to 2.36 at drum 1 (table 1). The flow decelerates as it approaches the bypass, which is not an ideal flow condition. However, with respect to the normal component and component ratio criteria, the flow conditions are acceptable. With straight-in flow, resultant velocities range from 1.21 ft/s at drum 5 to 1.08 ft/s at drum 3 to 1.23 ft/s at drum 1 (figure 13b). Corresponding normal components ranged from 0.43 ft/s at drum 5 to 0.33 ft/s at drum 3 to 0.45 ft/s at drum 1 (table 1) and component ratios ranged from 2.63 at drum 5 to 4.77 at drum 4 to 2.53 at drum 1 (table 1). Thus with straight-in approach flow and no stoplogging at the maximum discharge, observed flow conditions were generally good.

Stoplogging was then used to try to improve flow distribution. The stoplogging pattern used reflects a modified version of the optimum stoplogging pattern developed for the seven-drum bay (pattern A). This consisted of 80 percent blockage behind drums 4 and 5, 50 percent blockage behind drum 3, and 20 percent blockage behind drums 1 and 2. With passing approach flow and the maximum discharge this stoplogging yielded resultant velocities ranging from 1.53 at drum 5 to 1.40 at drum 2 and 1.14 at drum 1 (figure 13c). Corresponding normal components ranged from 0.39 at drum 5 to 0.47 at drum 2 to 0.33 at drum 1 (table 1) and corresponding component ratios ranged from 3.79 at drum 5 to 4.59 at drum 4 to 3.30 at drum 1 (table 1). Thus flow conditions are generally good across the first four drums. However, the pronounced deceleration across drum 1 is not desirable. The stoplogging therefore improves the flow distribution but does not yield the best possible conditions. The stoplogging tended to increase the magnitude of the resultant velocity but not of the normal component. This is because, with stoplogging, the angle of attack of the flow to the screens is flattened.
