**HYDRAULIC MODEL STUDY
ROZA FISH SCREEN, WASHINGTON**

Subject: Model Study for Roza Canal Fish Screen Structure - Yakima
Project Washington

HYDRAULIC MODEL STUDY
ROZA FISH SCREEN, WASHINGTON

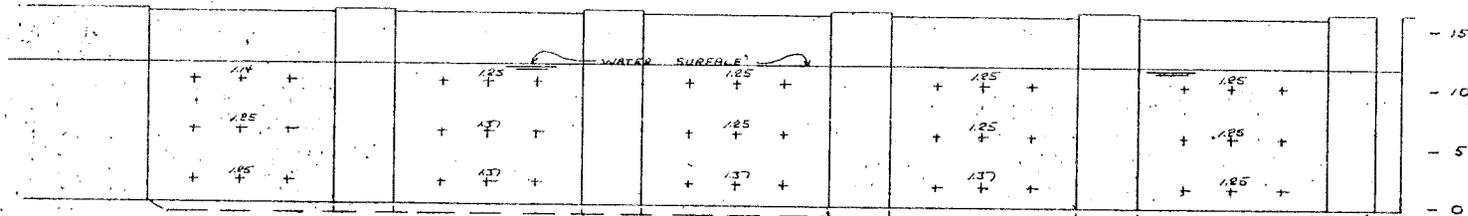
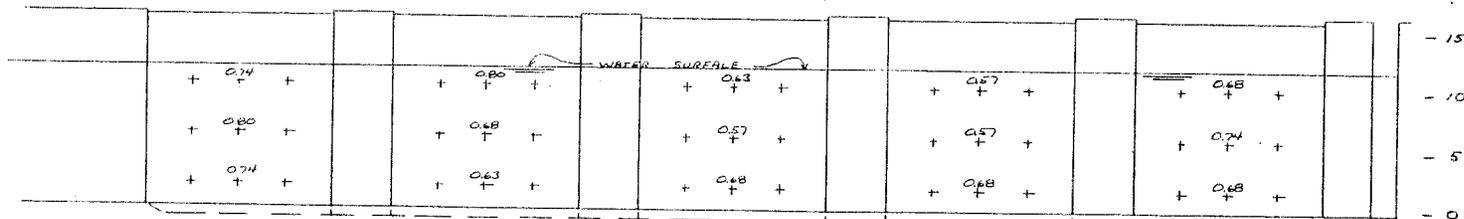
FIGURE 14

AVERAGE VELOCITY 1.21
 FT/S
 DISCHARGE 415 CFS
 STRAIGHT TAIL APPROACH FLOW
 WITH TRASHRACKS
 WITH STOPLOGGING PATTERN A

AVERAGE VELOCITY 0.74
 FT/S
 DISCHARGE 208 CFS
 PASSING APPROACH FLOW
 WITH TRASHRACKS
 NO STOPLOGGING

OBSERVED RESULTANT VELOCITY DISTRIBUTION - FIVE DRUM BAY

With straight-in approach flow resultant velocities were very uniform ranging between 1.21 ft/s and 1.33 ft/s (figure 14a). Normal components ranged from 0.45 ft/s at drum 5 to 0.27 ft/s at drum 4 to 0.47 ft/s at drum 1 (table 1) and component ratios ranged from 2.49 at drum 5 to 4.81 at drum 4 to 2.47 at drum 1 (table 1). Thus with stoplogging the observed flow patterns were very good; however, they were also quite good without stoplogging.

Finally, the five-drum bay was also studied operating at half discharge (208 ft³/s). This included a 50 ft³/s discharge through the fish bypass. As with the seven-drum bay, velocities at half discharge were substantially reduced (figure 14b). Normal velocity components were generally below 0.3 ft/s and all were within acceptable limits (table 1). Likewise observed
