FINAL REPORT OF THE HYDRAULIC MODEL STUDY
MCCLURE DAM EXISTING AND RCC EMERGENCY SPILLWAYS

**FINAL REPORT OF THE HYDRAULIC MODEL STUDY FOR THE MCCLURE DAM EXISTING
AND RCC EMERGENCY SPILLWAYS**

Kathleen L. Houston

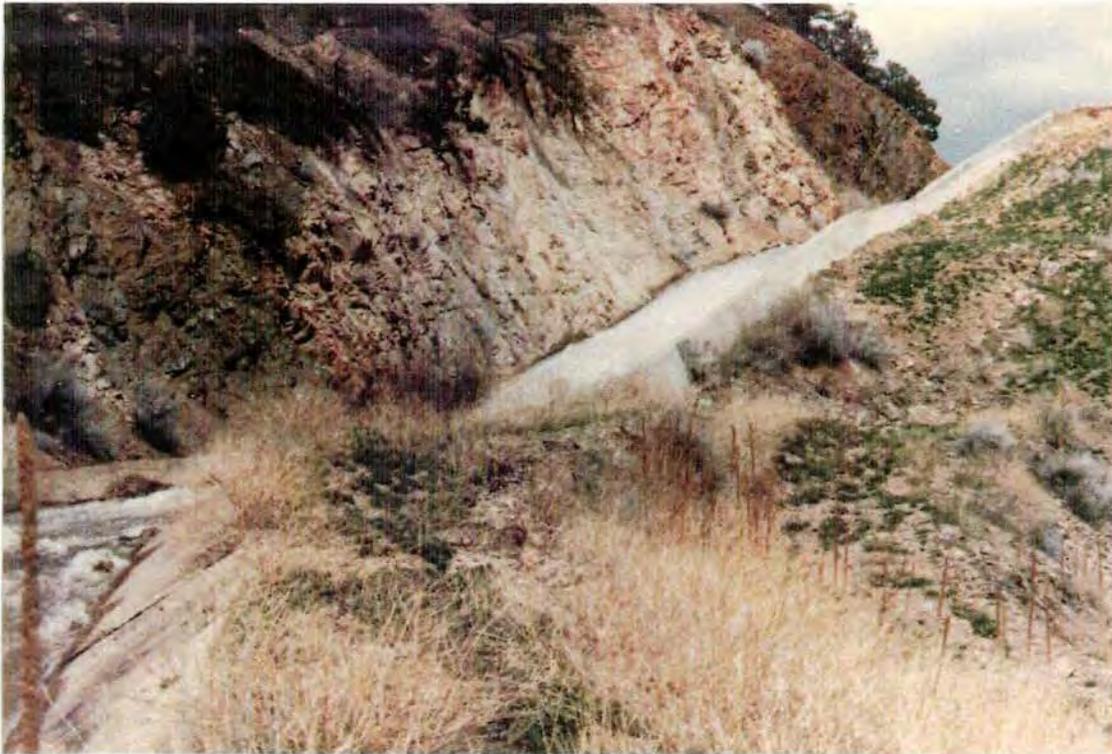
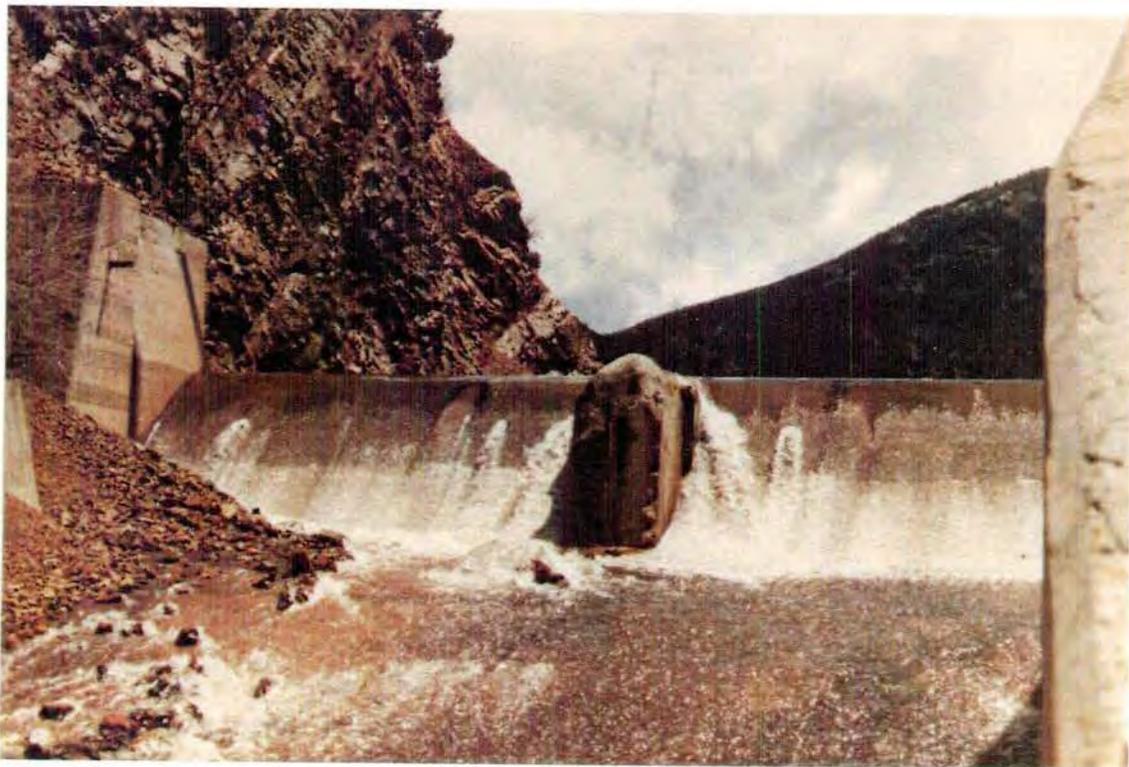
(Note: Center pier not included in model.)

Figure 3. - Existing service spillway at McClure Dam.

the remainder of the chute. The right side of the channel consists primarily of the excavated mountainside, the left side is a 5-foot-high wall (figure 3). The broad crest of the RCC spillway is 32.53 feet wide in the flow direction and 167 feet long. The stepped RCC spillway chute is located on the downstream face of the 2.18:1 sloping embankment dam. The chute and stilling basin walls, built on a 0.8:1 slope, will also be constructed of RCC. The RCC model spillway was constructed to allow modification of the step height, the convergence angle of the spillway chute walls, and the stilling basin width.
