WATER OPERATION AND MAINTENANCE

BULLETIN NO. 147

March 1989

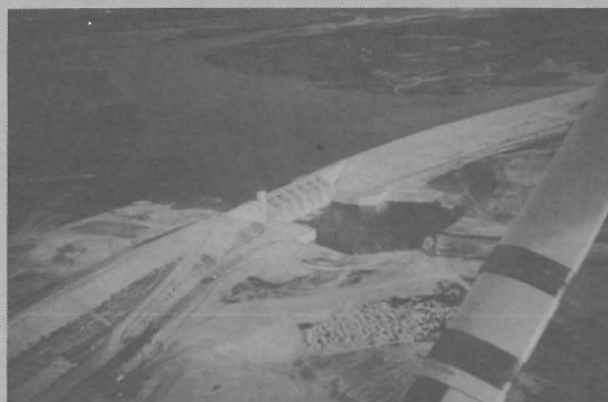
Cover photograph:

Aerial view of Brantley Dam and Reservoir showing maximum section of dam.

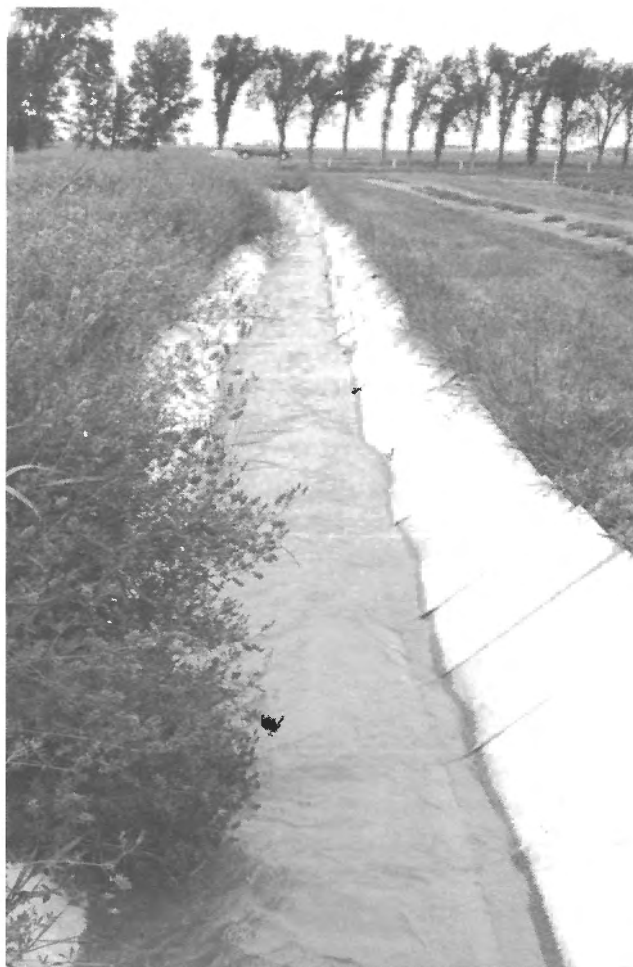
The sidewalk blocks, because they are not joined at the butt, have not suffered any cracking or misalignment from frost action.

With the concrete sidewalk block system, the channel is trimmed and graded to a smooth surface; a herbicide applied to prevent weed growth; the plastic sheeting laid down and keyed into the upper part of the sideslope; and finally, the 600- x 600- x 50-mm (24- x 24- x 2-inch) unreinforced concrete sidewalk blocks laid directly on top of the liner.

According to Dr. Sommerfeldt, the blocks have performed well since installation. The plastic appears to be in the same condition as when installed and this has been confirmed by recent laboratory tests done by the manufacturer, Canadian Industries Limited. A few weeds have grown between the joints. Their roots extend under the blocks between the plastic and the blocks themselves; however, no damage has occurred. The rigid blocks and flexible liner are not suffering any damage from frost heaving and normal problems associated with shifting soil.

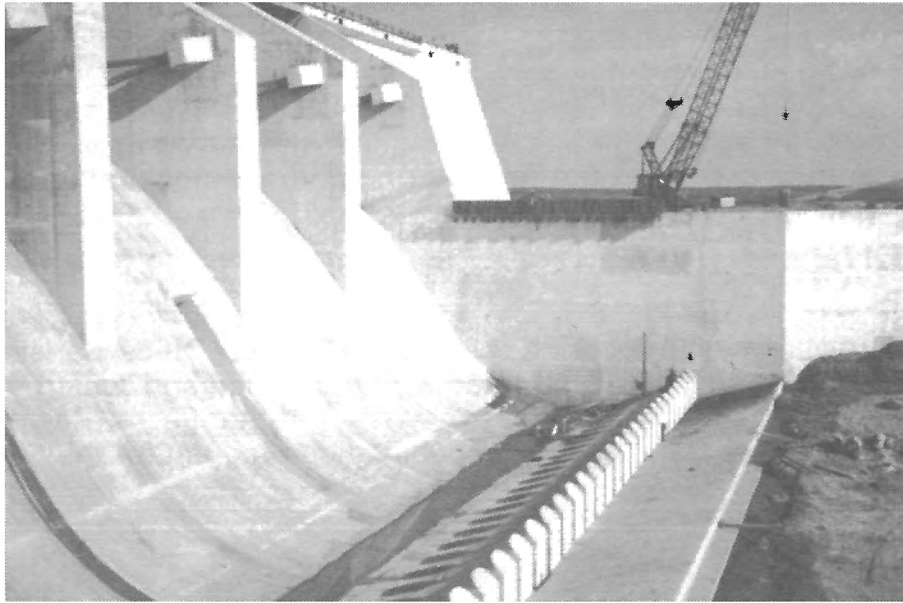
Figure 1. - Brantley Dam - Spillway chute and stilling basin.
10/4/87

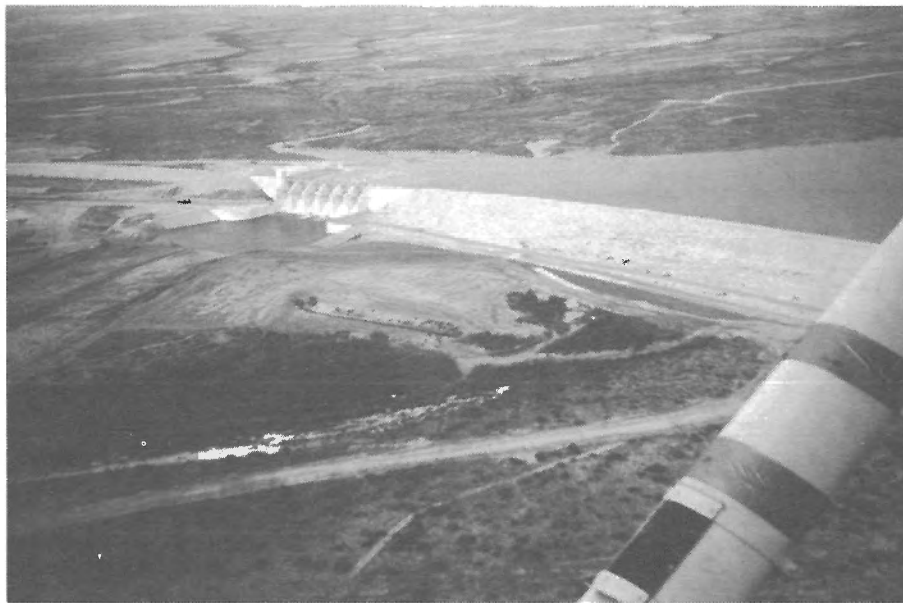
Figure 2. - Brantley Dam - Dam and Reservoir showing
old Pecos River channel in foreground.
9/22/88

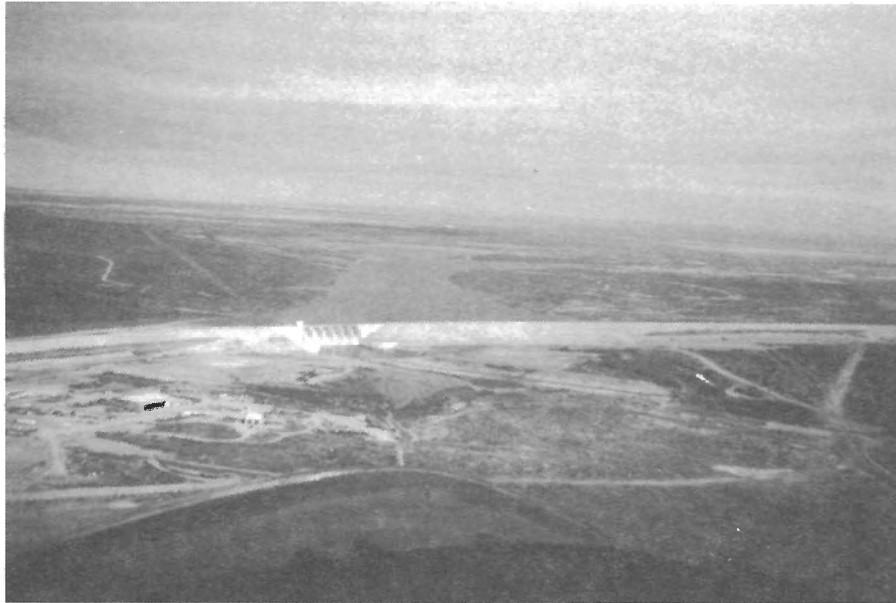
Figure 3. - Brantley Dam and Reservoir showing O&M complex in left foreground. 9/22/88

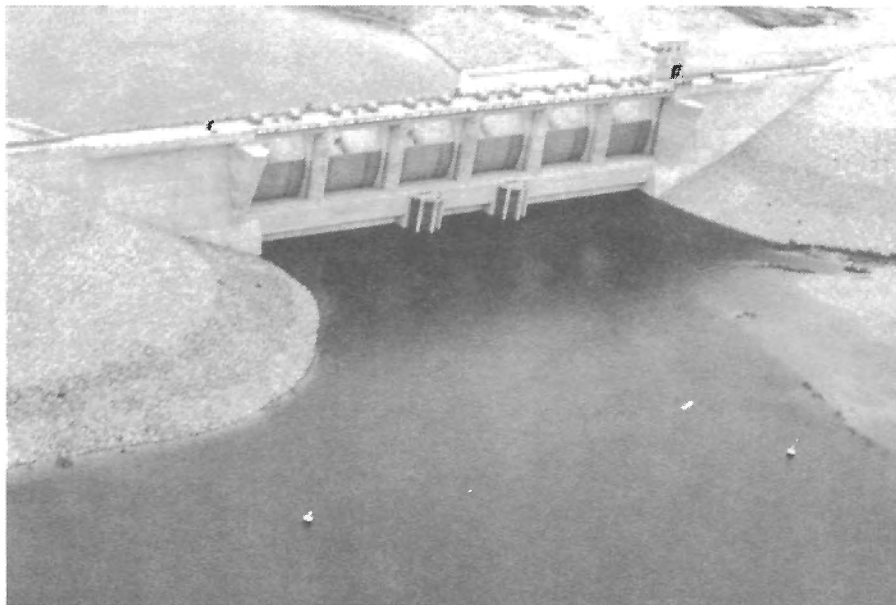
Figure 4. - Brantley Dam - Aerial view of the Reservoir and concrete structure. Note two safety buoys to which a safety float line will be connected between these buoys. 9/20/88

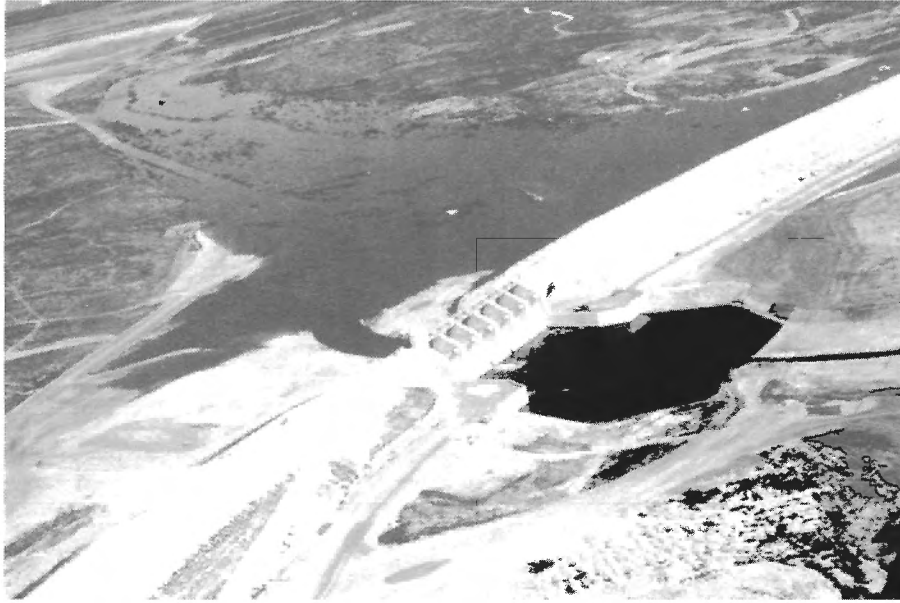
Figure 5. - Brantley Dam - Aerial view of concrete structure, stilling basin, left and right abutments, and Reservoir. 9/7/88

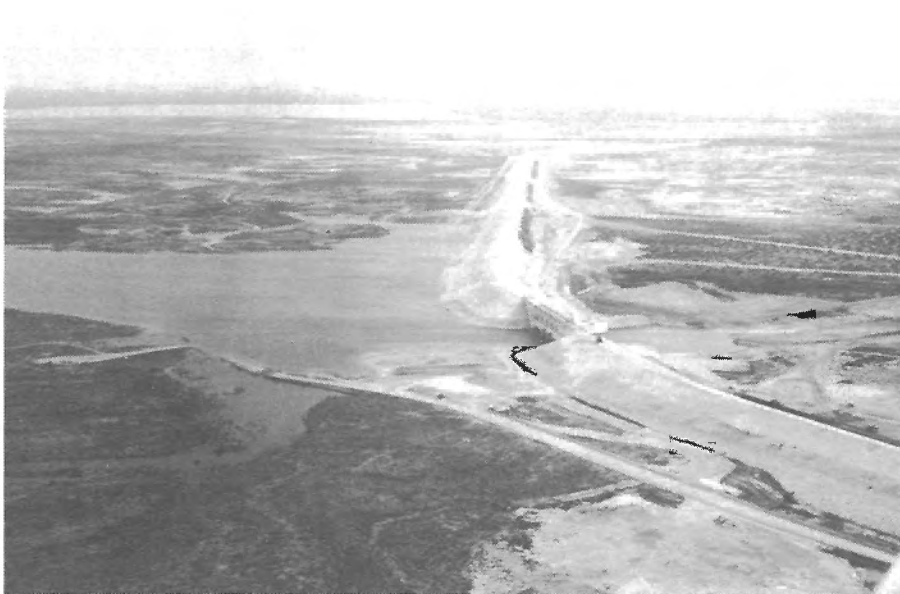
Figure 6. - Brantley Dam - Aerial view showing Dam and Reservoir. Lake McMillan can be seen in the background. Note curve of the earthen abutments. 9/29/88
