# MINIMIZING EMBANKMENT DAMAGE DURING OVERTOPPING FLOW

U.S. Department of Transportation  
Federal Highway Administration  
400 Seventh Street, SW  
Washington, D.C.

November 1988

1. Report No. FHWA/RD-88/181		2. Government Accession No.		3. Recipient's Catalog No. FHWA-RD-88-181	
4. Title and Subtitle MINIMIZING EMBANKMENT DAMAGE DURING OVERTOPPING FLOW				5. Report Date November 1988

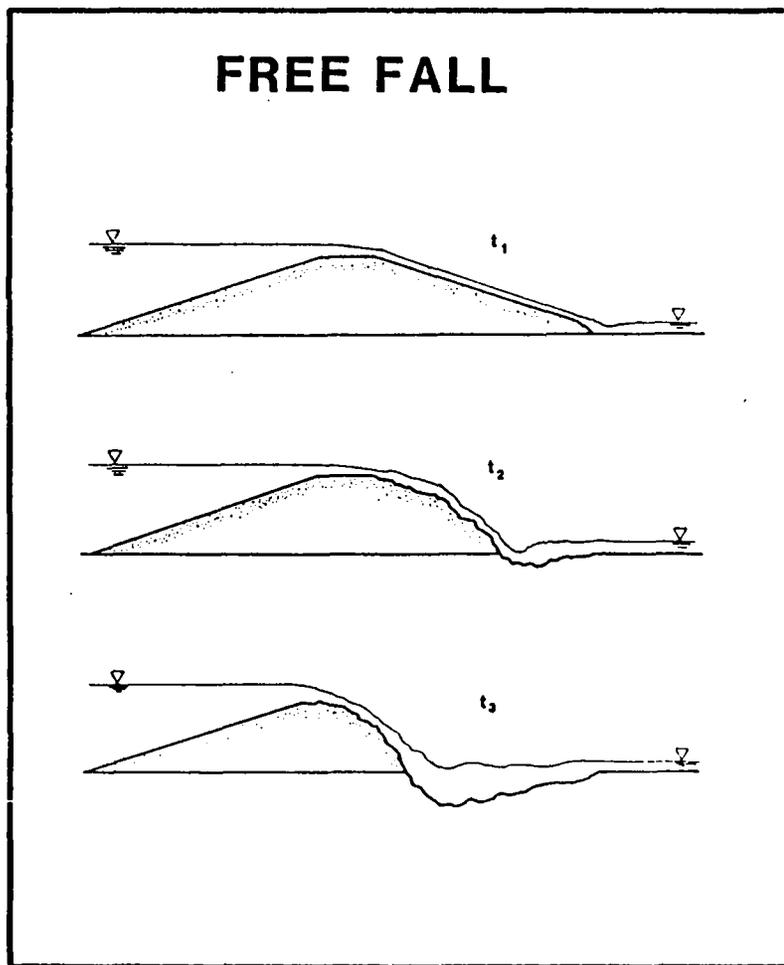
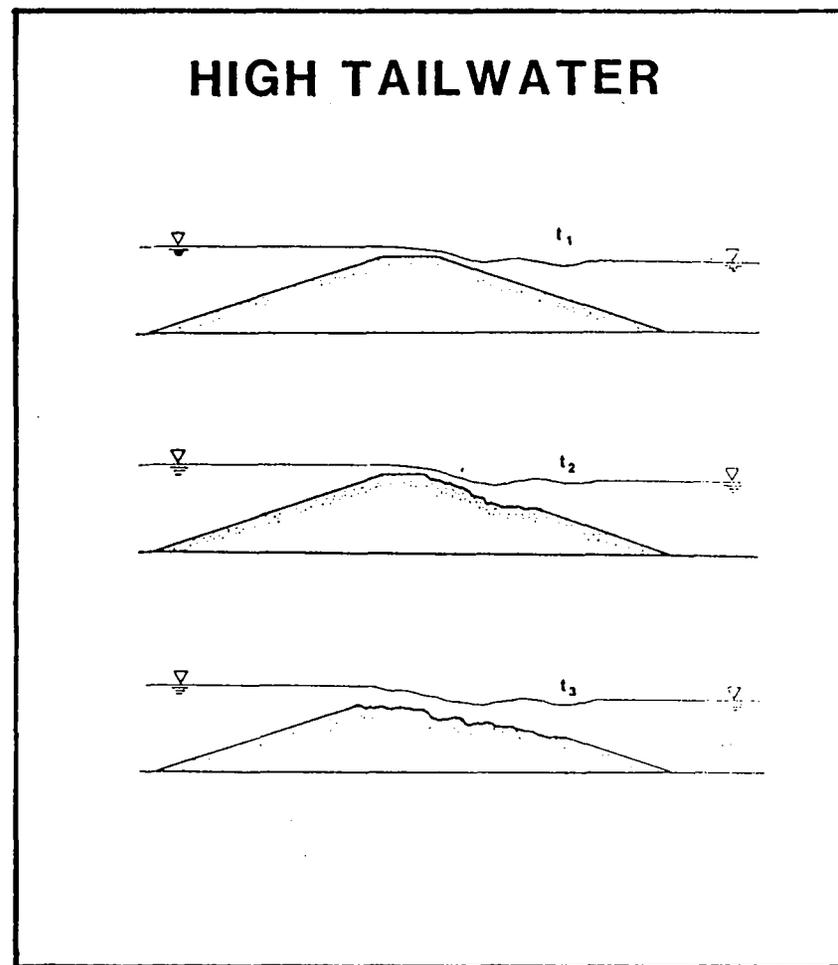
Figure 1. Progressive stages of unprotected embankment erosion under freefall and high tailwater conditions.

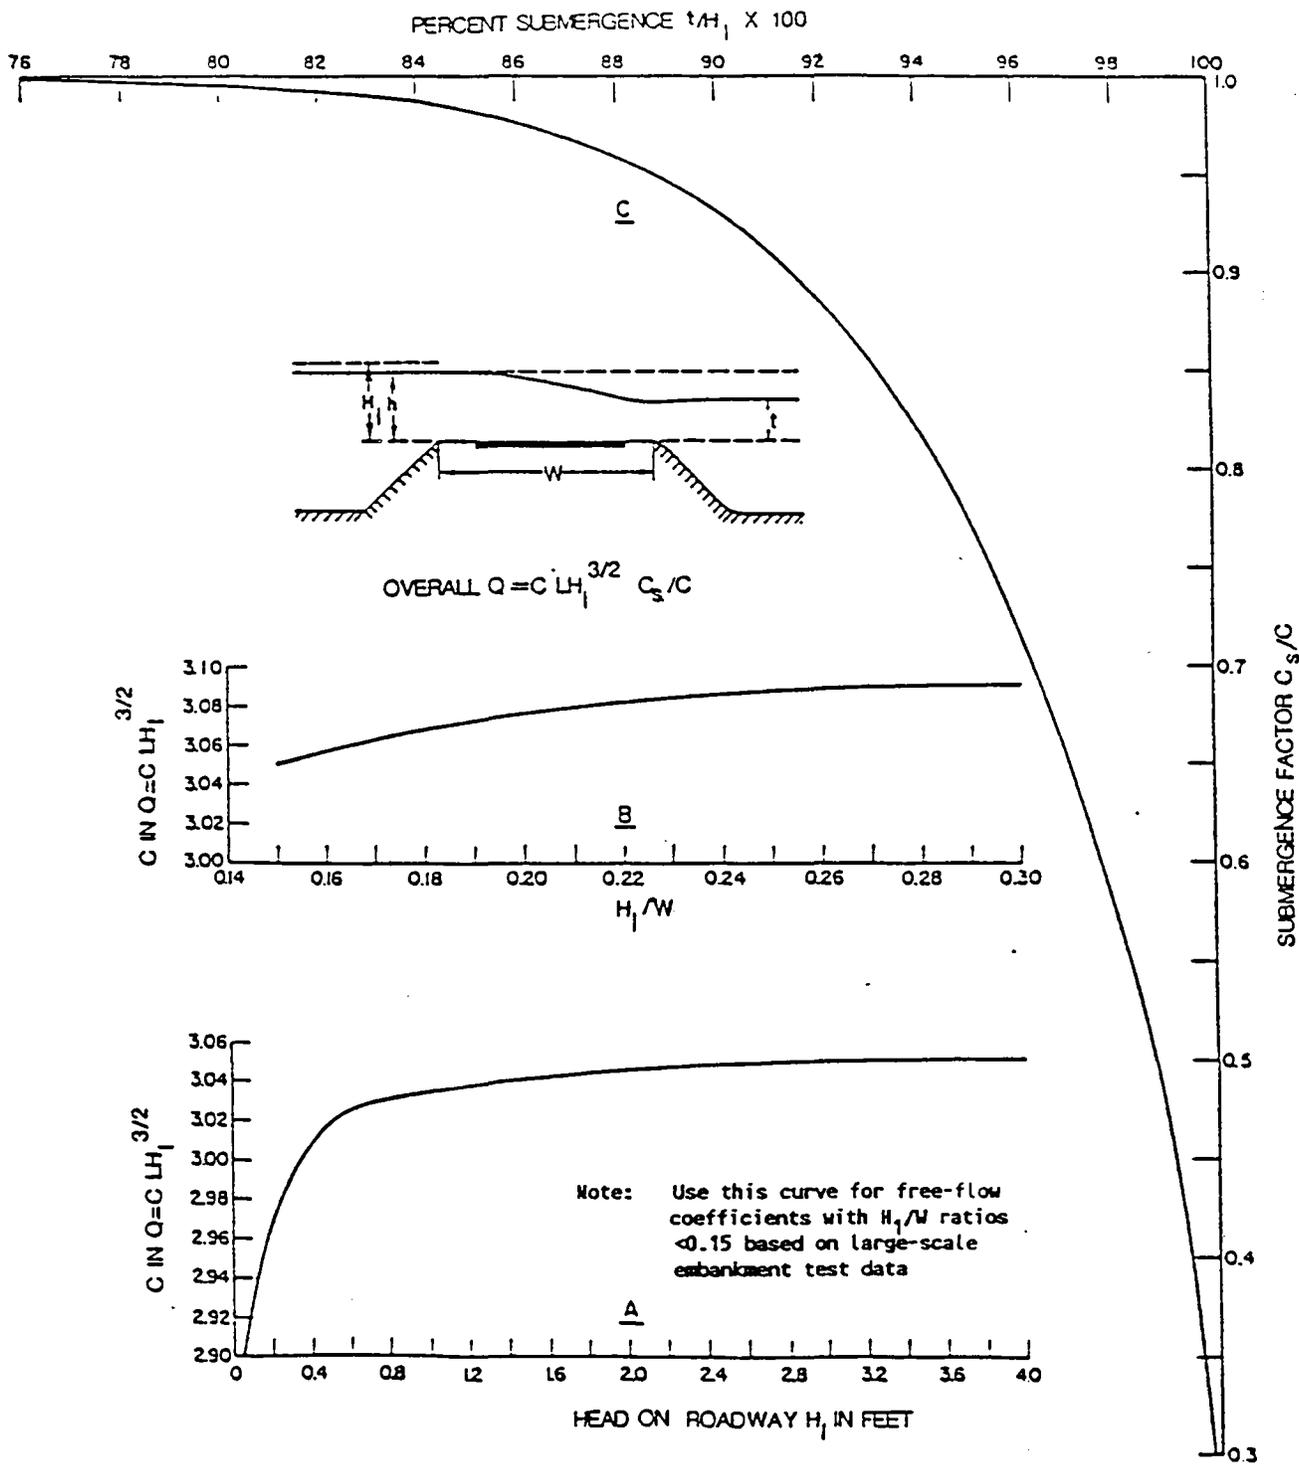
Figure 2. Discharge coefficients for flow over roadway embankment (3).

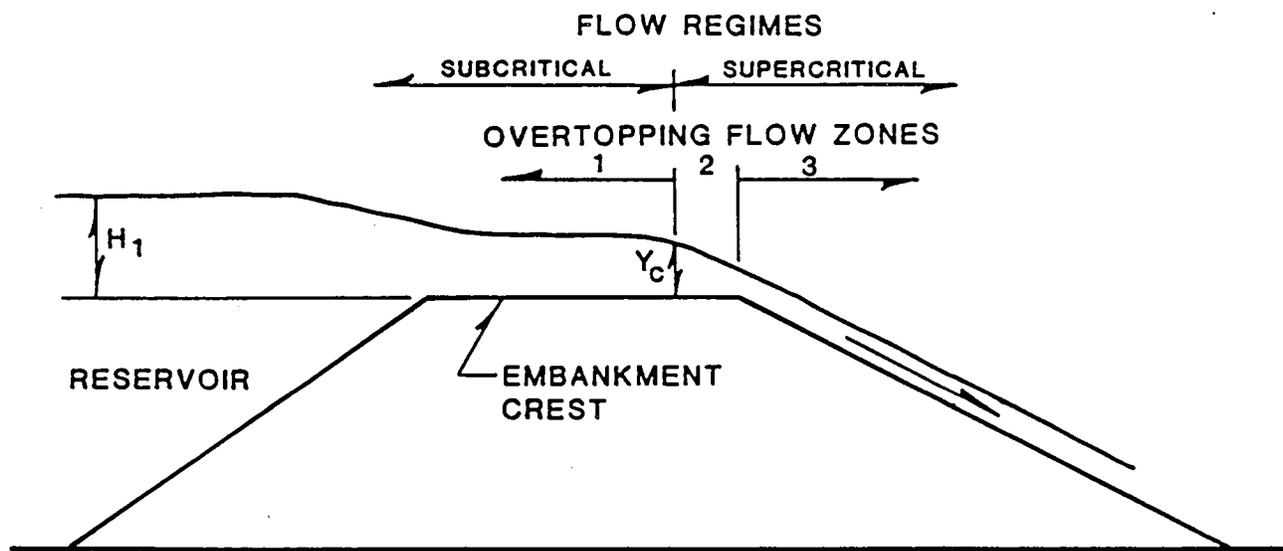
Figure 3. Hydraulic flow regimes and overtopping flow zones.

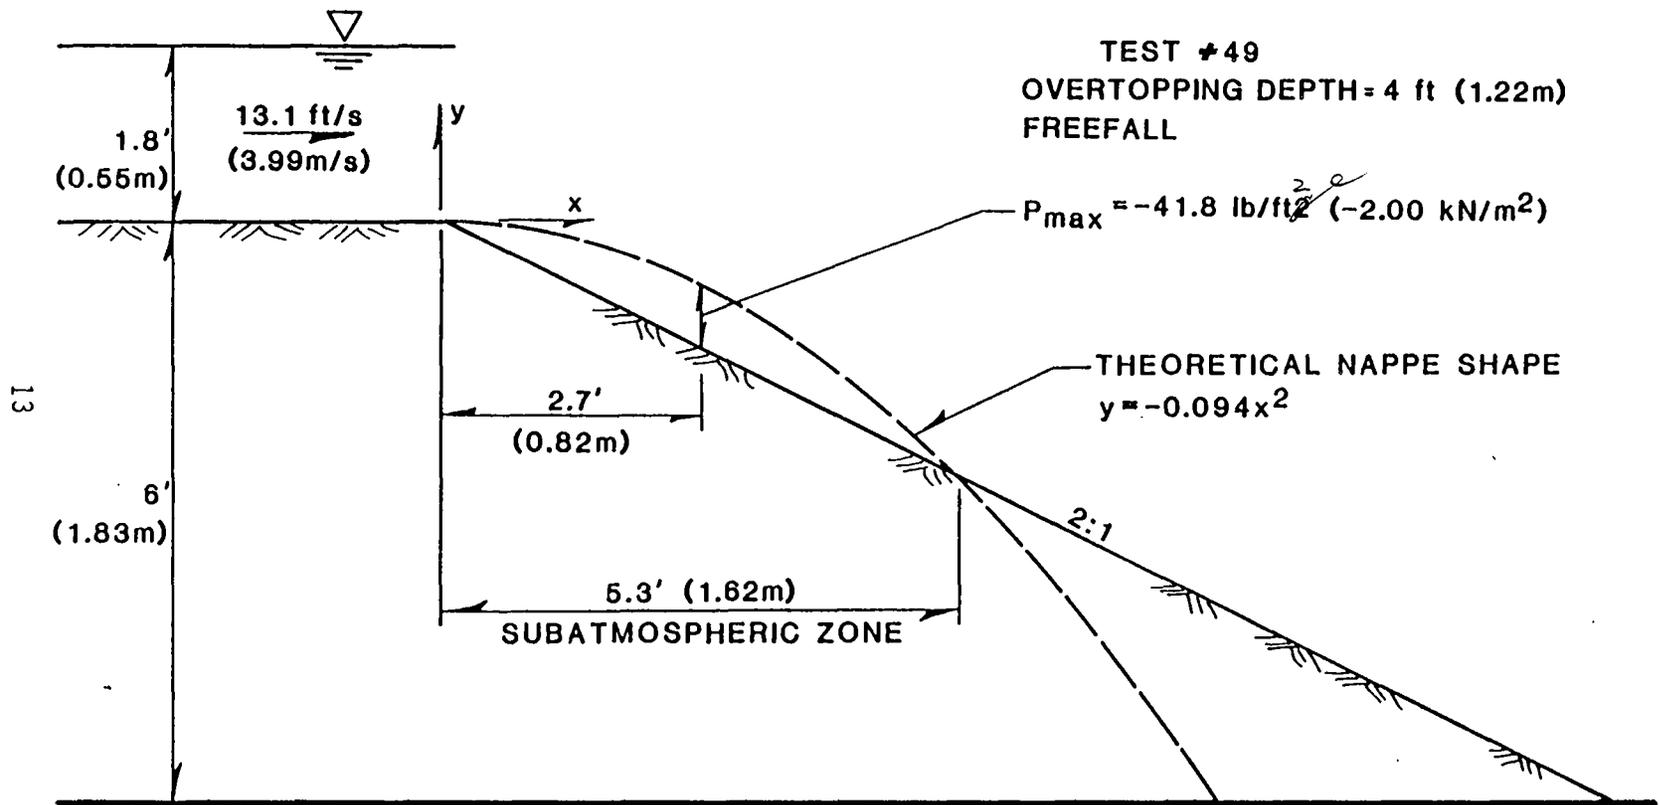
Figure 4. Comparison of theoretical nappe geometry versus rigid embankment for determination of subatmospheric pressure zone.

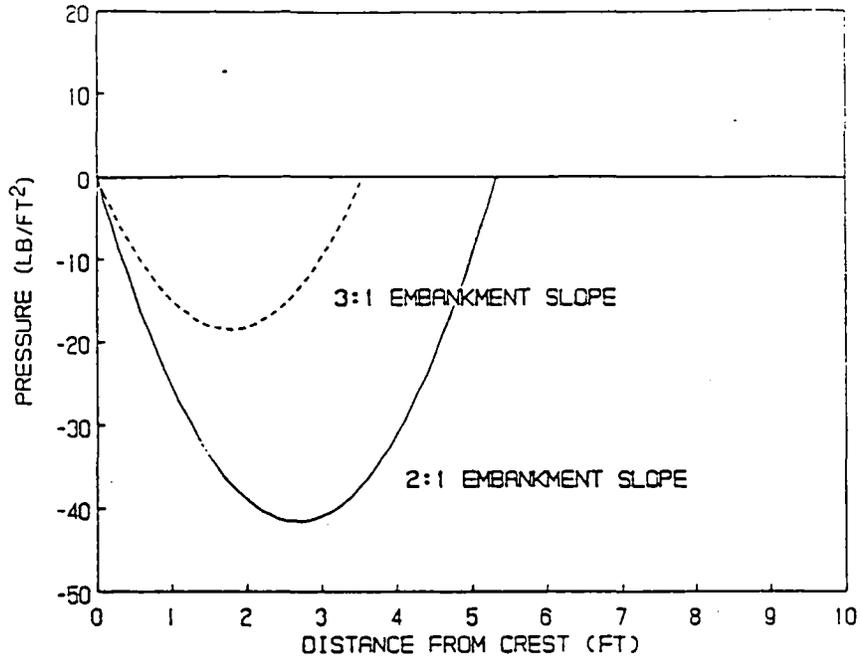
Figure 5. Theoretical pressure distribution on downstream slope corresponding to a 4-ft overtopping flow.

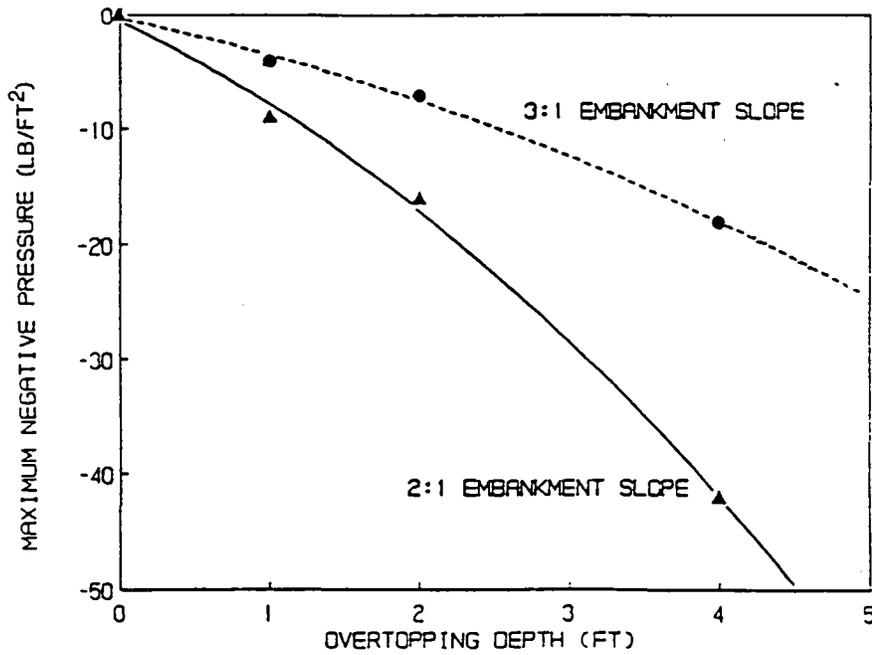
Figure 6. Variation of the theoretical maximum negative pressure developed during various overtopping depths of flow.

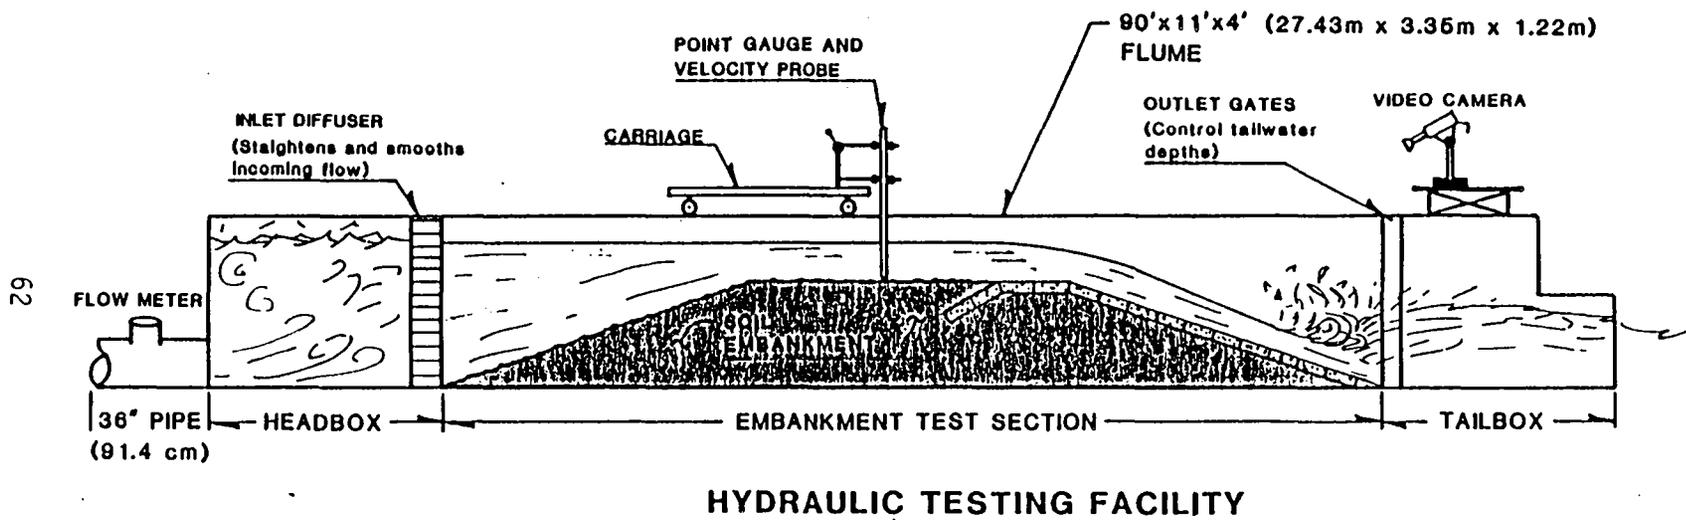
Figure 10. Profile of hydraulic testing facility.

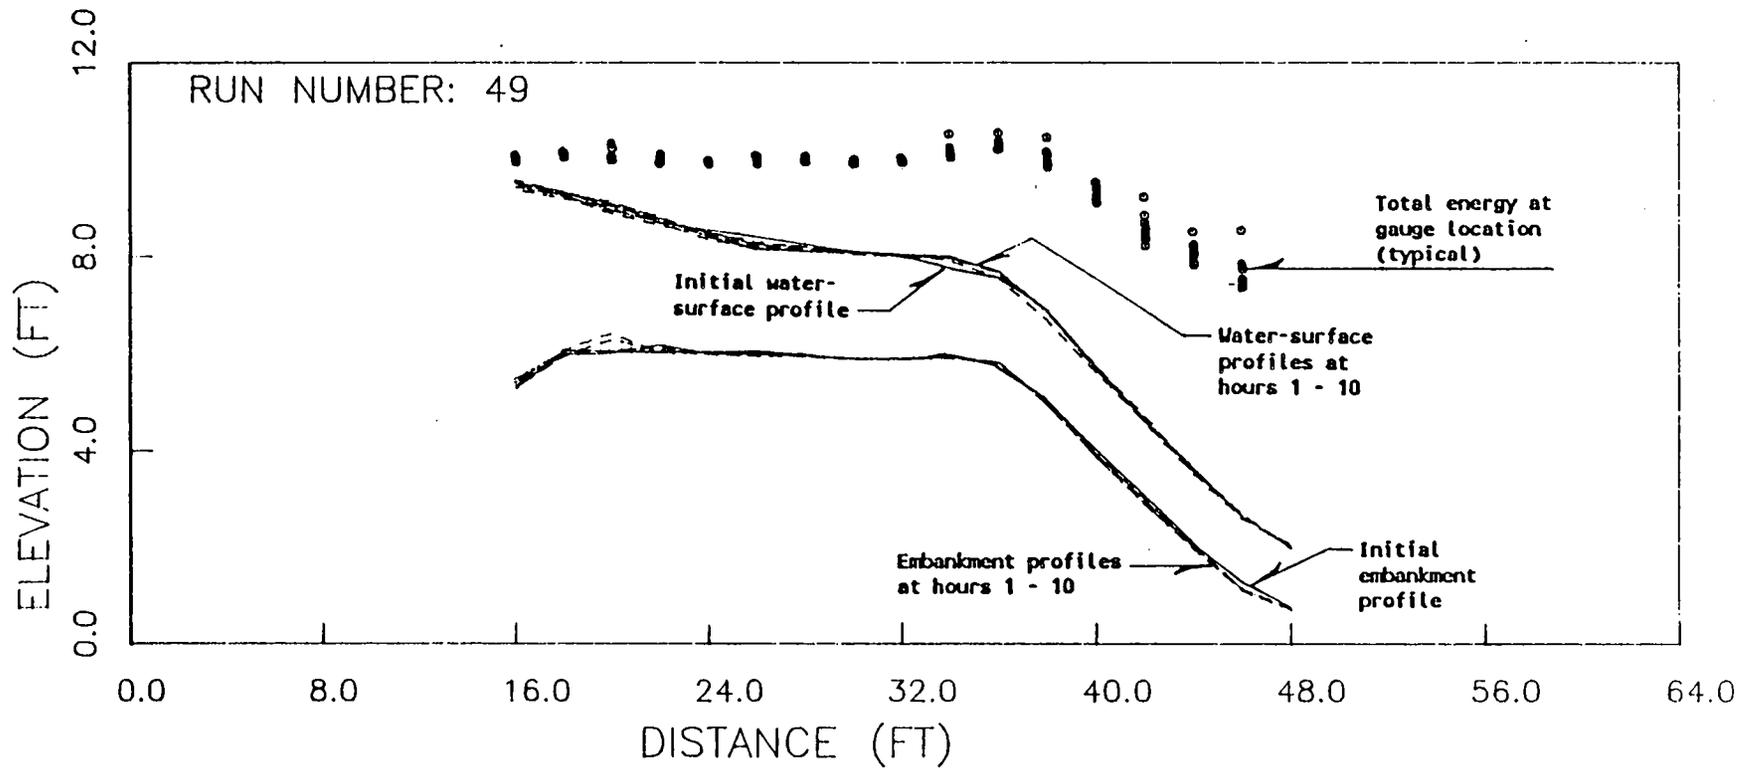
Figure 12. Embankment, water surface, and energy grade line profiles for test 49.

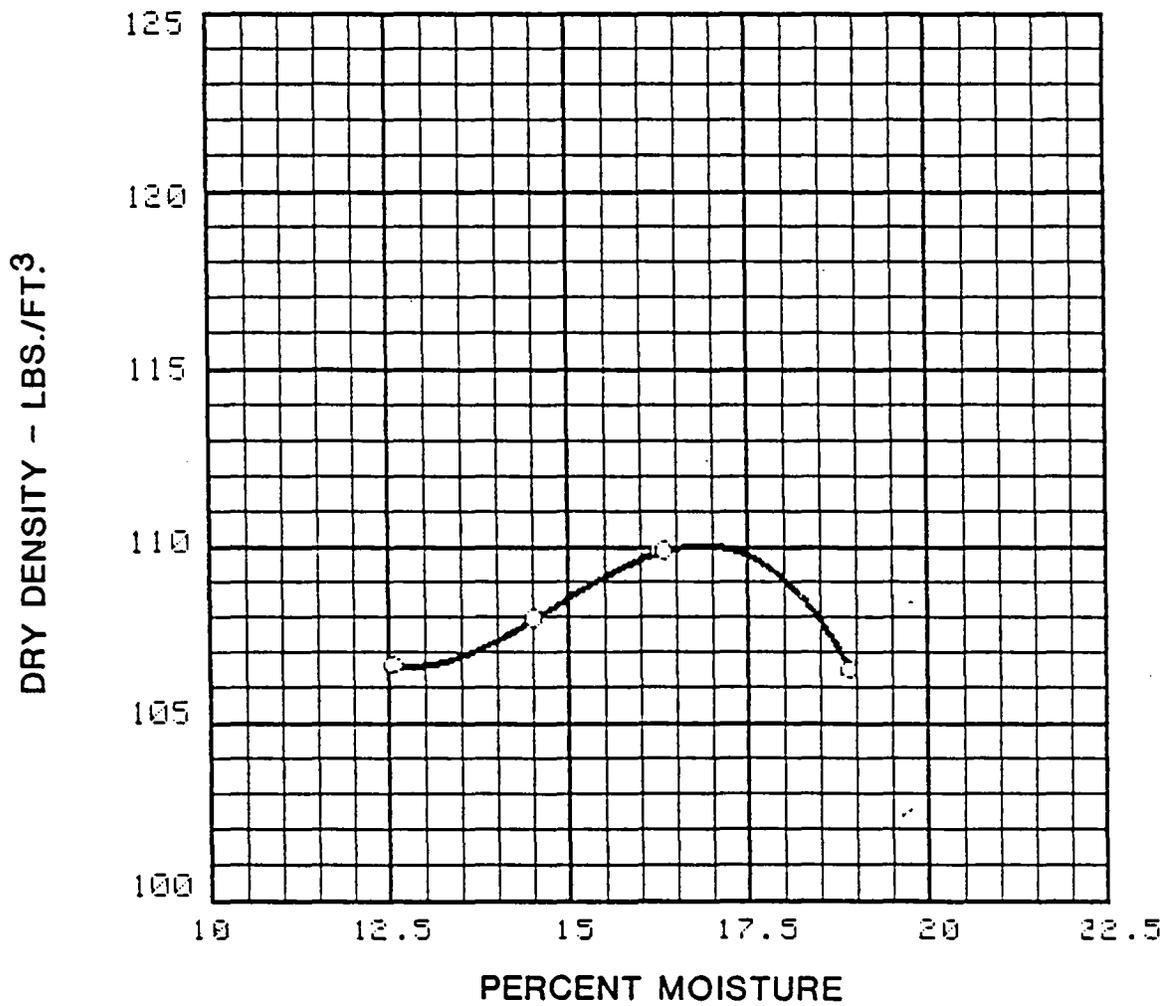
Figure 14. Moisture density curve for the type II soil.

The standard Proctor test determined the maximum dry density to be 110 lbs/ft<sup>3</sup> (17.3 kN/m<sup>3</sup>) at an optimum moisture content of 16.8 percent. The moisture-density curve is shown in figure 14. Permeability tests resulted in a range for hydraulic conductivity varying from  $1.9 \times 10^{-7}$  to  $4.8 \times 10^{-7}$  cm/s. The following Atterberg limits were determined: liquid limit--32.8 to 47.8, plastic limit--20.7 to 23.2, and plasticity index--11.6 to 24.6. The soil's grain-size distribution curve is given in figure 15. The D<sub>50</sub> for

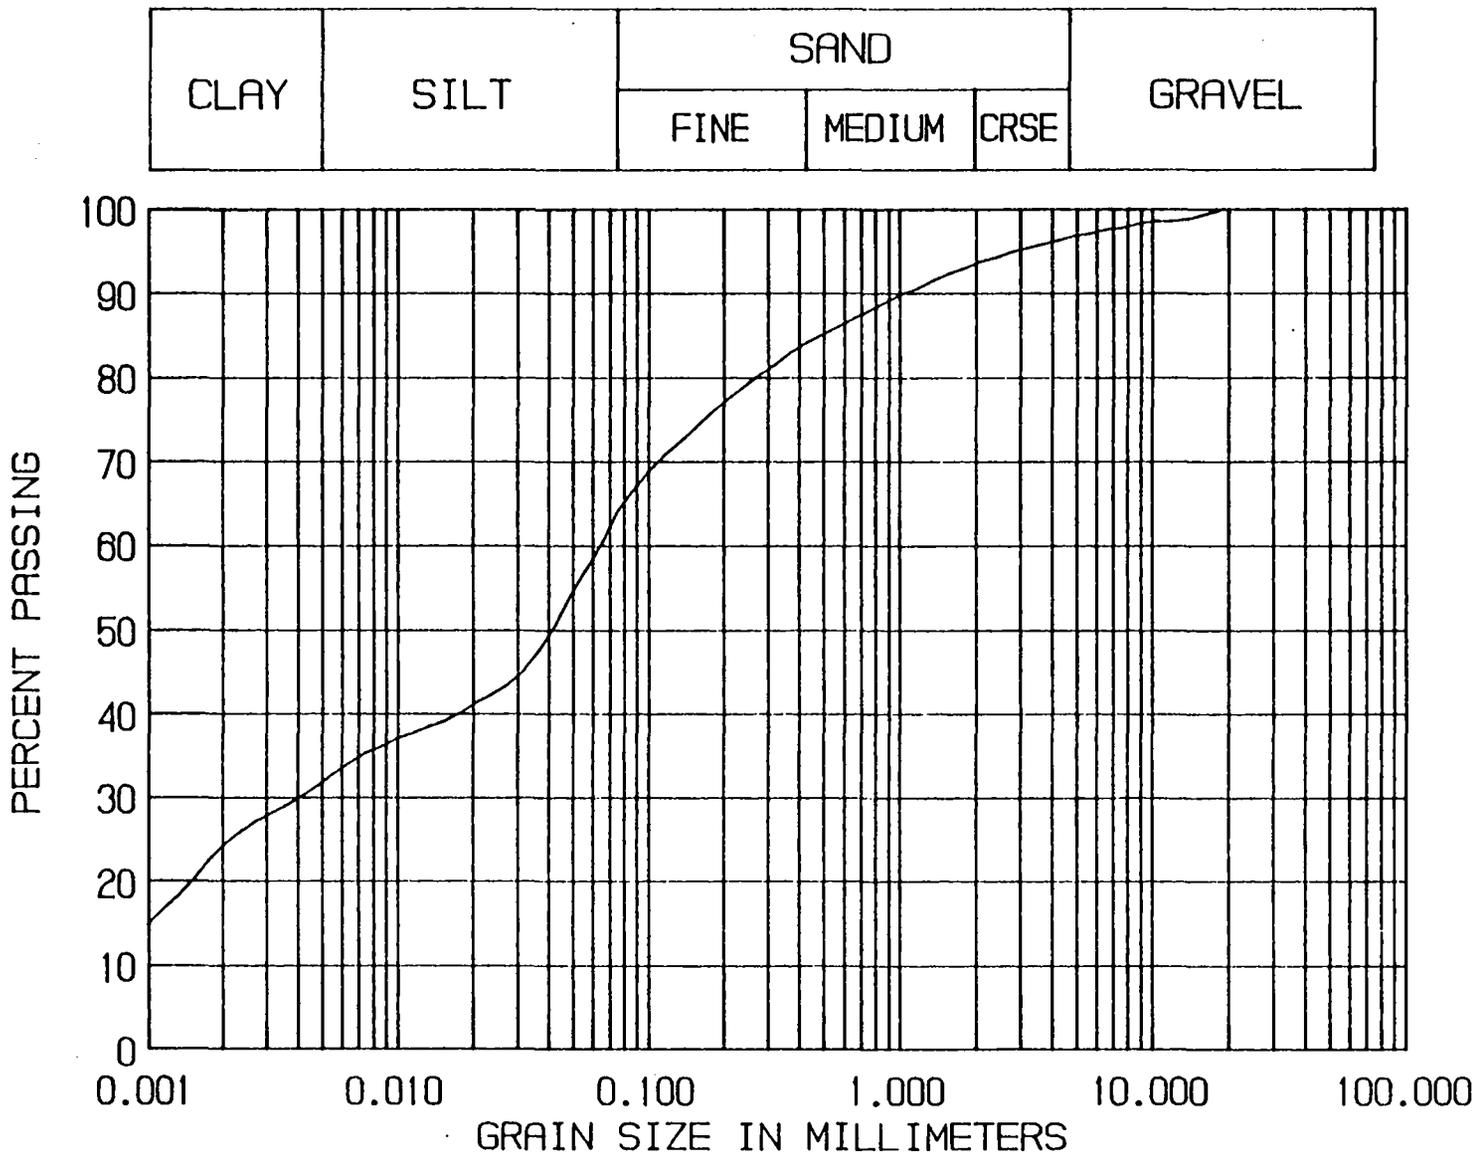
Figure 15. Grain size distribution curve for the type II soil.

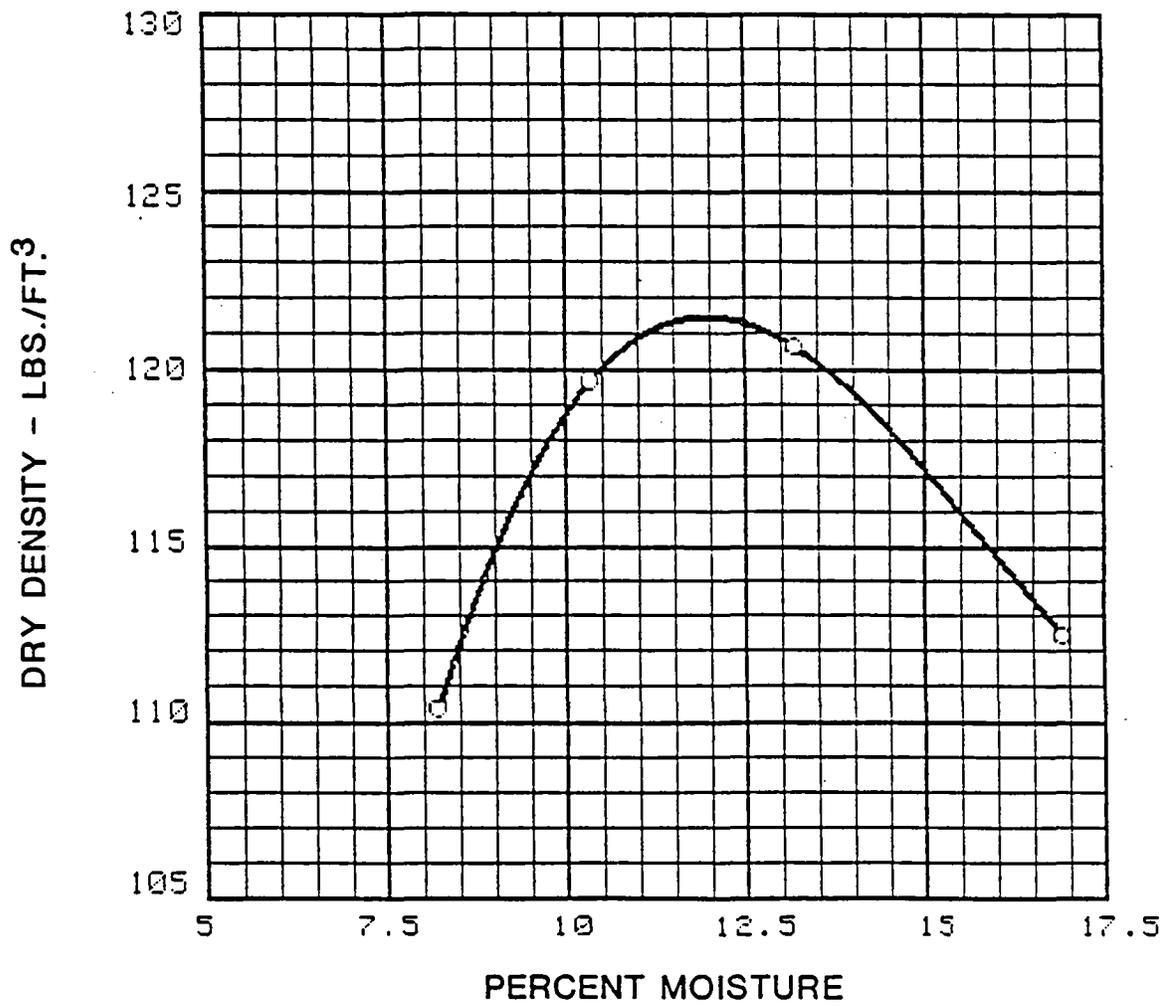
Figure 16. Moisture density curve for the type I soil.

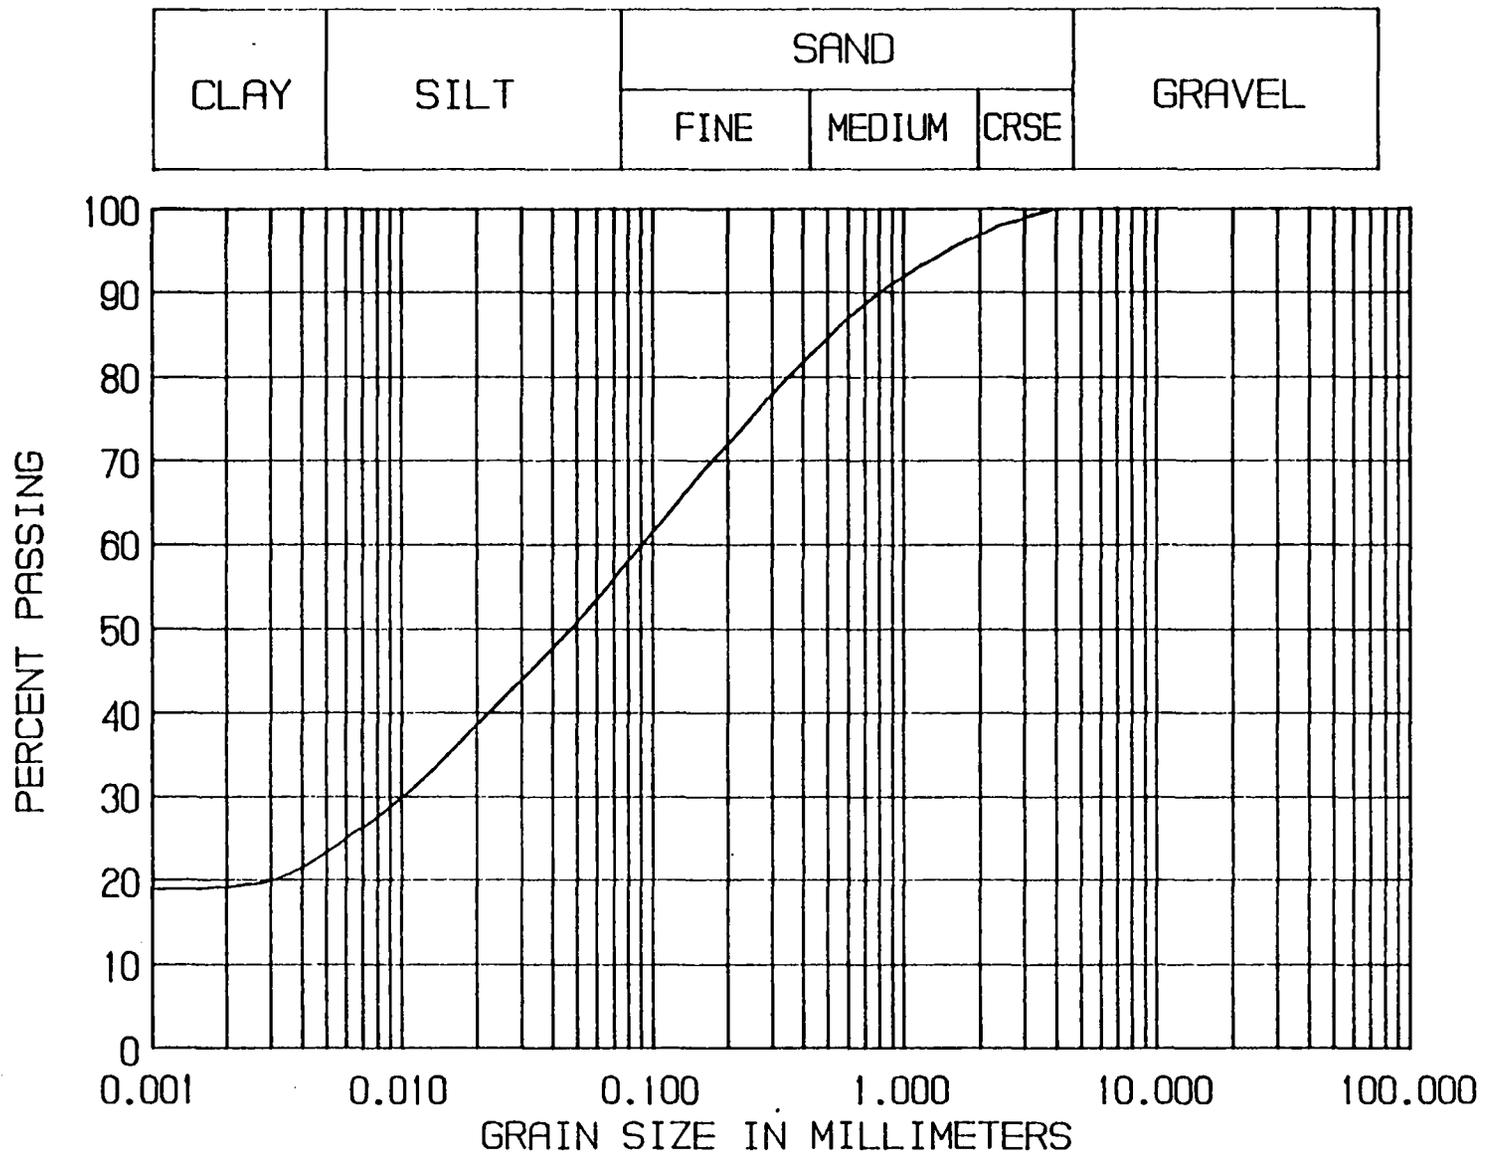
Figure 17. Grain size distribution curve for the type I soil.

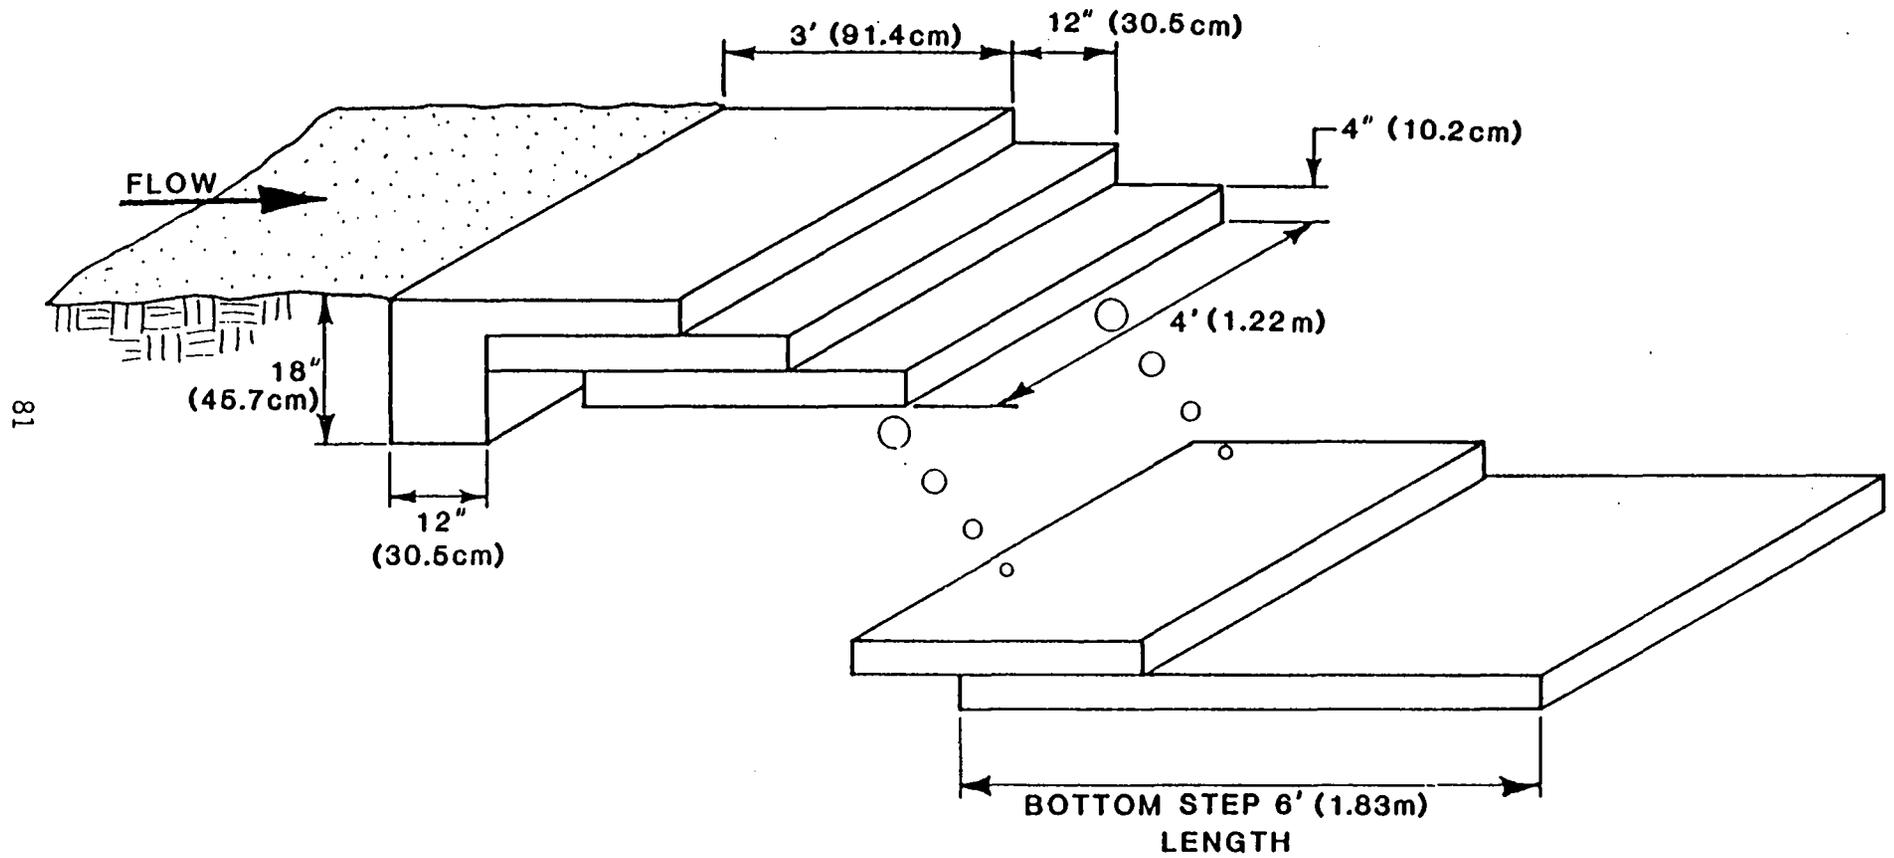
Figure 19. Sketch of the soil cement embankment (3H:1V slope).

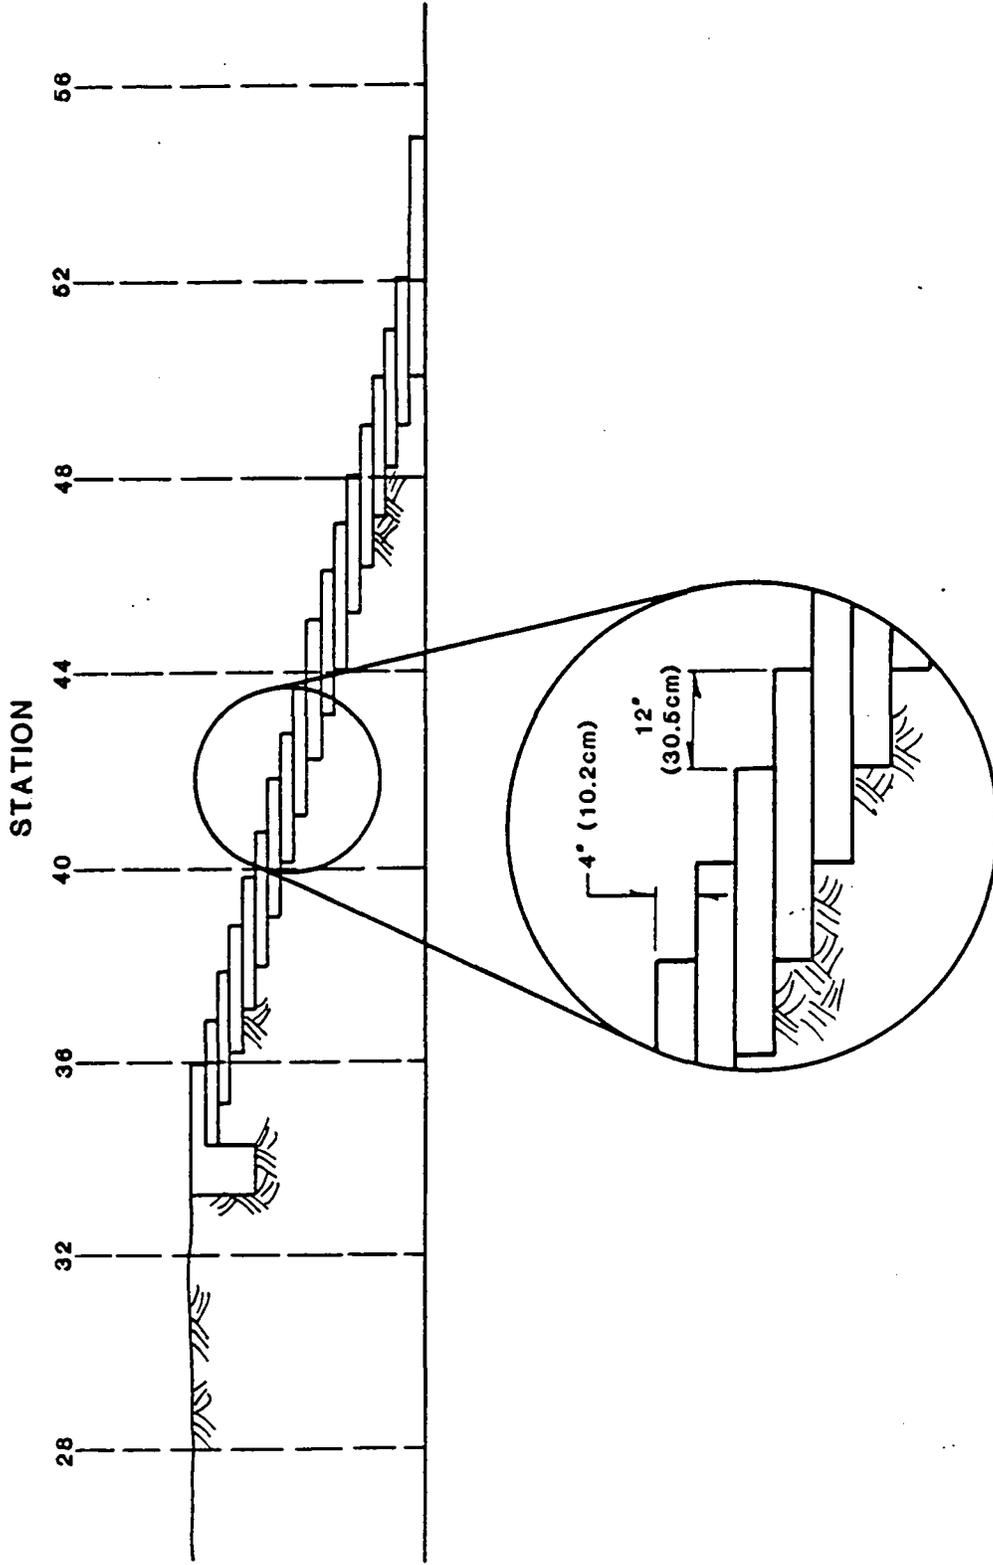
Figure 20. Profile of the soil cement embankment (3H:1V slope).

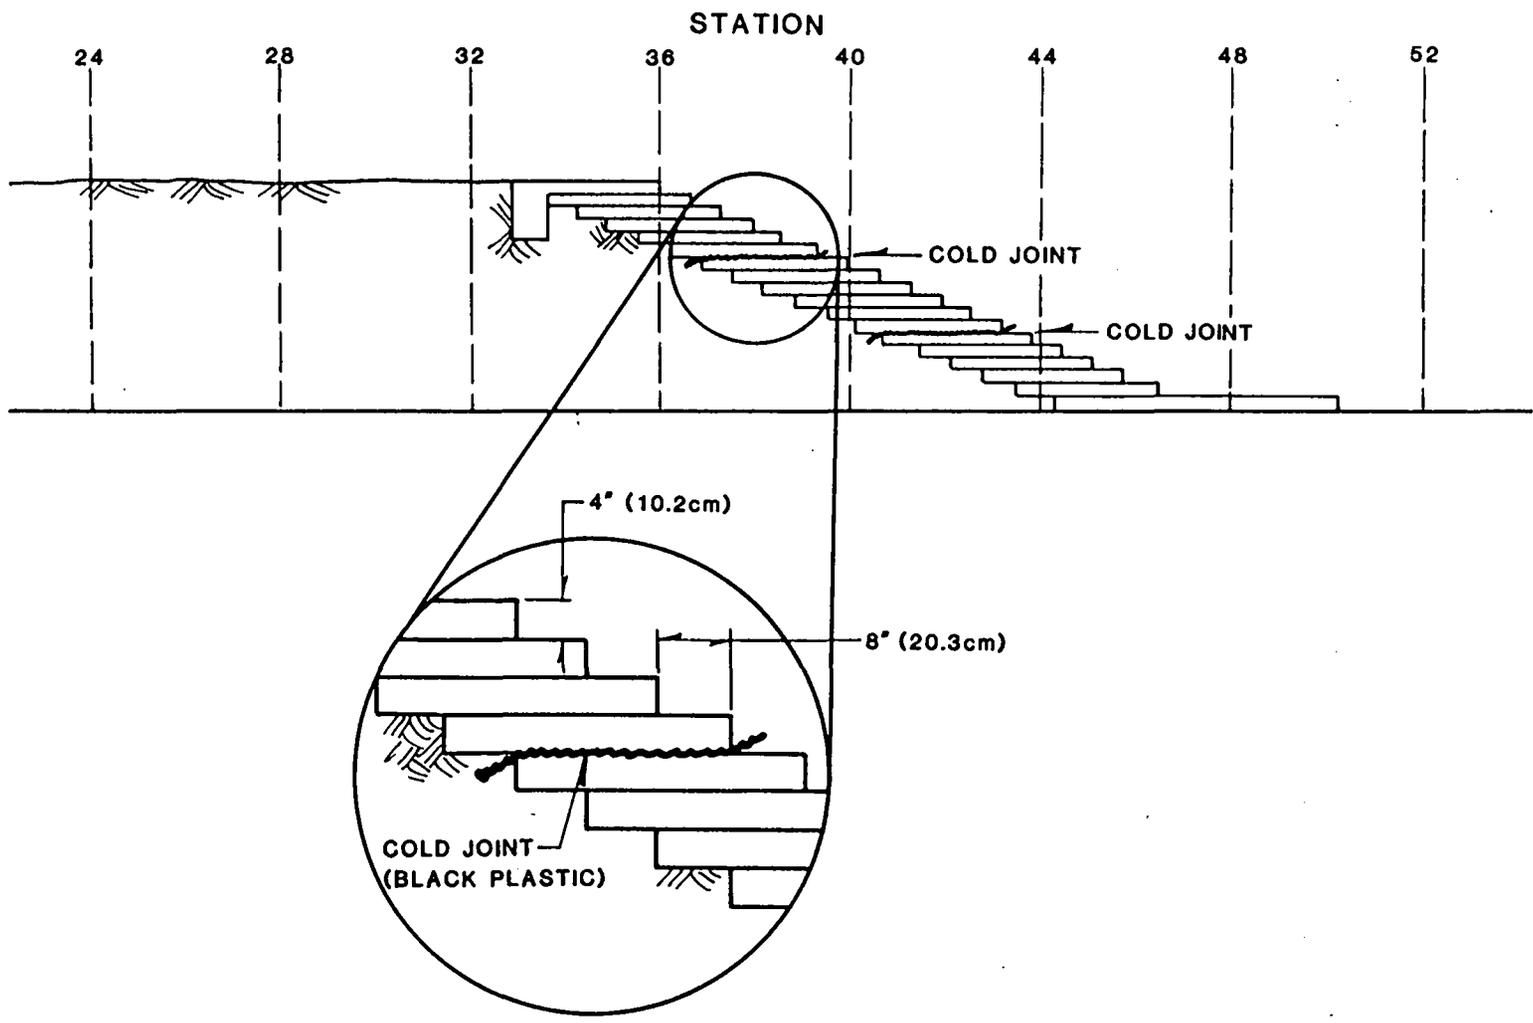
Figure 21. Profile of the soil cement embankment (2H:1V slope).

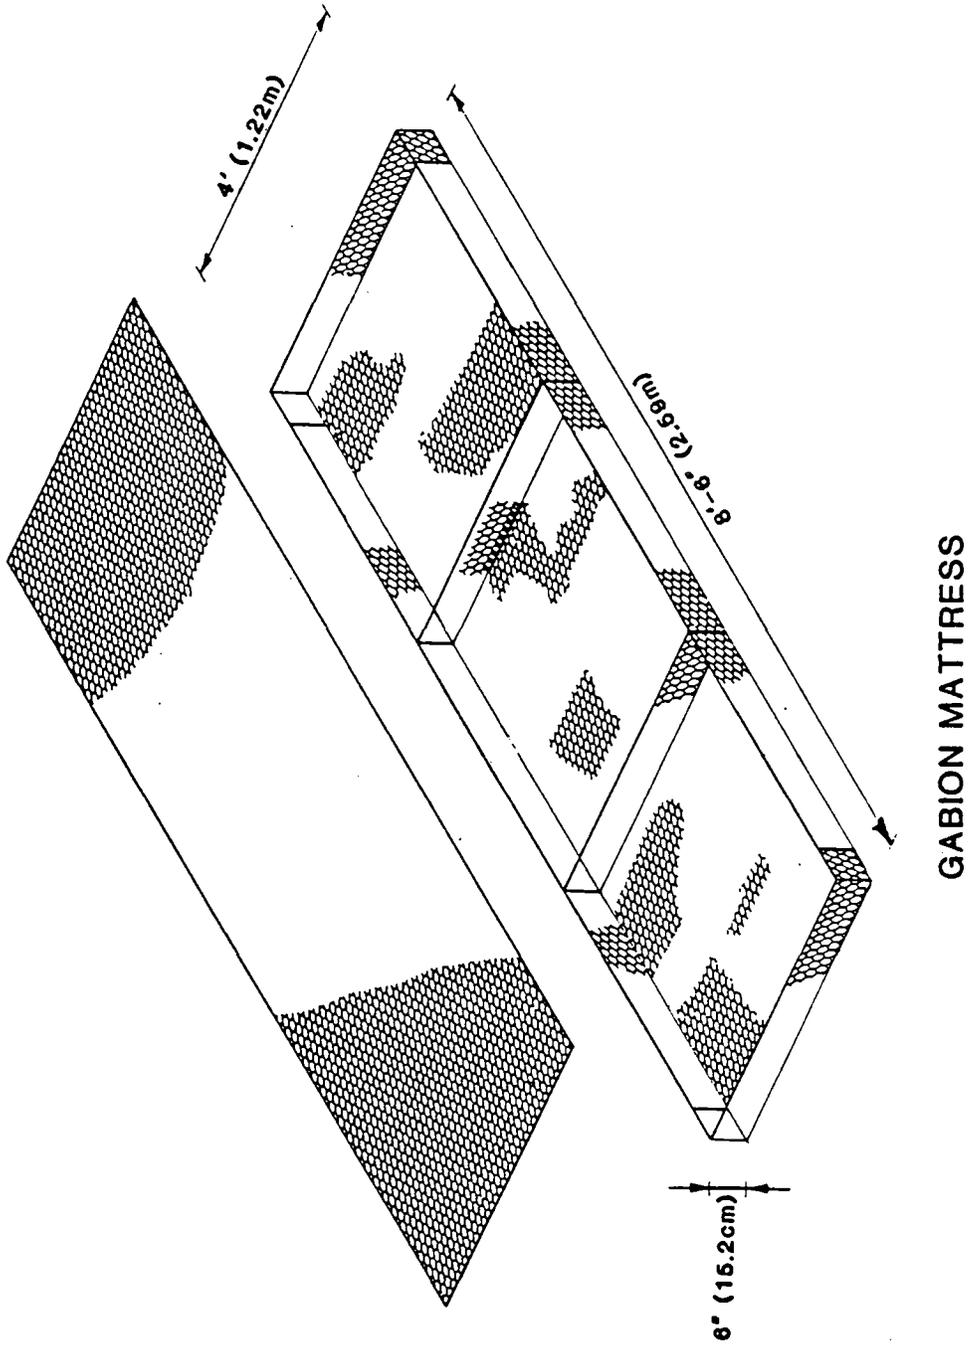
Figure 23. Sketch of 6-in (15.2 cm) gabion mattress and lid.

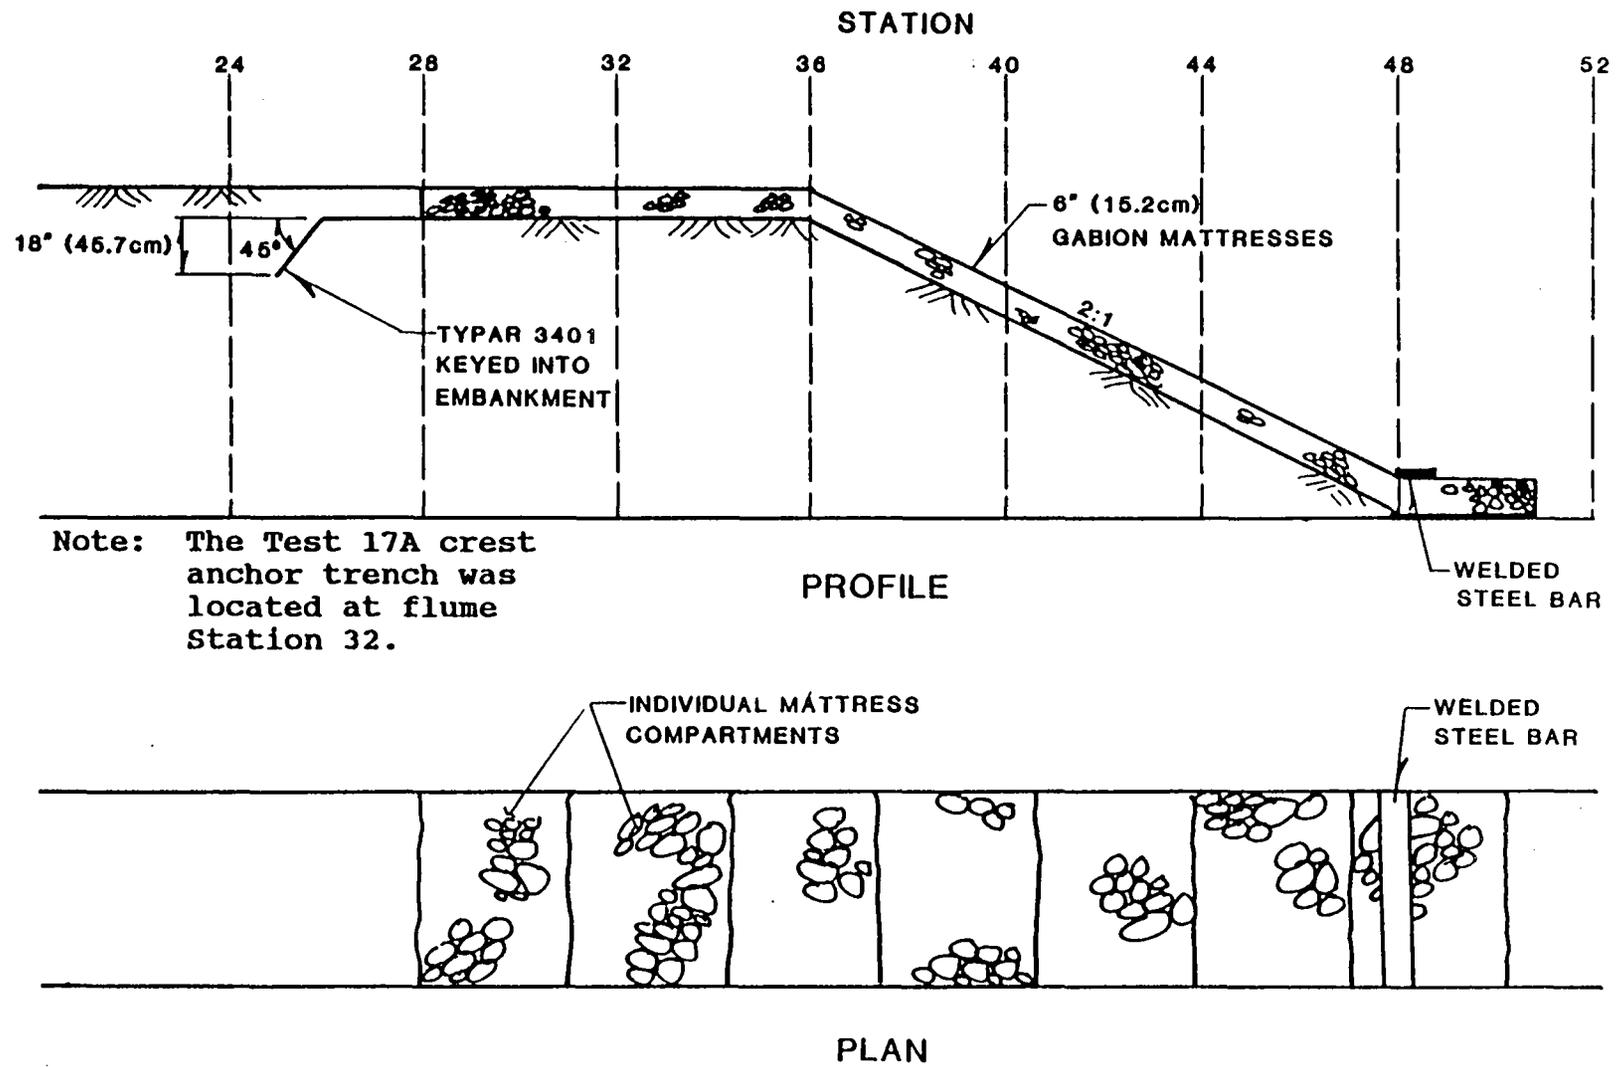
Figure 24. Sketch of typical 6-in (15.2 cm) gabion mattress system.
