# MINIMIZING EMBANKMENT DAMAGE DURING OVERTOPPING FLOW

U.S. Department of Transportation  
Federal Highway Administration  
400 Seventh Street, SW  
Washington, D.C.

November 1988

1. Report No. FHWA/RD-88/181		2. Government Accession No.		3. Recipient's Catalog No. FHWA-RD-88-181	
4. Title and Subtitle MINIMIZING EMBANKMENT DAMAGE DURING OVERTOPPING FLOW				5. Report Date November 1988

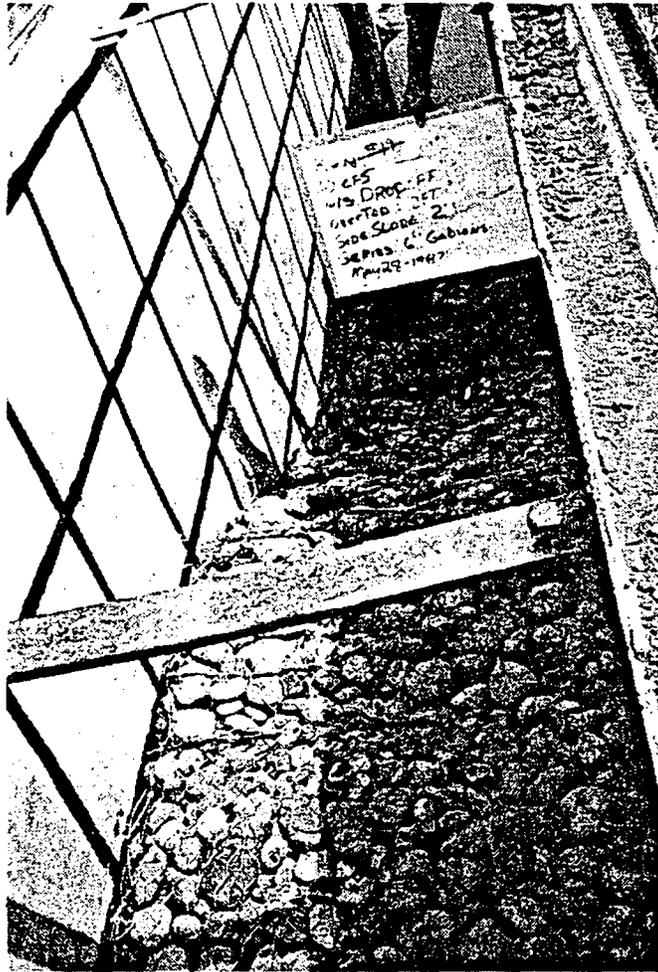
Figure 25. Typical 6-in (15.2 cm) mattress installation.

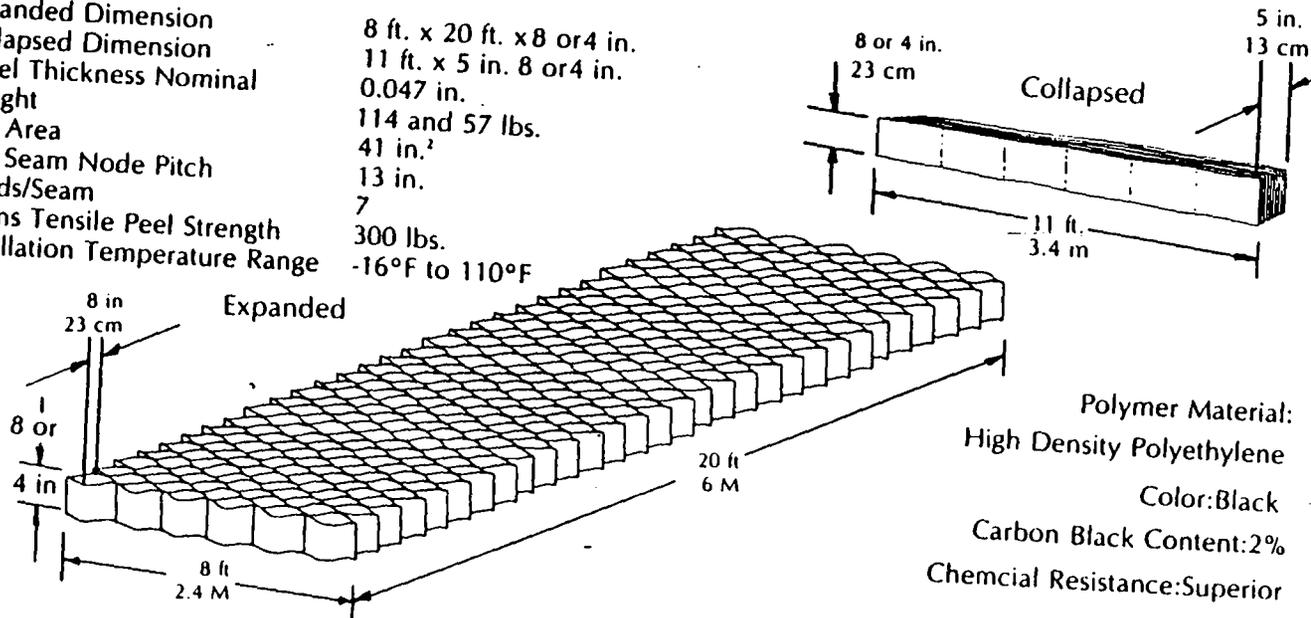
Figure 27. Geoweb grid confinement system.

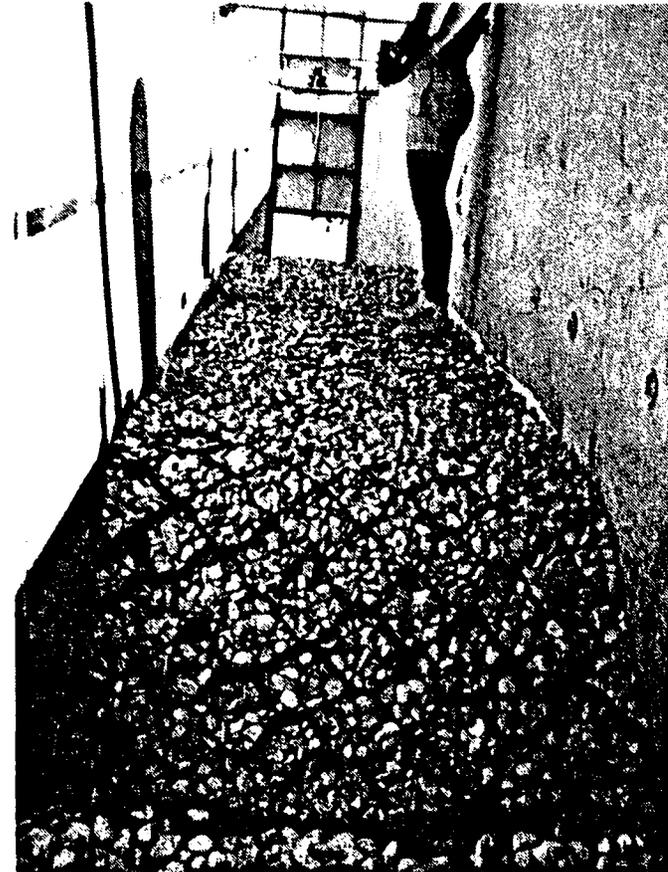
b. Looking downstream from the anchor trench.

Figure 29. Washed river rock [1 to 2 in (2.5 to 5.0 cm) diameter] used to fill the geoweb cells.

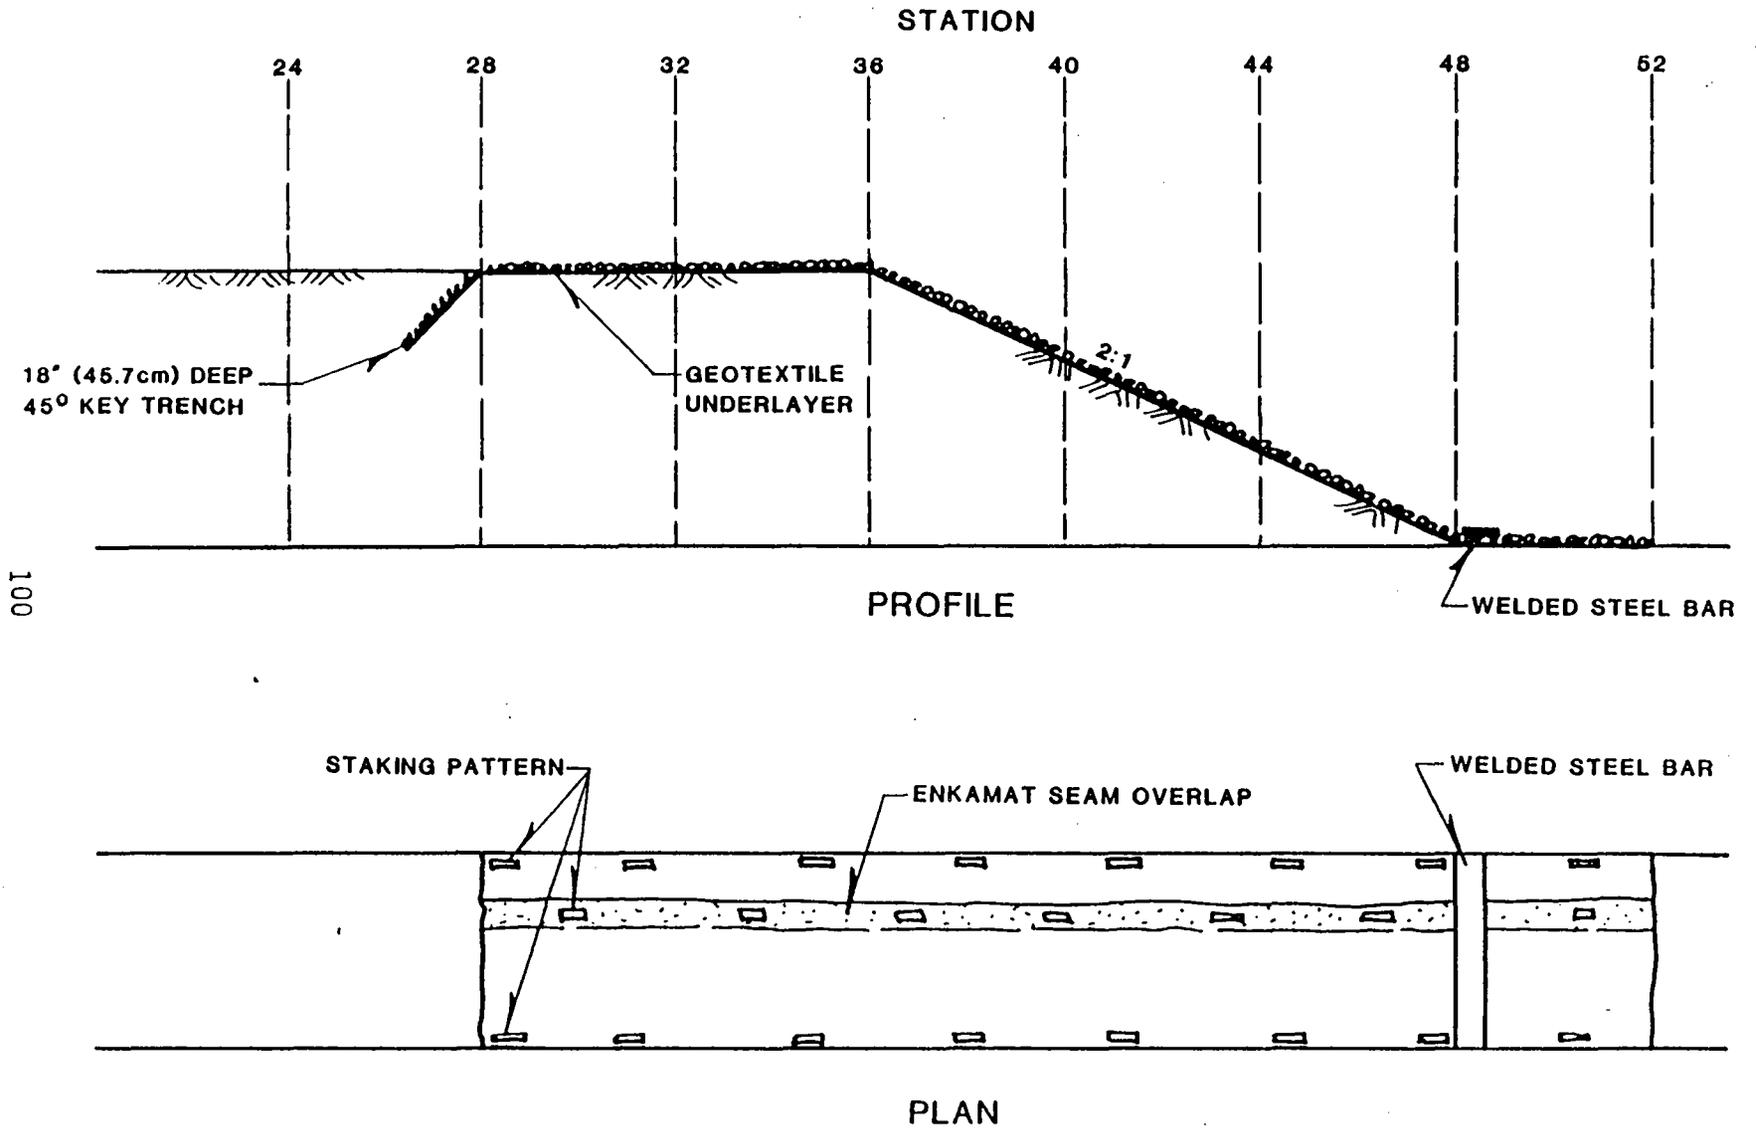
Figure 31. Sketch of Enkamat 7020 protection system.

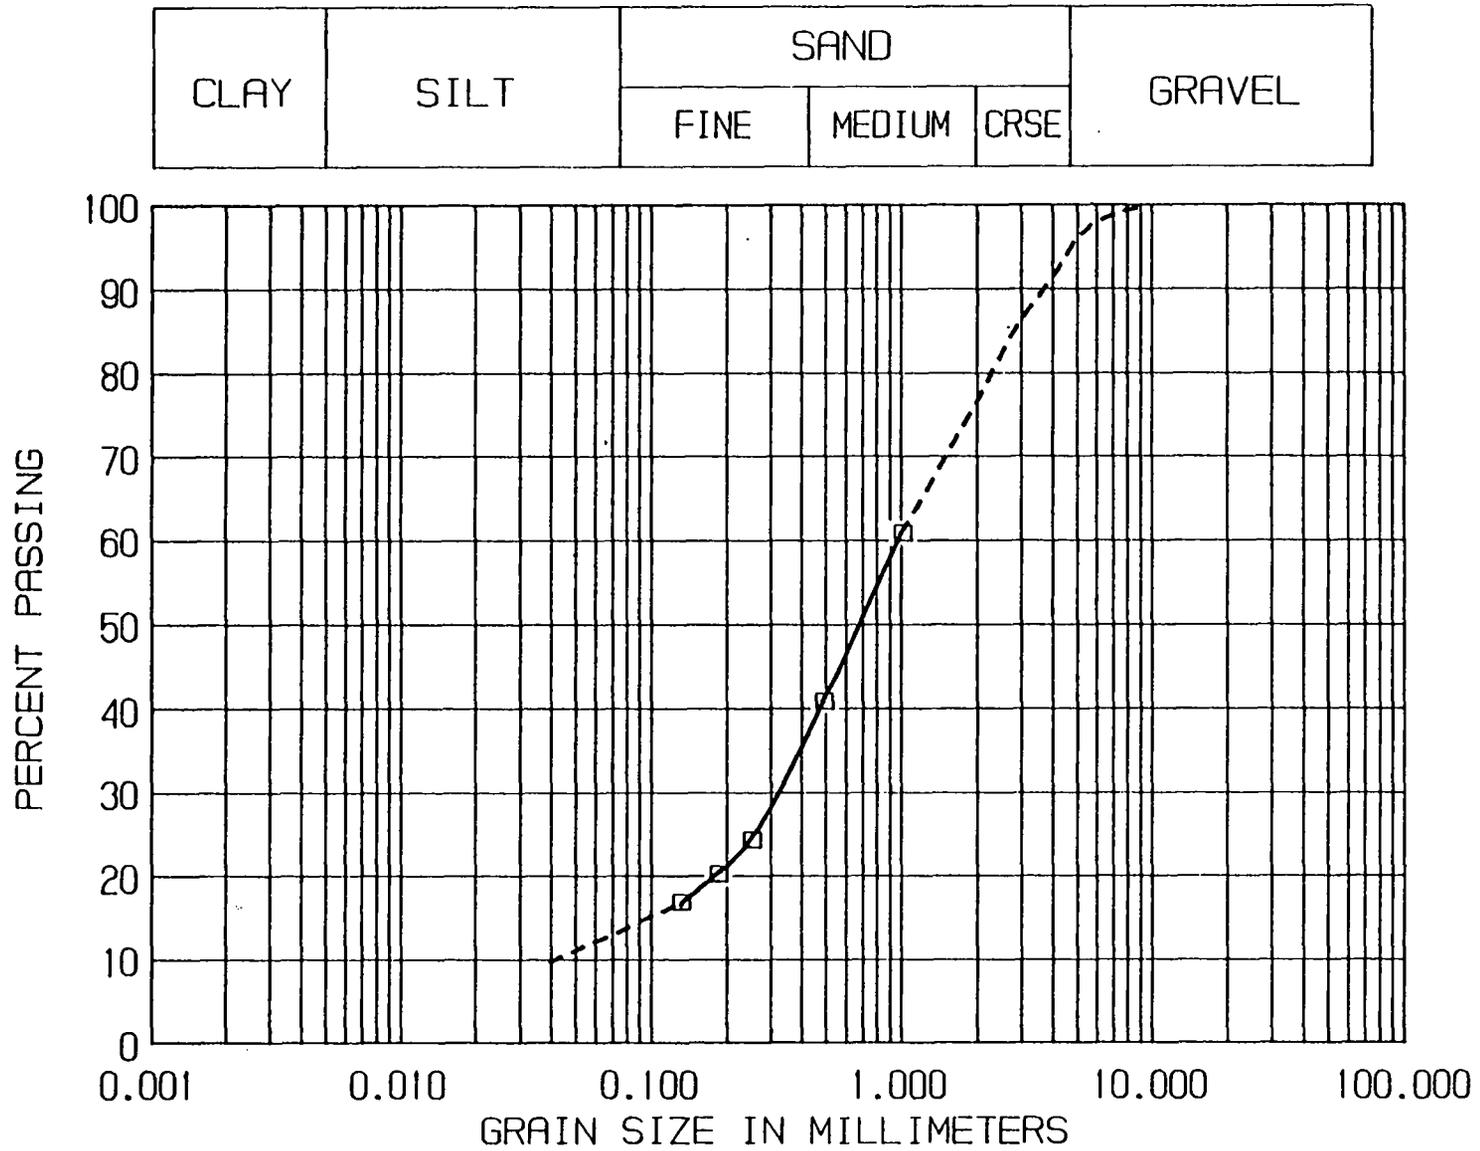
Figure 33. Grain size distributions curve for the asphalt aggregate.

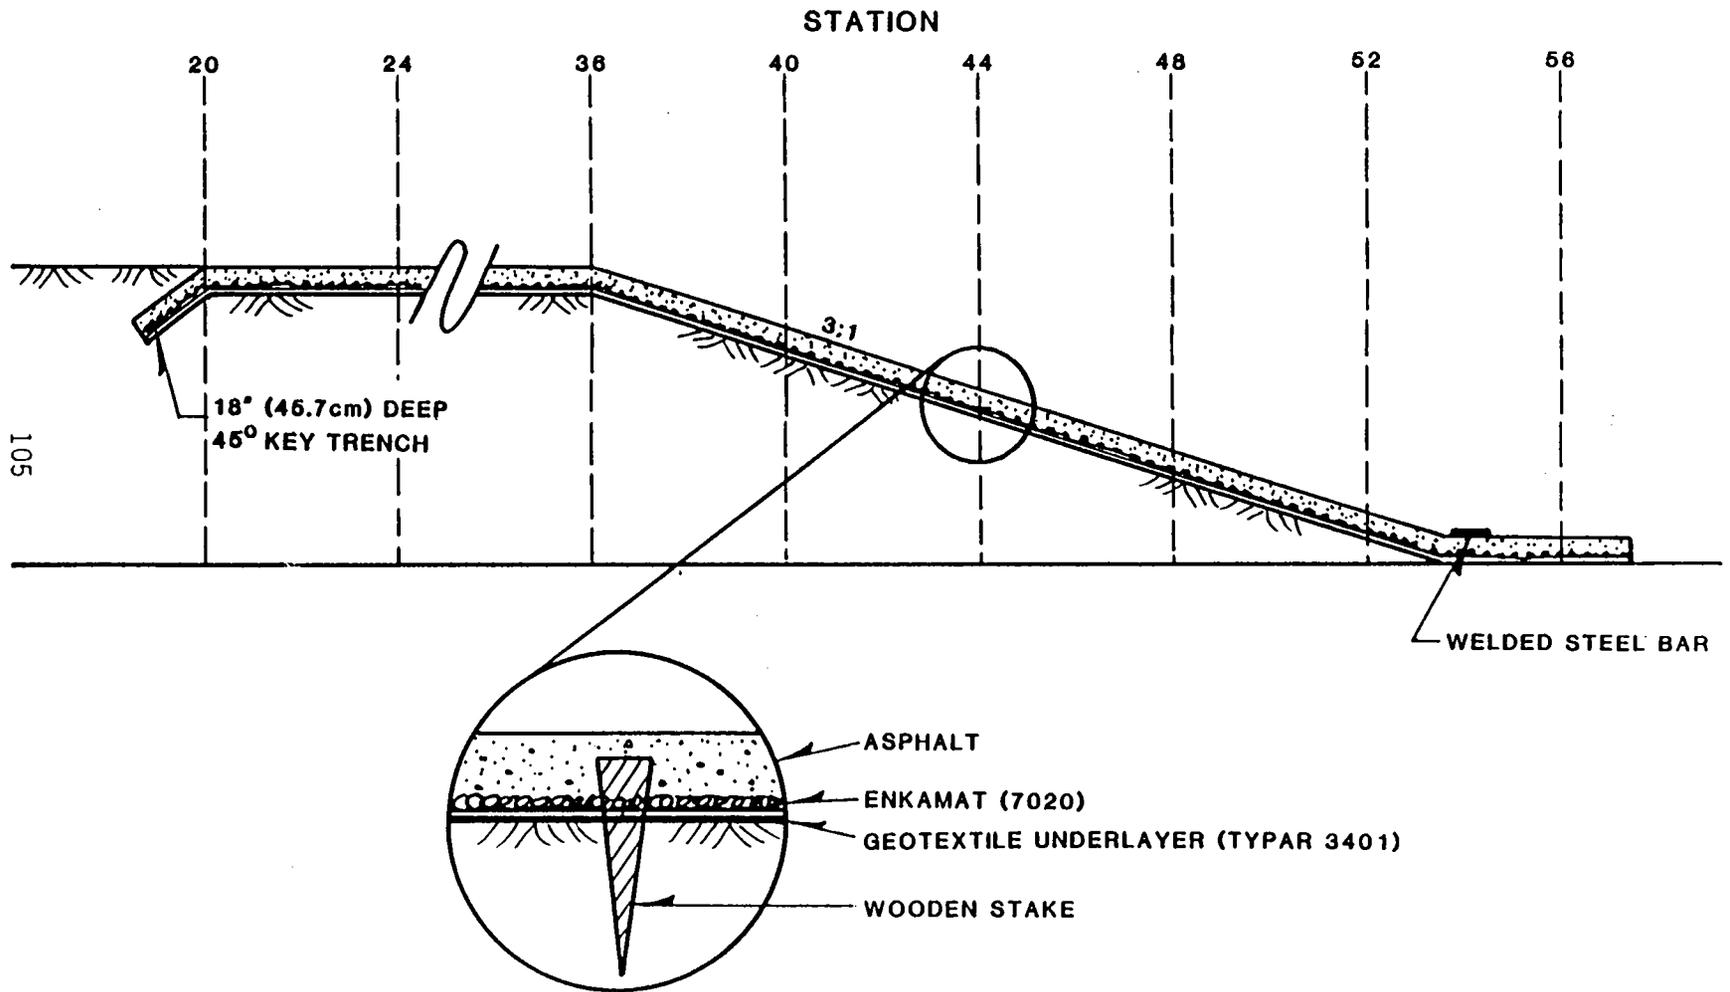
Figure 34. Sketch of Enkamat 7020 with 3-in (7.6 cm) asphalt cover.

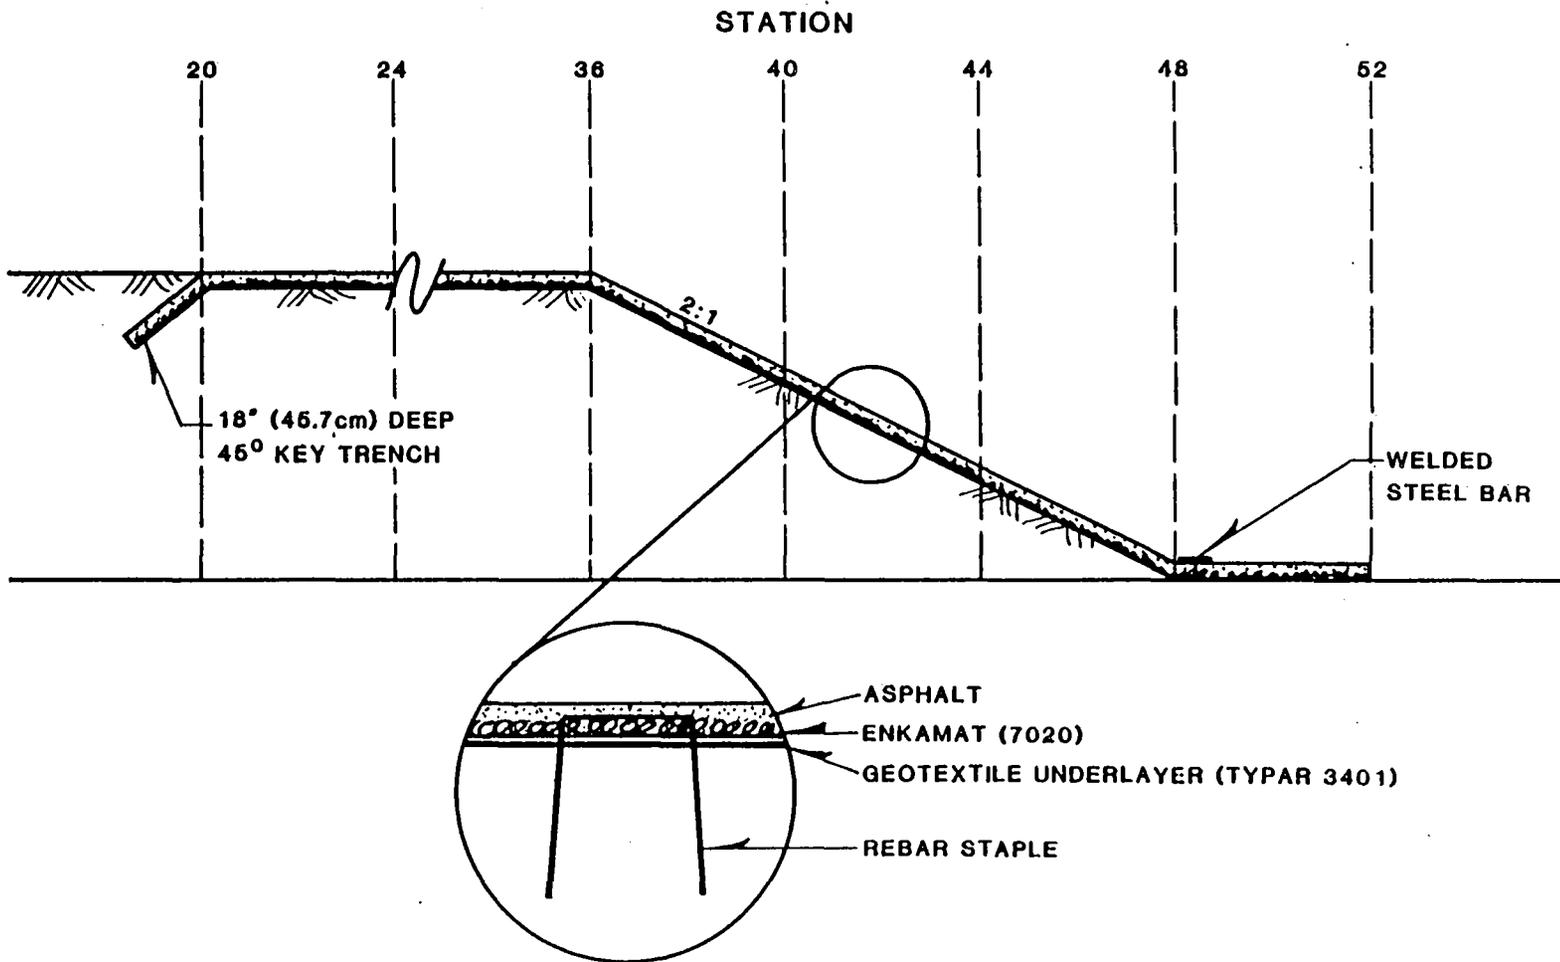
Figure 35. Sketch of Enkamat 7020 with 1-in (2.5 cm) asphalt cover.

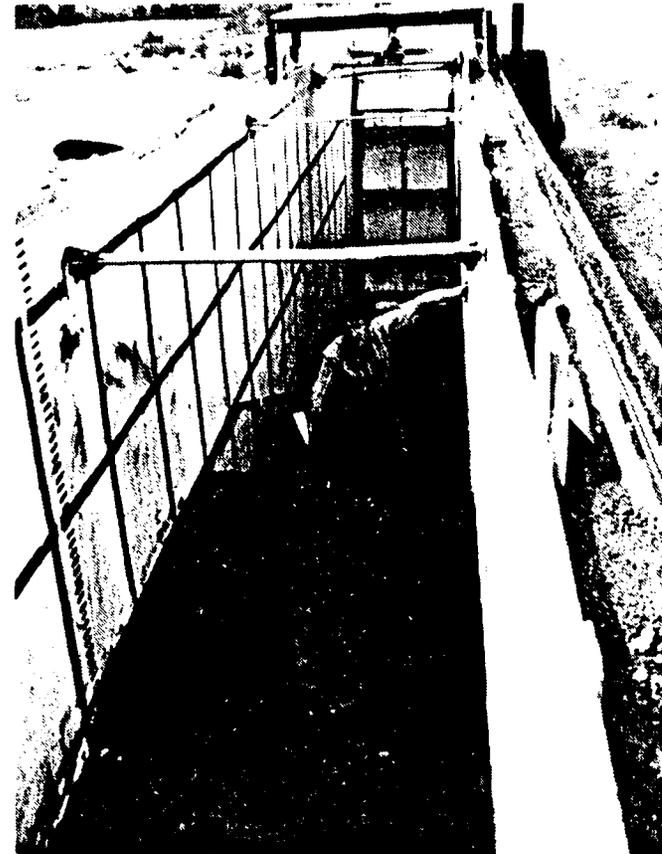
- b. Looking downstream at the embankment crest. Note deformation of system near right wall.

Figure 37. Failure of the enkamat with 1-in (2.5 cm) asphalt cover protection system.

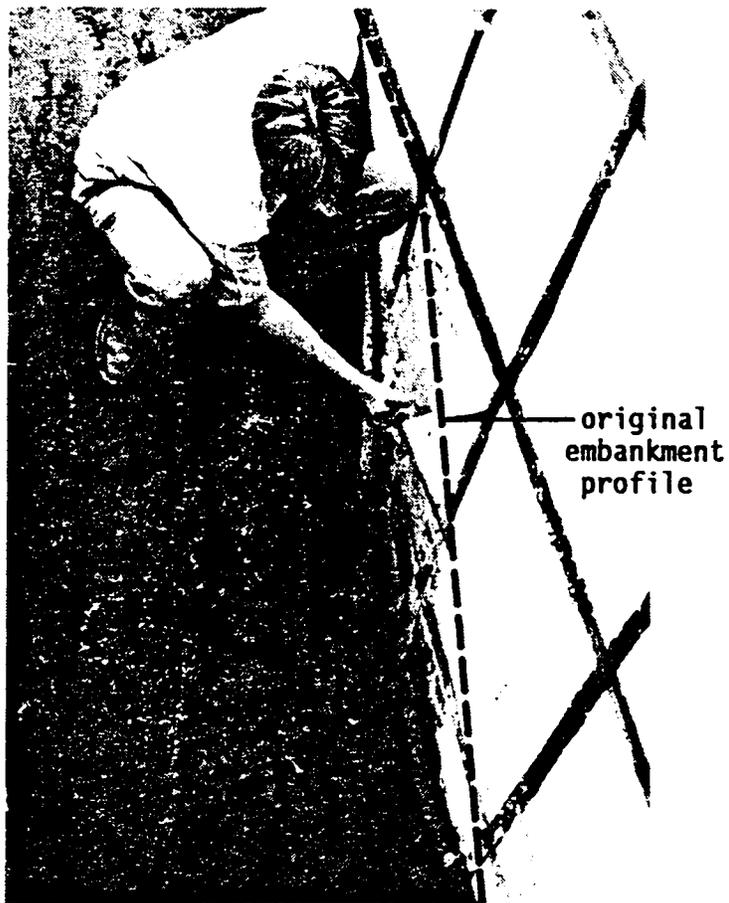
c. Looking upstream at the embankment shoulder. Note deterioration of asphalt surface.

Figure 37. Failure of the enkammat with 1-in (2.5 cm) asphalt cover protection system (continued).

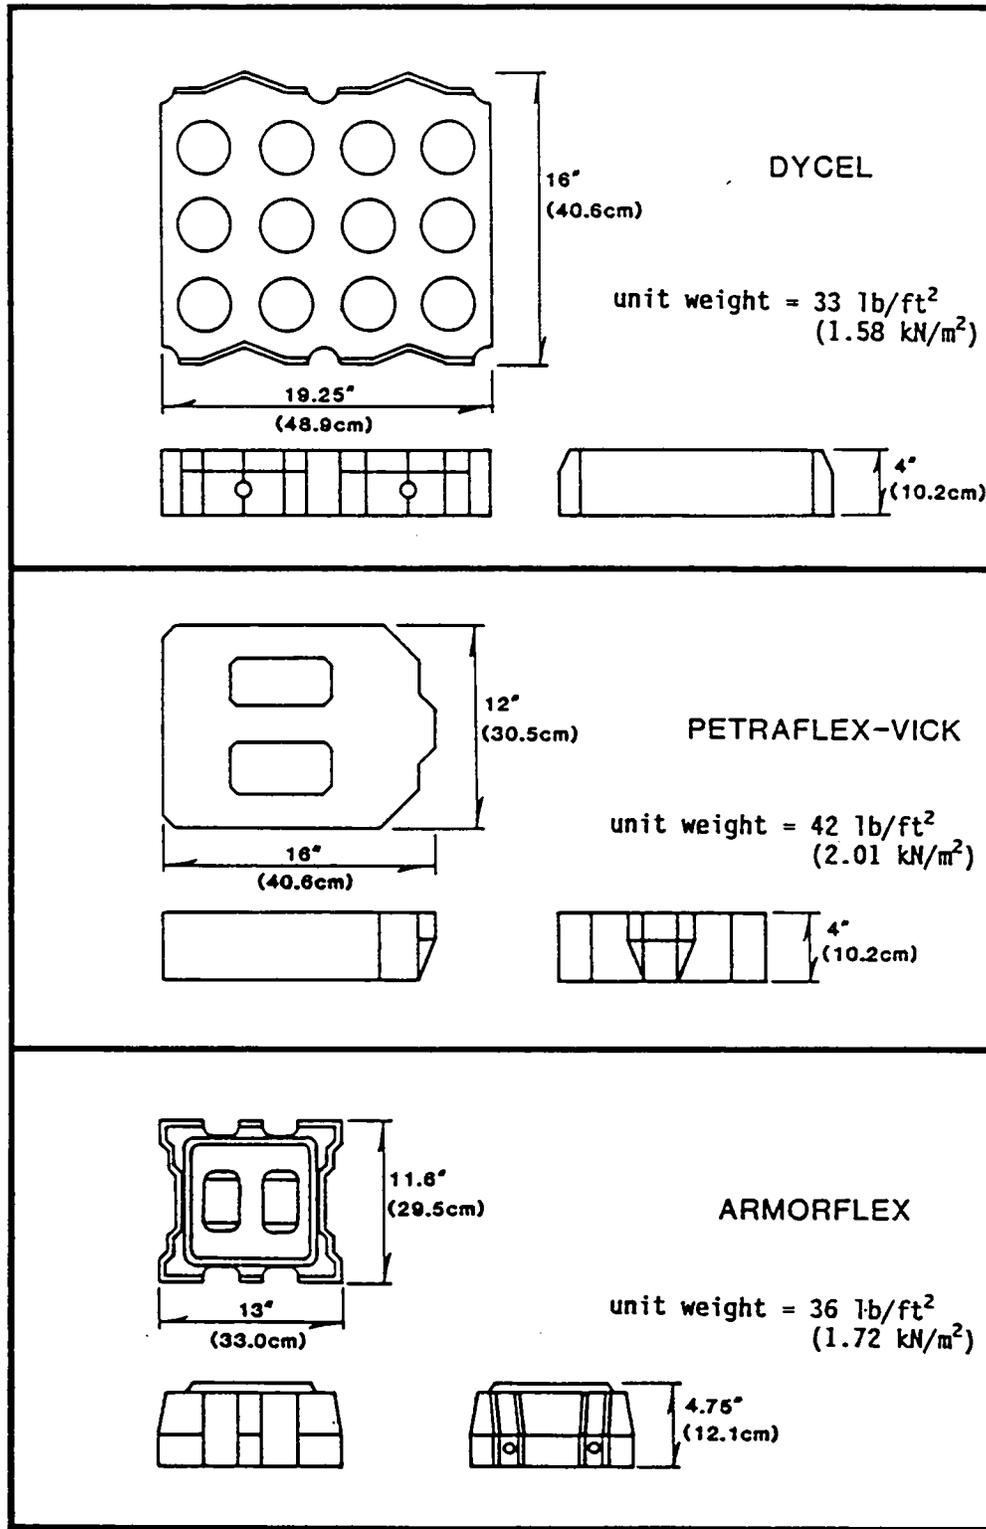
Figure 38. Sketches of the three types of concrete blocks tested.

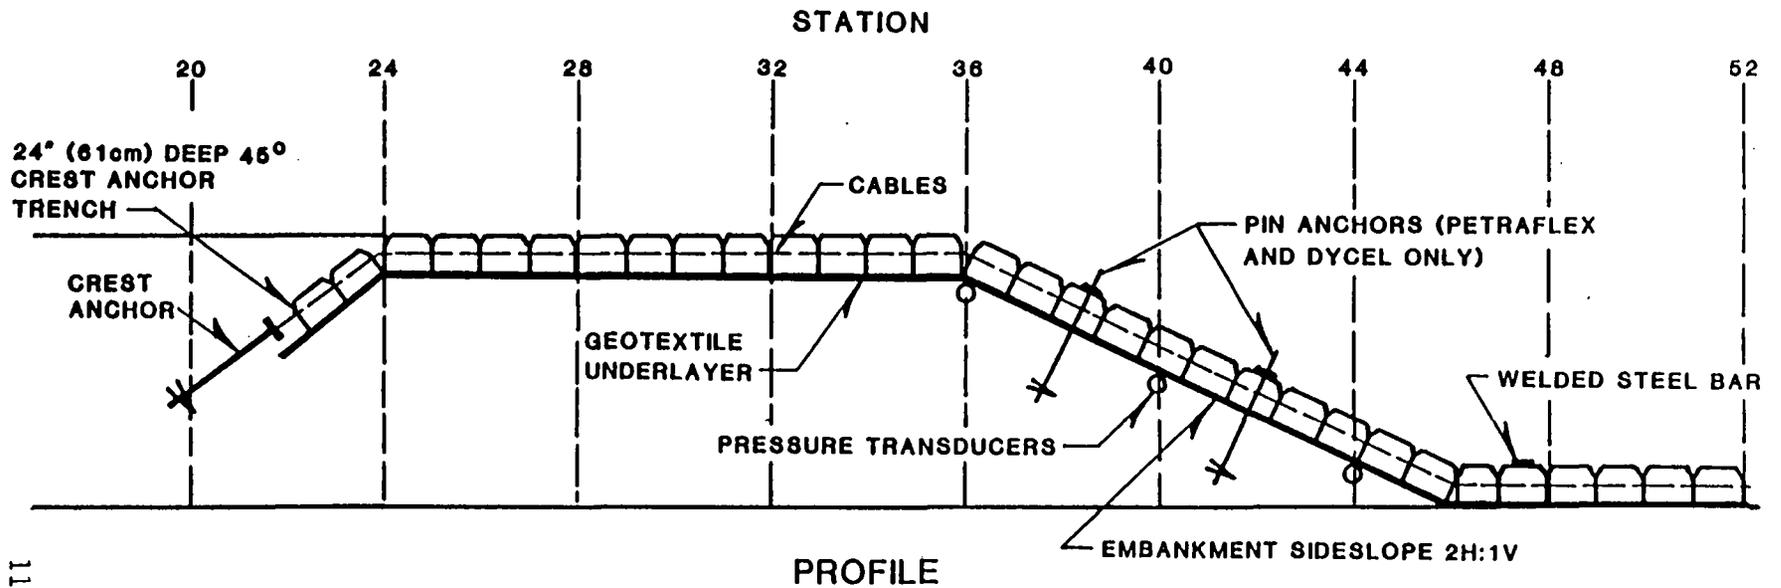
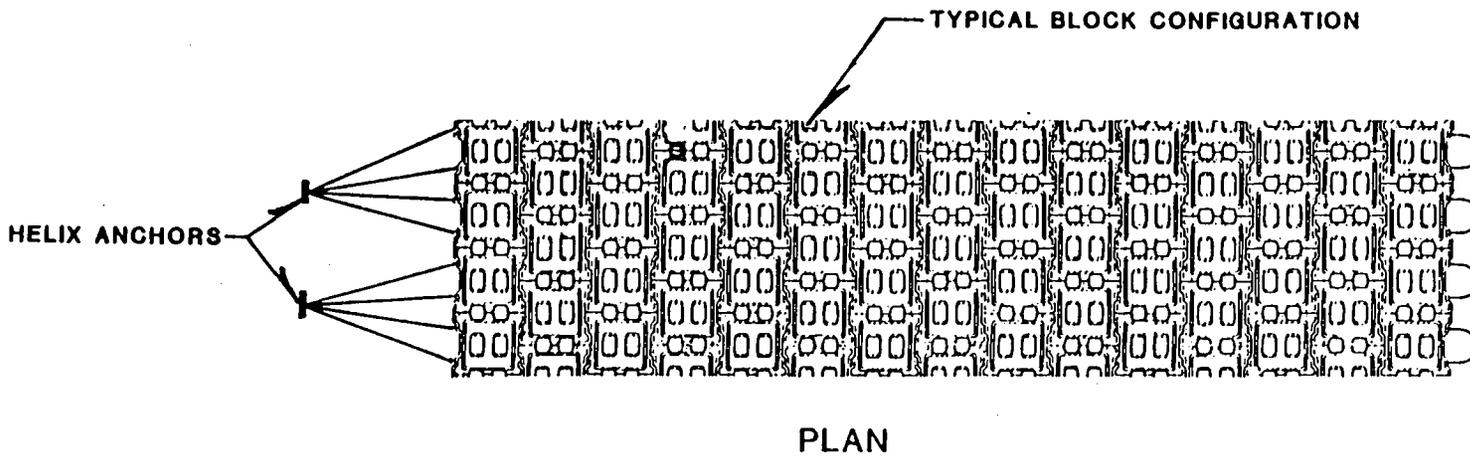
Figure 39. Typical concrete revetment system configuration.

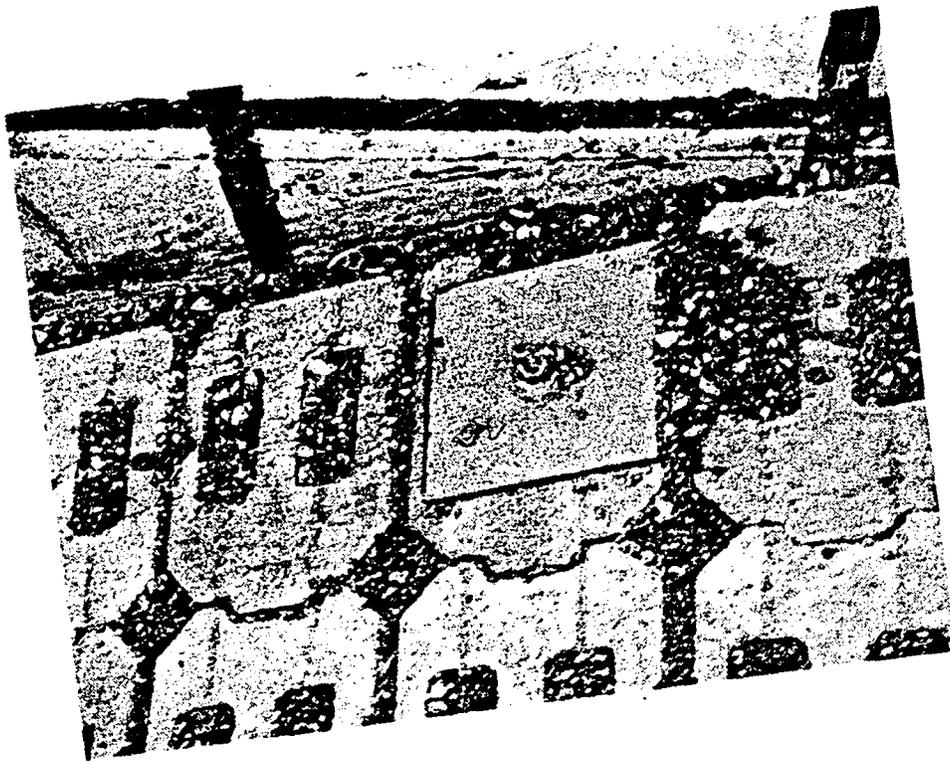
Figure 41. Anchoring system for the Petraflex-Vick revetment.

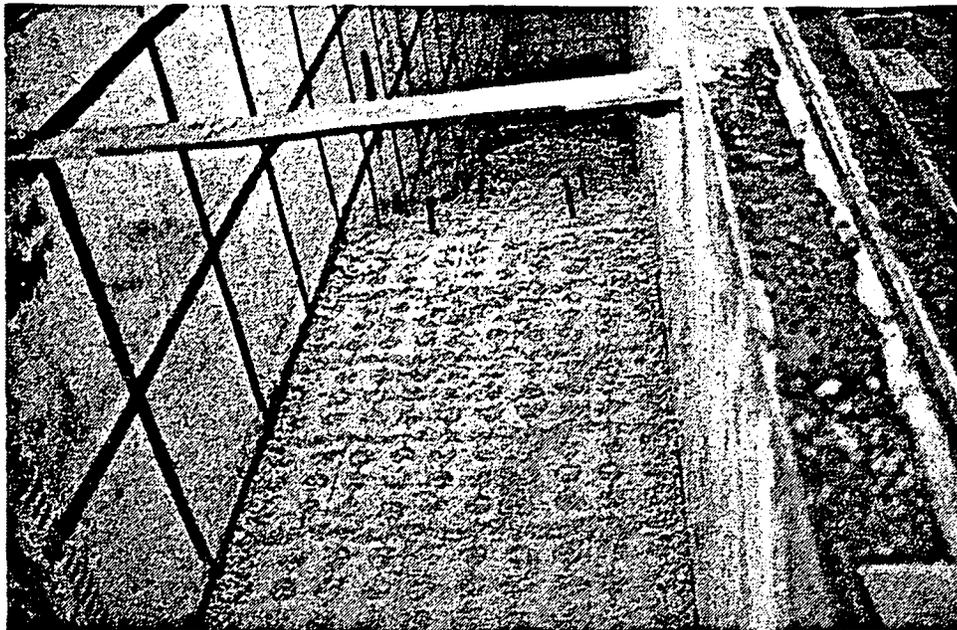
Figure 43. Completed Dycel concrete block embankment protection system (looking downstream).

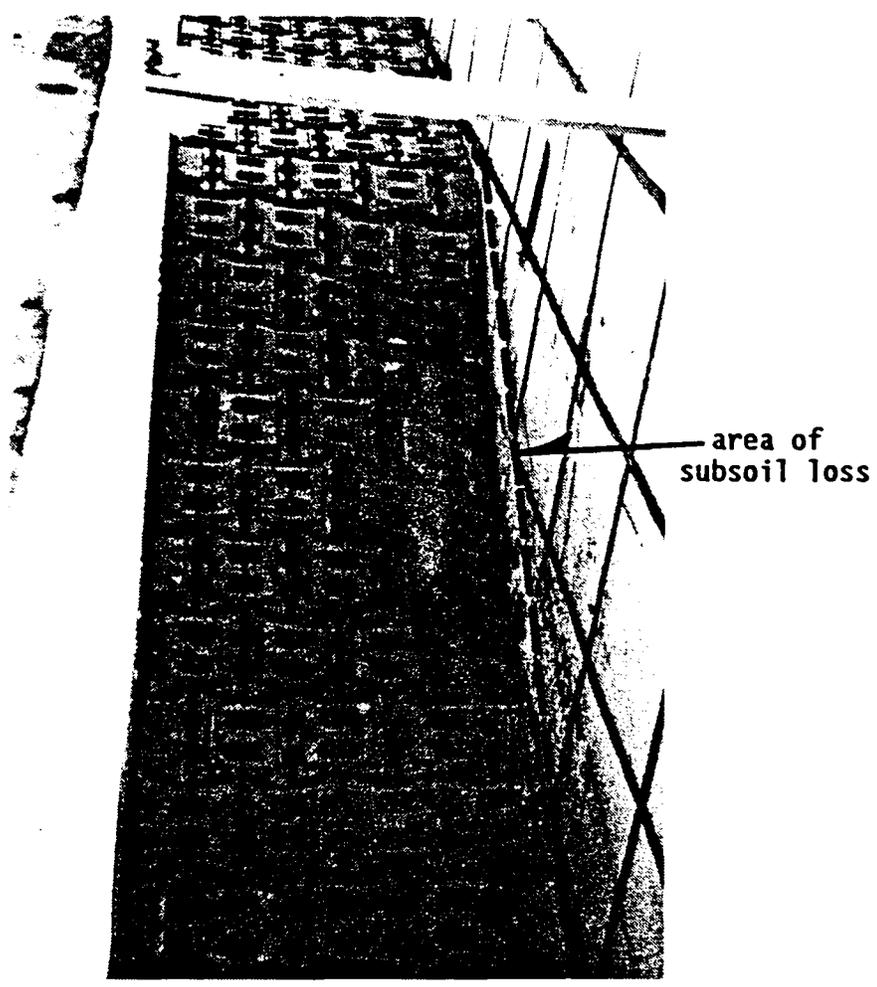
Figure 47. Localized failure exhibited by the Armorflex system.

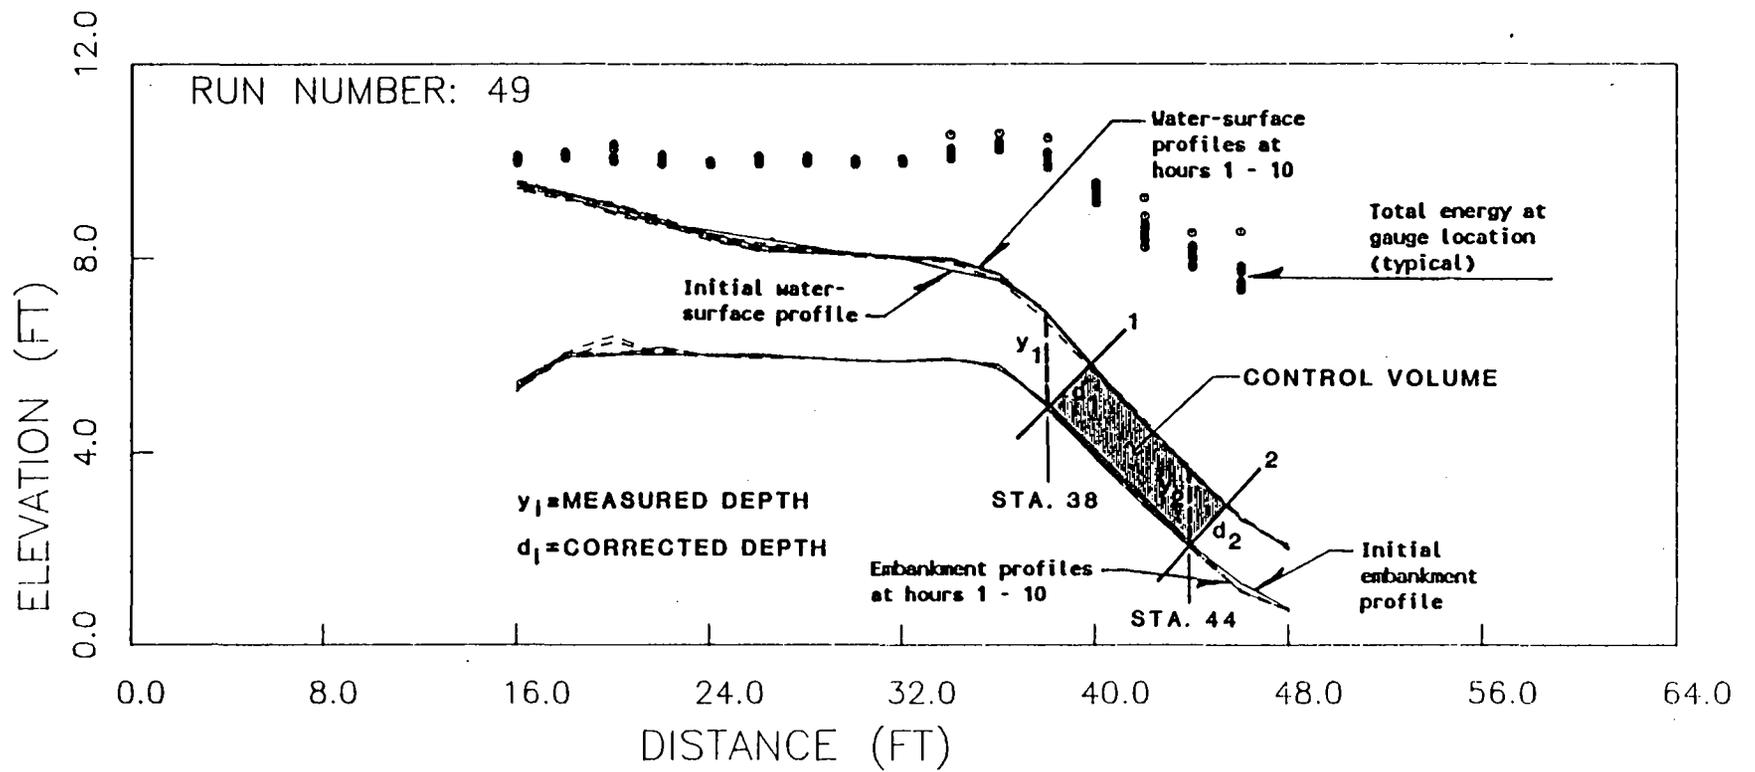
Figure 49. Control volume for test 49.

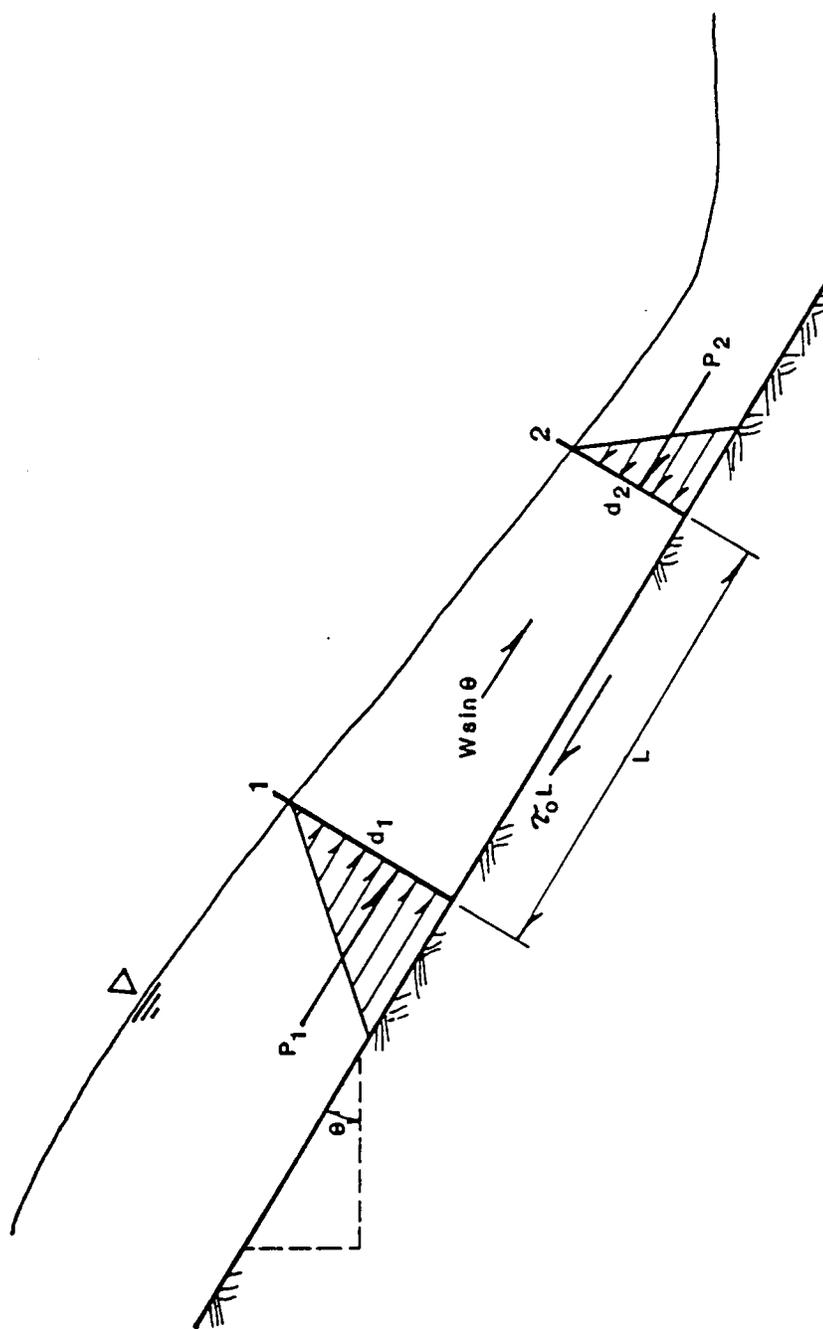
Figure 50. Typical control volume with momentum equation parameters.

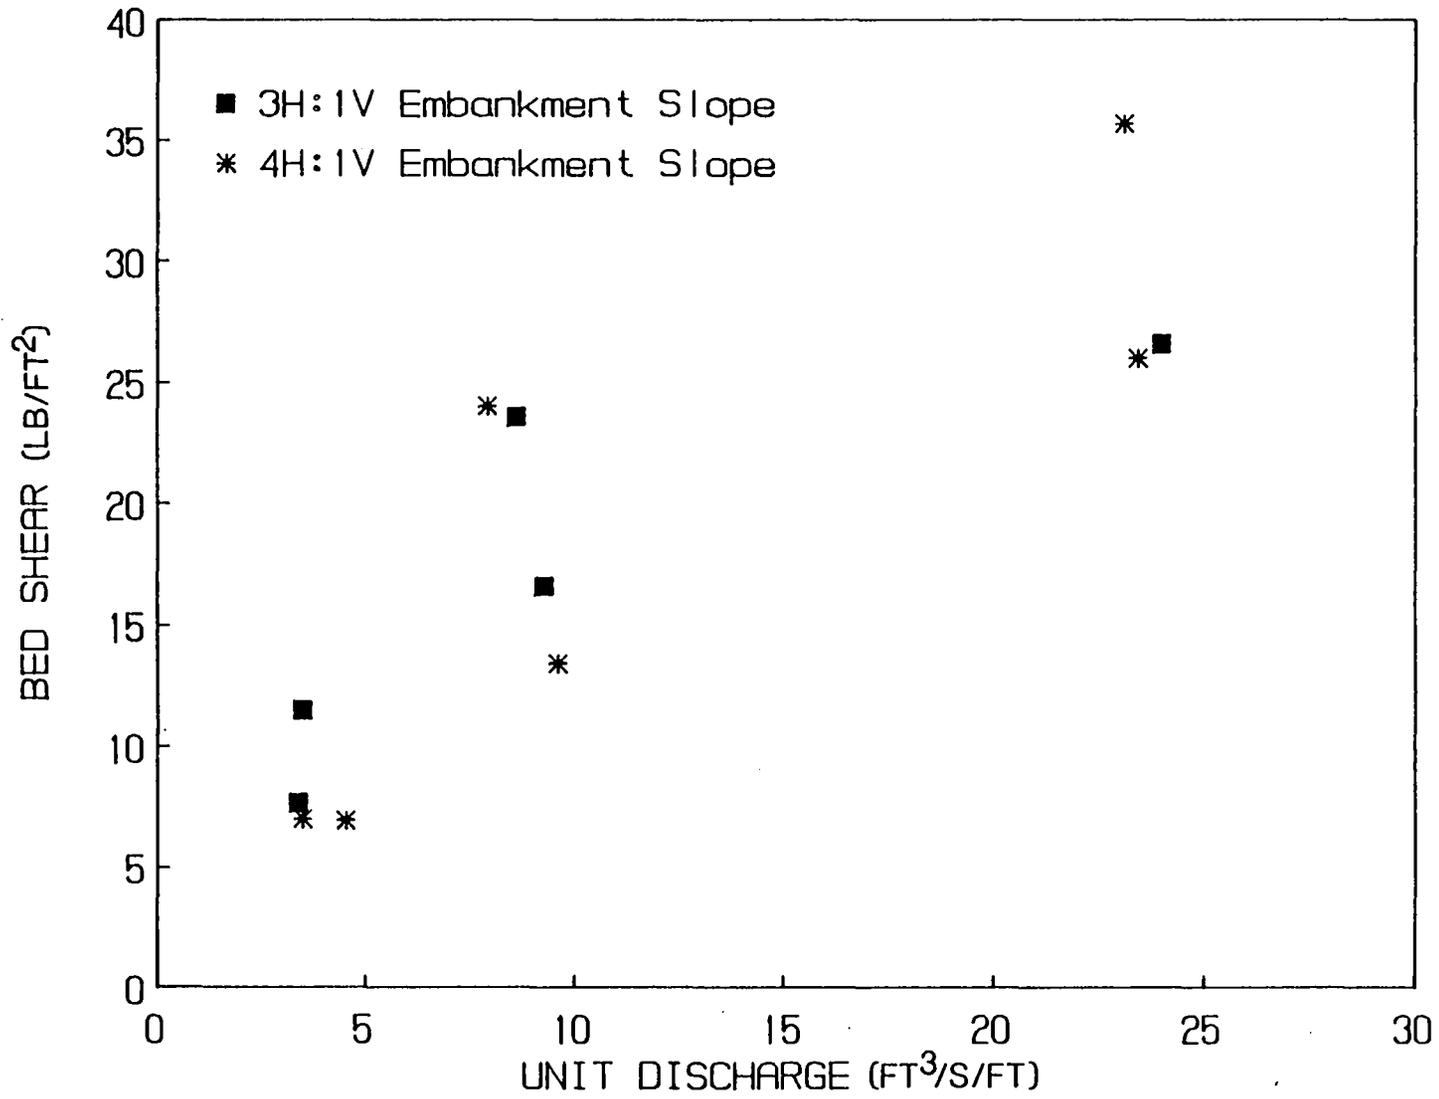
Figure 51. Bed shear versus unit discharge for bare soil freefall tests.

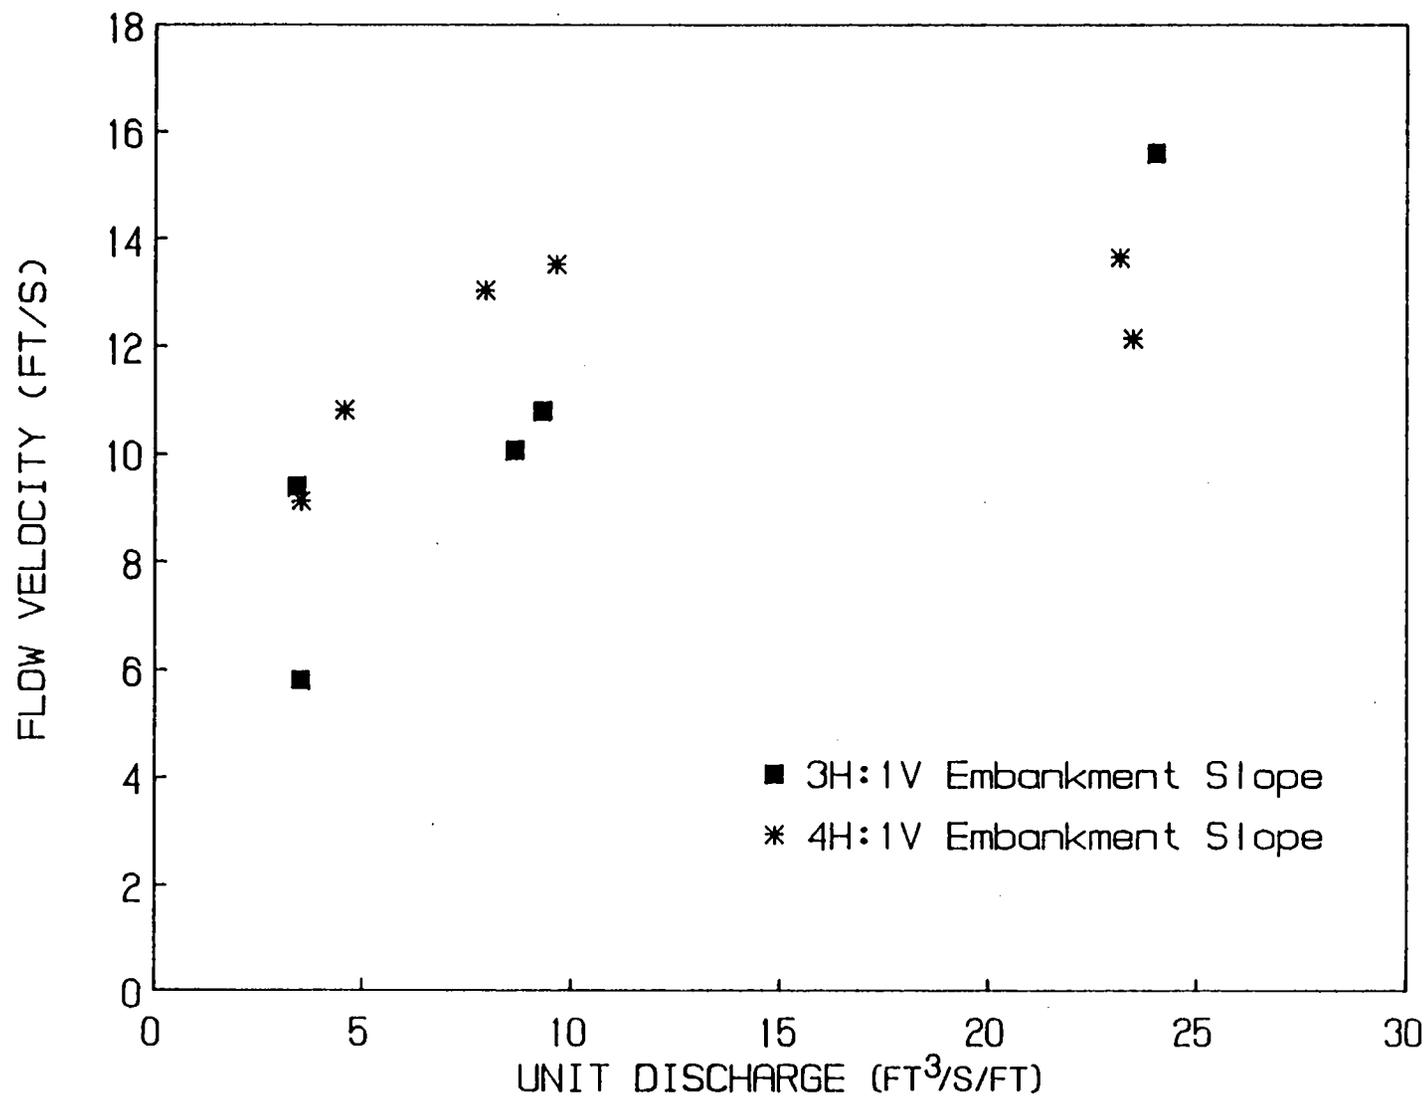
Figure 52. Flow velocity versus unit discharges for bare soil freefall tests.

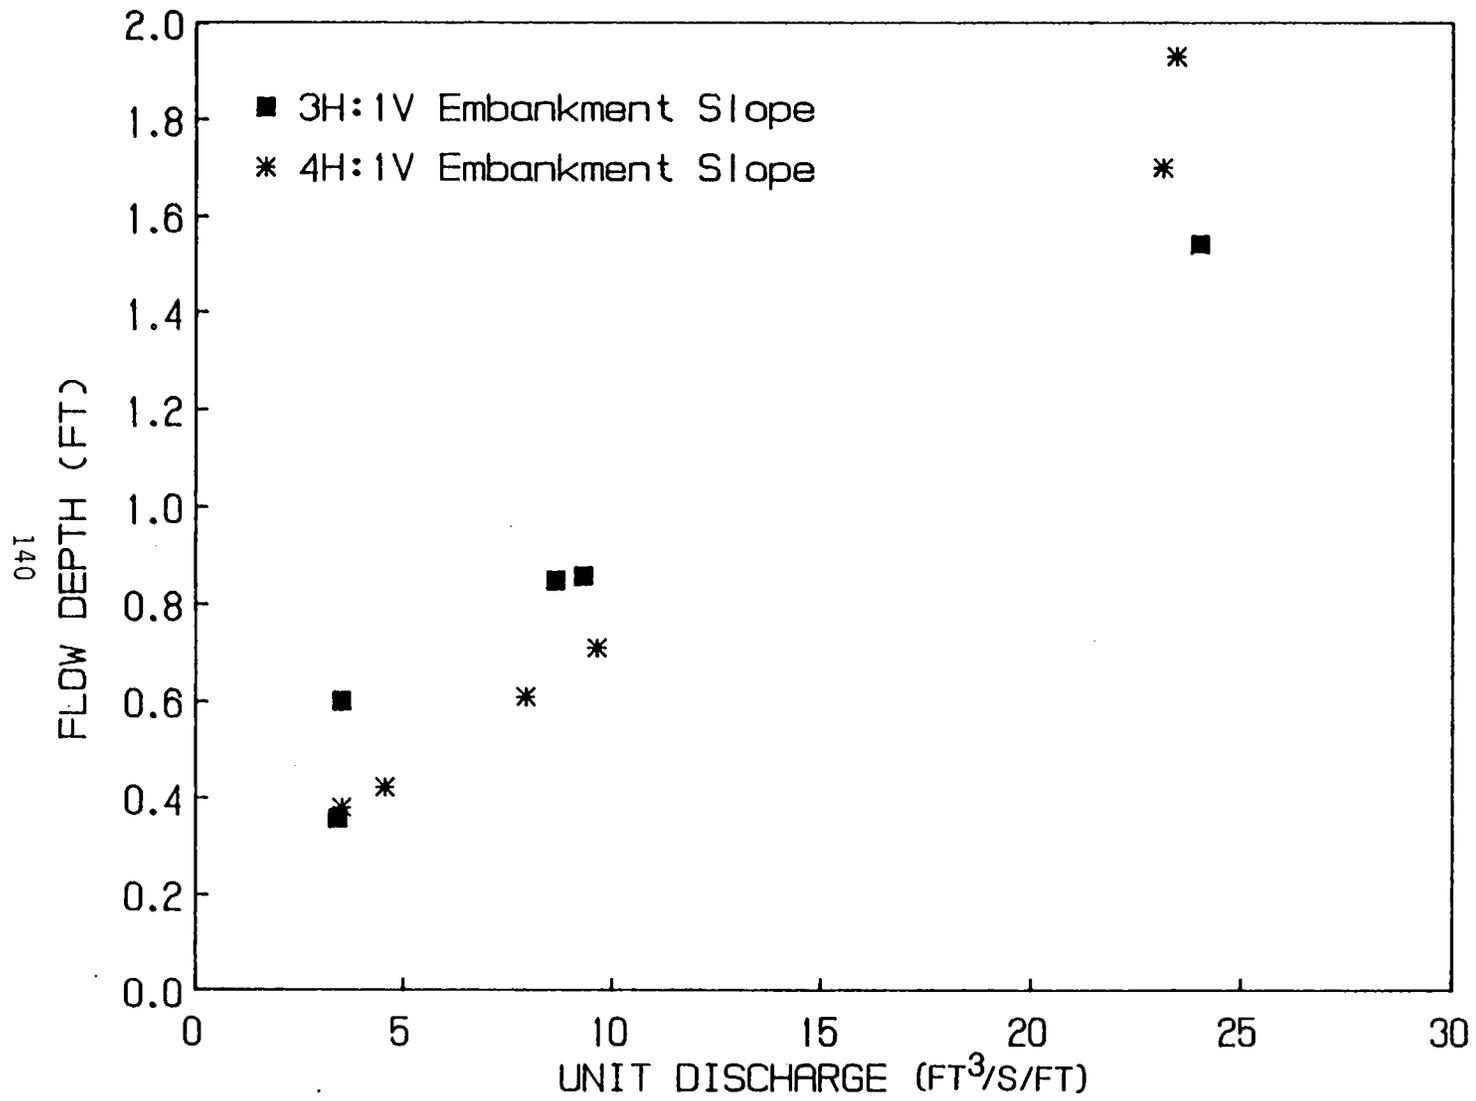
Figure 53. Flow depth versus unit discharges for bare soil freefall tests.
