# MINIMIZING EMBANKMENT DAMAGE DURING OVERTOPPING FLOW

U.S. Department of Transportation  
Federal Highway Administration  
400 Seventh Street, SW  
Washington, D.C.

November 1988

1. Report No. FHWA/RD-88/181		2. Government Accession No.		3. Recipient's Catalog No. FHWA-RD-88-181	
4. Title and Subtitle MINIMIZING EMBANKMENT DAMAGE DURING OVERTOPPING FLOW				5. Report Date November 1988

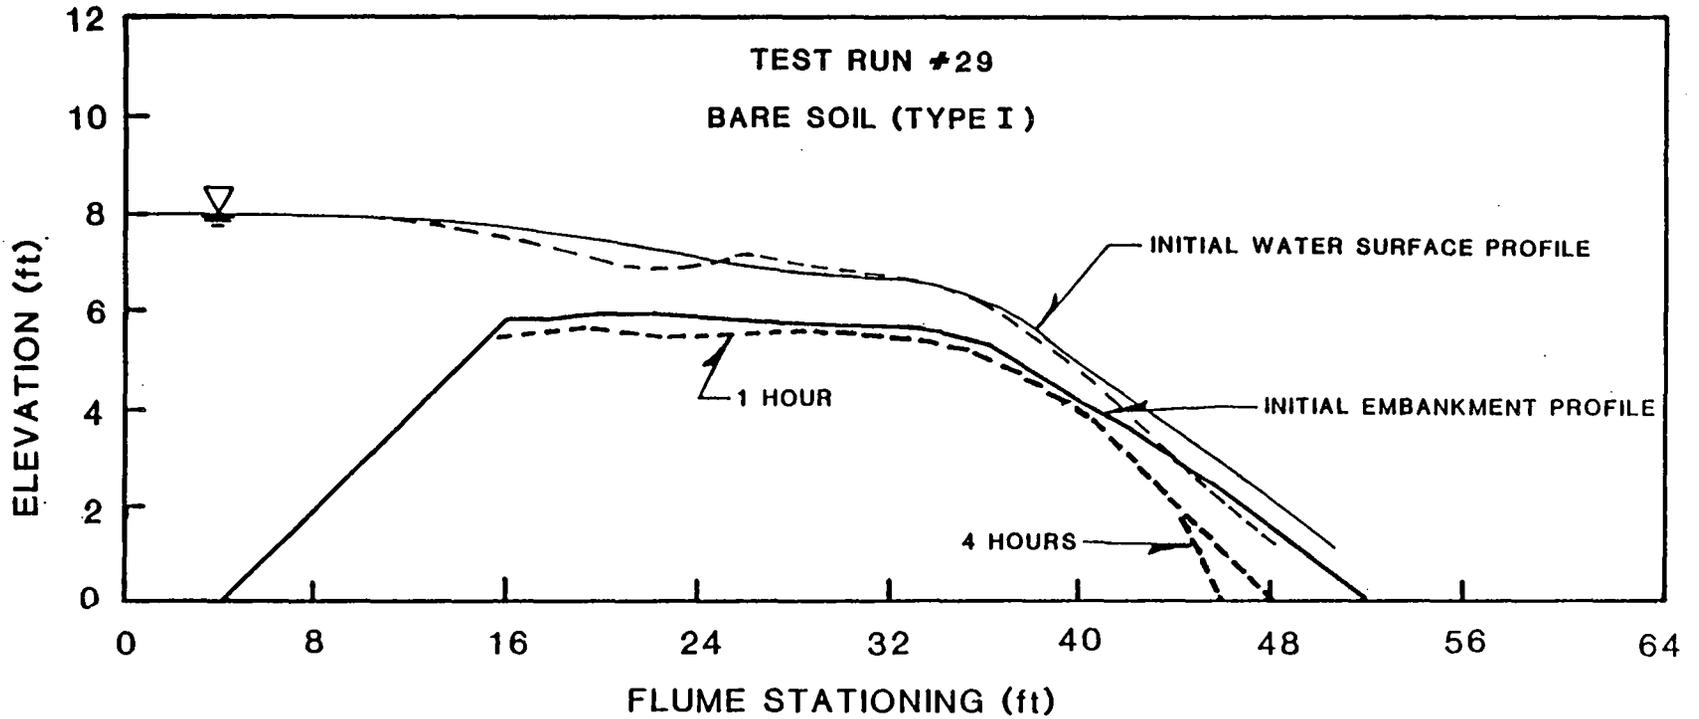
Figure 54. Erosion pattern for the test 29 bare soil embankment under freefall conditions [2-ft (0.61 m) overtopping depth].

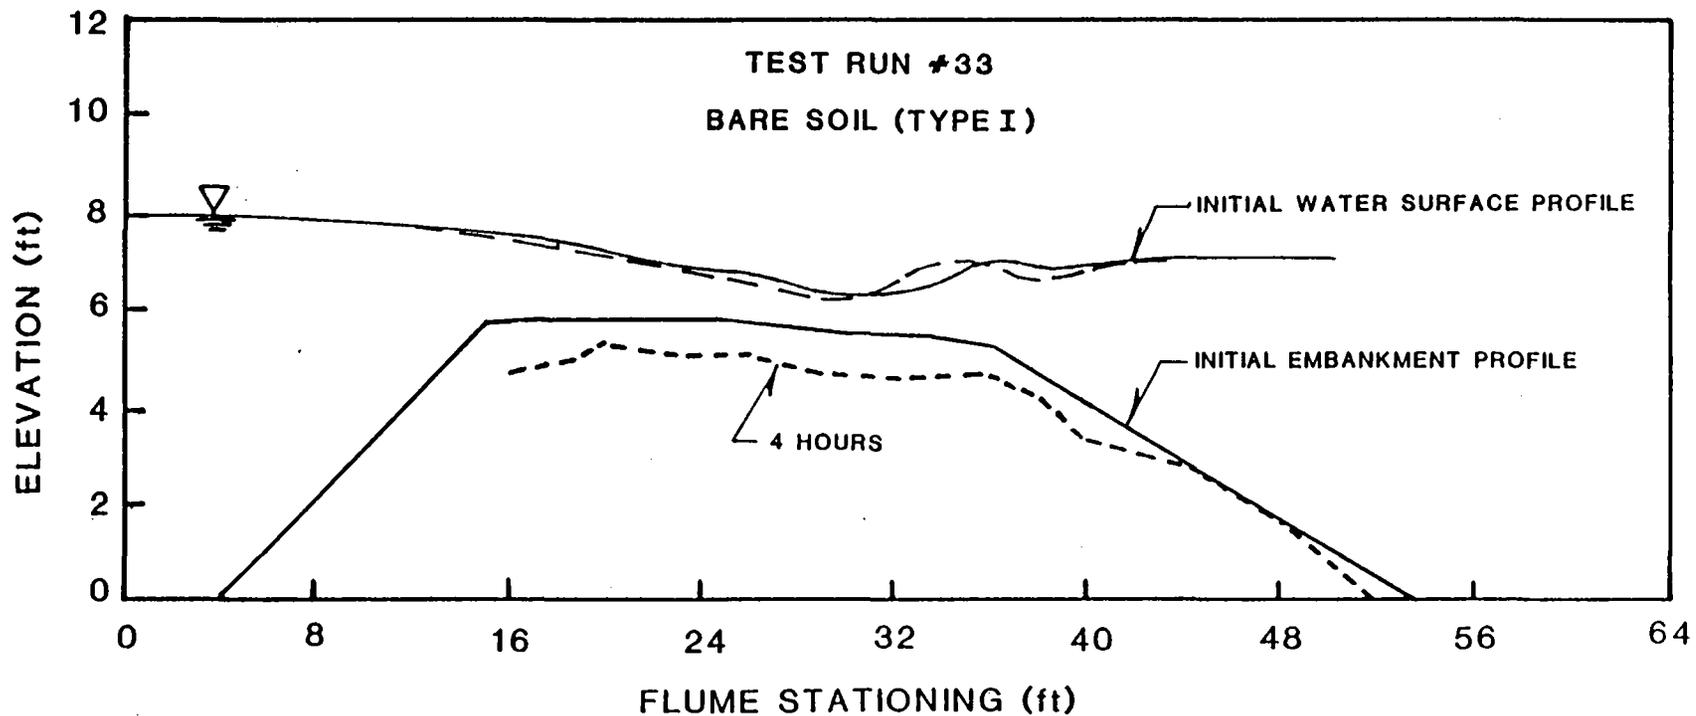
Figure 55. Erosion pattern for the test 33 bare soil embankment under tailwater conditions (2-ft (0.61 m) overtopping depth with a 1-ft (0.30 m) water surface drop).

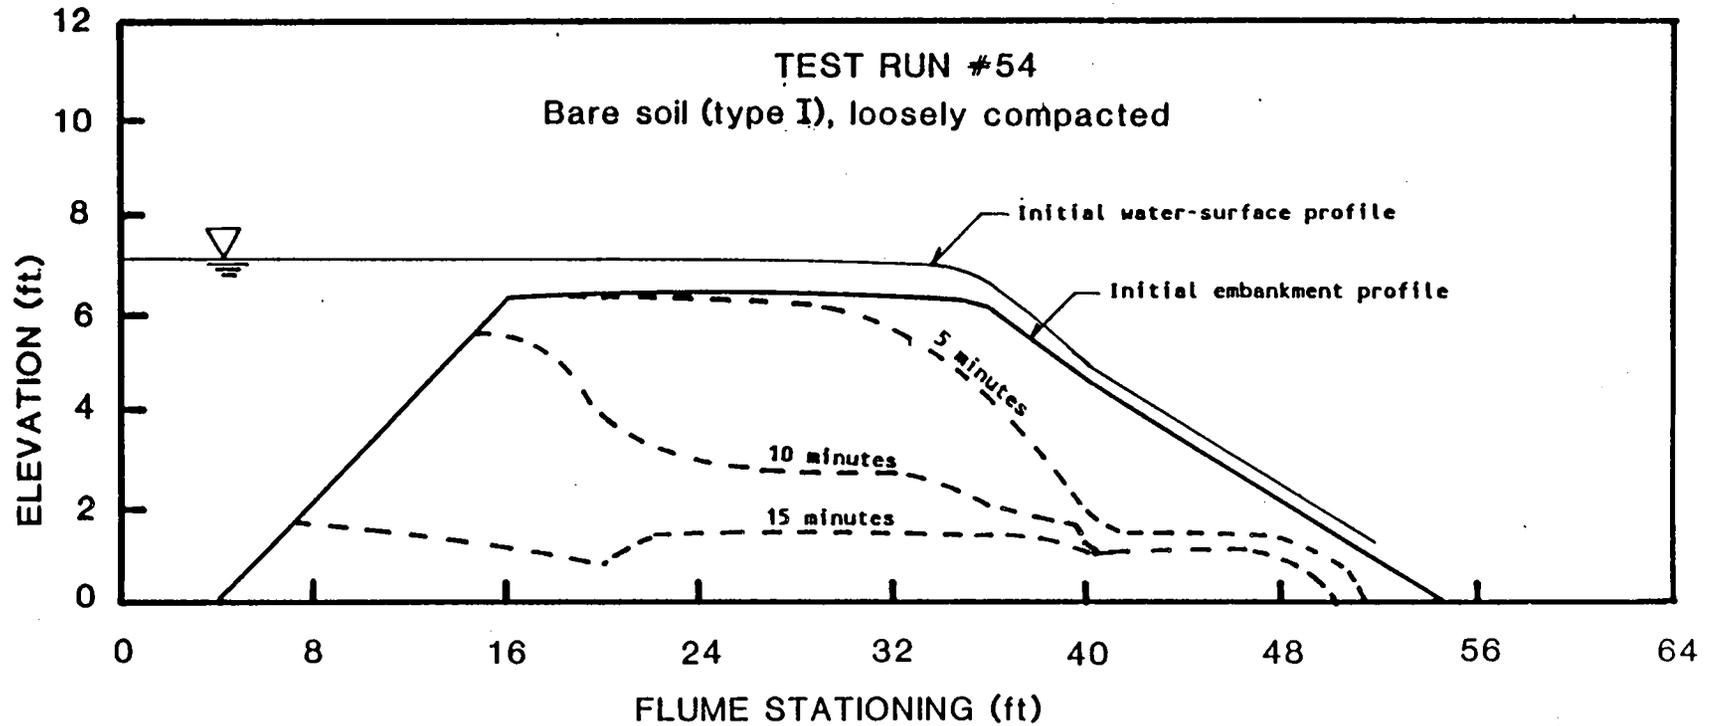
Figure 57. Erosion pattern for the test 54 bare soil embankment, loosely compacted, under freefall conditions [1-ft (0.30 m) overtopping depth].

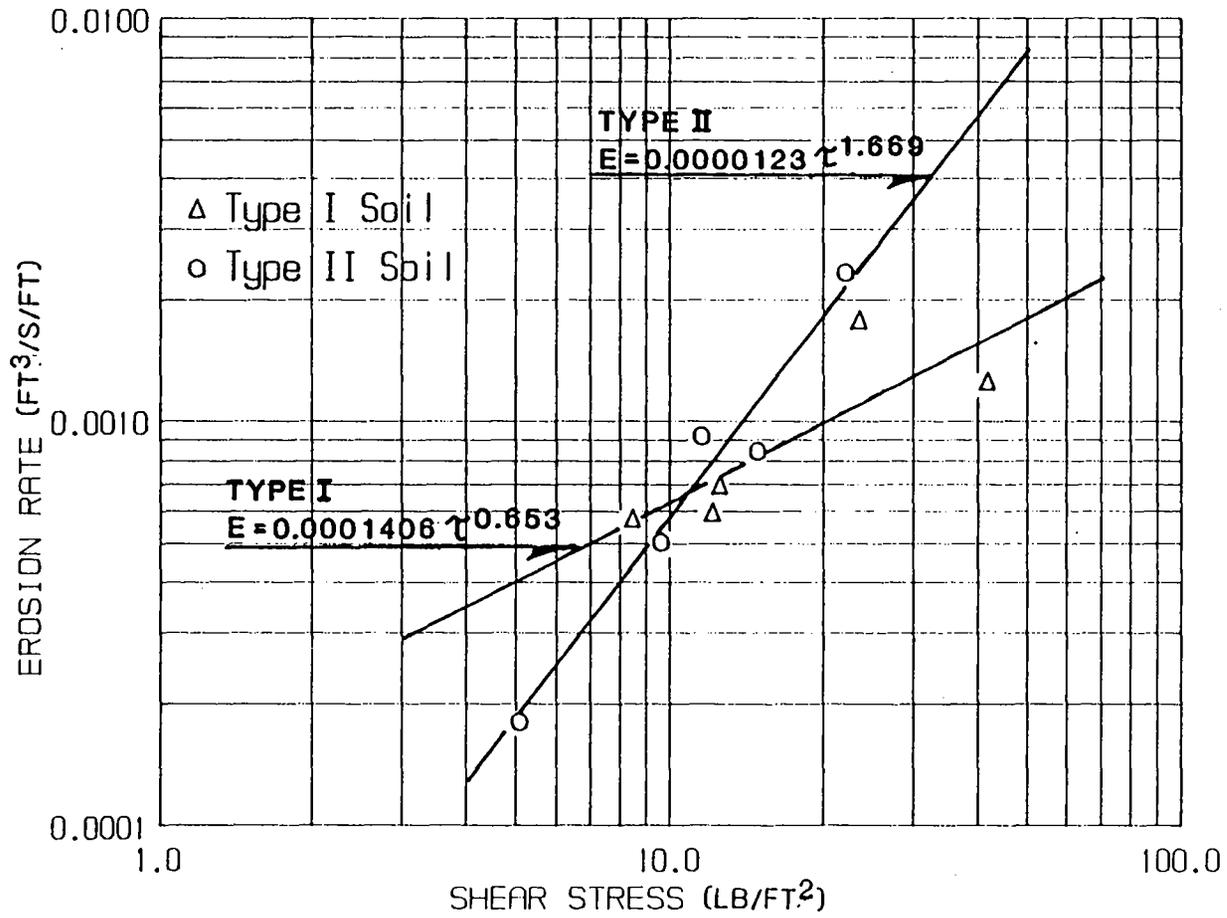
Figure 58. Detachment rate regression equations for soil types I and II.

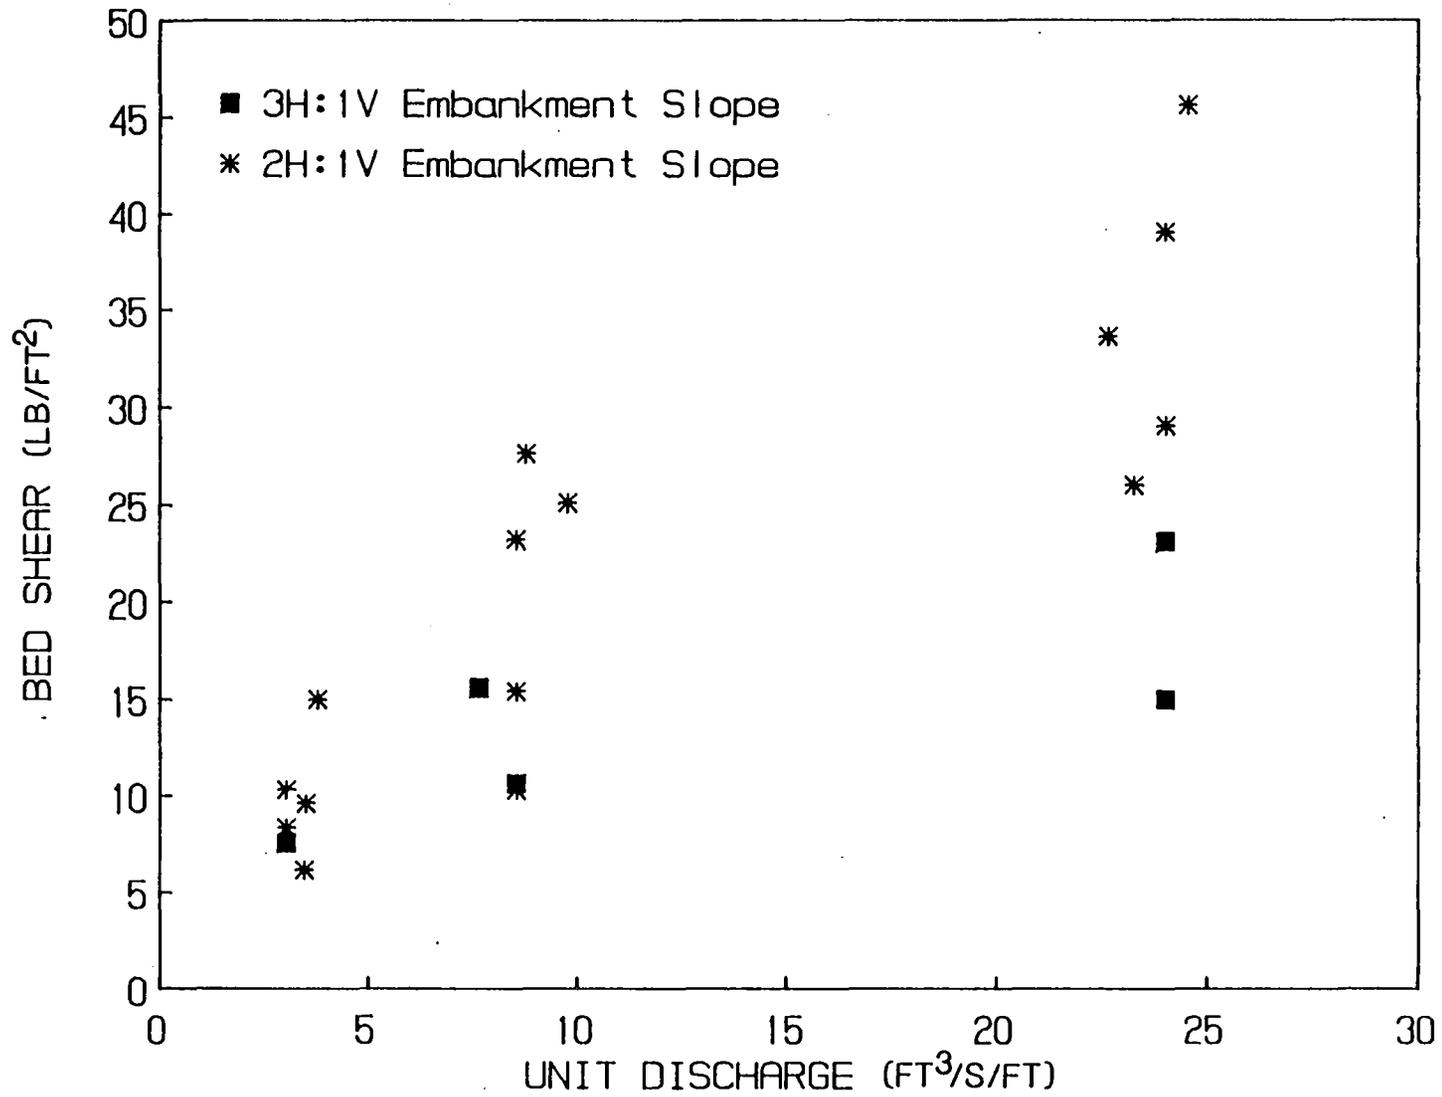
Figure 59. Bed shear versus unit discharge for protection system freefall tests.

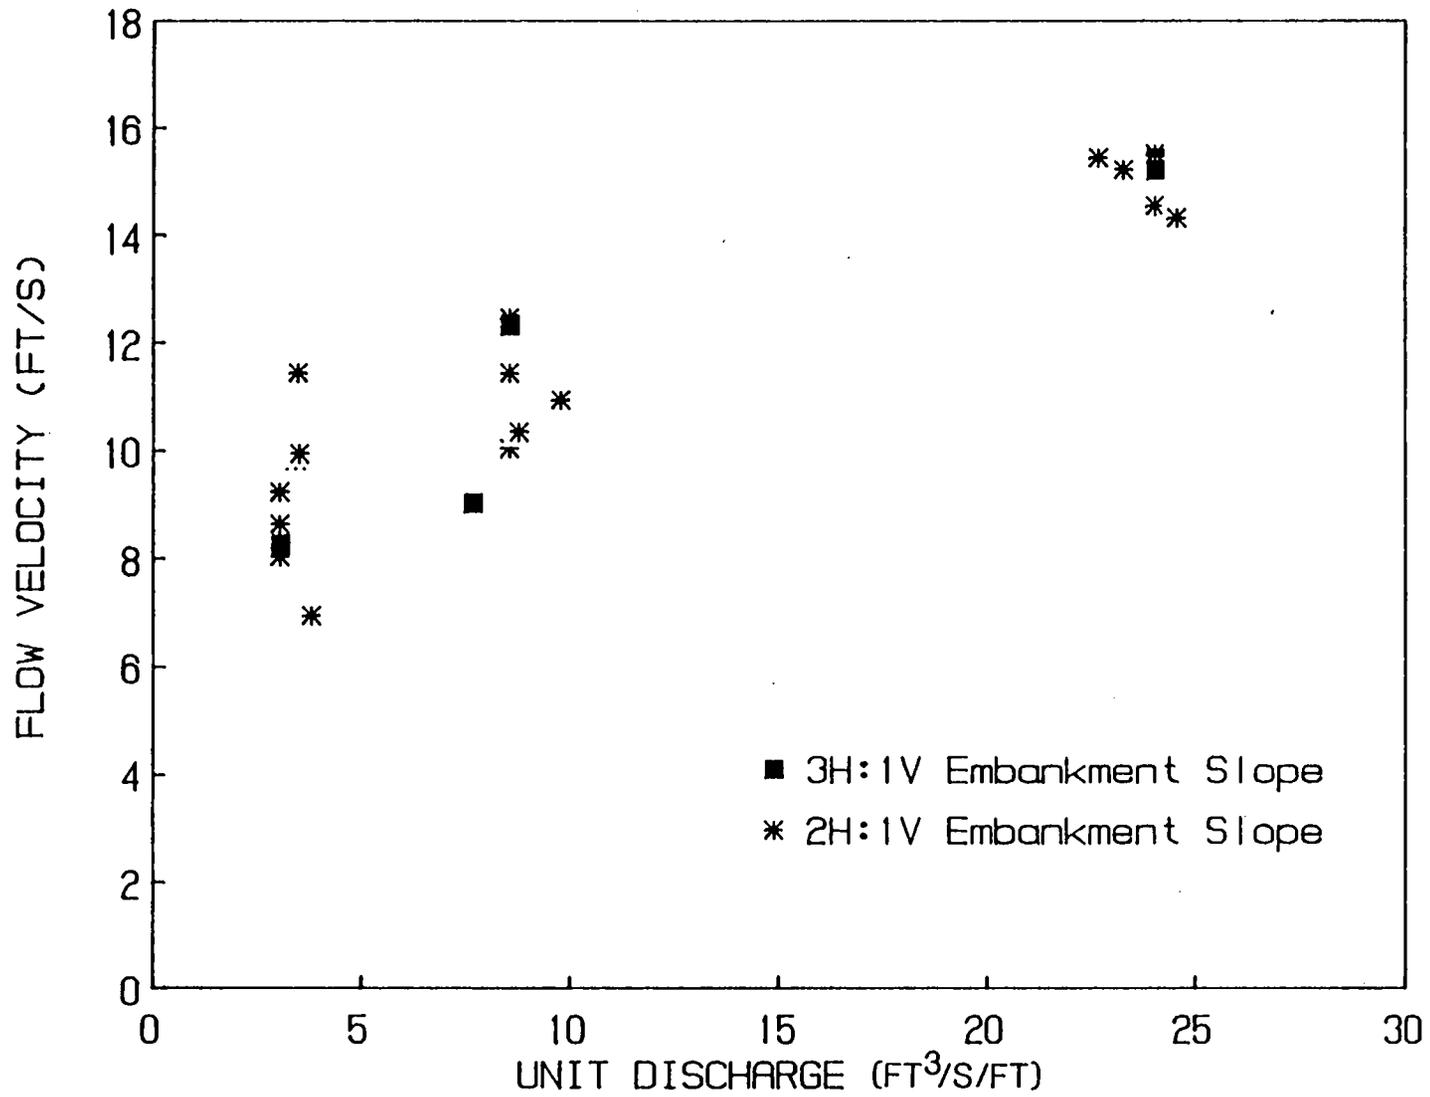
Figure 60. Flow velocity versus unit discharge for protection system freefall tests.

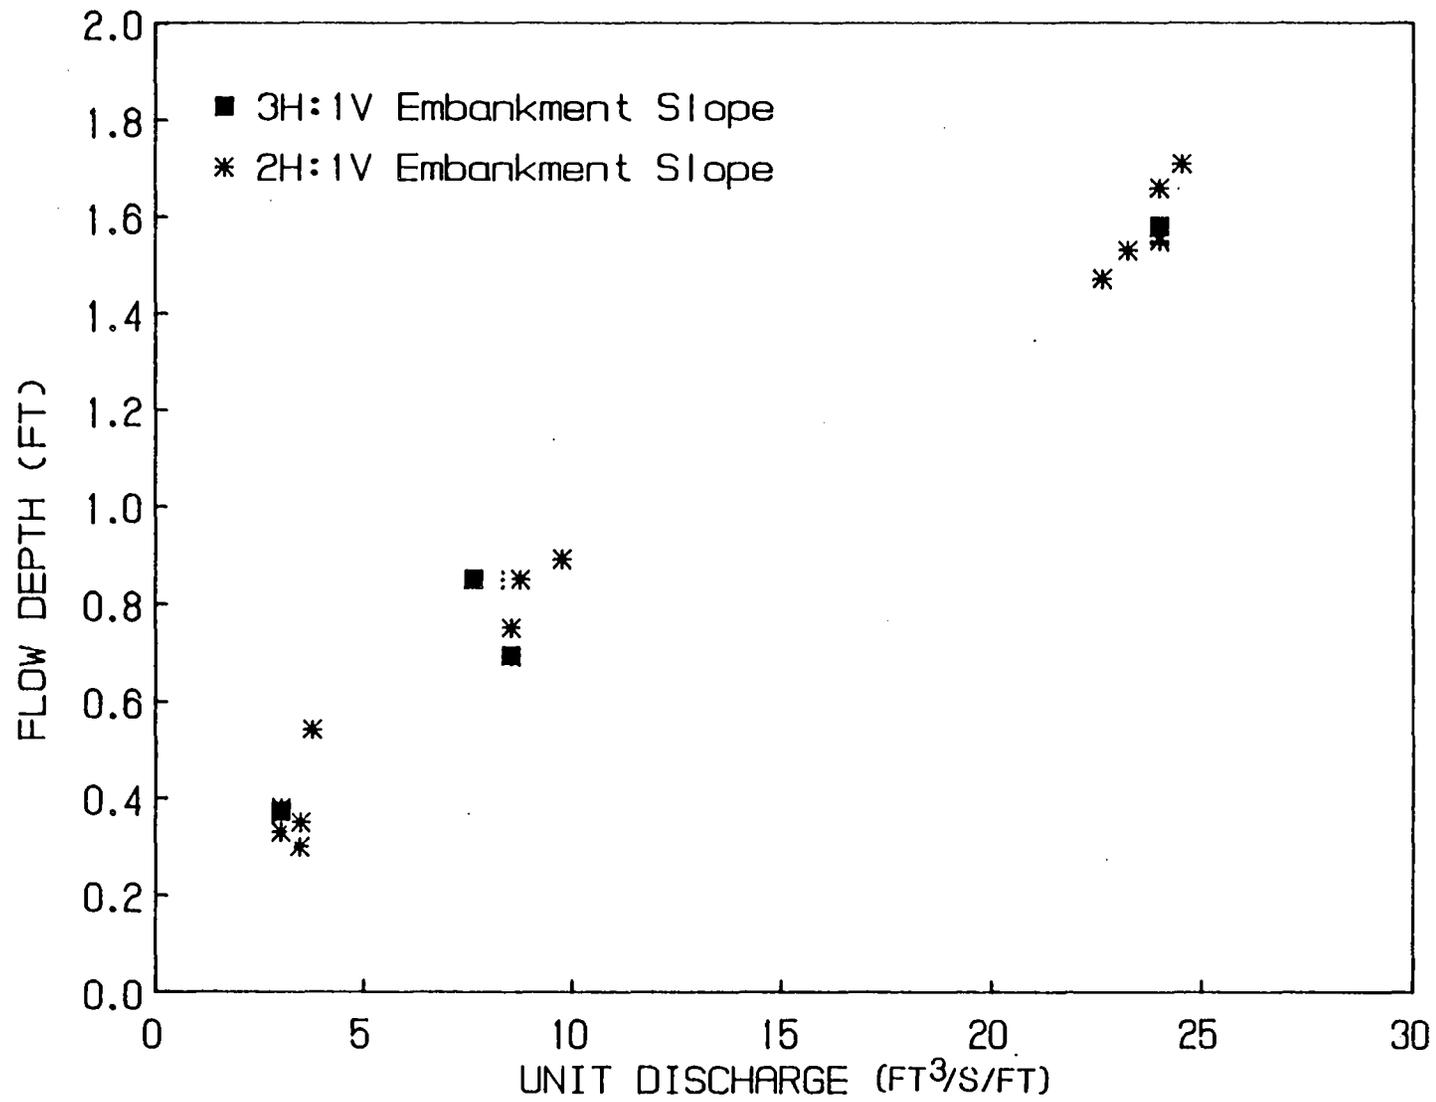
Figure 61. Flow depth versus unit discharge for protection system freefall tests.

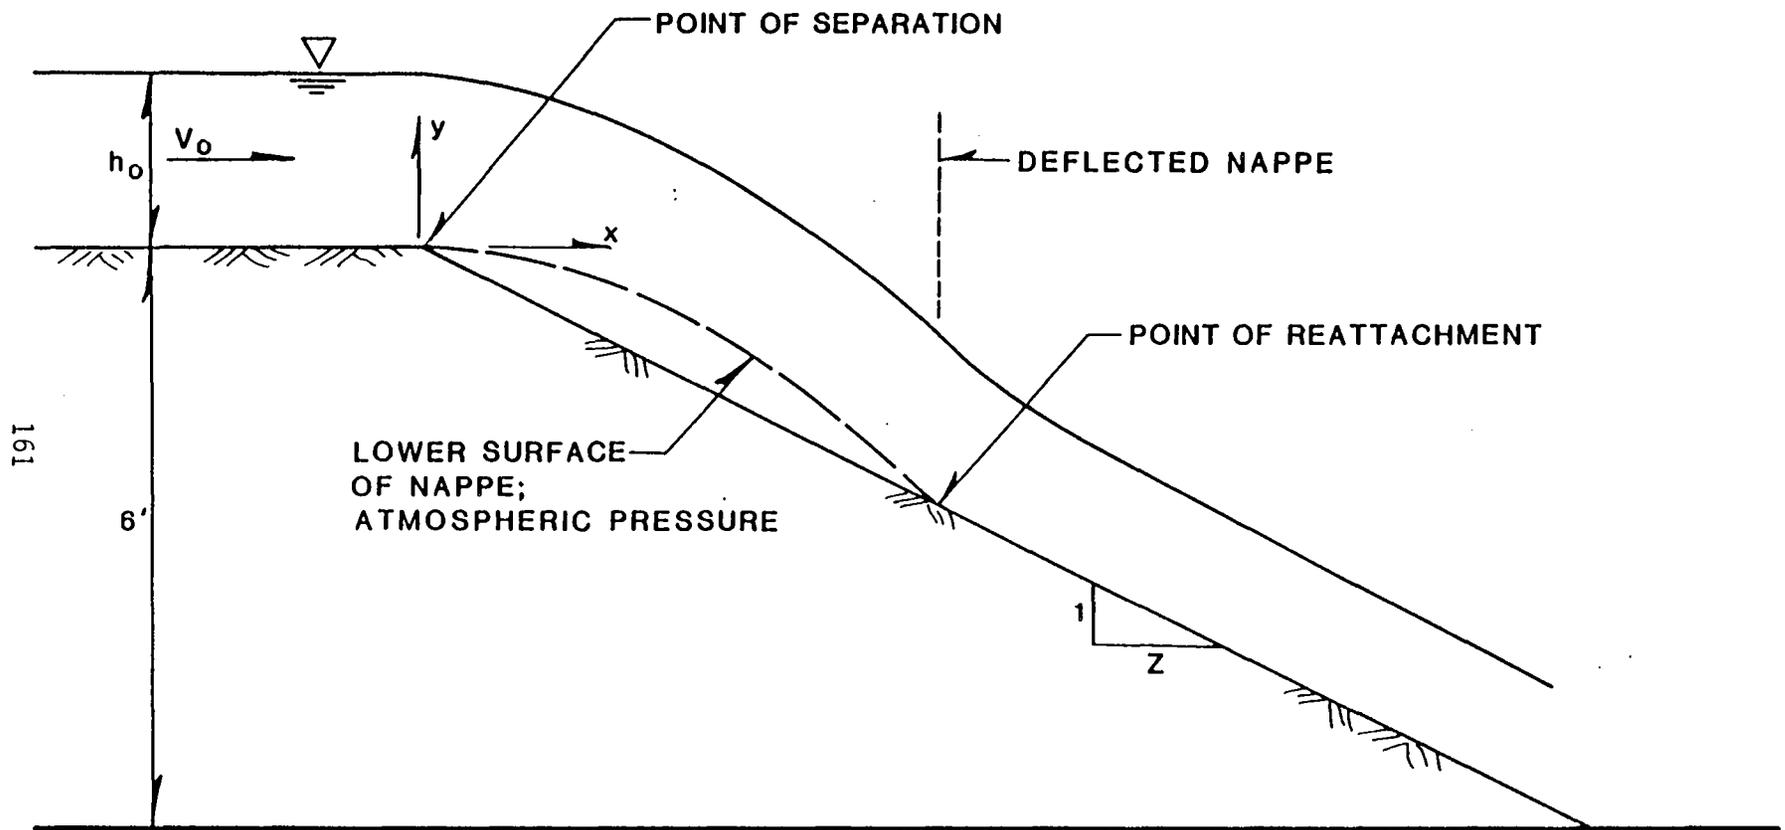
Figure 62. Profile of water nappe and theoretical subatmospheric pressure zone.

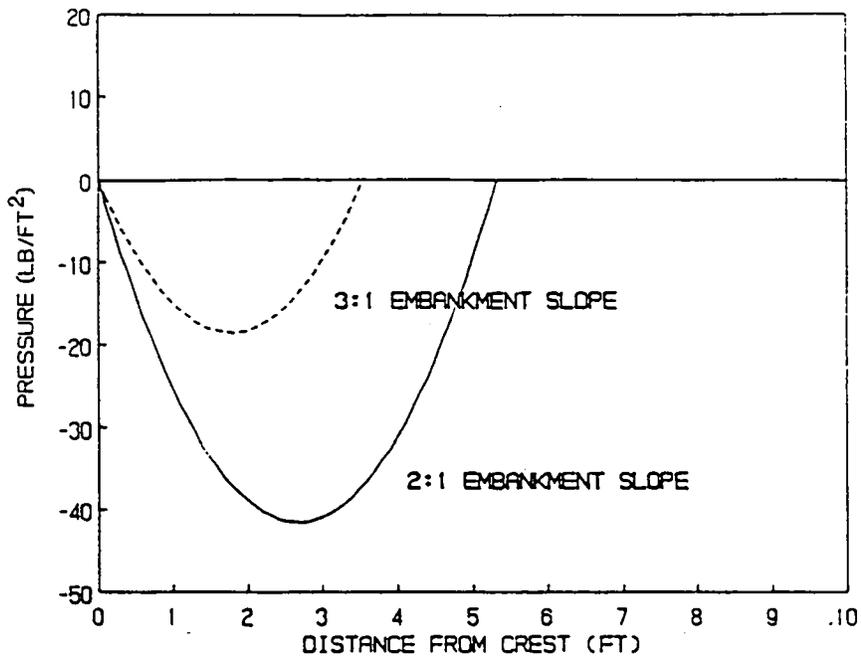
Figure 63. Theoretical pressure variation with distance from crest for 4-ft (1.2 m) overtopping depth.

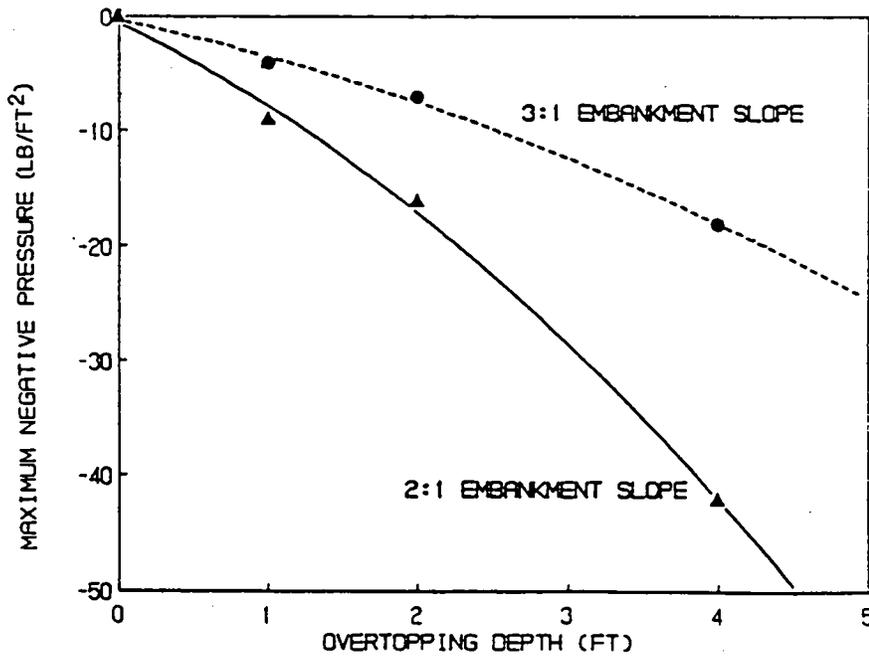
Figure 64. Theoretical maximum negative pressure variation with overtopping depth.

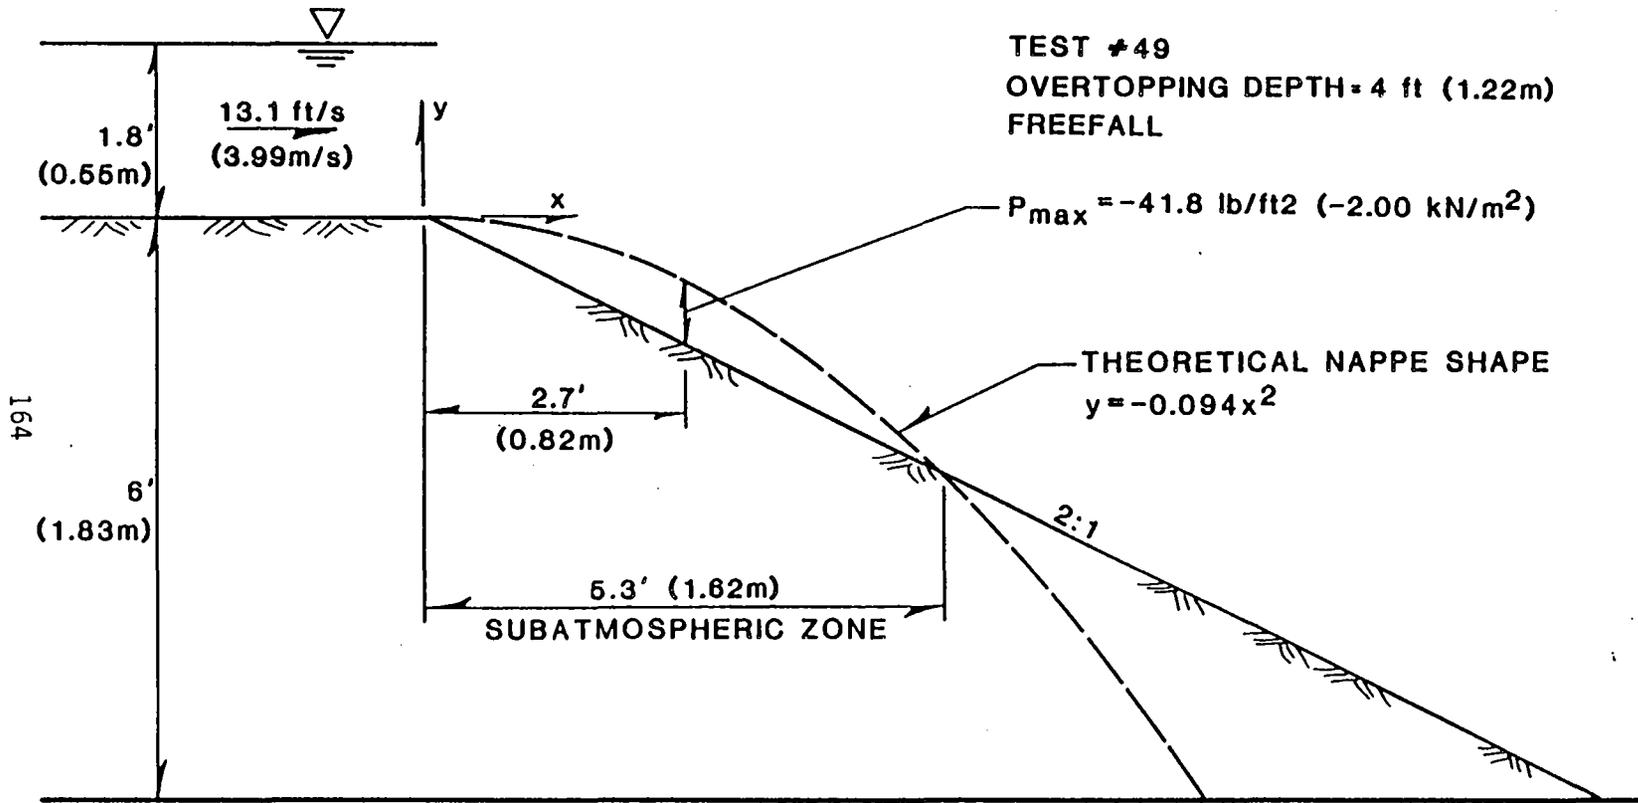
Figure 65. Theoretical negative pressure profile for test 49.

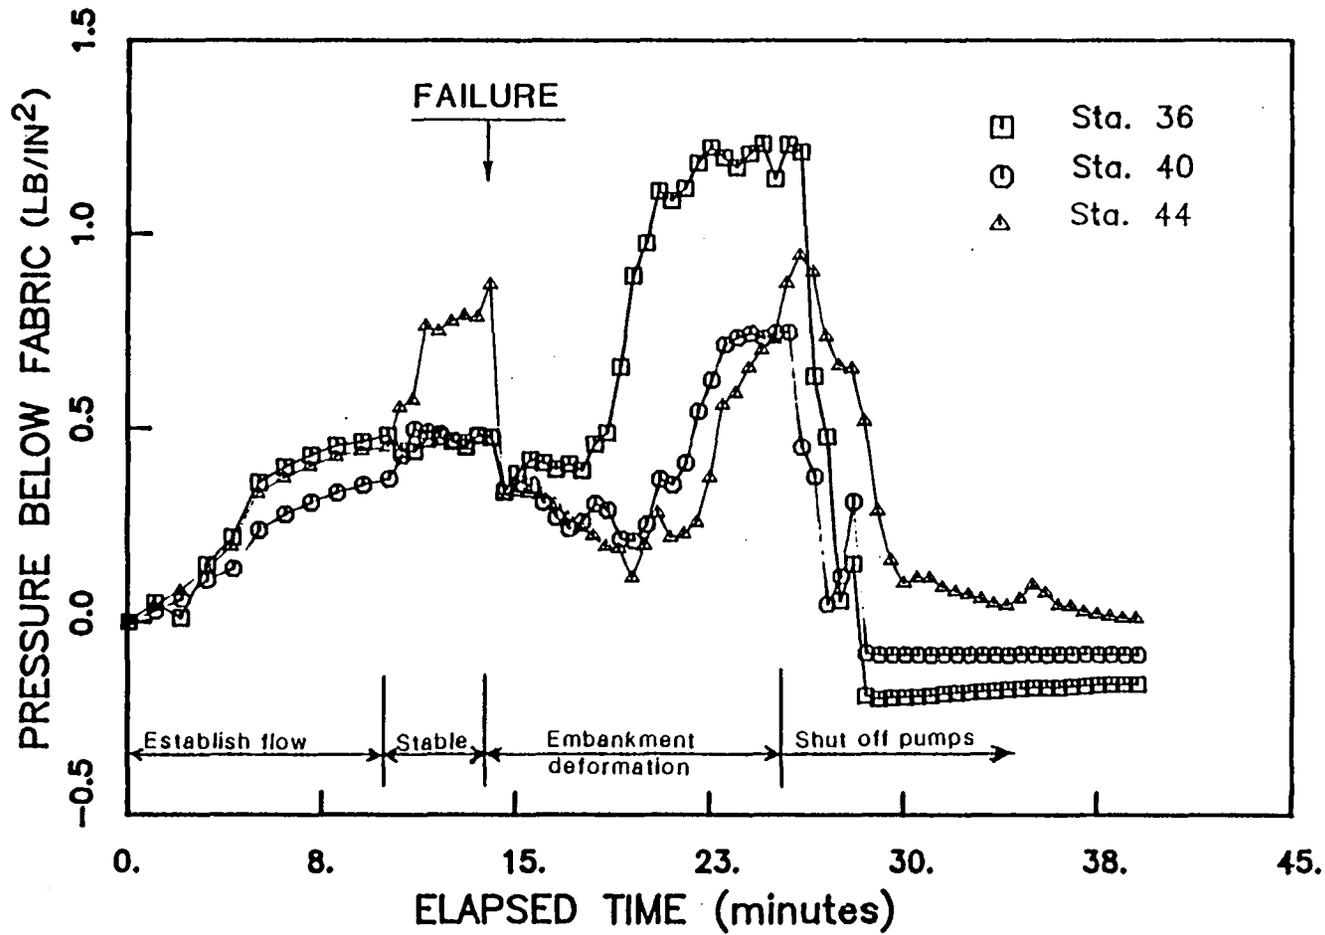
Figure 66. Pressure transducer readings taken during test 46A [4-ft (1.2 m) overtopping depth, freefall conditions, Armorflex block system]. Note the failure at 14 minutes into test.

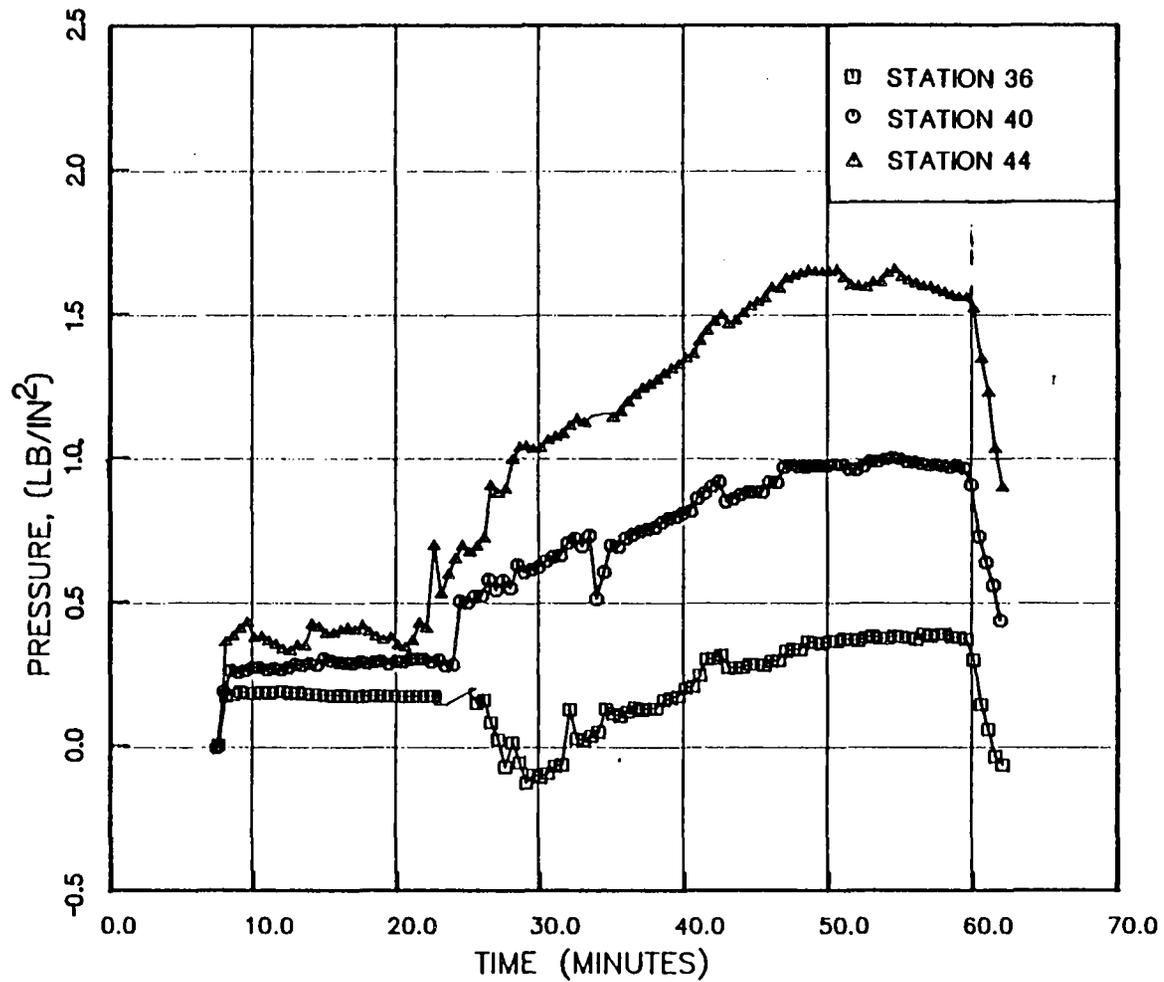
Figure 67. Pressure transducer readings taken during test 52 [1-ft (0.30 m) overtopping depth, freefall conditions, Dycel block system].

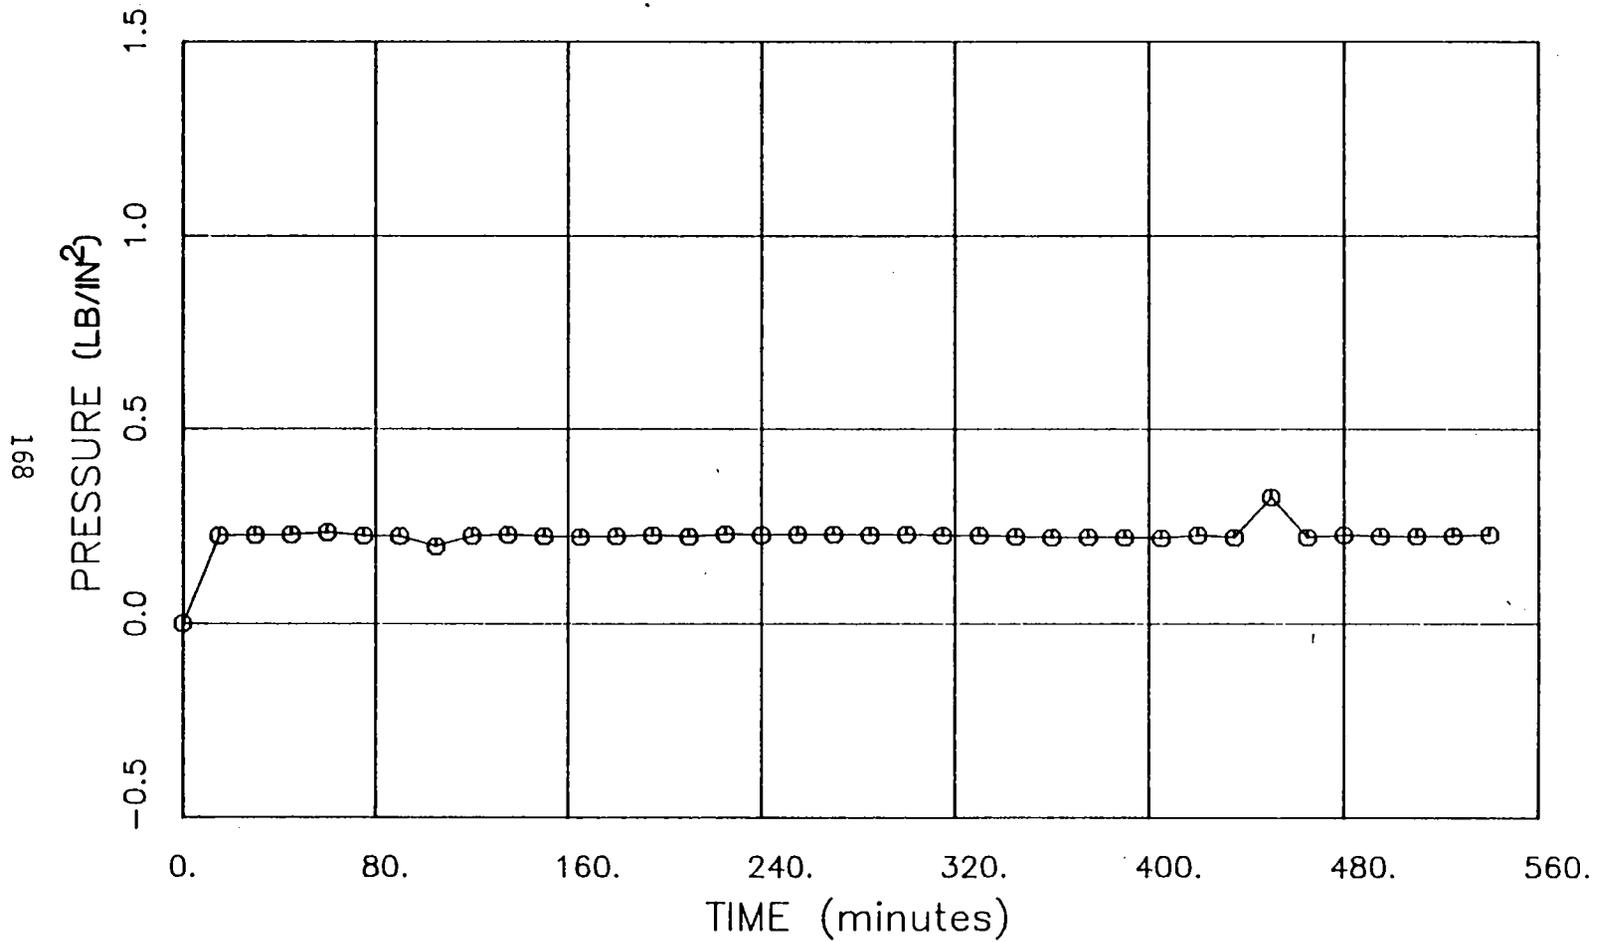
Figure 68. Pressure transducer readings taken at station 40 during test 47 [1-ft (0.30 m) overtopping depth, freefall conditions, Petraflex-Vick block system].

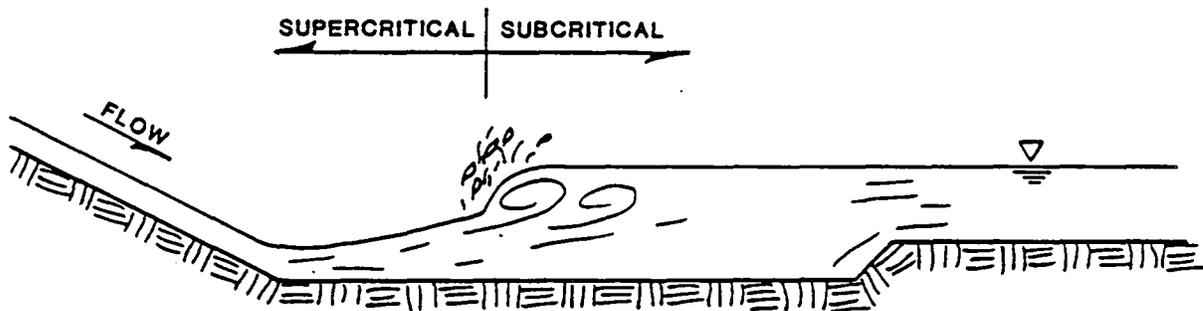
d. Hydraulic jump contained in stilling basin downstream of embankment slope.

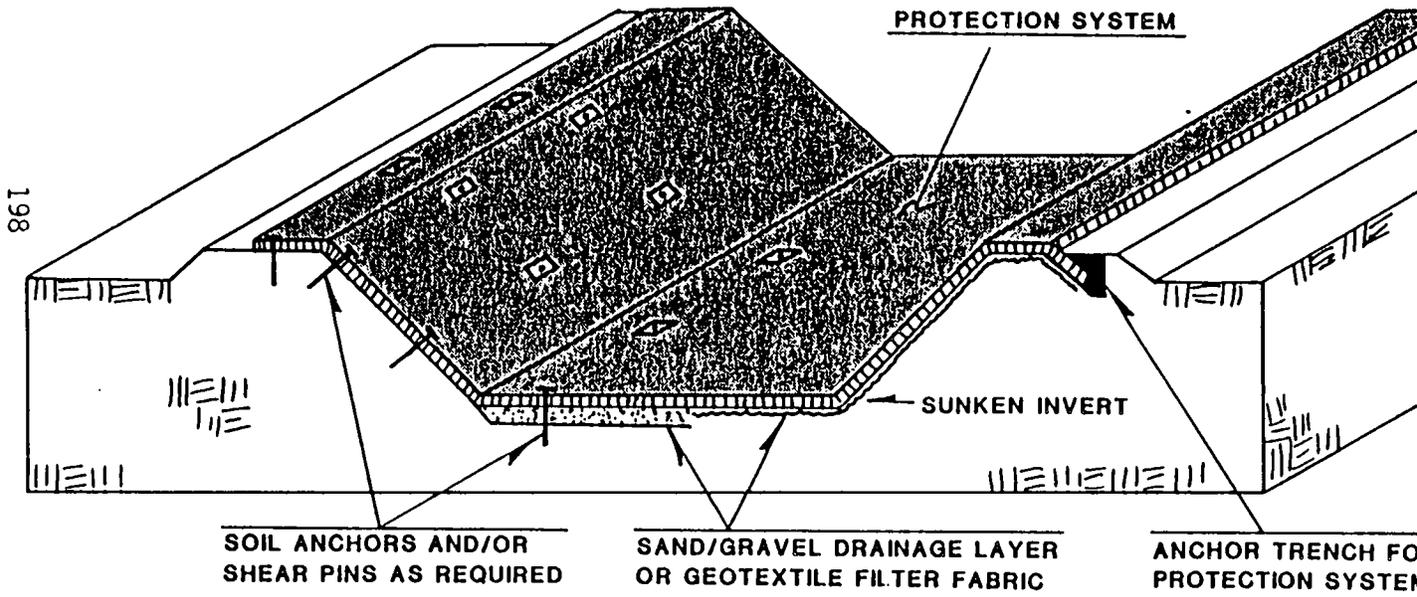
Figure 71. Typical cross section through protected waterway showing side termination options.
