PAP-726

Engineering Shakedown and Evaluations at Red Bluff Research Pumping Plant, 1995

April 1996

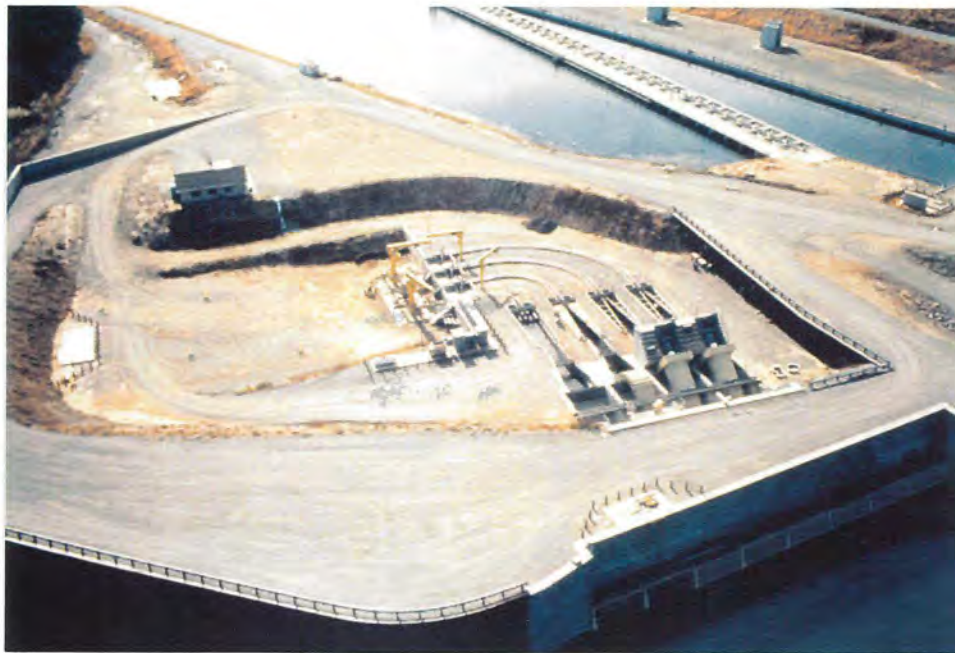
Figure 1: Aerial view of the Red Bluff Research Pumping Plant.

Construction was completed at RBRPP in May 1995. Figure 1 shows an aerial view of the completed structures.

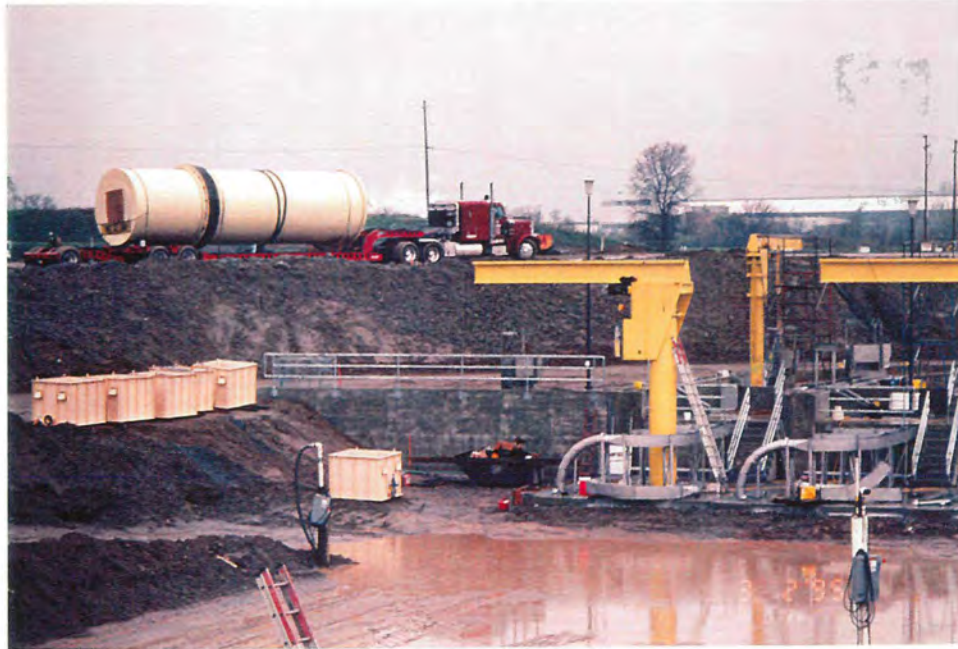
Figure 3: Archimedes pump being delivered to the construction site on a semi-trailer.

of 100 ft³/s when operated at 26.5 r/min. These pumps are 10 ft in diameter and have three internal continuously welded flights, figure 3. They are set on a 38° angle and feature a rotating seal at the lower end of the pump that has not previously been tested. Pump No. 1 operates on a direct drive at 26.5 r/min, pump No. 2 can be operated direct or with a variable speed drive, allowing rotational speeds from 1 to 26.5 r/min. Each Archimedes pump features an induction motor and a helical gear reducer.

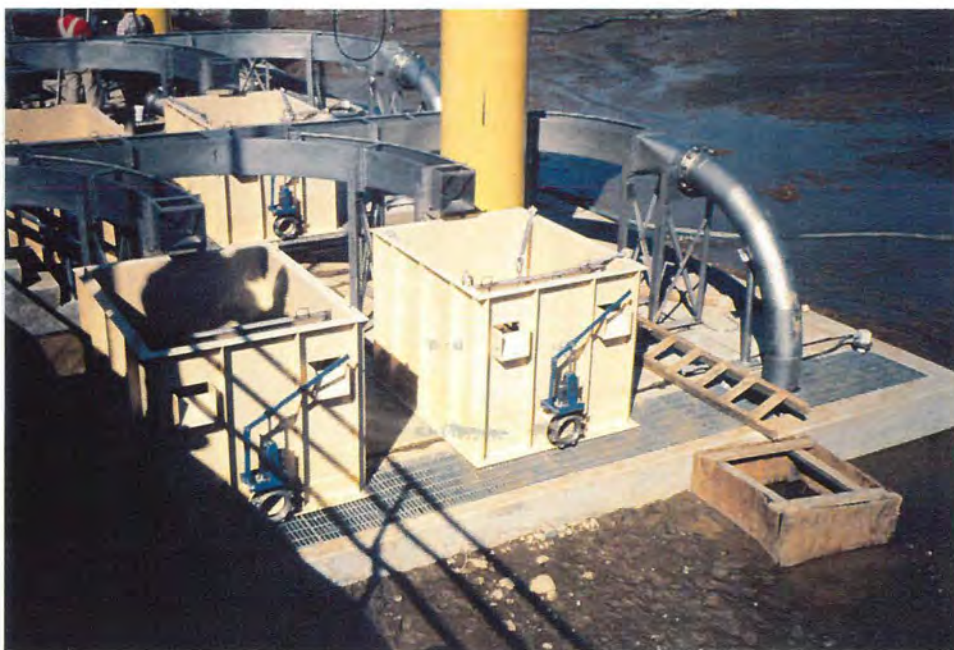
Figure 6: Fish evaluation facilities - holding tanks.

and all the way into the holding tanks. The jib cranes that are used to lift stoplog gates, the dewatering ramps, and the holding tanks were repaired. The pinch valves and associated level sensors were reset. The holding tanks were modified to allow for easier collection of fish.

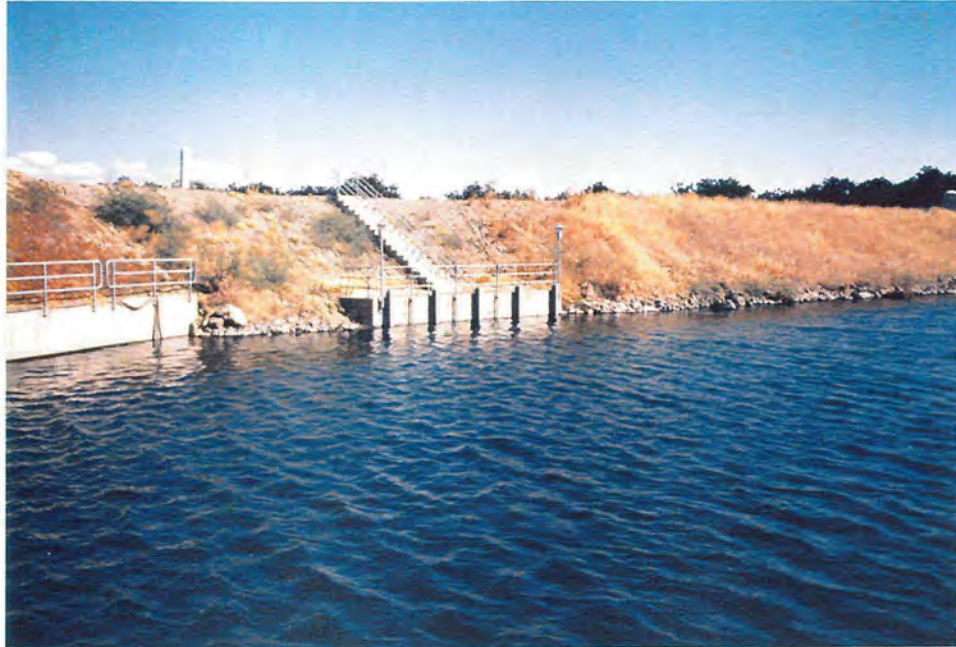
Figure 7: Discharge pipes emptying into the Tehama-Colusa Canal headworks.

through the vertical wedge-wire screens in the chevron screen structure and flows into the headworks of the Tehama-Colusa Canal, figure 7. Many features of the pumping plant were modified and changed during the first few months of operation. This shakedown period is still underway. The plant has operated for preliminary fisheries evaluations. However, much of the operation in 1995 was to correct deficiencies and improve facilities and techniques to allow the planned studies to be done.

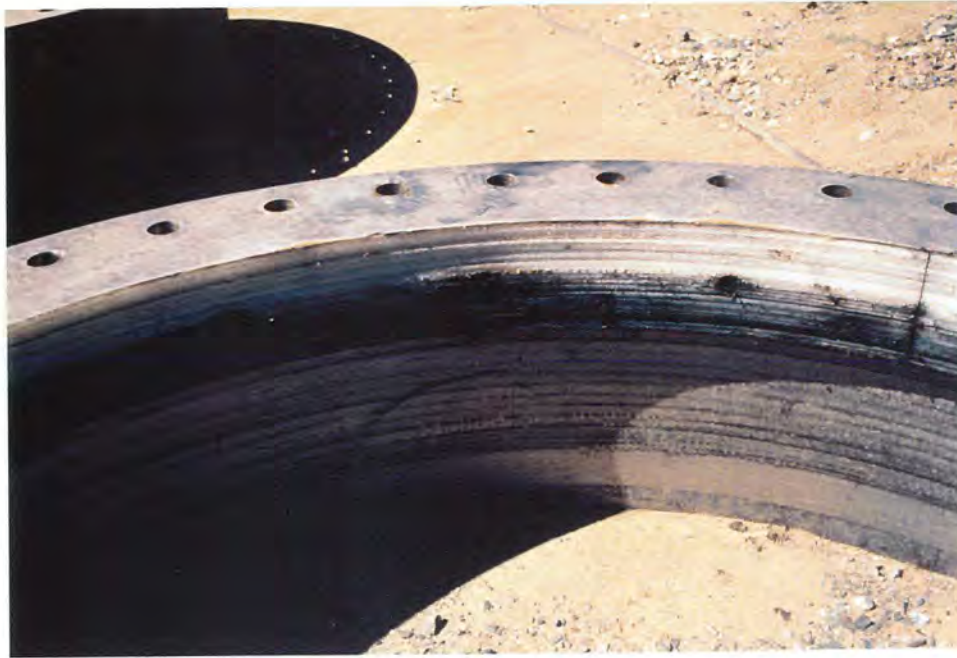
Figure 8: Damaged UHMW wearing ring and packing from Archimedes pump.

damaging the UHMW wearing ring and impregnating the compression packing, figure 8. It was decided at this time that a new seal arrangement was needed before further operation of the Archimedes pumps.

Reclamation requested that Wheelabrator/CPC provide a new seal design that would handle the expected sediment load. Through many iterations with the manufacturer (over a period of 5-6 months), it became apparent that an acceptable design from the manufacturer was unlikely. The Willows Construction Office decided to approach this problem in two phases: design and install a temporary seal that would allow the pumps to be operated beginning in March 1996, and proceed with the design and installation of a permanent fix by the end of the summer 1996. Engineers at Reclamation's Northern California Area Office (NCAO), RBRPP, and the Technical Service Center began work on achieving this schedule in November 1995.

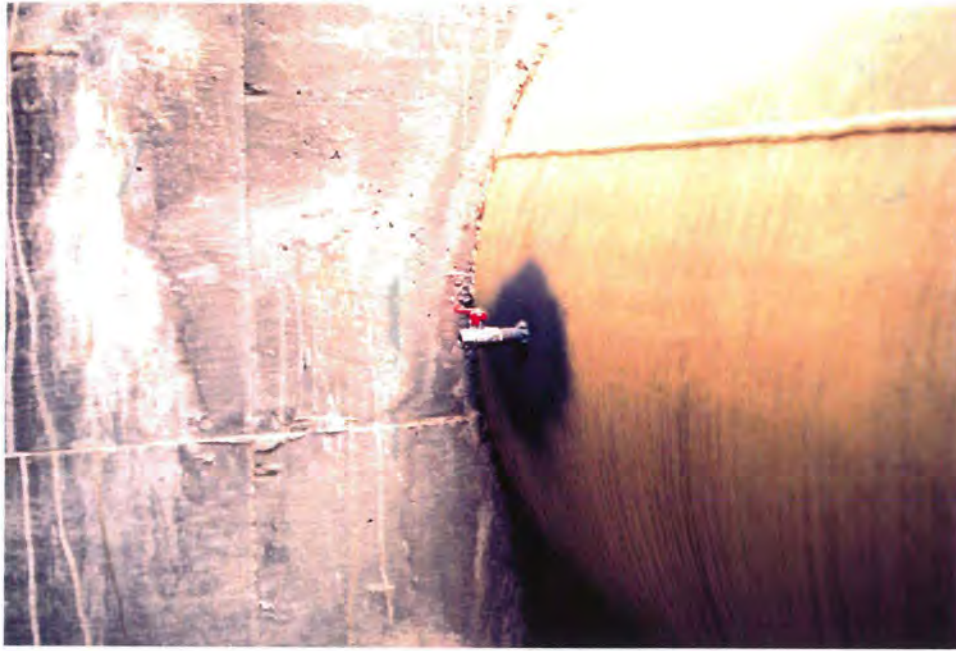
Figure 9: Piezometer tap installation on the intake pipe leading to the pumps.

Additional shakedown tasks in support of the pumps included installation of pressure taps on each of the three inlet pipes just upstream from the pumps, figure 9. Three pressure transducers were purchased and will be installed later.

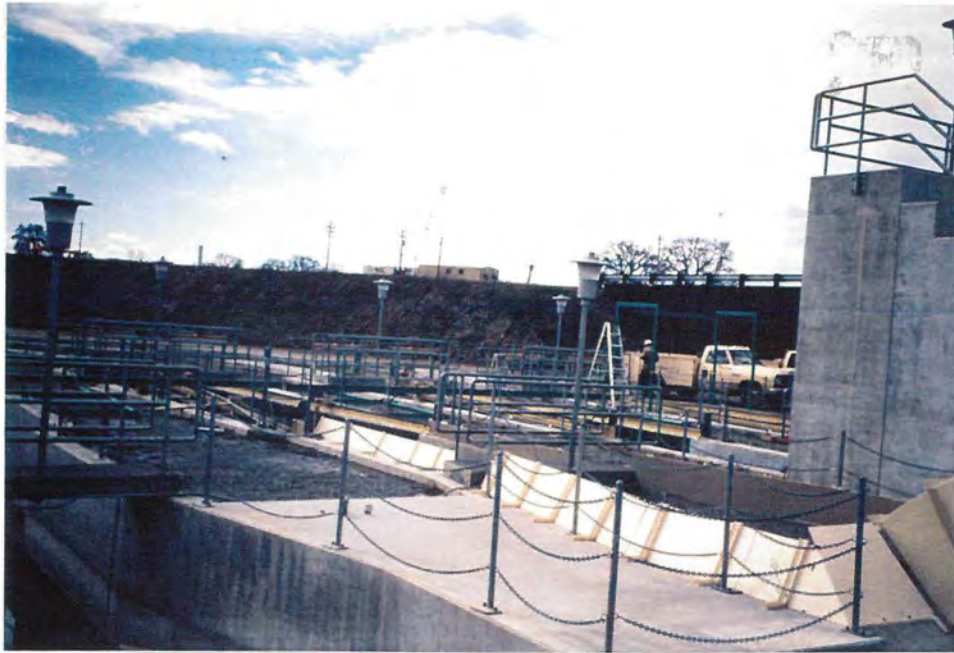
Figure 10: Splashguards installed on bay No. 3.

Initial pump tests showed several problem areas with the outfall area and channel leading to the angled vertical screens. Containing all the flow is important to ensure that all the fish carried by the pumps actually remain in the channel and make it to the bypass and evaluation facilities. Splashing at the outfalls was contained by constructing and installing splash guards, figure 10.

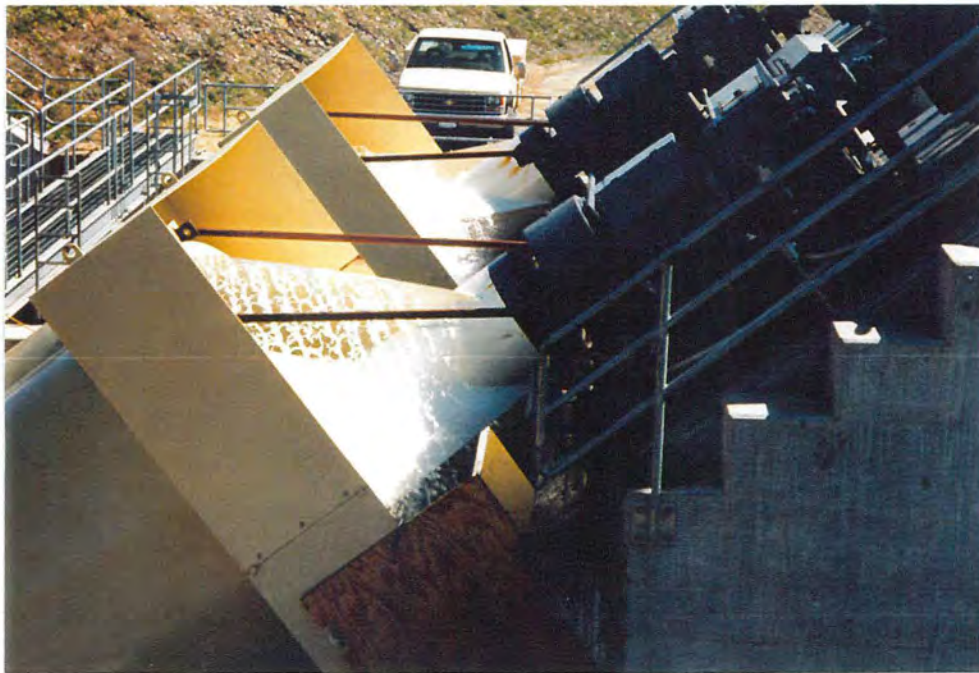
Figure 11: Carryover splashing at the Archimedes pump exit.

The Archimedes pumps exhibited less splashing at the outfall. However, there is quite a bit of splashing and carryover of water at the pump exit at a pump speed of 26.5 r/min, figure 11. Testing at slower rotational speeds indicated that this problem was greatly reduced. Solutions to containing this over-splash are still being considered. The vertical screen structure was an area where many modifications were needed. The brush system used for continuous cleaning of the screens did not operate properly due to high friction of the brush holders on the rail. Teflon strips originally designed for these rails could not be attached adequately in the field. This condition was greatly improved by applying grease to the rail area. Construction of temporary baffles on the screens was also required to prevent large head-drops across the wedge-wire screens. Plywood panels with holes to vary the open area were installed to the back of the screen frames, figure 12. Some additional caulking was required to plug some holes where fish could possibly escape the collection facility.

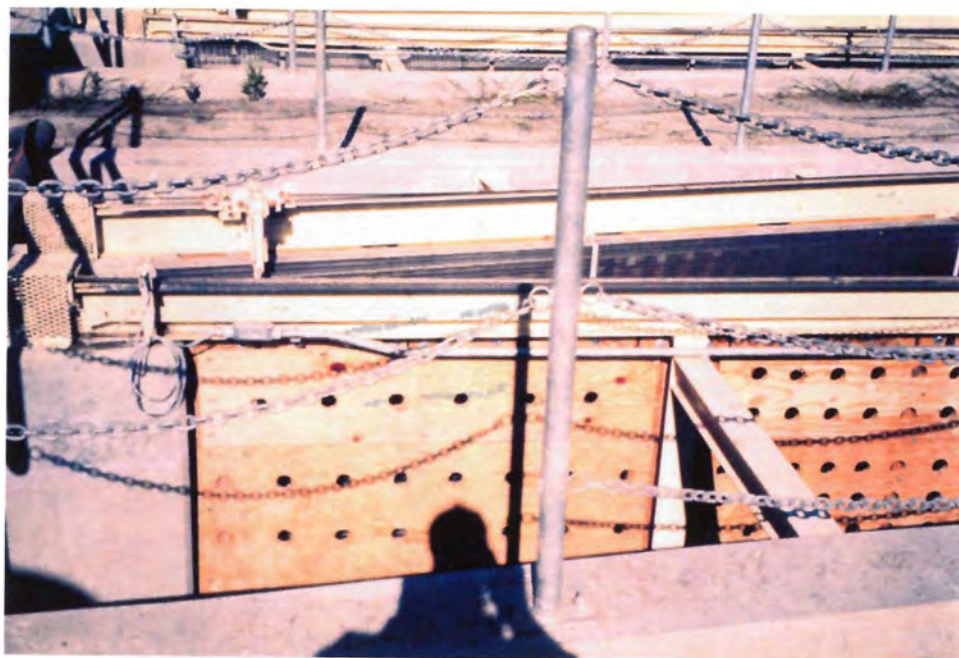
Figure 12: Temporary baffles on the vertical screen structures.

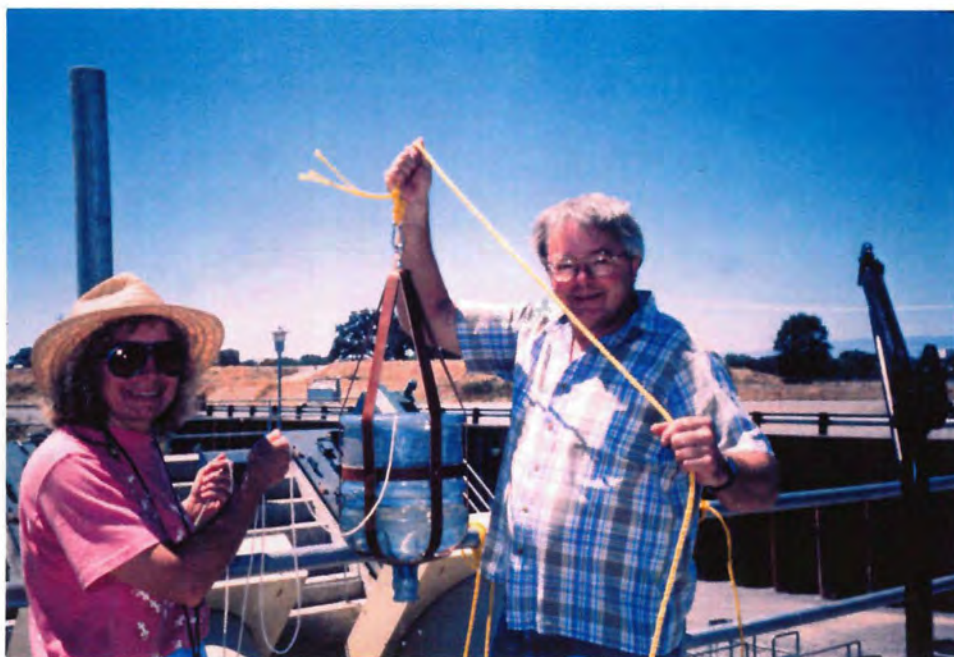
Figure 13: Fish injection device.

Several shakedown activities took place to prepare the bypass and fish evaluation facilities for operation. Fish injection containers and crowders were constructed and modified over a period of several months, figure 13. Holes were plugged and offsets smoothed along the bypass channels

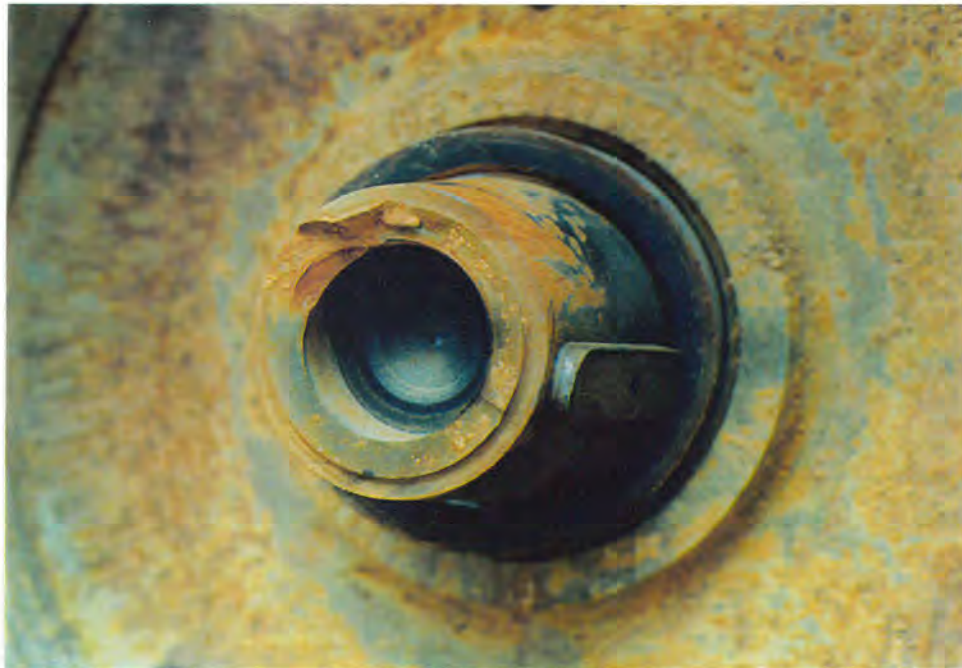
Figure 14: Fracture of shaft in centrifugal-helical pump.

Few formal evaluations were performed on the three pumps. As mentioned previously, the two Archimedes pumps only operated for a very short time during 1995 due to seal problems at the lower rotating seal. Operation of the centrifugal-helical pump did continue throughout the summer of 1995 for use in fisheries evaluations; however, little data were collected supporting mechanical and operational features of the pump. Operation of the pump was documented, including hours of operation, maintenance requirements, problems, etc. In September, the centrifugal-helical pump experienced a major problem. During operation, the pump's rotational parts seized and a motor stop was triggered. Upon disassembly of the pump, the impeller appeared to have shifted on the shaft causing it to contact the stationary casing and seize. Upon further inspection, this slippage was deemed to be the result of a complete fracture of the shaft, figure 14. Initial observations showed that the shaft failure indicated a fatigue failure. The manufacturer agreed to fix the problem as it occurred under warranty. The shaft was redesigned and manufactured at its facilities in Peru. The impeller was refurbished at its Salt Lake City plant. Plans are for the pump to return to the site in April and be running by the first of May 1996.

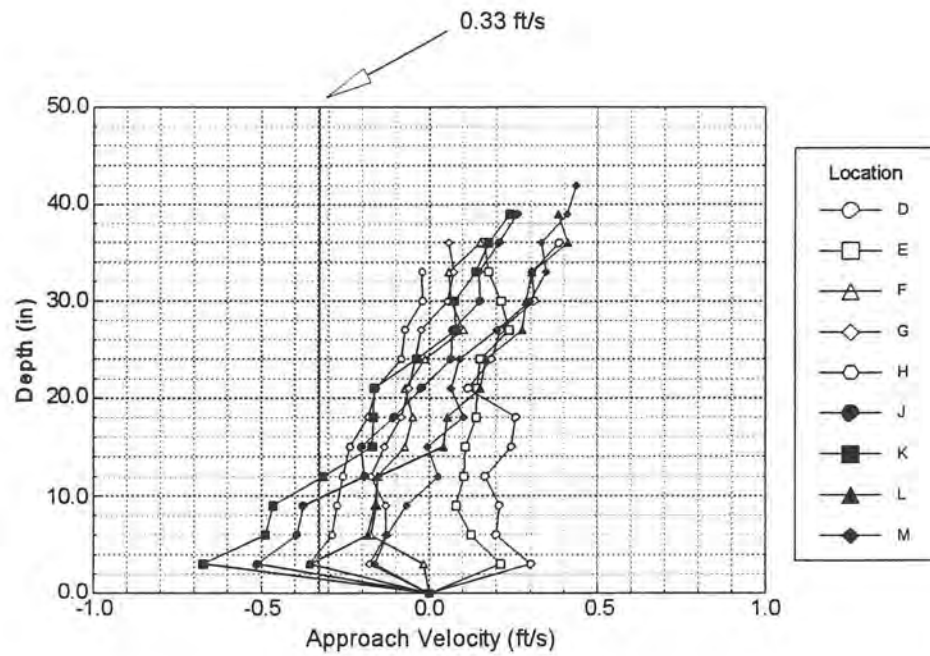
Figure 15a: Approach velocities, 3-in in front of screen face. Negative values are into the screen (velocity in ft/sec).

A set of velocity measurements was taken on the east side of the screen structure. The measurements were made with a three-dimensional acoustic velocity probe manufactured by SONTEK. This probe measures all three components of velocity at a point about 2 in below the probe. Data are fed into a laptop computer for processing and storage. A bracket was constructed to hold the probe at a location 3 in off the screen face and allow for traversing the entire flow depth and length of the screen panels. Velocity profiles were collected at two locations on each screen panel, stations A-M excluding I. Figure 15a&b show velocity profiles for the approach and sweeping velocity components along the east side of bay No. 3 for a flowrate of 110 ft³/s. Note the reverse flow component of the sweeping velocity near the bypass entrance. This flow condition indicates a submerged eddy caused by poor bypass entrance conditions. An inverted weir was designed to be placed in the bypass channel to accelerate the flow into the bypass. These weirs will be installed in 1996. In addition, these tests pointed to the need to be able to adjust the open area of the baffles easily so a permanent baffle attachment was designed and constructed.

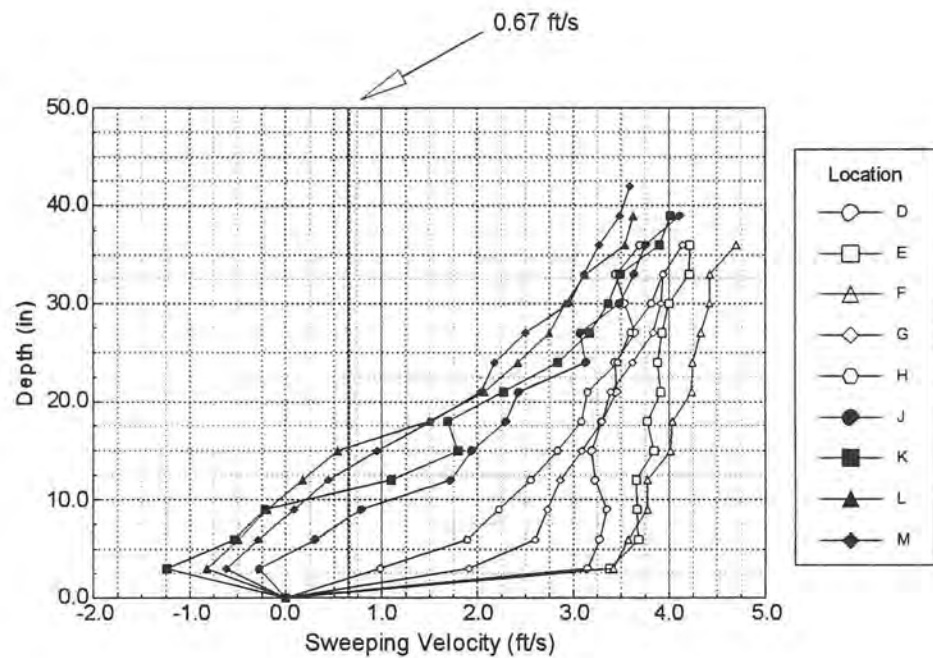
Figure 15b: Sweeping velocities, 3-in in front of screen face. Negative values are in the upstream direction.

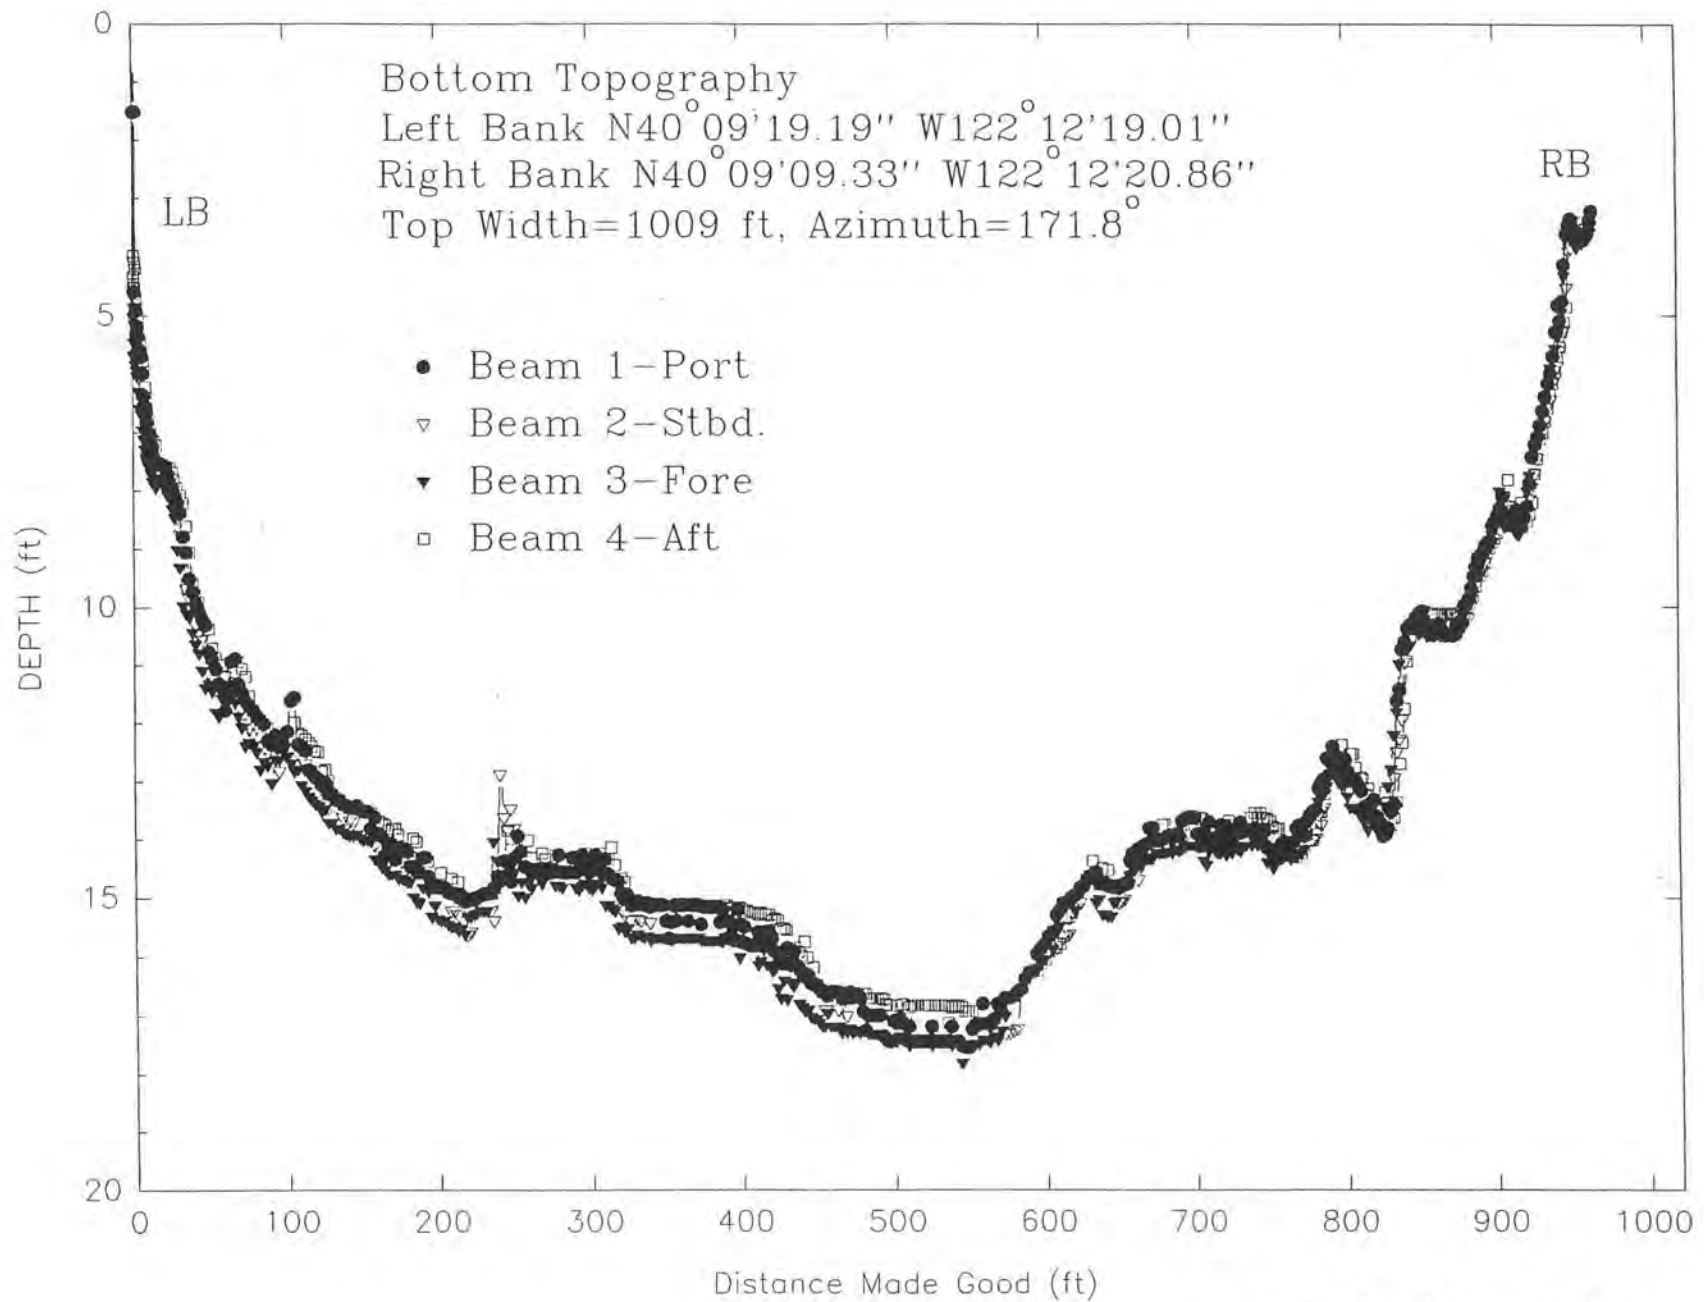
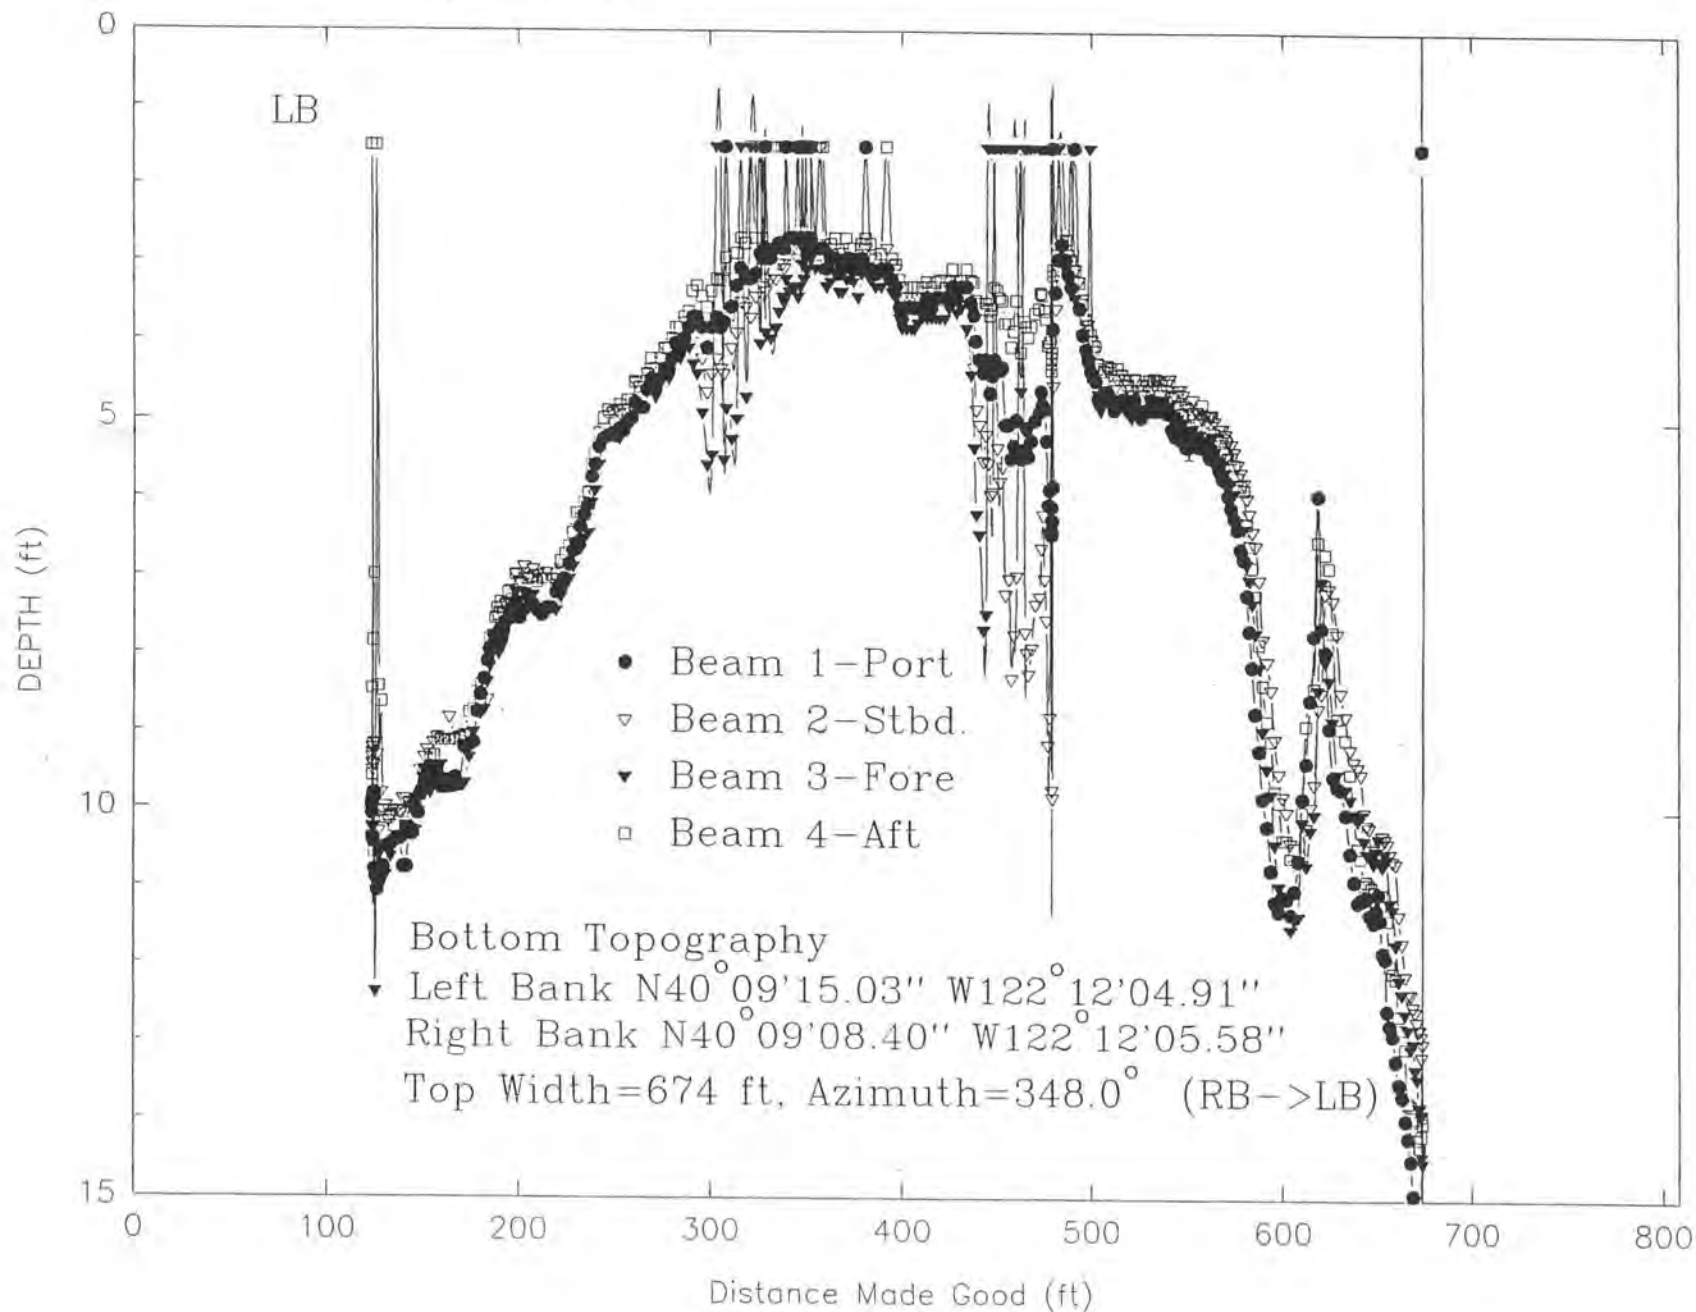
ADCP transects were used to plot the channel topography and also to measure the velocity field for each transect. Plots of velocity and topography data are attached as figures 1 through 8. The approximate location of each transect is shown in map 1. The channel topography plots were designed to be consistent in their presentation of the left bank

(looking downstream) on the left side and the right bank on the right side of the plot. In some cases, transect data were collected from the right bank to left bank so the distance (x-axis) increases from right to left for those data sets. Transects downstream of the dam were attempted but were unsuccessful because of the shallow depths in the center of the river channel (see figure 8). Plots of the bottom topography consist of four lines, where each line represents one of four acoustic beams. The best estimate of the bottom topography would be an average of the four depths. Small discontinuities in the bottom topography for any one beam are probably caused by debris. The distance (x) between the fore and aft beams and the port and starboard beams varies with depth ($x=2*\text{depth}*\tan\theta$). For example, for a depth of 22 ft, the distance between beams is 16 ft.
