PAP-726

Engineering Shakedown and Evaluations at Red Bluff Research Pumping Plant, 1995

April 1996

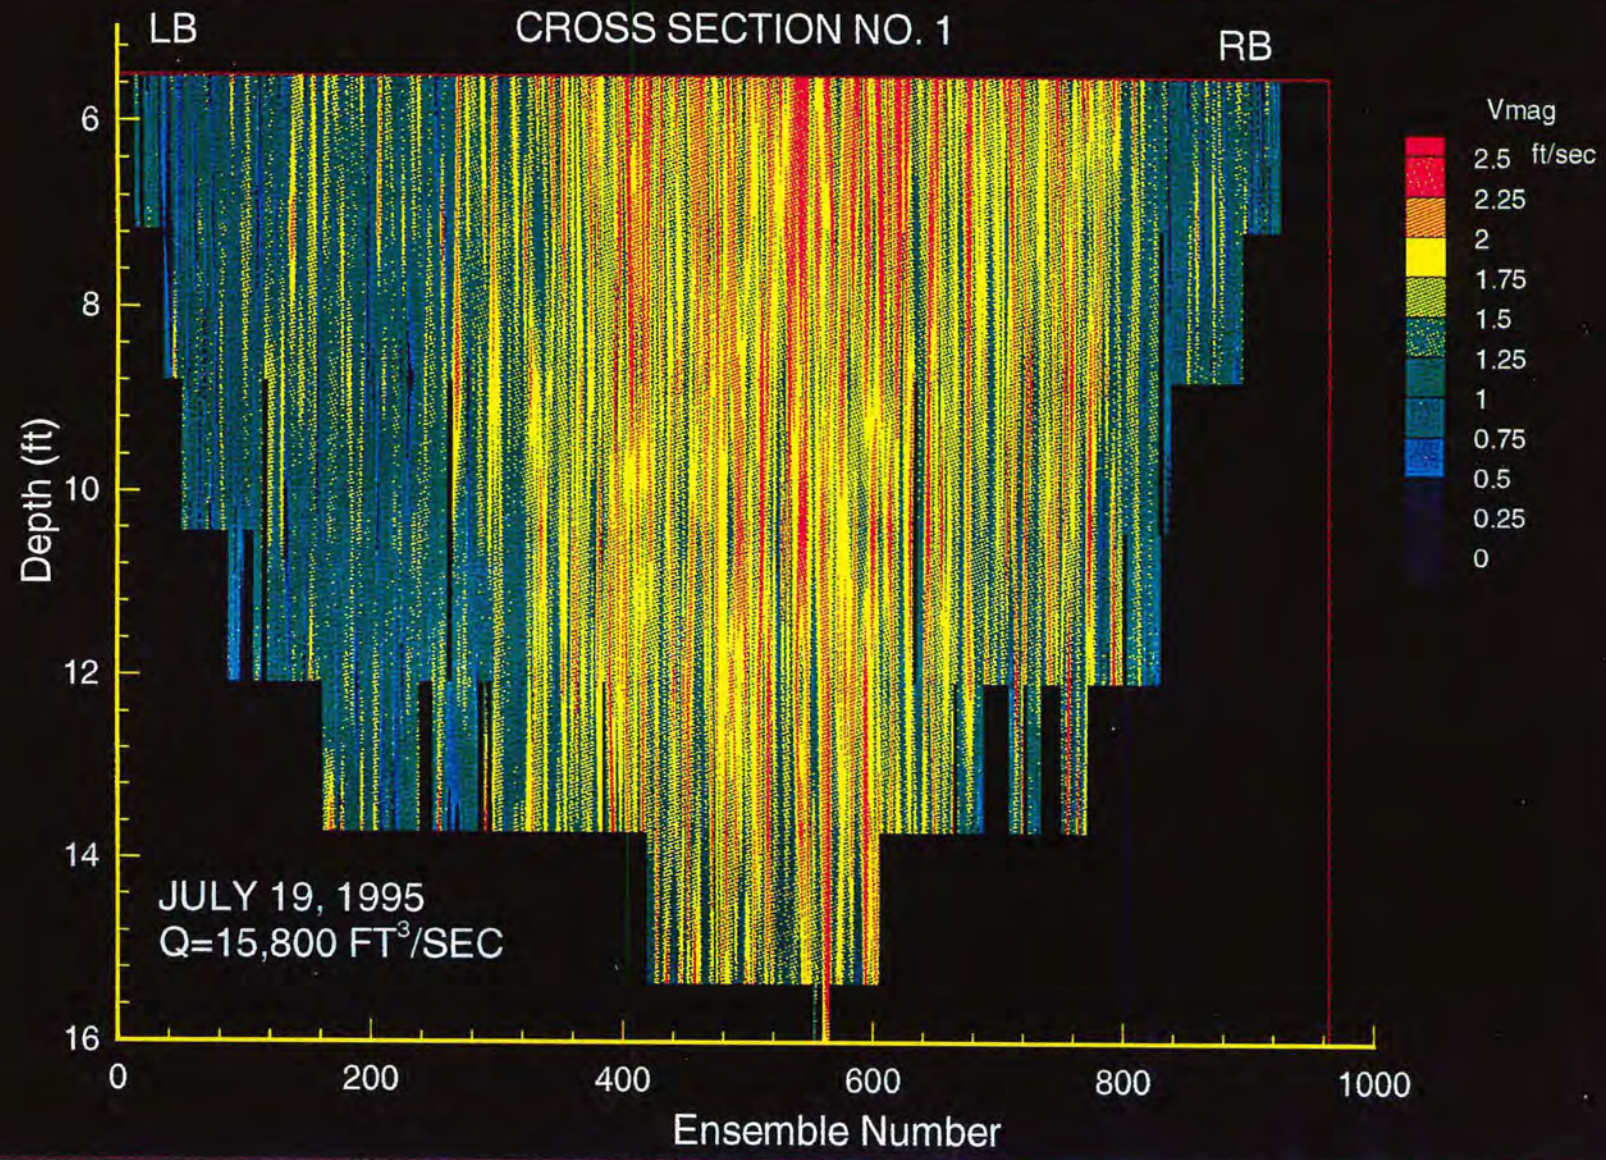
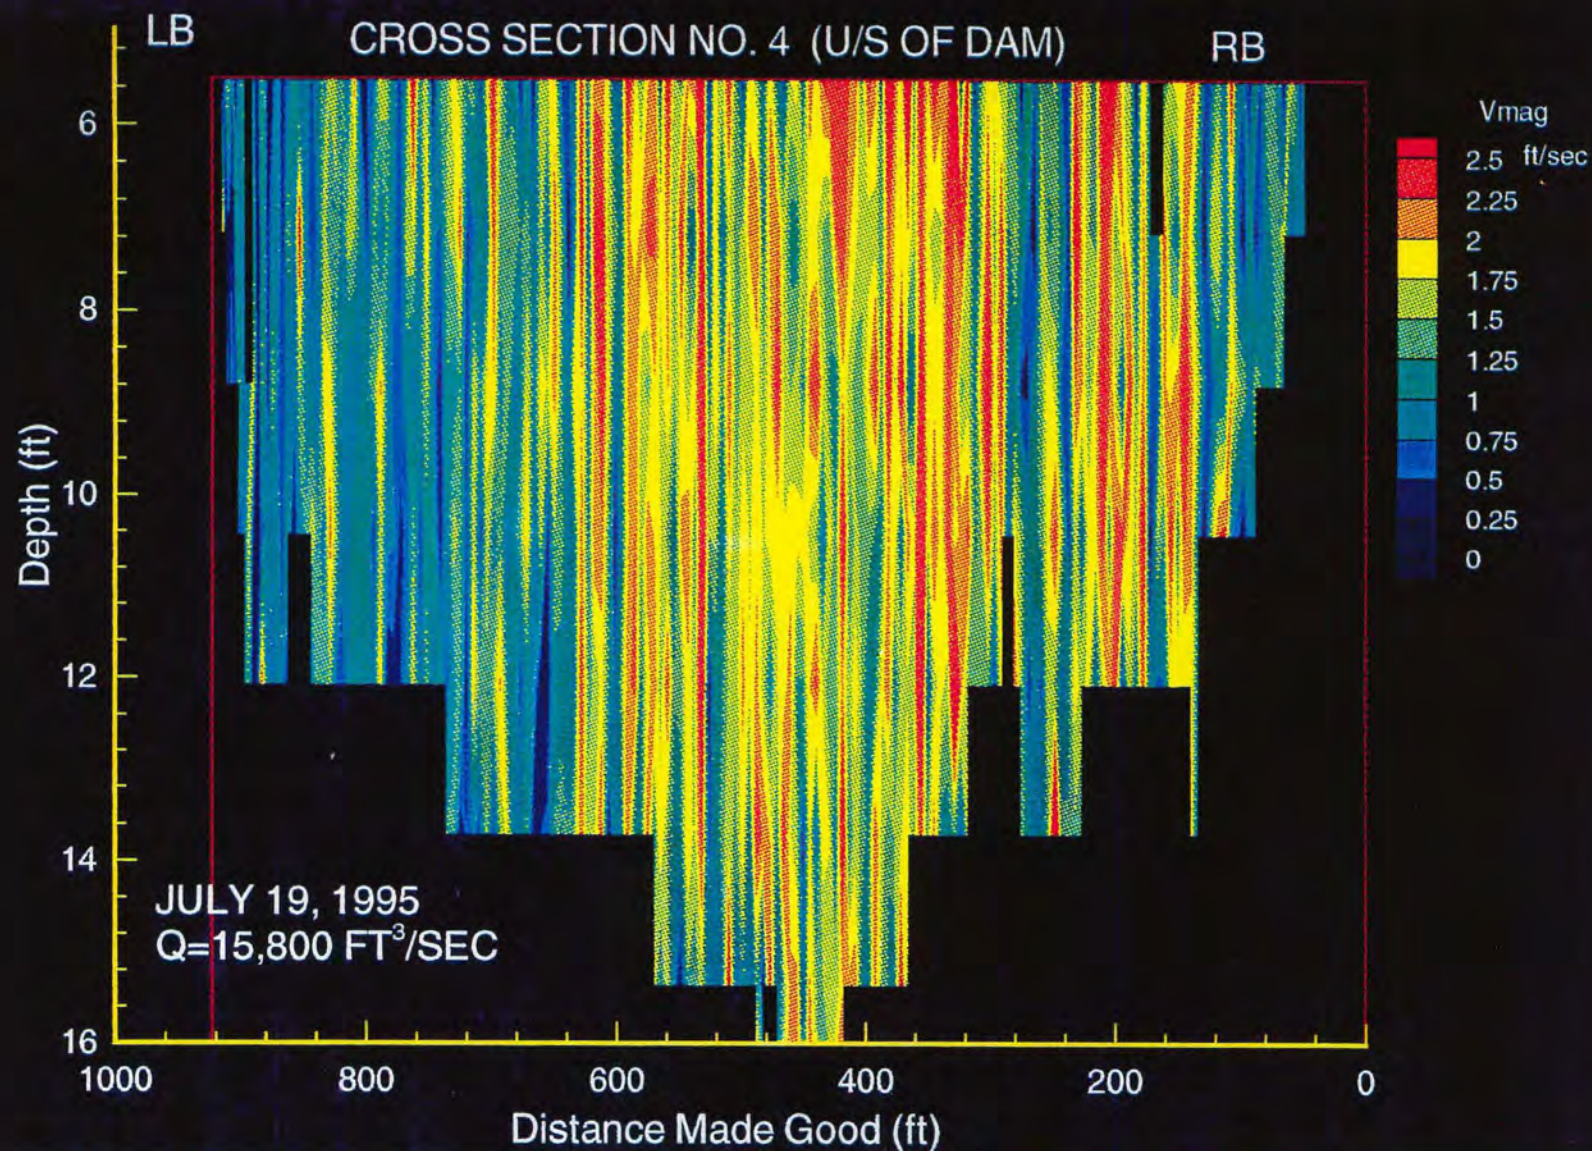
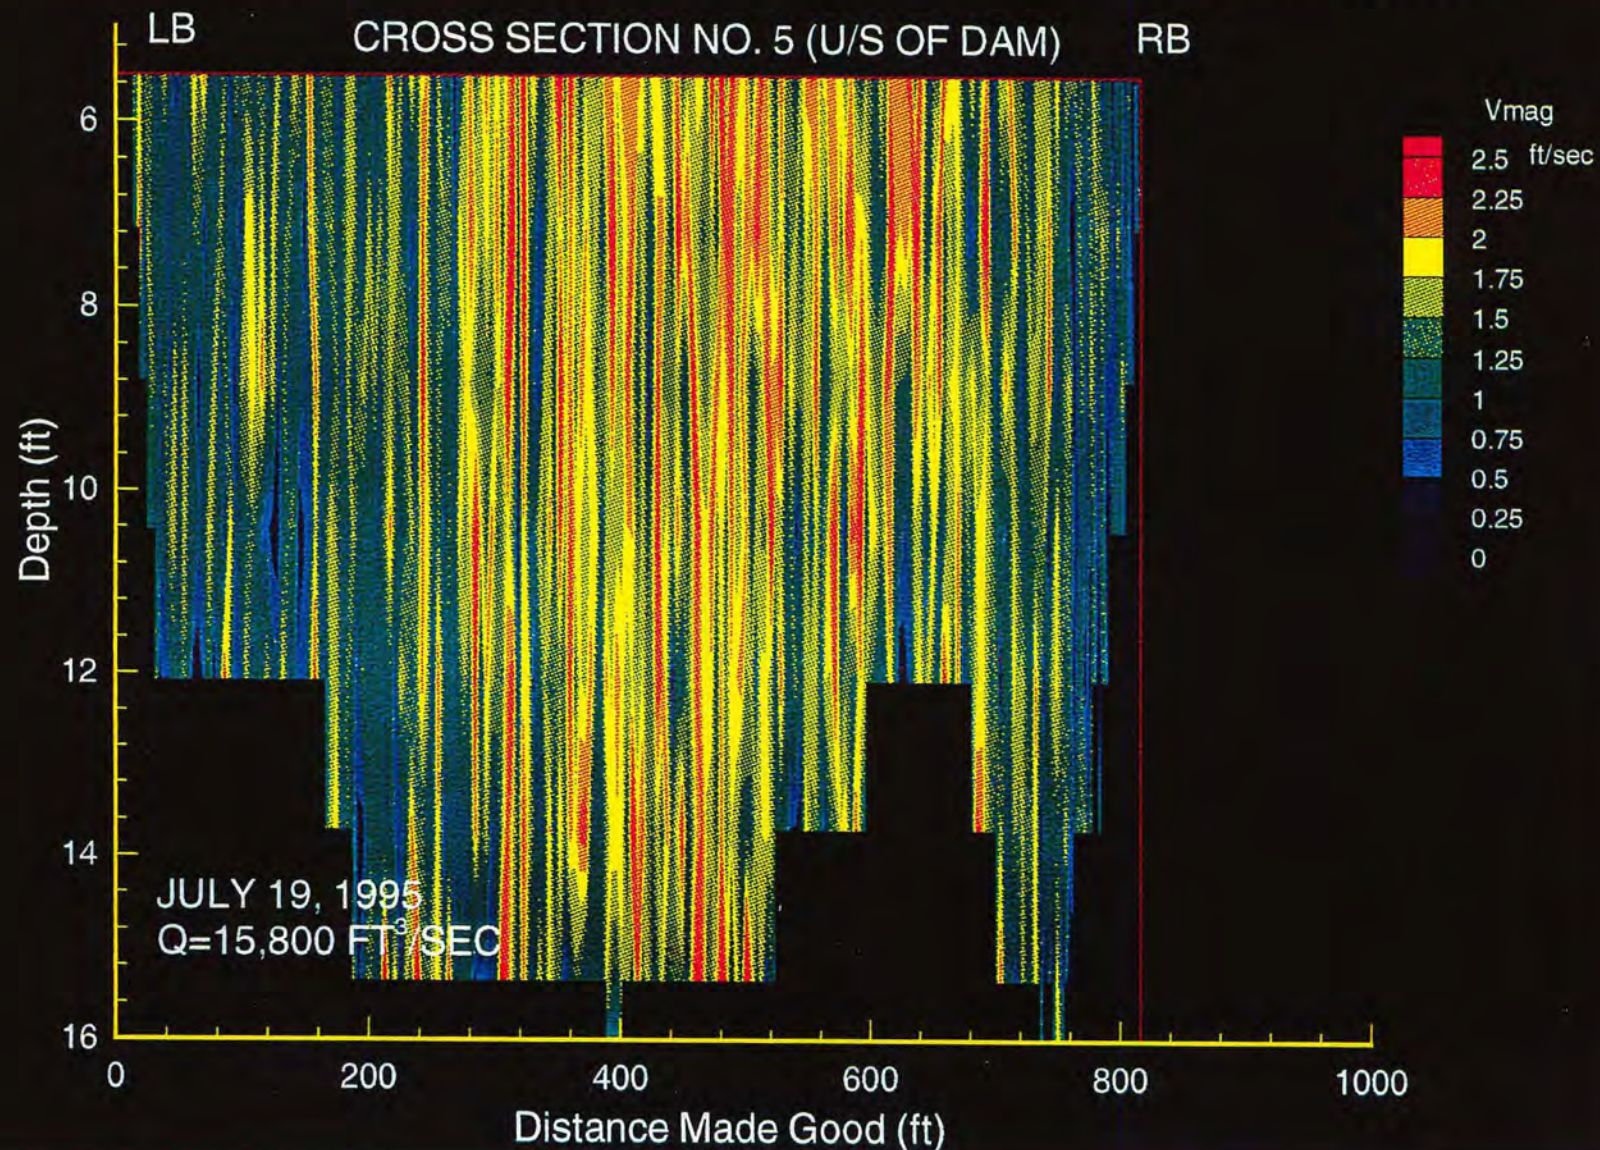
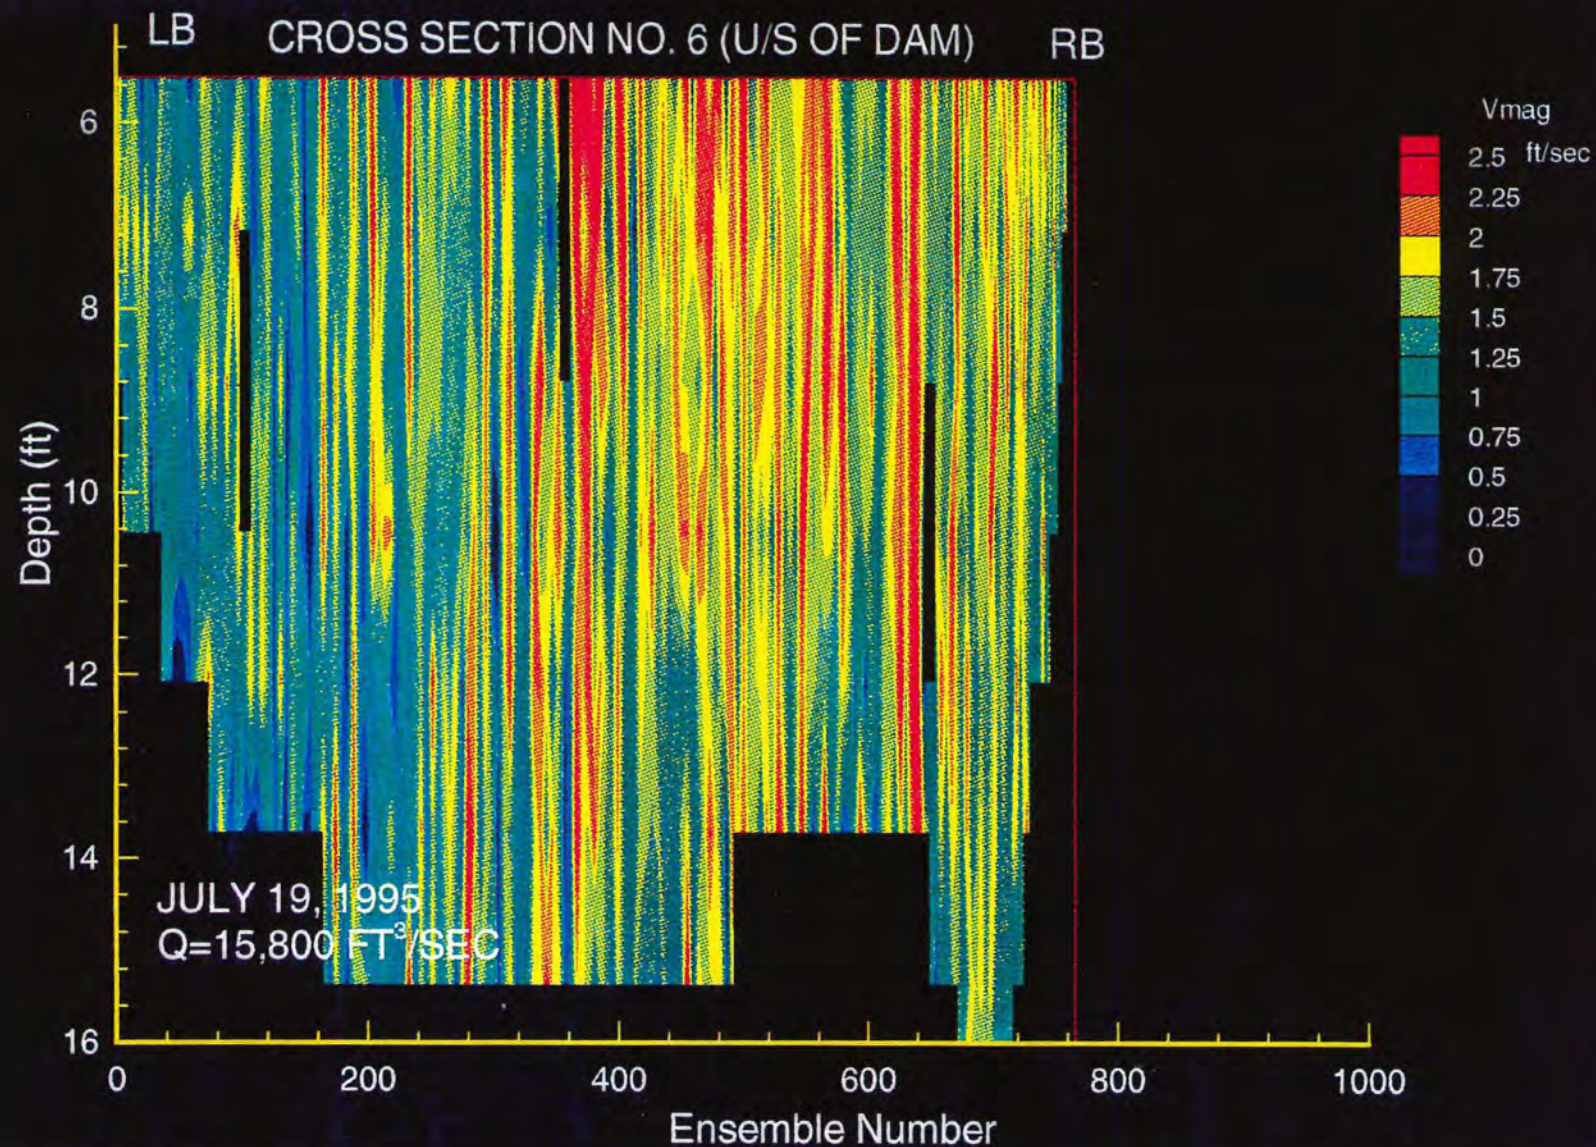
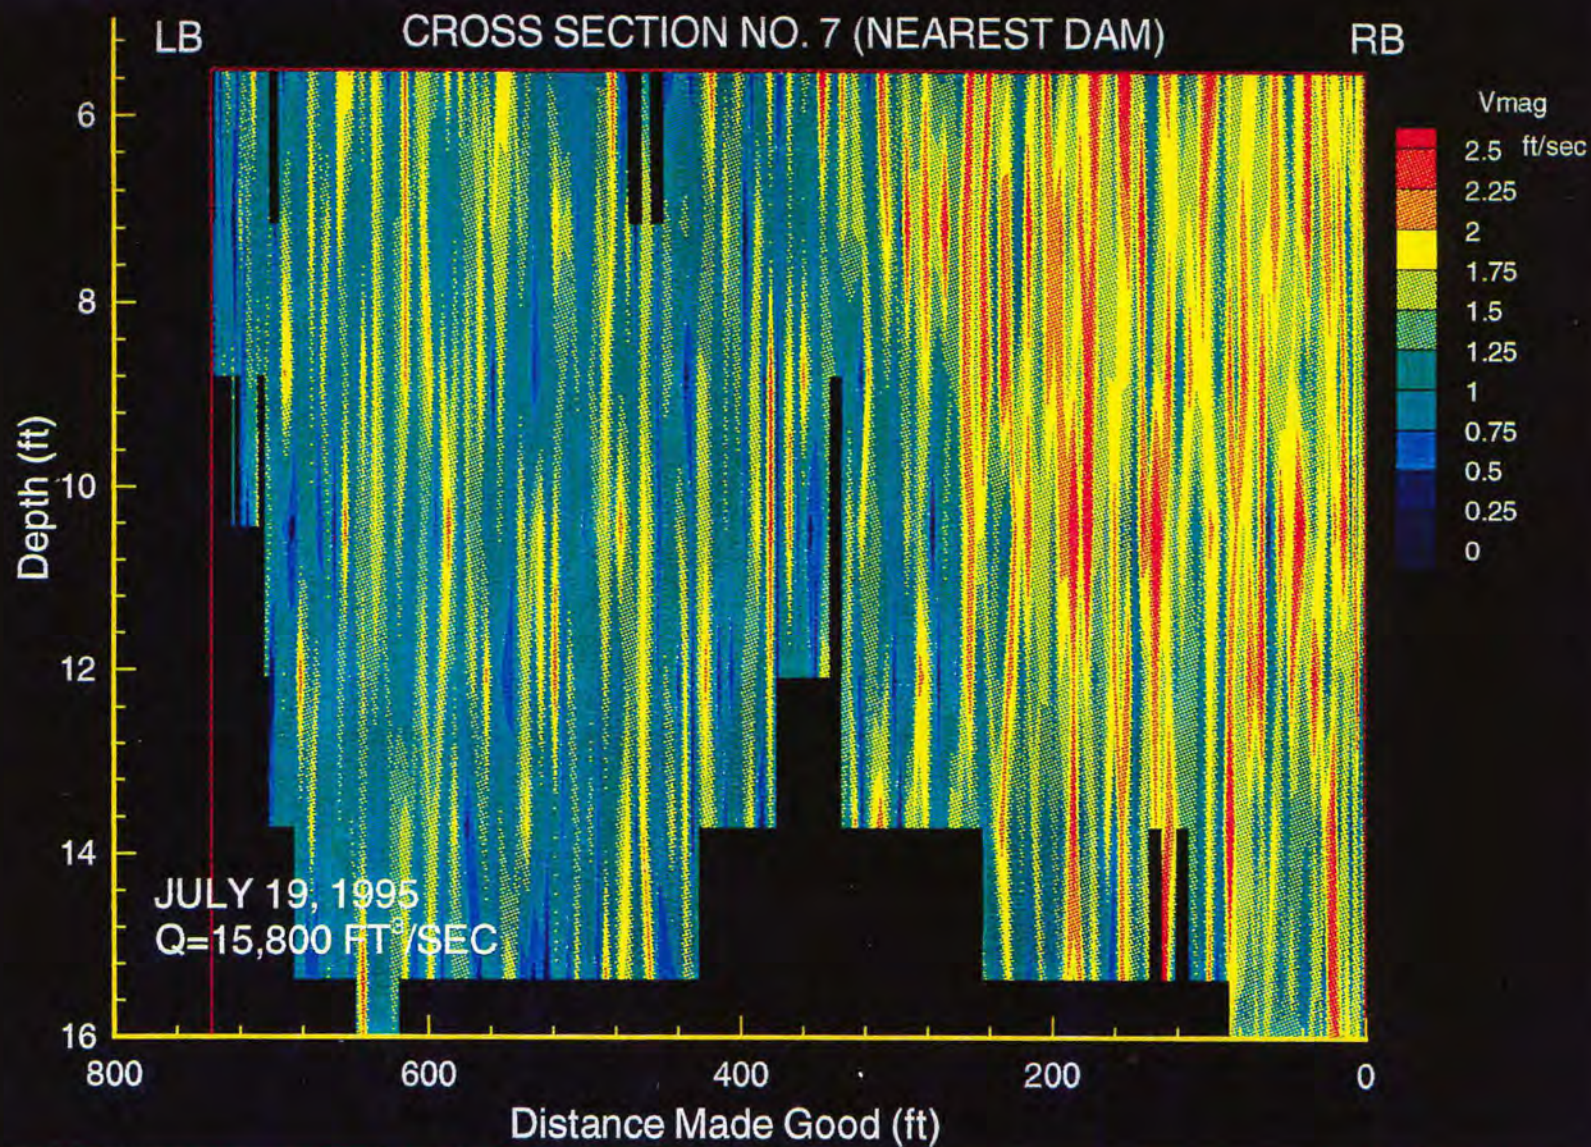
The velocity plots (figures 9-15) for transects collected upstream of the diversion dam show a typical velocity distribution for open channel flow at cross-section No. 1 (furthest upstream) with a maximum velocity of 2.5 ft/sec. However, for transects taken closer to the dam, the velocity distribution becomes skewed by the gate operations. For this data set, most of the flow through the diversion dam was passing through gates near the banks. During this test, flows were routed through gates 1, 2, and 3 near the left bank and through gates 9, 10, and 11 along the right bank. The fish ladders also carry some flow. The river discharge for July 19, 1995 was reported to be about 15,800 ft³/s at the Bend Bridge upstream of the diversion dam. The average discharge measured by the ADCP was 16,100 ft³/sec.

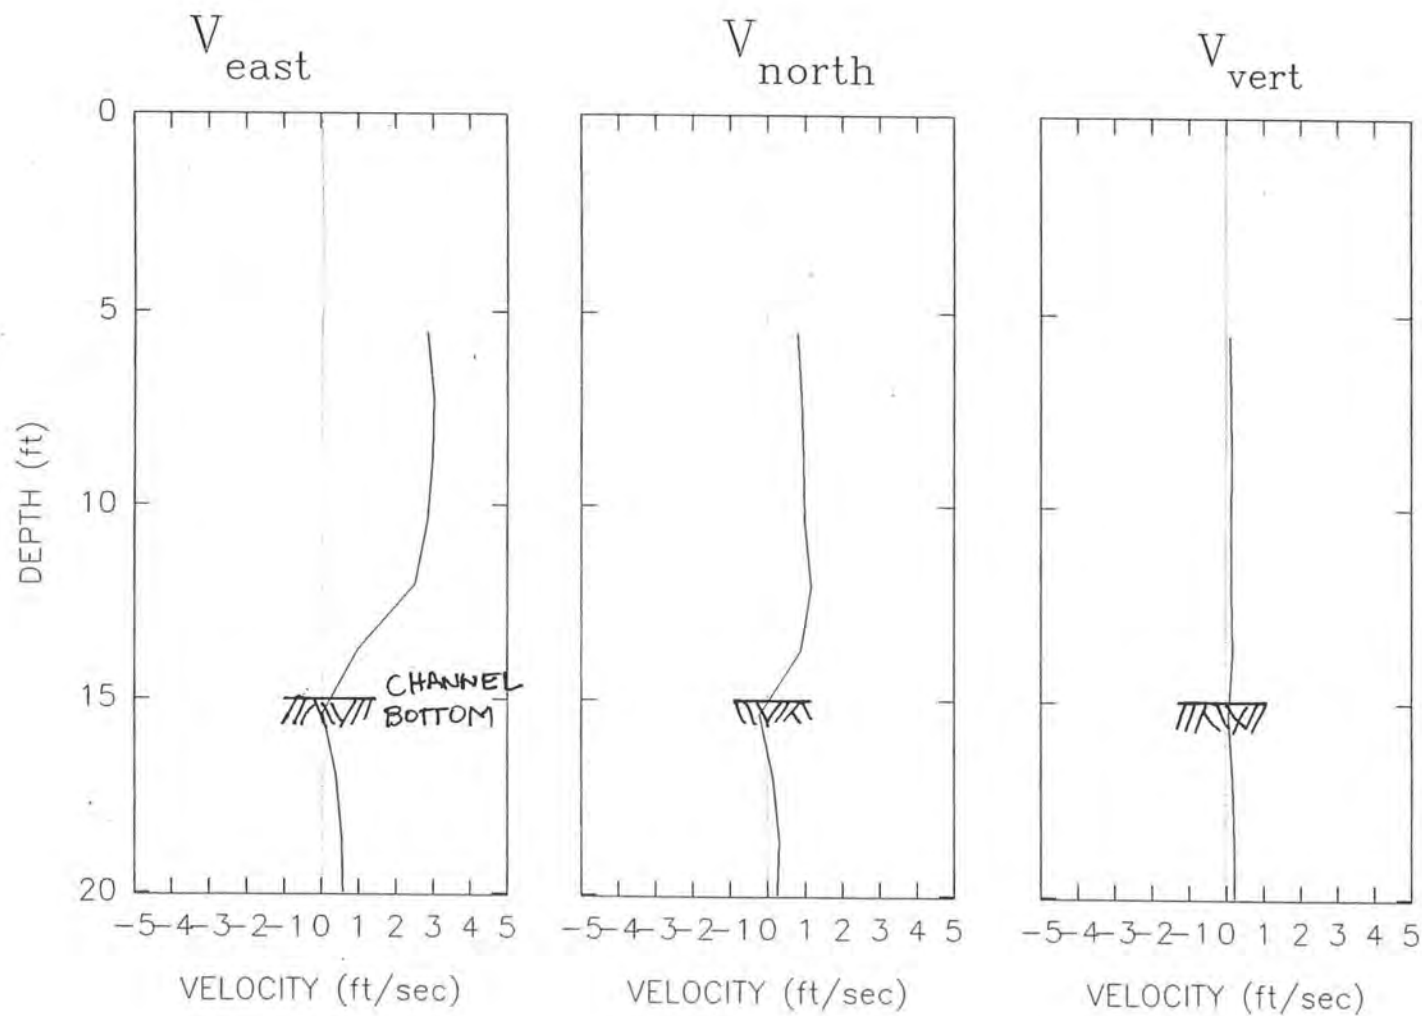
FIG. 23

Two stationary ADCP velocity profiles were measured while tied to the intake structure. Plots of the velocity (north, east, and vertical components) are shown in figures 23 and 24. The velocity profile data are the average of about 1000 individual profile measurements. One profile was taken at the upstream edge of the intake structure. The second profile was taken in front of the fourth pump intake bay. In summary, plots of the velocities show that the maximum sweeping velocity (east component) is between 3 and 4 ft/sec and the normal velocity (north component) is about 1 ft/sec.

VELOCITY PLOTS

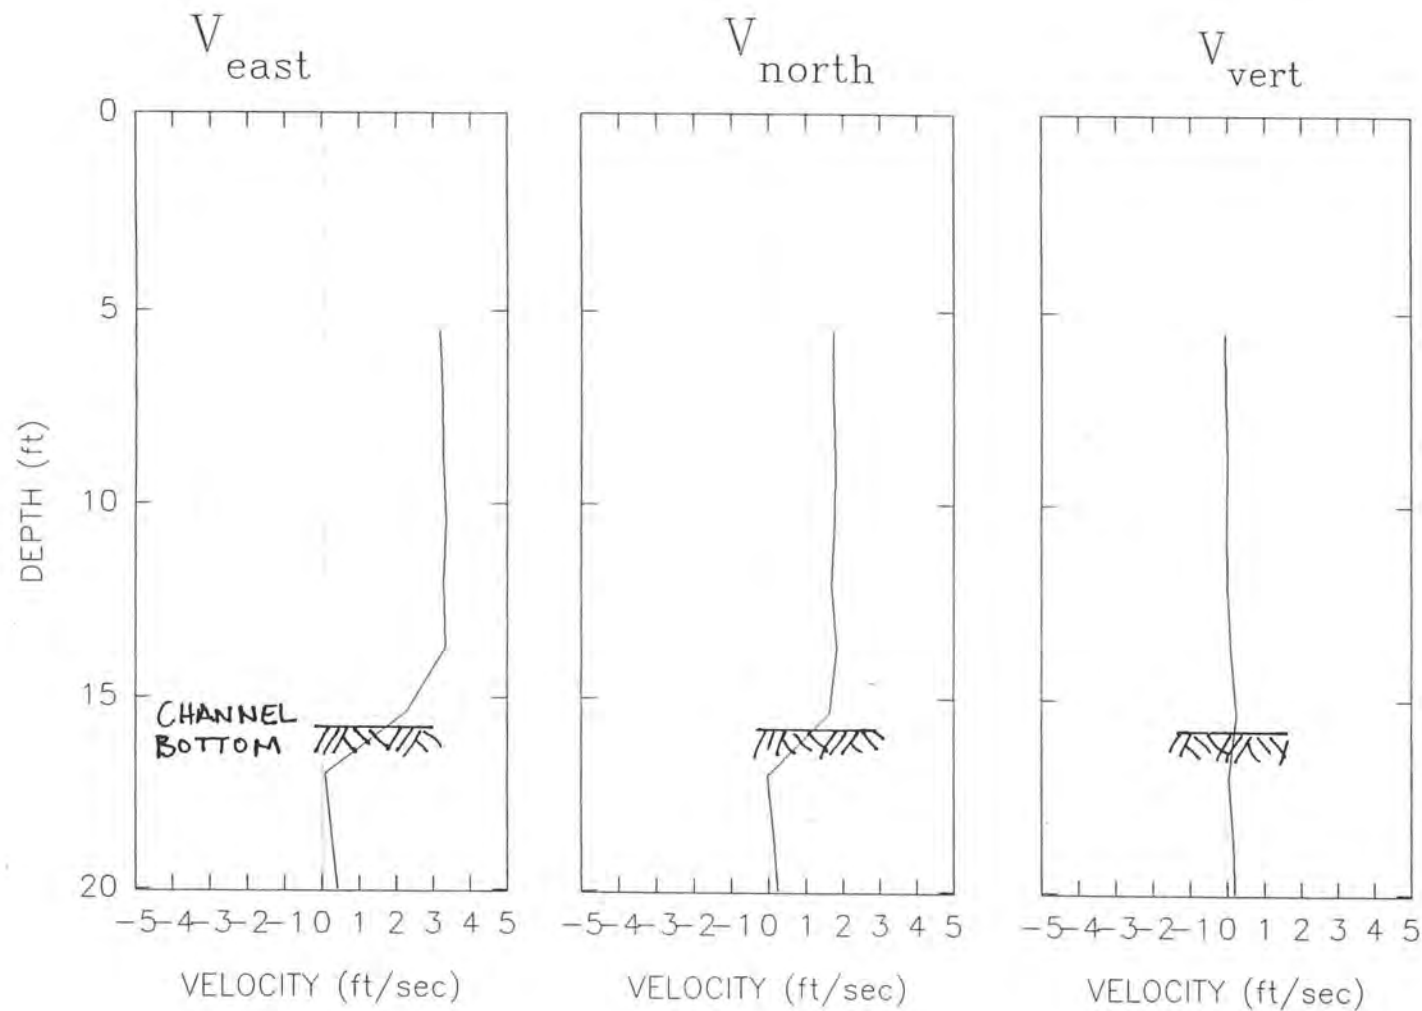
FIG-24

VELOCITY PLOTS FOR Q_L OF 4th PUMP INTAKE BAY
