Morning-Glory Shaft Spillways

A Symposium

Paper No. 2802

MORNING-GLORY SHAFT SPILLWAYS
A SYMPOSIUM

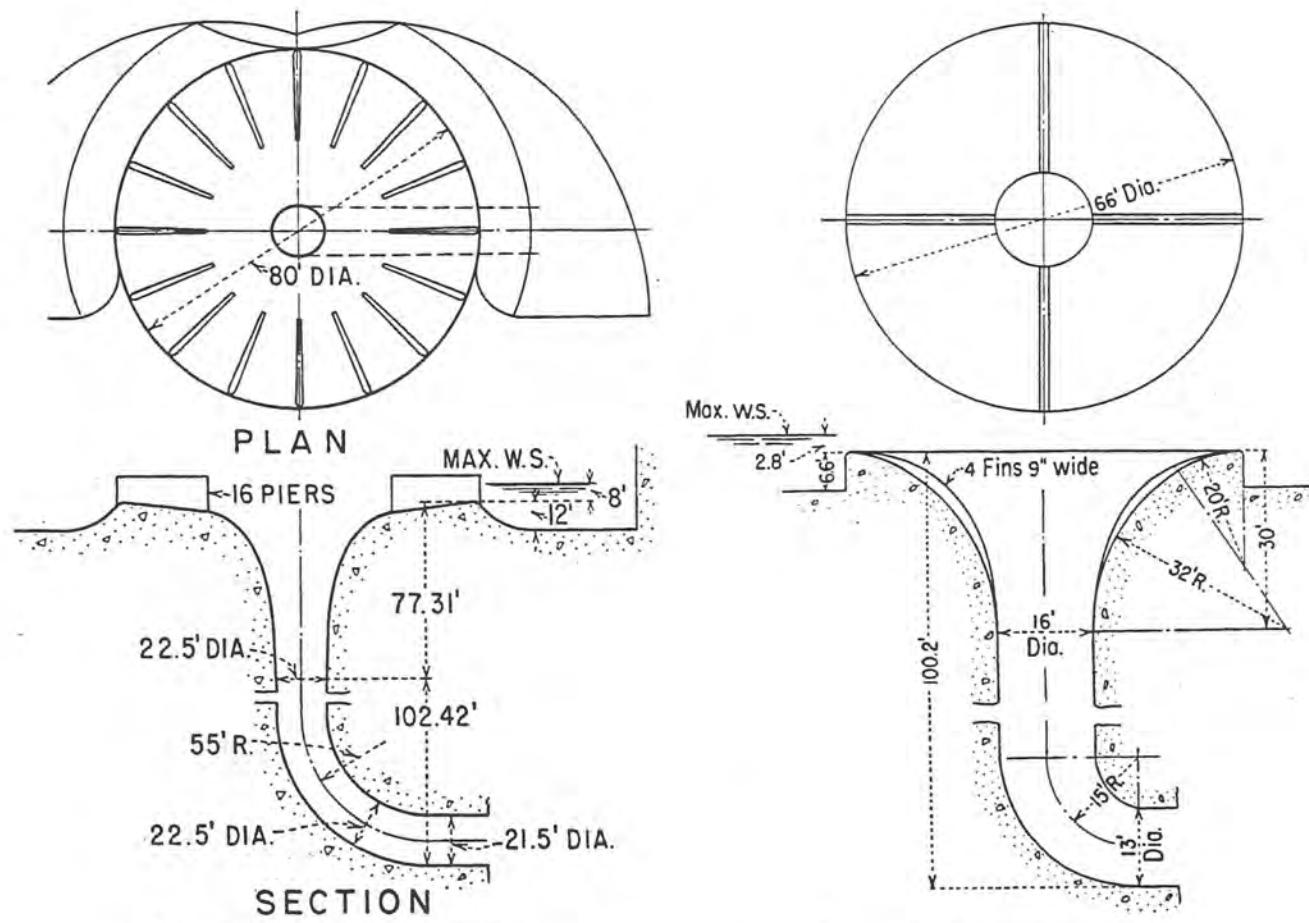
FIG. 3.—DAVIS BRIDGE DAM SPILLWAY

10,000 cu ft per sec for 15 hr. Inspection after the flood showed no appreciable erosion of the concrete in the horizontal part of the tunnel. An erosion pocket 3 ft wide by 6 ft long by 3 in. deep was apparent at the vertical bend, but it was not certain whether this was caused by erosion as a result of the velocity of the water or spalling caused by freezing and thawing of the concrete surfaces. In any event, the repairs were of a minor nature. All ice and debris which passed over the crest between the piers had readily gone through the spillway. Logs and trees 50 ft to 60 ft long were reported to have passed through the spillway at times. The spillway makes some noise when it is in operation, but this can be heard only a short distance from the dam, and vibration appears to be no problem. Sixteen piers on the crest act as an antivortex device.

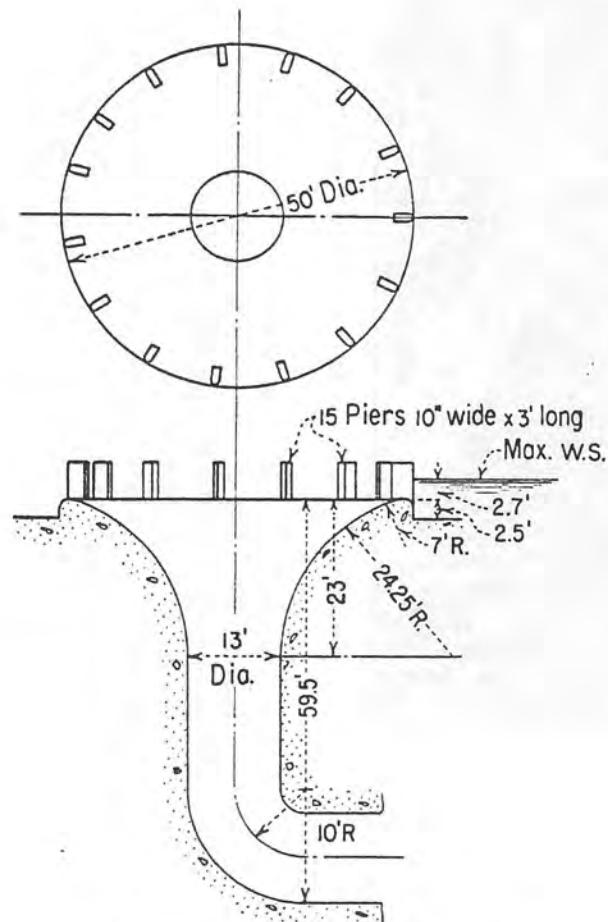
FIG. 7.—PONTIAN KETCHIL DAM SPILLWAY

Pontian Ketchil Dam.—The Pontian Ketchil Dam in Singapore was completed in 1931. The spillway was designed for a discharge of 2,700 cu ft per sec, a head of 2.7 ft on the crest, and a fall of 60 ft (Fig. 7). Information indicates that this spillway has operated as expected, without objectionable erosion and without unusual repairs. The spillway is located in the Malayan forest where cyclonic storms of such intensity occur as to uproot large trees and carry them for considerable distances. Many of these trees have passed through the spillway without damage. An emergency spillway was provided in case the morning-glory became partly blocked, but the emergency spillway has not been needed (as of 1955). The antivortex device consists of 15 piers on the crest.

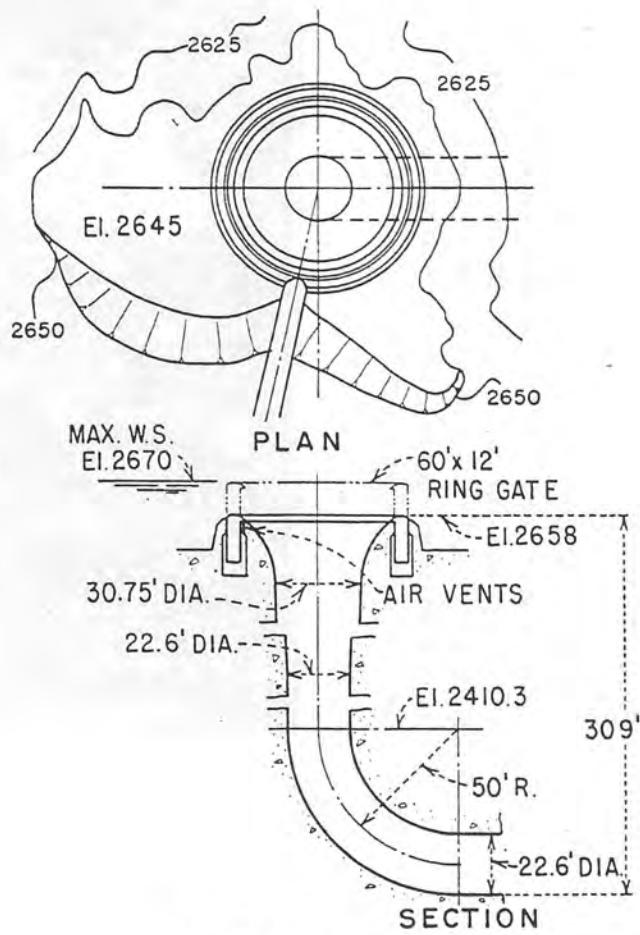
FIG. 8.—OWYHEE DAM SPILLWAY

Owyhee Dam.—The Owyhee Dam spillway in Idaho (Fig. 8), completed in 1932 by the USBR, was a daring design at the time. The capacity is 30,000 cu ft per sec, the maximum head on the crest for this discharge is 12 ft, and the water is dropped 320 ft through a vertical shaft. A flood occurred in 1936 in which 300,000 acre-ft of water were passed in 3 months. The maximum discharge recorded was 15,000 cu ft per sec, or one-half capacity. Subsequent to this flow, smaller discharges have passed through the spillway frequently. A flow of 6,600 cu ft per sec was recorded in 1951. The greatest flood occurred in 1952, when the spillway operated for more than a month. The maximum discharge through the spillway was 20,000 cu ft per sec, or 67% of capacity. Inspections of the spillway have been conducted frequently since the spillway first operated in 1936; the latest inspection was made after the 1952 flood. The spillway shaft appeared to be in excellent condition. The form board marks still appeared on the concrete surface. The visible part of

the invert of the vertical bend showed only slight surface wear, the maximum probably not exceeding $\frac{1}{4}$ in. in depth.

At the time of the inspection, 7 ft of water was standing in the tunnel so that it was impossible to inspect the lower part of the elbow except by probing. Probing with a piece of $\frac{1}{2}$ -in. pipe indicated no cavities or sign of excessive wear at the base of the vertical bend. As nearly as could be determined, the surface of the concrete in this area was not smooth, but the roughness probably did not exceed $\frac{1}{2}$ in. in depth. The invert of the horizontal tunnel was also inspected by probing. No signs of excessive wear were found in this area, and the surface of the concrete appeared to be of about the same roughness as that observed near the base of the elbow. No evidence of vibration has been apparent during spillway operation, and the jet does not flutter even with the gate in a raised position. It is also of interest to note that a single pier controls the vortex action and also houses the ring-gate operating equipment.

As this spillway is unusual so far as size is concerned, a few of the operating characteristics will be cited. For heads of from 1 ft to 2 ft over the gate, the water falls in a solid sheet toward the center of the shaft, apparently entraining air faster than it can be released at the outlet end of the tunnel. This entrainment causes the pressure to increase until it is sufficient to "break back"; then air emerges with sufficient force to carry spray 50 ft or 60 ft above the level of the gate, as shown in Fig. 9. This phenomenon occurs sometimes as often as once every 5 min, depending on the tailwater elevation. For heads less than 1 ft on the crest, entrained air can apparently move back up the spillway shaft unhampered. For heads greater than 2 ft, the air pressure is not sufficient to break back and the air is forced through the outlet end of the tunnel, causing spray to be thrown high into the canyon. This action is directly related to the tailwater as a rather large tailwater depth causes a jump to form in the tunnel for most discharges.

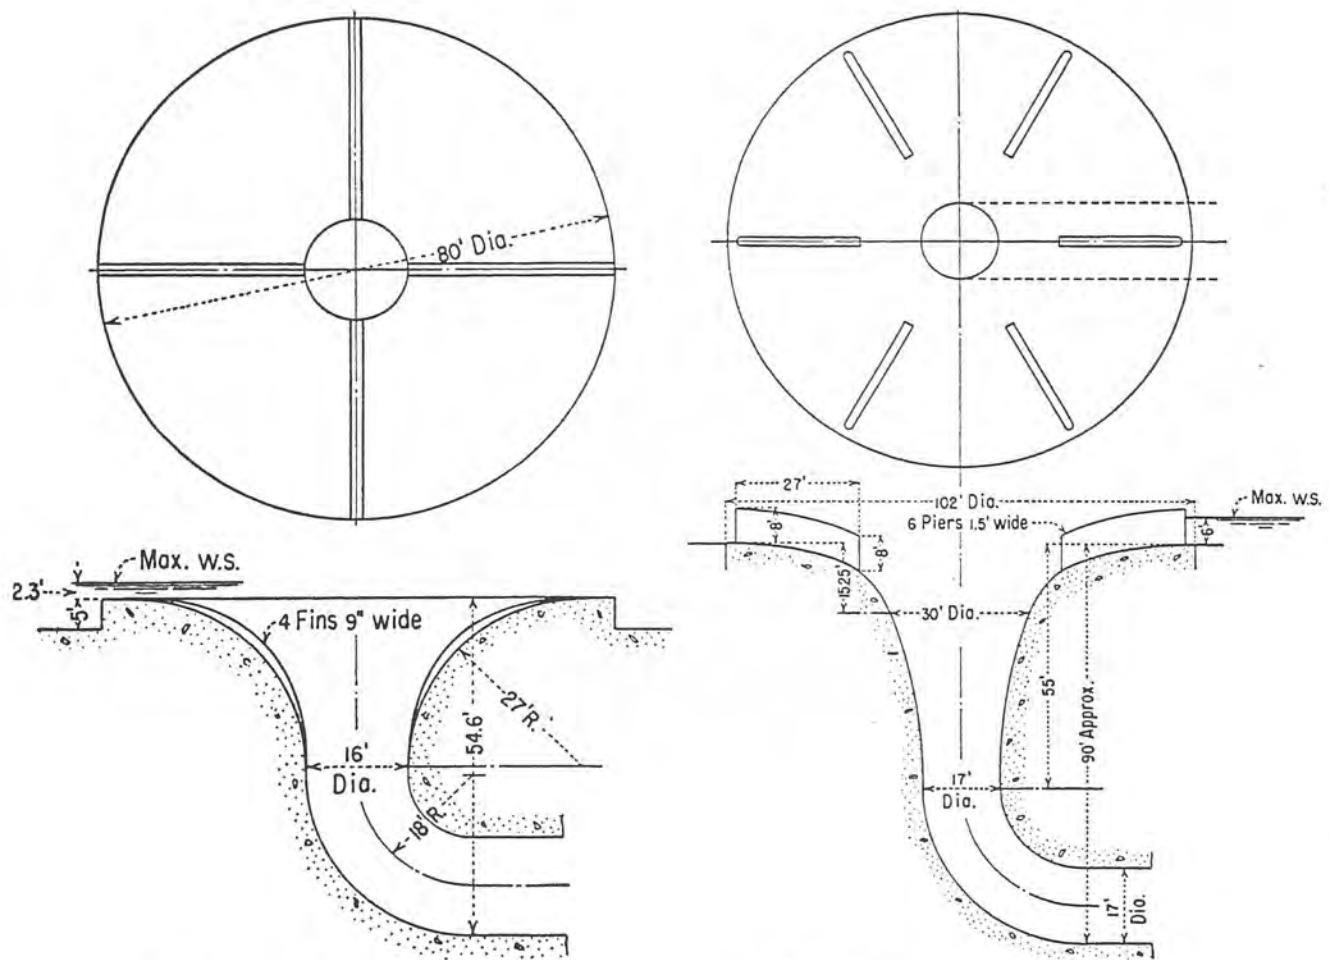
FIG. 10.—SILENT VALLEY DAM SPILLWAY

The Silent Valley Dam.—The spillway for the Silent Valley Dam in Ireland (Fig. 10) was designed for a capacity of 2,500 cu ft per sec, a head of 2.3 ft on the crest, and a fall of 55 ft. Apprehension that erosion might occur caused the designers to line the vertical bend with cast iron. The spillway has operated several times, as expected, without any unusual erosion or repairs.

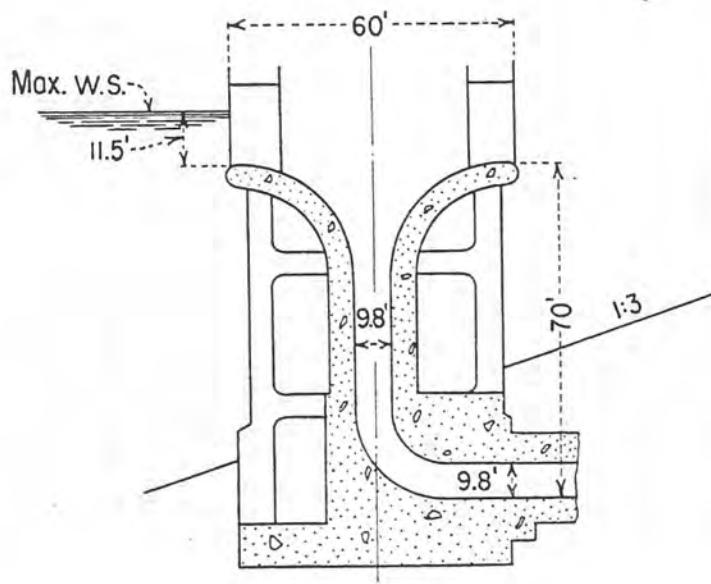
FIG. 20.—AKONGTIEH DAM SPILLWAY

Akongtien Dam.—The Akongtien Dam in South Taiwan was completed in 1951. The spillway was designed for a maximum discharge of 3,250 cu ft per sec, with a head of 11.5 ft on the crest. The drop from headwater to invert of the horizontal tunnel is approximately 81 ft. The spillway discharged for approximately 5 days in 1953, with a maximum discharge of 1,000 cu ft per sec, or approximately one third of capacity. The volume of water passed was approximately 27,300 acre-ft. No erosion could be found in the shaft, vertical bend, or horizontal tunnel. This spillway operates submerged at about half capacity. Vibration was unnoticeable and noise was not objectionable. Very little debris passed over the spillway during the flood.

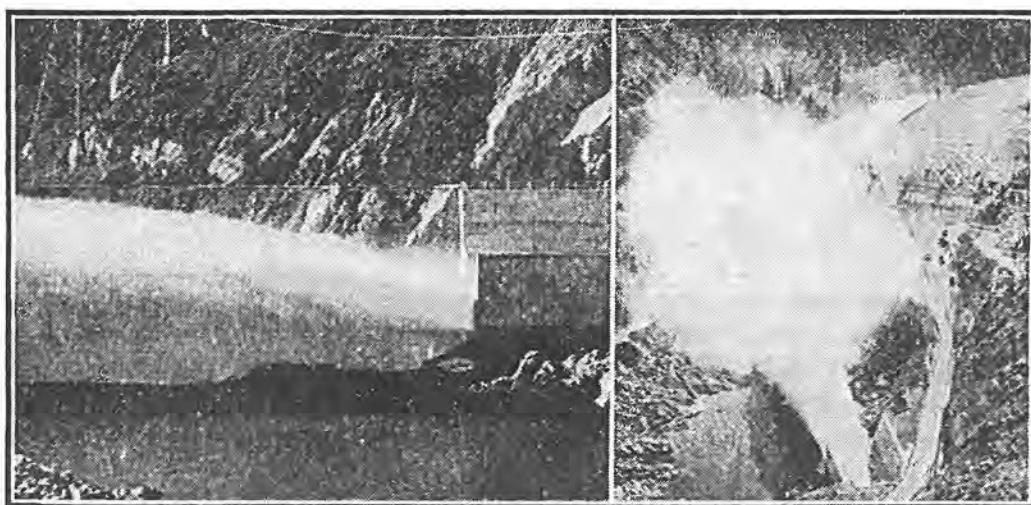
FIG. 23.—SPILLWAY JET AT DEFLECTOR

the Owyhee Dam morning-glory spillway. It was noted that the minimum flow required in the tunnel to cause the flow to spring free of the deflector was between 1,000 cu ft per sec and 1,500 cu ft per sec.

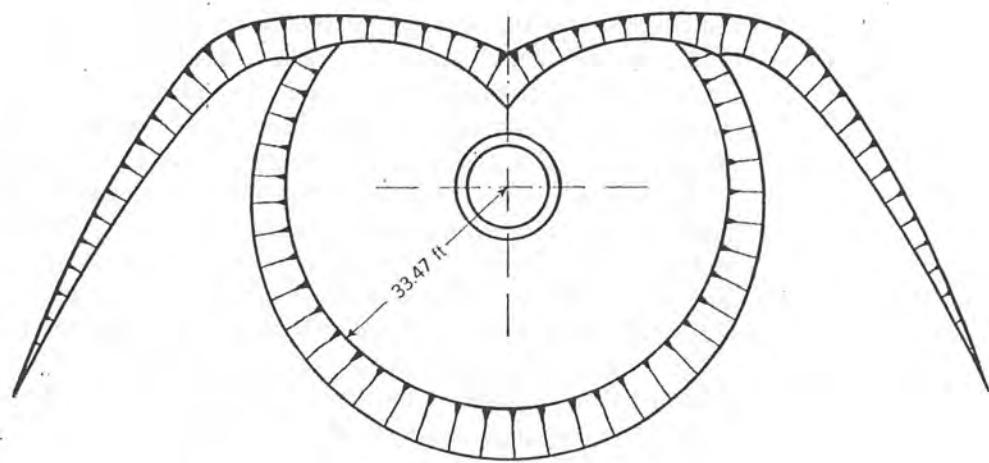
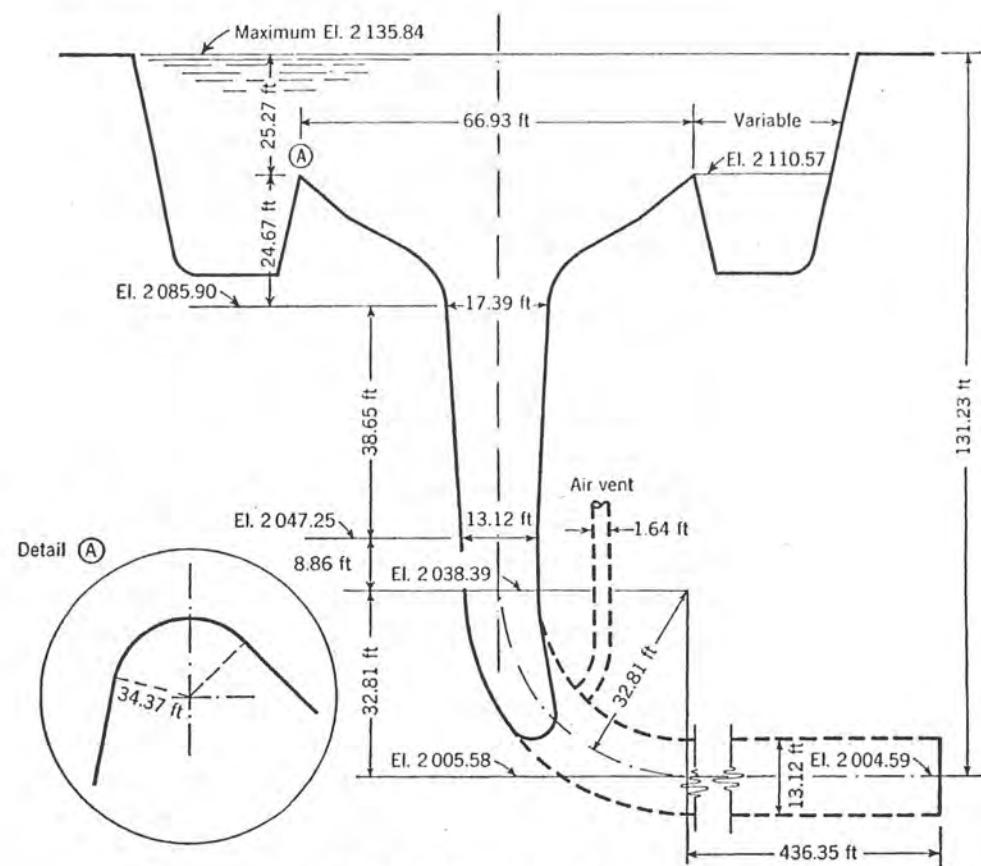
FIG. 25.—SAN ROQUE DAM SPILLWAY

Pressures registered on the model caused the installation of an air-vent pipe of 20-in. diameter from the inner curve of the 90° bend.

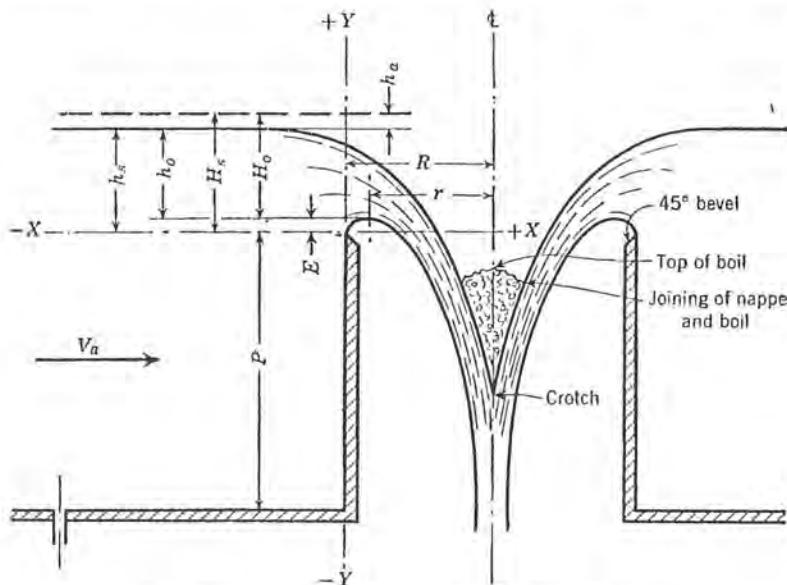
FIG. 1.—PRINCIPAL ELEMENTS OF CIRCULAR WEIR

In Fig. 1, h_s is the observed head on the weir measured, in feet, 22 in. from the weir crest; V_a denotes the average velocity of approach, in feet per second, computed 22 in. from the weir crest; h_a is the average velocity head, in feet, and is equal to $V_a^2/2g$; H_s is equal to h_s plus h_a and is the total head, in feet, above the weir crest; E represents the maximum rise, in feet, of the lower-nappe surface above the sharp crest of the weir; h_o is the observed head, in feet, above the high point on the lower-nappe surface; H_o is equal to h_o plus h_a and is the total head, in feet, above the high point on the lower-nappe surface; R denotes the radius, in feet, of the sharp crest of the test weir; P is the depth, in feet, of the

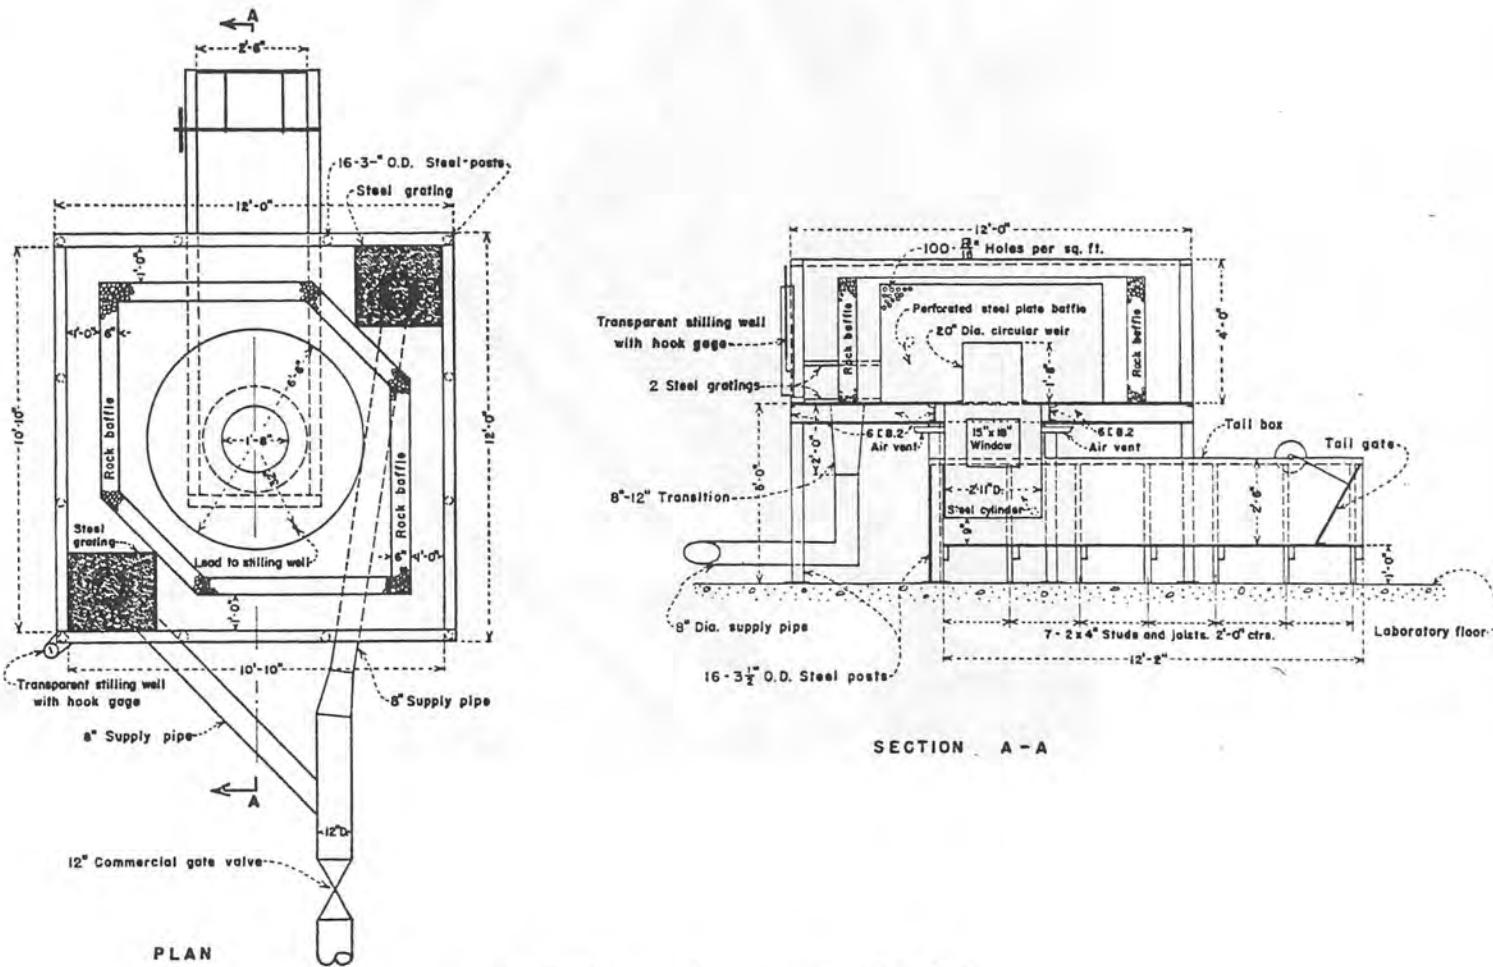
FIG. 2.—GENERAL ARRANGEMENT OF TEST WEIR

The Test Weir.—The general arrangement of the test weir is shown in Figs. 2 and 3. The test weir was fabricated from a 20-in. length of seamless steel pipe having a 20-in. outside diameter with a $\frac{1}{2}$ -in. wall. A steel flange for bolting the test weir to the floor of the head box was welded to one end of the cylinder. The outside surface of the other end of the cylinder was machined to form a true circle, 1.6593 ft in diameter. A 45° bevel was then machined from the

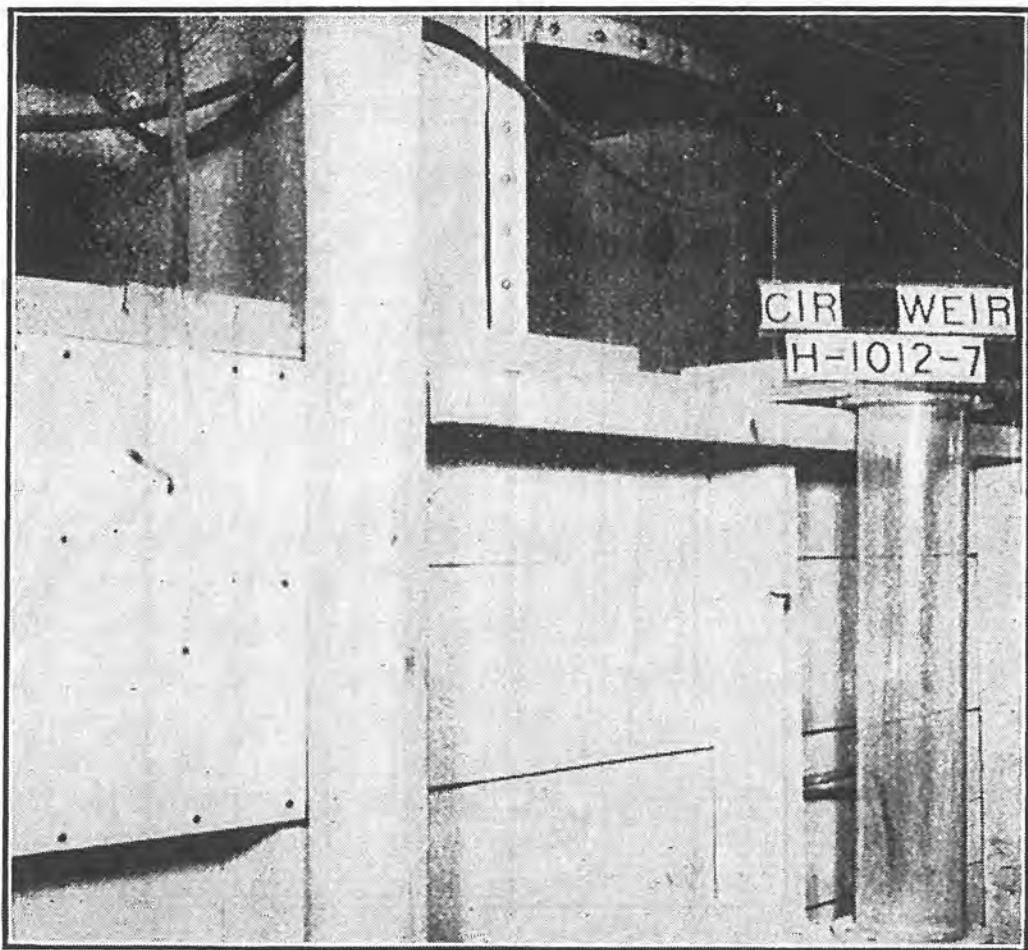
FIG. 7.—TAIL BOX AND CYLINDER FOR REDUCING PRESSURE UNDER THE NAPPE

The pressure in the chamber was measured by a differential U-tube manometer filled with water. The legs of the manometer were tilted at a 45° angle to permit reading of the differential pressure to 0.001 ft.

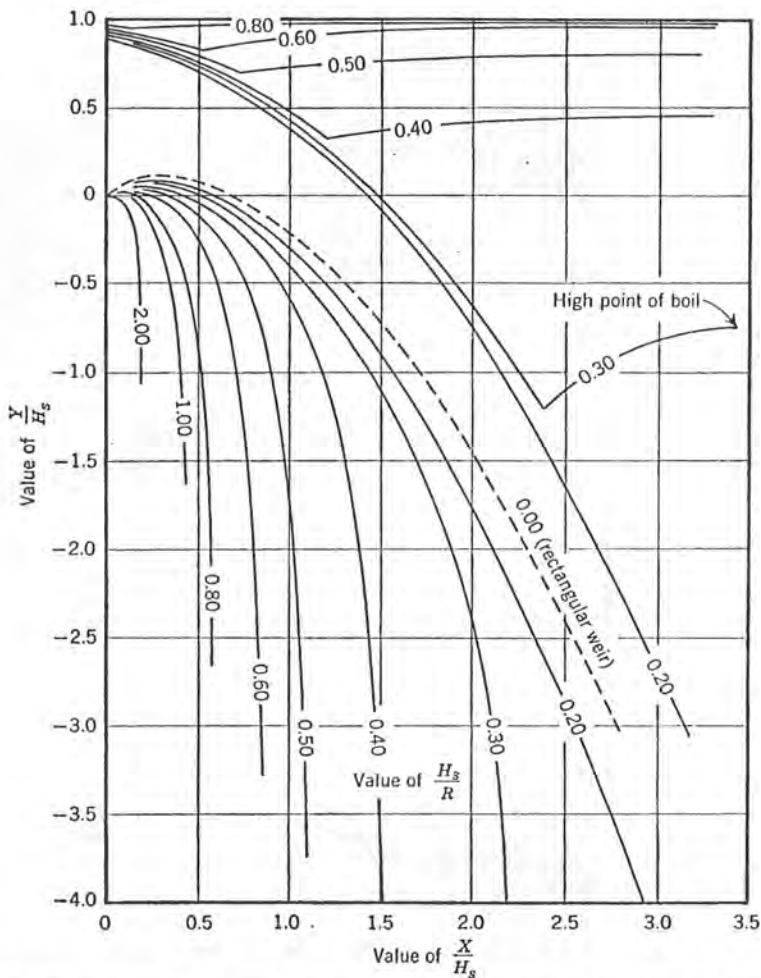
FIG. 8.—TYPICAL UPPER-NAPPE AND LOWER-NAPPE SURFACES (AERATED NAPPE AND NEGLIGIBLE VELOCITY OF APPROACH)

Nappe Profiles.—Fig. 8 shows the general shapes of the upper and lower surfaces of the nappe expressed in terms of head with an aerated nappe and a

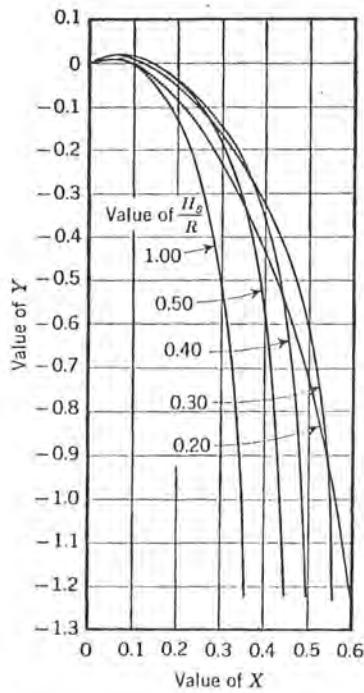
FIG. 11.—TYPICAL LOWER-NAPPE PROFILES

In the case of the rectangular weir, the lower-nappe traces spring farther from the weir crest as the head increases. This is not true, however, with the circular weir. In Fig. 11, it can be seen that for an increase in head or (H_s/R) -ratio the profile springs farther from the weir crest only in the region of the high point of the trace. Below the weir crest the traces cross, and the profile for the higher head falls inside those for the lower head. Therefore, if a morning-glory spillway is designed for the maximum head, it appears that subatmospheric pressures along the lower part of the trace will occur for heads less than maxi-

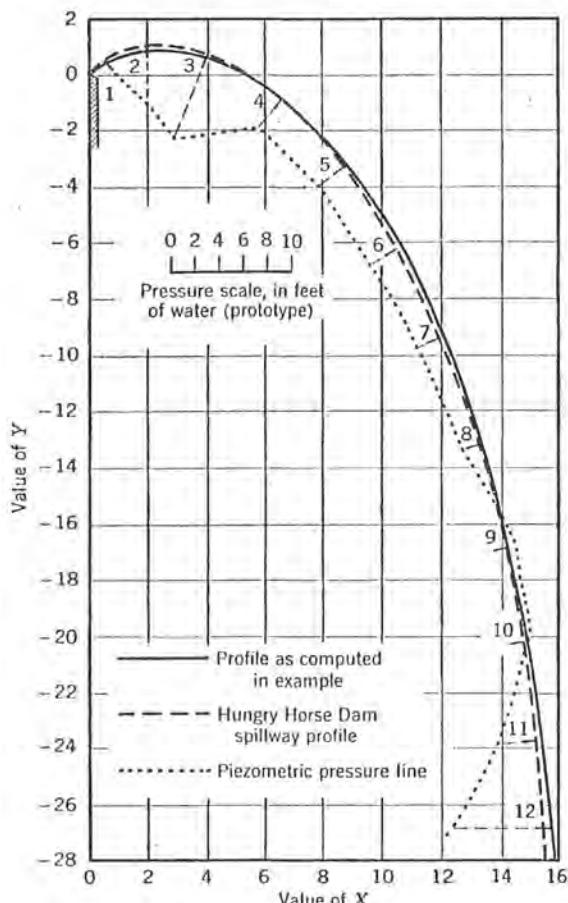
FIG. 14.—COMPARISON OF SPILLWAY PROFILES

With the ratio, $H_s/R = 0.53$, it is possible to determine the shape of the overflow section. The (X/H_s) - and (Y/H_s) -coordinates for a 30% vacuum crest are given in Table 3 for (H_s/R) -values of 0.50 and 0.60. By interpolation, sufficient coordinates to describe the curve for $H_s/R = 0.53$ are obtained.

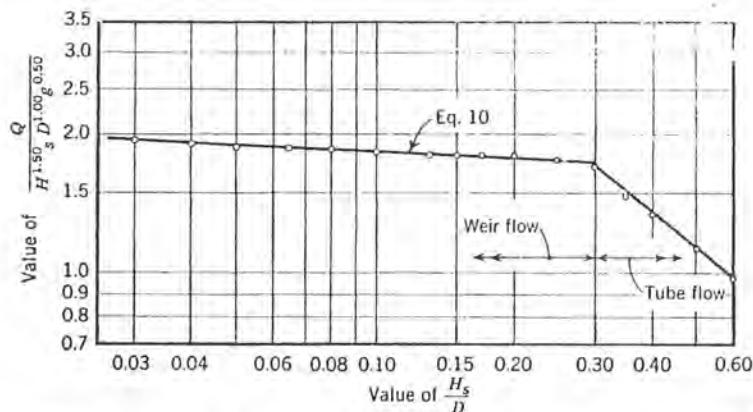
FIG. 16.—THE RELATIONSHIP BETWEEN $Q/(H^{1.50} s D^{1.00} g^{0.50})$ AND H_s/D FOR THE REGION WHERE H_s HAS NO INFLUENCE

$$\frac{Q}{H^{1.50} s D^{1.00} g^{0.50}} = 1.66 \left(\frac{H_s}{D} \right)^{-0.04} \dots \dots \dots \quad (10)$$

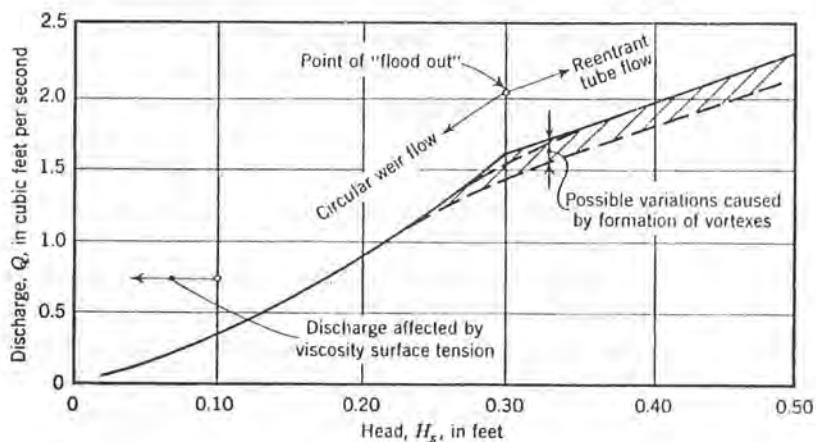
FIG. 18.—HEAD-DISCHARGE RELATIONSHIP FOR FLOW OVER A CIRCULAR WEIR HAVING A DIAMETER OF 1 FT

The point at which weir flow is "flooded out," the regime changing to flow through a re-entrant tube, was found in the Lehigh experiments to occur when H_s/D was approximately equal to 0.30 (the upper limit) above which weir flow cannot exist. However, if a vortex is formed, the flow diverges from weir flow at an earlier point. This is probably why Mr. Wagner and earlier investigators found the limit for free discharge to be lower than 0.30. The effect of vortex formation is to reduce the discharge for a given head,¹² as shown in Fig. 18 which is a discharge-head curve for an arbitrary 1-ft-diameter

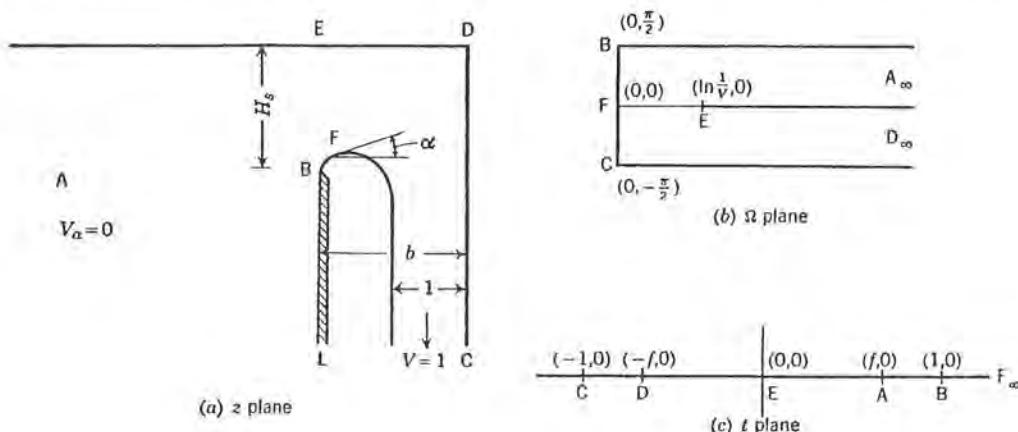
FIG. 19.—TRANSFORMATION PLANES

If the weir is completely submerged and the depth of approach is infinite, a relationship for the coefficient of discharge can be derived analytically for the two-dimensional counterpart of the flow. Although this analytical approach has been developed for two-dimensional flow only, the results obtained can be

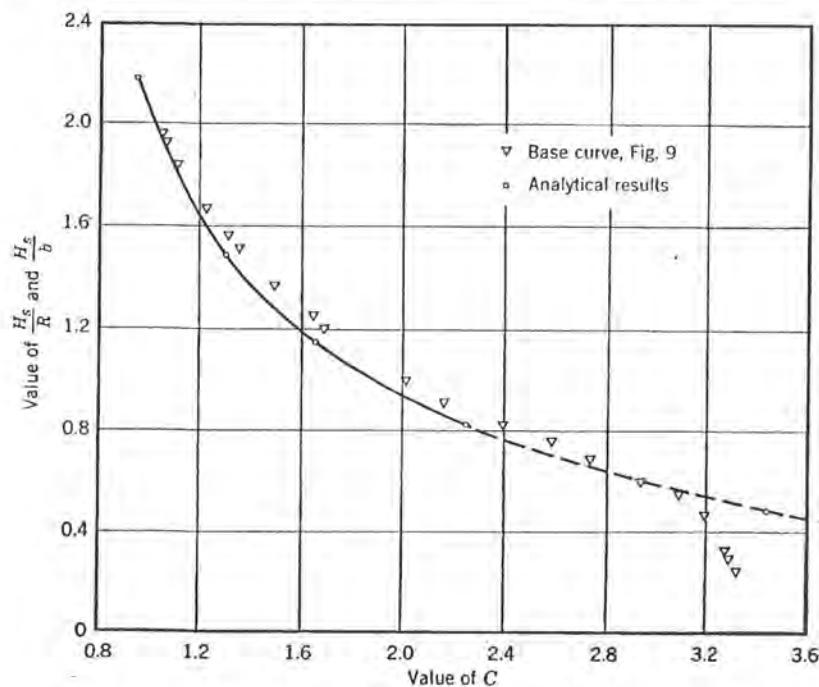
FIG. 20.—COMPARISON OF ANALYTICAL AND EXPERIMENTAL RESULTS

The computed results are compared with the author's observations on the basis of the assumption that the ratios H_s/b and H_s/R are identical. Values of C , in the form used by Mr. Wagner, have been plotted against H_s/b in Fig. 20, in which results from Fig. 9 are included. The analytically computed coefficients of discharge correspond remarkably well with the experimental coefficients for $H_s/R > 0.8$. For $H_s/R \geq 0.8$ the surface above the weir is practically horizontal, which is the condition assumed for the upper free surface in the analytical solution. The values of the coefficients of discharge C obtained from the test results are consistently slightly higher than those

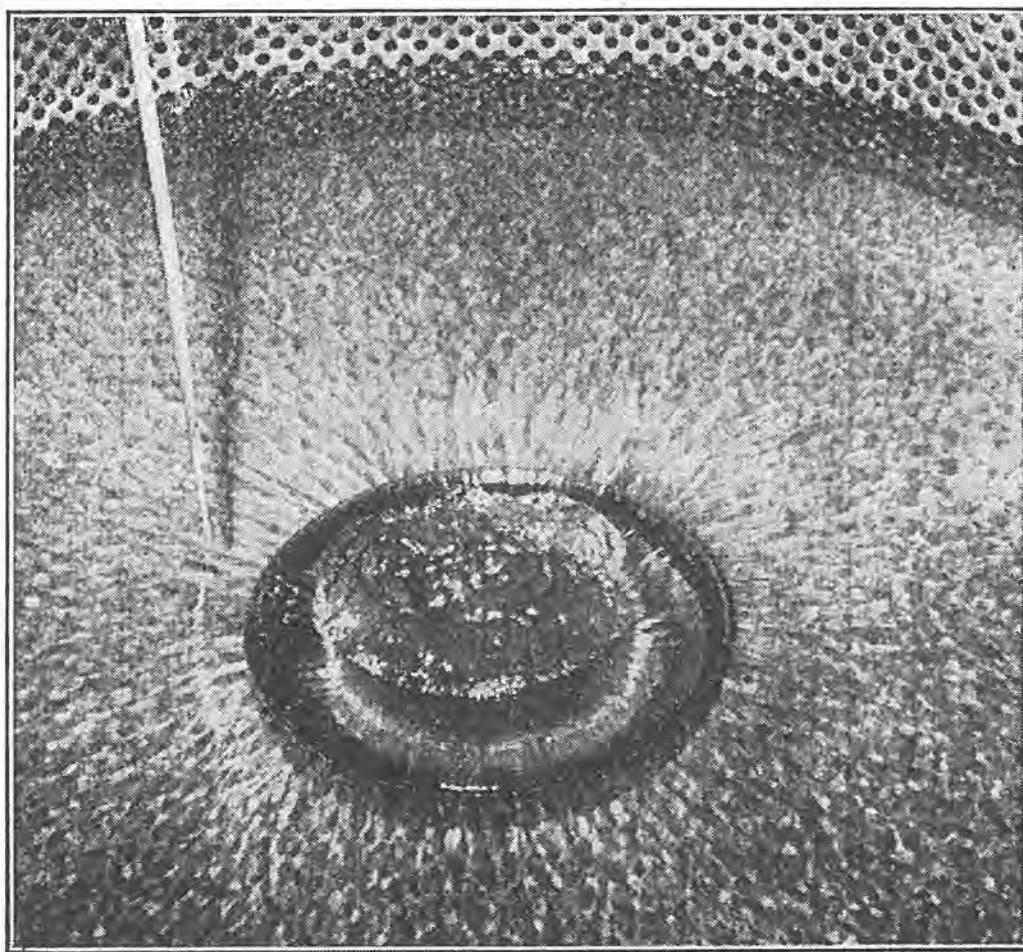
FIG. 24.—FLOW WHEN $H_s/R = 0.50$

The writer questions whether a vortex can form in the range of flows where H_s/R is less than 0.60 as suggested by Messrs. White and McPherson.

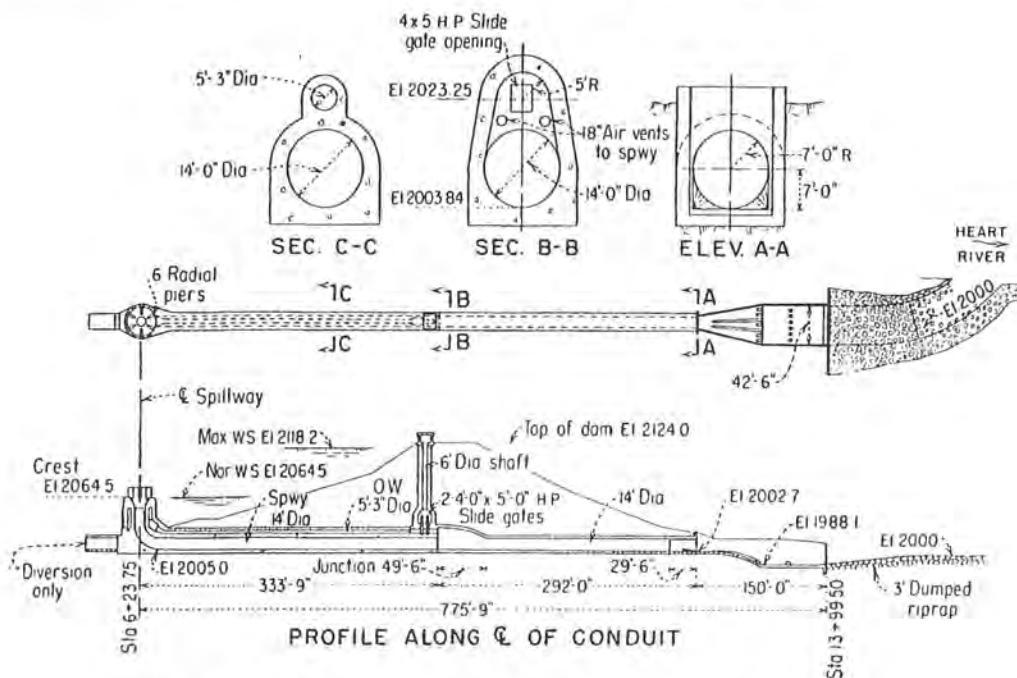
FIG. 1.—GENERAL PLAN AND SECTIONS FOR SPILLWAY AND OUTLET WORKS

The Heart Butte Dam is located on the Heart River 60 miles west of Bismarck, N. Dak., and is a part of the Heart River unit of the Missouri River Basin Project. The dam is of compacted earth fill with a rock riprap cover, rises 135 ft above the Heart River stream bed, and is 1,860 ft long (Fig. 1). The dam is a combined irrigation and flood-control structure, with no power being developed. The reservoir at maximum water-surface elevation contains 392,500 acre-ft from a drainage area of 1,810 sq miles.

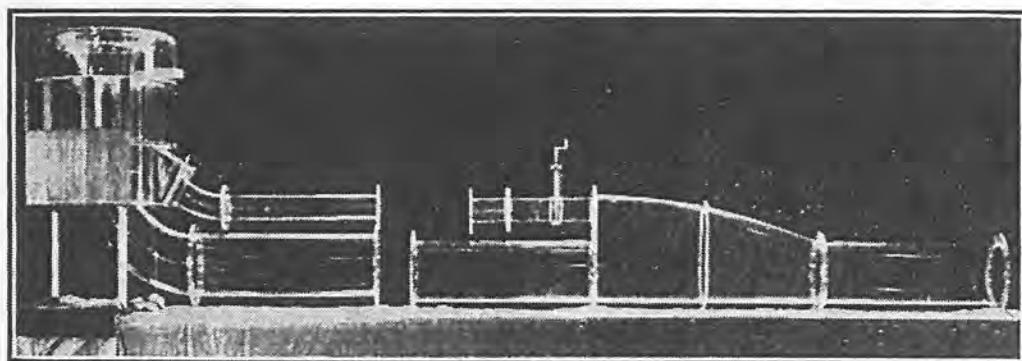
FIG. 2.—TRANSPARENT-PLASTIC MODEL OF THE SPILLWAY AND OUTLET WORKS

The feasibility of a combined spillway and outlet structure was determined, and the detailed shape and arrangement of the various parts of the structure were developed from hydraulic model tests on a 1 : 21.5 model.
