**Flaming Gorge Tunnel Spillway Aerator Analysis**

Kathleen H. Frizell

**U.S. Bureau of Reclamation**

April 30, 2001

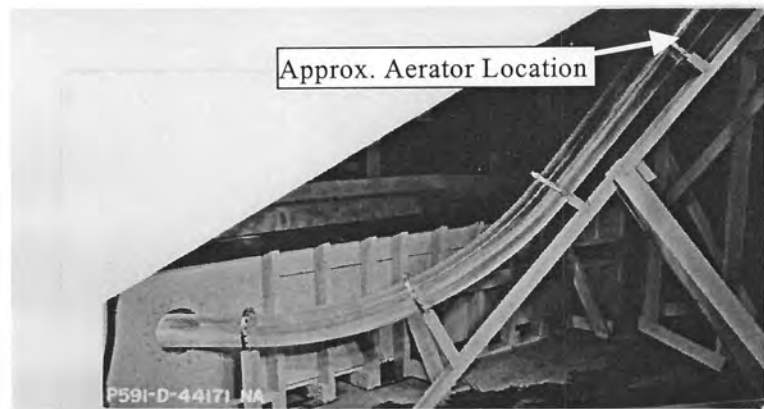
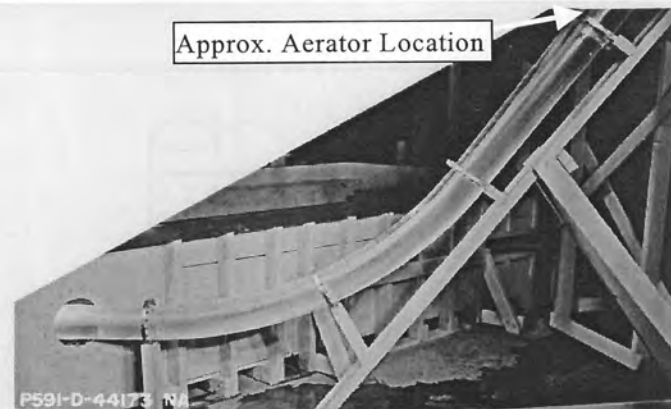
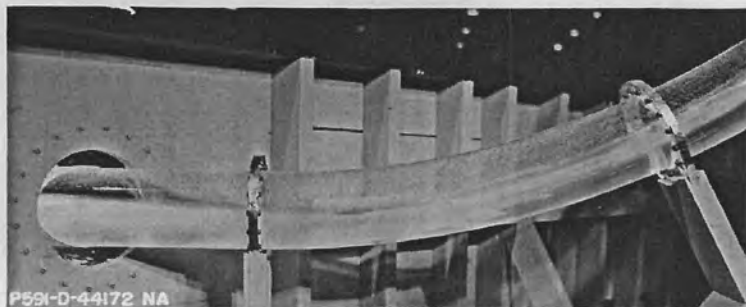
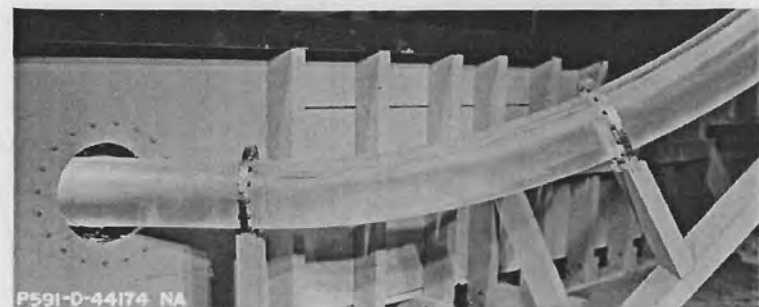
Discharge = 15,000 cfs

Discharge = 28,800 cfs

FLAMING GORGE DAM  
1:36 Scale Model

Flow in Sloping Tunnel, Vertical Bend  
and Horizontal Tunnel

Figure 2. - Photograph from 1964 hydraulic model study prior to aerator design and installation. Note the depth of flow at the approximate aerator location.

Hydraulic modeling was performed in 1964 for the original design of the tunnel spillway without the aerator [3]. These studies dealt with the intake geometry, pier and crest geometry and flip bucket design. Photographs were taken of the spillway operation at 15,000 and 28,800 ft<sup>3</sup>/s, figure 2. The aeration device location at Sta. 2+60 is approximately indicated on the photographs. Notice the depth of flow in the tunnel at this point and further downstream below the elbow where the report states, “the depth of flow in the horizontal section was about 0.85 of the tunnel diameter, but because of the smooth flow conditions the space above the water surface was considered adequate”. Unfortunately, it also appears that the flow depth in the area of the aerator is also quite deep. This information was used with further investigation of the hydraulic and cavitation parameters in the final recommendations
