# Hydraulic Model Study of the Grand Valley Irrigation Company Fish Screen Structure

U.S. Department of the Interior  
Bureau of Reclamation  
Technical Services Center  
Water Resources Research Laboratory  
Denver, Colorado

May 2003

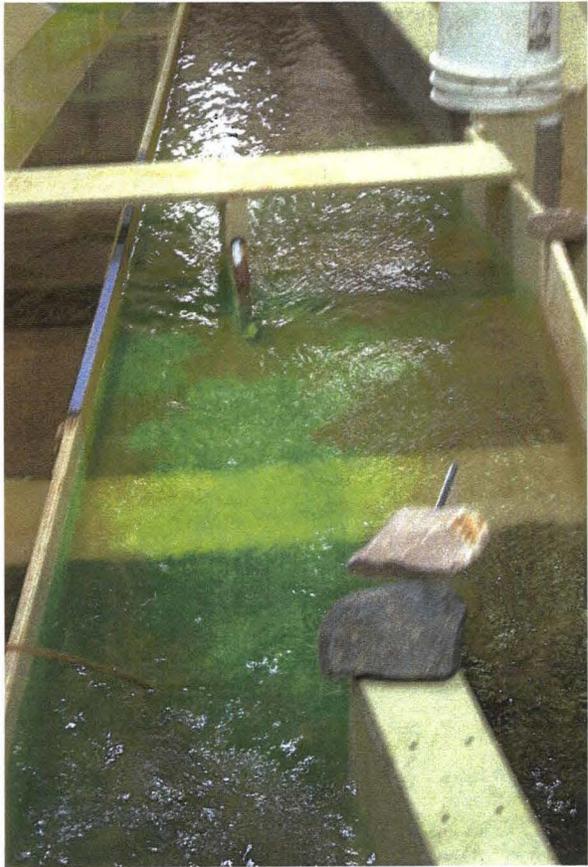
**Figure 23. - Test 13, close up view of dye tracing from downstream of the left (south) gates for a canal discharge of  $640 \text{ ft}^3/\text{s}$  for the 15.5-degree, 21-ft-long deflector with the straight angled left wall with the right wall installed. Note that a portion of the flow now spreads towards the right side of the channel.**

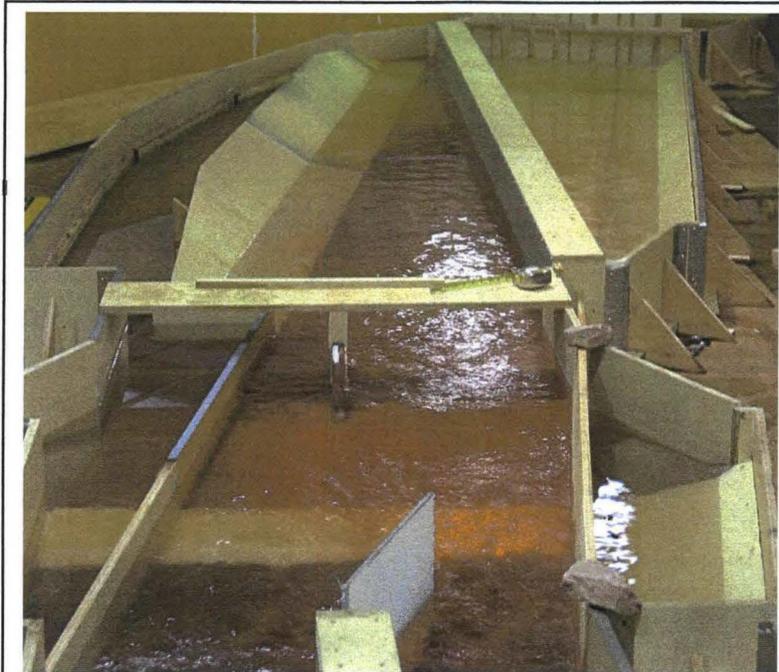
**Figure 29. - Overall view of the canal operating under a discharge of 640 ft<sup>3</sup>/s and river El. 4681 with the final deflector and the toe of the 2:1 sloping wall opposite the screen located on the same line as the vertical wall.**

Flow conditions upstream of the bridge remain identical. Figure 29 shows the larger flow area and slightly less wavy flow surface along the screen compared to the vertical wall for the 640 ft<sup>3</sup>/s canal discharge. Figure 30 shows that the dye travels almost directly downstream but does spread laterally somewhat.

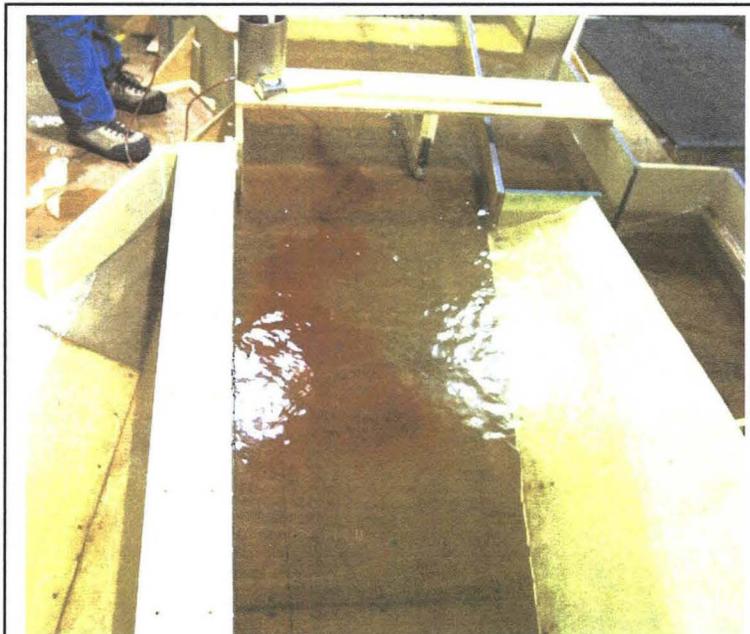
**Figure 30. - Close up of dye tracing near the screen with the 2:1 sloping wall in the downstream screen section for a discharge of 640 ft<sup>3</sup>/s and river El. 4681.**
