Technical Memorandum No. MERL-08-10

Hole Erosion Tests for Wolf Creek Dam

U.S Army Corps of Engineers, Nashville District
Russell County, Kentucky

May 2008

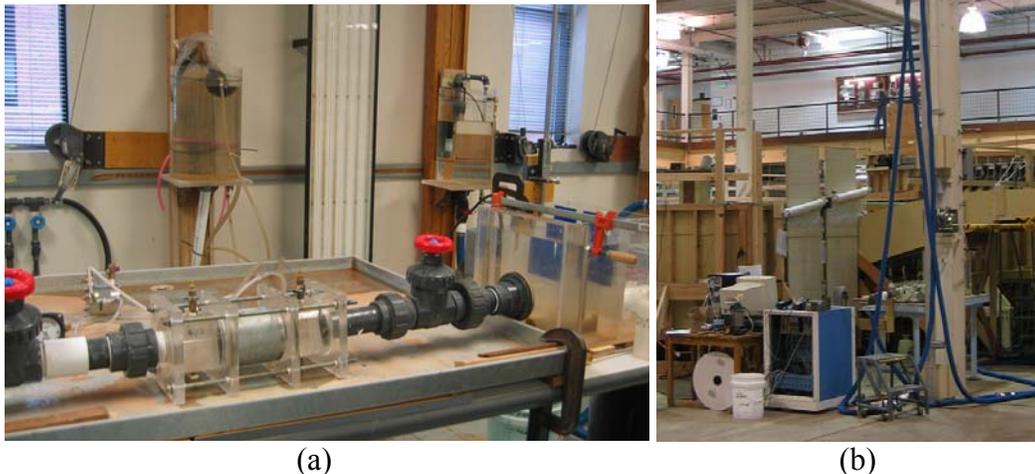
Figure 3. — The standard HET apparatus in the soils laboratory (a) is limited to about 1600 mm net head, while the new high-head facility (b) can produce a maximum head of about 5400 mm..

Figure 3 shows the standard and high-head HET test facilities in the Bureau of Reclamation laboratory in Denver, Colorado. Flow rate through the specimen is measured by a custom 10° V-notch weir calibrated in place. Measurements of differential head across the specimen and head on the weir are recorded by a computerized data acquisition system that records data at 5 second intervals throughout a test. The maximum test head using the facility in Fig. 3(a) is about 1600 mm, limited by laboratory ceiling height and flow capability. The maximum head used by Wan and Fell (2004) was 1200 mm. During the course of the testing program, the high-head HET facility was constructed, allowing testing at heads up to 5400 mm.

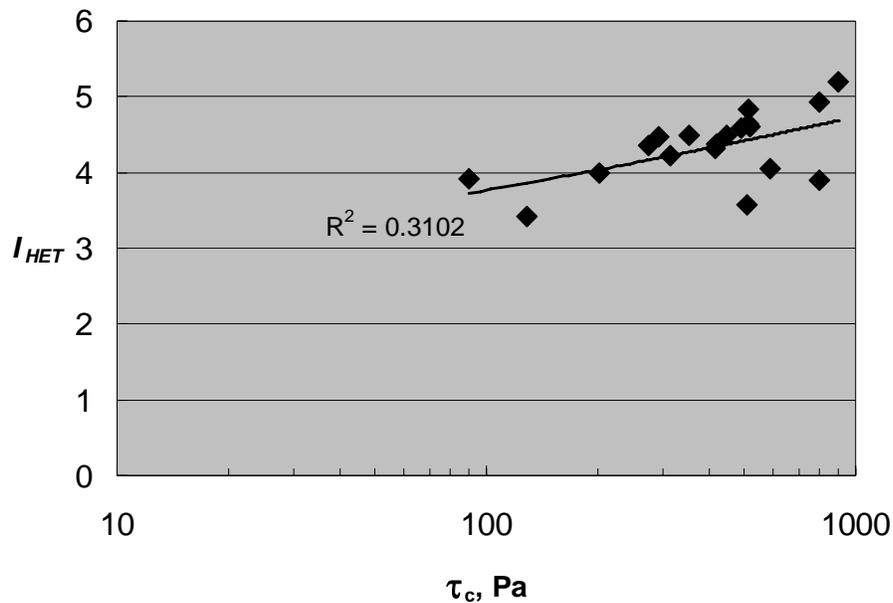
Figure 4. — Erosion rate index values and critical shear stresses.

The I_{HET} value and critical shear stress were observed to be weakly related to the Torvane shear strength, plasticity index, and liquid limit. The I_{HET} value and the critical shear stress were correlated to one another, as expected, although there is significant scatter around the best-fit line. Figures 4, 5, 6, and 7 show the HET results graphically. Figure 8 shows the results ranked in order of decreasing erosion rate or increasing value of I_{HET} .

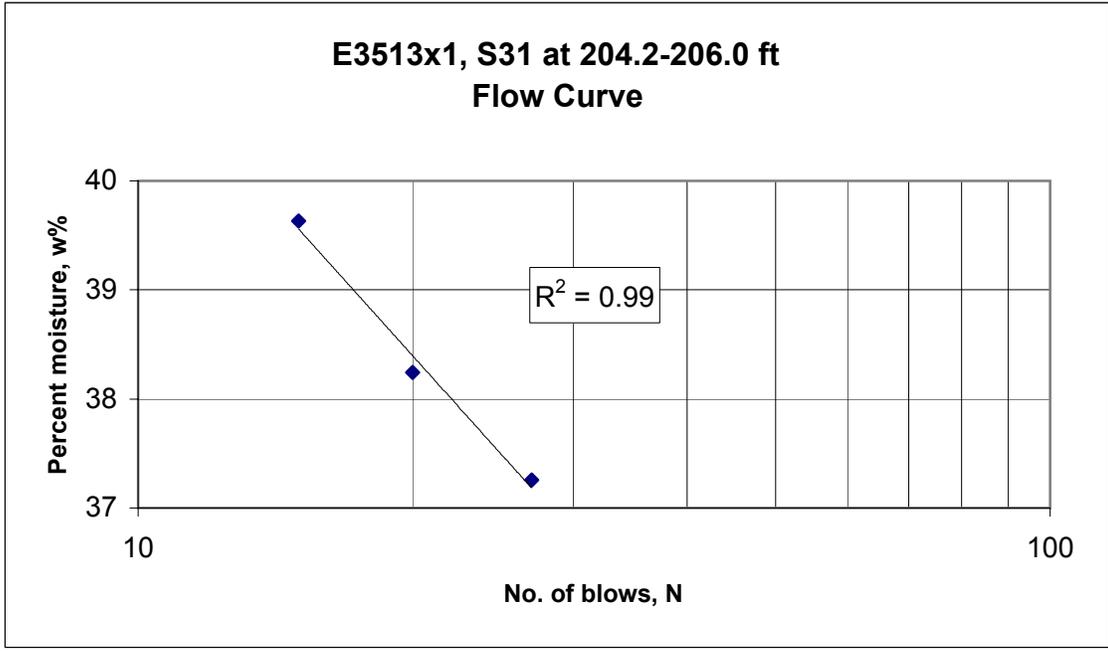
Soil Consistency Test (Three-Point Liquid Limit Method)					
Sample No.	E3513x1, S31 at 204.2-206.0 ft				
Feature	Wolf Creek Dam				
Project	USACE				
Date	3/17/2008				
Test	Plastic Limit		Liquid Limit		
Trial No.	1	2	1	2	3
Dish No.	133	S-56	99	S-68	87
No. of blows	N/A	N/A	27	20	15
Mass of dish+wet soil (g)	14.099	14.205	21.841	24.900	20.300
Mass of dish+dry soil (g)	12.972	13.209	17.616	20.312	16.312
Mass of dish (g)	6.742	7.674	6.276	8.316	6.250
Mass of water (g)	1.127	0.996	4.225	4.588	3.988
Mass of dry soil (g)	6.230	5.535	11.340	11.996	10.062
% moisture	18.1	18.0	37.3	38.2	39.6
Average plastic limit	18				
LL = 37	PL = 18	PI = 19	Fi = -9.3

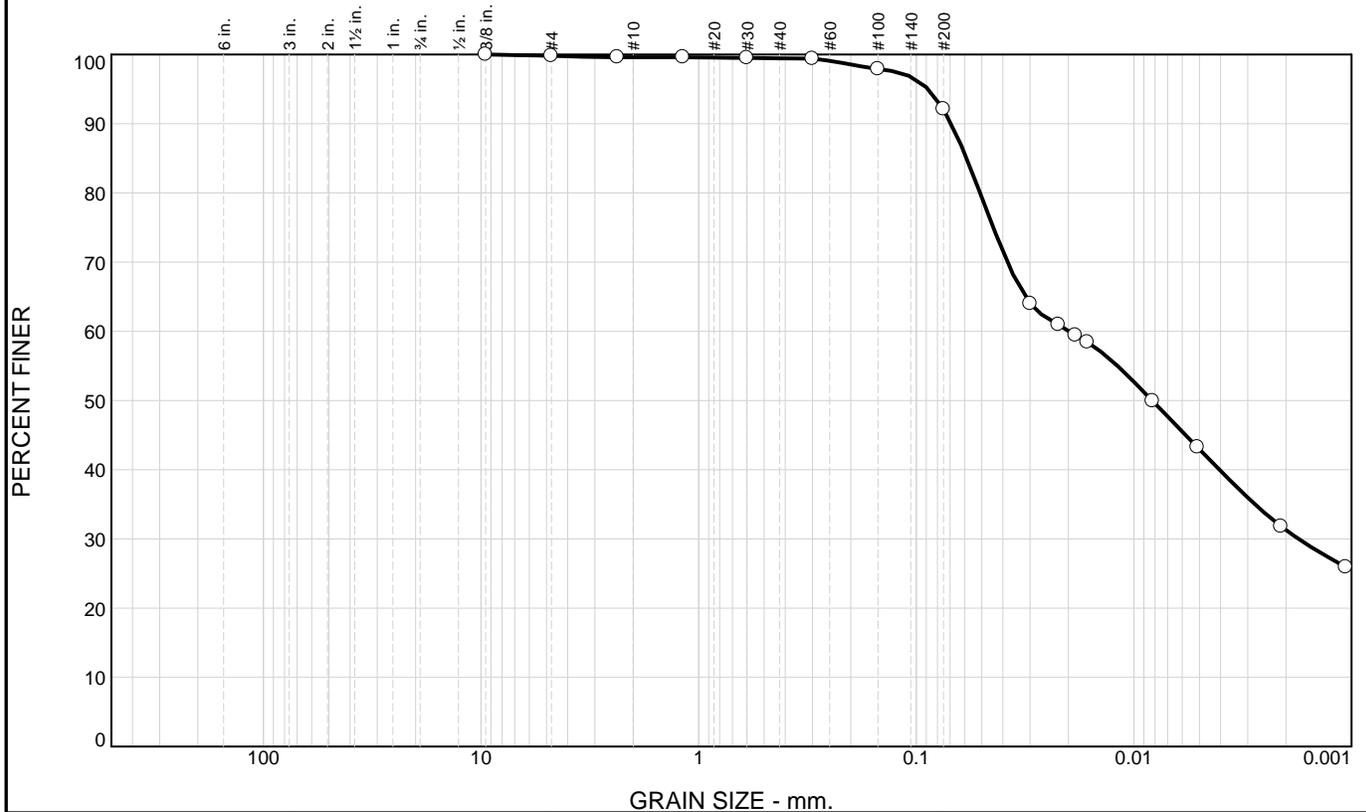
Particle Size Distribution Report

% +3"	% Gravel		% Sand			% Fines	
	Coarse	Fine	Coarse	Medium	Fine	Silt	Clay
0.0	0.0	0.2	0.2	0.2	7.3	49.1	43.0

SIEVE SIZE	PERCENT FINER	SPEC.* PERCENT	PASS? (X=NO)
.375	100.0		
#4	99.8		
#8	99.6		
#16	99.6		
#30	99.5		
#50	99.4		
#100	97.9		
#200	92.1

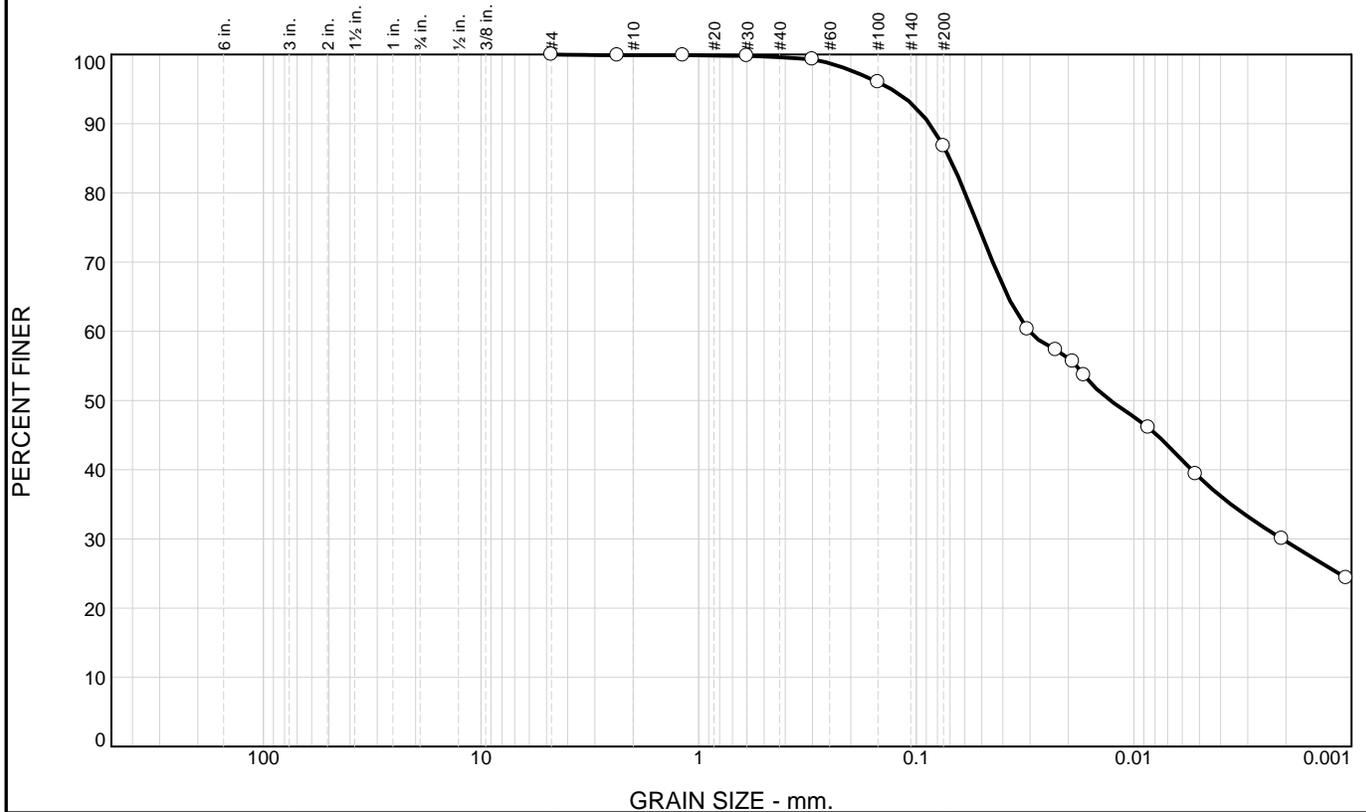
Particle Size Distribution Report

% +3"	% Gravel		% Sand			% Fines	
	Coarse	Fine	Coarse	Medium	Fine	Silt	Clay
0.0	0.0	0.0	0.1	0.3	12.8	47.9	38.9

SIEVE SIZE	PERCENT FINER	SPEC.* PERCENT	PASS? (X=NO)
#4	100.0		
#8	99.9		
#16	99.9		
#30	99.8		
#50	99.3		
#100	96.0		
#200	86.8

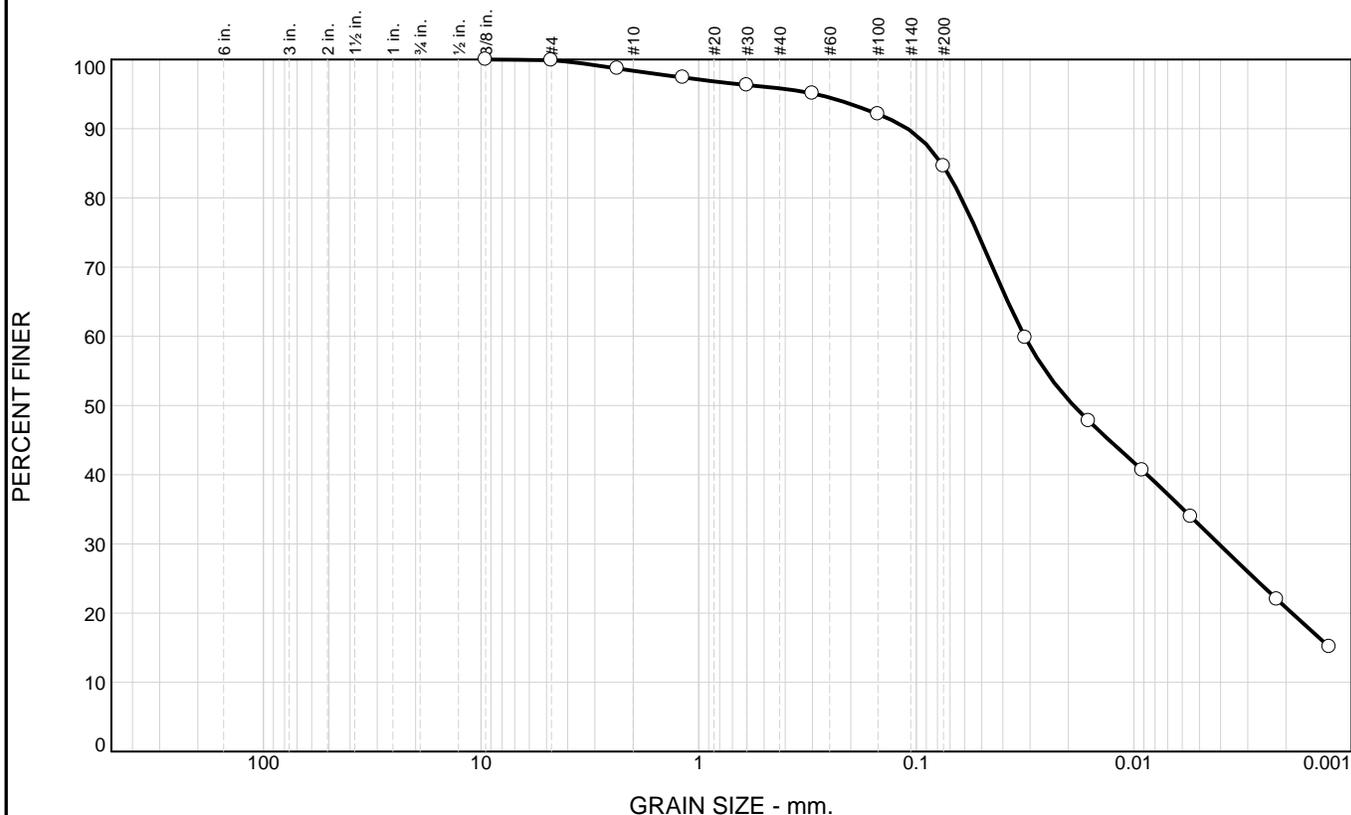
Particle Size Distribution Report

% +3"	% Gravel		% Sand			% Fines	
	Coarse	Fine	Coarse	Medium	Fine	Silt	Clay
0.0	0.0	0.1	1.5	2.6	11.2	51.9	32.7

SIEVE SIZE	PERCENT FINER	SPEC.* PERCENT	PASS? (X=NO)
.375	100.0		
#4	99.9		
#8	98.7		
#16	97.4		
#30	96.3		
#50	95.1		
#100	92.1		
#200	84.6

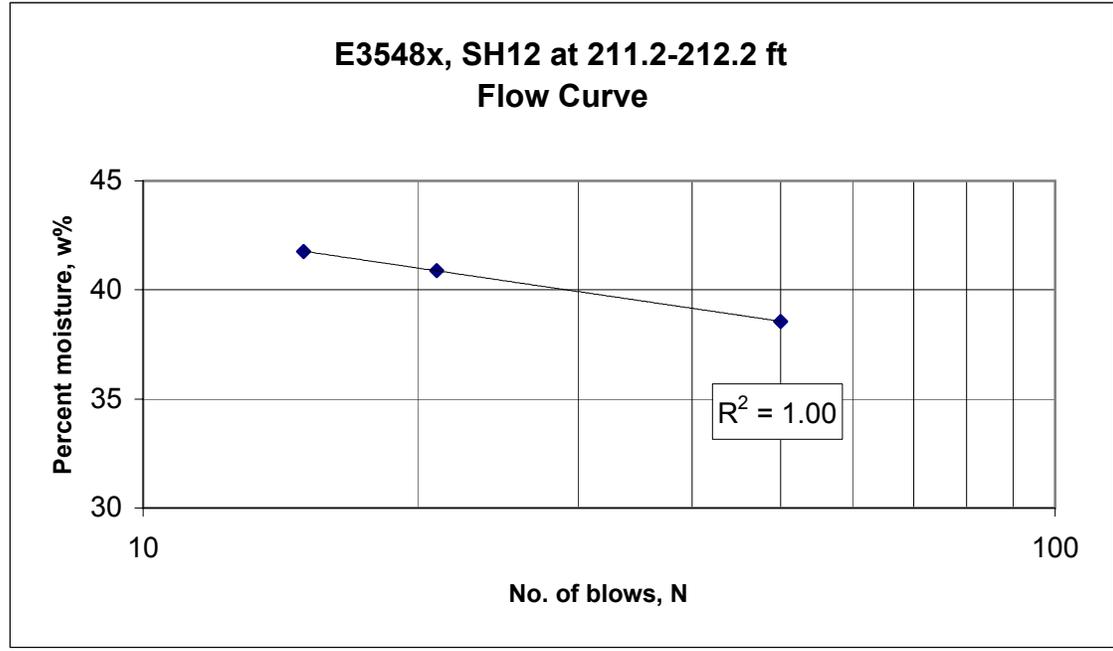
Test	Plastic Limit		Liquid Limit		
	1	2	1	2	3
Trial No.					
Dish No.	92	108	125	S-49	128
No. of blows	N/A	N/A	21	15	50
Mass of dish+wet soil (g)	13.431	14.629	20.130	26.396	22.923
Mass of dish+dry soil (g)	12.173	13.168	15.988	21.485	18.500
Mass of dish (g)	6.266	6.334	5.858	9.726	7.029
Mass of water (g)	1.258	1.461	4.142	4.911	4.423
Mass of dry soil (g)	5.907	6.834	10.130	11.759	11.471
% moisture	21.3	21.4	40.9	41.8	38.6
Average plastic limit	21

LL = 40 PL = 21 PI = 19 Fi = -6.1

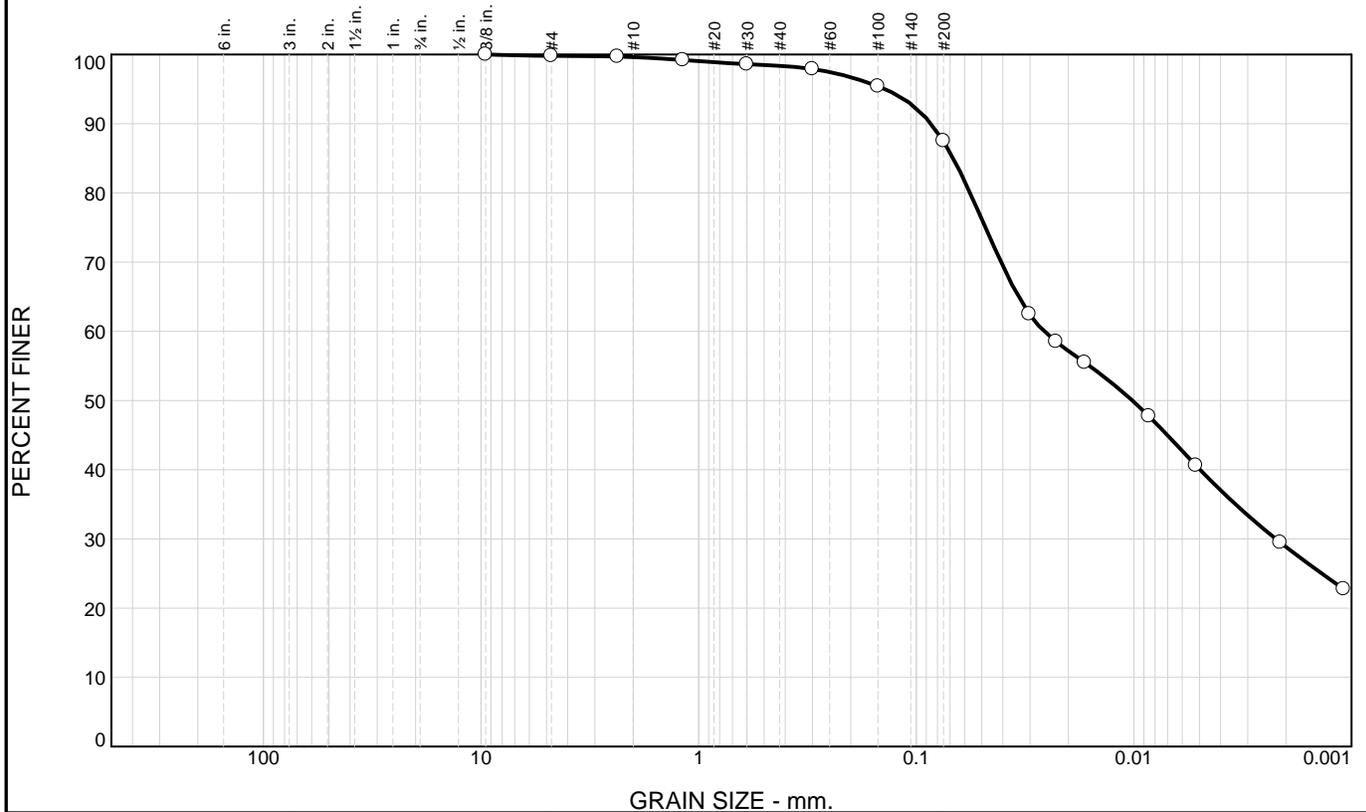
Particle Size Distribution Report

% +3"	% Gravel		% Sand			% Fines	
	Coarse	Fine	Coarse	Medium	Fine	Silt	Clay
0.0	0.0	0.2	0.2	1.2	10.9	47.4	40.1

SIEVE SIZE	PERCENT FINER	SPEC.* PERCENT	PASS? (X-NO)
.375	100.0		
#4	99.8		
#8	99.7		
#16	99.2		
#30	98.6		
#50	97.9		
#100	95.4		
#200	87.5

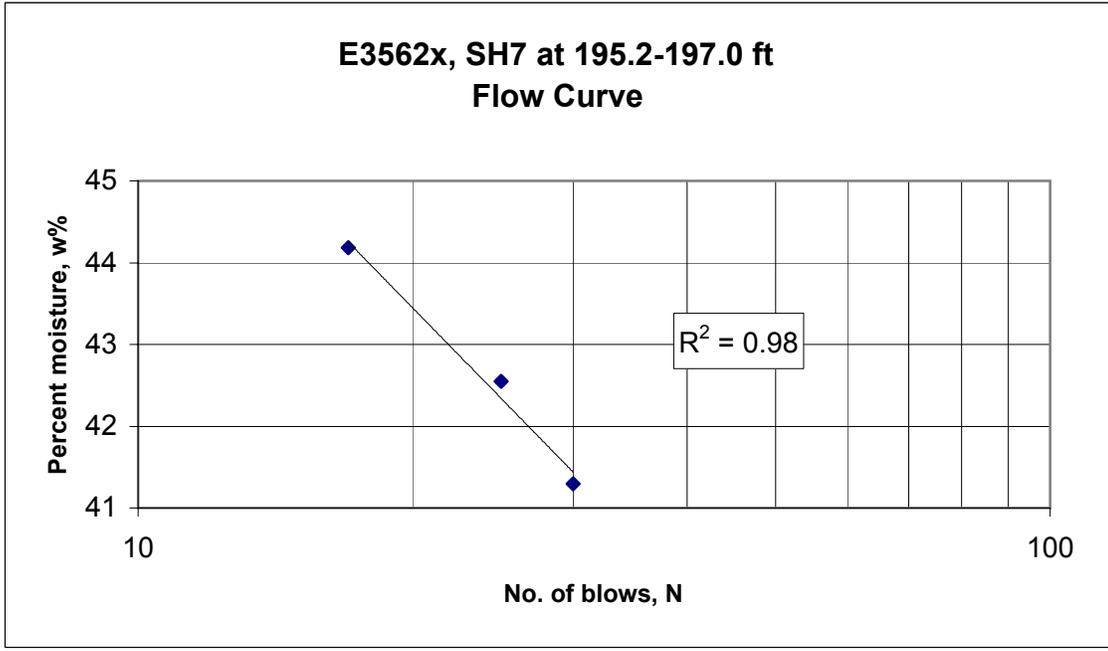
LL = 42 PL = 20 PI = 22 Fi = -11.4

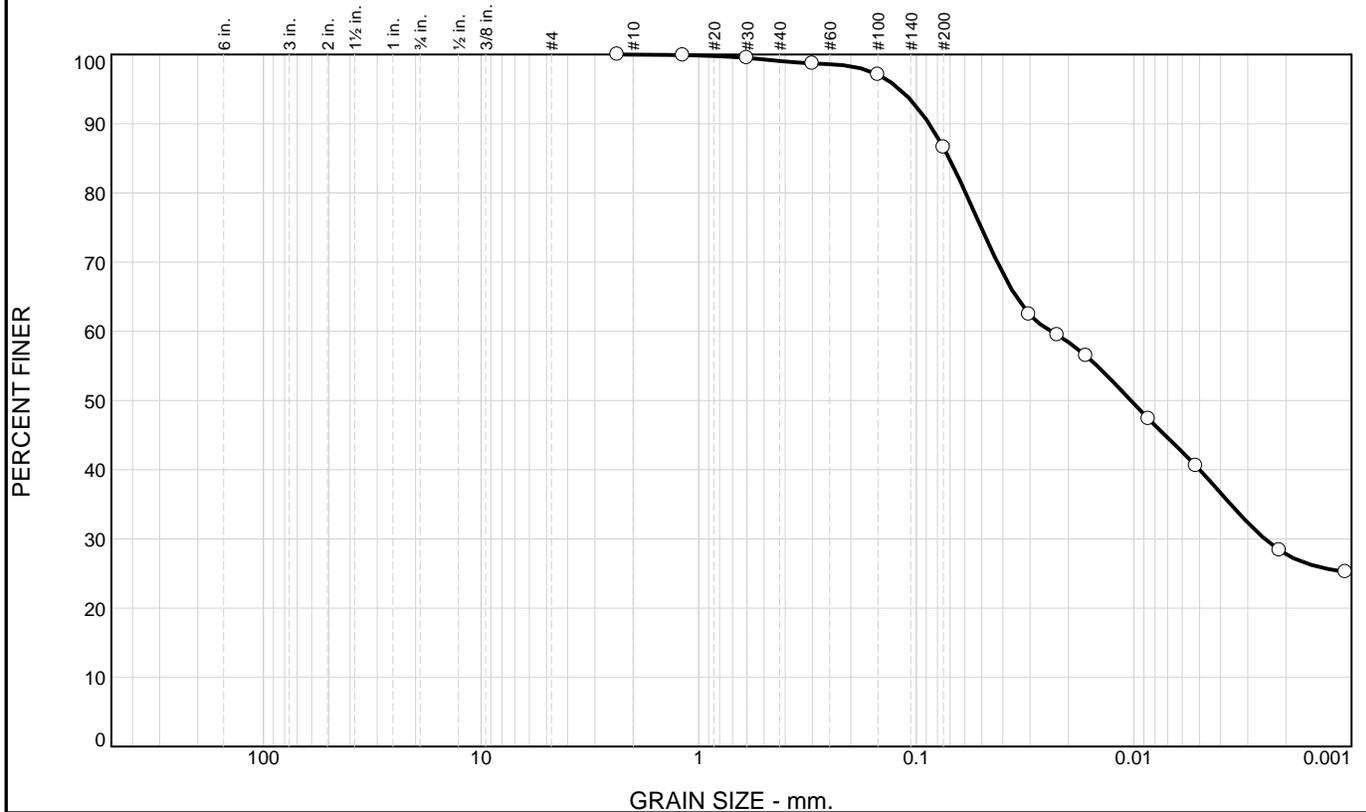
Particle Size Distribution Report

% +3"	% Gravel		% Sand			% Fines	
	Coarse	Fine	Coarse	Medium	Fine	Silt	Clay
0.0	0.0	0.0	0.0	0.9	12.5	46.6	40.0

SIEVE SIZE	PERCENT FINER	SPEC.* PERCENT	PASS? (X=NO)
#8	100.0		
#16	99.9		
#30	99.5		
#50	98.7		
#100	97.1		
#200	86.6

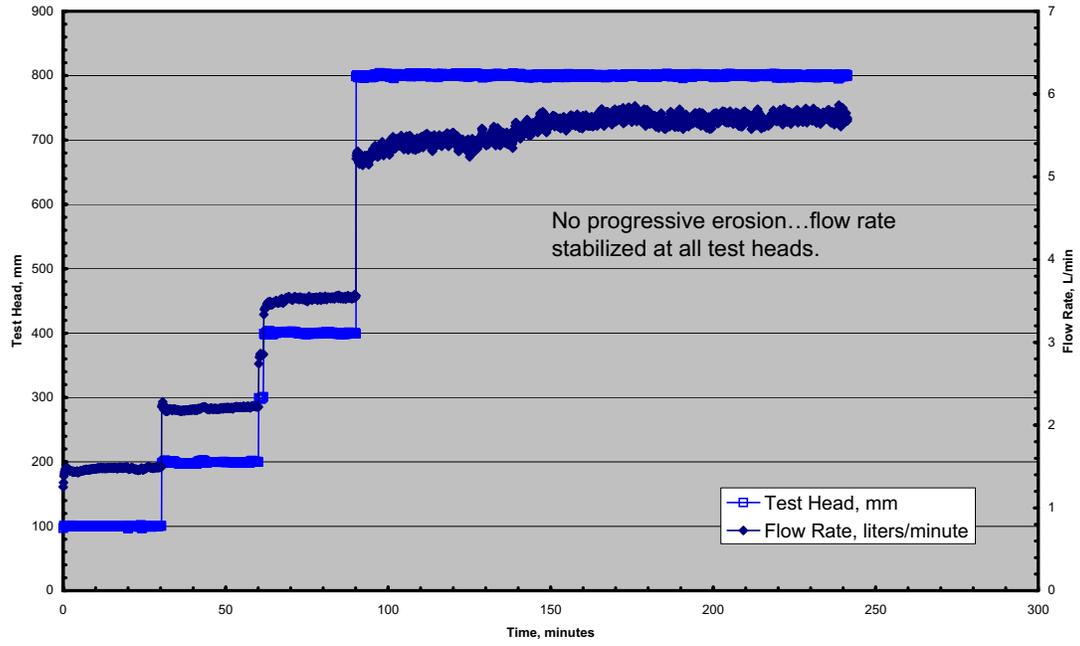
HET Test Record

E35-13x1, S40 Test HET-2 12-07-2007

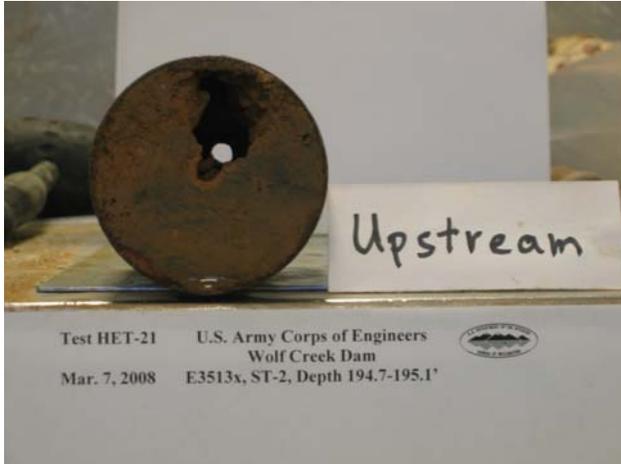
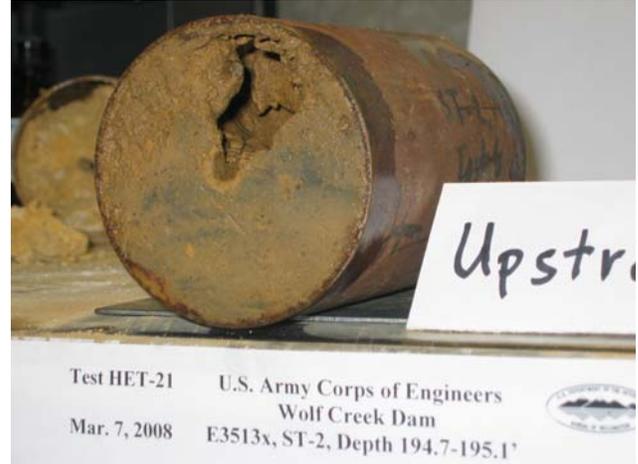
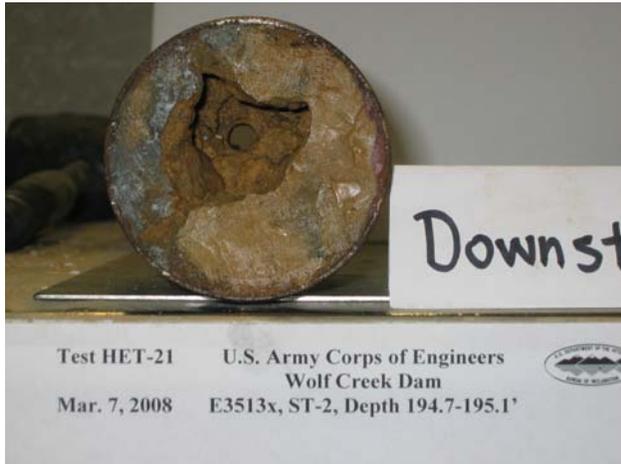
Figure C1- Specimen E3513x, ST2 at 194.7-195.1 ft, applied heads: 100 and 200 mm. After high-head HET#21 (a), (b) Upstream end, and (c), (d) Downstream end. Unable to analyze this test.

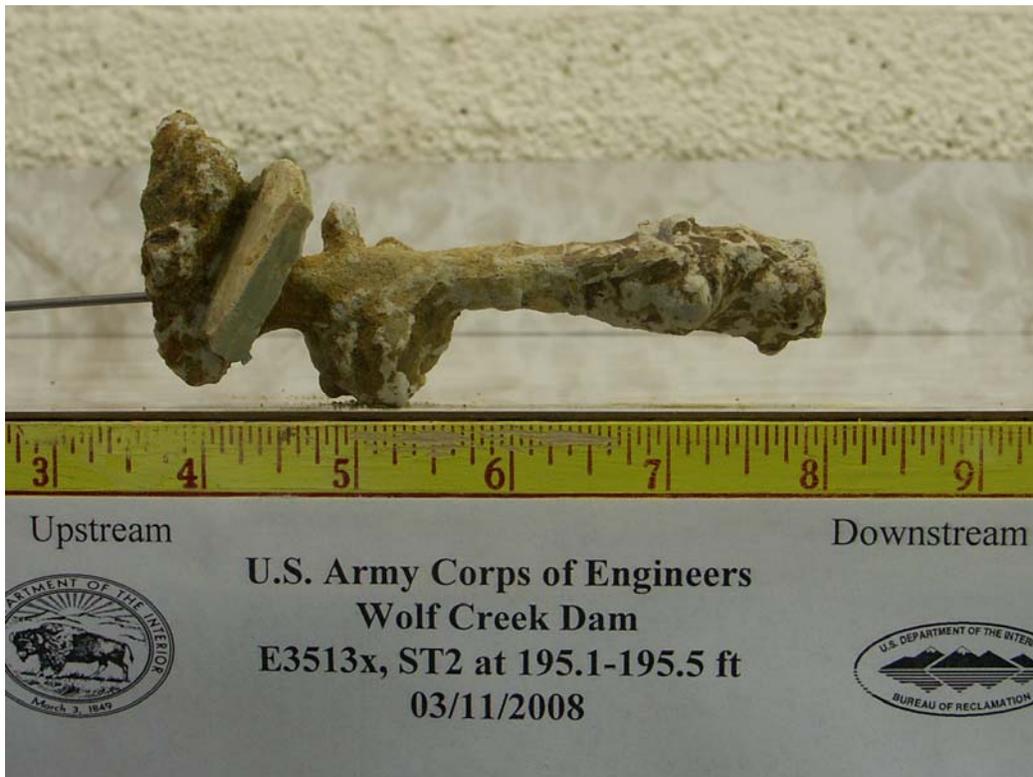
Figure C1 (cont)- Specimen E3513x, ST2 at 195.1-195.5 ft, applied heads: 120, 210, 400, and 570 mm After high-head HET#23 (e) Upstream end, (f) Downstream end, and (g) Enlarged hole cast in hydrostone. Some gravel encountered during hole drilling.

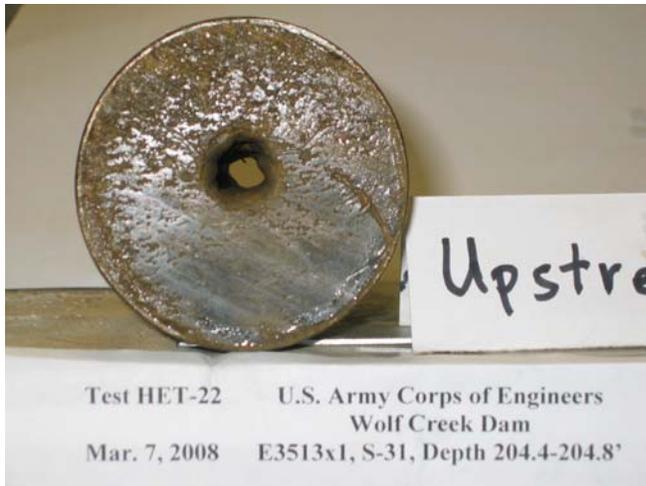
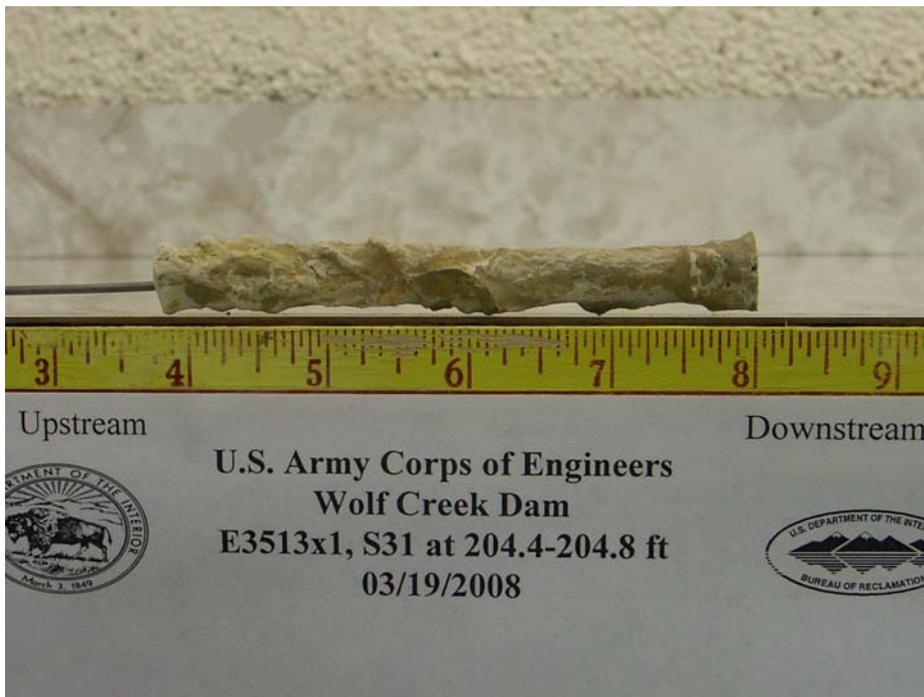
Figure C2- Specimen E3513x1,S31 at 204.4-204.8 ft, applied heads: 770, 1560, 2280, 3200, and 3700 mm, good test. After high-head HET#22 (a) Upstream end, (b) Downstream end, and (c) Enlarged hole cast in hydrostone.

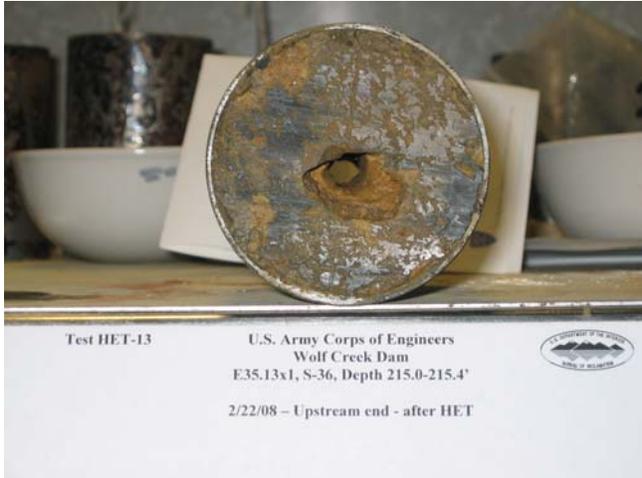
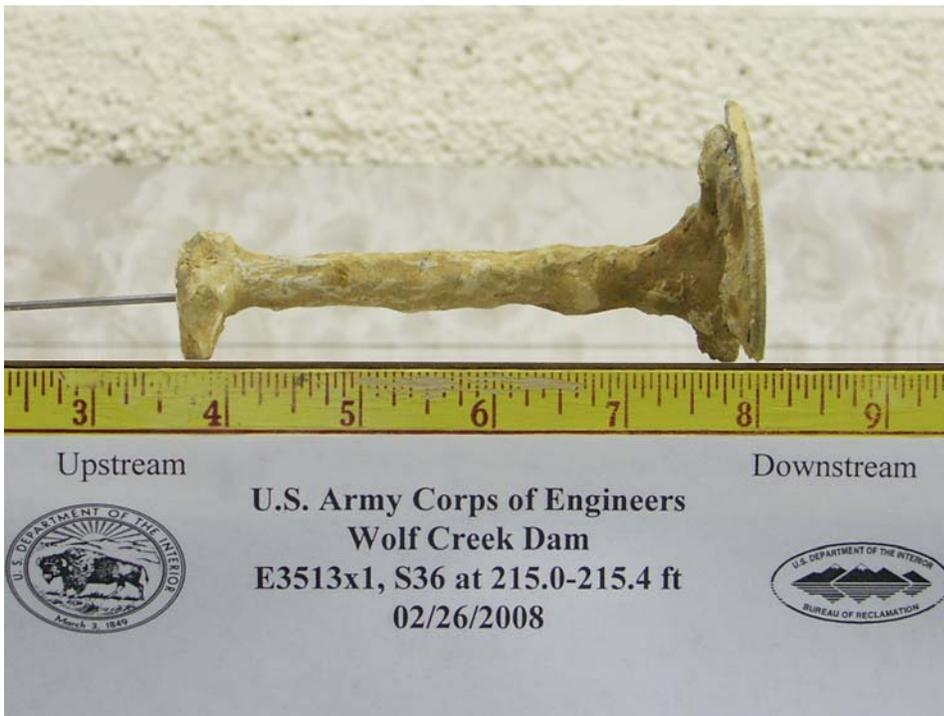
Figure C3- Specimen E3513x1, S36 at 215.0-215.4 ft, applied heads: 1620 and 3180 mm, good test. After high-head HET#13 (a) Upstream end, (b) Downstream end, and (c) Enlarged hole cast in hydrostone.

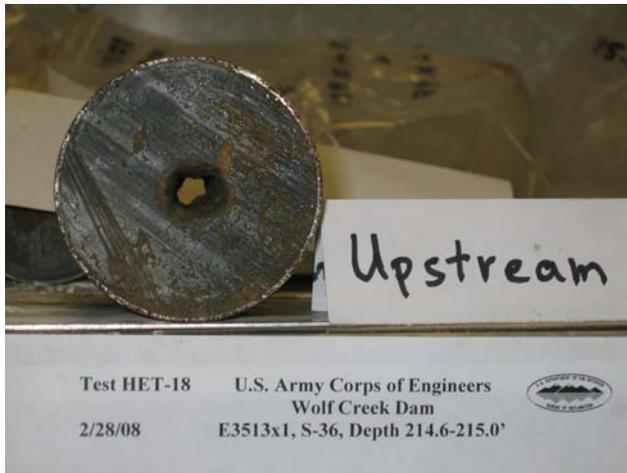
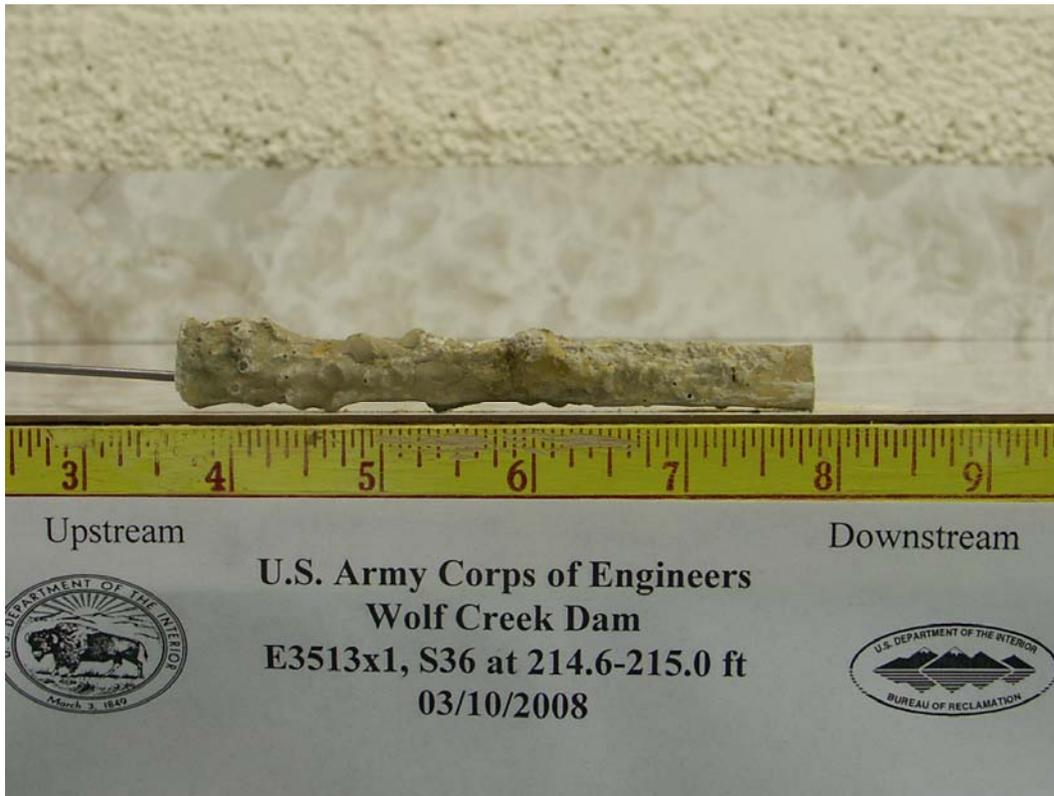
Figure C3 (cont)- Specimen E3513x1, S36 at 214.6-215.0 ft, applied heads: 2000, 2400, 2800, 3200, and 4000 mm. After high-head HET#18 (d) Upstream end, (e) Downstream end, and (f) Enlarged hole cast in hydrostone.

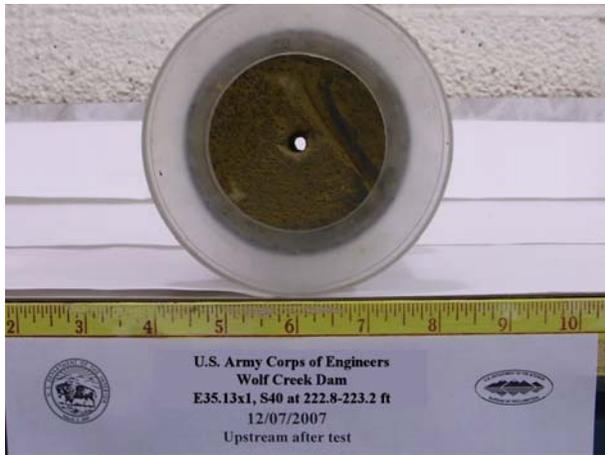
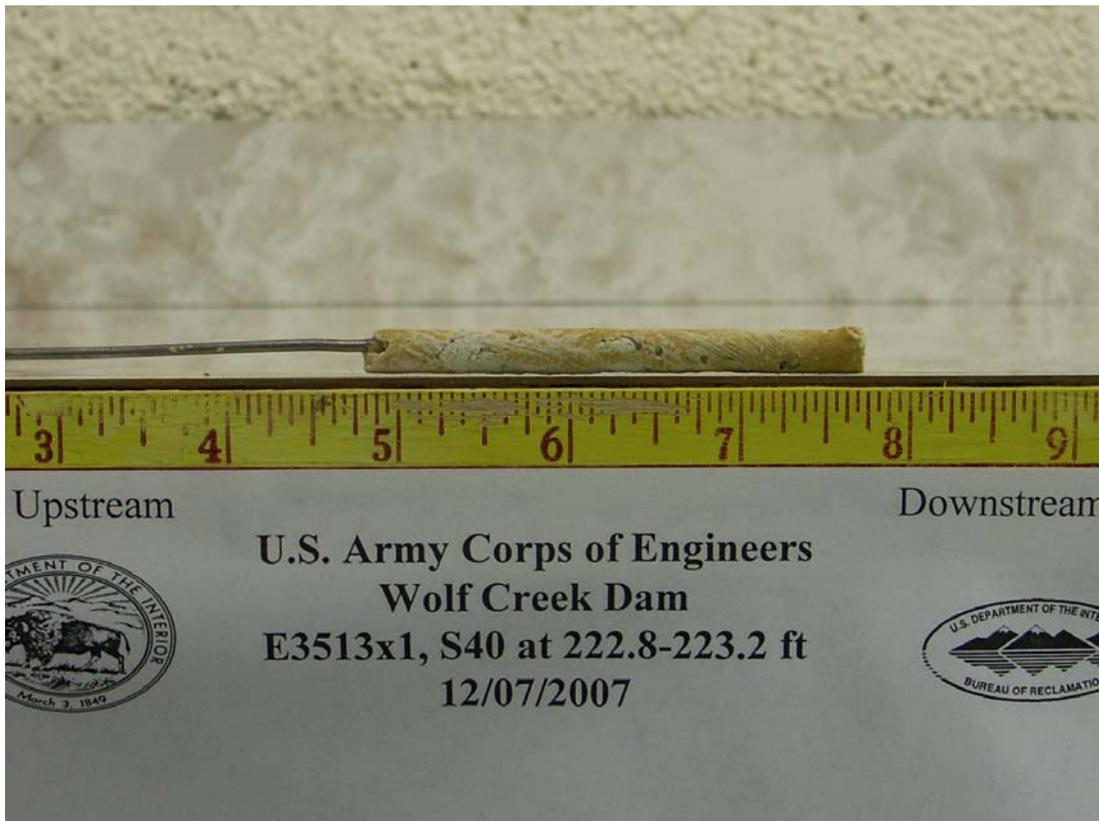
Figure C4- Specimen E3513x1, S40 at 222.8-223.2 ft, applied heads: 800 and 1600 mm, no erosion. After HET#2 (a) Upstream end, (b) Downstream end, and (c) Enlarged hole cast in hydrostone.

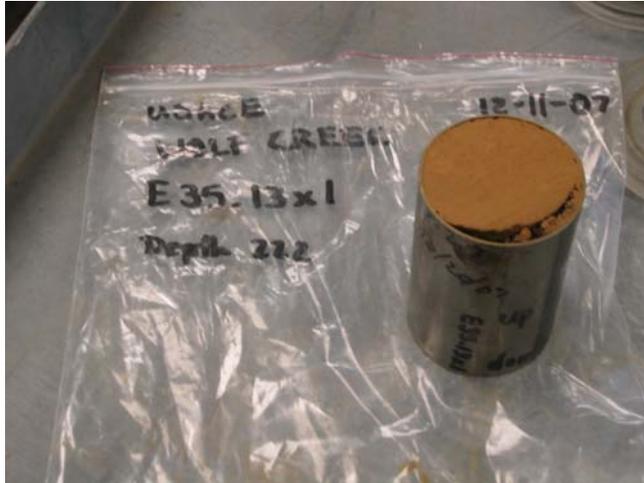
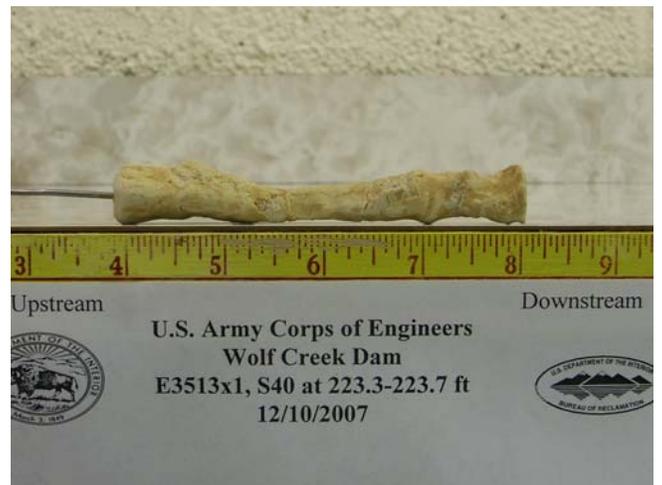
Figure C4 (cont)- Specimen E3513x1, S40 at 223.3-223.7 ft, applied heads: 800 and 1600 mm HET#4 (d) Before test upstream end, (e) After test upstream end, (f) After test downstream end, and (g) Enlarged hole cast in hydrostone.

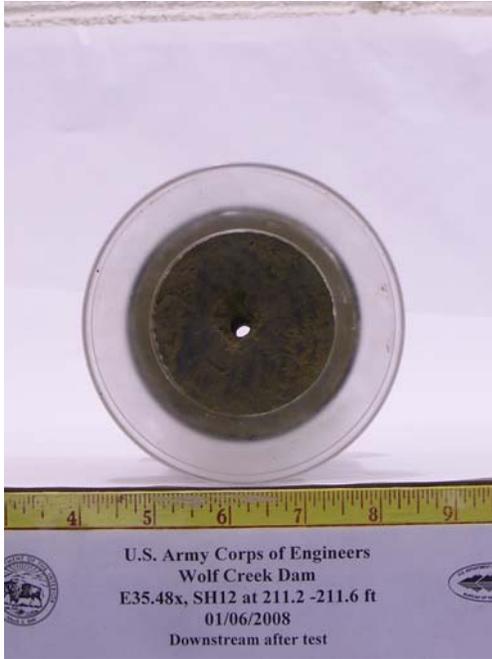
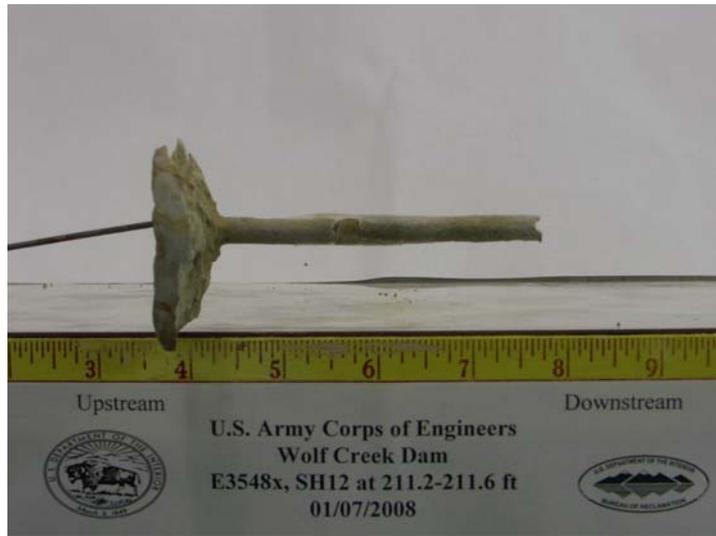
Figure C5- Specimen E3548x, SH12 at 211.2-211.6 ft, applied heads: 200, 400, 820, 1590 mm
No erosion was observed. After HET#7 (a) Downstream end, and (b) Final hole cast in hydrostone.

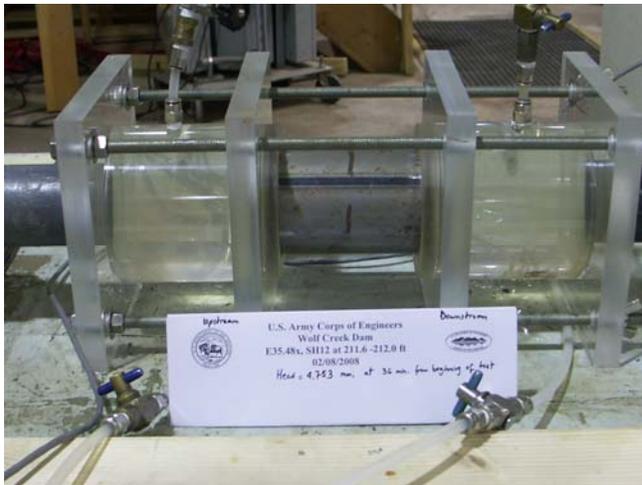
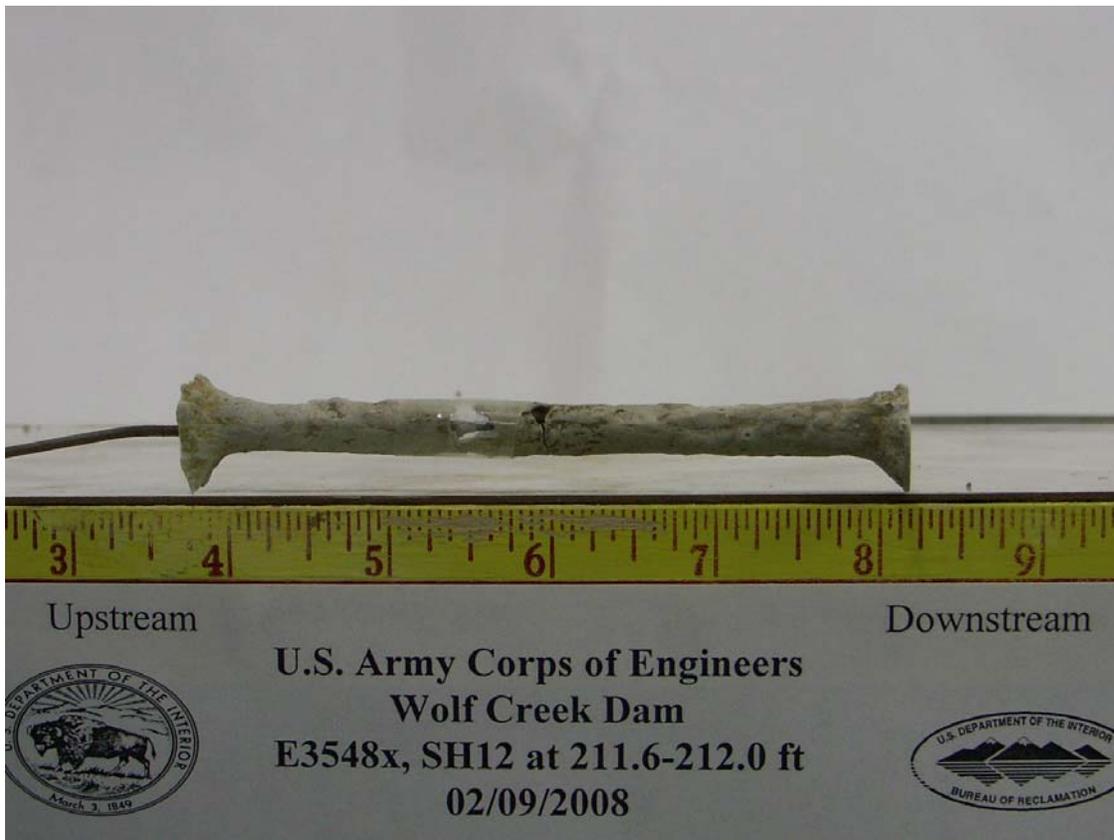
Figure C5 (cont)- Specimen E3548x, SH12 at 211.6-212.0 ft, applied heads: 3200, 4800, and 5300 mm. No progressive erosion. After high-head HET#10 (e) Upstream end, (f) Downstream end, and (g) Enlarged hole cast in hydrostone.

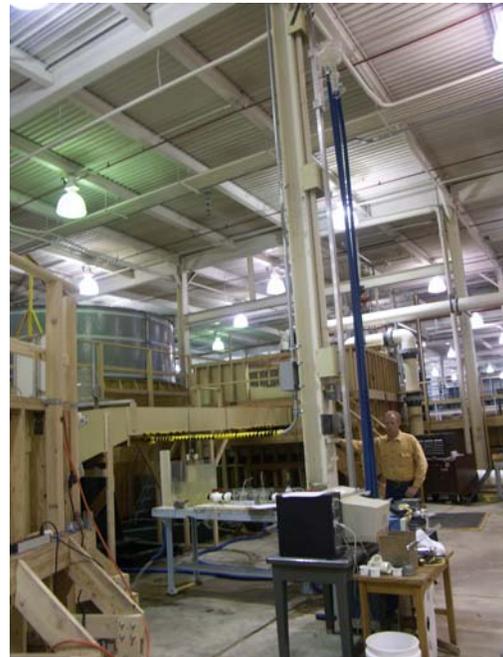
Figure C5 (cont)- Specimen E3548x, SH12 at 211.6-212.0 ft during high-head HET#10
(c) Head at 4753 mm at 36 min from beginning of test, (d) high-head HET apparatus.

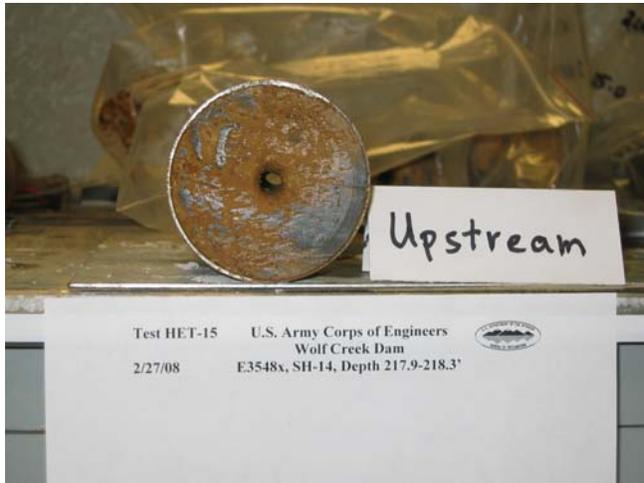
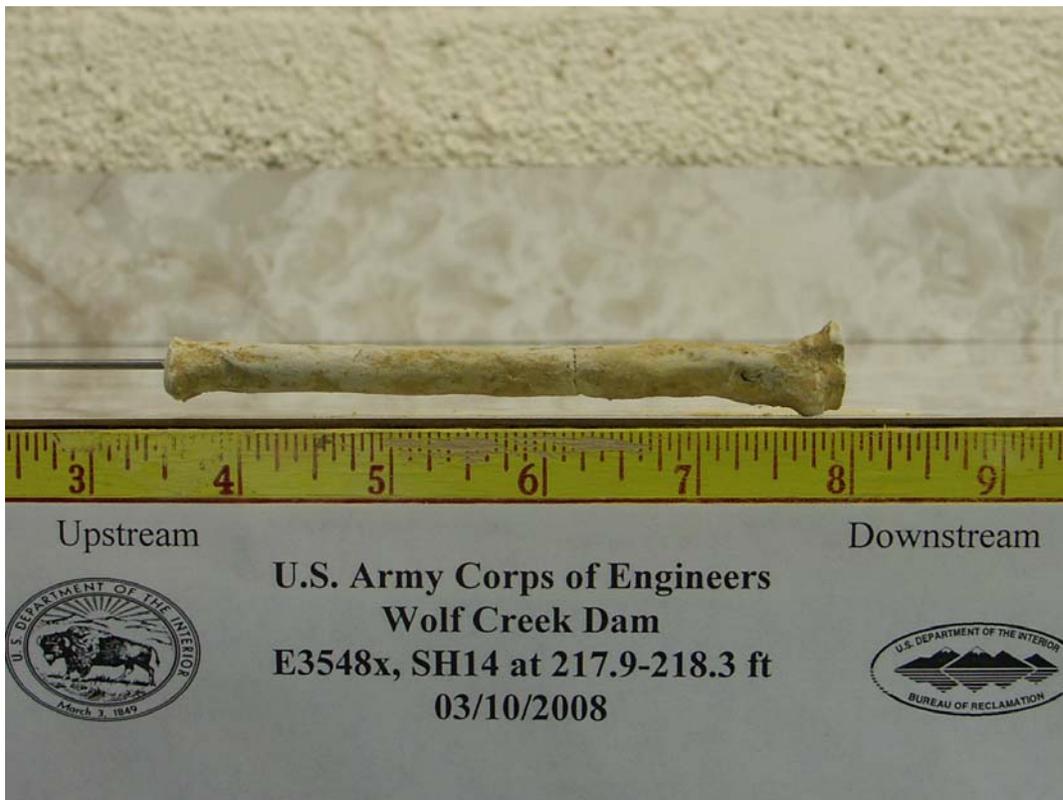
Figure C6- Specimen E3548x, SH14 at 217.9-218.3 ft, applied heads: 1600, 2400, and 3200 mm, good test. After high-head HET#15 (a) Upstream end, (b) Downstream end, and (c) Enlarged hole cast in hydrostone.

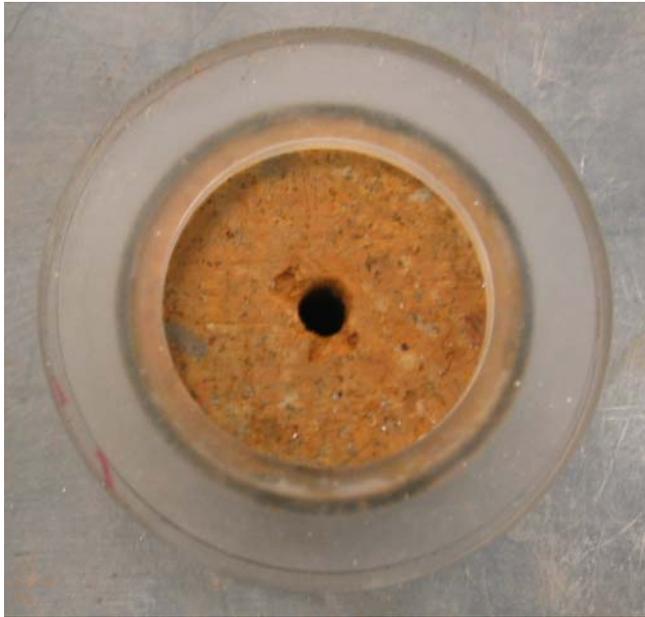
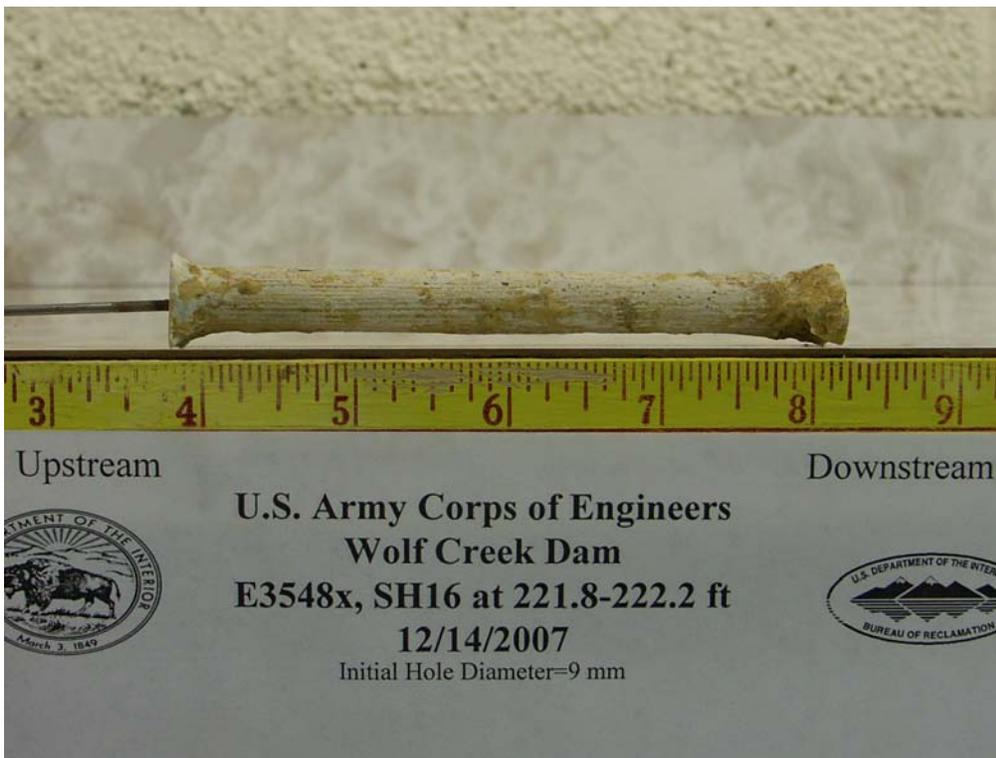
Figure C7- Specimen E3548x, SH16 at 221.8-222.2 ft. Initial hole diameter=9.52 mm. Applied head: 1560 mm. No erosion was observed after 1 hr, and test was terminated. After HET#5 (a) Upstream end, (b) Downstream end, and (c) Final hole cast in hydrostone.
