Technical Memorandum No. MERL-08-10

Hole Erosion Tests for Wolf Creek Dam

U.S Army Corps of Engineers, Nashville District
Russell County, Kentucky

May 2008

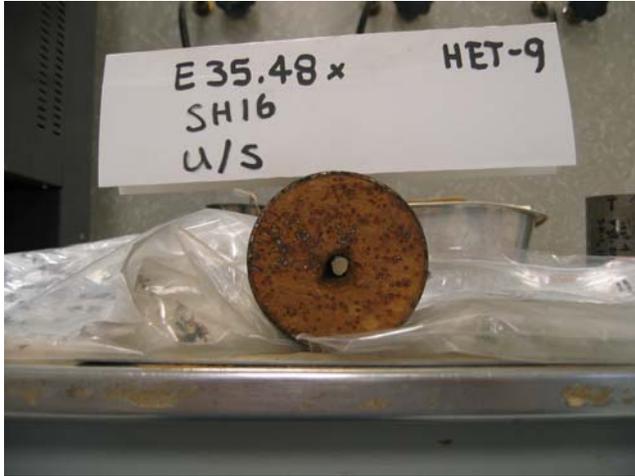
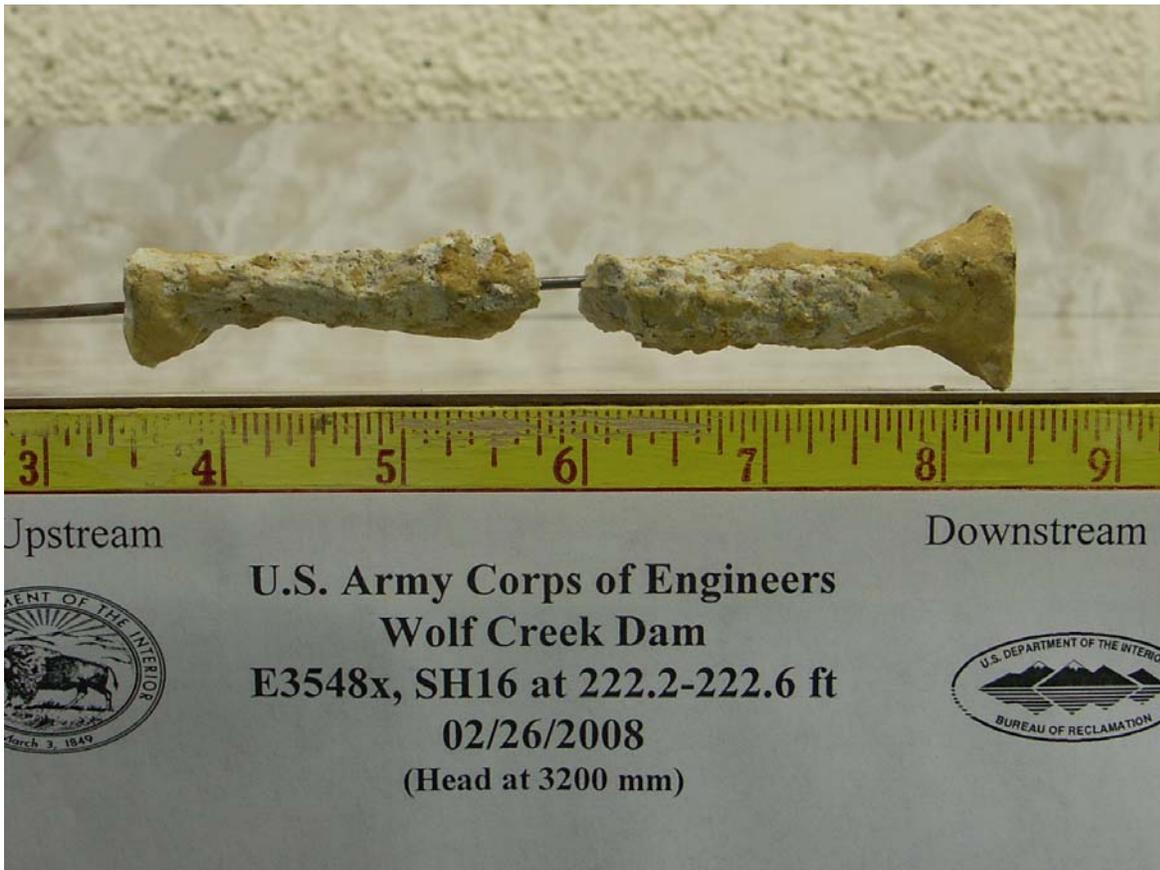
Figure C7 (cont)- Specimen E3548x, SH16 at 222.2-222.6 ft, applied head: 3200 mm. Good test. After high-head HET#9 (d) Upstream end, (e) Downstream end, and (f) Enlarged hole cast in hydrostone.

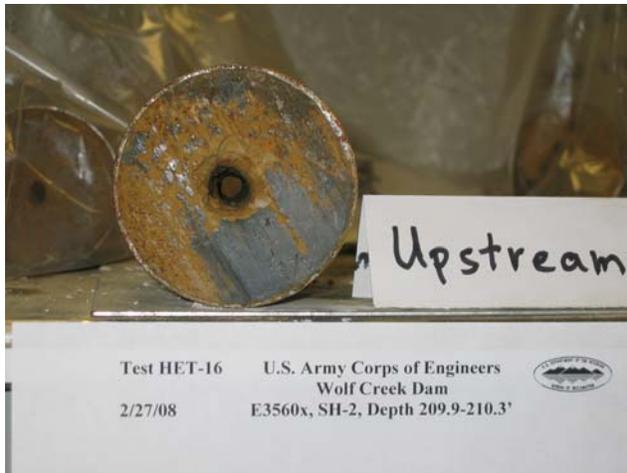
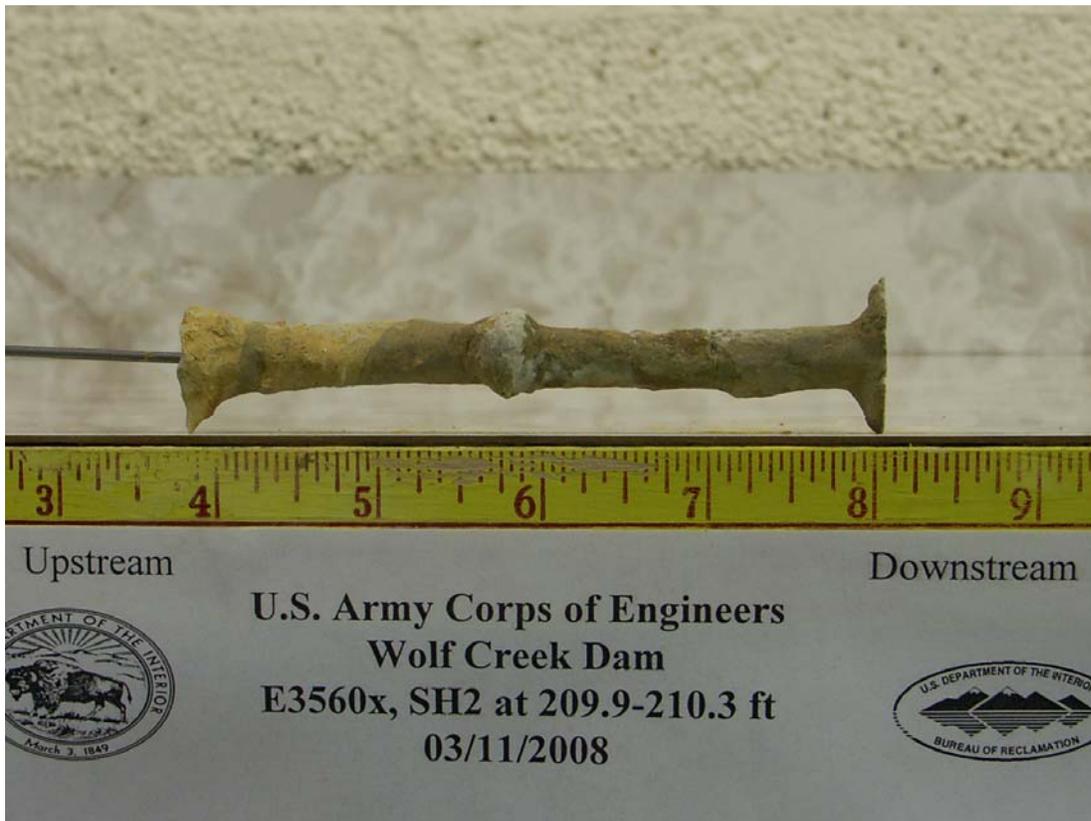
Figure C8- Specimen E3560x, SH2 at 209.9-210.3 ft, applied heads: 1600, 2400, 3200, and 4800 mm. Good test. After high-head HET#16 (a) Upstream end, (b) Downstream end, and (c) Enlarged hole cast in hydrostone. While erosion was occurring, discharge was still extremely clear (no fines in suspension).

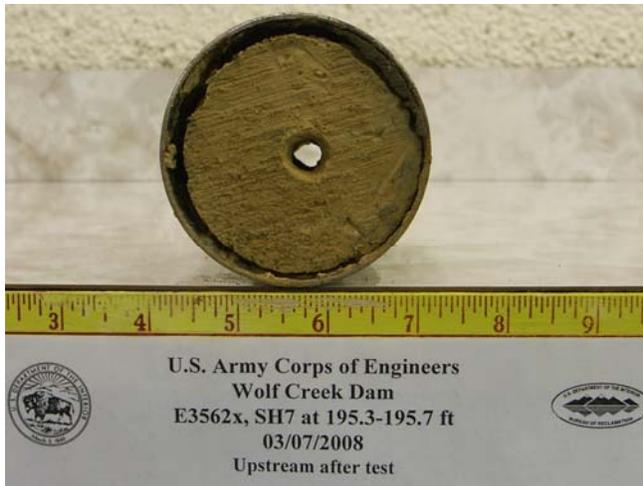
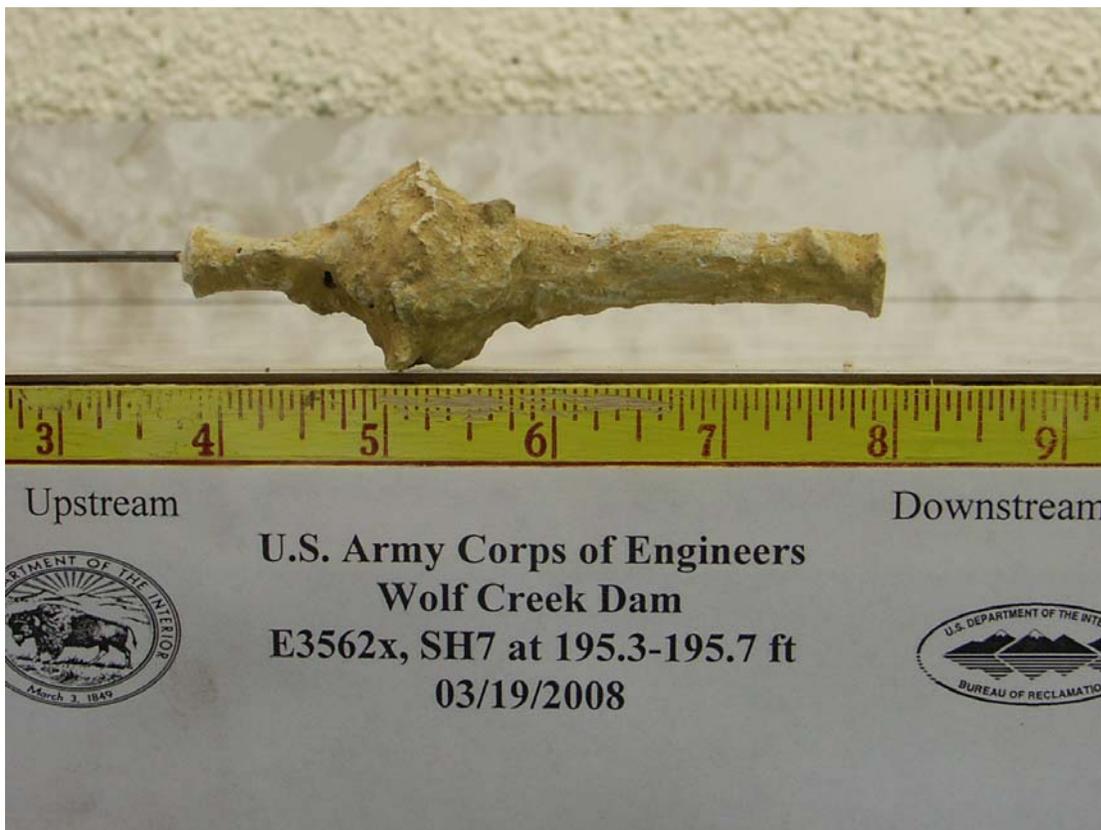
Figure C9- Specimen E3562x, SH7 at 195.3-195.7 ft, applied head: 750 mm. Good test. After high-head HET#20 (a) Upstream end, (b) Downstream end, and (c) Enlarged hole cast in hydrostone. Photos (a) and (b) were taken after specimen was oven-dried.

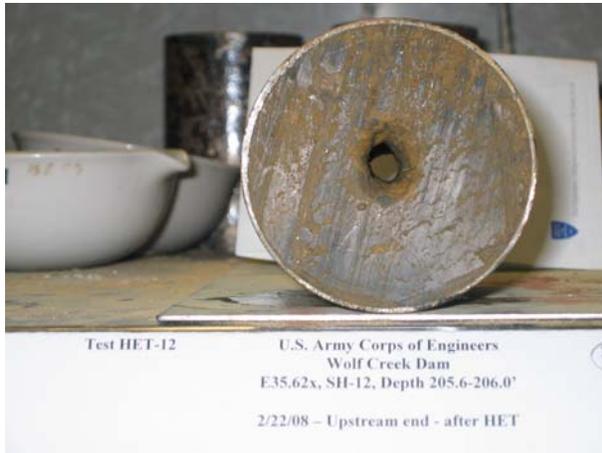
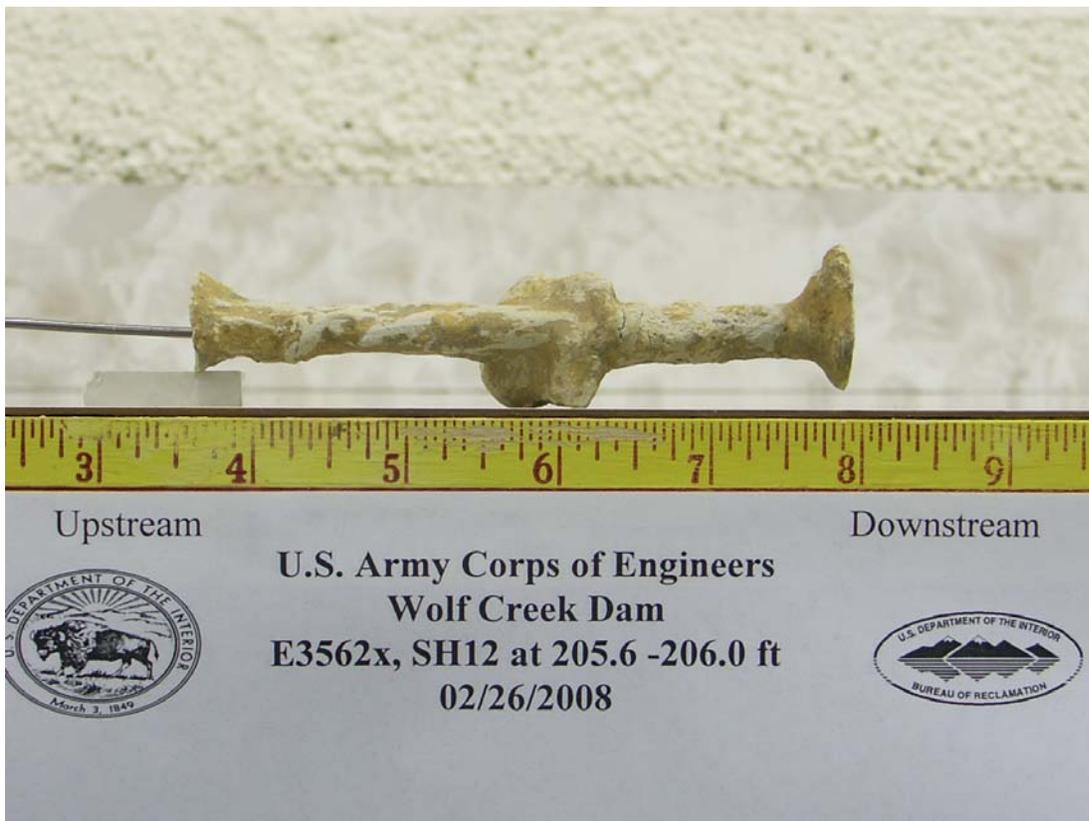
Figure C10- Specimen E3562x, SH12 at 205.6-206.0 ft, applied heads: 1600 and 3200 mm. Good test. After high-head HET#12 (a) Upstream end, (b) Downstream end, and (c) Enlarged hole cast in hydrostone.

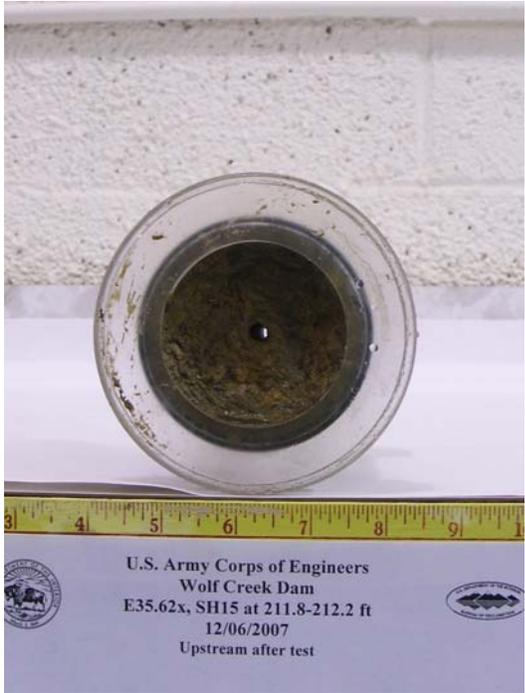
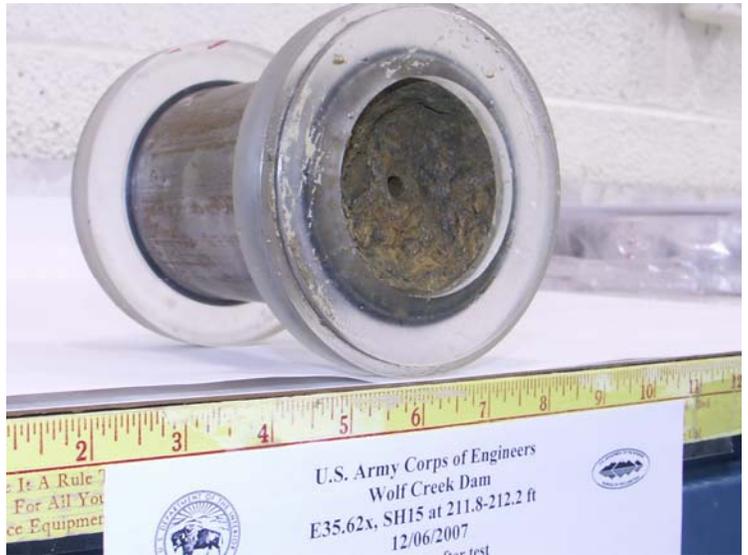
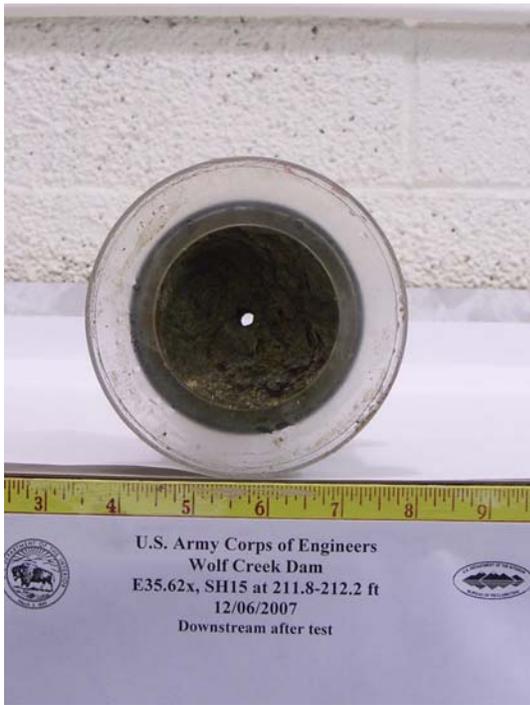
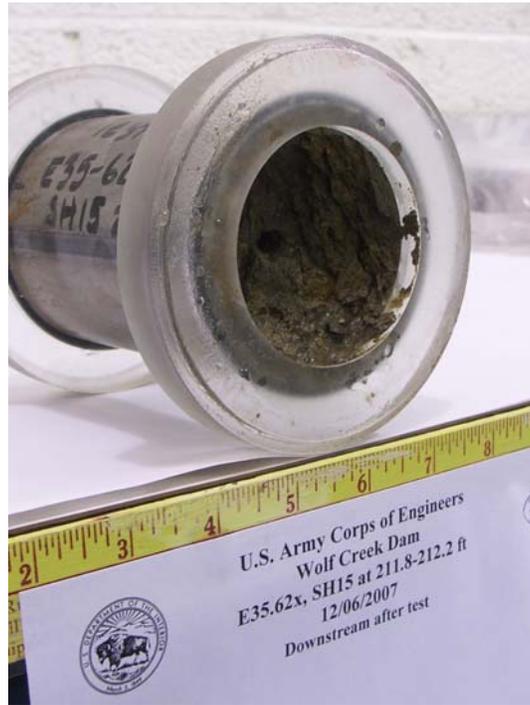
Figure C11- Specimen E3562x, SH15 at 211.8-212.2 ft, applied heads: 100, 200, 400, and 800 mm Progressive erosion not achieved. After HET#1 (a), (b) Upstream end, and (c), (d) Downstream end.

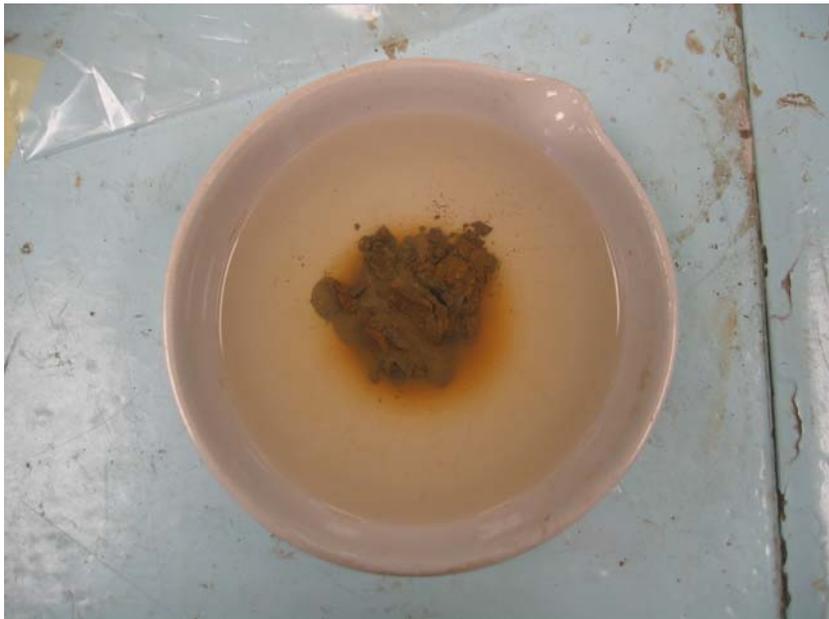
Figure C11 (cont)- Specimen E3562x, SH15 at 211.8-212.2 ft after HET#1
(e) Final hole cast in hydrostone, and (f) Crumb test after 20 hours.

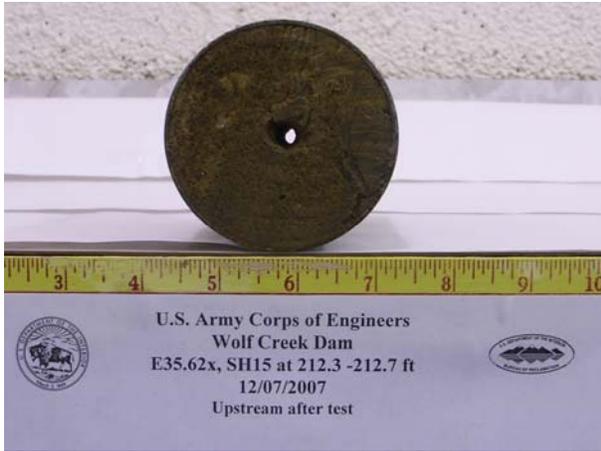
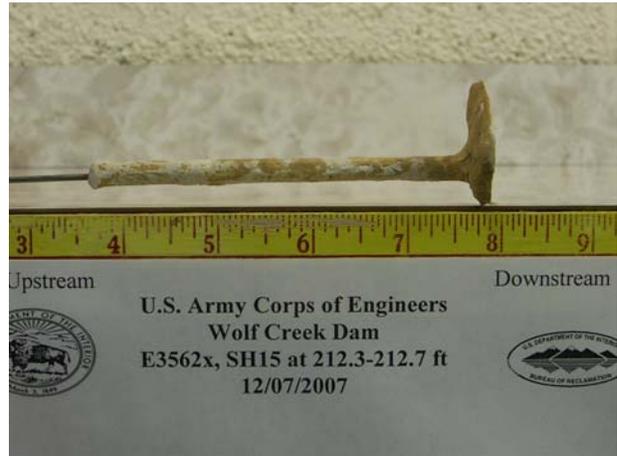
Figure C11 (cont)- Specimen E3562x, SH15 at 212.3-212.7 ft, applied heads: 800, 1400, and 1600 mm Progressive erosion not achieved. After HET#3 (g) Upstream end, (h), (i) Downstream end, and (j) Final hole cast in hydrostone.

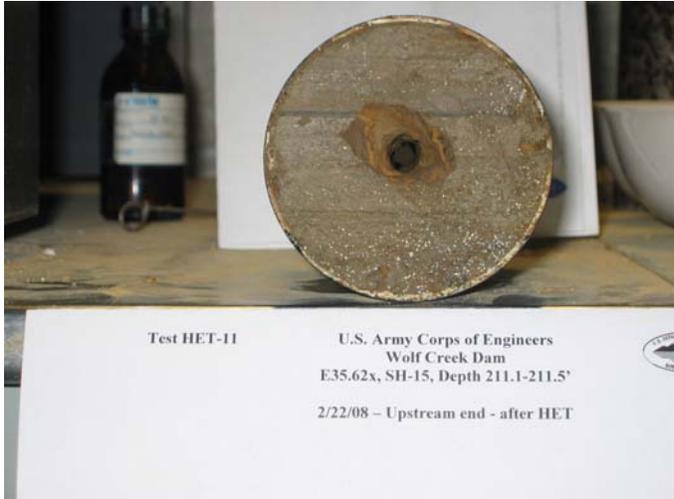
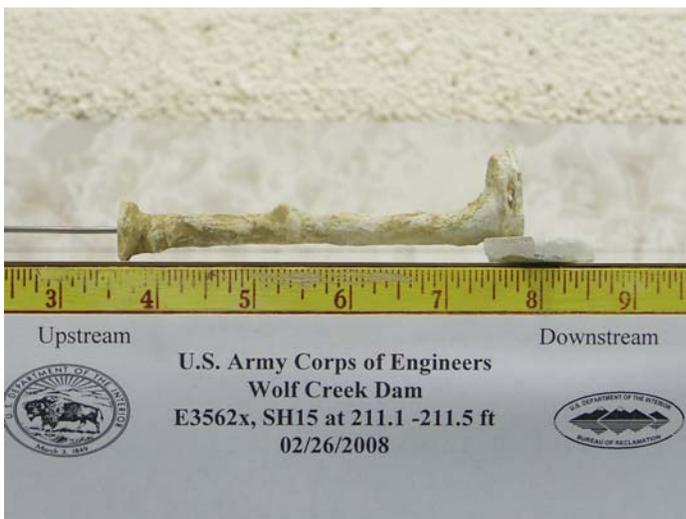
Figure C11 (cont)- Specimen E3562x, SH15 at 211.1-211.5 ft, applied heads: 1600 and 3400 mm, good test. After high-head HET#11 (k), (l) Upstream end, (m), (n) Downstream end, and (o) Enlarged hole cast in hydrostone.

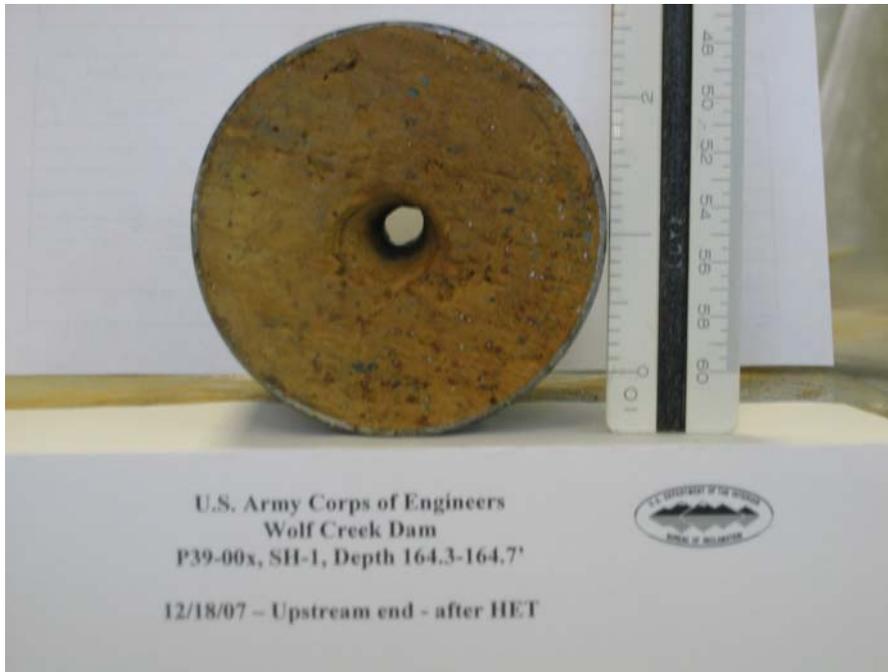
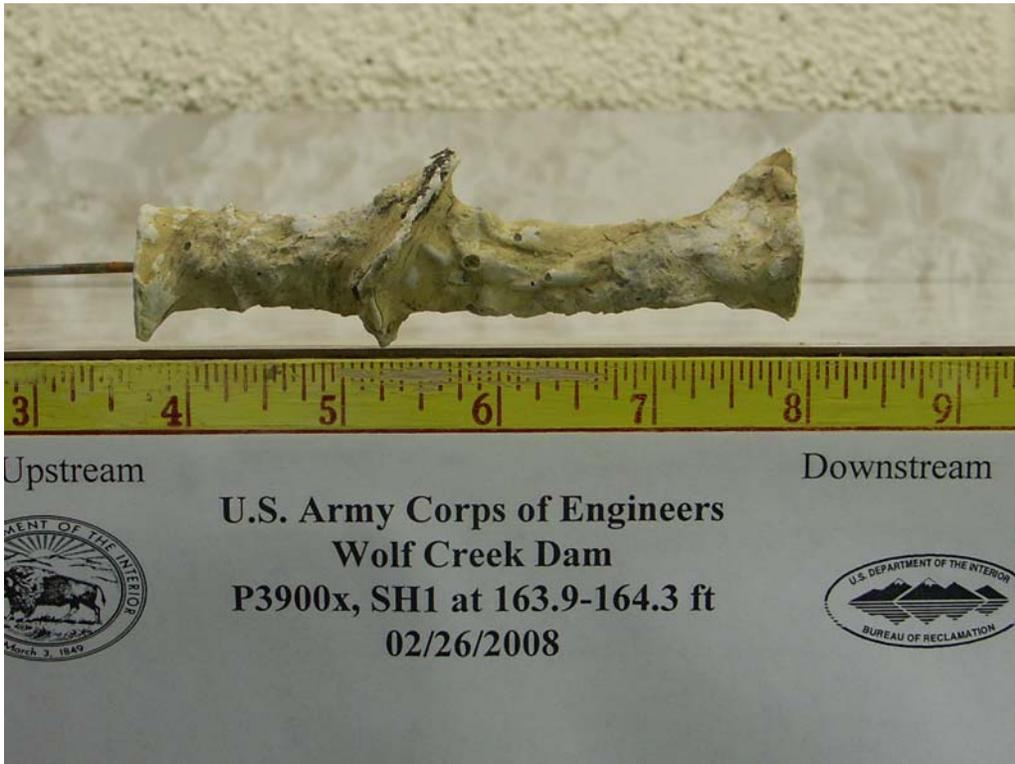
Figure C12 (cont)- Specimen P3900, SH1 at 163.9-164.3 ft, applied head: 3200 mm. Erosion progressed rapidly. Outflow pipe from HET apparatus became kinked and plugged, terminating test early. Photos after high-head HET#8 (c) Upstream end, (d) Downstream end, and (e) Enlarged hole cast in hydrostone.

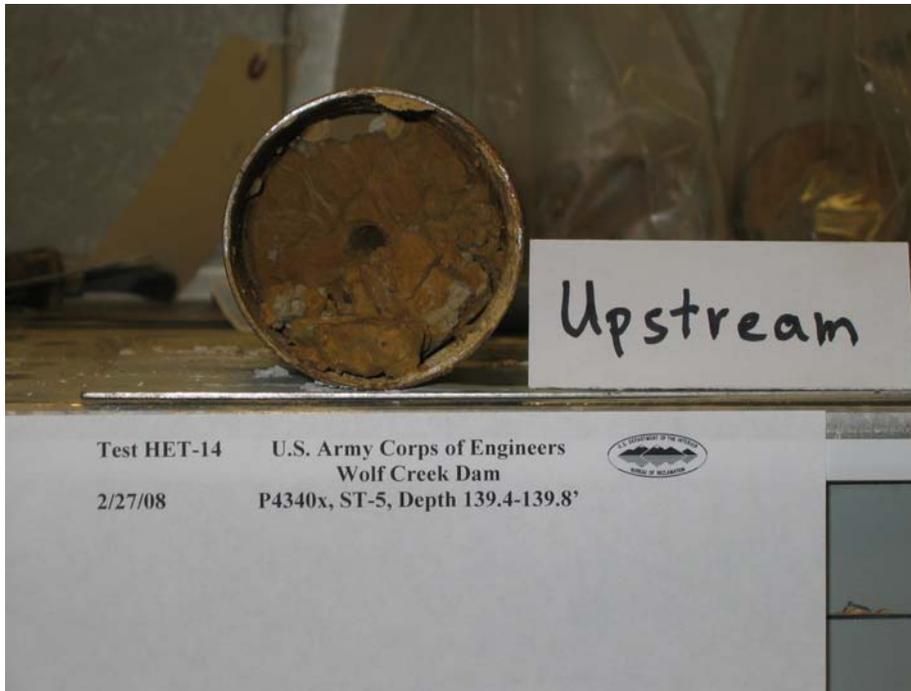
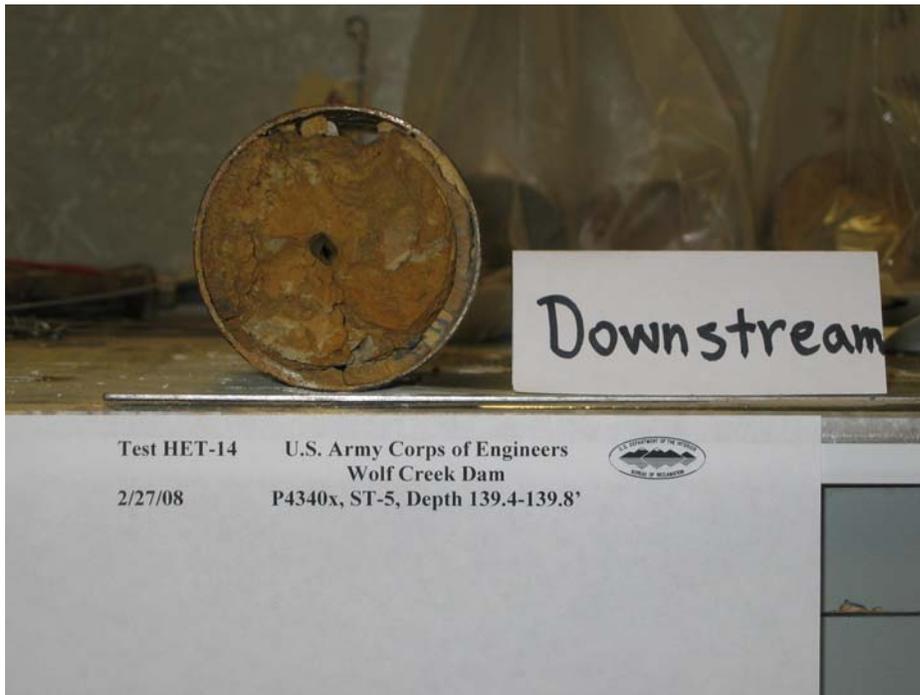
Figure C13- Specimen P4340, ST5 at 139.4-139.8 ft, applied head: 800 mm.
Bad test. Specimen failed rapidly through a void along the tube wall. After high-head HET#14
(a) Upstream end, and (b) Downstream end.

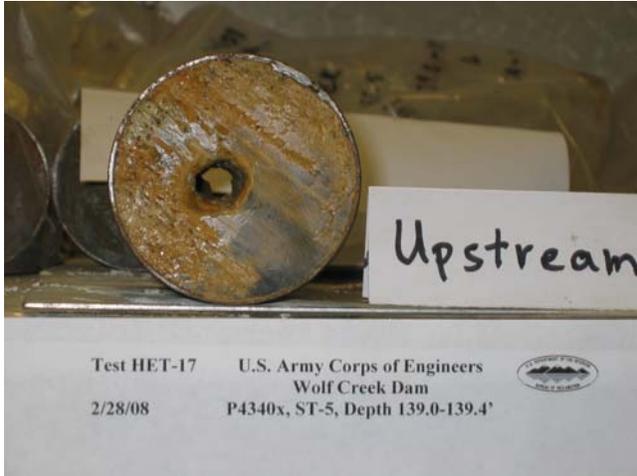
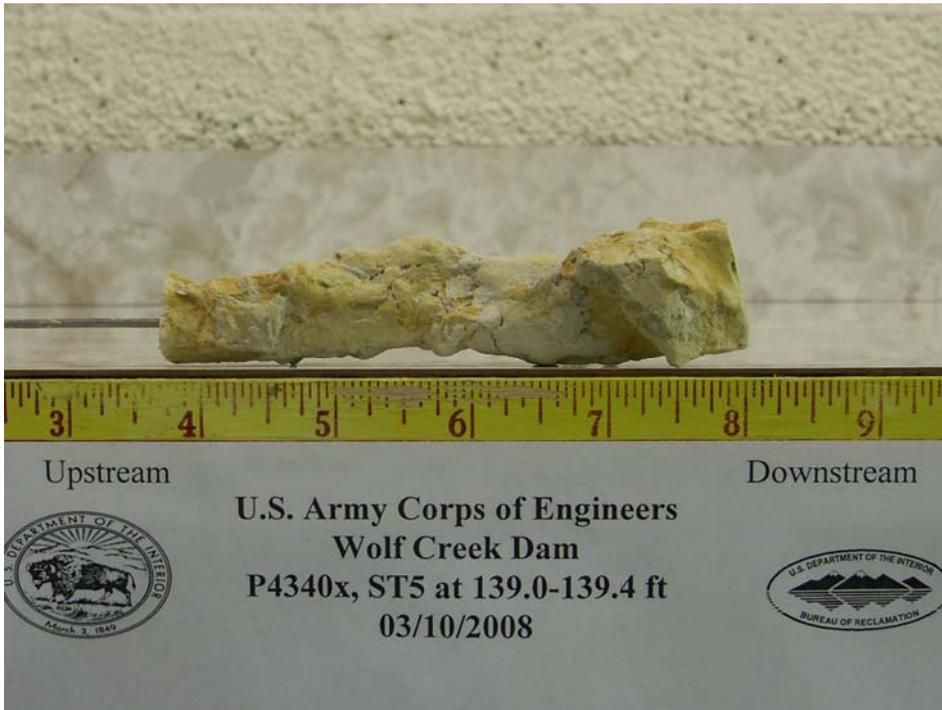
Figure C13 (cont)- Specimen P4340x, ST5 at 139.0-139.4 ft, applied head: 2000 mm
Good test but initial head was probably higher than needed to initiate erosion. After high-head HET#17 (c) Upstream end, (d) Downstream end, and (e) Enlarged hole cast in hydrostone.

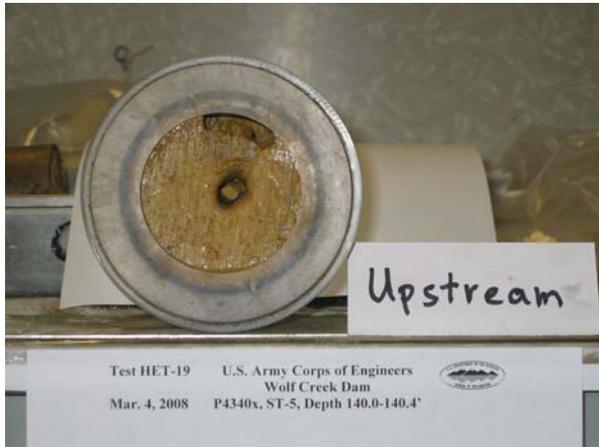
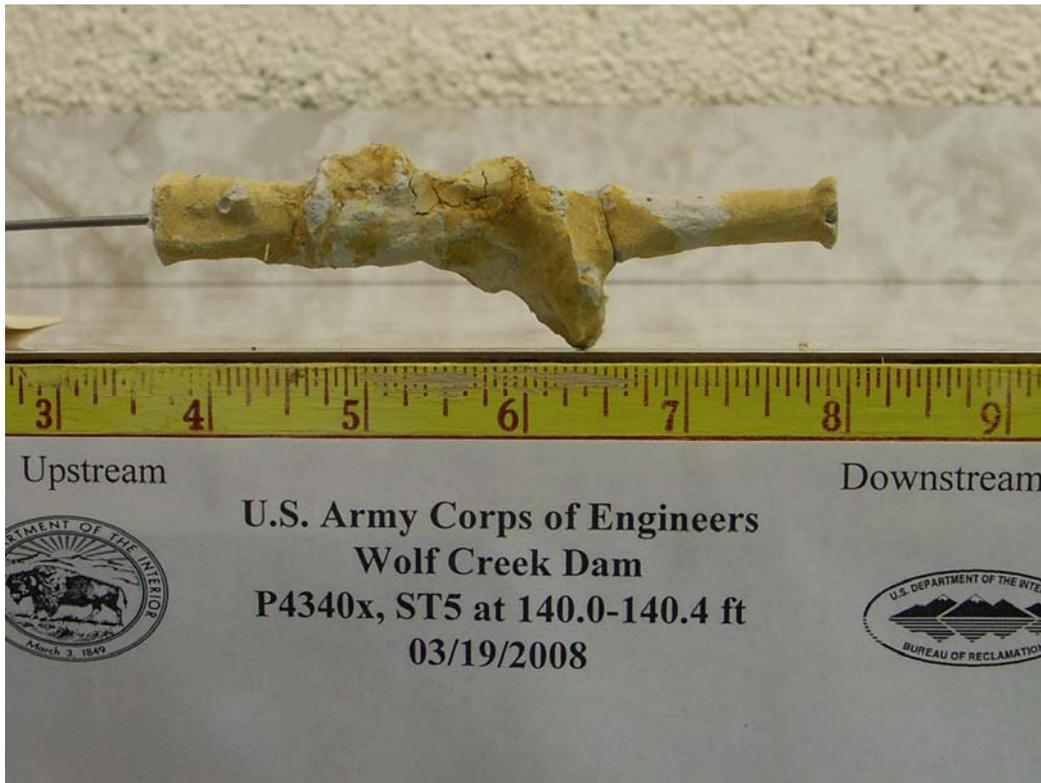
Figure C13 (cont)- Specimen P4340x, ST5 at 140.0-140.4 ft, applied heads: 200, 300, 400, 600, 800, 1100, 1600, 2300, 3200, 4200, and 5300 mm. Good test. After high-head HET#19 (f) Upstream end, (g) Downstream end, and (h) Enlarged hole cast in hydrostone.

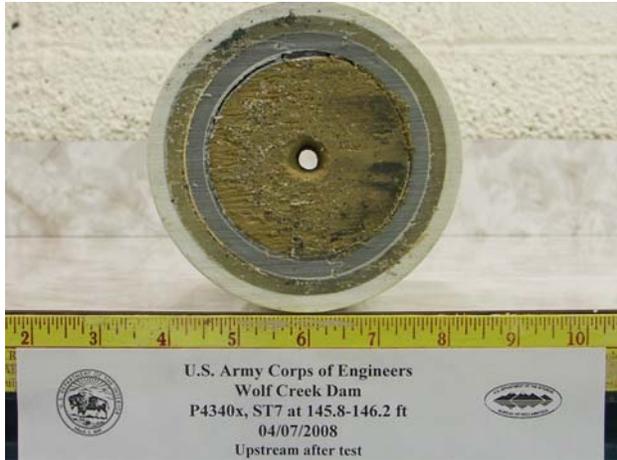
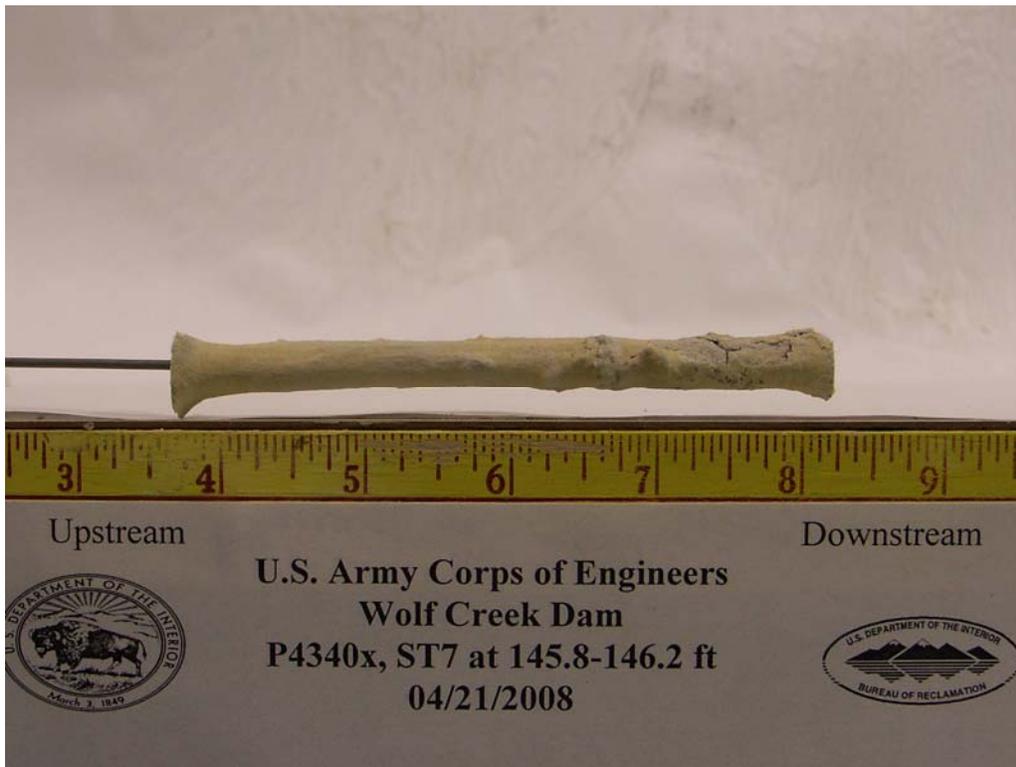
Figure C14- Specimen P4340x, ST7 at 145.8-146.2 ft, applied heads: 100, 200, 400, 800, and 1700 mm. Flow became erratic possibly due to some gravel particles. Analysis requires subjectivity. After high-head HET#26 (a) Upstream end, (b) Downstream end, and (c) Enlarged hole cast in hydrostone.

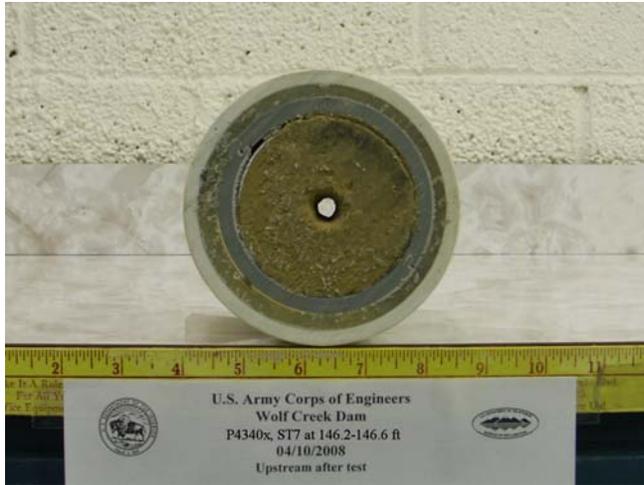
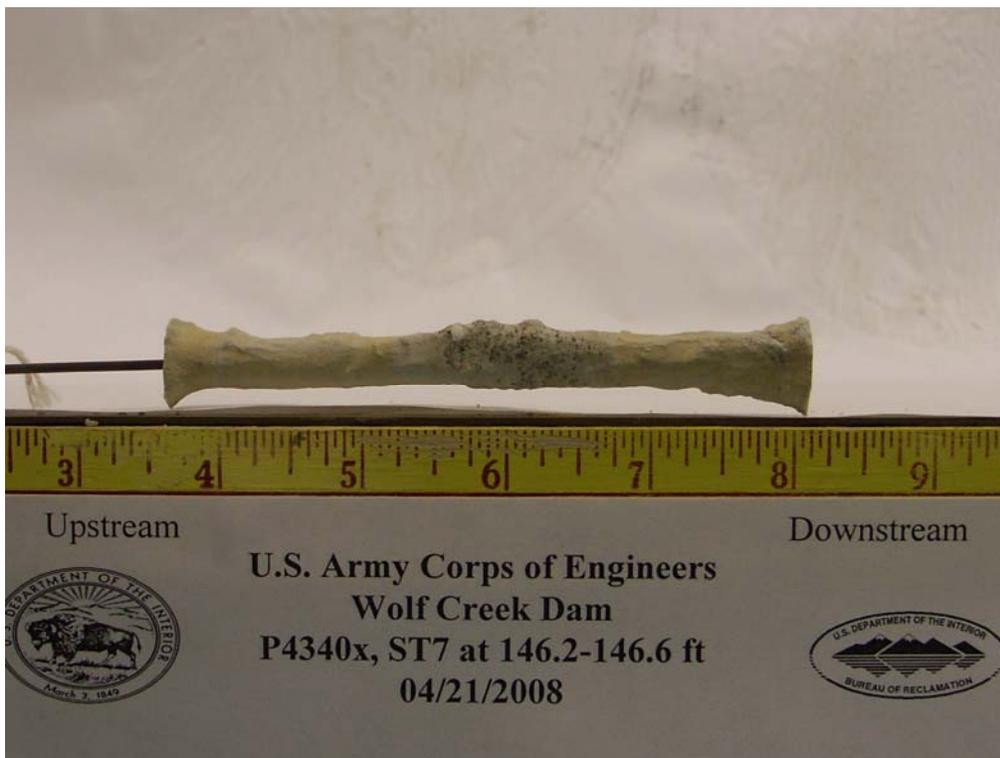
Figure C14 (cont)- Specimen P4340x, ST7 at 146.2-146.6 ft, applied heads: 200, 400, 800, 1600, and 2200 mm, good test. After high-head HET#32 (d) Upstream end, (e) Downstream end, and (f) Enlarged hole cast in hydrostone.

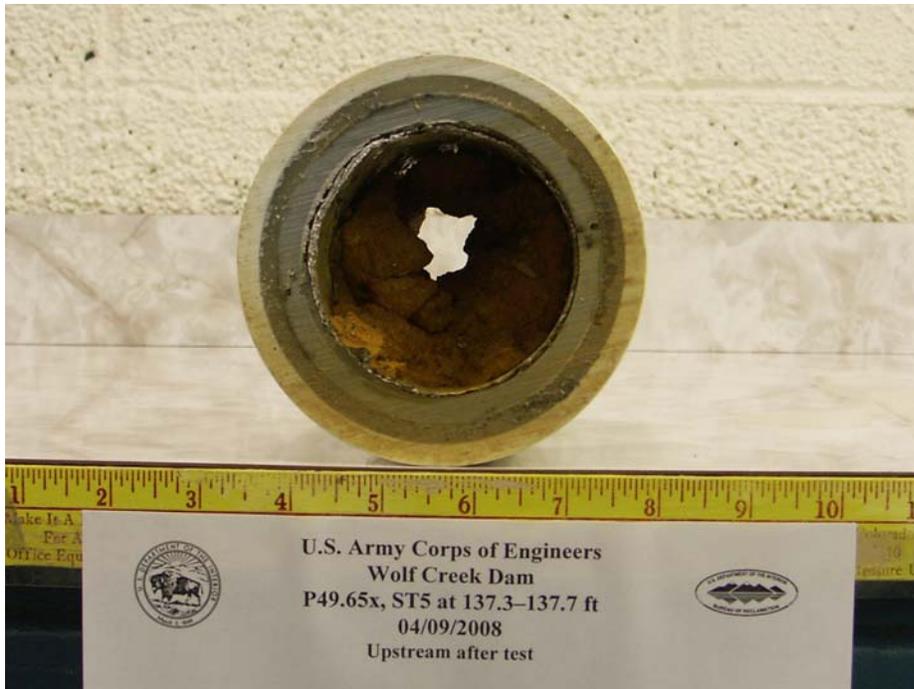
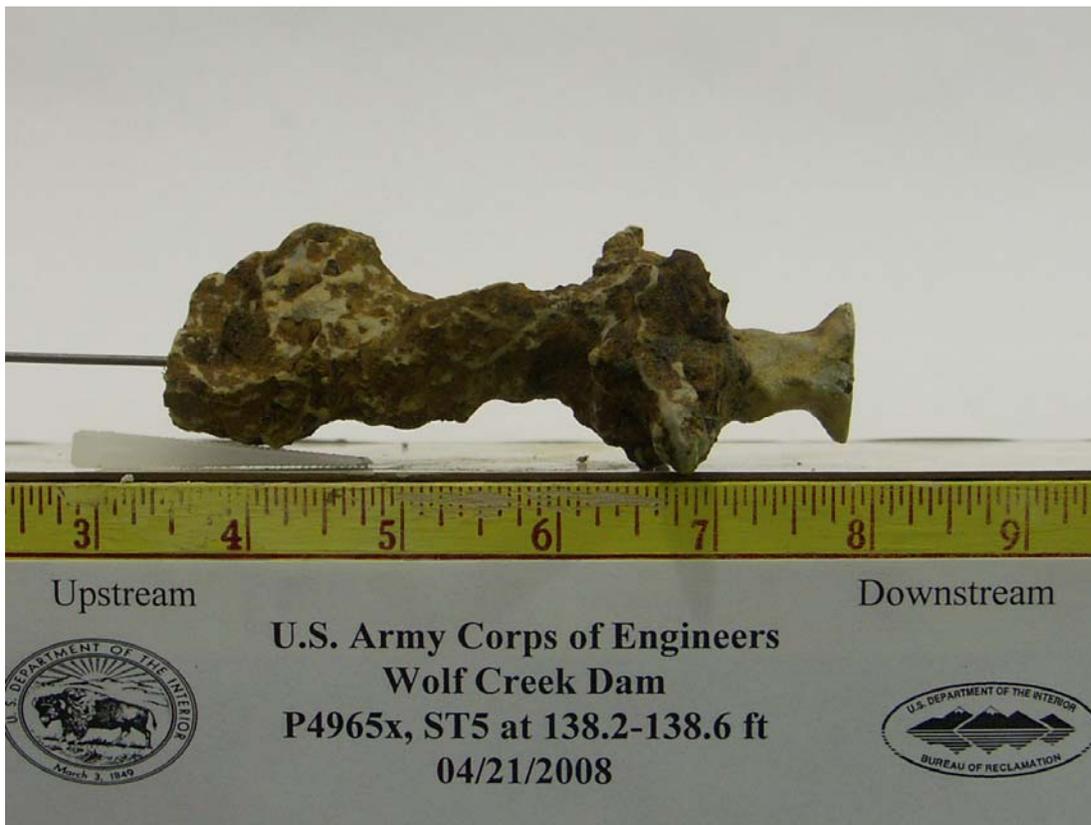
Figure C15 (cont)- Specimen P4965x, ST5 at 138.2-138.6 ft, applied heads: 100, 200, 400, 800, 1600, and 2200 mm. Progressive erosion started at 2200 mm head, and there was intermittent hole clogging. After high-head HET#34 (c) Upstream end, (d) Downstream end, and (e) Enlarged hole cast in hydrostone. This sample was loose in the tube and cracked longitudinally during hole drilling [crack is visible at top of photo (c)].

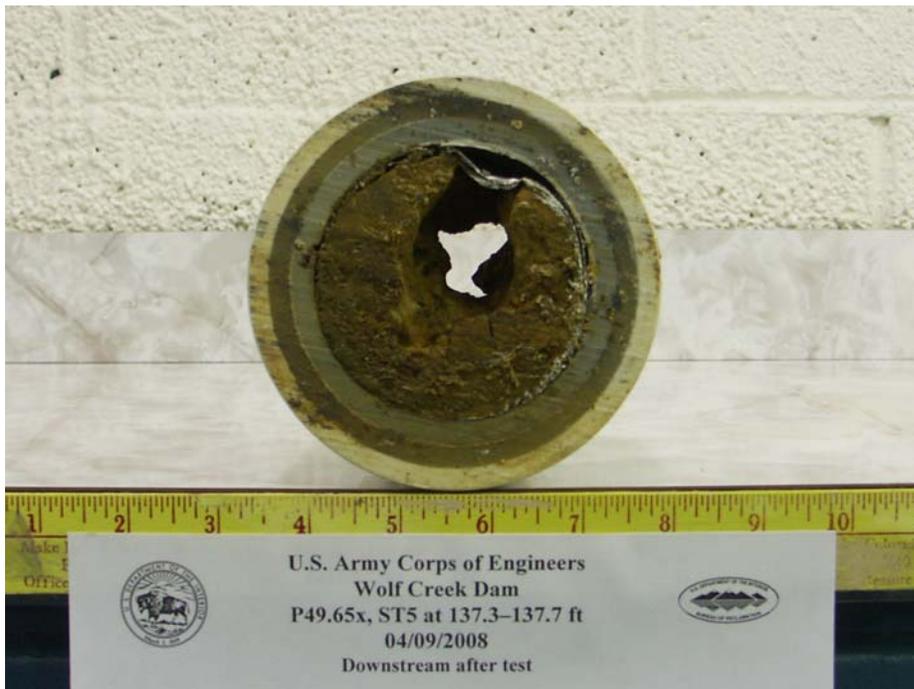
Figure C15- Specimen P4965x, ST5 at 137.3-137.7 ft, applied heads: 140, 400, 600, 800, 1100, and 1600 mm. Progressive erosion was just beginning at 1600 mm head when flow became erratic. Specimen breached along edge of tube. After high-head HET#29 (a) Upstream end, and (b) Downstream end.

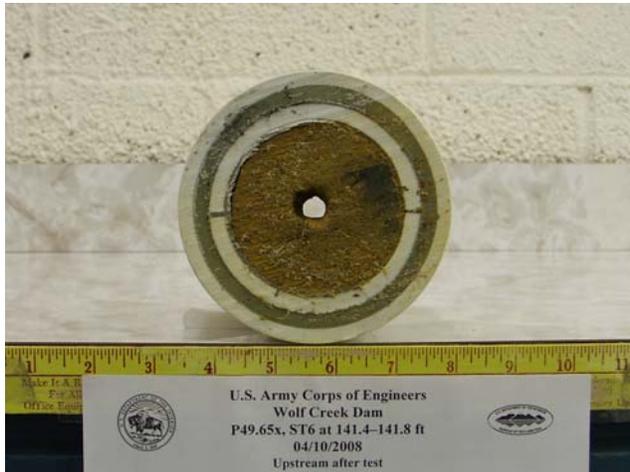
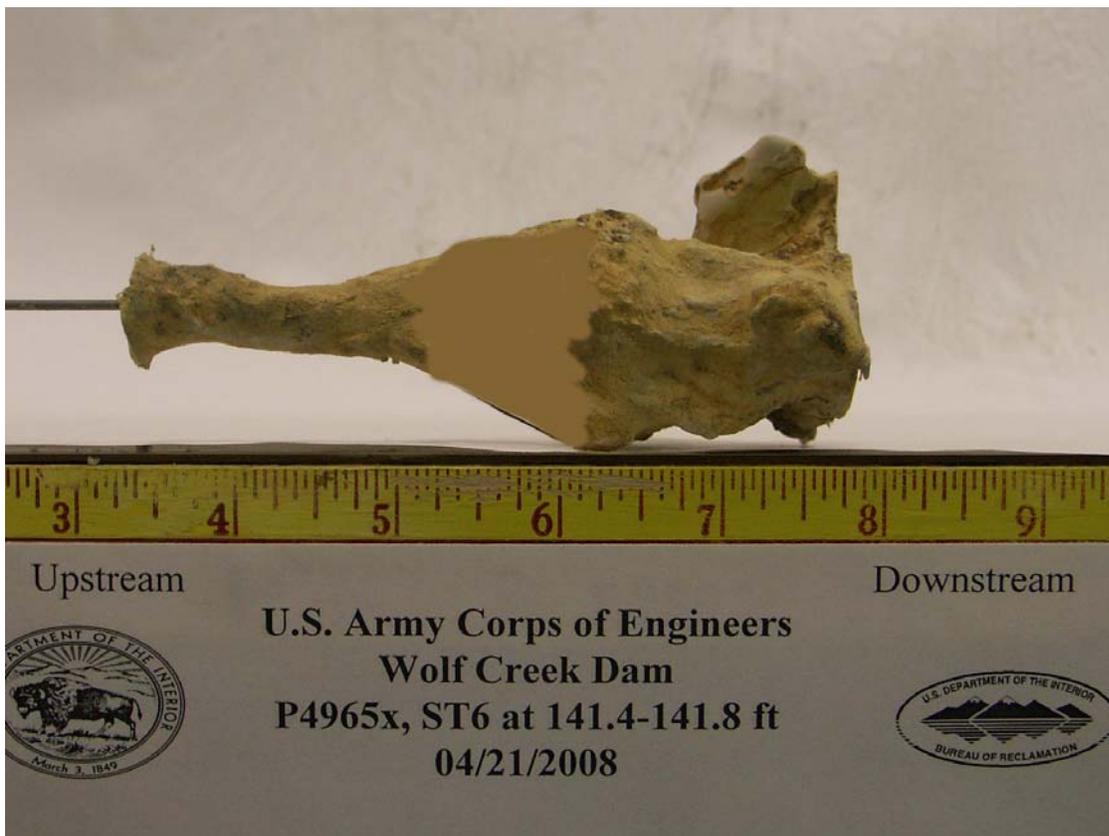
Figure C16- Specimen P4965x, ST6 at 141.4-141.8 ft, applied heads: 240, 400, 850, and 1100 mm, good test. After high-head HET#31 (a) Upstream end, (b) Downstream end, and (c) Enlarged hole cast in hydrostone. Photo (c) is retouched to fill an air void in the casting.

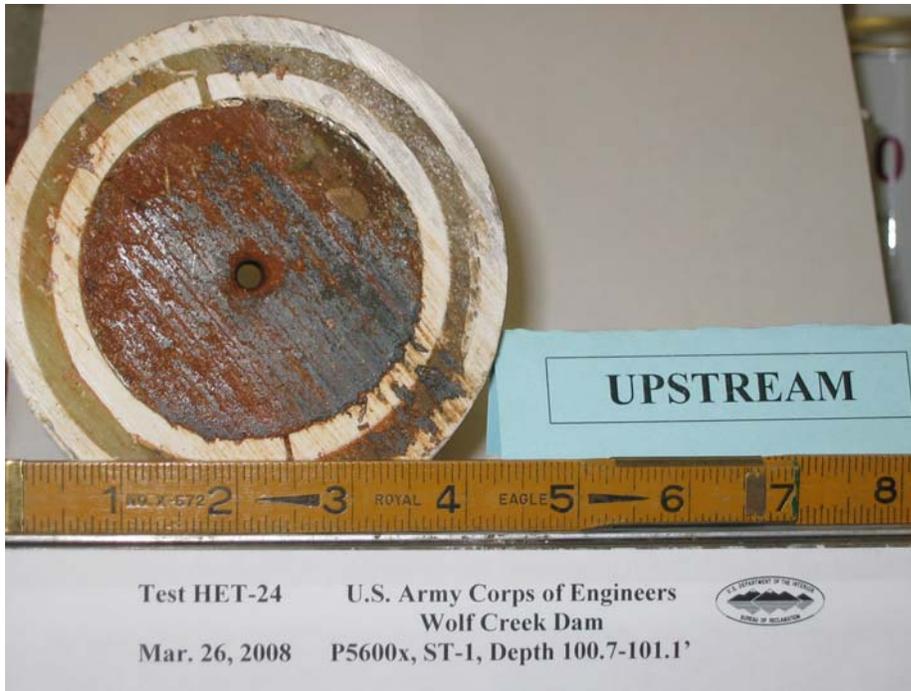
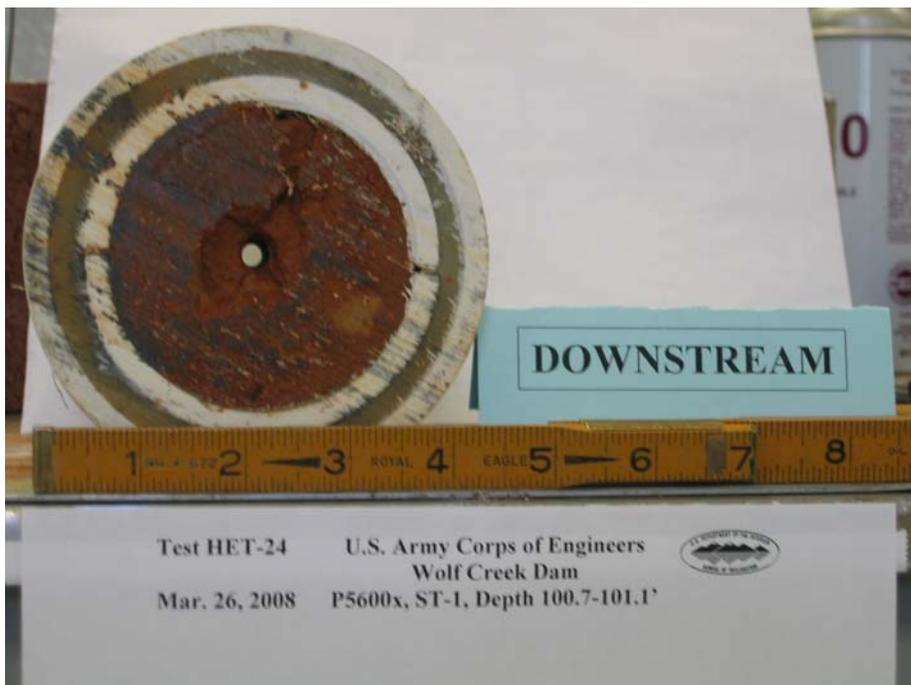
Figure C17- Specimen P5600x, ST1 at 100.7-101.1 ft, applied head: 100, 200, 300, 400, 600, 800, 1100, 1600, 2200, 3300, 4500, and 5400 mm. Geomesh (u/s) turbulence filter and 15 mm end plates (u/s and d/s) installed. No progressive erosion observed. After high-head HET#24 (a) Upstream end, and (b) Downstream end.

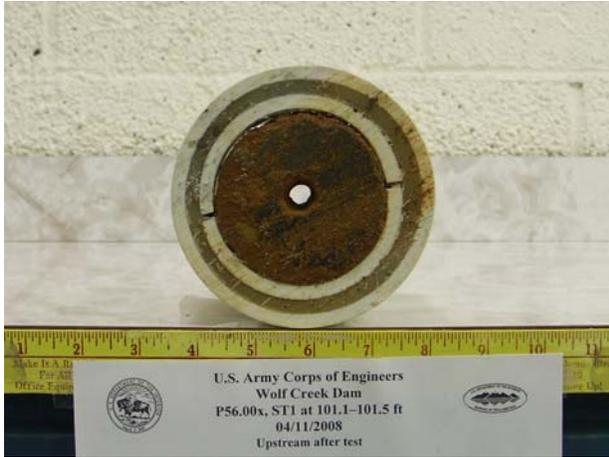
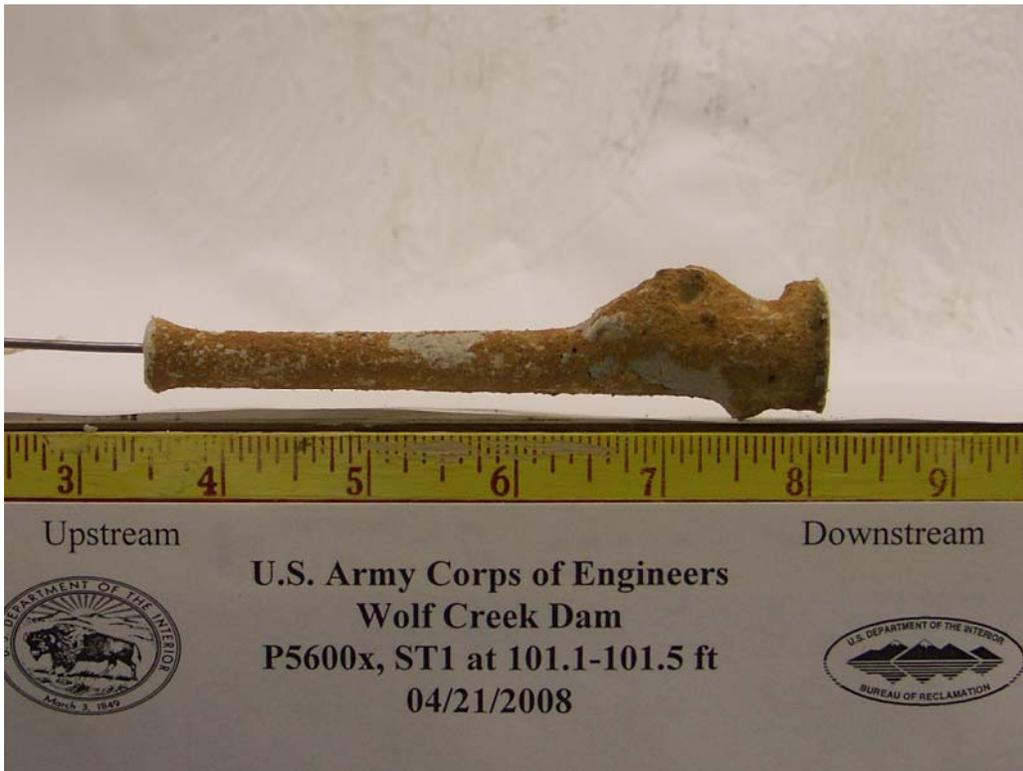
Figure C17 (cont)- Specimen P5600x, ST1 at 101.1-101.5 ft, applied heads: 200, 400, 800, 1600, and 3200 mm. Initial hole diameter was 9.5 mm. Progressive erosion occurred at 3200 mm head. After high-head HET#33 (c) Upstream end, (d) Downstream end, and (e) Enlarged hole cast in hydrostone

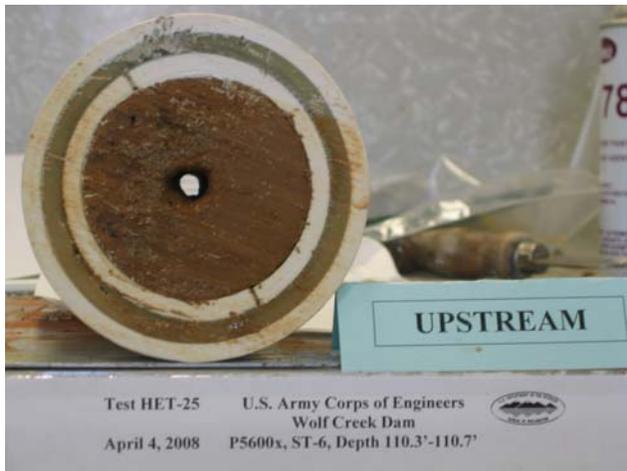
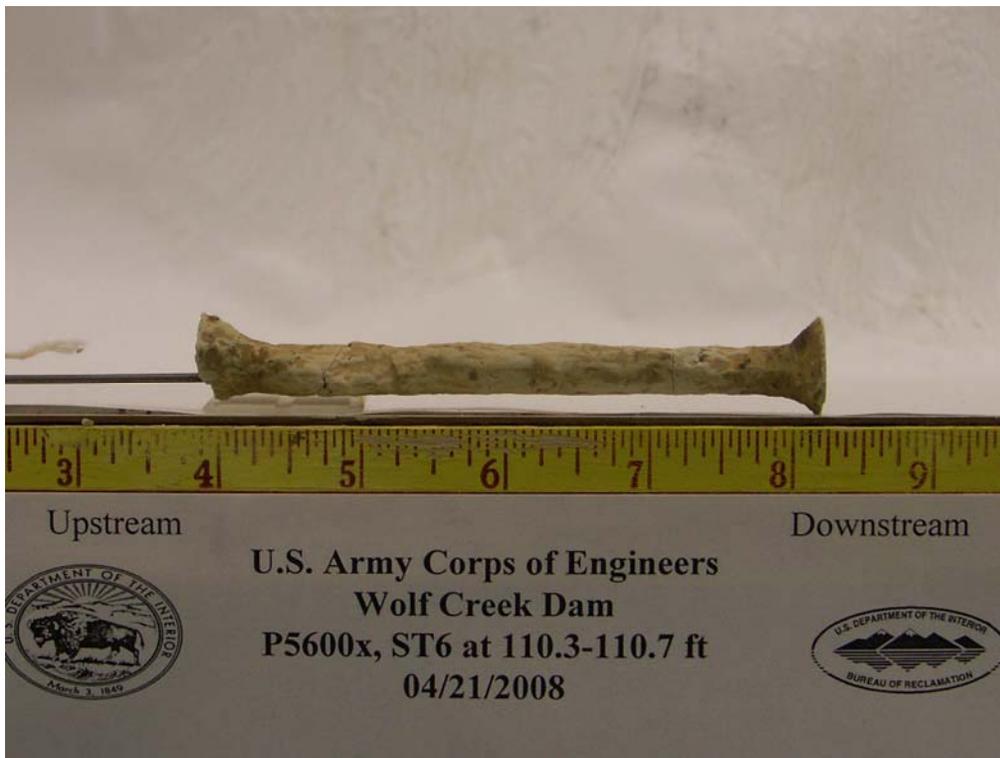
Figure C18- Specimen P5600x, ST6 at 110.3-110.7 ft, applied heads: 100, 200, 400, 550, 800, 1100, 1600, 2300, 3300, 4500, and 5400 mm, good test. After high-head HET#25 (a) Upstream end, (b) Downstream end, and (c) Enlarged hole cast in hydrostone.
