Technical Memorandum No. MERL-08-10

Hole Erosion Tests for Wolf Creek Dam

U.S Army Corps of Engineers, Nashville District
Russell County, Kentucky

May 2008

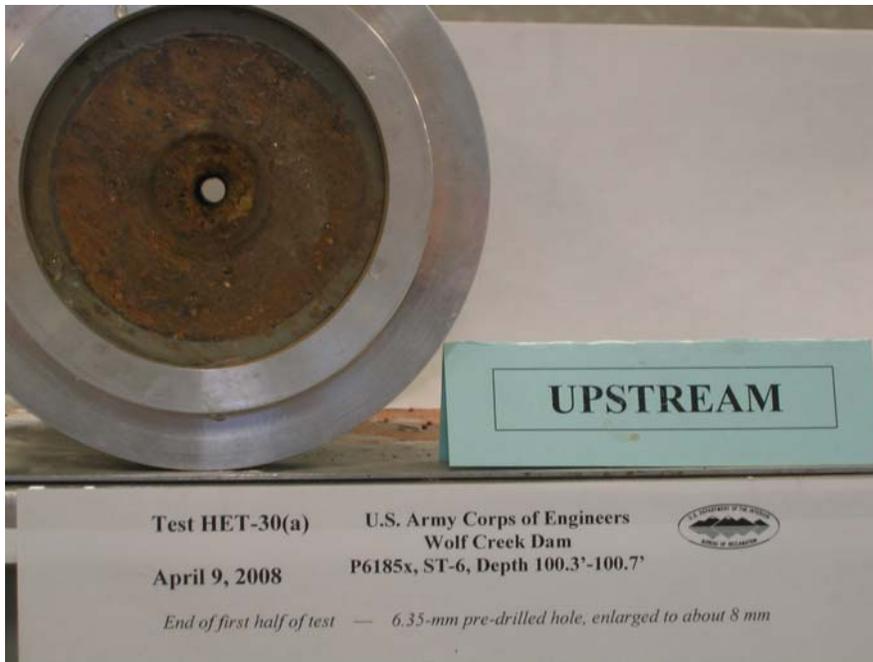
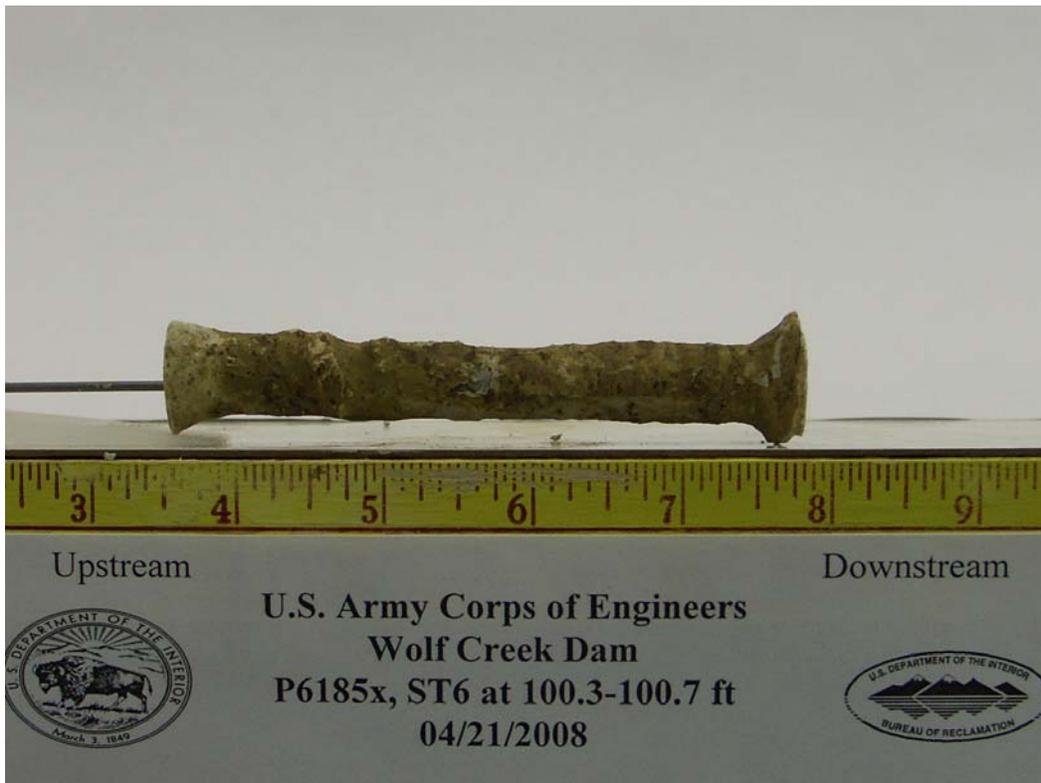
Figure C19 (cont)- Specimen P6185x, ST6 at 100.3-100.7 ft, applied heads: 2150, 4500, and 5100 mm, no progressive erosion. After high-head HET#30. Hole pre-drilled to 12.25 mm, and enlarged to 14 mm during test, but erosion was not progressive (erosion rate decelerating throughout test). (e) Upstream end, (f) Downstream end, and (g) Enlarged hole cast in hydrostone.

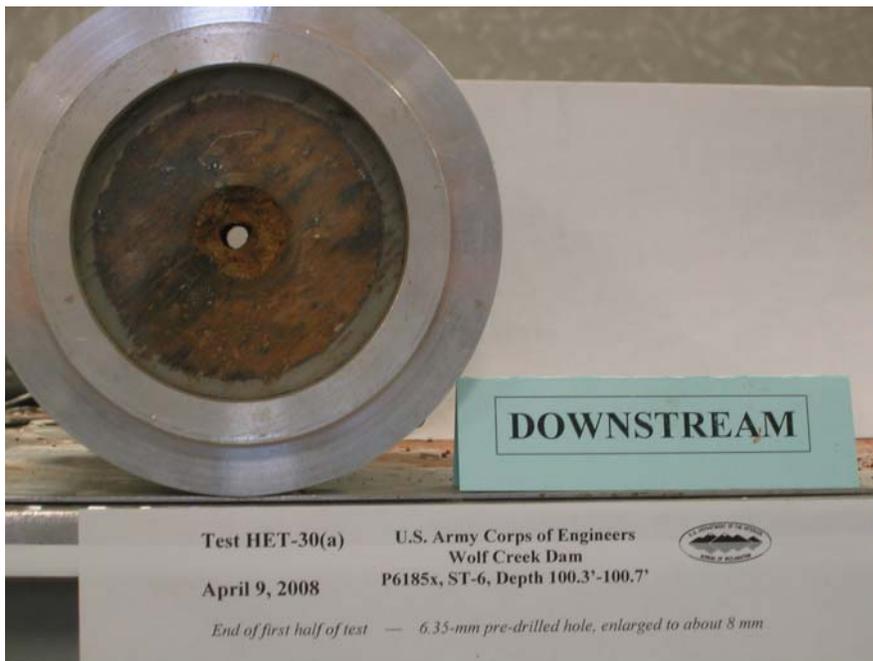
Figure C19- Specimen P6185x, ST6 at 100.3-100.7 ft, applied heads: 240, 400, 800, 1600, 2300, 3200, 4500, and 5400 mm, no erosion. End of first segment of three-part high-head HET#30 (a) Upstream end, and (b) Downstream end. Initial hole drilled to 6.35 mm, enlarged during test to 8 mm, but erosion was not progressive (erosion rate decelerating throughout test).

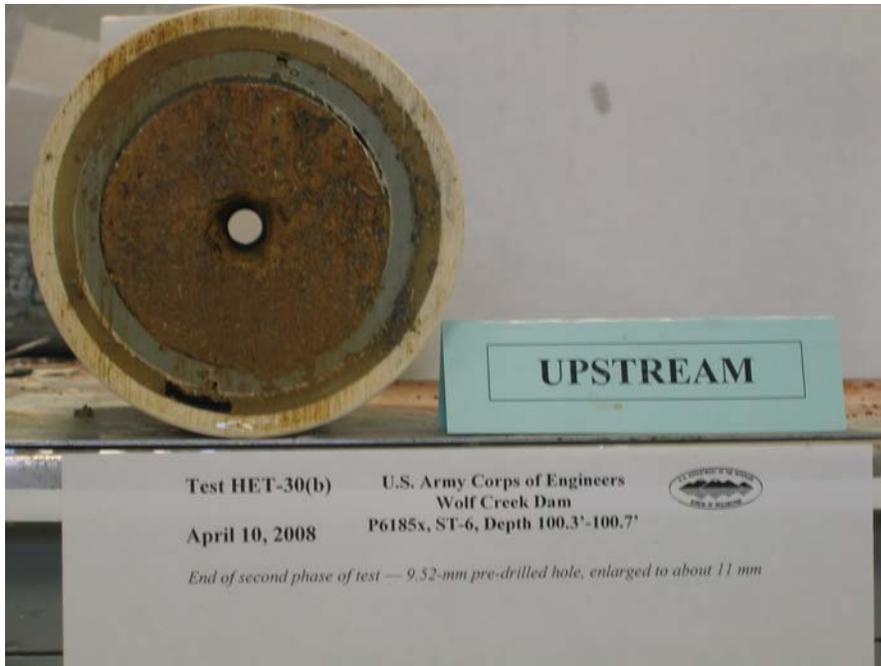
Figure C19 (cont)- Specimen P6185x, ST6 at 100.3-100.7 ft, applied heads: 1600, 2400, 3200, 4500, and 5400 mm, no erosion. End of second part of three-part high-head HET#30. Hole re-drilled to 9.52 mm, and enlarged during test to 11 mm, but erosion was not progressive (erosion rate decelerating throughout test). (c) Upstream end, and (d) Downstream end.

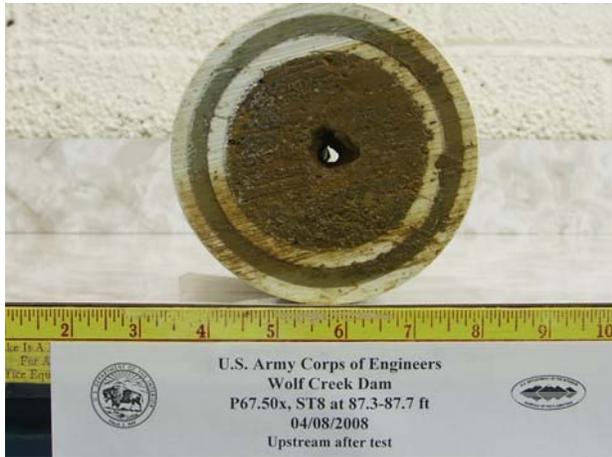
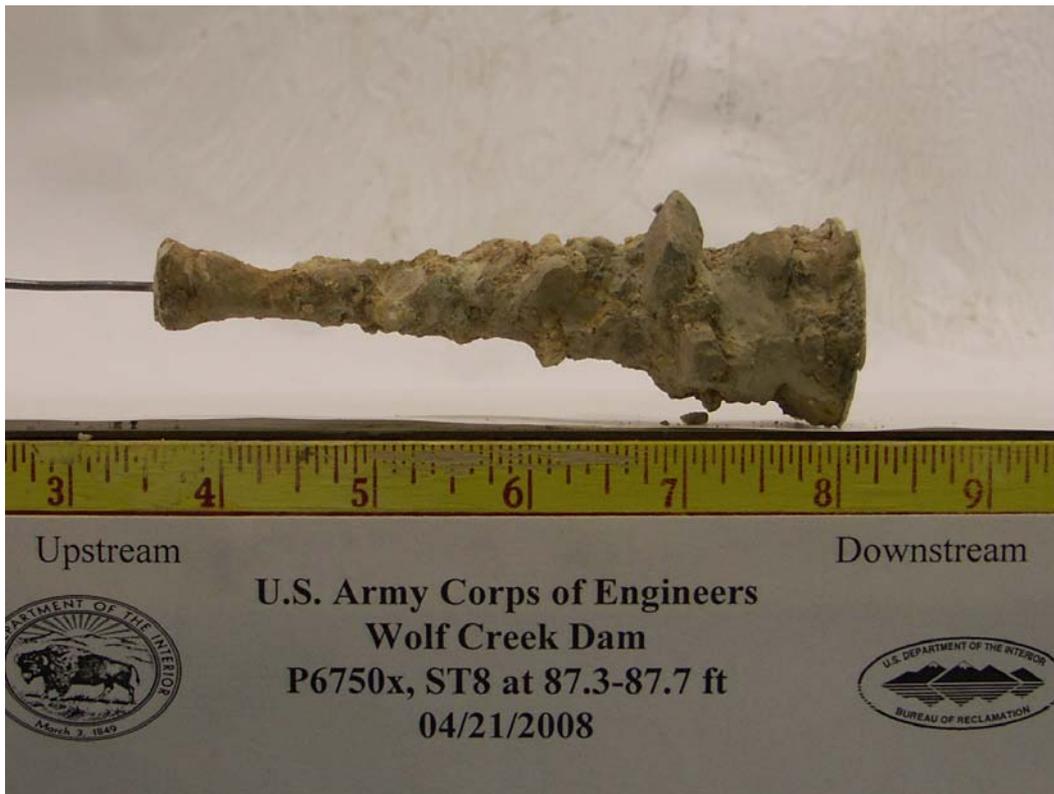
Figure C20- Specimen P6750x, ST8 at 87.3-87.7 ft, applied heads: 150, 200, 400, 800, 1150, 1600, 2250, and 3200 mm. A short period of erosion at 2250 mm. Initial hole was angled due to hitting gravel particles during hole drilling. After high-head HET#27 (a) Upstream end, (b) Downstream end, and (c) Enlarged hole cast in hydrostone.
