**Hydraulic Laboratory Technical Memorandum**

## **Durango Pumping Plant Fish Screens Field Evaluation**

**August 2009**

**Animas-La Plata Project, Colorado**  
**Upper Colorado Region**

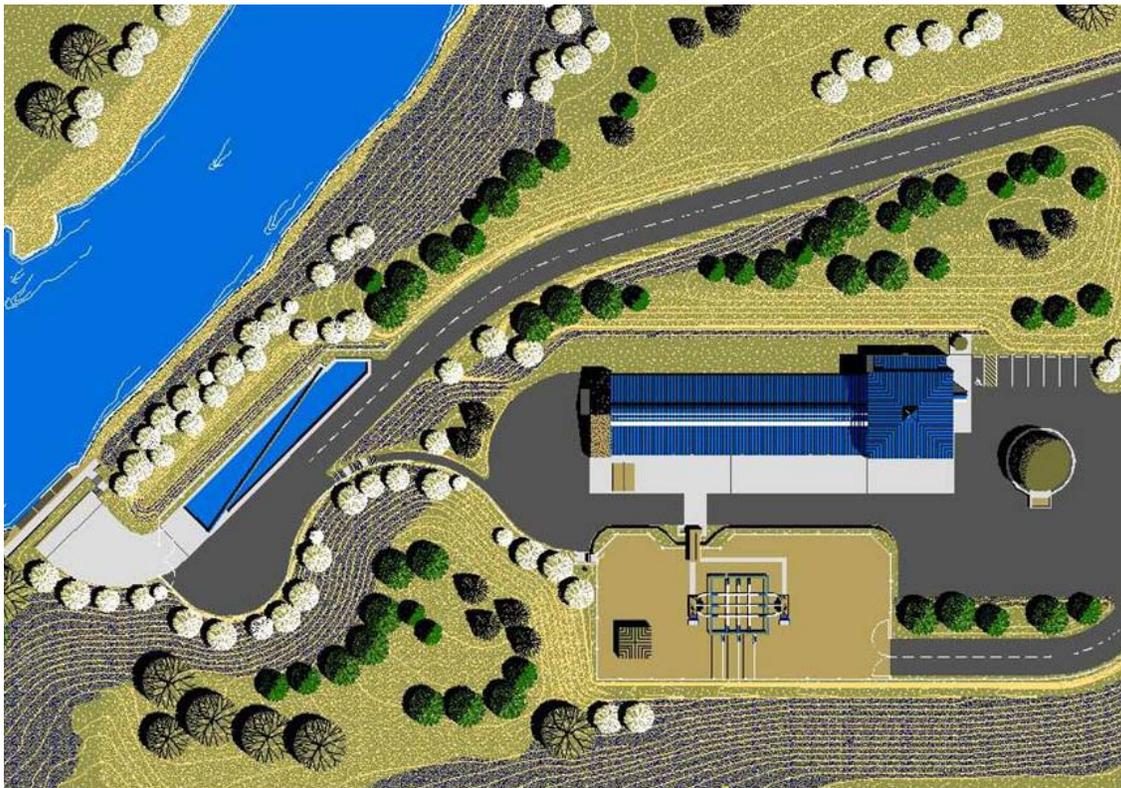
**Figure 1. Artist's rendering of the Durango intake structure, fish screen, and pumping plant (drawn by J.F. Pattie).**

The Durango Pumping Plant, located in Durango, Colorado, diverts up to 280 ft<sup>3</sup>/s from the Animas River through the Ridges Basin inlet conduit and into Lake Nighthorse. The pumping plant consists of an intake structure, a service yard, and a surge chamber (figure 1). The intake structure allows water from the river to pass through a positive-barrier fish screen and into the pumping plant. The 100-ft-long fish screen keeps fish from entering the pumping plant. A fish bypass pipe at the end of the fish screen carries fish to the river downstream from the pumping plant.

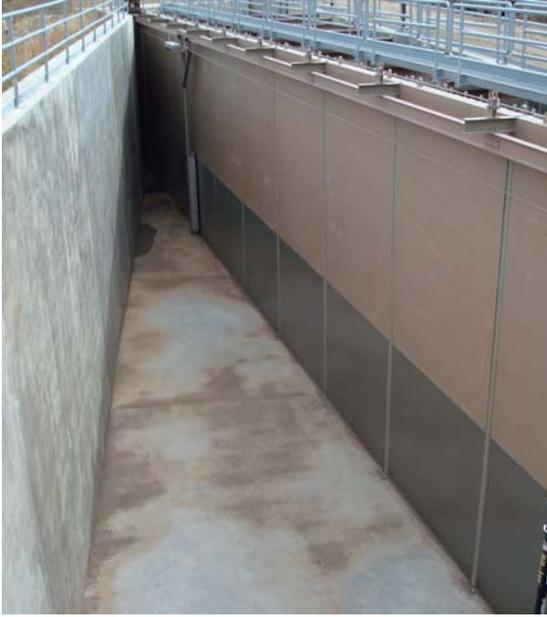
**Figure 2. Dewatered fish screen structure with brush cleaner. The bypass pipe is at the narrow end of the screening structure.**

River flow enters the intake through a trashrack structure and follows a curved section to a 23-ft-wide inlet channel with an invert elevation of 6429.75. Twenty feet downstream from the end of the curve, the fish screens are oriented at an angle of 10 degrees with the right side of the inlet channel (figure 2). The ten fish screen bays are 9.63 ft wide by 8 ft high. The screen material has a mesh size of 1.75 mm with an open area of approximately 40%. Solid steel barrier panels above the fish screens extend 13.17 ft to the ground surface. A brush cleaner system runs at a regular interval to remove debris that accumulates on the screen face. Seven vertical louvers (baffles) were installed behind each fish screen panel to allow lateral adjustment of the flow through the screen (figure 3).

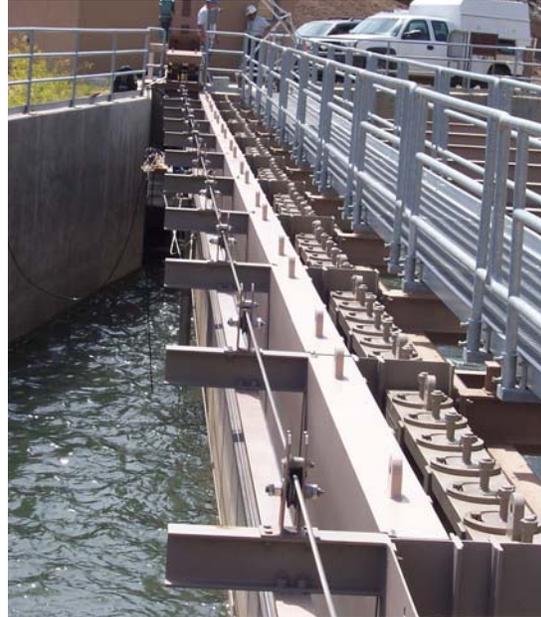
**Figure 3. Seven adjustable vertical louvers behind each screen can be set to optimize flow uniformity through the fish screen panels.**

In order to improve velocity uniformity along the length of the screen face, the vertical louvers located behind certain screens had to be individually adjusted. The bolts on the baffle adjustment assemblies were rusted shut, so the process of adjusting the seven vertical louvers at each screen required considerable time and effort. The vertical louvers on screens 5 through 10 were adjusted to approximately 6% open to drive more flow through the upstream screens. Screens 1 through 4 remained set at 10% open.

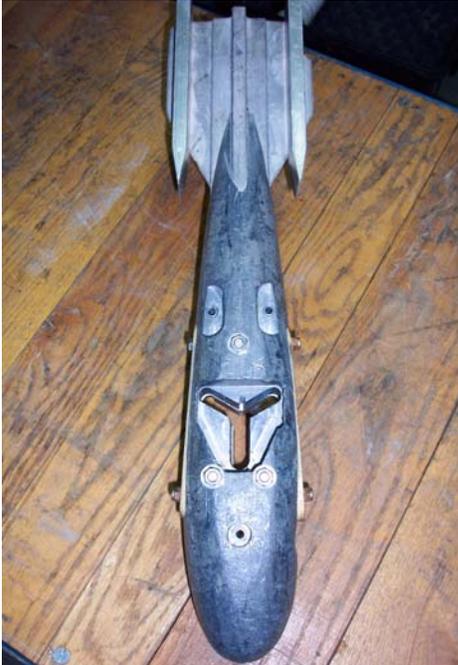
**Figure 4. Bottom side of the modified 50-lb sounding weight.**

Velocity data were collected with a SonTek/YSI 16-MHz Micro ADV (acoustic Doppler velocimeter). Data were collected at 25 or 50 Hz for 30 seconds at a sample volume located 5 cm below the acoustic transceivers. The ADV was placed inside of a modified 50-lb sounding weight (figure 4). The ADV transducers were located in a pocket to protect the probe from debris and contact with the channel bottom. The conditioning module was secured in a metal pipe to prevent rotation of the probe (figure 5). The sounding weight was suspended 9 ft in front of the brush cleaner with a metal cable attached to the brush cleaner traversing cable (figure 5). An electric winch was mounted on top of the brush cleaner to control the vertical position of the instrument by raising and lowering the sounding weight. The brush cleaning control system was used to move the instrument along the screens to the desired lateral sampling location.

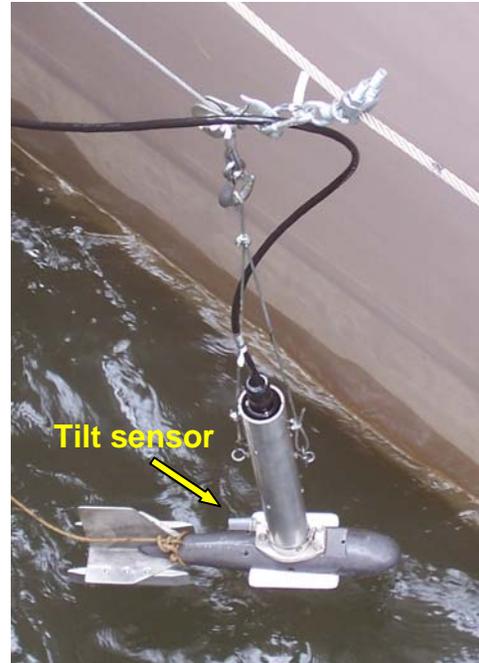
**Figure 5. ADV mounted inside of a 50-lb sounding weight. A tilt sensor was attached to the pipe.**

An Onset HOBO Pendant-G (three-dimensional tilt sensor) data logger was attached to the pipe surrounding the ADV's conditioning module to document the orientation of the sounding weight while in the flow (this sensor can be seen in figure 5 on the back side of the pipe). There was concern that the drag on the sounding weight would cause the ADV to tilt. ADV rotation was controlled with a tagline. The tilt sensor data were analyzed to detect vertical tilt or rotation of the sounding weight. Tilt sensor data were collected at a 1 second interval and were analyzed to determine if the tilt angles were large enough to change the magnitude of the 3-dimensional velocity vectors. The typical tilt angle was between 2 and 3 degrees. For sweeping velocities of 1 ft/s, a 3 degree tilt angle will create an apparent vertical velocity of 0.05 ft/s. Likewise, the sweeping velocity vector would under-register by only 0.001 ft/s. As a result, tilt angles were considered minimal and were not corrected for in the velocity data processing.

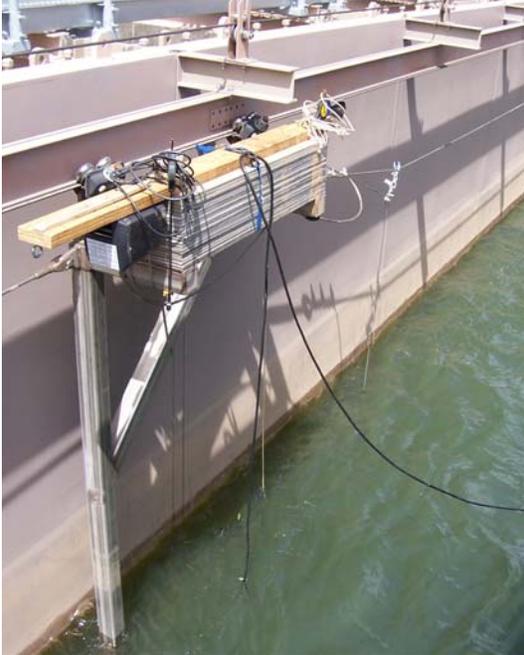
**Figure 6. ADV mount attached 9 ft upstream from brush cleaner system.**

With this setup, data were collected approximately 6 to 9 inches from the screen face (figure 6). In order to measure closer to the screen, a boom cart was positioned on the access platform and the instrument and sounding weight were lowered against the screen face (figure 7). With the boom cart setup, data could be collected 3 inches from the screen face; however, the brush cleaning system could not be operated while the

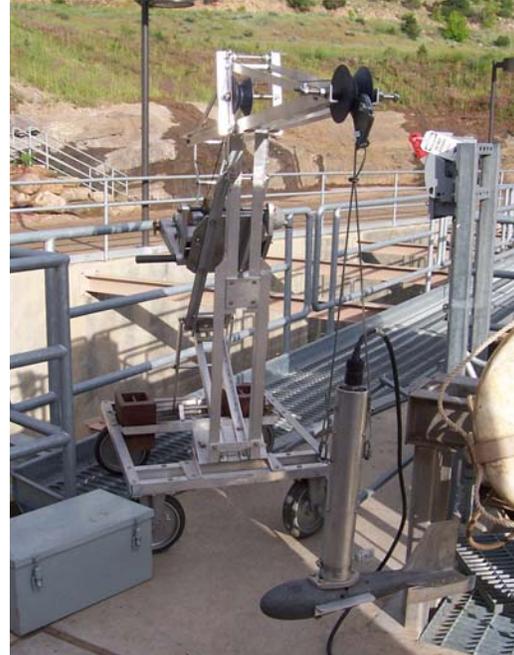
**Figure 7. ADV mount attached to boom cart on access platform.**

instrument was in the water. During the time needed to collect data on a screen, submerged debris began to clog the screen. Velocity data collected with the boom cart revealed high and low velocity regions produced by localized debris. Although this near-screen setup appeared to produce accurate velocity data, the data were not repeatable so they could not be used to gain an overall view of the screen performance needed for vertical louver adjustment. Conversely, with the brush cleaner setup, the brush cleaned the screen prior to each measurement. Although the instrument measured velocities further from the screen face, this setup provided repeatable measurements required to make vertical louver adjustments.
