**Hydraulic Laboratory Technical Memorandum
No. YEL-8460-IE-2009-2**

Yellowtail Dam Issue Evaluation – Jet Erosion Tests of Breccia Core Samples

Pick-Sloan Missouri Basin Project, Montana
Great Plains Region

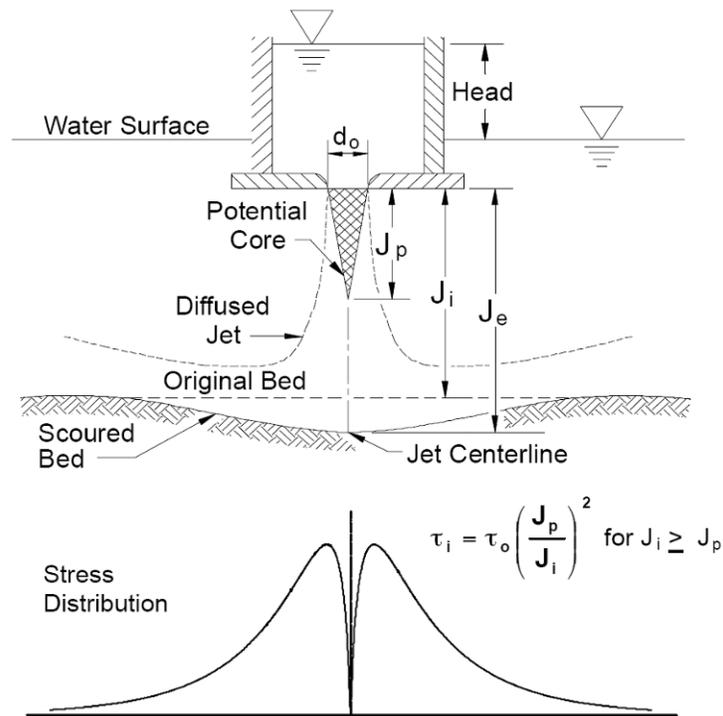
Figure 1. — Schematic of circular submerged jet test (from Hanson and Cook 2004).

Two jet erosion tests were conducted March 24, 2009 on core samples obtained from the vicinity of Yellowtail Dam. The tests were performed in the hydraulics laboratory using a jet test apparatus constructed by Reclamation in accordance with ASTM D-5852, *Standard Test Method for Erodibility Determination of Soil in the Field or in the Laboratory by the Jet Index Method*. This test uses measurements of the scour caused by an impinging hydraulic jet to quantify the erodibility of soil materials. A schematic diagram of the test setup is shown in Figure 1. In recognition of the fact that the samples being tested were likely to be very erosion resistant compared to the soil specimens typically tested with the apparatus, water was supplied from a head tank providing approximately 235 inches (approx. 20 ft) of driving head to the submerged jet, a much larger head than is typically used for such tests (18-60 inches).

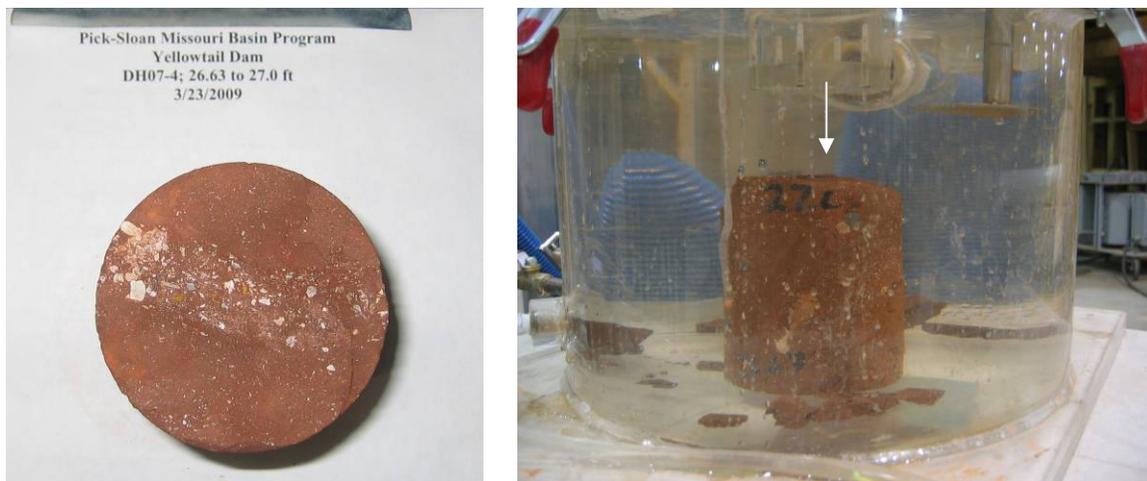
Figure 2. — DH07-4 specimen before (left) and during test. In the right hand photo, note erosion of breccia fragments from around top perimeter of specimen, but no downward erosion of the specimen at the center (beneath the impinging jet location, indicated by the arrow).

There was immediate removal of breccia fragments around the top perimeter of the specimen when the test was started, as the jet washed away fragments that had been pre-existing or were produced by cracking that occurred during the coring operation. It should be noted that if the sample had been confined in a tube or soil mold as is typical with soil specimens tested in the submerged jet apparatus, most of these fragments probably would have remained in place. Directly beneath the impinging jet, where scour depth measurements were made during the test, there was absolutely no erosion throughout the test period. In fact, over the course of the test, the elevation of the top surface increased by 0.01 ft (about 1/8 in.), indicating that the specimen was swelling as it became saturated, figure 2.

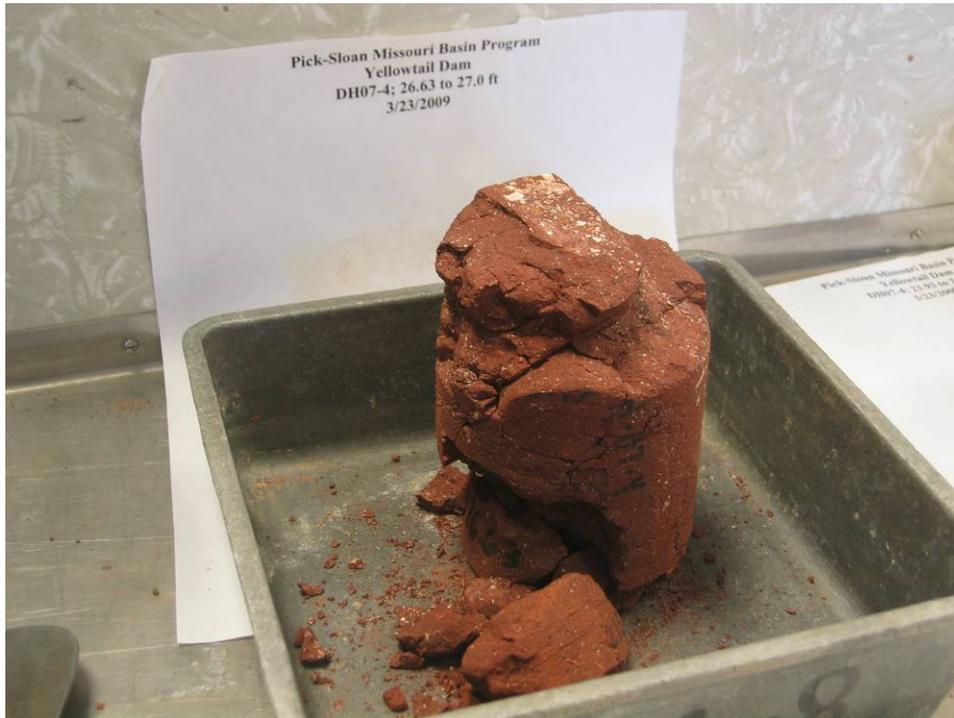
Figure 3. — DH07-4 specimen after jet test. Loose fragments from the bottom of the specimen are being used to prop it up for viewing.

At the end of the test, the tank was drained and the sample carefully removed from the tank. Despite the care exercised, the bottom part of the specimen crumbled loose when the specimen was picked up. Some of the pieces that came loose could be further broken down by hand and their texture and tendency to cloud the water remaining in the tank suggested the presence of small amounts of silt and clay. Figure 3 shows the specimen after it had been air-dried overnight.

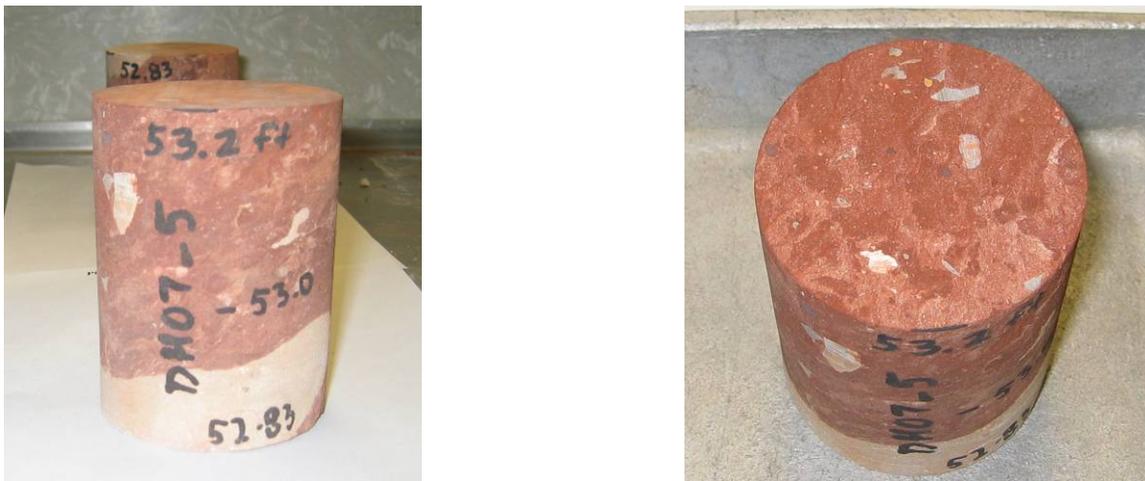
Figure 4. — Photos of DH07-5 test specimen before (left) and after submerged jet testing. Note that the depth interval shown on the paper label is incorrect.

This sample was also tested in an inverted orientation with the jet impinging on the 53.2-ft depth surface. The ¼-in. diameter submerged hydraulic jet was positioned initially 0.161 ft above the sample surface, producing a computed peak hydraulic shear stress against the surface of 324 Pa (6.8 psf). The impingement velocity against the specimen was about 29.0 ft/s. Measurements of the scour depth below the jet were made at test times of 5, 49, and 121 minutes. No significant erosion of this sample was observed during the test, but the scour depth measured at the 5-minute mark did show a scour depth of 0.001 ft (smallest measurable amount), which is probably indicative of removing the thin layer of material from the surface that was disturbed when the specimen was cut from the original core. For the remainder of the 2-hour test period, the specimen was completely stable. This specimen did not swell during the test like the DH07-4 specimen, and when it was removed from the apparatus at the end of the test it was completely intact, with no loose fragments on any part of the specimen, figure 4.
