Hydraulic Laboratory Technical Memorandum PAP-1021

Blue River Fish Barrier: Additional Physical Modeling to Optimize the Fish Barrier

U.S. Department of the Interior
Bureau of Reclamation
Technical Service Center
Hydraulic Investigations and Laboratory Services Group
Denver, Colorado

July 2010

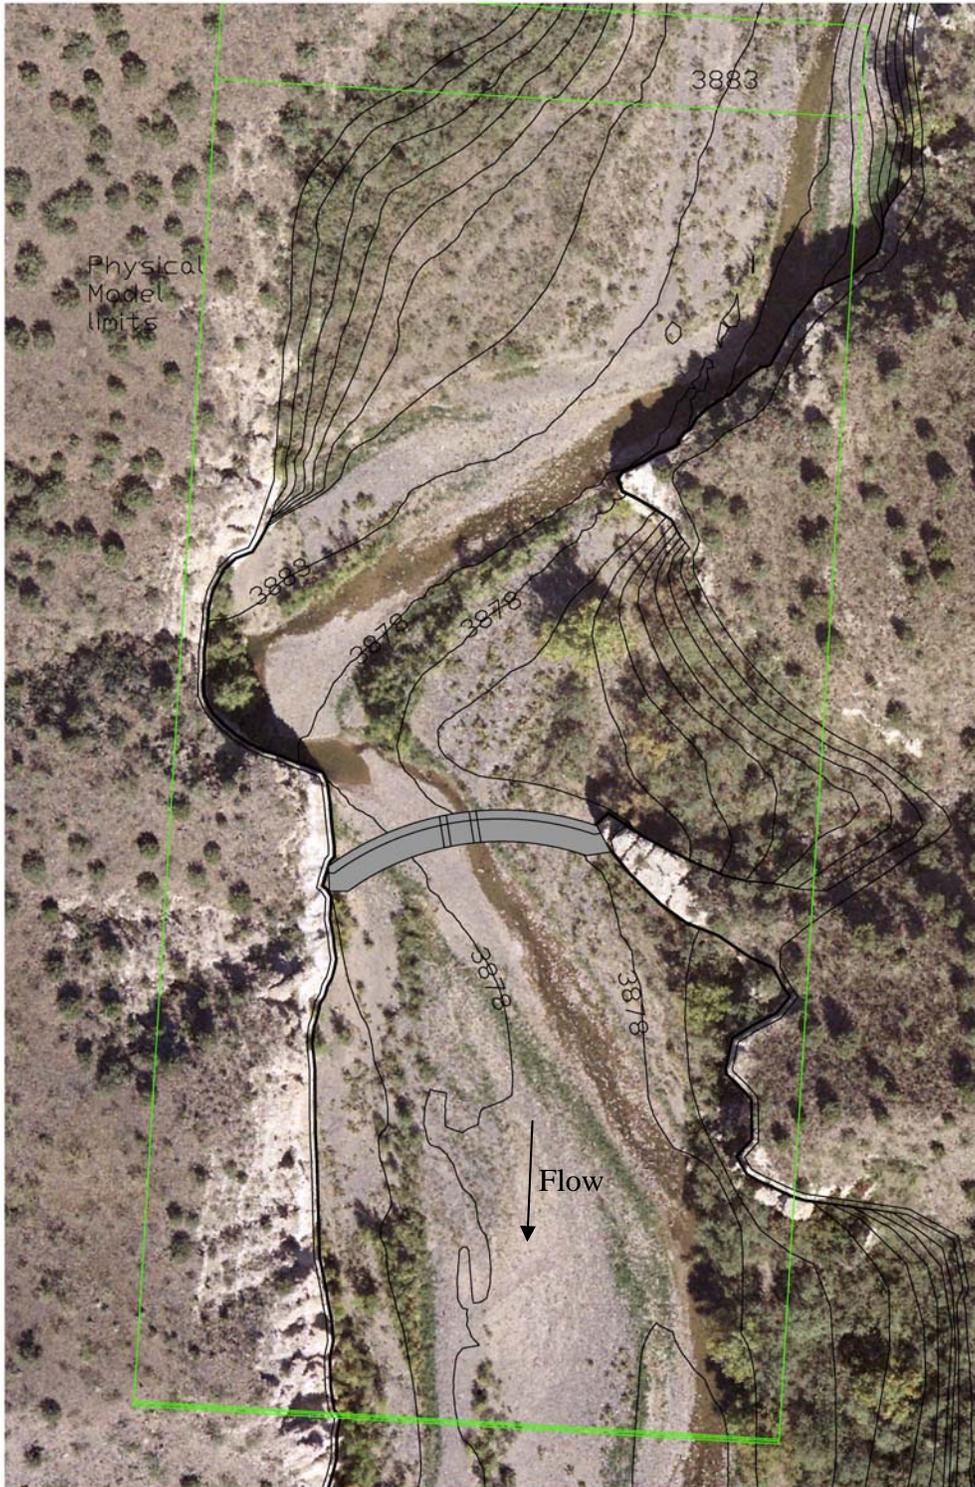
Figure 3. Existing conditions 5-ft contour map. At the sides the barrier is at elevation 3880.85 and 3879.7 in the center.

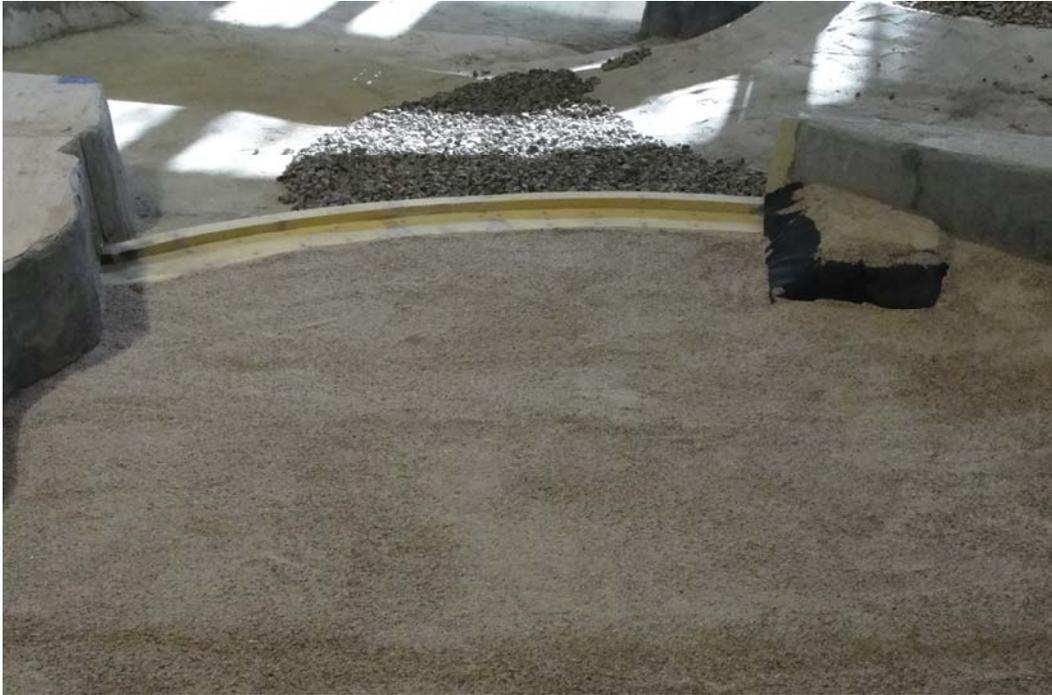
Figure 10. Recommended design with the existing downstream topography.

Figures 10-22 show the recommended design at the mean daily, 2-, 25-, and 100-yr flow conditions, and the resulting scour. Contour maps detailing scour and deposition relative to the pre-test river bed were obtained with photogrammetry techniques.

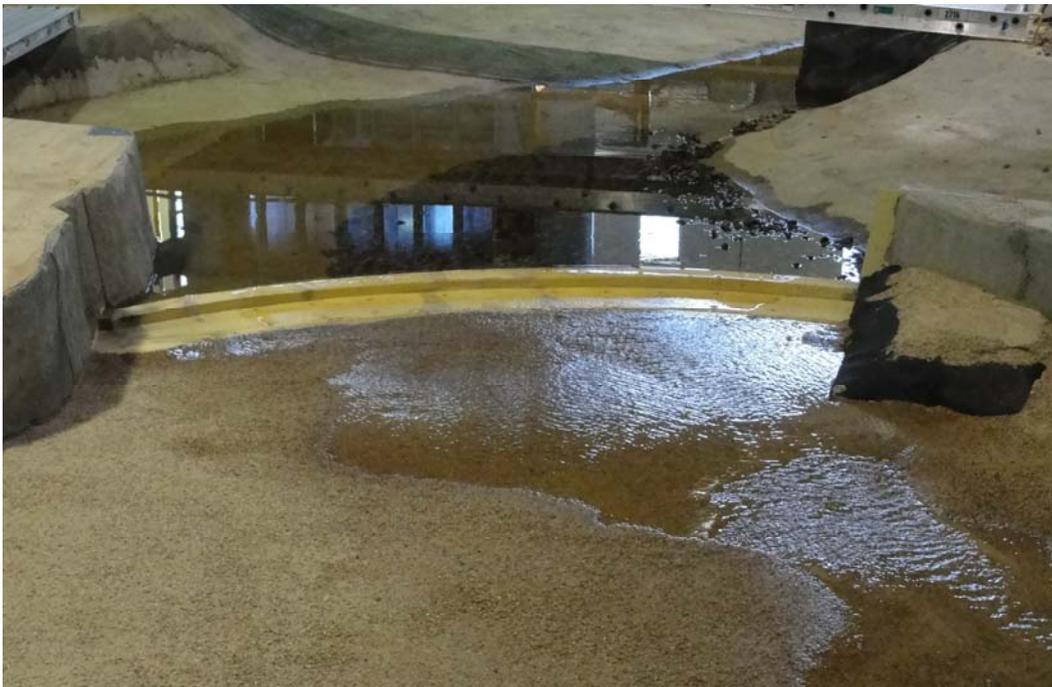
Figure 11. Recommended design at the mean daily discharge.

- Average depth of scour for clear water tests at the mean daily discharge is less than 1 ft.
- The apron is not backwatered during the mean daily discharge.

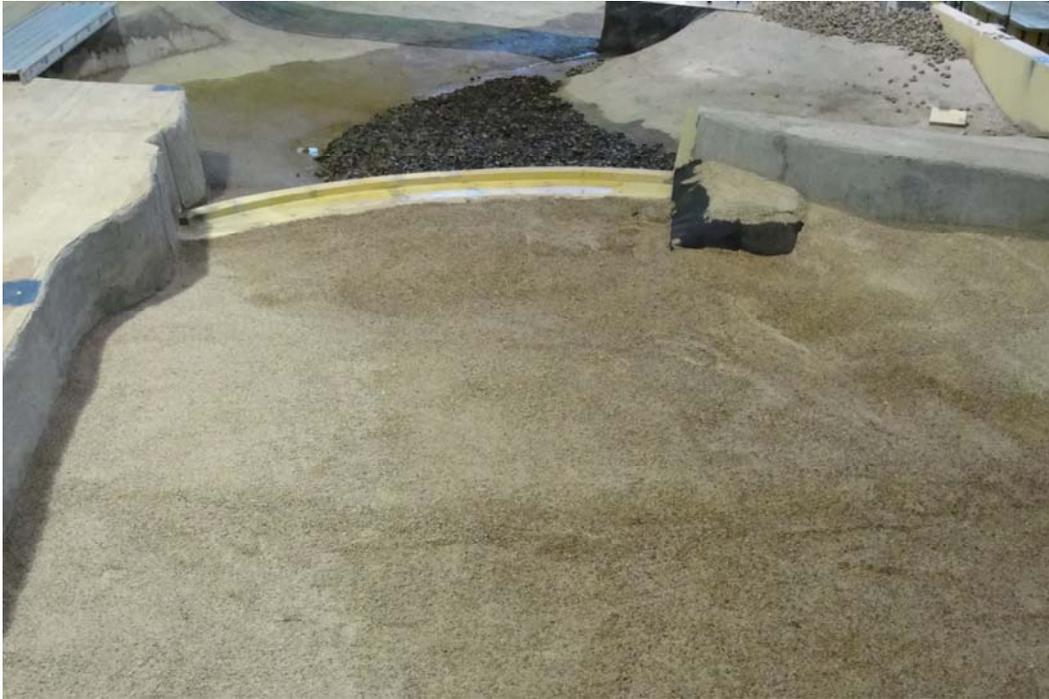
Figure 12. Recommended design showing scour after the mean daily discharge.

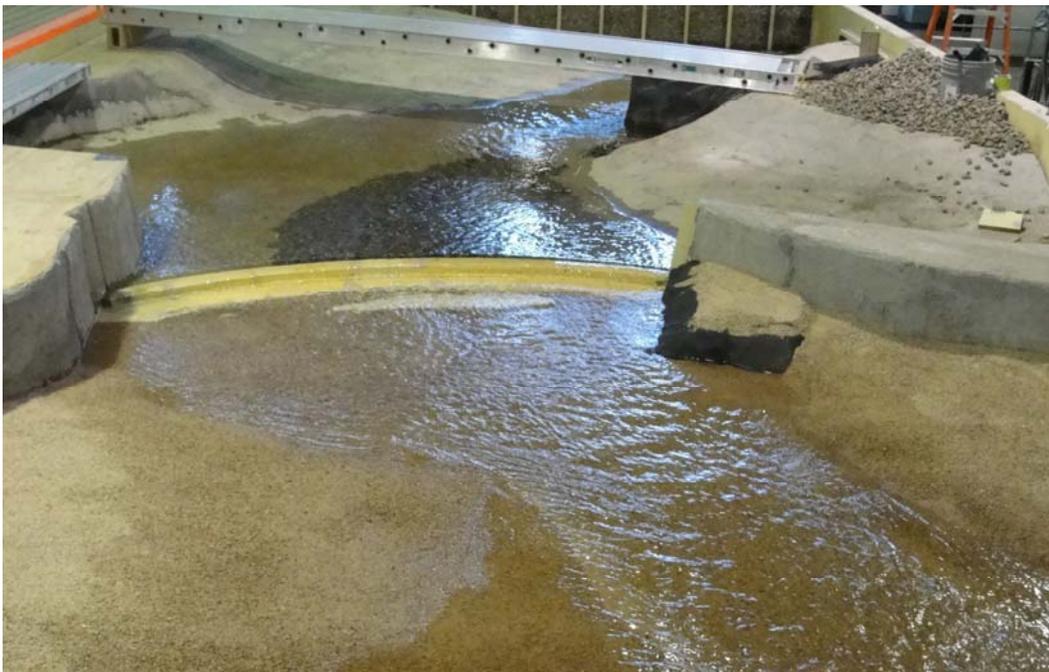
Figure 13. Recommended design at the 2-yr discharge.

- Average depth of scour for clear water tests at the 2-yr discharge is about 2 ft, located on the deflection block.
- At the 2-yr discharge 90 % of the apron is not affected by backwater; there are small backwater influences near the abutments.

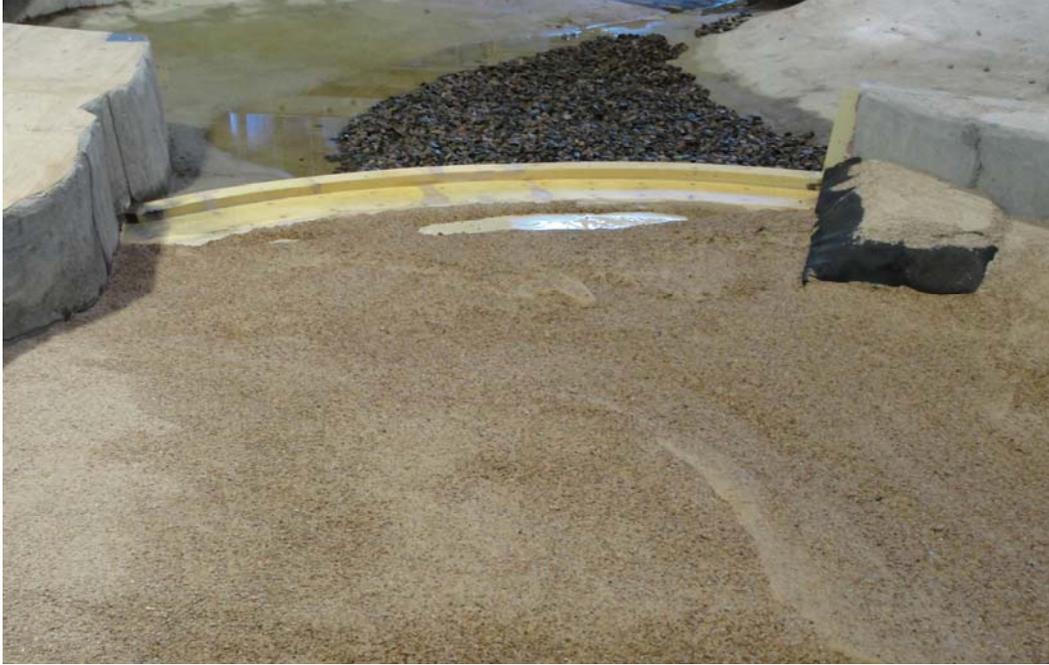
Figure 14. Recommended design showing scour at the 2-yr discharge.

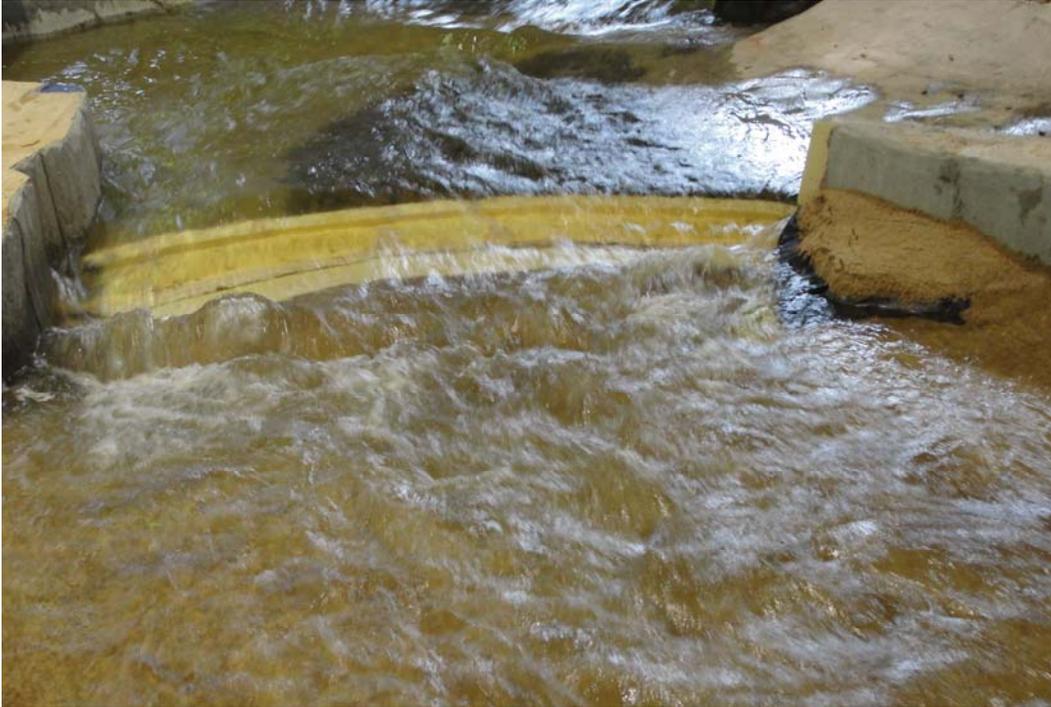
Figure 19. Recommended design at the 100-yr discharge.

- Average localized depth of scour for clear water tests at the 25-yr discharge is about 12 ft with holes reaching 16 ft.
- Average localized depth of scour for clear water tests at the 100-yr discharge is about 16 ft with holes reaching 26 ft.

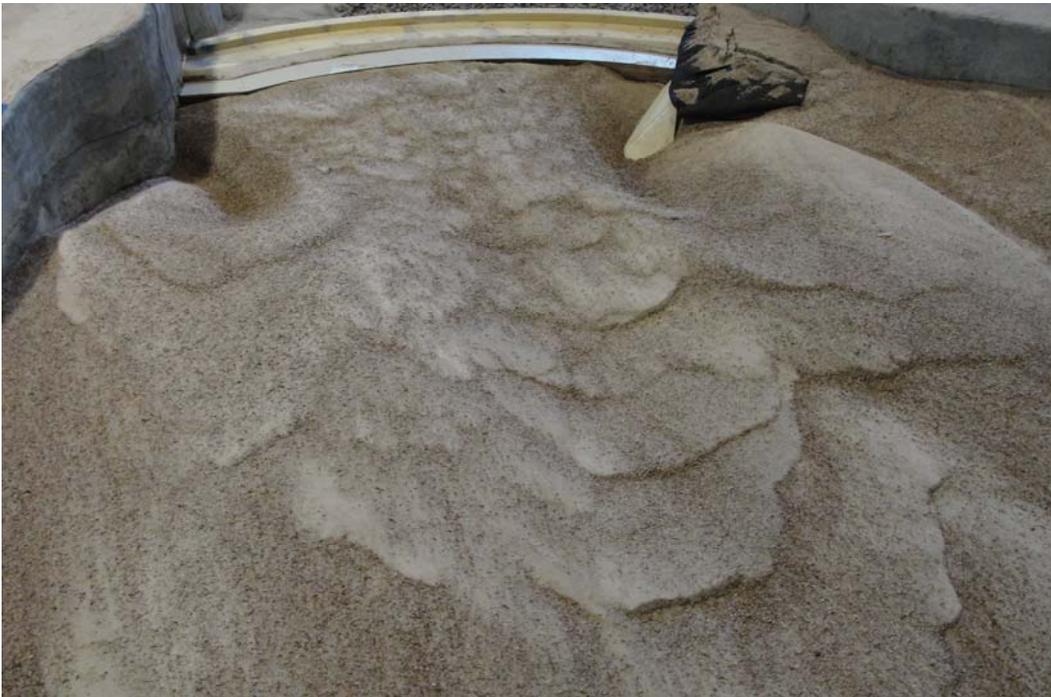
Figure 20. Recommended design showing scour at the 100-yr discharge.
