PAP-1040

Physical Hydraulic Modeling of Canal Breaches

Tony L. Wahl, Dale J. Lentz, Bruce D. Feinberg
U.S. Department of the Interior
Bureau of Reclamation
Technical Service Center
Hydraulic Investigations & Laboratory Services
Denver, CO

Dam Safety Conference 2011
Washington, D.C.
September 26-29, 2011

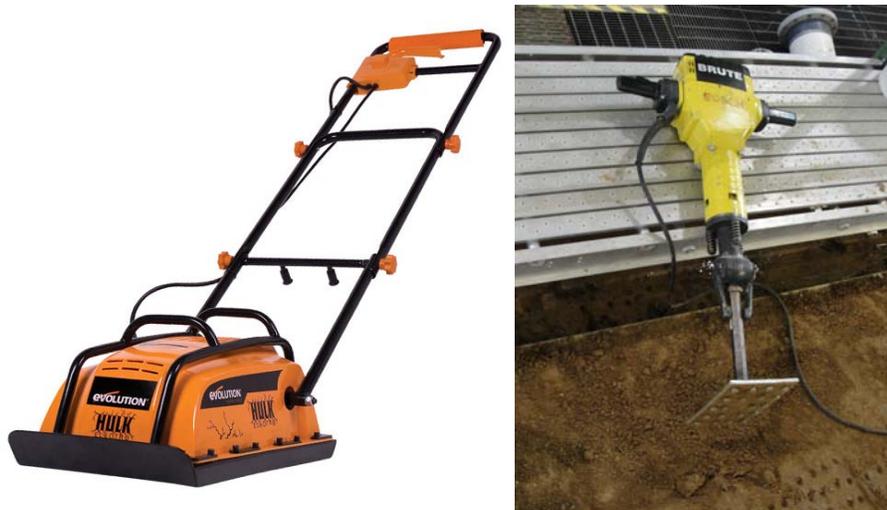
Figure 7. — Equipment used to compact test embankments.

Embankment construction began with soil being brought into the lab and stockpiled adjacent to the test facility where it was moistened and mixed using forklifts and front-end loaders. When the desired water content was reached, material was moved by conveyor into the test section and placed in 4- to 5-inch loose lifts, then compacted to about 3-inch lift thicknesses. Each lift of the first embankment was compacted with two passes of a vibratory plate compactor and one pass of a jackhammer with a shop-built, knobby compaction plate meant to produce kneading action similar to that of a sheep's foot roller (Figure 7). The jackhammer device did the most to effectively compact the material. The second and third embankments received three and four passes of the vibratory plate compactor, respectively, and were not compacted with the jackhammer device. All of the embankments were constructed on top of a wood-framed support table which did not offer a firm base that would be typical of compaction over a solid ground surface. As a result, relatively low densities were achieved, especially for the second and third embankments.

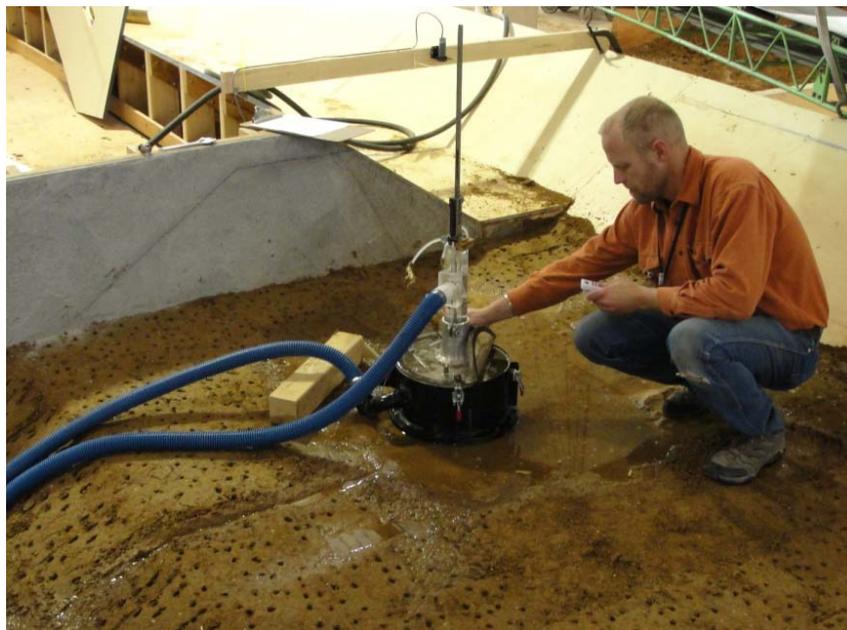
Figure 8. — Performing *in situ* submerged jet erosion test.

As each embankment reached the canal invert elevation, placement was temporarily halted to allow a sand cone density test and in situ submerged jet test to be run (Figure 8).

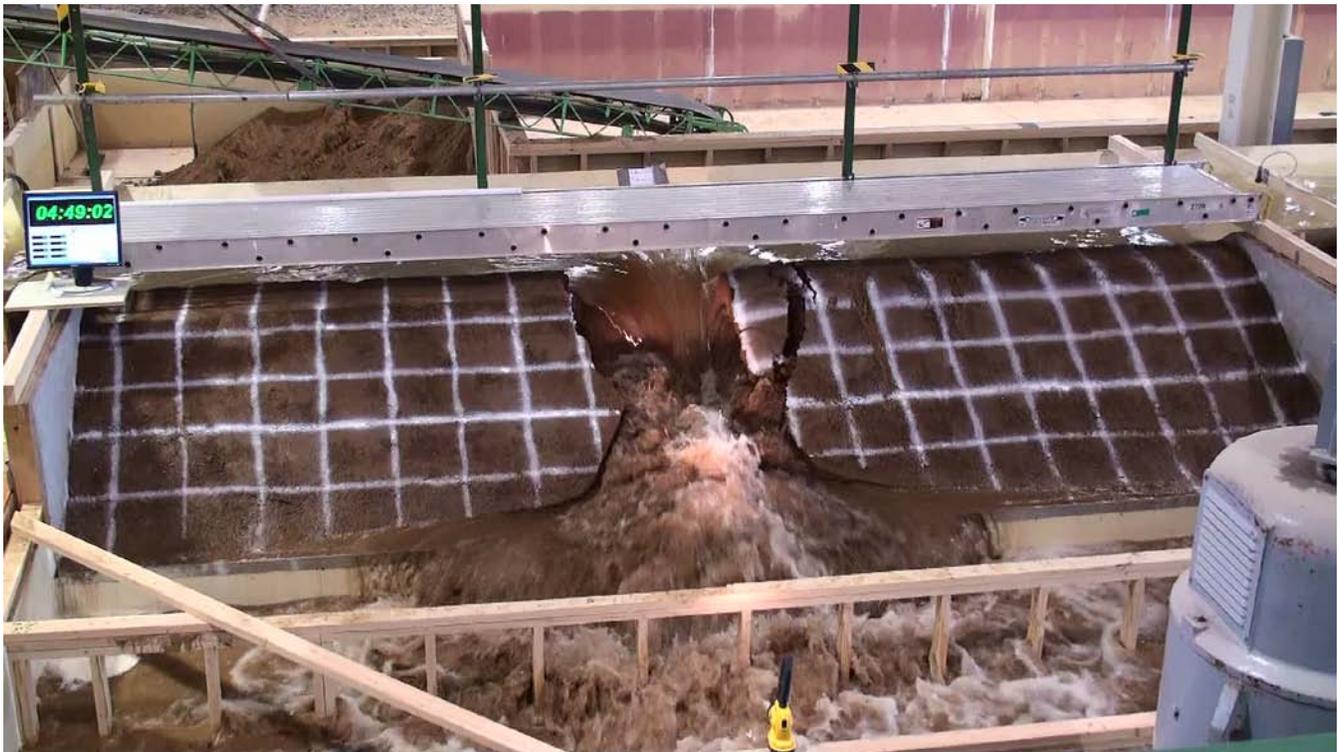
Figure 10. — Embankment number 3 eroding during breach development phase, following the collapse of the bridge over the initial piping hole. Original canal flow is right to left. The breach is progressing into the canal prism by continued headcutting through the upstream (canal-side) embankment slope, and widening due to a sequence of large mass-wasting events at the edges of the breach. One such mass failure is occurring at the upstream side of the breach (right side of photo).

Embankment 3 was also relatively erodible, as it was compacted about 2% dry of optimum and with only slightly more compaction effort than embankment 2. The failure mode for this embankment was also piping, but the pipe was located high in the embankment, about 1.5 inches below the canal water surface (24 inches in a prototype 16 times larger than this model), with a hydraulic gradient of only 0.054 ft/ft. This is representative of an animal burrow or other defect that might occur at a higher elevation within the embankment. The low head on the pipe produced a very small flow that was able to cause headcutting into the embankment, but at a very slow rate (Figure 9). It took about 4.75 hours for this headcut to advance upstream to the embankment crest and breach into the canal prism. Although the flow rate out of the pipe was not directly measured, it did not appear to increase significantly during the time that headcut advancement was taking place, so we believe the hydraulic gradient and associated shear stress were too low in this test to cause enlargement of the hole. Once the headcut broke into the canal prism, breach development and widening (Figure 10) were very rapid and the breach reached the 17 ft³/s peak outflow rate within about 4 minutes. This test illustrated the dramatic difference in erosion rates that can occur in the breach initiation phase and breach development phase as a result of the lower initial hydraulic gradient.
