Hydraulic Laboratory Technical Memorandum
PAP-1045

Starvation Dam Issue Evaluation – Erosion Tests of Zone 1 Core Samples and Index Testing of Zone 3 Shell Sample

December 2011

**Central Utah Project – Bonneville Unit - Utah
Upper Colorado Region**

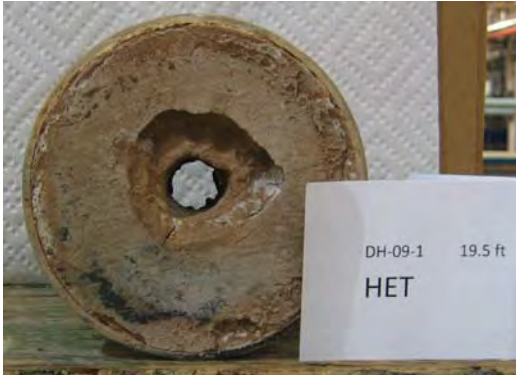
Figure 1. — Post-test photo of HET specimen from sample 37Q-160, DH-09-01, depth 19.5 ft.

Three hole erosion tests were performed. Sample 37Q-160 from depth 19.5 ft was tested first. The initial test head for this sample was set to about 180 mm, which caused immediate progressive erosion and enlargement of the pre-drilled ¼” diameter hole in the soil specimen. The test was stopped after 26 minutes when the flow rate had increased from about 1 L/min to nearly 21 L/min. Figure 1 shows a post-test photo of the eroded hole through the test specimen. Final diameter of the hole was estimated to be 23 mm from direct measurement of the specimen immediately after the test. Figure 2 shows graphical analysis of the test data leading to the determination of the I_{HET} index value of 3.4 for this sample. This index value indicates moderately rapid erosion on the descriptive scale developed by Wan and Fell (2004).

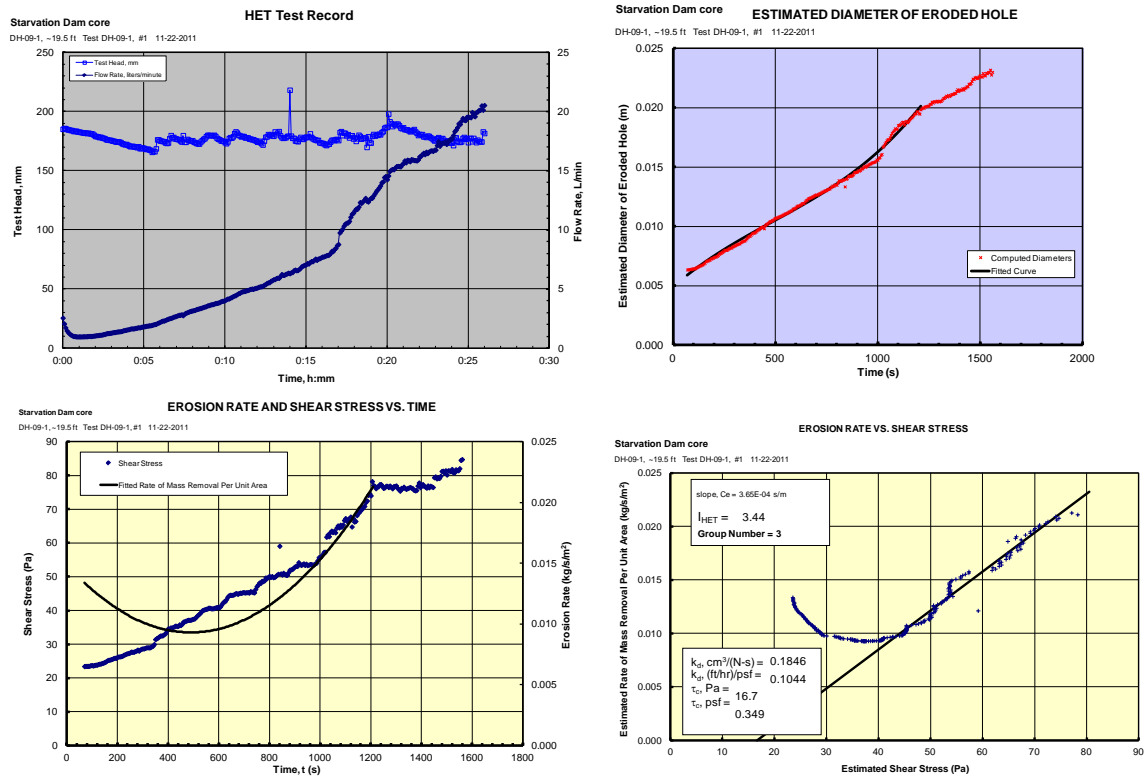
Figure 2. — Analysis of HET test data for sample 37Q-160.

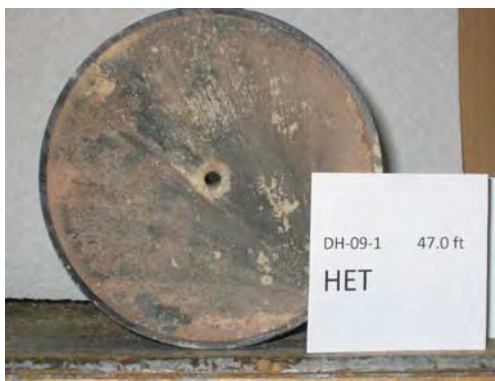
Figure 4. — Photograph of HET specimen from sample tube 37Q-171 prior to erosion test.

The last HET specimen came from sample tube 37Q-171 at a depth of about 47 ft (Figure 4). This sample was tested beginning at about 160 mm of head. The sample exhibited no significant erosion of the hole, as indicated by steady flow rates through the hole under a fixed head. The head was repeatedly increased to 250, 400, 800, 1600, and 3200 mm. At the last two head settings, it became apparent that the middle of the sample tube contained an erosion resistant clay lens about $\frac{3}{4}$ " thick that was preventing any enlargement of the hole. Upstream and downstream from this layer, the upper half of the specimen was largely eroded away. When the flow was stopped and the specimen removed from the test apparatus, the original pre-drilled $\frac{1}{4}$ " diameter hole was found unaffected as it passed through the clay lens. Figure 5 shows several views of the specimen after the completion of the test. The material in the clay lens was very solid, while the soil on the upstream and downstream side of the lens was fully saturated and very soft. Because the hole did not enlarge, quantitative analysis of this test was not possible. Flow rate at each head setting was essentially constant, except for slight flow increases associated with the shortening of the hole due to erosion of the areas upstream and downstream from the clay lens.

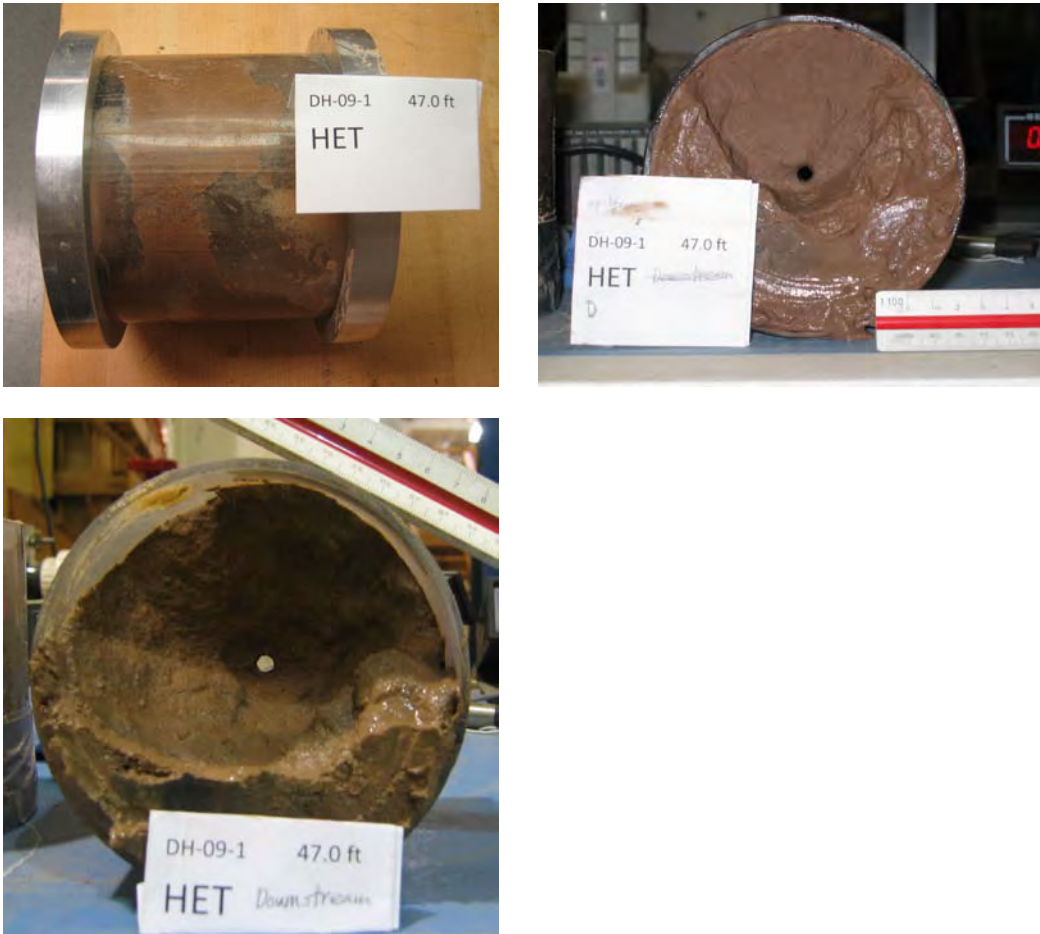
Figure 5. — Several views of HET specimen from sample tube 37Q-171, following erosion test. Clockwise from top-left: top view through specimen tube showing clay lens left of center (flow right to left); upstream end of specimen; and downstream end of specimen.

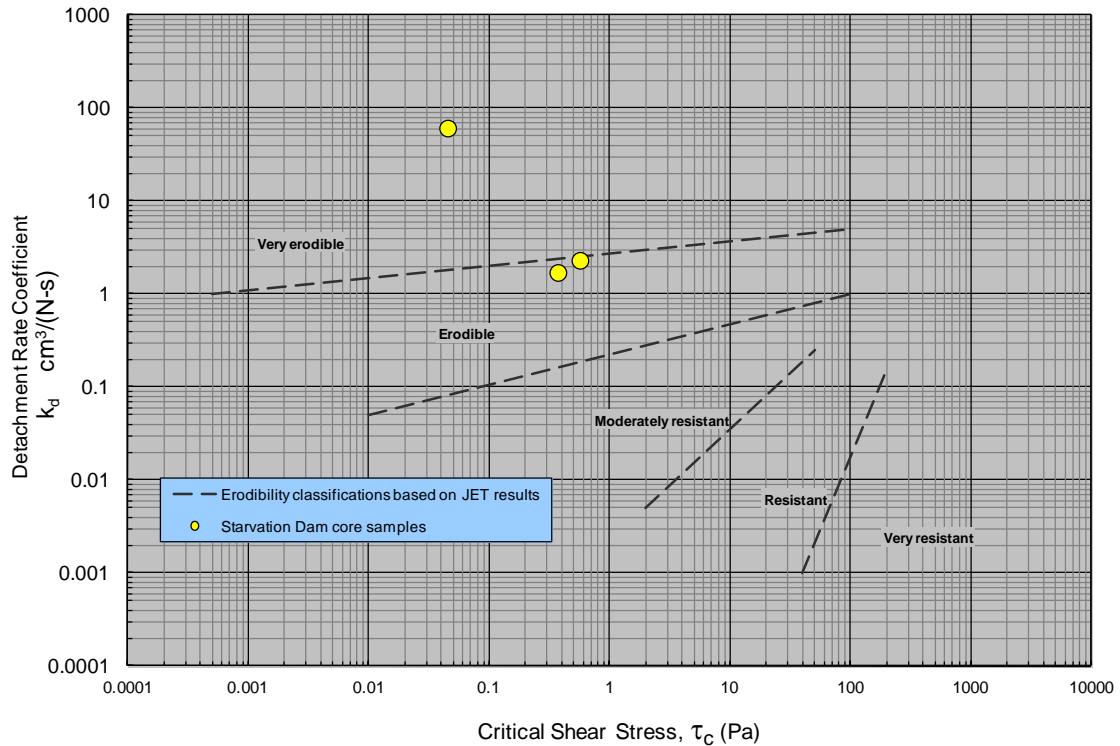
Figure 7. — JET erosion test results. Erodibility classifications are those proposed by Hanson and Simon (2001). Note unit conversions: 1 cm³/(N-s) = 0.5655 ft/hr/psf; 1 Pa = 0.0209 psf.

Three submerged jet erosion tests were performed on soil samples cut from the sample tubes adjacent to the HET samples. The jet erosion test is performed in the apparatus shown in Figure 6. The jet is produced through a ¼” diameter orifice. The flow impinges on the soil surface causing scour of the surface that is measured as a function of test time. The jet pressure is held constant during the test. The data are analyzed to estimate the critical shear stress needed to initiate detachment of soil particles and the detachment rate coefficient expressing the change in erosion rate per unit of additional excess stress. Results of the three tests are plotted in Figure 7, relative to erodibility classifications proposed by Hanson and Simon (2001). Two of the samples (depths 19.5 and 47.0 ft) plot very close to one another, on the margin between erodible and very erodible. The third sample (17.0 ft) plots in the very erodible range. Figure 8 shows the post-test condition of the jet test samples.
