Hydraulic Laboratory Technical Memorandum PAP-1067

## Rock Slough Fish Screen Hydraulic Evaluation

Contra Costa Water District

September 2012

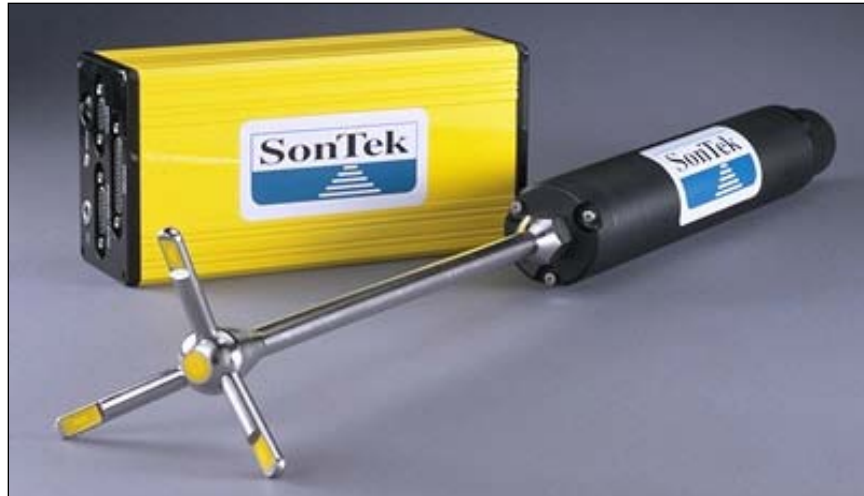
Figure 5 SonTek/YSI Field ADV probe and splash-proof signal processing module.

A major component of the hydraulic evaluation was velocity measurements over the majority of the fish screens. Three-dimensional velocity measurements were taken approximately 3 inches from the screen face using Acoustic Doppler Velocimeters (ADV) as shown in Figure 5. The 10 MHz ADVs have an accuracy of  $\pm 1\%$  of the measured velocity with a velocity range from  $\pm 0.003$  to 8.2 ft/s. Data were acquired at sampling rates of 25 Hz, allowing for the measurement of turbulence characteristics of the flow.

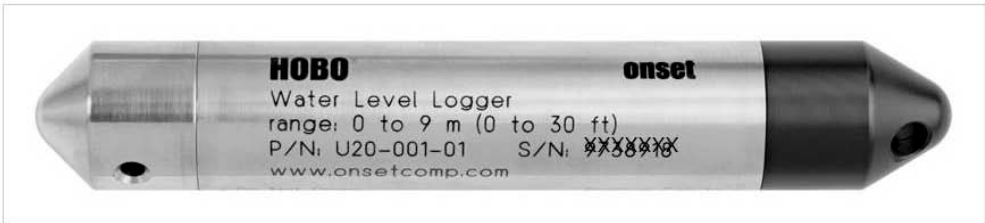
**Table 3.** HOBOTM Water Level Logger performance specifications (photograph was taken from ONSET’s online product brochure).

Two HOBOTM submersible water level loggers (see table 4 for manufacturer’s specifications) were located at the pressure relief bay for measuring head differential across the screen structure. One logger was placed upstream and one logger downstream of the screen at the same distance from the top of the screens to log water depths. A third transducer was mounted to one of the ADV probes during testing to help monitor depth at the time of each velocity measurement. A barometric pressure logger was also deployed to collect atmospheric pressure data necessary to convert absolute pressure measurements to water depths.

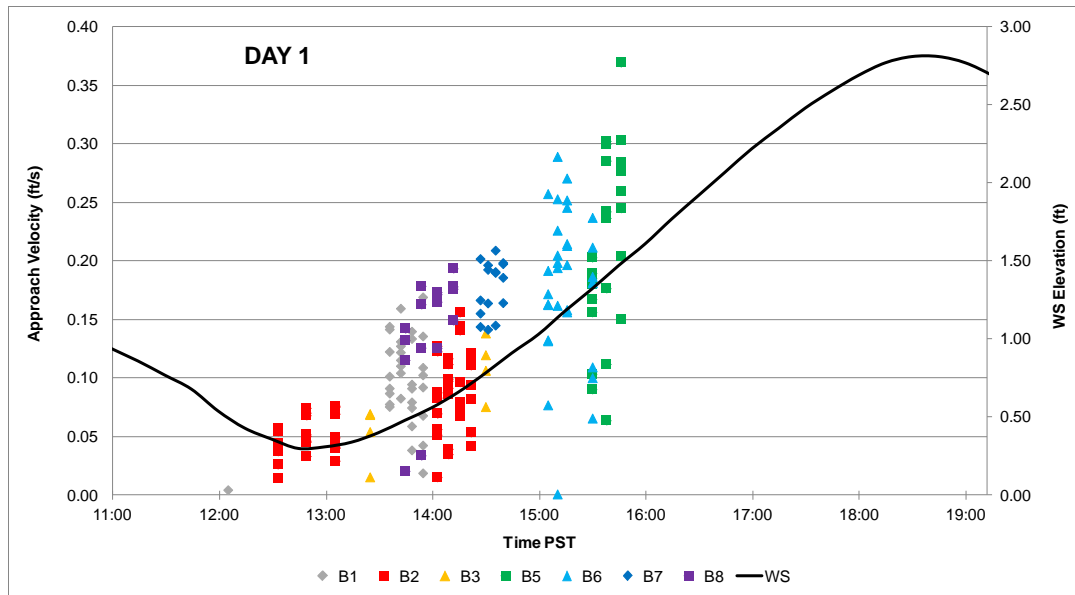
**Figure 8.** Approach velocity and water surface elevation data from Day 1 (October 11, 2011).

Velocity testing for Day 1 was conducted from 11:45 to 16:00 PST during low tide and incoming flood tide. Figure 8 shows velocity data taken for each bay and the water surface elevation at the screens throughout the testing period. Testing began with the 2-probe configuration on screen bay B1. Much of the data taken before 12:00 was discarded because of outward flow through the screen caused by an outgoing tide. These velocity measurements were repeated beginning around 13:30 as the incoming tide and pumping at Pumping Plant No. 1 generated flow through the screen into the Contra Costa Canal. Only a few measurements were made at screen bay B3 and none at B4 because access was blocked by a trash rake stuck in front of the second screen of B3.

At 13:30, velocity measurements with the 1-probe configuration were started at B8. Velocities were collected working upstream toward the middle of the structure (B5). Since the screens were not being cleaned during testing, debris was visually apparent on most of the screen panels and weeds periodically fouled the ADV probes. The increasing velocity trend in figure 8 was likely attributed to progressive debris accumulation on the screens. As a result, all velocity measurements made after 15:30 were excluded from the overall analysis of screen performance.

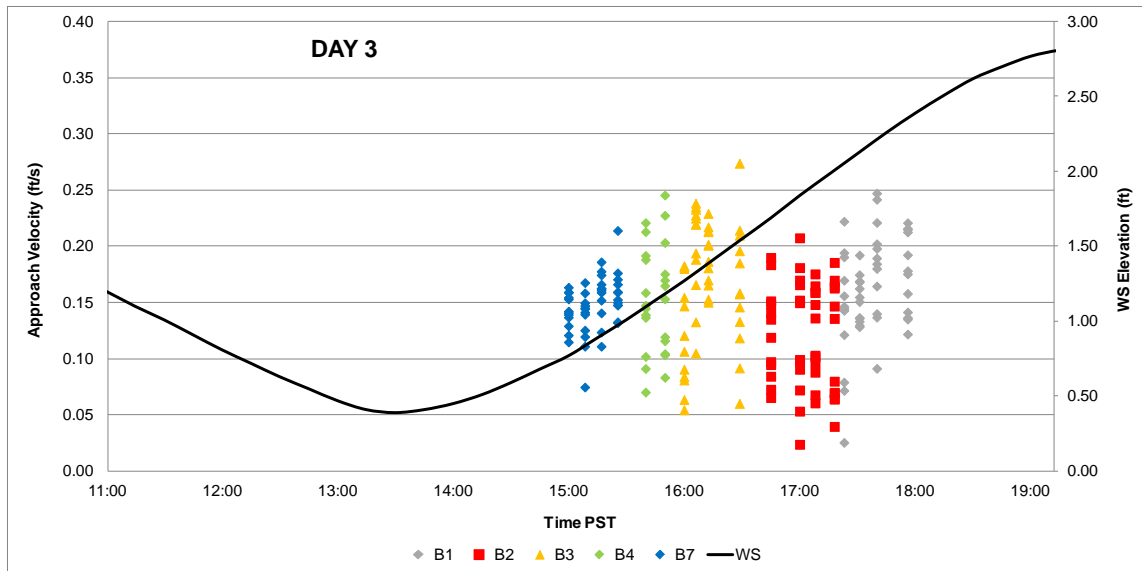
**Figure 10.** Approach velocity and water surface elevation data from Day 3 (October 13, 2011).

Only the 2-probe configuration was used on Day 3. B7 was tested first to confirm results from Days 1 and 2. After B7 velocities were measured, the ADVs were moved to B4 and data were collected upstream to B1. The trash rake servicing bays 5-8 was restarted in automatic mode. This approach was taken because some of the upstream bays had not yet been measured during the highest flow with clean screens. Debris on the screens was not visually apparent until about 18:00 near the end of the test period. As a result, approach velocity data from Day 3 are much more uniform than the previous two days as shown in figure 10.
