Hydraulic Laboratory Technical Memorandum PAP-1068

Preliminary Water Savings Verification Results for Florida Farmers Ditch Company Canal Lining Project

September 2012

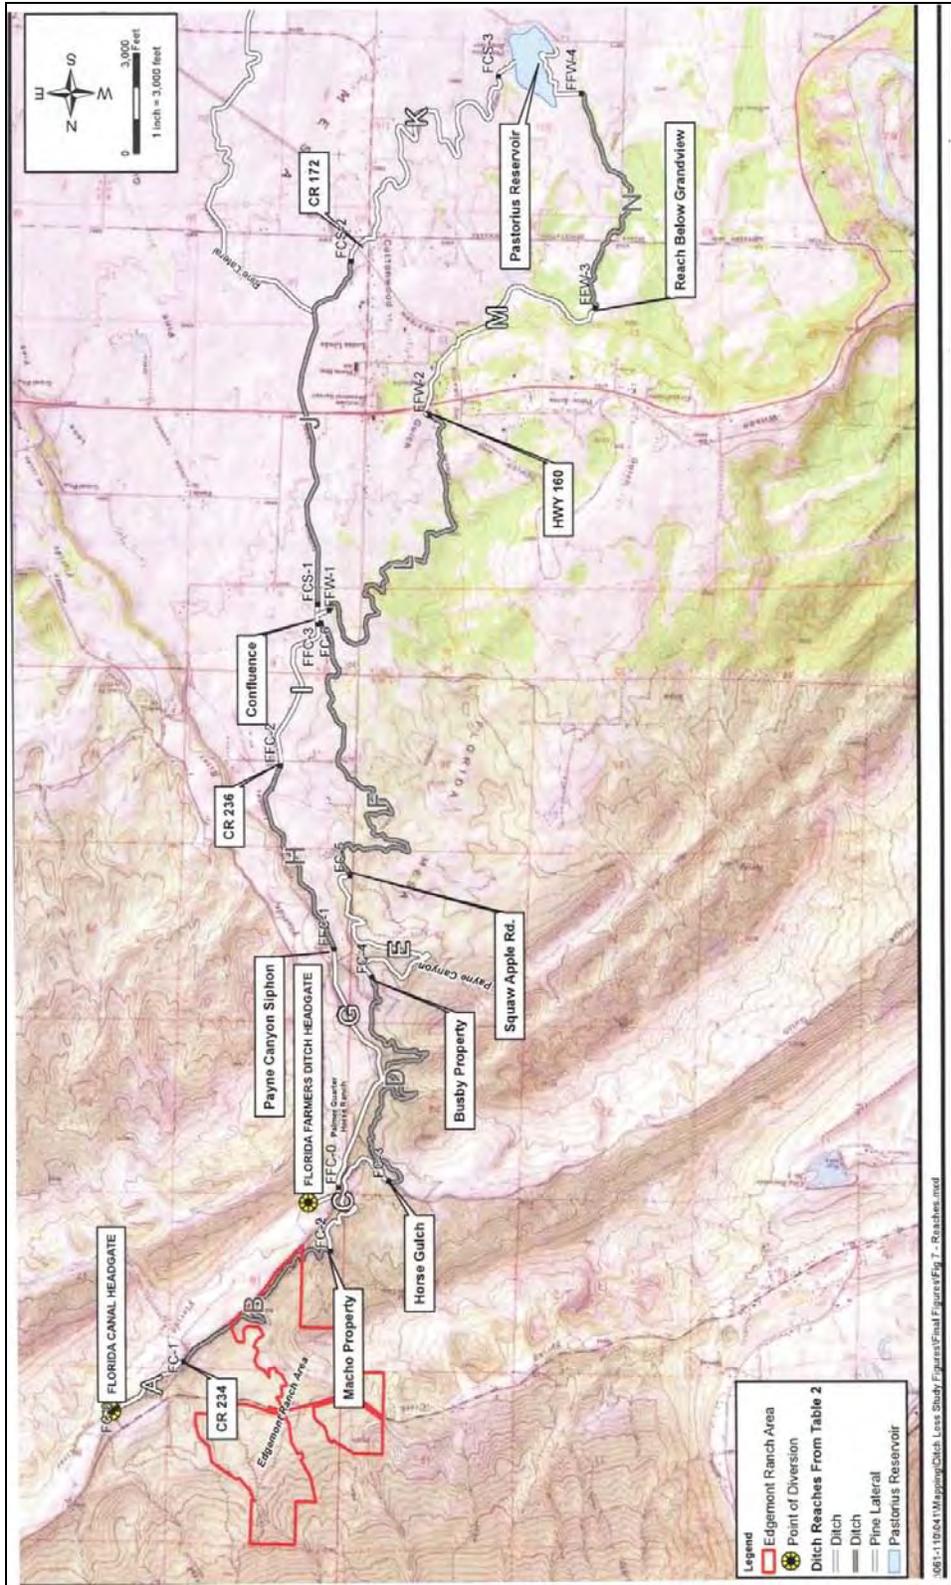
Figure 1. Map of Florida Farmers Ditch and key project locations (WWE 2009)

The plan for water savings verification consists of pre- and post-project inflow/outflow measurements to estimate pre- and post-lining seepage from the to-be-lined Florida Farmers Ditch section. Two sets of measurements were to be taken (early and late season) using two or more types of acoustic Doppler current profiler devices. Proposed measurement locations are near the canal's diversion point and liner terminus (designated as Reach G by WWE), and at operational turnouts within the to-be-lined section.

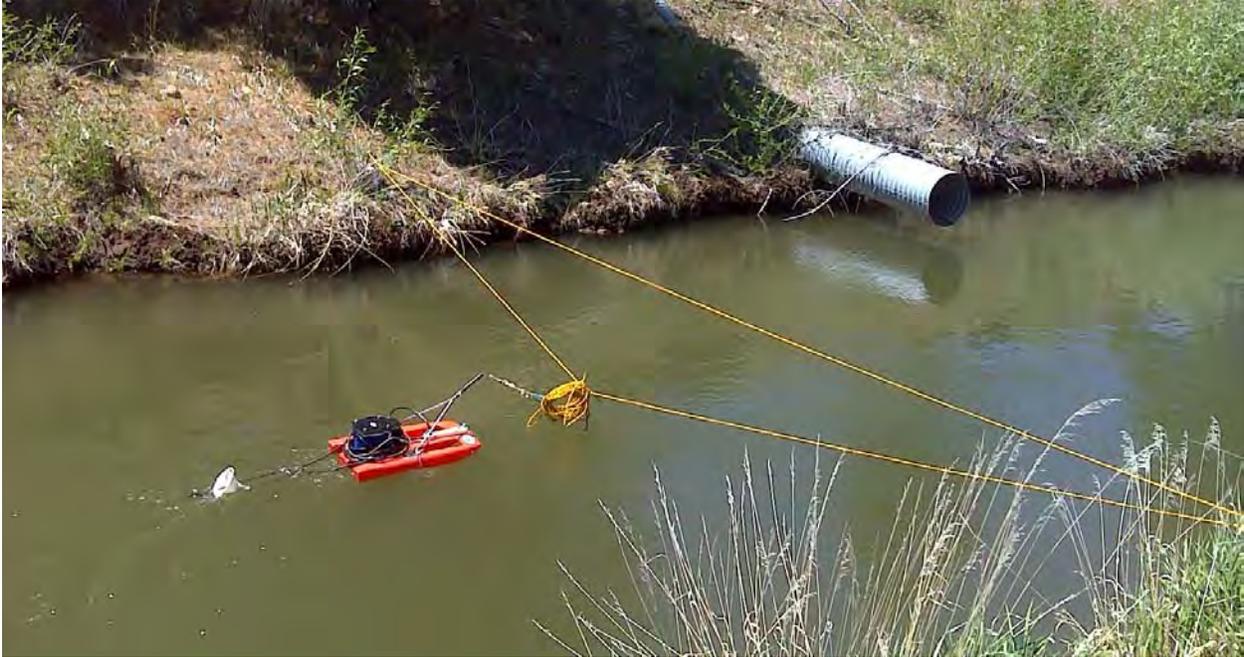
The first flow measurement location was at the downstream end of the canal lining project, located just upstream from the Payne Canyon Siphon (Figure 2). This site was located about 180 feet upstream from the siphon entrance and 300 feet downstream from the nearest bend in the canal alignment. The site was free of aquatic vegetation and the cross section was relatively uniform with a mean depth of about 3.2 feet. A moving-bed test did not detect any bed sediment transport which could compromise the discharge measurements. Flows were measured with a portable Teledyne/RD Instruments Streampro acoustic Doppler current profiler (Figure 2). A total of 12 Streampro discharge measurement transects (passes across the channel) were made and the results are summarized in Table 1. The average flow was 172.9 cubic feet per second (cfs) with a standard deviation of ± 4.2 cfs. The range of discharge measurements was 165 to 180 cfs.

Figure 2. Photograph of the flow measurement cross section upstream from the Payne Canyon Siphon (flow is from right to left). The Teledyne/RDI Streampro and tagline were temporarily installed for this flow measurement.

The second flow measurement was at the same location used on May 29, 2012 (Figure 2). This site was located about 370 ft upstream from the 10-ft concrete Parshall Flume that measures the Florida Farmers Ditch diversion. The water was clear enough to see the bottom, which was primarily sand and gravel. The site was still free from any significant aquatic vegetation and the cross section was relatively uniform with a mean depth of depth about 2.8 ft. A moving-bed test did not detect any bed sediment transport.

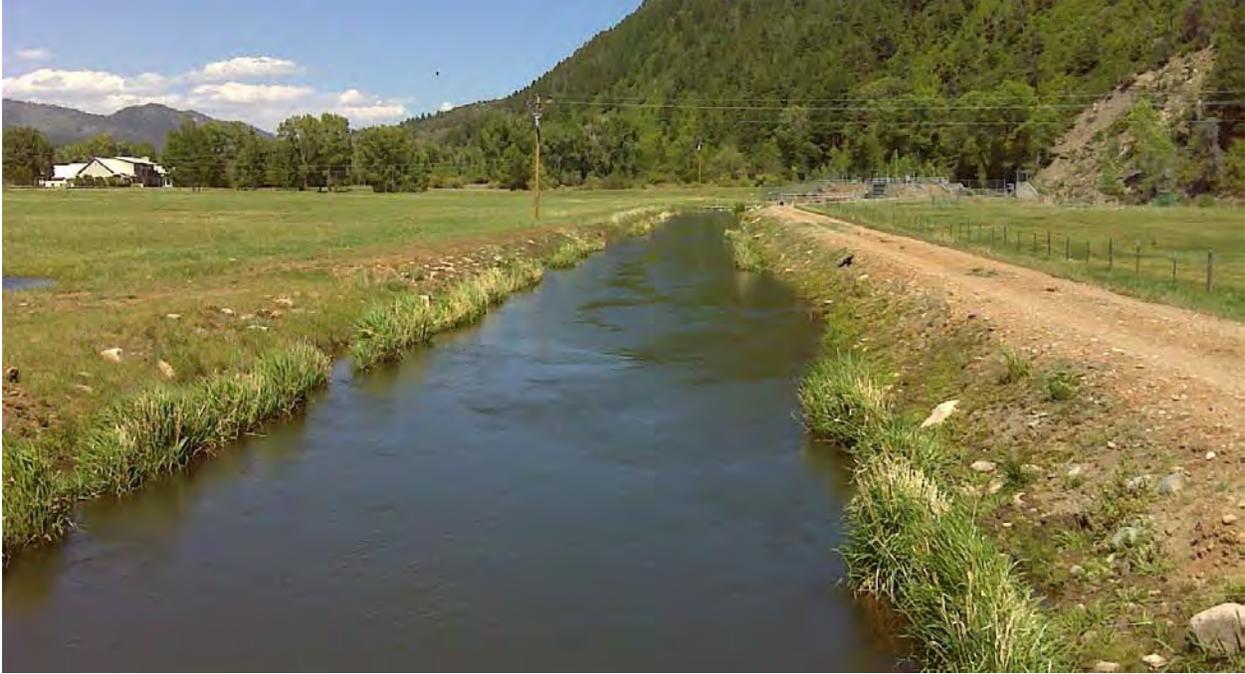
The second flow measurement location was upstream from the start of the canal lining project, located just downstream from a wood bridge (Figure 3). This site was located about 370 feet upstream from the 10-ft concrete Parshall Flume that measures the Florida Farmers Ditch diversion. The Colorado Division of Water Resources maintains a gaging station at this flume (see figure 4). The gaging station is about 1,000 feet below the head gate on the Florida River. The ditch upstream is straight and has a relatively uniform cross section (figure 4). The site was free from any significant aquatic vegetation and the cross section was relatively uniform with a mean depth of about 3.3 feet. A moving-bed test did not detect any bed sediment transport at the time of this flow measurement.

Figure 3. Photograph looking upstream from the wood bridge crossing the Florida Farmers Ditch above the flow measurement site.

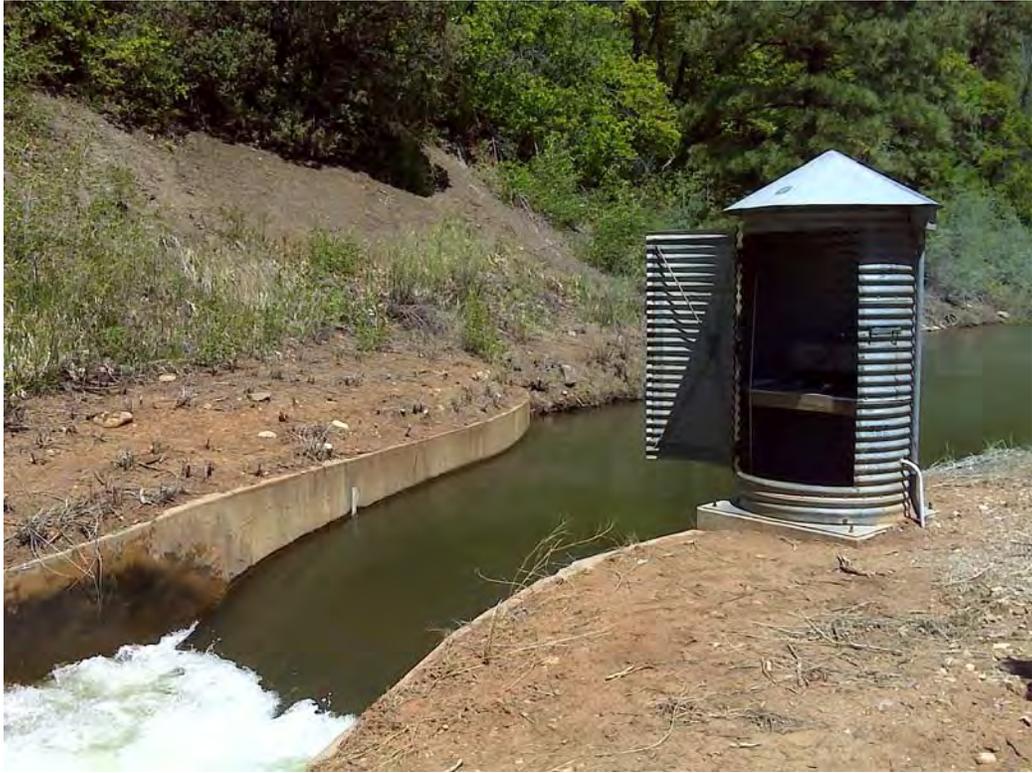
Discharge measurements, using a Streampro, were collected from 3:00 to 3:10 pm. A total of 8 discharge measurement transects (passes across the channel) were made and the average flow was 180.1 cfs with a standard deviation of ± 2.6 cfs (Table 2). The range of Streampro discharge measurements was 176 to 184 cfs. The discharge from the Colorado Division of Water Resources gaging station (FARMERCO) was reported to be 178 cfs at 3:00 and 3:15 p.m. The difference between the measured and reported discharge is 1.1 percent, which is well within the uncertainty range of both flow measurements. A review of the FARMERCO discharge records showed the flow was steady at 177 to 179 cfs for 24 hours prior to the Streampro measurements.

Figure 4. Photograph of 10-ft concrete Parshall Flume and water stage recorder used to monitor Florida Farmers Ditch diversions (DWR Site: FARMERCO).

The close agreement between Streampro measurements and the flow measured using the 10-ft Parshall Flume (FARMERCO) creates confidence in both the flume's calibration and the Streampro's performance. For 2013 seepage measurements, the 10-ft Parshall Flume can be used to determine the Florida Farmers Ditch diversion flow.

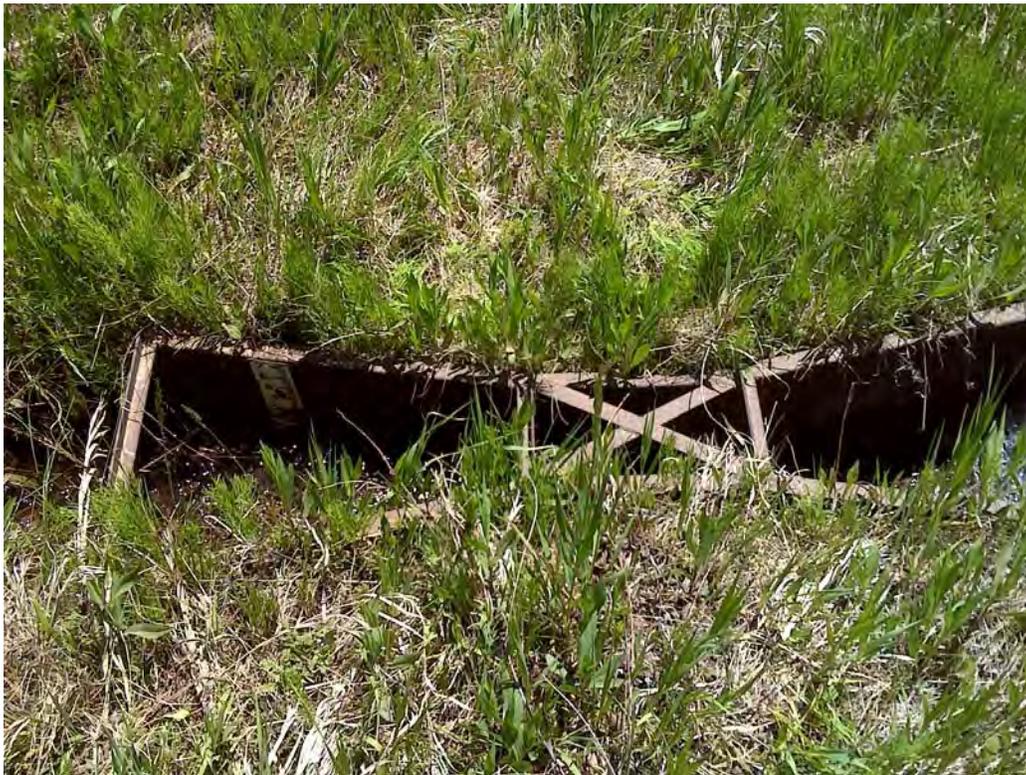
During the May 29, 2012 flow measurements, Mr. Vermeyen visited two small turnouts along Reach G. The turnout near the Horse Gulch siphon was delivering 0.25 cfs according to the 6-in Parshall Flume (figure 5). A field measurement was not taken because measurement of the low flow in the undefined channel would have been less accurate than the flume measurement. There was a second turnout near the Payne Canyon siphon, but it was shut-off during these flow measurements. The condition of these Florida Farmer Ditch flow measurement flumes were documented in a WWE report (WWE, May 4, 2012).

Figure 5. Photograph of 6-in Parshall Flume on Farmers Florida Ditch diversion near the Horse Gulch siphon, N37.28947° W107.79643°.

The repairs to the two 6-inch Parshall Flumes measuring turnout flows near the Horse Gulch and Payne Canyon siphons recommended by WWE (2010), should be completed prior to the 2013 seepage tests.

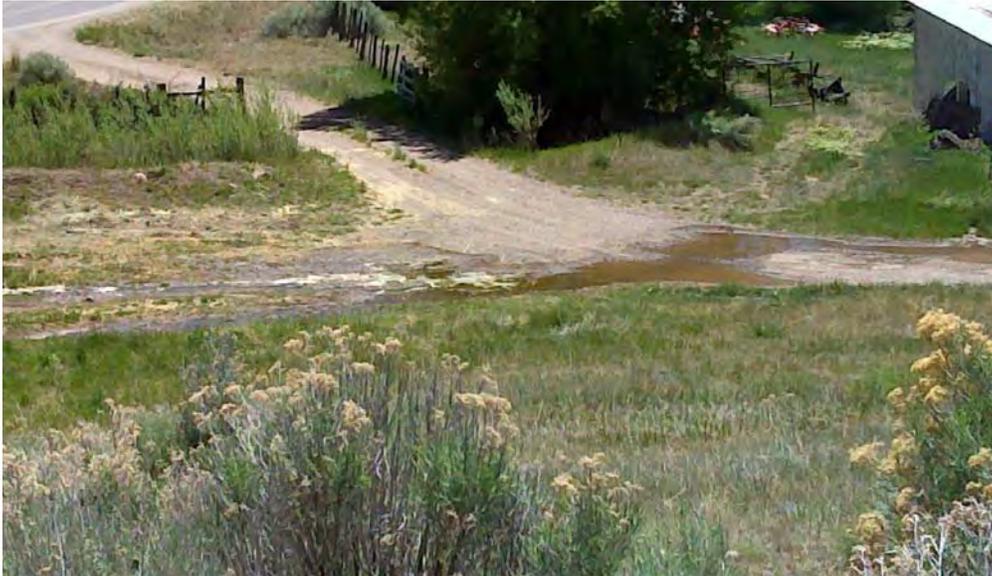
On May 29, 2012, Mr. McCoy took Mr. Vermeyen to an area of significant seepage from the Florida Farmers Ditch. The seepage site is located about 0.4 miles downstream from the gaging station. Figure 6 is a photograph of the seepage area located between the ditch and CO Rd 234. According to Mr. McCoy, this seepage was typical for this relatively high flow in the ditch.

Figure 6. Photograph of canal seepage from the Florida Farmers Ditch near N37.28796° W107.79712°.

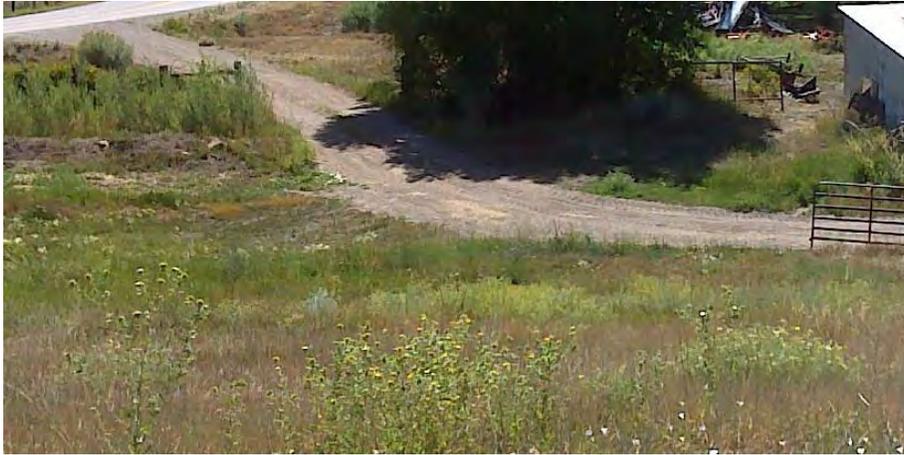
The seepage site that was observed on May 31, 2012 (figure 6) was observed to be dry on July 31, 2012. Figure 7 is a photograph of the dry seepage area.

Figure 7. July 31, 2012 photograph of the same canal seepage area from May 29, 2012 (shown in figure 6) that had dried up, N37.28796° W107.79712°.
