Hydraulic Laboratory Technical Memorandum PAP-1071

Canal Lining Drawdown Tests and Development of New Drawdown Criteria for the Charles Hansen Feeder Canal

Colorado-Big Thompson Project

December 2012

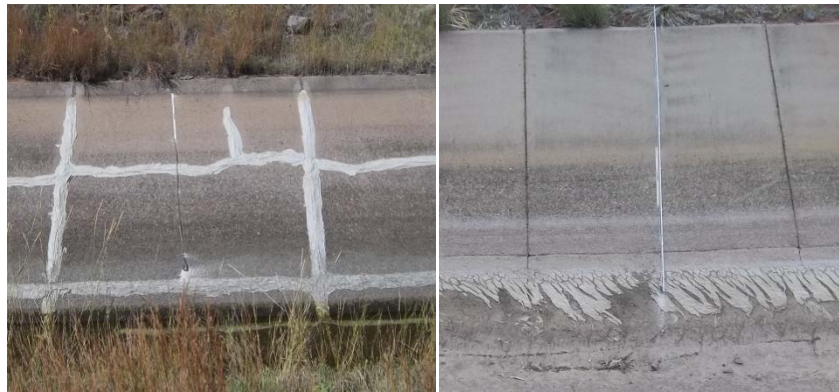
Figure 1 shows examples of the piezometer installations in the two canal sections. A notable difference in the canal conditions was that the 550 section has had cracks heavily patched with Sikaflex caulking over most of the length of the canal. Most of the 930 section was less cracked, and only a few short reaches have had cracks patched. In the 930 section we did encounter several canal panels that had been replaced in recent years (since 1988 judging by dates scratched into the concrete surface) and were apparently much thicker than the original design specification (4 inches), since we were unable to drill a hole completely through the lining into the soil. When this occurred, we tried to select a new panel nearby that was older (original in many cases).

Figure 1. — Piezometer installations in the 550 section (left) and 930 section (right).

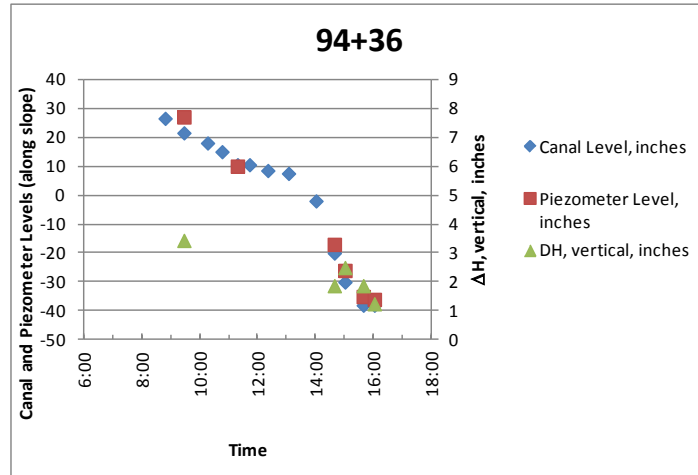
Testing of the 550 section took place on Tuesday, October 11, 2011, eleven days after refilling of the canal began. Three drawdowns of the canal were made, the first two in the morning targeted to be approximately 6 inches vertical, and the last targeted to be approximately 12 inches vertical. Although the changes were made in steps, attenuation of the flow change caused the actual drawdowns to be relatively gradual in nature throughout the day. The actual drawdown amounts varied along the canal due to backwater effects and were much larger in magnitude than the target value at some locations. Examples are shown in Figure 2 for the piezometer at approximate station 94+36 near the upstream end of the 550 section, and in Figure 3 for a station at the downstream end of the 550 section. From the start of the test to about 1:00 p.m. the drawdown was about 20 inches along the slope or 12.5 inches vertical (divide by 1.6 to convert slope distances to vertical, or multiply by 1.6 to convert vertical distance to slope distance). From 1:00 p.m. to 3:45 p.m. the drop at the upstream station was about 48 inches on the slope, or 30 inches vertical. At the downstream station the second drop was about 25 inches along the slope, or 16 inches vertical.

Figure 2. — Canal and piezometer levels during the drawdown test of the 550 section. This piezometer is located near the upstream end of the 550 section. DH is the vertical distance between the piezometer level and the canal level as displayed on the secondary y-axis (right). Piezometer levels were not visible (below the canal water surface) for most of the time from 10:00 a.m. to 2:00 p.m. Hence, there is no DH value shown at 11:15 a.m., because the value was negative and the secondary y axis is configured to show only positive values, which are of primary interest for this study.

Figures 2 through 4 show the highest pore water pressures recorded during the 550 test. Most piezometers in the 550 test indicated that pore water pressure behind the canal lining responds relatively rapidly to canal drawdown, or that the pressure behind the lining is always less than the canal level. The stations labeled 94+36 and 109+60 exhibited differential head behind the lining of about 3 inches of water or less under a sustained drawdown of about 11 inches per hour (vertical).

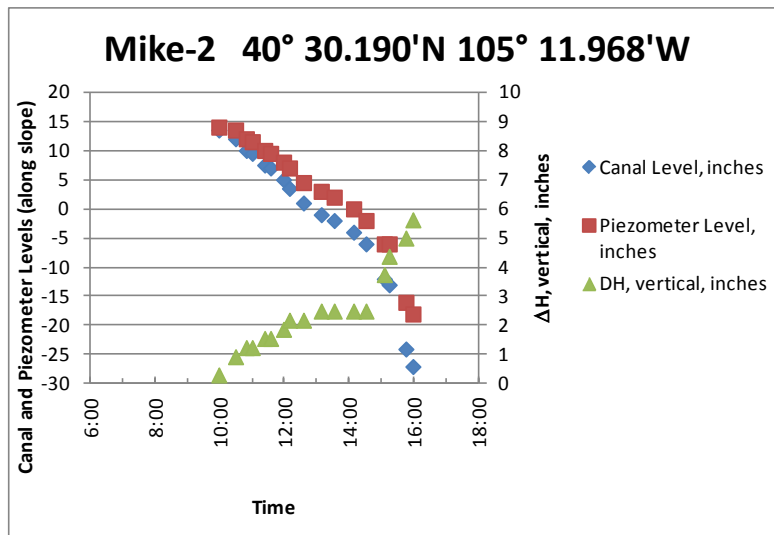
Figure 3. — Canal and piezometer levels at a section near the downstream end of the 550 section. This piezometer recorded the highest differential heads behind the lining of any piezometer during the 550 test.

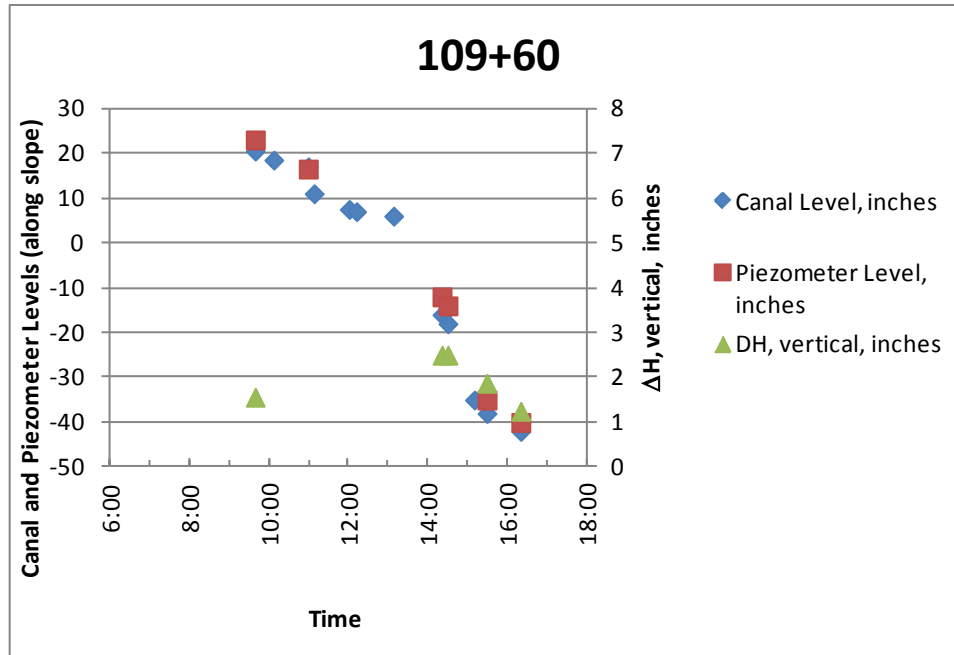
Figure 4 shows the third useful piezometer with significant positive pressures behind the canal lining. (Figure 2 and Figure 3 showed the other two such piezometers). This site was near the 94+36 station shown in Figure 2, and experienced similar drawdown conditions during the tests.

Figure 4. — Piezometer in upstream reach of the 550 section. No DH is shown at 11:00 because the value at this time was slightly negative.

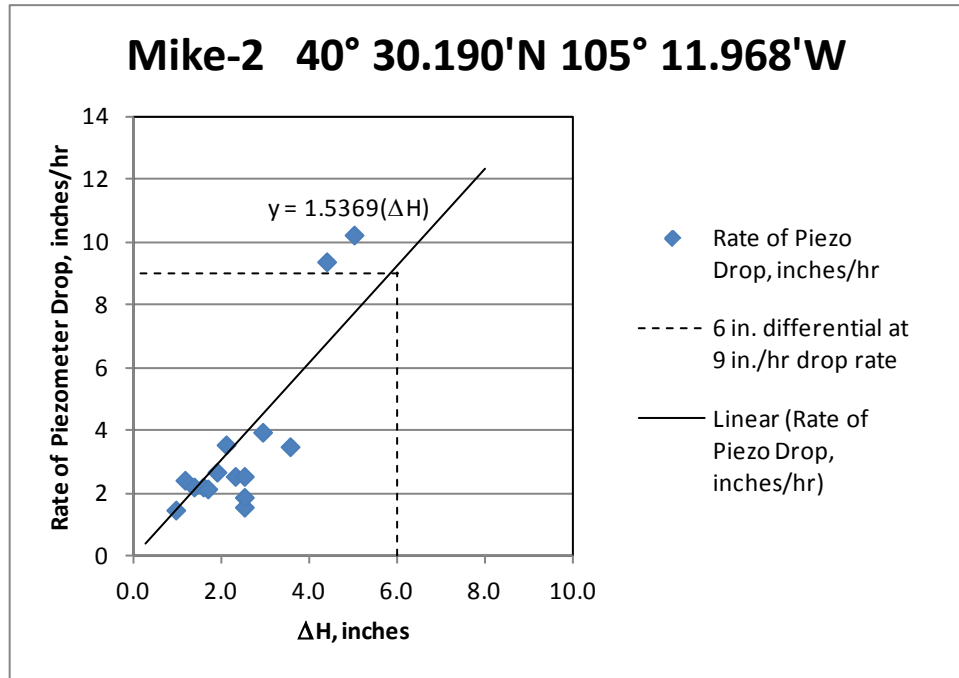
in piezometer level as a function of the differential head across the lining. The y-axis positioning of the top two points (between 9 and 11 inches/hr) indicates that the rate of piezometer drop began to approximate the rate of canal stage drawdown (9 inches/hr), so this test was probably approaching equilibrium when monitoring was stopped. The corresponding differential head across the canal boundary was between 4 and 5 inches. A linear trendline fitted to all of the data gives a conservative estimate that a sustained differential head of 6 inches and corresponding piezometer drawdown rate of 9 inches/hr would have developed at this location, given a sustained canal stage drawdown rate of 9 inches/hr.

Figure 5. — Correlation between differential head across the lining and the rate of piezometer pressure drop.

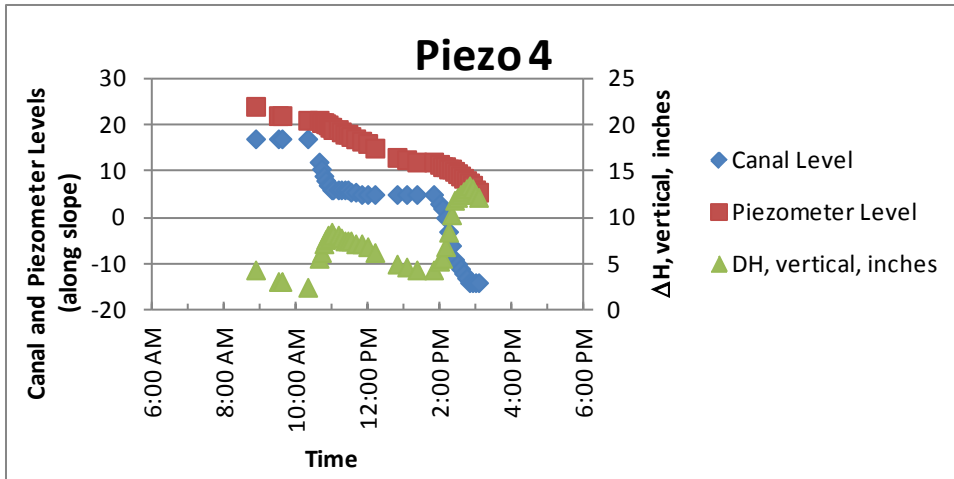
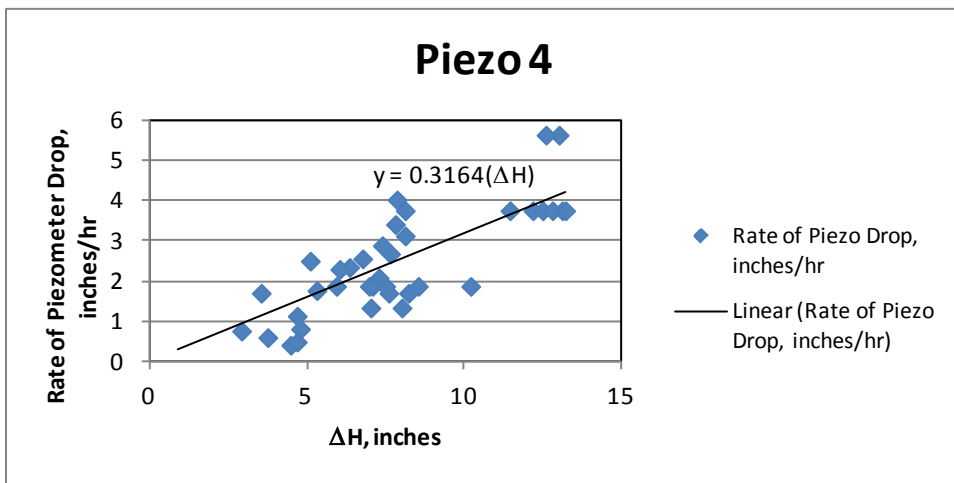
Figure 6. — Piezometer observations at station Piezo 4 during the 930 test.

Piezo 4 — This piezometer showed that the first two drawdowns produced differential heads that dissipated from 7.5 inches back toward levels of 2 to 4 inches before the next drawdown started. The third drawdown produced a differential head of about 12.5 inches that was beginning to dissipate when monitoring ended. There was a roughly linear relation between the rate of pressure drop behind the lining and the differential head across the lining.

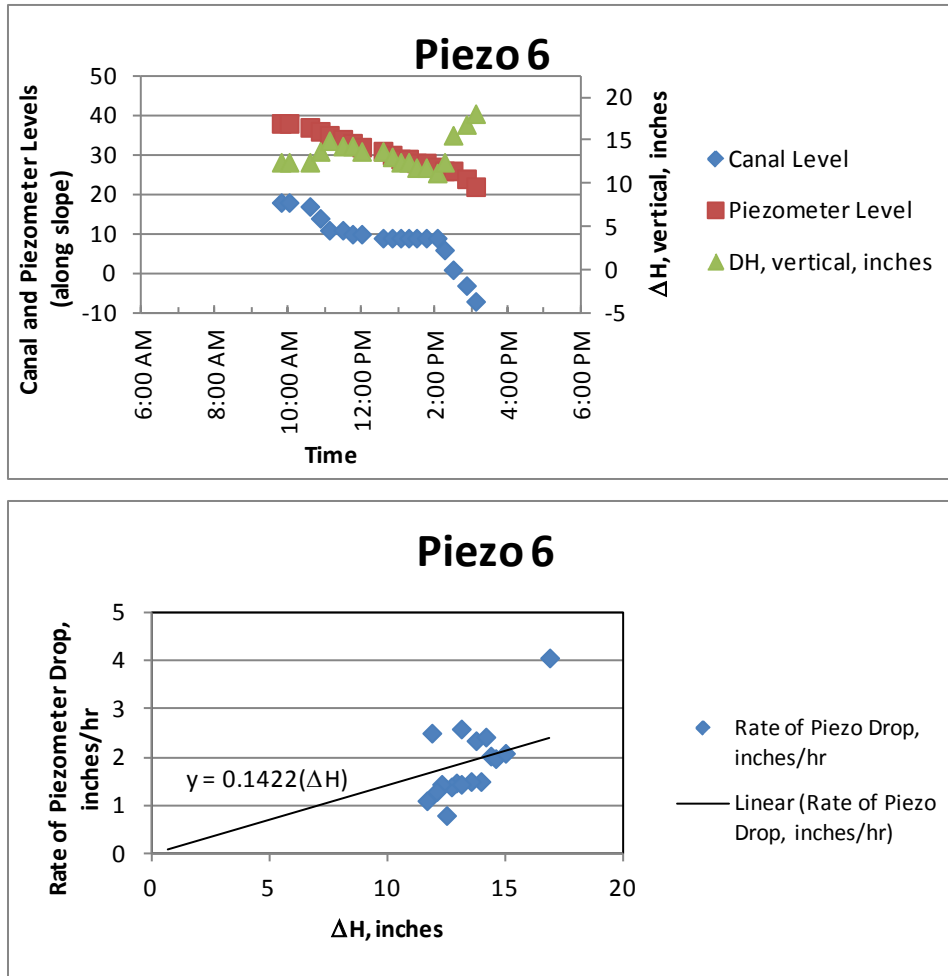
Figure 7. — Piezometer observations at station Piezo 6 during the 930 test.

Piezo 6 — This piezometer acted partially plugged when first charged with dye at the start of the day. The water level was at the canal level when dye was first added and enough dye was injected to raise the piezometer to about 12 inches above the canal level. The piezometer then began to decline slowly. This piezometer was not monitored for most of the first drawdown period. Prior to the initiation of the second drawdown, the piezometer was still higher than the original canal level. When the second drawdown began, the canal dropped about 4 inches vertical in 30 minutes, and the piezometer level continued dropping steadily at the same rate as before. When the third drawdown began, the rate of piezometer level decline increased, indicating a connection between the piezometer behavior and the canal level. The coefficient relating the rate of piezometer decline and the differential head was about half of the value obtained at Piezo 4. The maximum differential head was about 17 inches vertical, but it should be kept in mind that the piezometer pressures measured through most of the test were artificially inflated; adding dye to the piezometer tube raised the piezometer reading above the original canal steady state level and the original piezometer level, and the piezometer was draining back toward the initial steady state for most of the day.

Existing drawdown criteria for the Charles Hansen Feeder Canal allow a drawdown of 6 inches in the first hour, and a second step change of 6 inches can be made after one hour has elapsed (not to exceed 12 inches in 24 hours). This drawdown schedule will produce a differential head of 6 inches immediately following the first change, and using the pressure dissipation rate observed in Piezo 6, the approximate drop in differential pressure over the one hour following the first 6 inch change would be only $0.1422 \times 6 = 0.85$ inches. When the second change is made, the differential head would increase further to $(6 - 0.85) + 6 = 11.15$ inches. This far exceeds the structural static limits discussed in the previous paragraph. It is also noteworthy that a differential head of about 18 inches was measured at Piezo 6 at the end of the test of the 930 section (Figure 7).

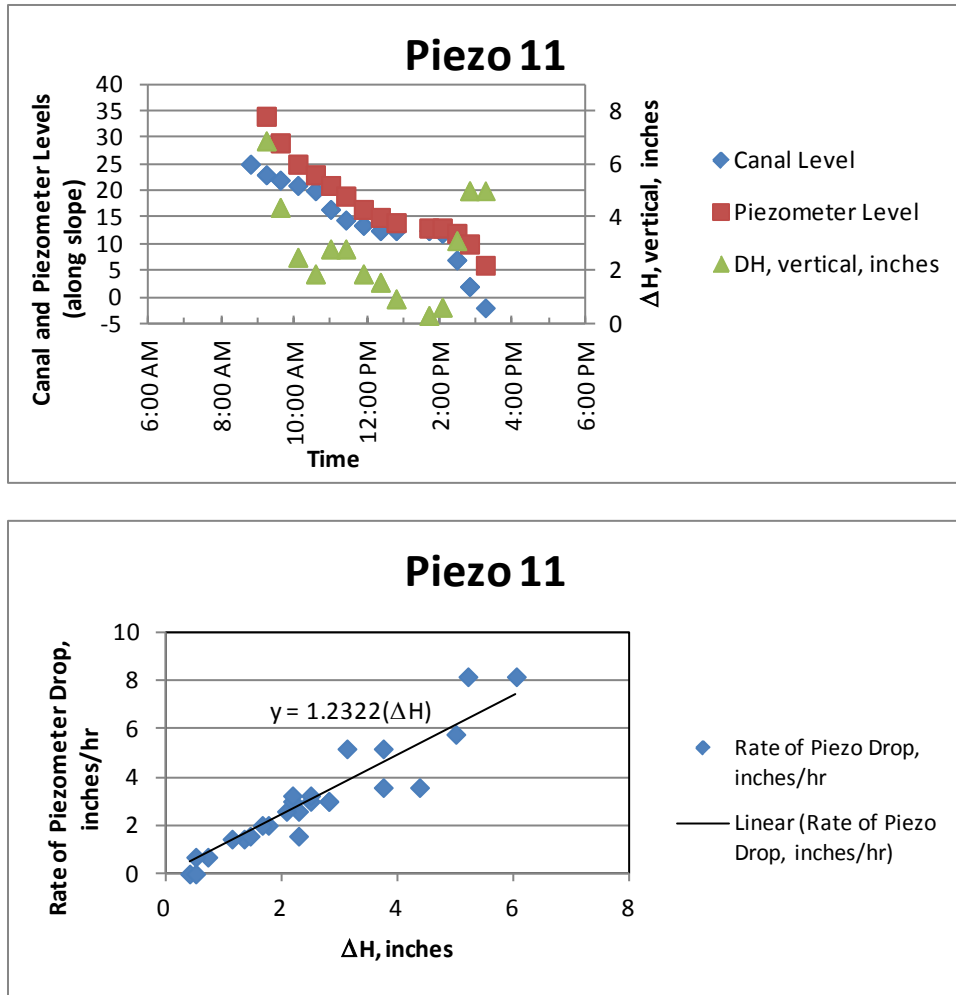
Figure 9. — Piezometer observations at station Piezo 11 during the 930 test.

Piezo 11 — This piezometer was located in the midst of the longest and deepest cut section on the canal. Early readings from this piezometer were distorted by the process of adding dye to the piezometer tube. Like all piezometers, the water level at the start of dye injection was equal to the canal level. After dye was added, the piezometer was registering a level well above the initial canal steady state elevation. Maximum differential heads were recorded during this time when the piezometer reading was above the initial condition. By the time that the second drawdown began to reach this location (just before 11:00 a.m.), the differential head had receded to about 3 inches vertical. The piezometer caught up to the canal before the third drawdown began around 2:00 p.m. During this drawdown the canal dropped at a rate of 7.5 inches/hr, and the differential head behind the lining increased to about 5 inches. The pressure behind the lining was holding steady when monitoring was stopped. The plot of piezometer decline versus differential head was roughly linear, and the coefficient relating the two was relatively large.

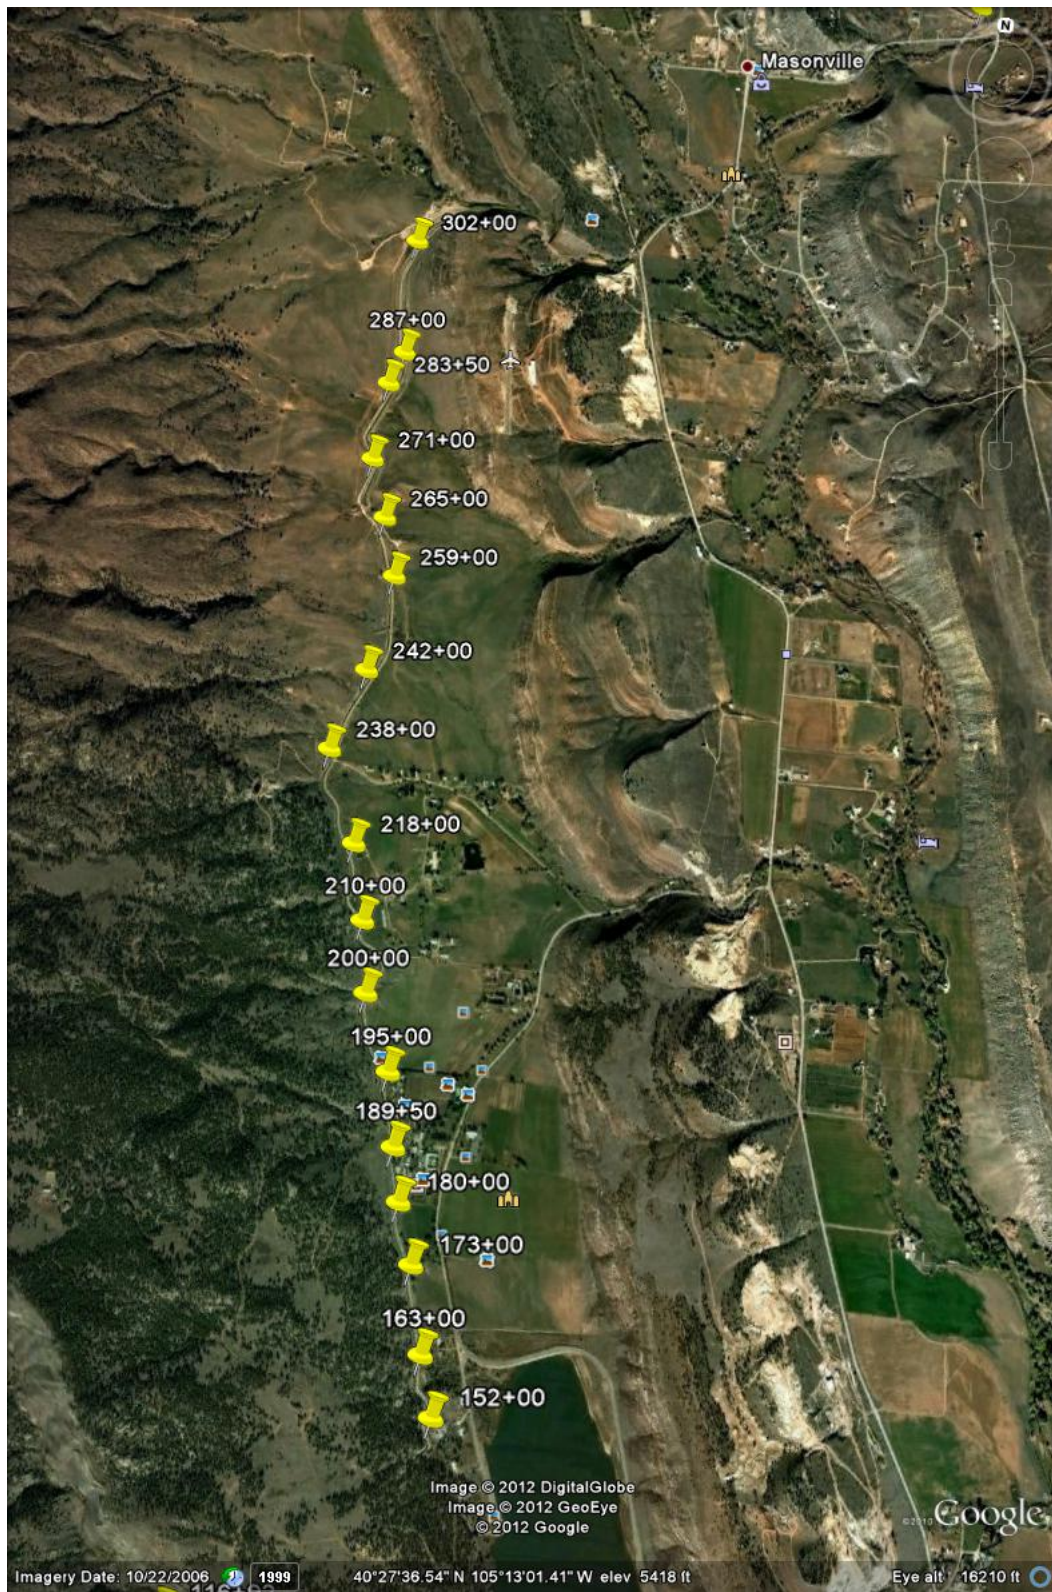
Figure 13. — Detail of piezometers in middle reach of 550 section.

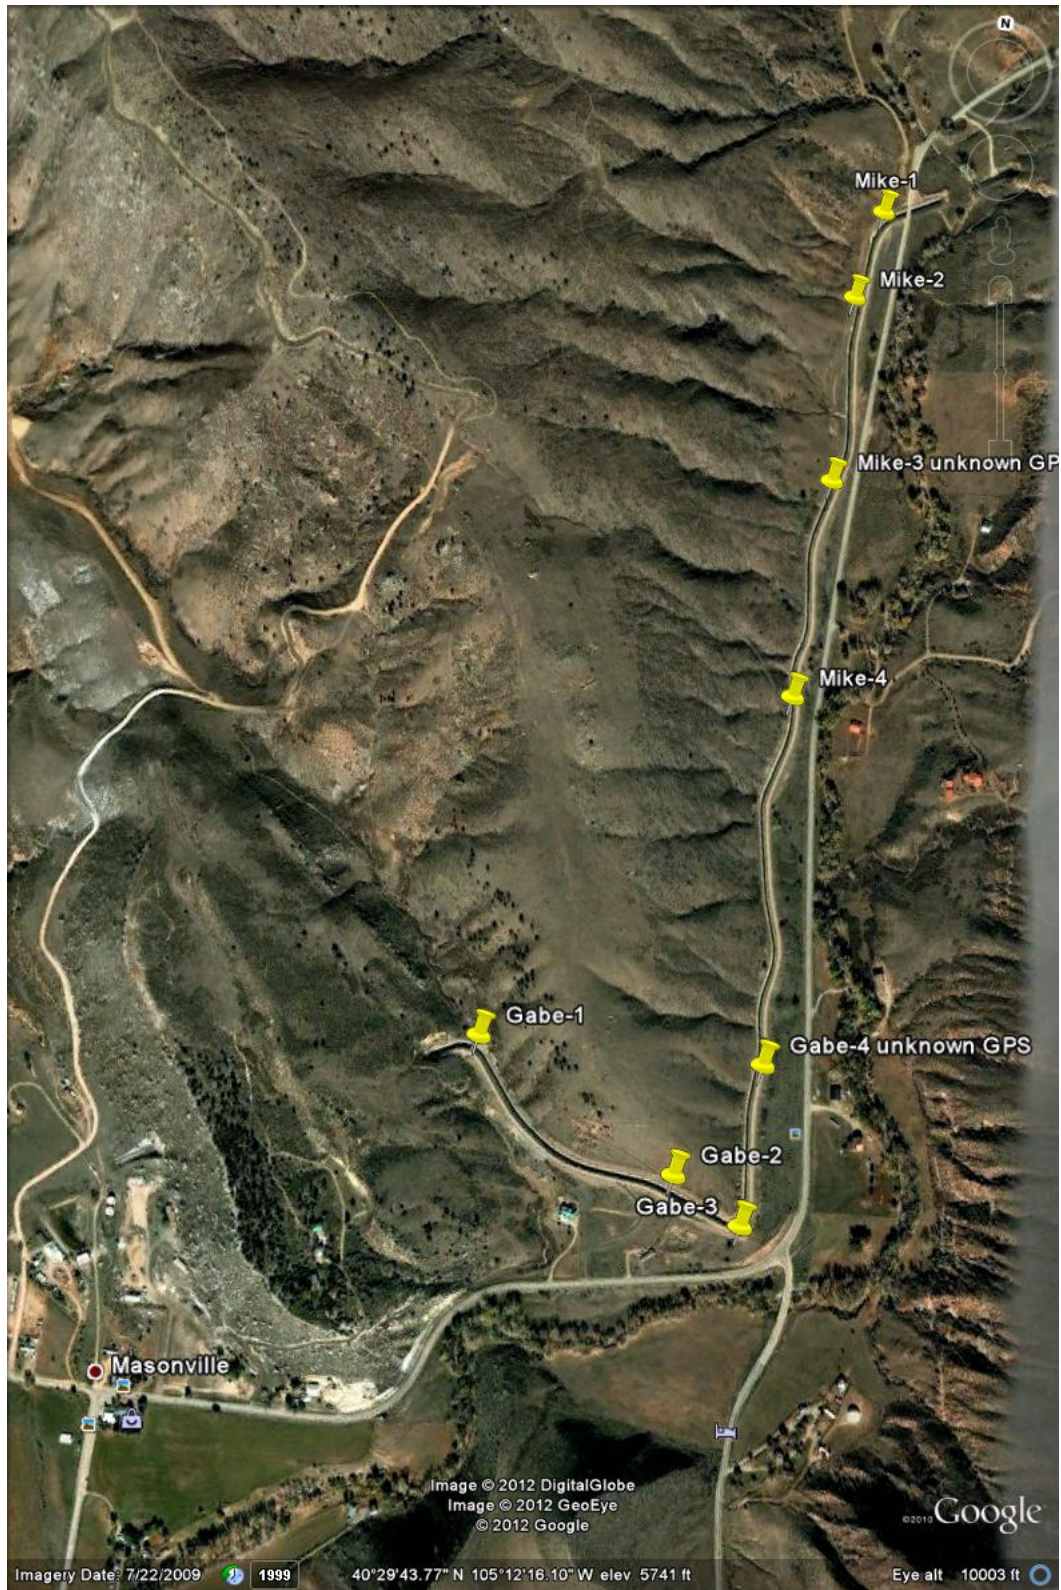
Figure 14. — Detail of piezometers in downstream reach of 550 section.

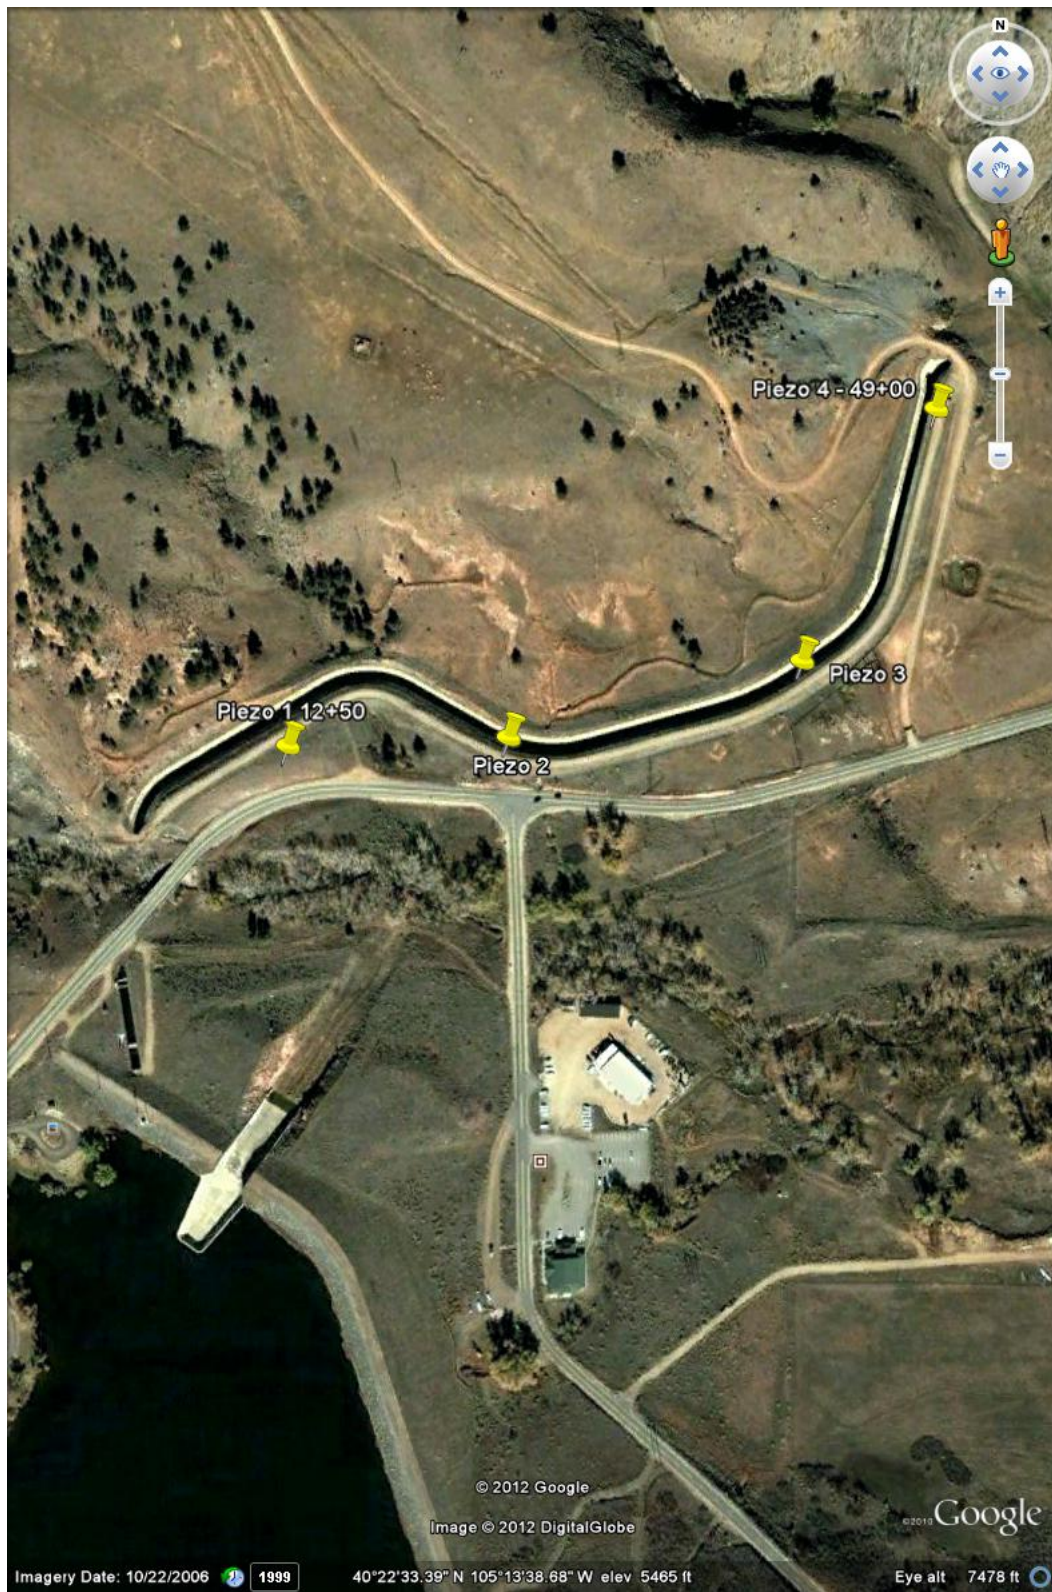
Figure 16. — Detail of piezometers in the 930 section.

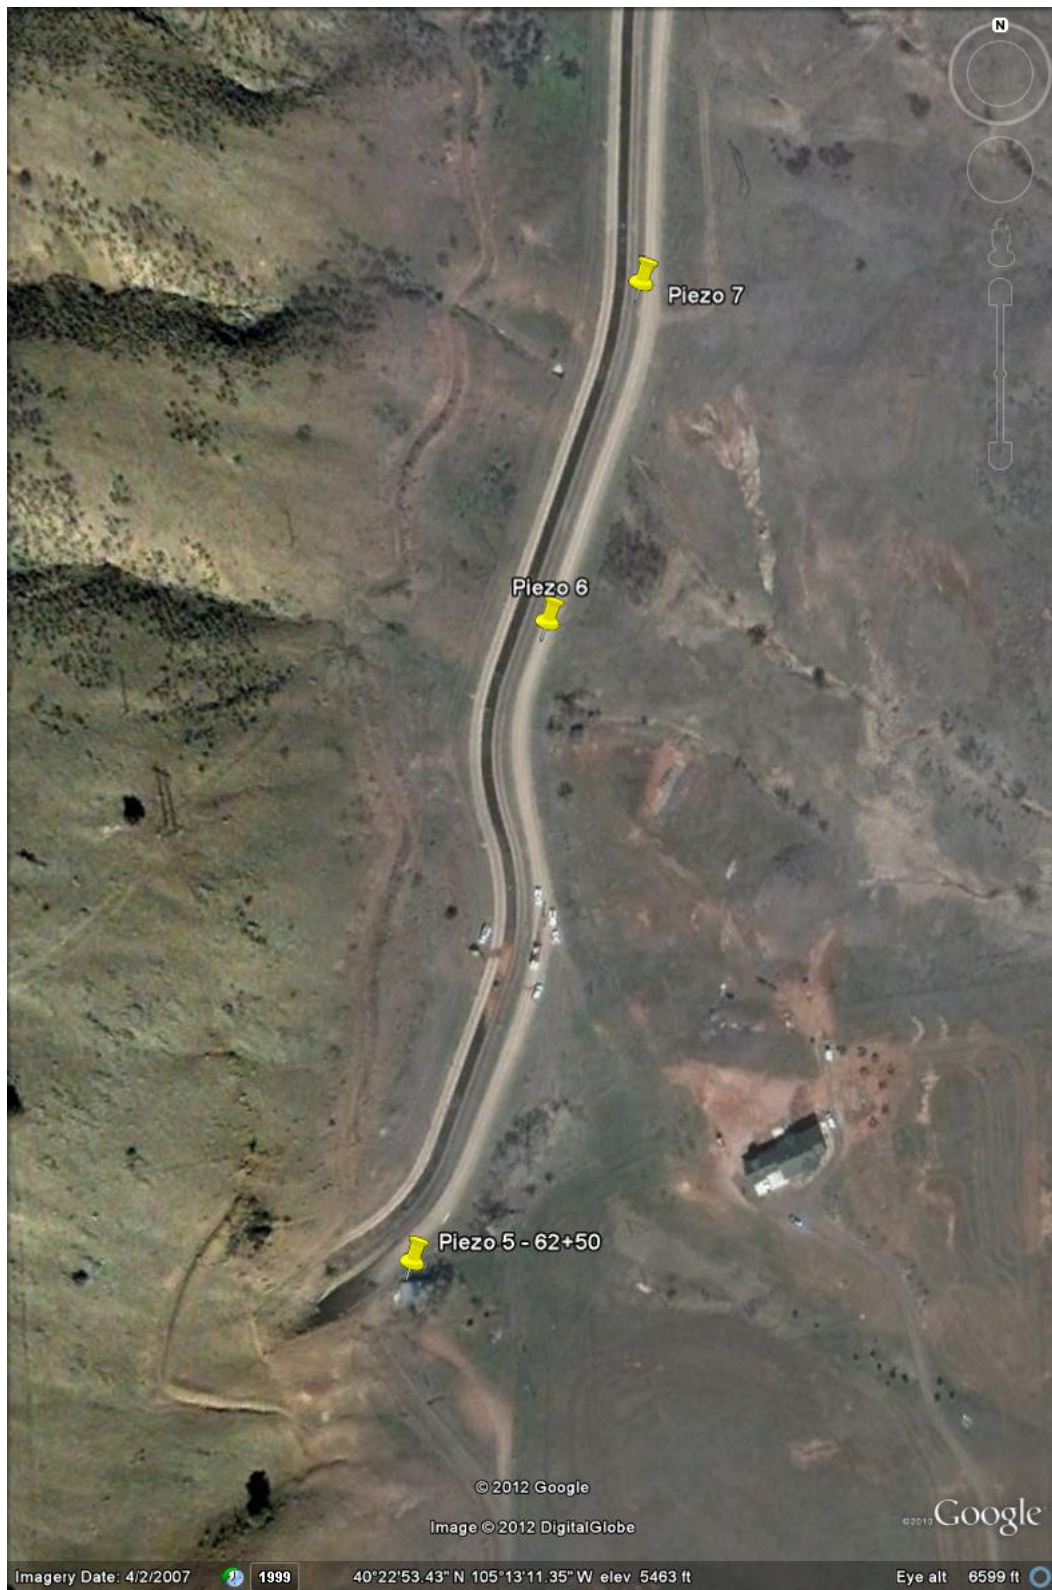
Figure 17. — Detail of piezometers in the 930 section.

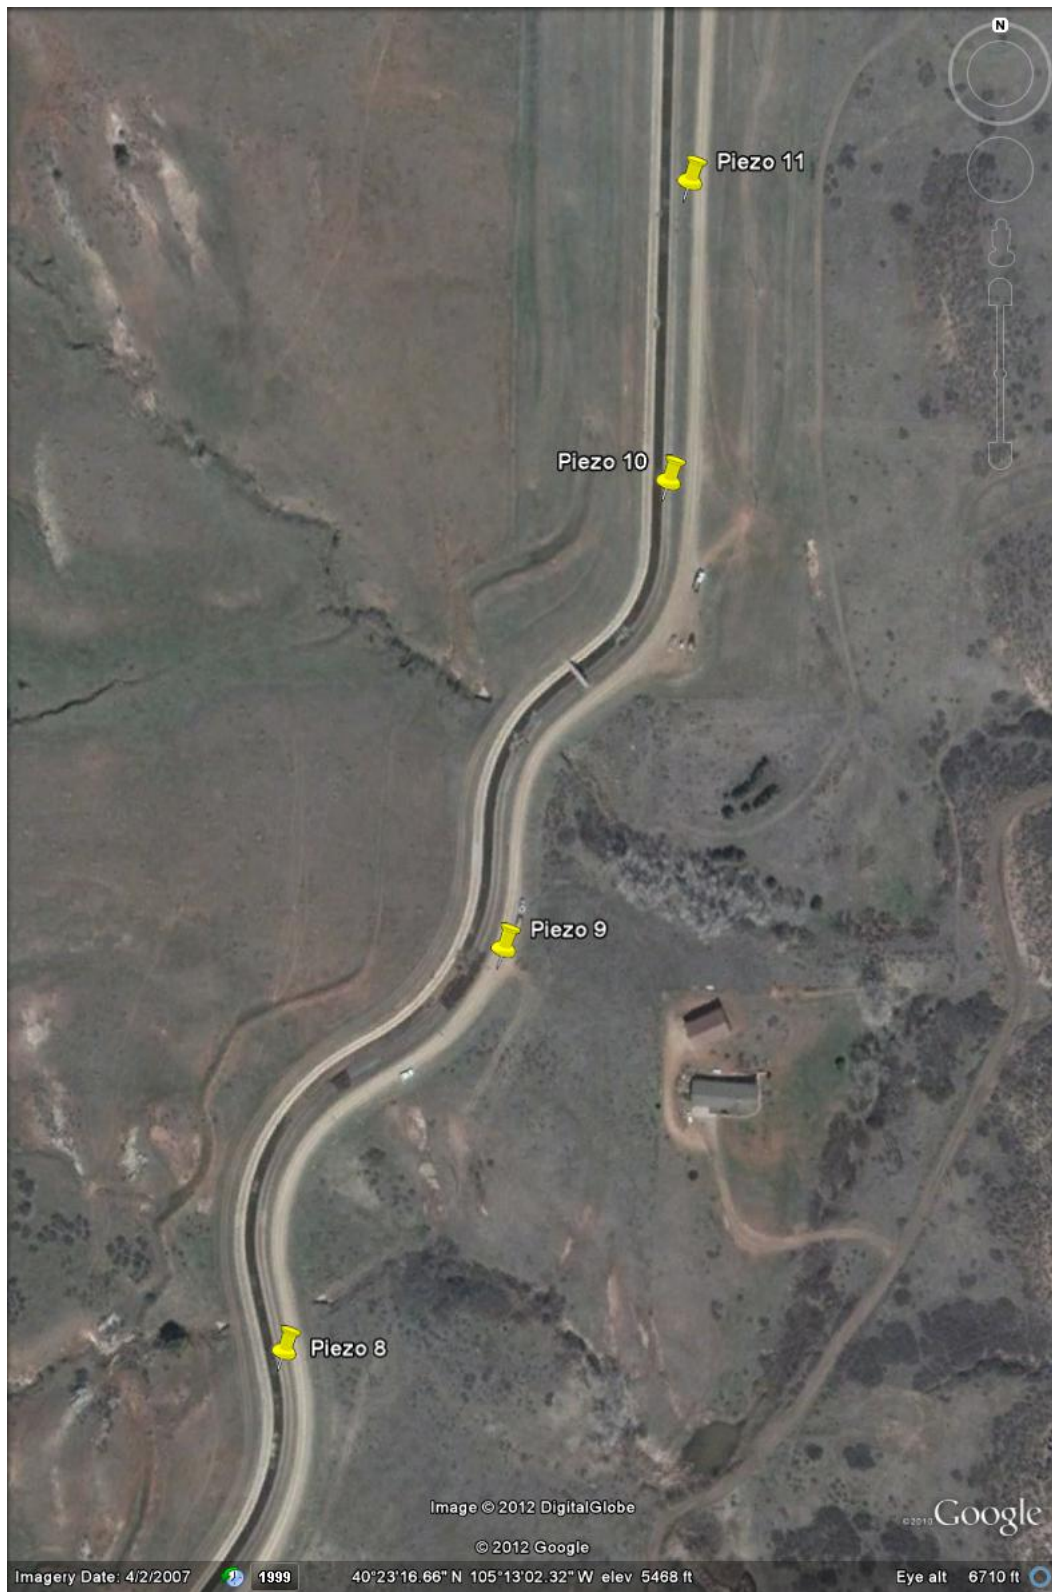
Figure 18. — Detail of piezometers in the 930 section.

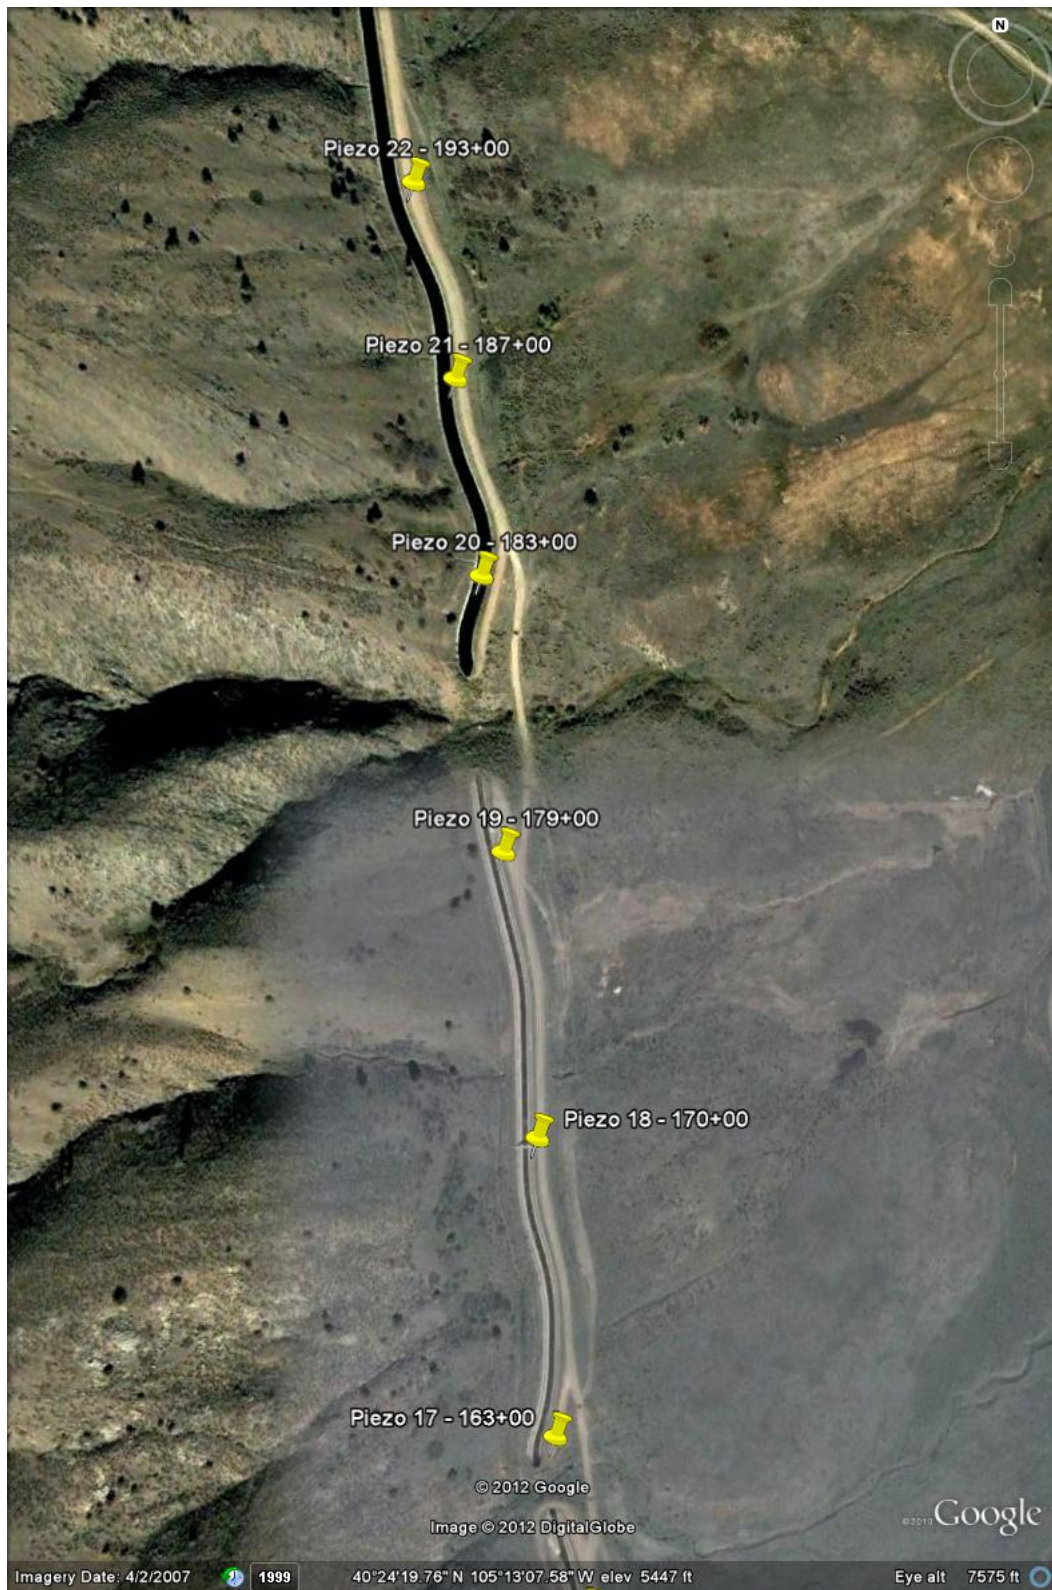
Figure 20. — Detail of piezometers in the 930 section.
