Hydraulic Laboratory Technical Memorandum PAP-1072

## Scanning Sonar Survey Report- Buffalo Bill Dam River Outlet and Powerplant Intakes

Shoshone Project

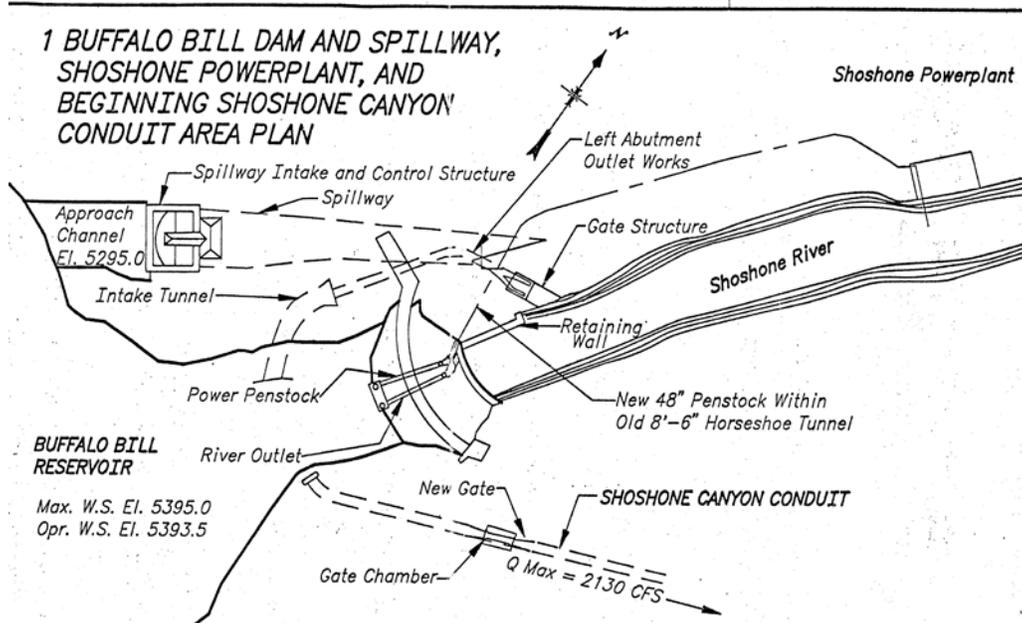
Figure 1. Plan view of Buffalo Bill Dam (Drawing 1458-601-64, Dated May 29,1992)

The intakes to the Shoshone power penstock and the river outlet are located near the upstream toe of the dam (figure 1). Each intake consists of a 28-ft-high intake well with a cylindrical trashrack structure set on top. The intake well was added to the intake to raise the trashrack above accumulated sediment. The trashrack structure consists of a 3.5-ft-high collar, a 6.0-ft-tall trashrack with a 4.0-ft-high cone-shaped lid for a total height of 13.5 ft. The trashrack diameter is 8.3 ft. The lower portion of the trashrack fits inside the 6.3 ft diameter intake well. The trashrack is seated at El. 5158.0 ft. The top of the trashrack is approximately at elevation 5171.5 ft. Note: all dimensions were scaled from figure 2.

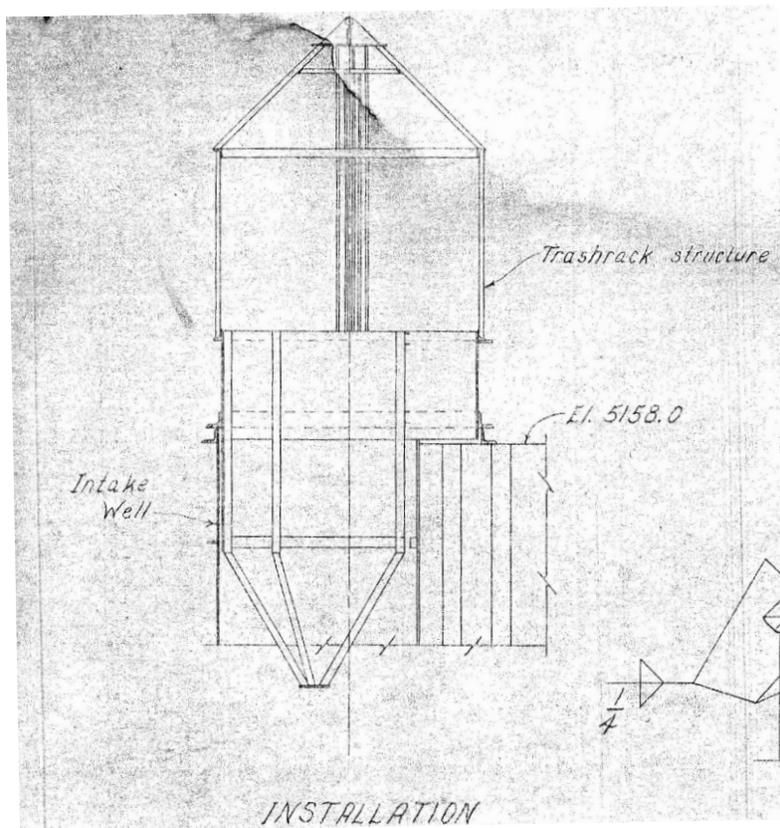
Figure 2. Drawing of trashrack installation detail for penstock and river outlet intakes (Drawing 26-D-2498, 1975).

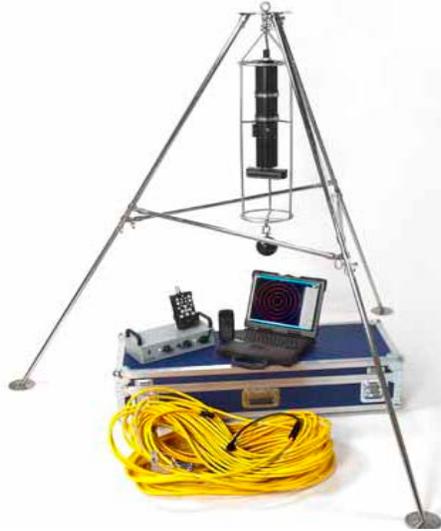
Figure 3. Photograph of a KML MS1000 Scanning Sonar System similar to the one used for this project. (Photo courtesy of Kongsberg-Mesotech Ltd)

A Kongsberg Mesotech MS1000 scanning sonar system (Figure 3) was used for the imaging and profile data collection in the forebay. The MS1000 system with a 675 kHz scanning sonar (Model 1171) was used to collect an accurate two dimensional representation of underwater structural features and detailed bathymetric data. The sonar has a range of 1.5 to 600 ft with a resolution of about 0.06 ft. A detailed specification sheet for the sonar head is included as an appendix to this report.

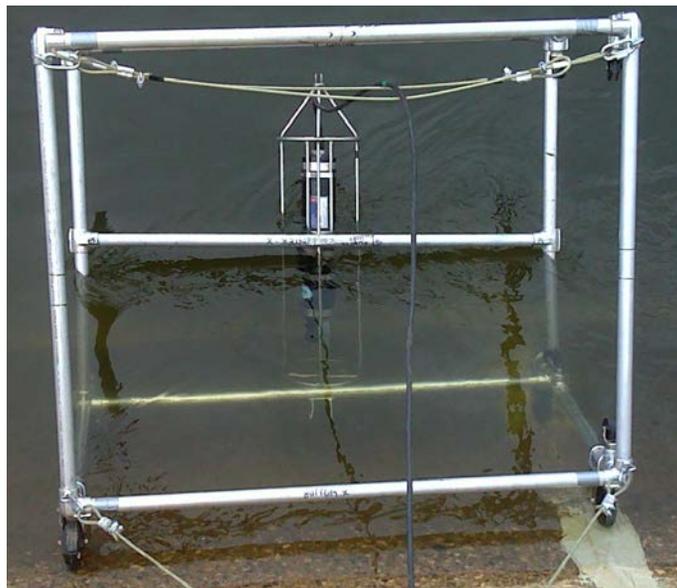
Figure 4. Photograph of cage with sonar mounted so the transducer was oriented perpendicular to image the concrete surface (Note: this photo was not taken at Buffalo Bill Dam).

For sonar imaging, the MS1000 was deployed using a tubular aluminum cage with casters (figures 4 and 5). The sonar was mounted to the cage so that its long-axis was perpendicular to the dam face. The images are produced using a fan-beam transducer with a 30° field of view (FOV). The cage was lowered to several elevations while collecting images of the dam face and the reservoir bottom near the toe of the dam. For the first set of sonar scans, the sonar transducer was offset about 1.5 ft from the upstream face of the dam. A second and third set of sonar images were collected with the transducer offset 4.0 and 8.5 ft upstream from the dam face, respectively. Figure 5 is a photograph of the modified sonar mount used to offset the sonar 8.5 ft from the dam face. The reason for relocating the sonar was to image the upstream face of the penstock intake trashrack. Sonar images were collected at depths of 40, 70, 110, 140, 160, and 190 ft below the water surface.

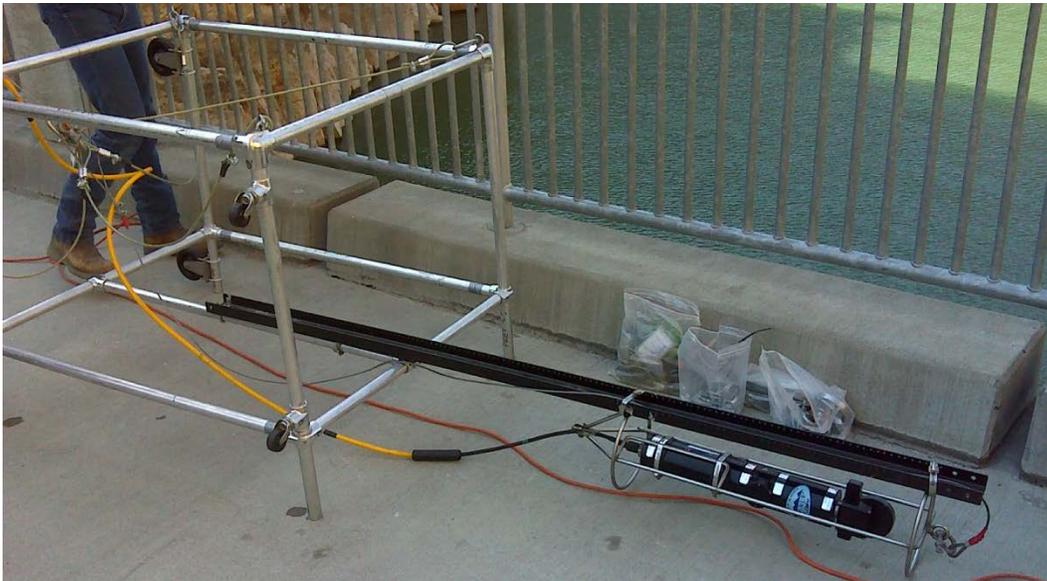
Figure 5. Modified sonar setup used to offset the transducer 8.5 ft from the dam face. This modification was made in an effort to image the upstream face of the trashrack.

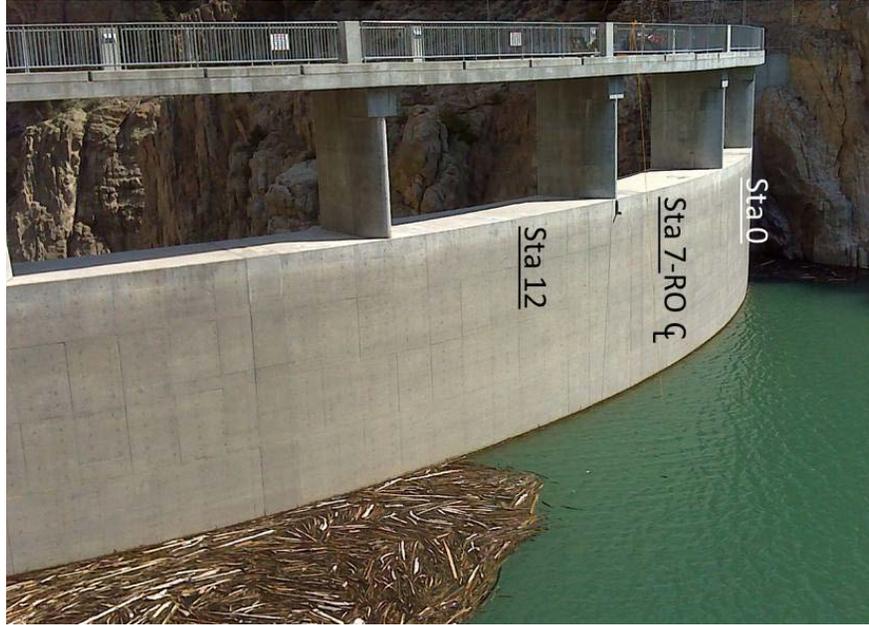
For sonar profiling, the sonar was repositioned in the cage so that the sonar was oriented horizontally and parallel to the upstream dam face. The cage was lowered using the Kevlar communication cable and was supported at a fixed elevation of 5368 ft (3 ft below the water surface). Sonar profiles were collected at 5-ft stationing covering a distance of 60 ft. Station 7 was located along the centerline of the river outlet intake (figure 6). Profiling was suspended at station 12 because of large woody debris that had accumulated in the left abutment area. Sonar profiles were collected from 9:00 to 10:00 a.m. on September 18, 2012.

Figure 6. Photograph of Buffalo Bill Dam forebay and the stationing used during bathymetry measurements. A total of 13 sonar profiles were collected to map the reservoir bottom in the dam's forebay.

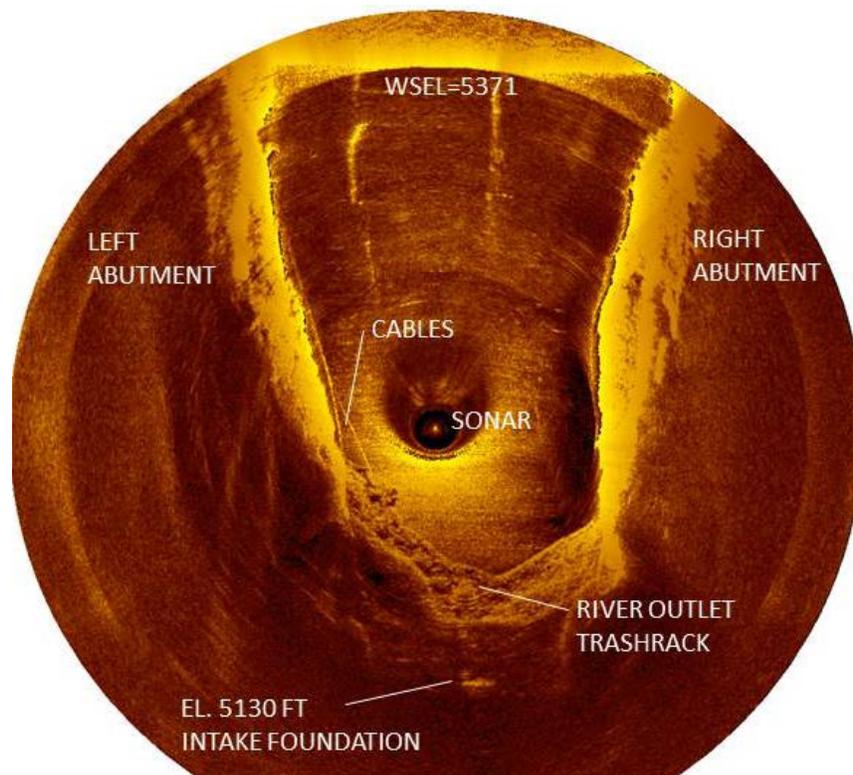
Figure 7 is a sonar image with the sonar located at EL. 5228 ft which is about 57 ft above the top of the river outlet trashrack. This sonar image was collected using a scanning range of 150 ft to capture the entire cross section of the forebay.

The image is oriented as if looking at the dam from upstream. The major features in the sonar image are the canyon walls, dam face, river outlet trashrack structure, two cables (reported by Jack Buffkin to be attached to the trashrack structures), and sediment which has accumulated on the concrete dam. There appears to be a strong acoustic reflection from the river outlet intake foundation at elevation El. 5132 ft. It is possible to image the foundation floor because acoustic energy can pass through the trashrack bars, strike the foundation, and be reflected back to the sonar.

Figure 7. Sonar image of the face of Buffalo Bill Dam, including the right and left abutment walls, river outlet trashrack structure, and what appears to be the floor of the intake foundation at El. 5130. Two cables connected to the trashracks are visible along the left abutment.

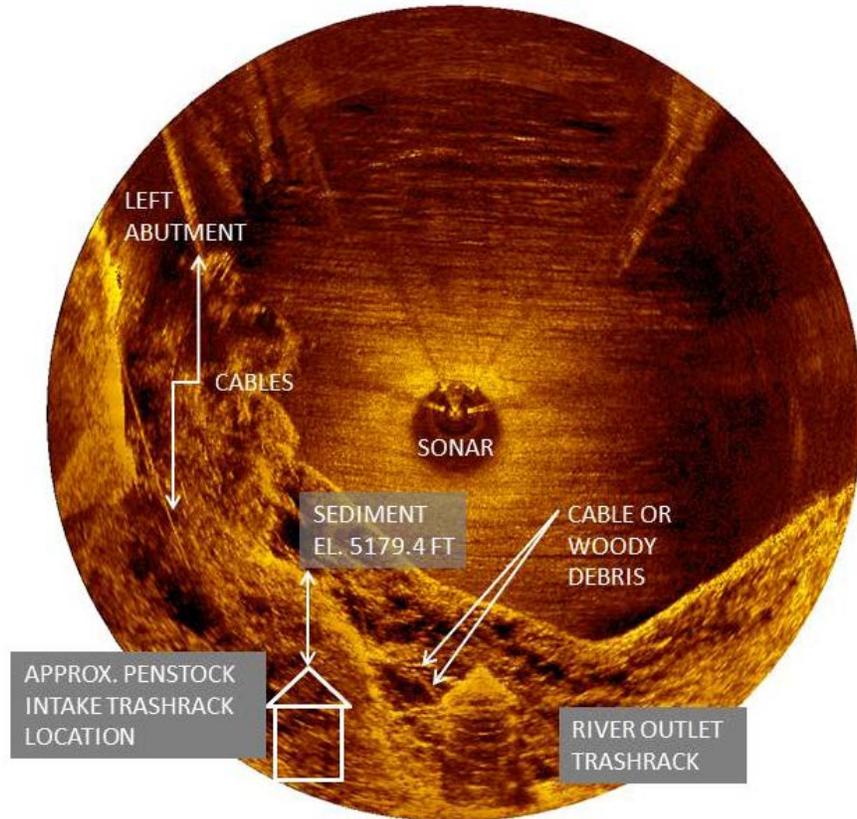
Figure 8 is a short range sonar image with the sonar located at EL. 5197.5 ft which is 27 ft above the top of the river outlet trashrack. This sonar image was collected using a scanning range of 45 ft which covers a smaller area, but has a higher image resolution. The major features in the image are the dam face, river outlet trashrack, two cables, and the sediment which has accumulated around the penstock intake trashrack. There are no signs in the sonar image of structural components of the penstock intake trashrack. This image was collected with the sonar located between the dam face and the downstream side of the trashrack. As a result, it is possible that there are some portions of the upstream side of the trashrack that are not covered by sediment and/or debris. These sonar images

support the observation of reduced power capacity at the Shoshone powerplant which is consistent with blockage of the trashrack structure.

Figure 8. Sonar image showing the river outlet trashrack and the approximate penstock intake location. The sediment elevation around the intake was estimated to be at El. 5179.4 ft which is about 8.0 ft of sediment accumulation above the top of the trashrack

It is important to note that sonar images of the low-level intakes are not photographs and are open to interpretation. However, careful review of the sonar images and the design drawings provided a high level of confidence in the sonar records which showed significant sediment accumulation around the Shoshone Powerplant intake structure. This sediment accumulation observation supports the reduced power generation capacity at the Shoshone powerplant.

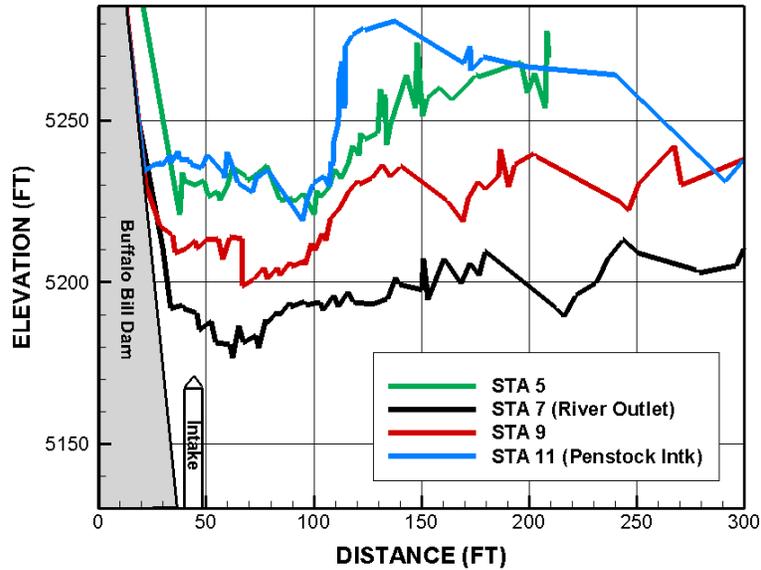
Sonar profiles in the forebay were collected to measure the bathymetry in the vicinity of the intakes. A review of available drawings had the original streambed elevation at El. 5125 (1910) and drawing 1458-600-151 dated June 1987 has the existing silt level at El. 5180 ft. Thirteen sonar profiles were collected at 5-ft stationing covering a length of 60 ft. Profiles were made perpendicular to the dam face. Station 7 was located near the centerline of the river outlet intake. Figure 9 shows a sample of the forebay bottom profiles. The station 7 profile shows the greatest amount of scour which explains why the river outlet trashrack structure was detected in the sonar image. Meanwhile, the station 11 profile shows significant sediment accumulation in the vicinity of the penstock intake trashrack structure. An analysis of the bathymetry profiles showed the average

bed elevation at cross sections 70 and 125 ft uplake from the intakes is 5213.4 and 5230.0 ft, respectively. The sediment elevation, 5213.4 ft, about is 33 ft higher than the silt level El. 5180 ft reported on drawing 1458-600-151 dated 1987(location was not specified). On figure 10, the station 4 profile shows the sediment level is approaching the intake elevation of the Shoshone Canyon Conduit, El 5233.0 ft, which is located approximately 200 ft uplake from the dam. Likewise, the station 11 profile shows sediment level has reached the left abutment intake tunnel.

Figure 9. Plot of bathymetry profiles collect at stations along the bridge handrail at Buffalo Bill Dam. The profiles illustrate the difference in sediment levels at the river outlet and penstock intake trashracks.

Bathymetry data were analyzed to estimate the average sediment elevation in the forebay. The average bed elevations at cross sections 70 and 125 ft uplake from the intakes are 5213.4 and 5230.0 ft, respectively.

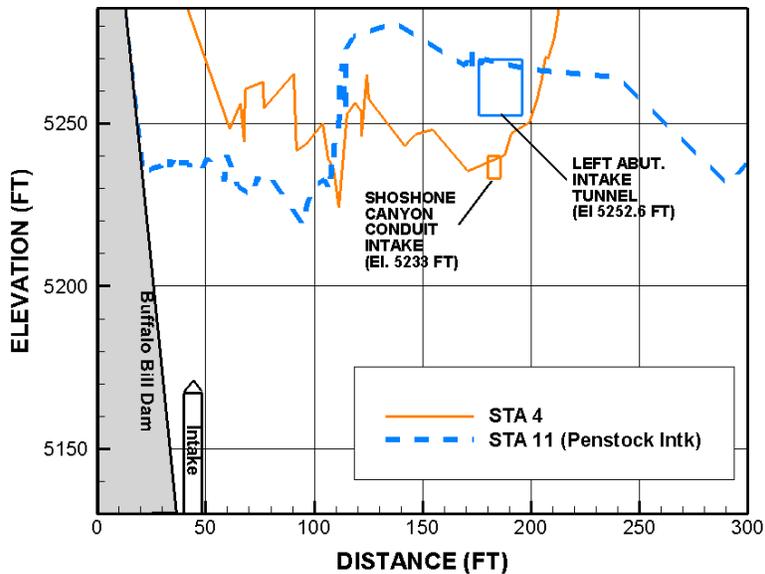
Figure 10. Sonar profiles collected through the approximate section through the left abutment intake tunnel and the Shoshone Canyon conduit intake on the right abutment.

Both profiles show that sediment deposition levels may have encroached on each intake. NOTE: Intake locations (distance and elevations) were estimated from drawing 1458-601-64.

The project scope did not include performing a sonar survey of the Shoshone Canyon Conduit or the left abutment outlet works intakes. However, bathymetry data suggest that sediment levels have reached these intakes. As such, it is recommended that these intakes be inspected in the future to document the extent of sediment accumulation.
