Hydraulic Laboratory Technical Memorandum PAP-1114

Roza Powerplant – Forebay Load Rejection Study

Study provided for the Yakima Field Office

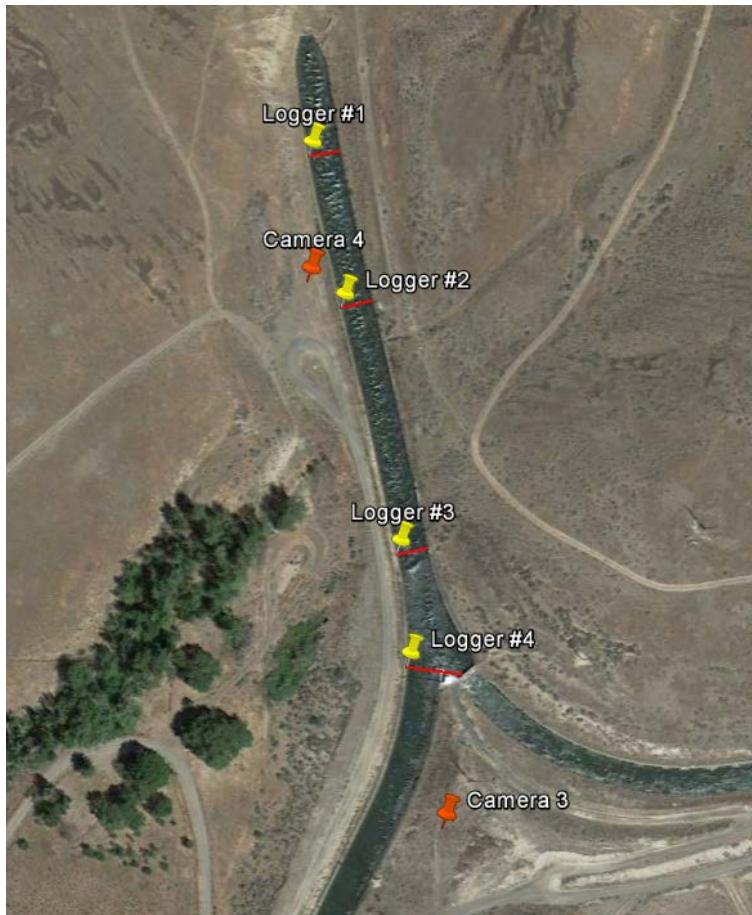
Figure 1 Locations of water-level data loggers 1-4 on the canal upstream from the bifurcation to the Roza Irrigation District and camera locations that were used for video during the field test.

Data were collected in the canal and forebay and from the unit inside the powerplant. Water surface elevations were measured in the canal and forebay using eight Hobo water-level data loggers recording at 1 second intervals. Seven were installed on the main canal and forebay section downstream from the tunnel, and one upstream from the tunnel. Four video cameras were also used on the canal and forebay to capture the surge from the load rejection (Figure 1 and Figure 2). Data collected from inside the powerplant included generator power (recorded with Roza's Monarch Data Chart Recorder), unit flow (Winter-Kennedy pressure taps), and wicket gate opening (percent open). These data (except for power) were collected at 100 Hz using an IOTech Personal DAQ data acquisition system connected to a laptop computer. Attempts to measure the penstock pressure were unsuccessful due to a faulty transducer.

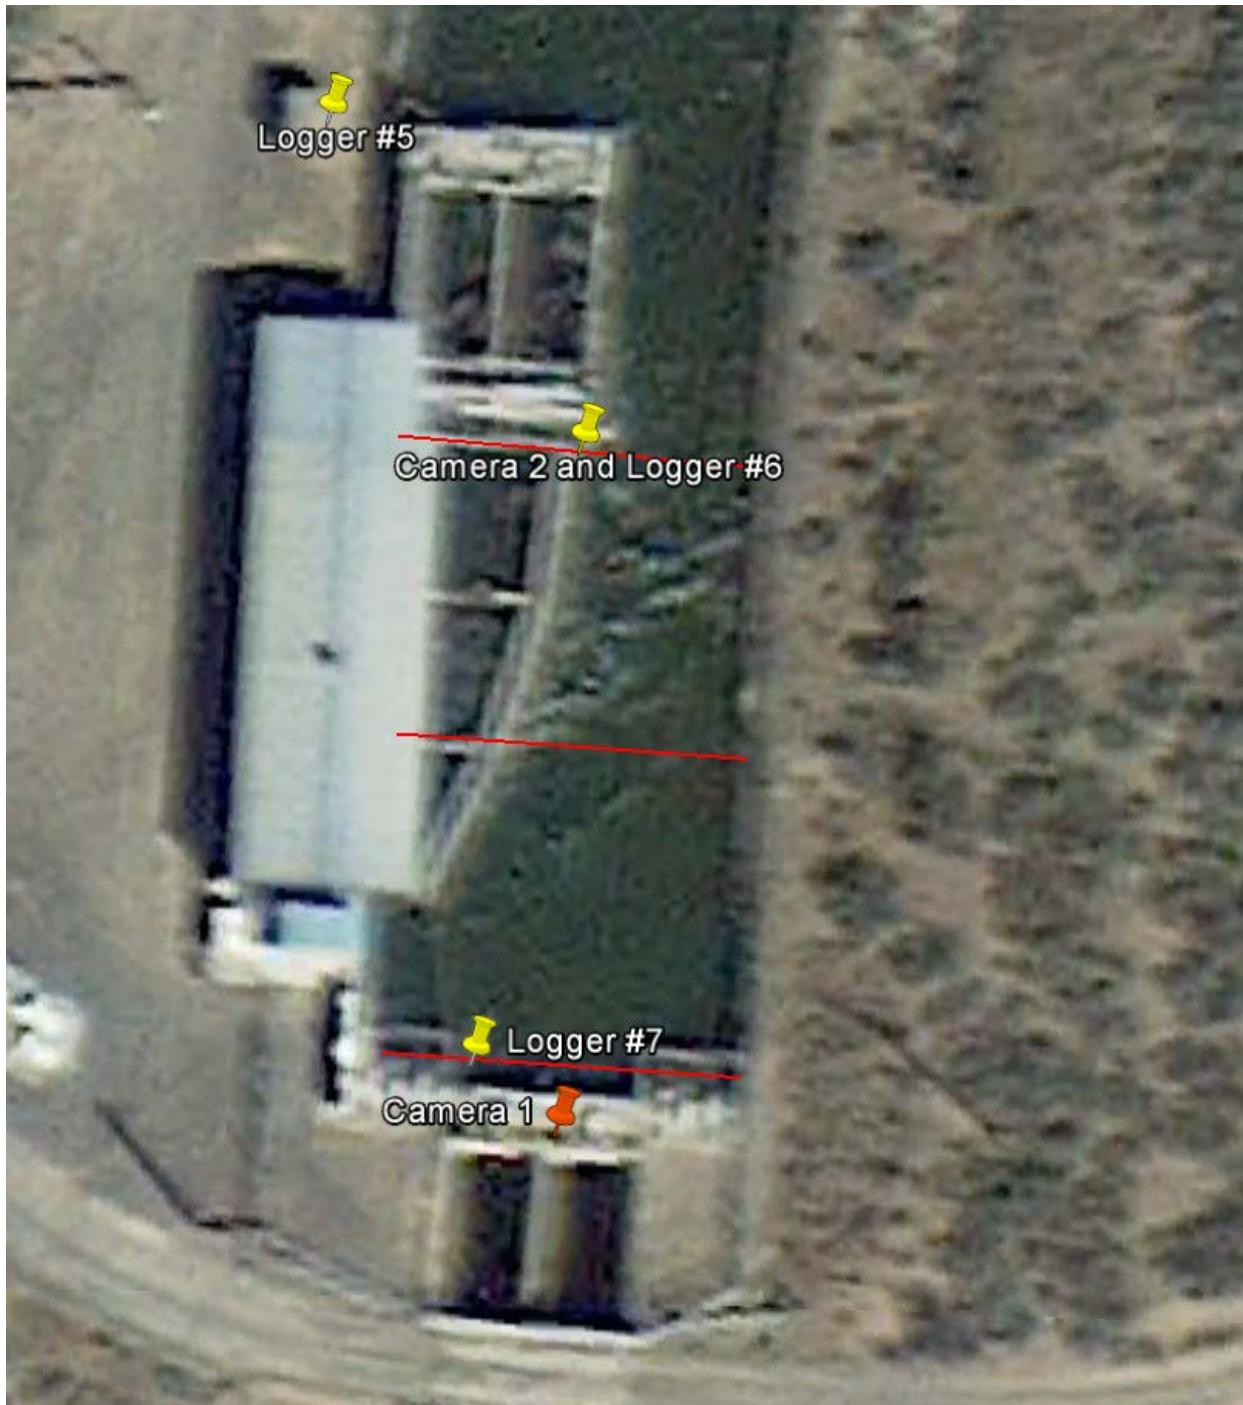
Figure 2 Water-level data logger and camera locations on the forebay near the penstock intake and siphon spillway. Red lines indicate cross-section locations that were used in the HEC-RAS model.

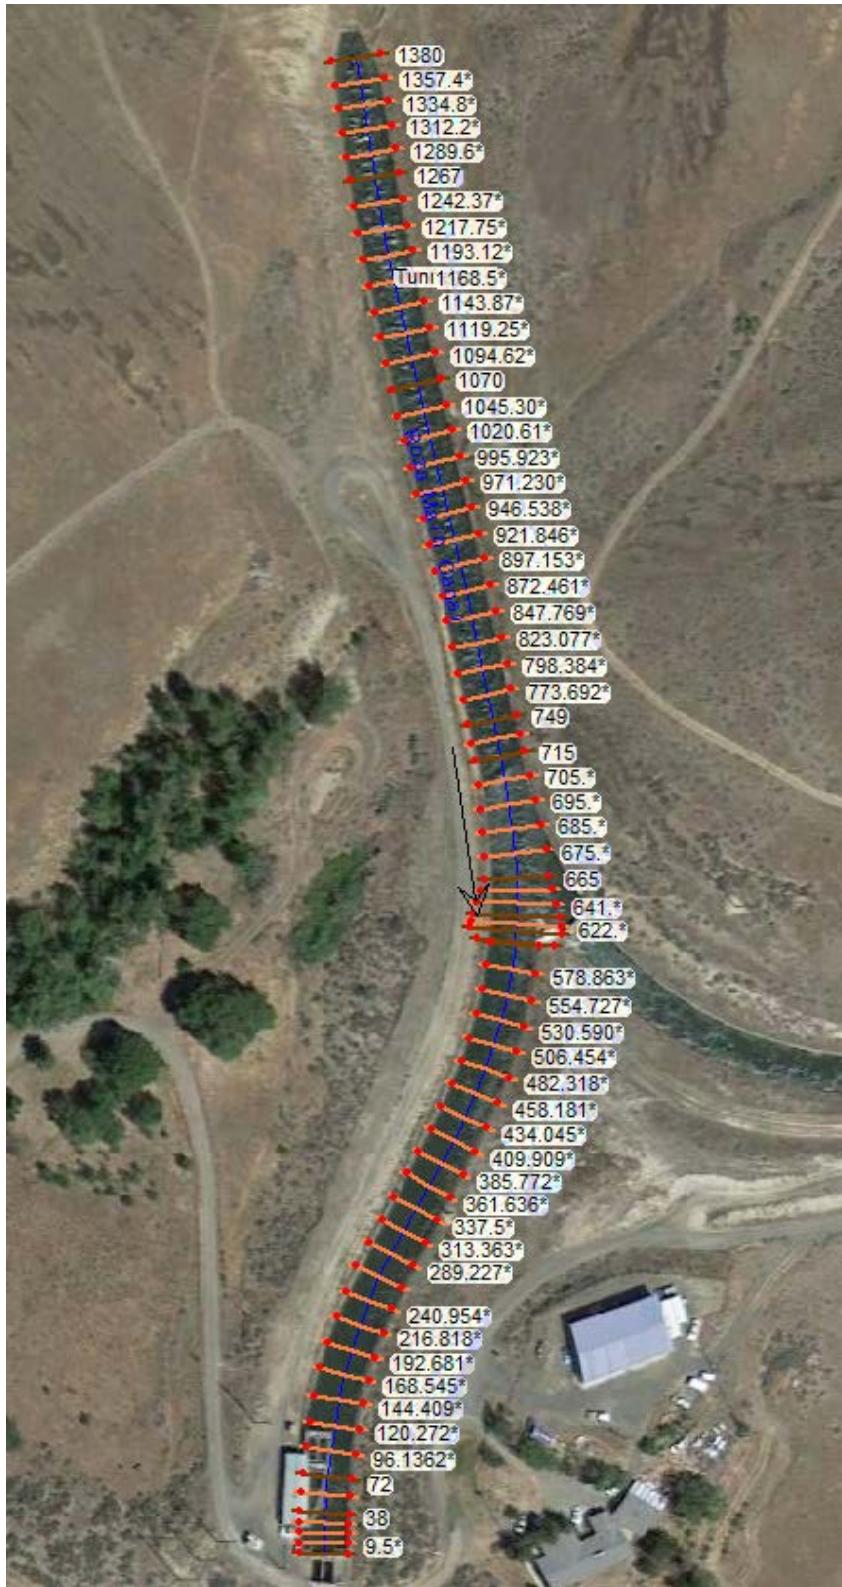
Figure 3 Canal and Forebay reach and cross-sections of the HEC-RAS model. Dark brown cross-sections were created from existing canal geometry and orange cross-sections are interpolated geometry.

Cross-sections of the canal geometry were placed at the same stationing as the water-level loggers using survey data from the field and Roza Canal drawings (Table 2). Additional cross-sections were placed near the RID bifurcation to simulate the increased area and volume of the canal at that location. Interpolated cross-sections were then created by the model and were spaced about 25 ft apart through most of the model and about 12 ft apart at transitions near the RID bifurcation and penstock intake (Figure 3).

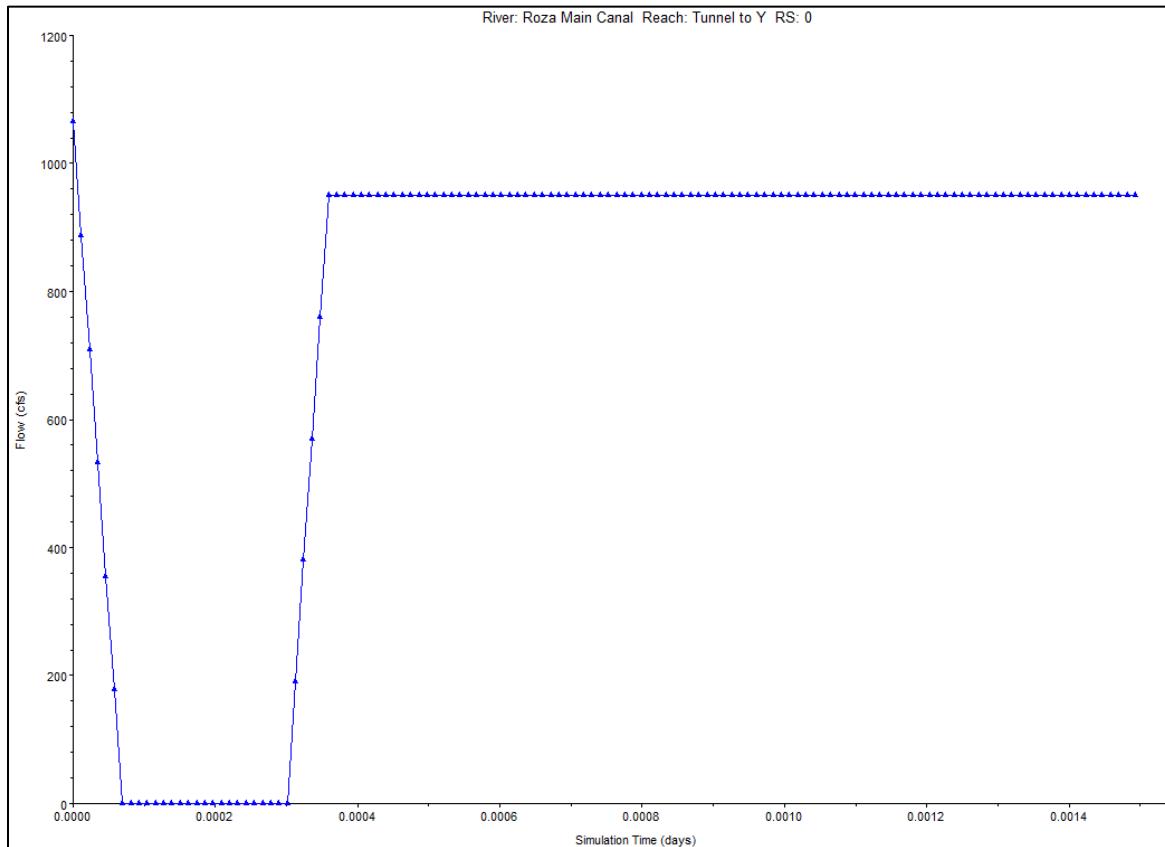
Figure 4 Flow hydrograph for the Normal-rated scenario. This simulates flow at the downstream end of the model by rapidly decreasing flow (wicket gates closed) and then increasing again (siphons activated) to the flow capacity of the siphon.

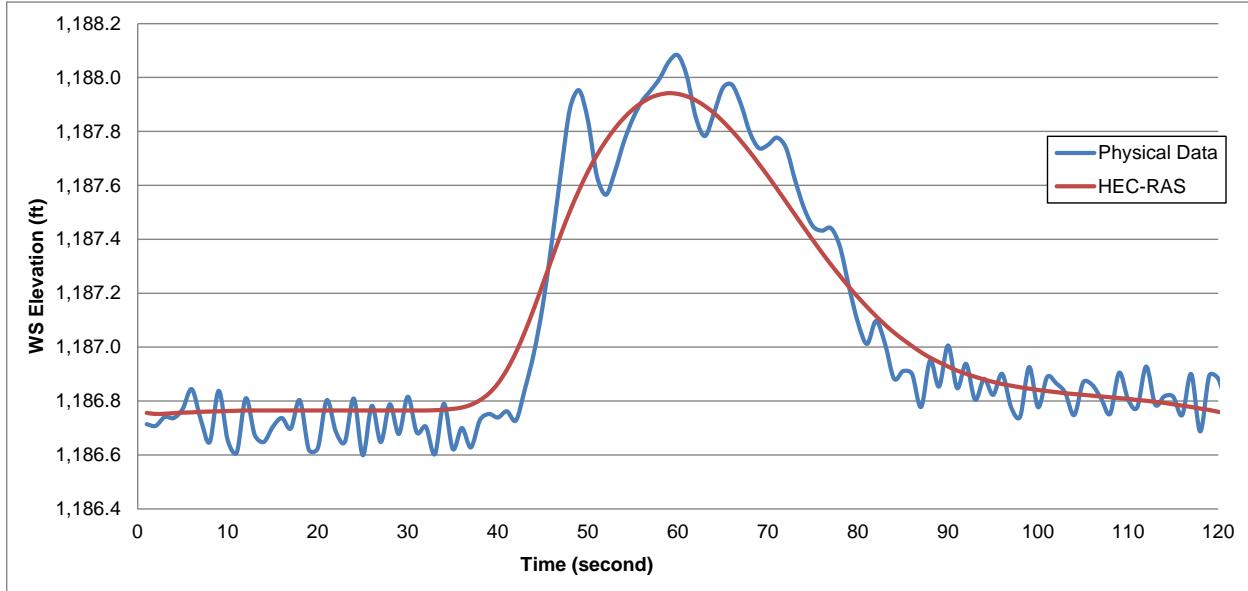
Figure 5 Comparison of field test and numerical hydrograph of the water surface elevation at station 605 performed during the model calibration.

The travel time of the surge up the canal was also of interest. Figure 5 compares both the timing and magnitude of the surge in the canal to ensure correct calibration of the numerical model. Only two minutes of the load rejection were simulated in every case because that is about the amount of time it took the surge to reach the tunnel outlet. Since the tunnel geometry was not included in the model any results after two minutes (when reflections from the tunnel outlet begin to influence water levels observed in the field) would not be representative of actual canal conditions.

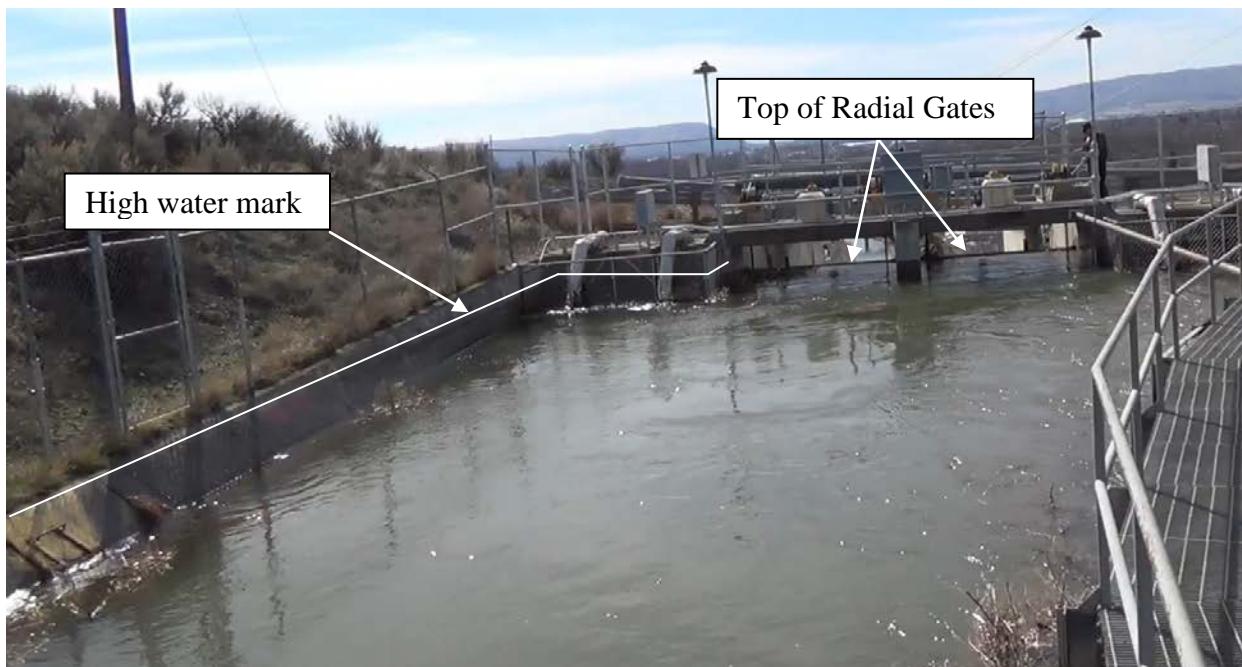
Figure 6 Forebay near the siphons and radial gates after the initial surge and while the siphons were activated. The high water mark shows where the surge came near the top of the lining and overtopped the radial gates.

The field test performed in March of 2014 was equivalent to a load rejection of about 943 ft³/s. Unit flow at the beginning of the test was about 1056 ft³/s which was also the total discharge through the canal, as there was no irrigation flow. The unit discharge was decreased to about 113 ft³/s by closing the wicket gates from 76% to 13% open in about 5.2 seconds. Generator power was also decreased from 12.9 MW to 1.1 MW in about 7 seconds. This caused a surge in the forebay that eventually activated all four siphons and overtopped both radial gates (Figure 6). The surge then traveled up the canal with an average velocity of 12.6 ft/s until it was damped by the tunnel. Surge results are shown in Figure 7 and Table 4. Video of the canal near the RID bifurcation showed that both RID gates were also overtopped for a short period of time. Additional photos of the field test are shown in Appendix A.

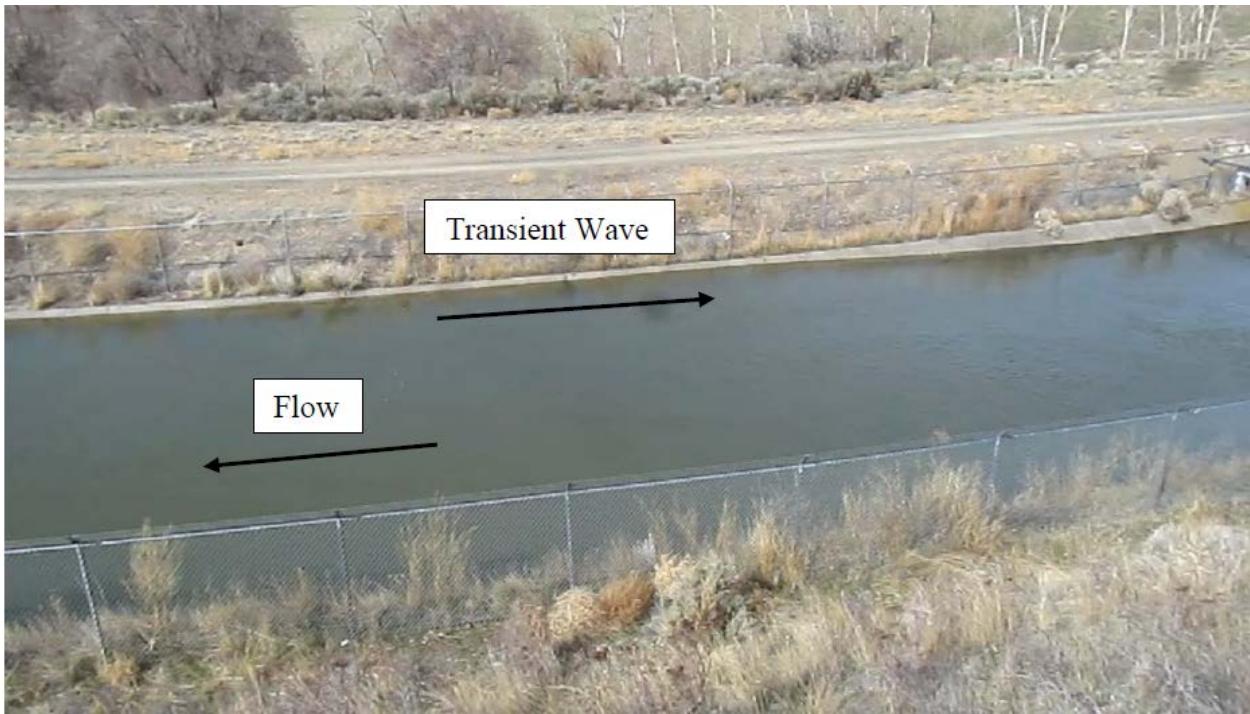
Figure 7 Surge traveling up the canal during the 2014 field test.

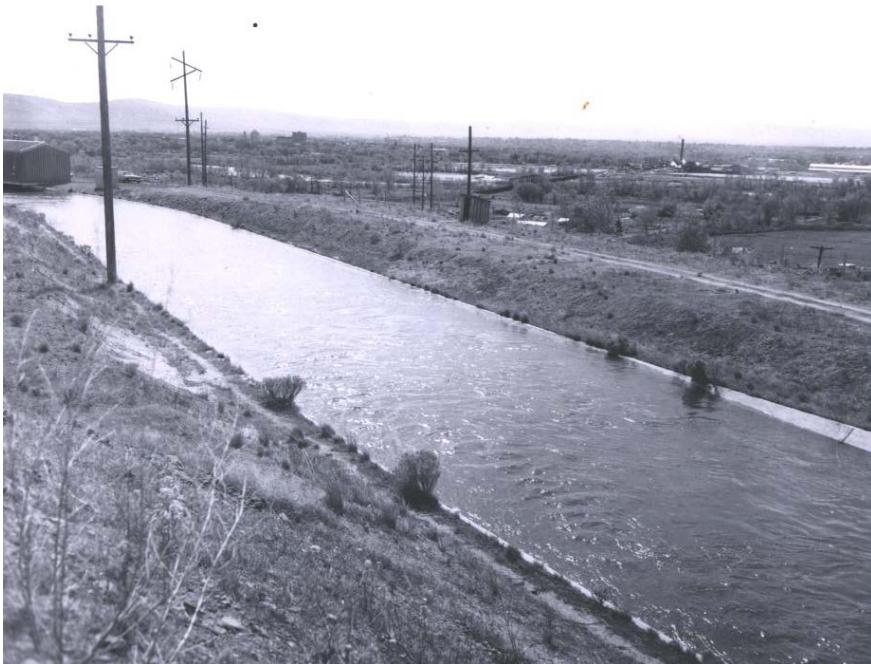
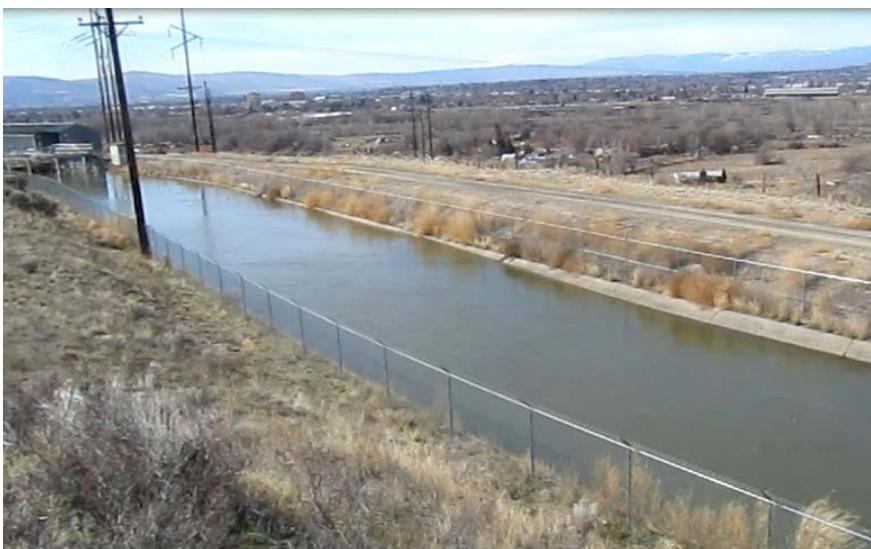
Figure 8 Photo comparison of the surge during the 1960 rejection test of $1,100 \text{ ft}^3/\text{s}$ (top) and the 2014 rejection test of $943 \text{ ft}^3/\text{s}$ (bottom).

The photos in Figure 8 show a slightly higher surge during the 1960 test that comes very close to the top of the lining of the canal. All photos and video from both field tests show the 1960 surge near the top of the lining for the entire canal length to the tunnel with the 2014 surge a few inches below the lining top as expected.

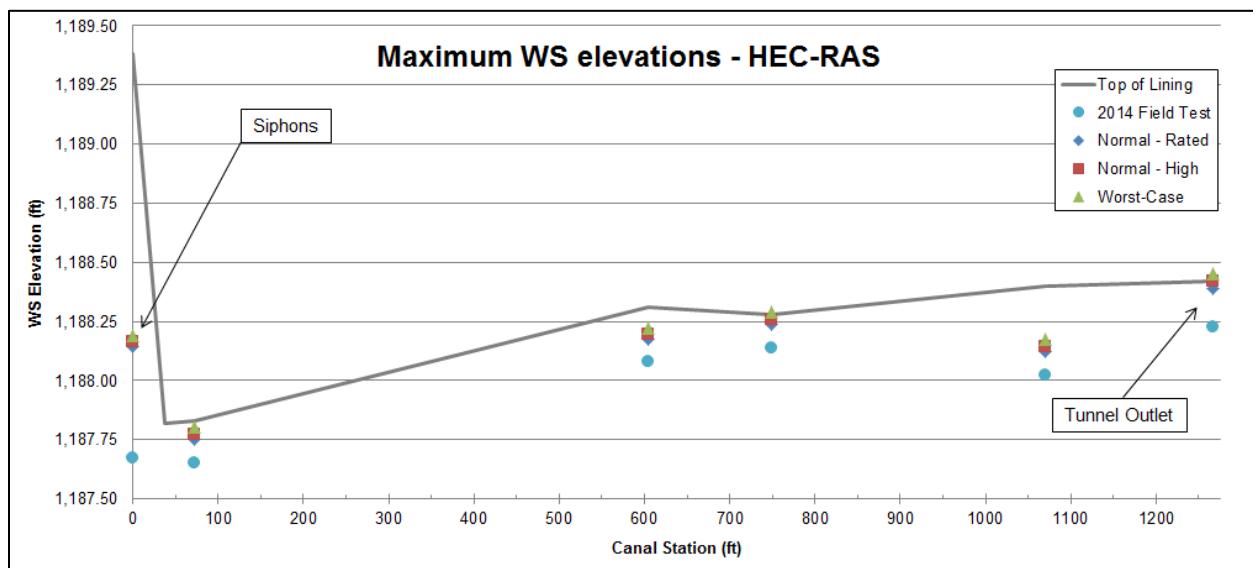
Figure 9 HEC-RAS estimations of maximum water surface elevations of the moving surge.

Maximum water surface elevations caused by the surge were predicted for full load rejections under the three current operating scenarios and compared to the 2014 field test data for the partial load rejection (Figure 9). Overall, numerical results followed the same trend found in the field test. Differences in water surface results of the three scenarios were not significant since the model flow rates were similar in magnitude. The traveling surge comes close to the top of the lining for most of the canal and did reach the top at Station 749. This is may be due to decreased flow velocities as the volume increased near the RID bifurcation entrance, or maybe just because of the local drop in canal lining elevation at that location. Water surfaces were highest at Station 1267 near the tunnel outlet which is probably caused by an increased surge as the transient wave hits the tunnel entrance. In any case, overtopping the canal lining is not a concern because of the short duration of the surge and the small flow depth above the lining which would always be contained in the main channel by the additional height of the canal embankments.

Using maximum water surface and survey data from Figure 9, remaining freeboard data are presented in Table 6. Again, the model predicts slight overtopping at stations 749 and 1267 with surges very close to the lining along most of the canal. These results seem to reflect historic photos of the 1960 test even though no water surface data along the canal are available for confirmation.

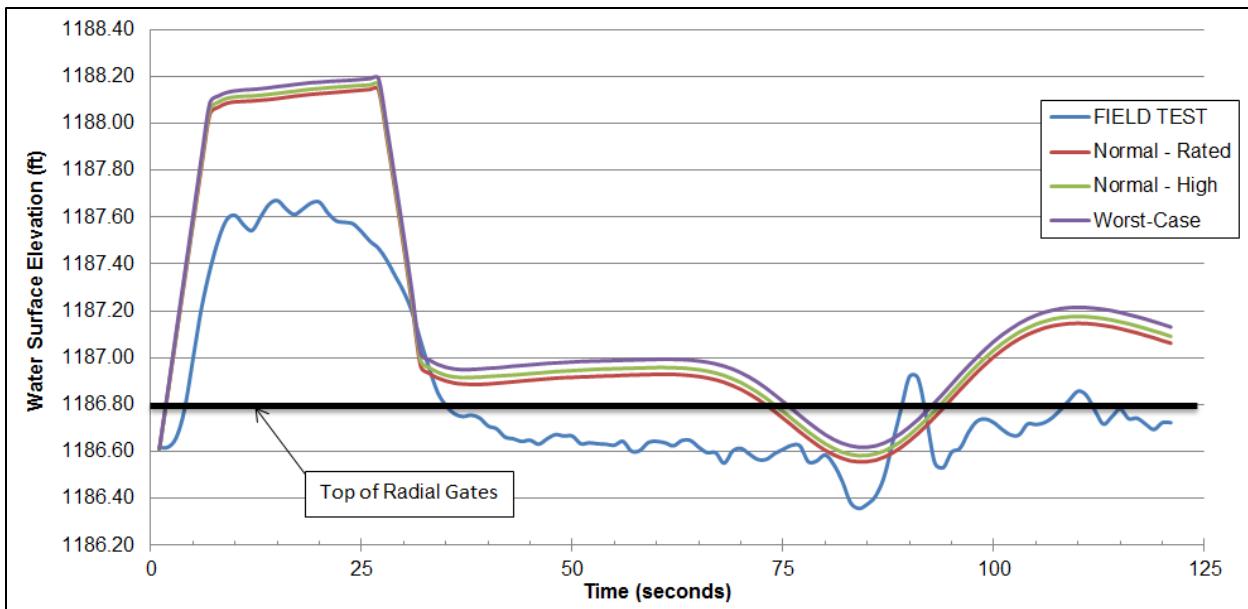
Figure 10 HEC-RAS predictions of the water surface elevation hydrograph at Station 0 relative to the top of the radial gates.

Ideally the flow imbalance in the forebay would be solved by using the radial gates to supplement the siphon flow and produce a forebay outflow equal to the inflow. For a load rejection of 1,100 ft³/s both radial gates would need to be opened only about 0.4 ft for a flow of 150 ft³/s to supplement the 950 ft³/s discharged by the siphons. However, this is complicated by the possibility of not being able to raise the gates due to continuous overtopping.

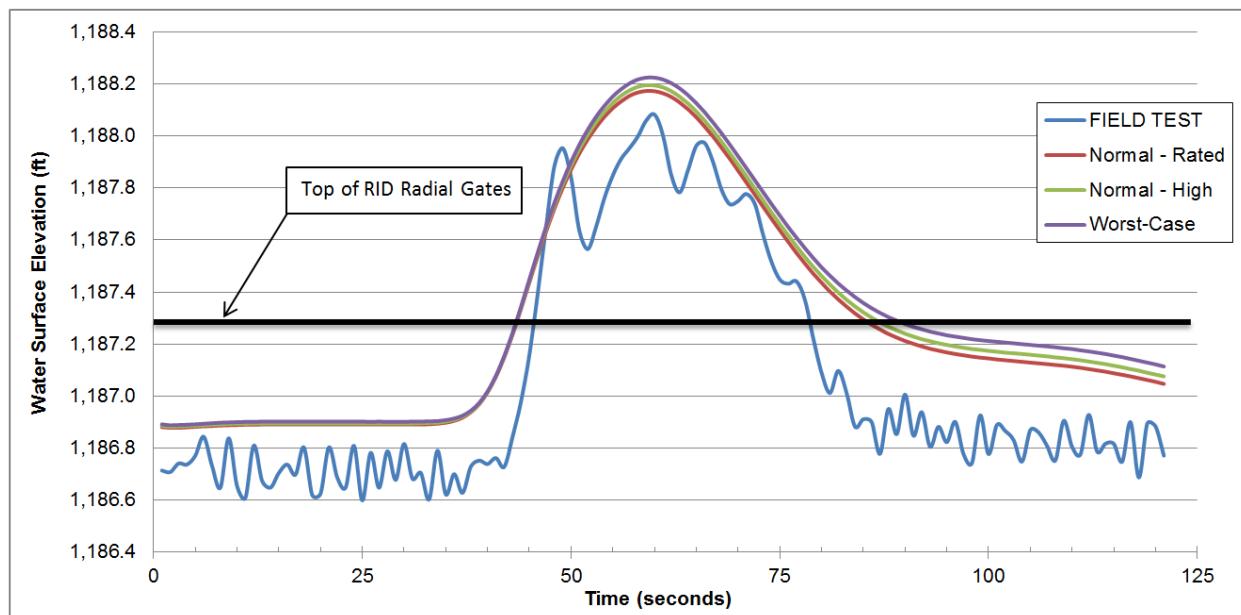
Figure 11 HEC-RAS predictions of the water surface elevation hydrograph at Station 605 relative to the top of the radial gates at the RID bifurcation.

Field and numerical results show that the radial gates that control the flow to the RID canal are overtopped for up to 40 seconds when in the fully closed position (Figure 11). Assuming that the RID gates are overdesigned similar to the spillway gates, this is not a major concern due to the short period of overtopping. The water surface returns to below the top of the gates after the initial surge has passed. Actual RID gate dimensions are not known and elevations were estimated from DOC drawings and gate heights of the spillway gates were assumed to be the same as the spillway gates.

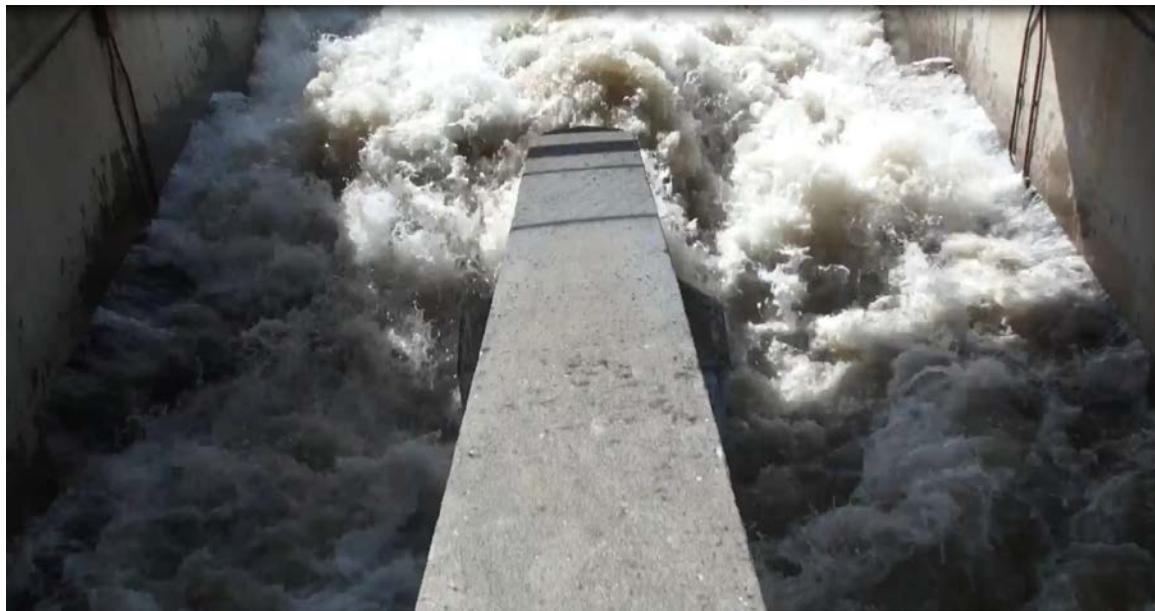
Figure 12 Water discharging out of the siphon outlets immediately downstream from the radial gates. Visually, discharge appeared equal from all four siphons which seemed to become fully primed about the same time.

The field test verified that all four emergency siphons performed as designed. All four were primed at approximately the same water surface elevation and appeared to have an equal discharge. Flow through the siphons was estimated by the change in penstock flow before and during the test ($943 \text{ ft}^3/\text{s}$) which is very near the design flow of $950 \text{ ft}^3/\text{s}$. As the water surface was lowered at the conclusion of the test one siphon did not break on its own, indicating that the air vent pipe was probably blocked with debris.

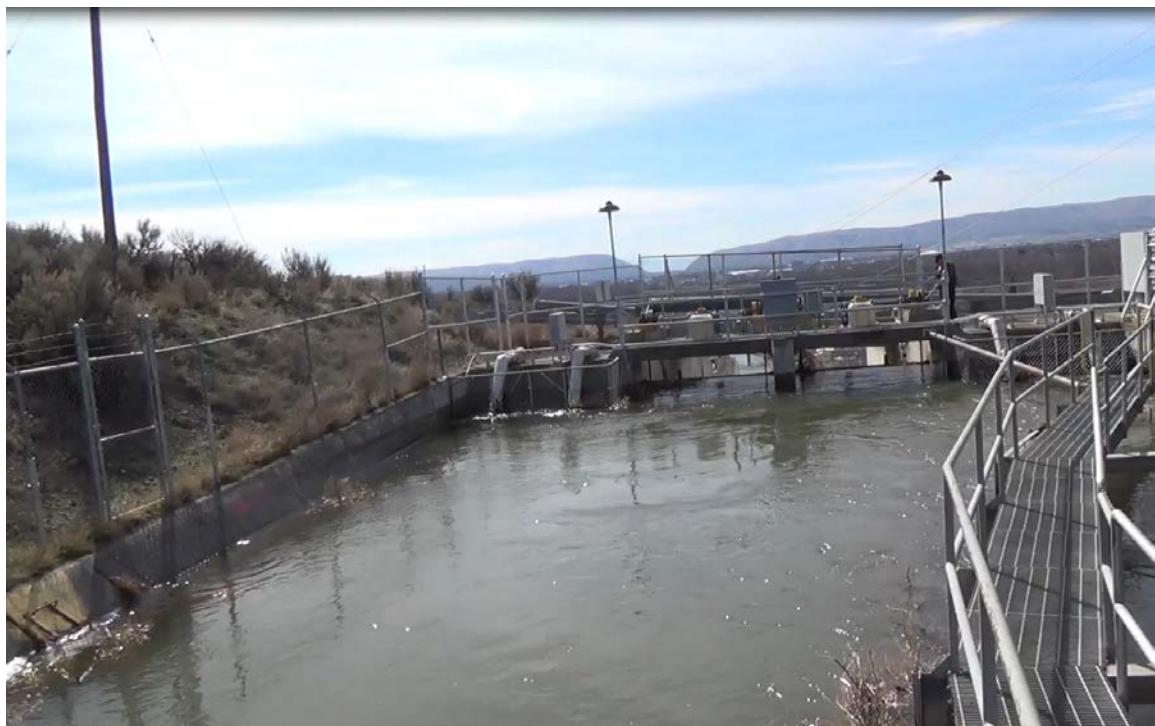
Figure 13 Forebay near the penstock intake just upstream from the siphons and radial gates (looking downstream) Siphons are activated and the water surface has been drawn down to just below the top of the radial gates.

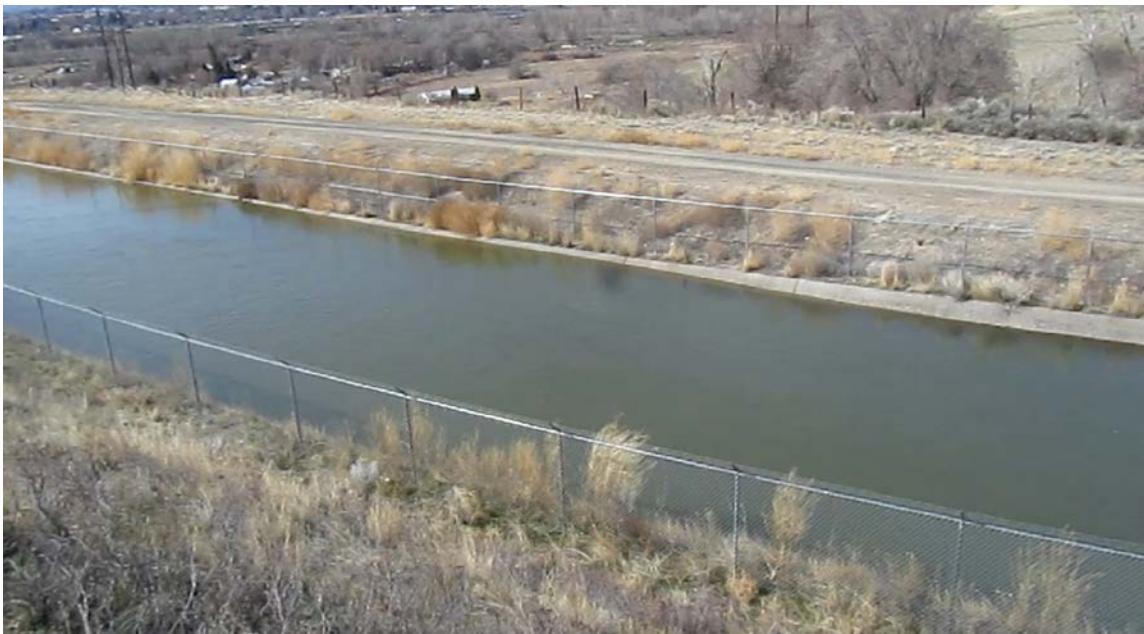
Figure 14 Surge in the canal just downstream from the RID bifurcation. Canal flow is moving to the left and the transient wave is moving to the right.

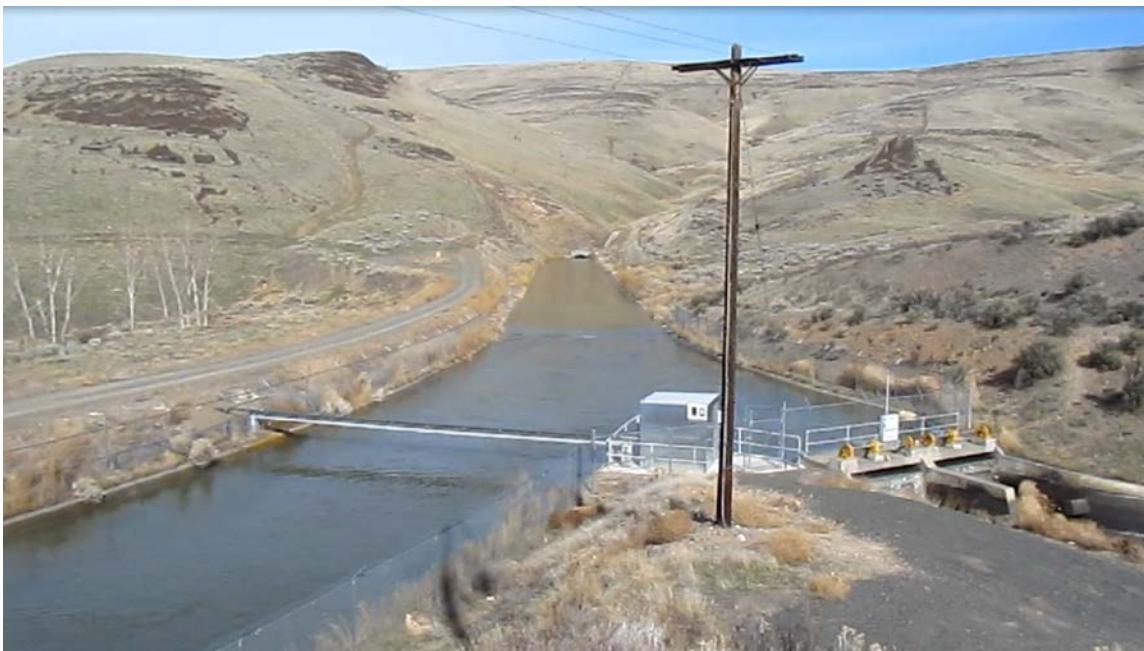
Figure 15 Surge moving through the entrance to the RID bifurcation. Flow also overtopped the radial gates at the RID entrance as shown in the photo.

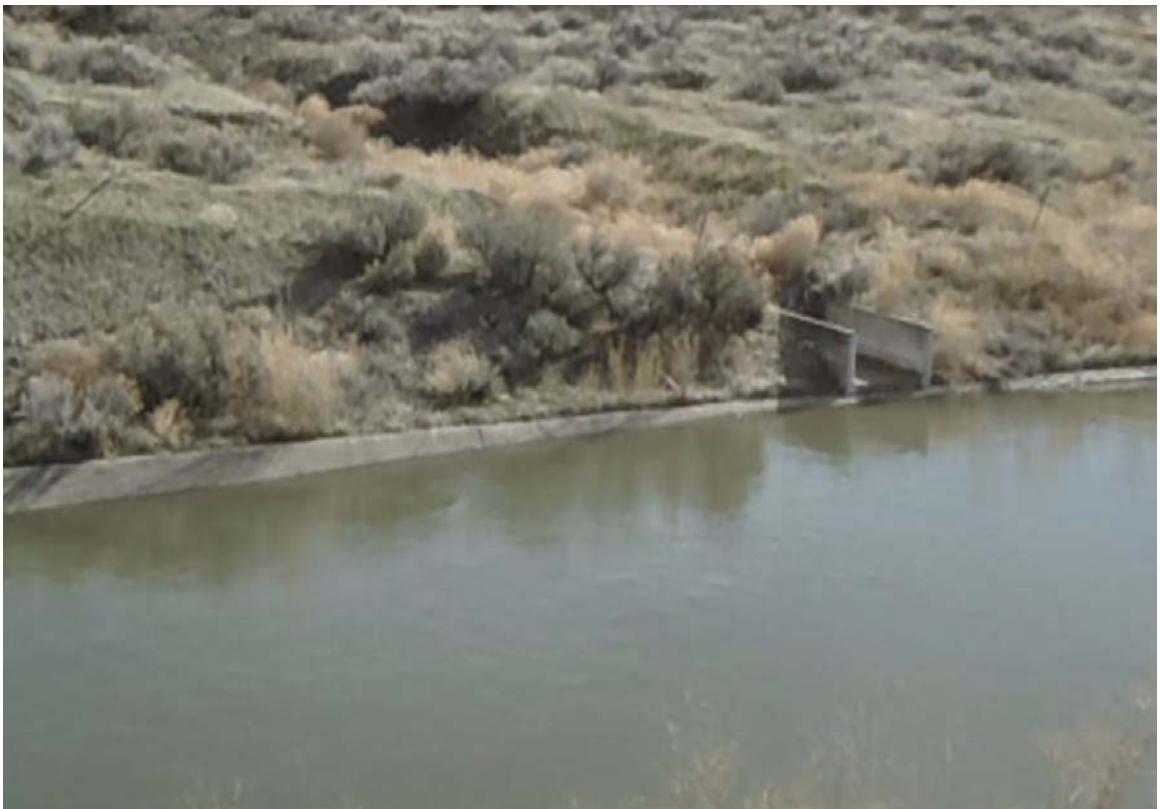
Figure 16 Surge in the canal just downstream from the tunnel outlet. Canal flow is moving to the right and the transient wave is traveling to the left.

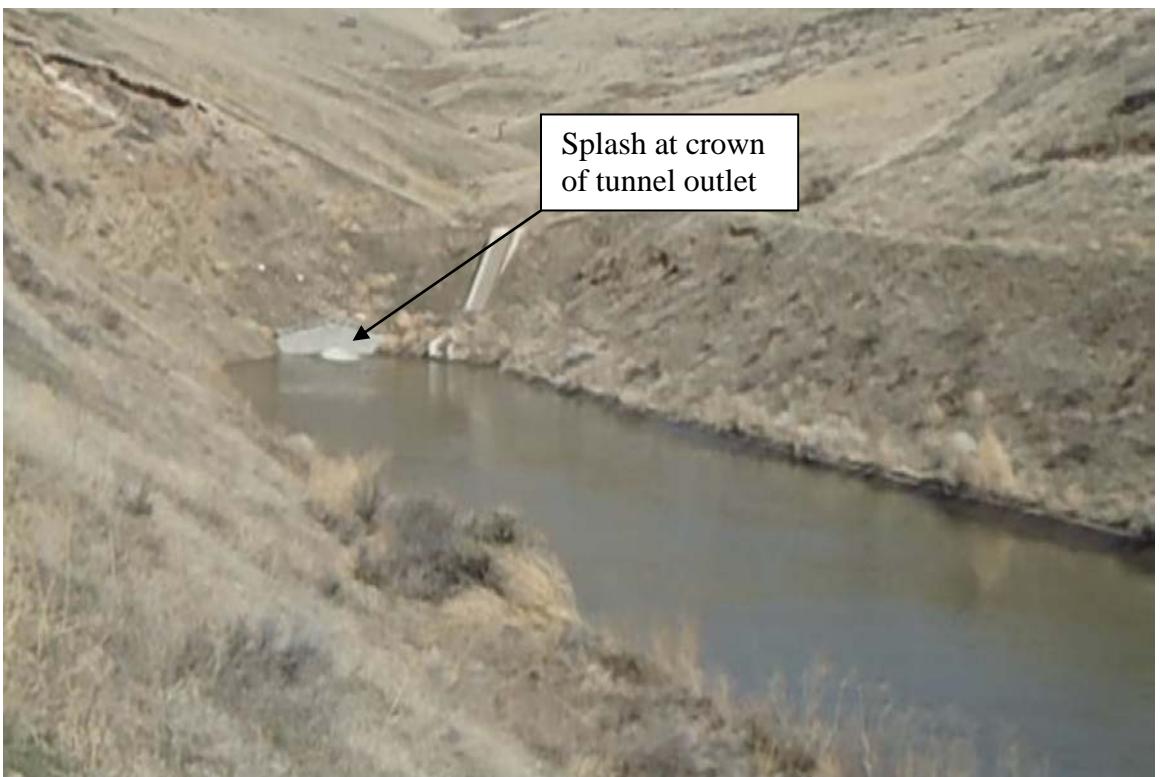
Figure 17 Splashing caused by the surge as it entered into the tunnel.

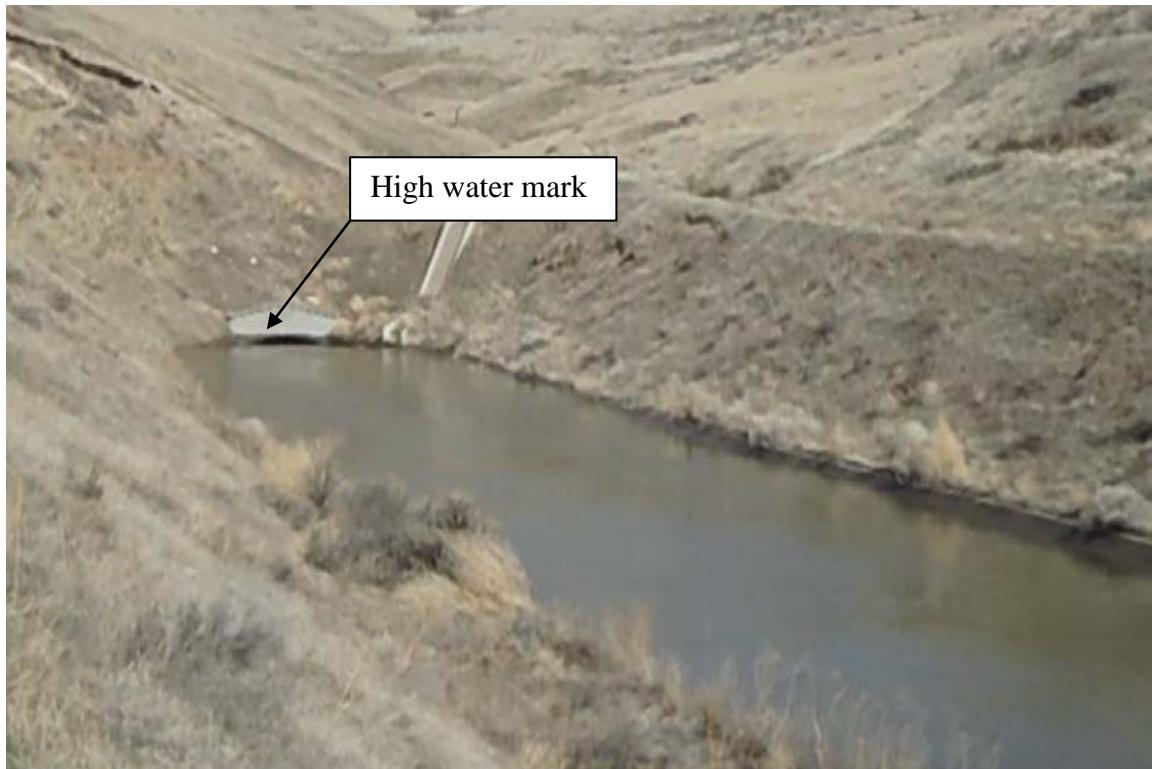
Figure 18 High water mark caused by the surge seen on the canal lining and tunnel outlet structure.

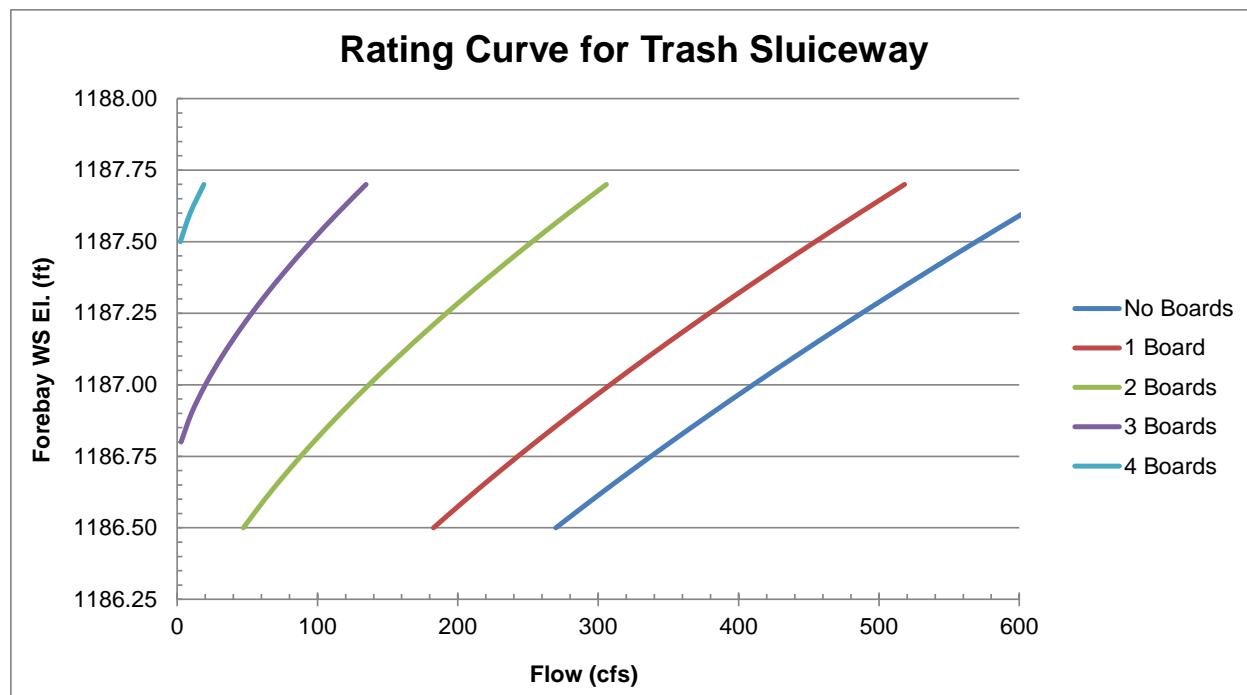
Figure 19 Plot of Forebay water surface elevation vs. sluiceway flow for different numbers of stoplog boards installed at the entrance. Data are tabulated in Table 7. Three boards would be required to hold the forebay elevation required for a normal operating condition.

Table 7 Sluiceway flow estimations based on the number of stop log boards installed at the inlet and the forebay water surface elevation. Estimations were made using a standard suppressed rectangular weir equation.

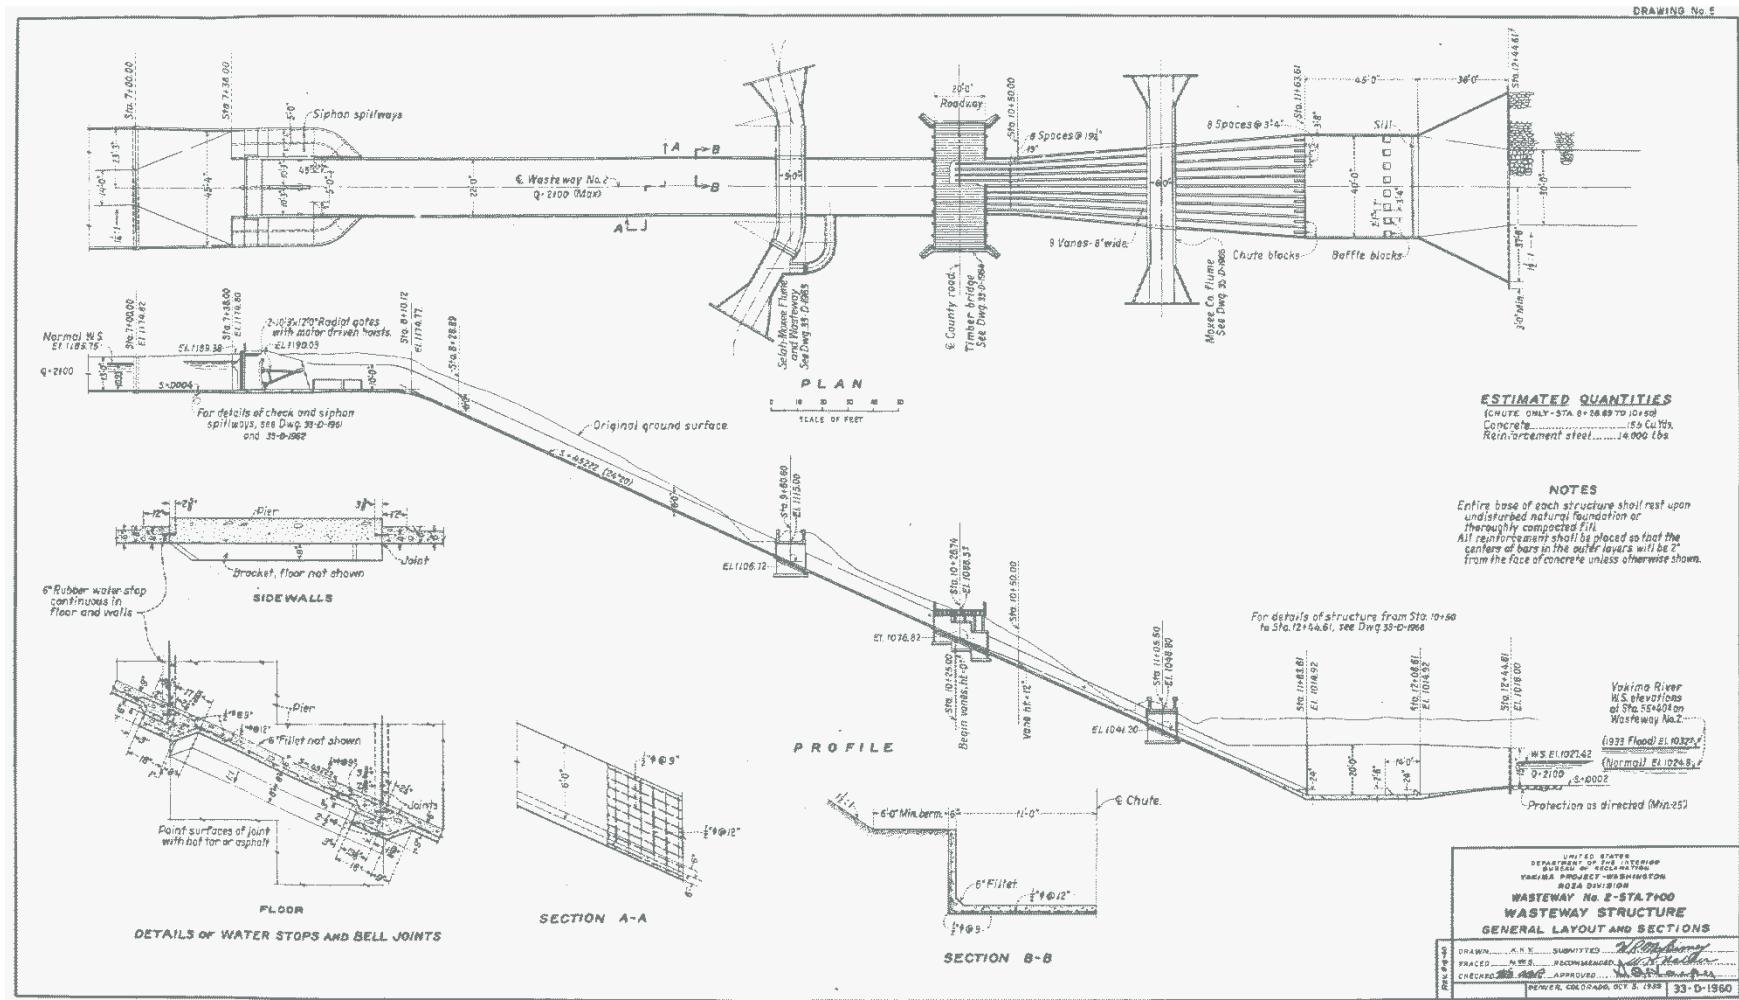
Figure 20 Drawing 33-D-1960 of Roza Powerplant forebay and spillway.
