Hydraulic Laboratory Technical Memorandum PAP-1114

Roza Powerplant – Forebay Load Rejection Study

Study provided for the Yakima Field Office

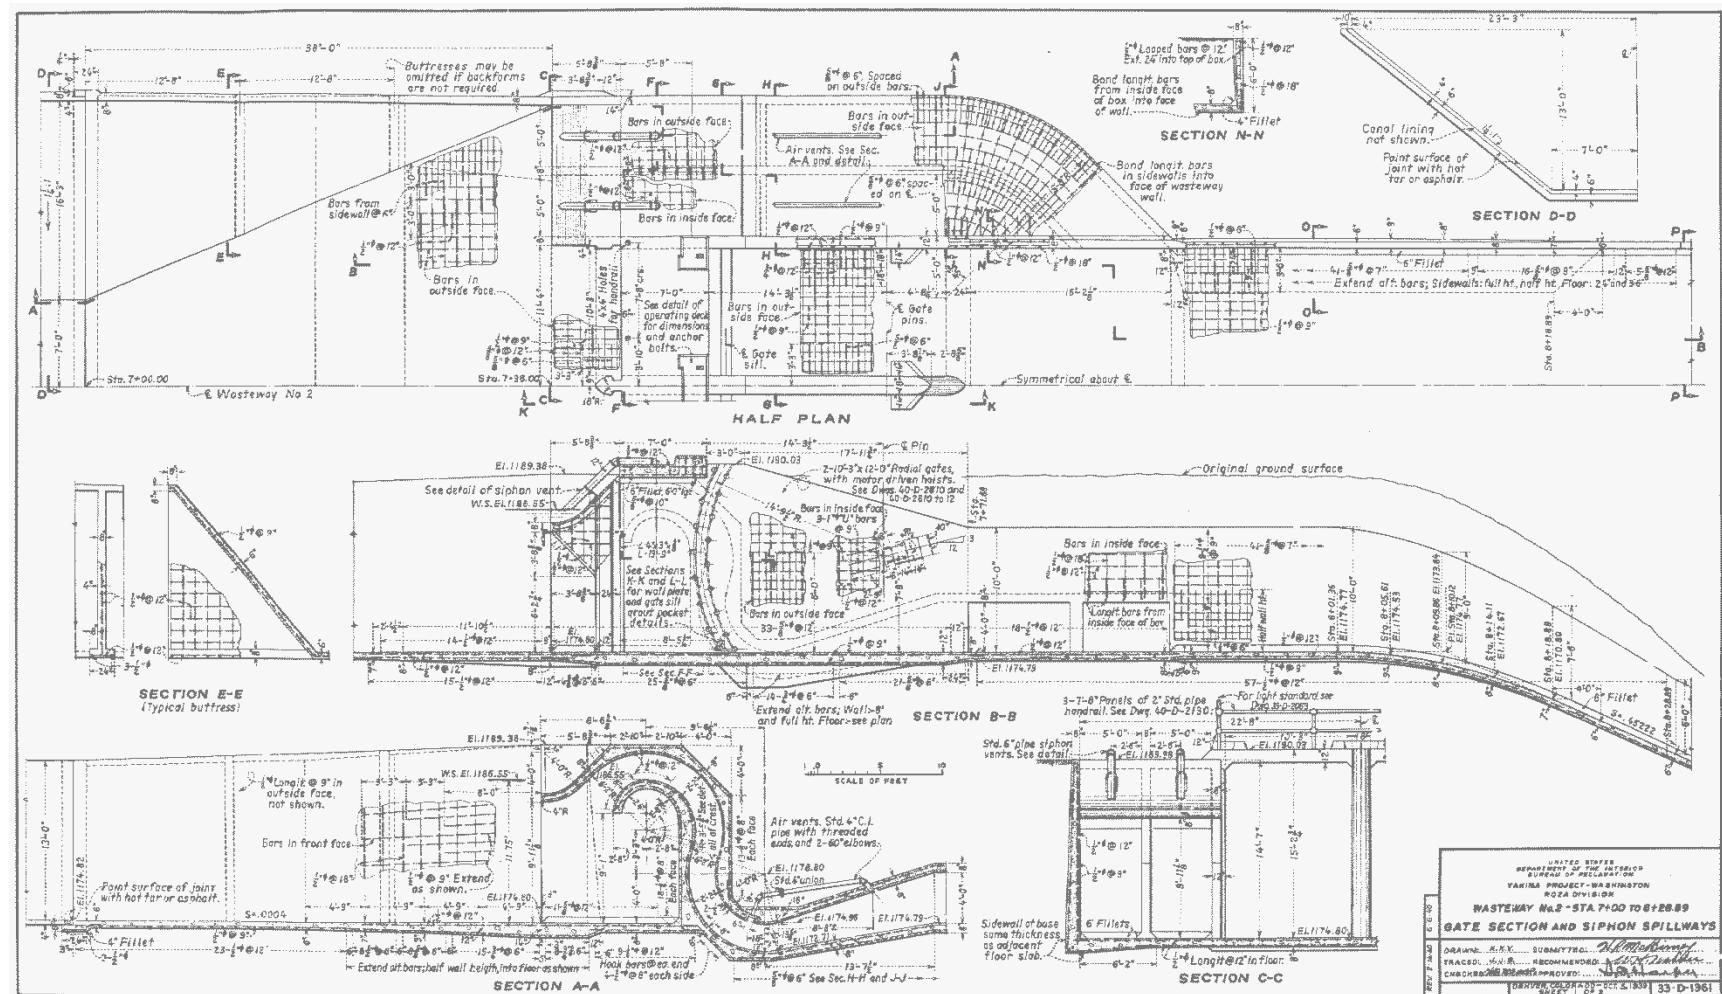
Figure 21 Drawing 33-D-1961 of emergency siphons.

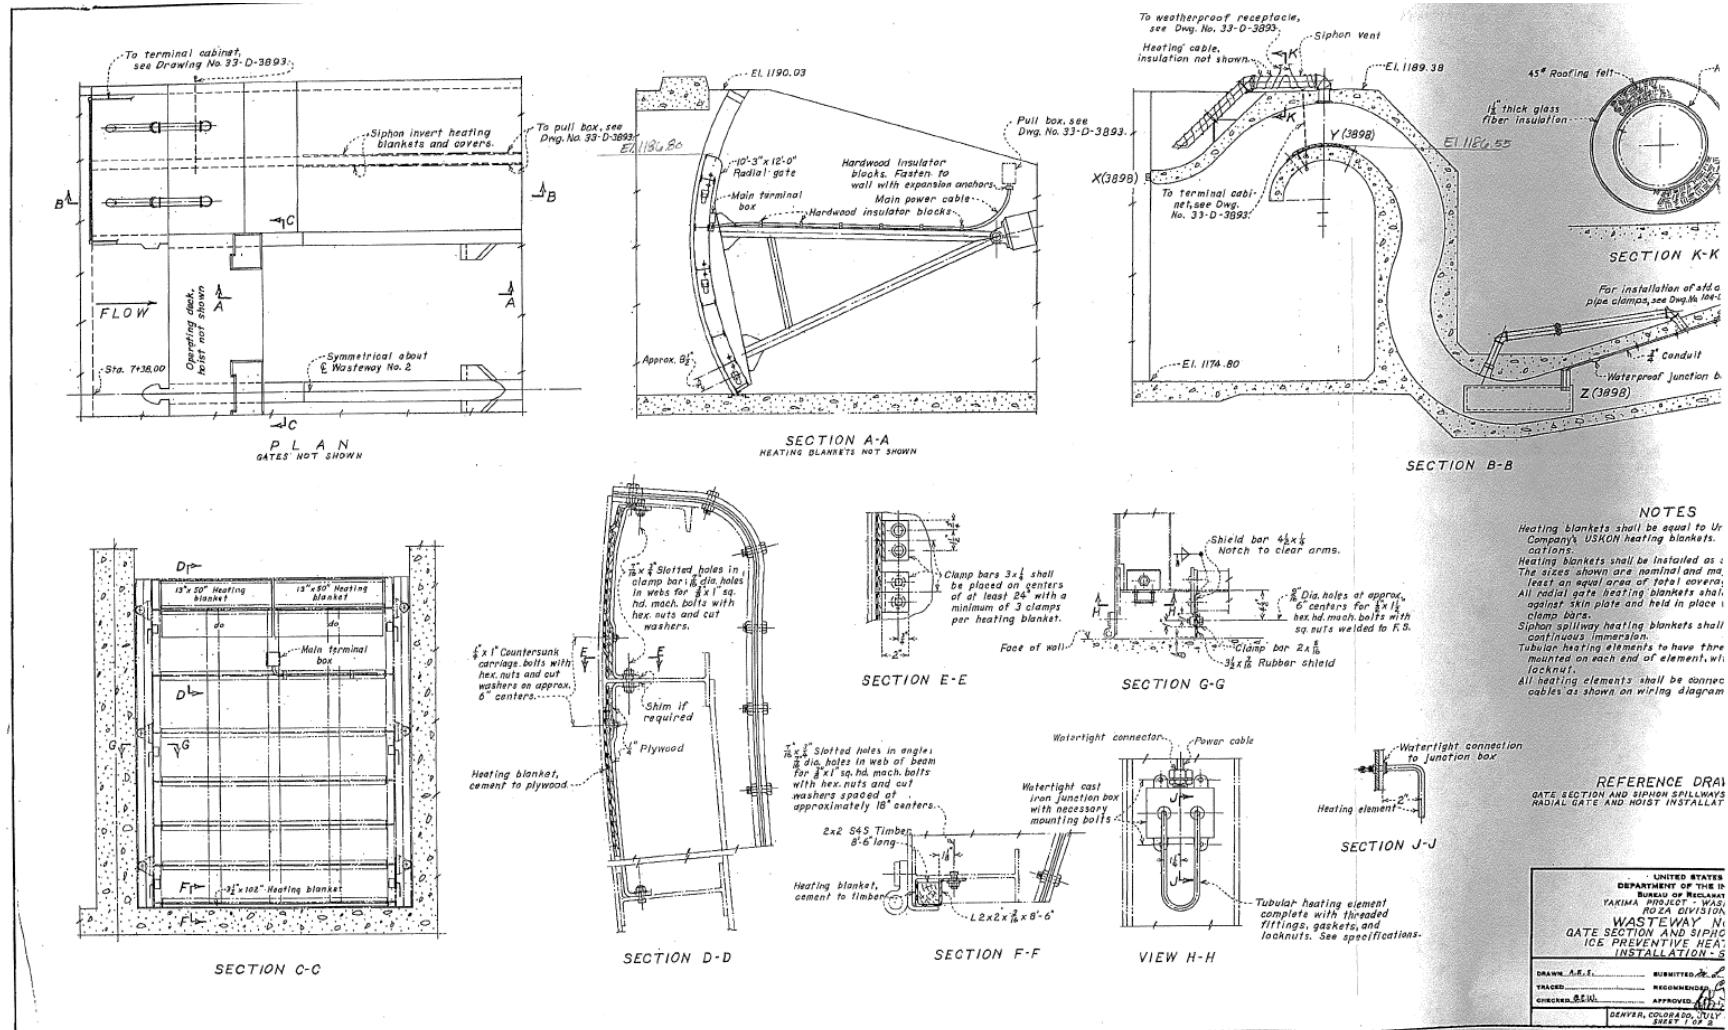
Figure 22 Drawing of siphon and radial gates (drawing no. unknown) taken from the Roza Powerplant Designers' Operating Criteria (Bureau of Reclamation).

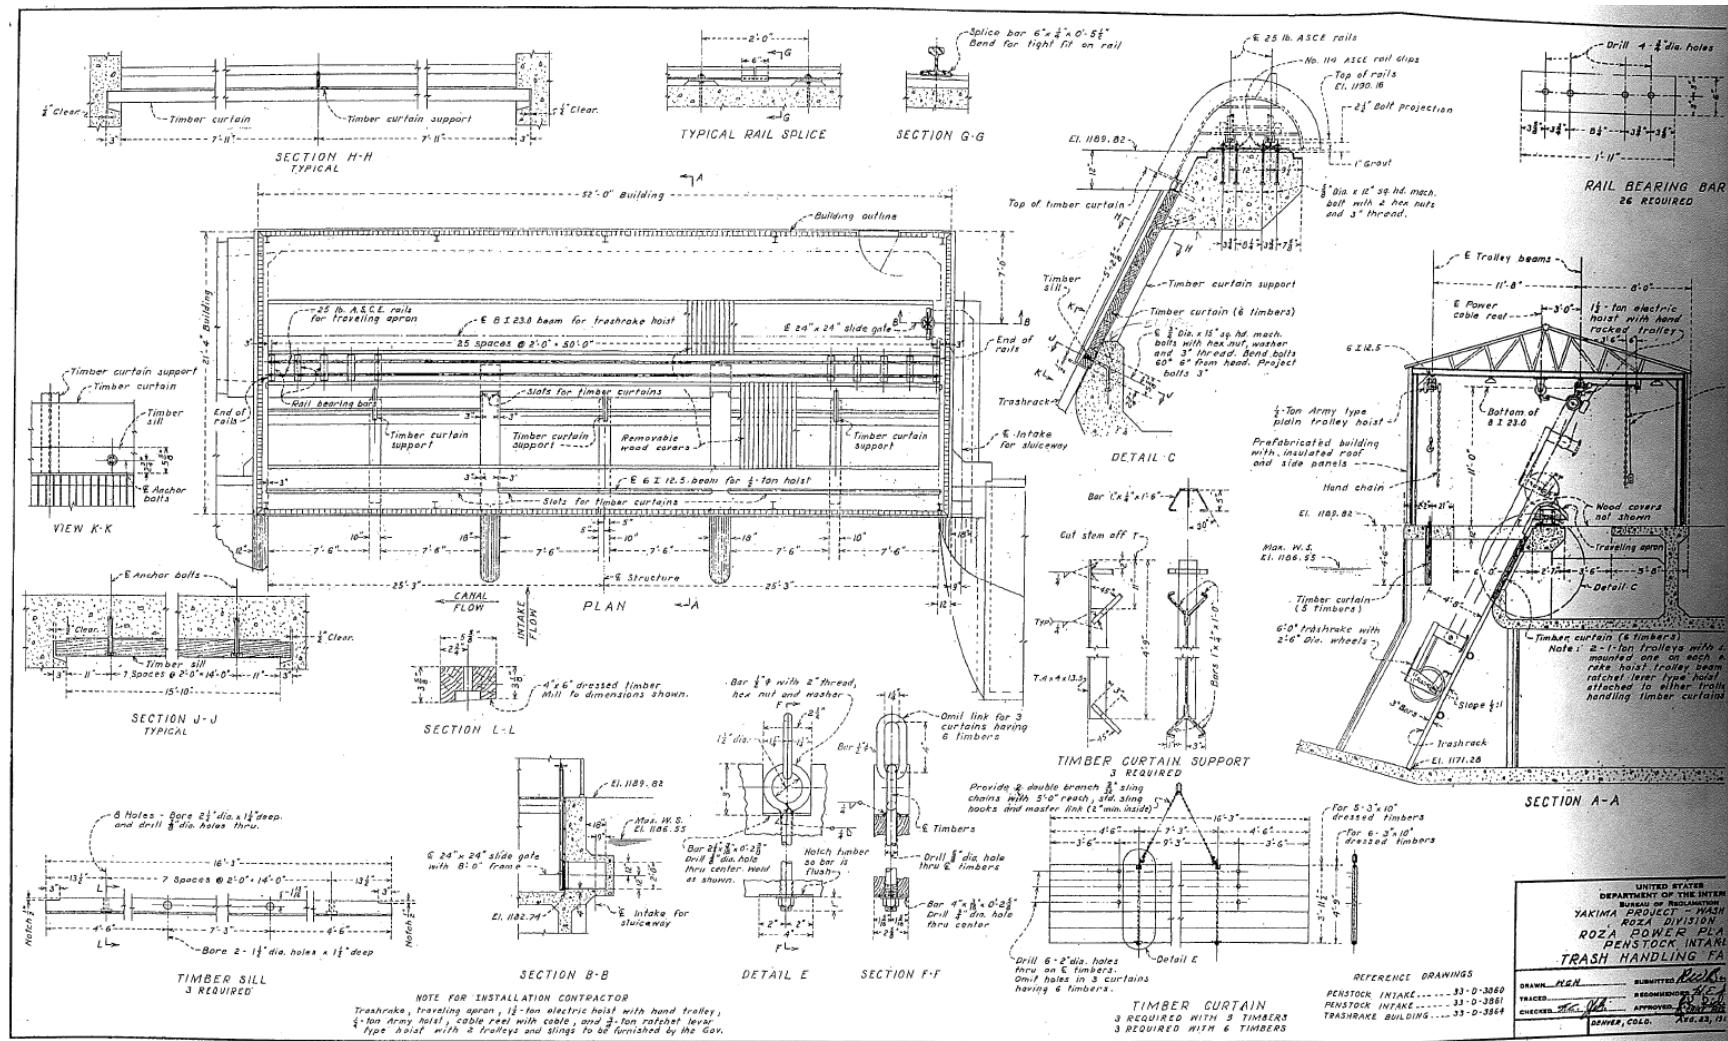
Figure 23 Drawing of trash handling facility at the penstock and sluiceway entrance (drawing no. unknown) used for geometry to estimate flow through sluiceway. Taken from the Roza Powerplant Designers' Operating Criteria (Bureau of Reclamation).
