WATER SAVINGS VERIFICATION RESULTS FOR Florida Farmers Ditch Company Canal Lining Project (WEEG-11-141)

**U.S. Department of the Interior
Bureau of Reclamation
Technical Service Center
Hydraulics Investigations and Laboratory Services Group
Denver, Colorado**

October 2014

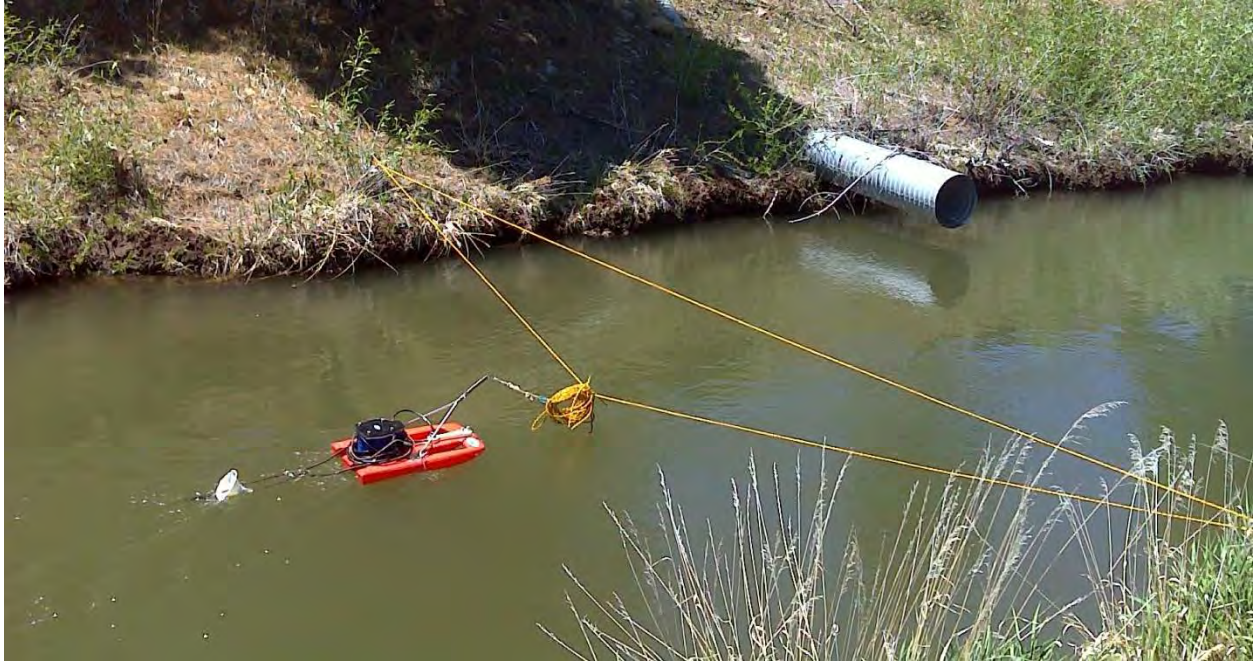
Figure 2. Photograph of the flow measurement cross section upstream from the Payne Canyon Siphon (flow is from right to left). The Teledyne/RDI Streampro and tagline were temporarily installed for this flow measurement.

The second flow measurement was at the same location measured on May 29, 2012 (Figure 2). This site was located about 370 ft upstream from the 10-ft concrete Parshall flume that measures the Florida Farmers Ditch diversion. The water was clear enough to see the bottom which was primarily sand and gravel. The site was still free from any significant aquatic vegetation and the cross section was relatively uniform with a mean depth of depth about 2.8 ft. A moving-bed test did not indicate any bed sediment transport.

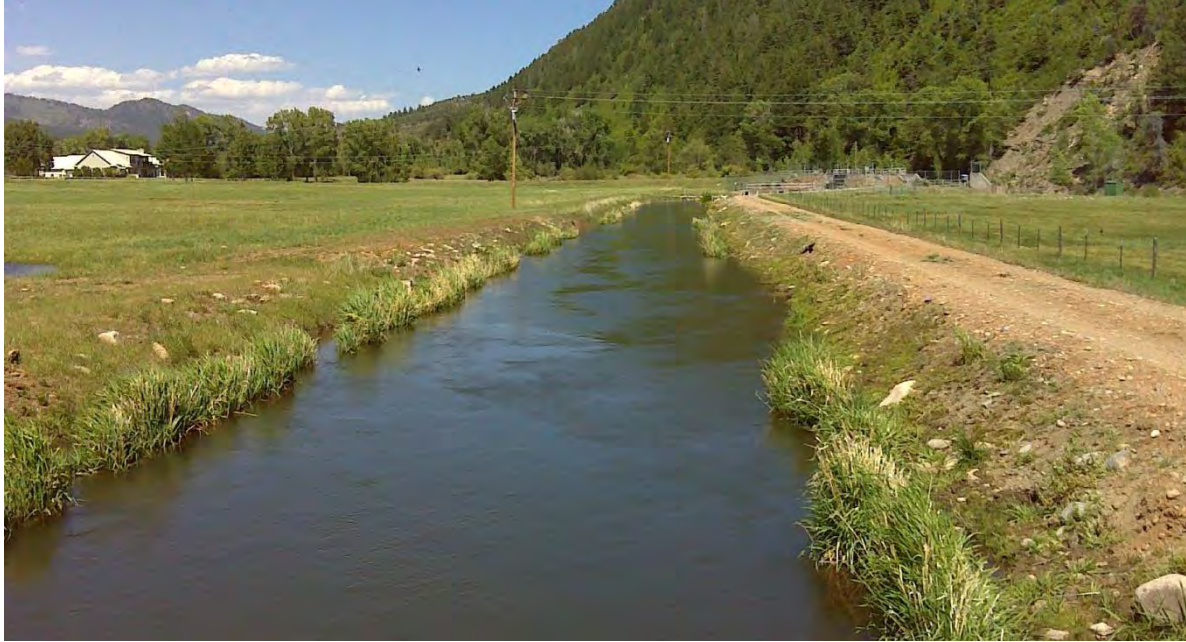
The second flow measurement location was upstream from the start of the canal lining project, located just downstream from a wood bridge (Figure 3). This site was located about 370 feet upstream from the 10-ft concrete Parshall Flume that measures the Florida Farmers Ditch diversion. The Colorado Division of Water Resources maintains a gaging station at this flume (see figure 4). The gaging station is about 1,000 feet below the head gate on the Florida River. The ditch upstream is straight and has a relatively uniform cross section (figure 4). The site was free from any significant aquatic vegetation and the cross section was relatively uniform with a mean depth of about 3.3 feet. A moving-bed test did not detect any bed sediment transport at the time of this flow measurement.

Figure 3. Photograph looking upstream from the wood bridge crossing the Florida Farmers Ditch above the flow measurement site.

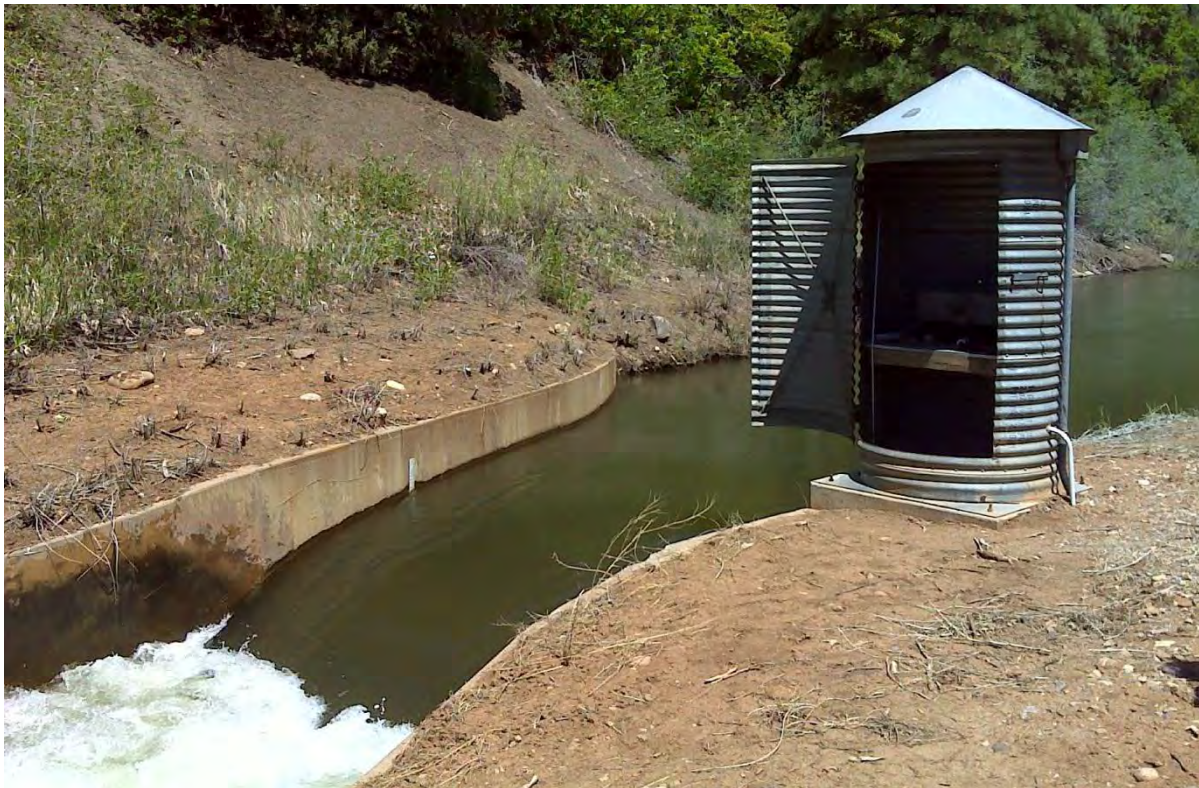
Figure 4. Photograph of 10-ft concrete Parshall Flume and water stage recorder used to monitor Florida Farmers Ditch diversions ([DWR Site: FARMERCO](#)).

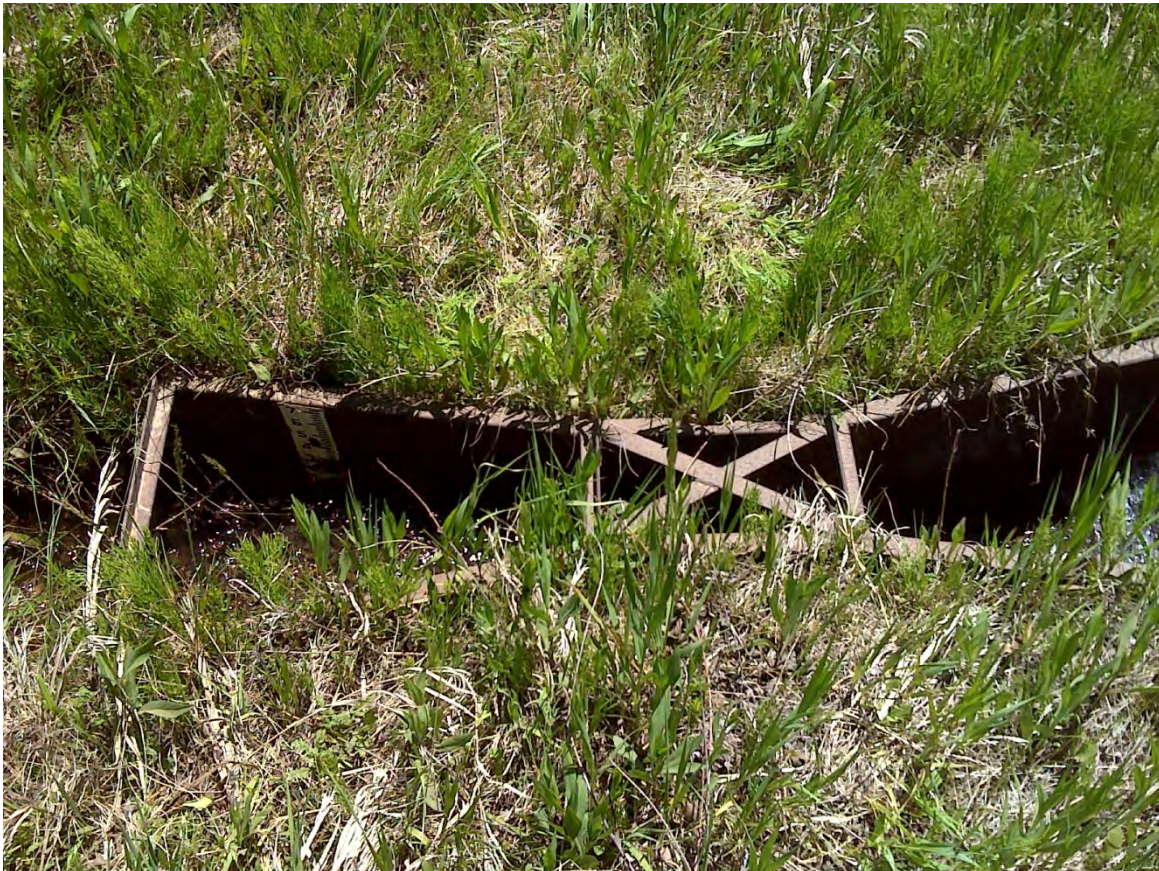
During the May 29, 2012 flow measurements, Mr. Vermeyen visited two small turnouts along Reach G. The turnout near the Horse Gulch siphon was delivering 0.25 ft³/sec according to the 6-in Parshall Flume (figure 5). A field measurement was not taken because measurement of the low flow in the undefined channel would have been less accurate than the flume measurement. There was a second turnout near the Payne Canyon siphon, but it was shut-off during these flow measurements. The condition of these Florida Farmer Ditch flow measurement flumes were documented in a WWE memorandum (WWE, May 2012).

Figure 5. Photograph of 6-in. Parshall Flume on Farmers Florida Ditch diversion near the Horse Gulch siphon, N37.28947° W107.79643°.

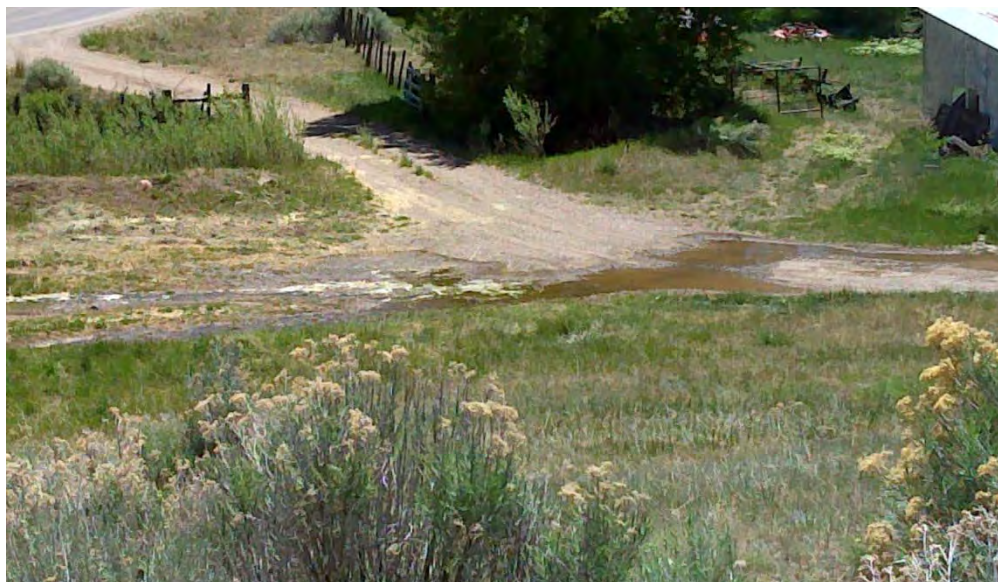
On May 29, 2012, Mr. McCoy took Mr. Vermeyen to an area of significant seepage from the Florida Farmers Ditch. The seepage site is located about 0.4 miles downstream from the gaging station. Figure 6 is a photograph of the seepage area located between the ditch and CO Rd 234. According to Mr. McCoy, this seepage was typical for this relatively high flow in the ditch.

Figure 6. Photograph of canal seepage from the Florida Farmers Ditch near N37.28796° W107.79712°.

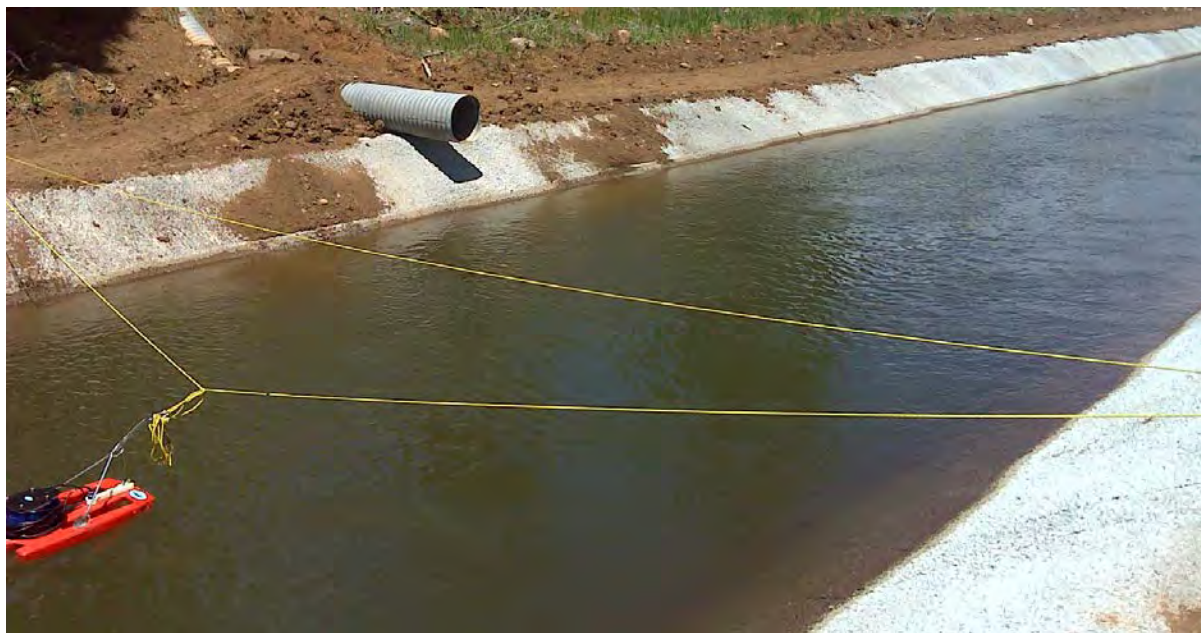
Flow measurements were repeated at the end of the canal lining project, located just upstream from the Payne Canyon Siphon (Figure 8). This canal reach was designated as “G” in previous studies by Wright Water Engineers. The site was the same as previous measurement except the canal was now lined with shotcrete. The canal cross section was very uniform with a mean and max depth of 2.8 and 3.8 ft, respectively. A moving-bed test did not detect any bed sediment transport which could compromise the discharge measurements. Flows were measured with the same Teledyne/RD Instruments Streampro acoustic Doppler current profiler used for the 2012 pre-project measurements. A total of 6 Streampro discharge measurement transects (passes across the channel) were made from 12:17 until 12:25 p.m. (Table 5). The average flow was $167.47 \text{ ft}^3/\text{sec}$ with a standard deviation of $\pm 2.29 \text{ ft}^3/\text{sec}$. The range of discharge measurements was 165 to $172 \text{ ft}^3/\text{sec}$ and the average channel velocity was $2.79 \text{ ft}/\text{sec}$.

Figure 8. Photograph of the flow measurement cross section upstream from the Payne Canyon Siphon (flow is from right to left). The Teledyne/RDI Streampro and tagline were installed at the same location as pre-project measurements.

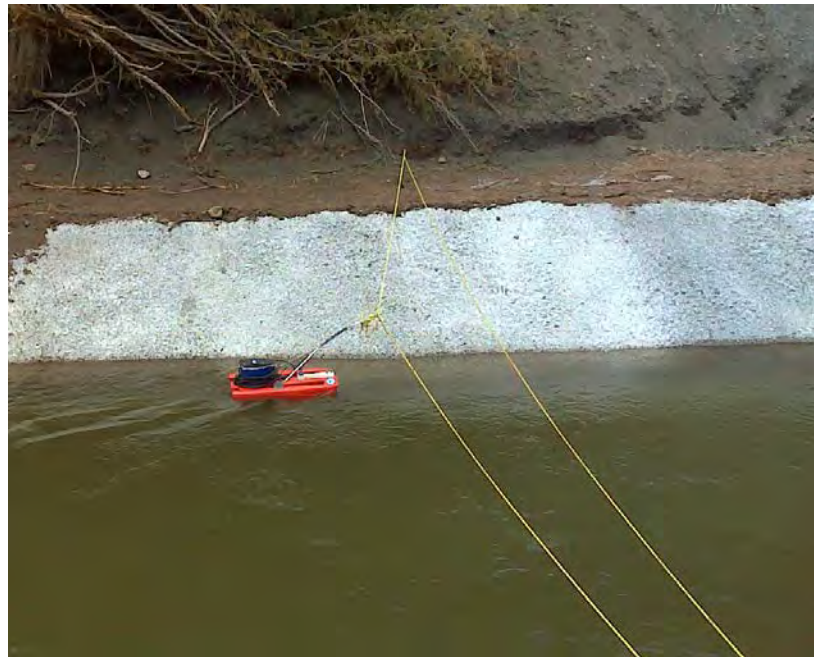
Figure 9. Photograph of Streampro measurement located 640 ft downstream from the start of canal lining. This location was selected to be an adequate distance downstream from a bend in the canal, N37°17'24.4" W107°47'46.5".

The second flow measurement site (figure 9) was setup 640 ft downstream from the start of the canal lining project. The canal lining project begins about 900 ft downstream from the 10-ft Parshall Flume. This flow measurement site was located about 1,540 feet downstream from the 10-ft concrete Parshall Flume that measures the Florida Farmers Ditch diversion. The measurement site was in a straight section of lined canal about 230 ft upstream from the Horse Gulch siphon. A moving-bed check did not detect any bed sediment transport at the time of this flow measurement.
