Hydraulic Performance Evaluation of the Replacement Primary Bypass Intakes and Transition Boxes at Tracy Fish Collection Facility

Volume 40

U.S. Department of the Interior
Bureau of Reclamation
Mid-Pacific Region
Technical Service Center

July 2007

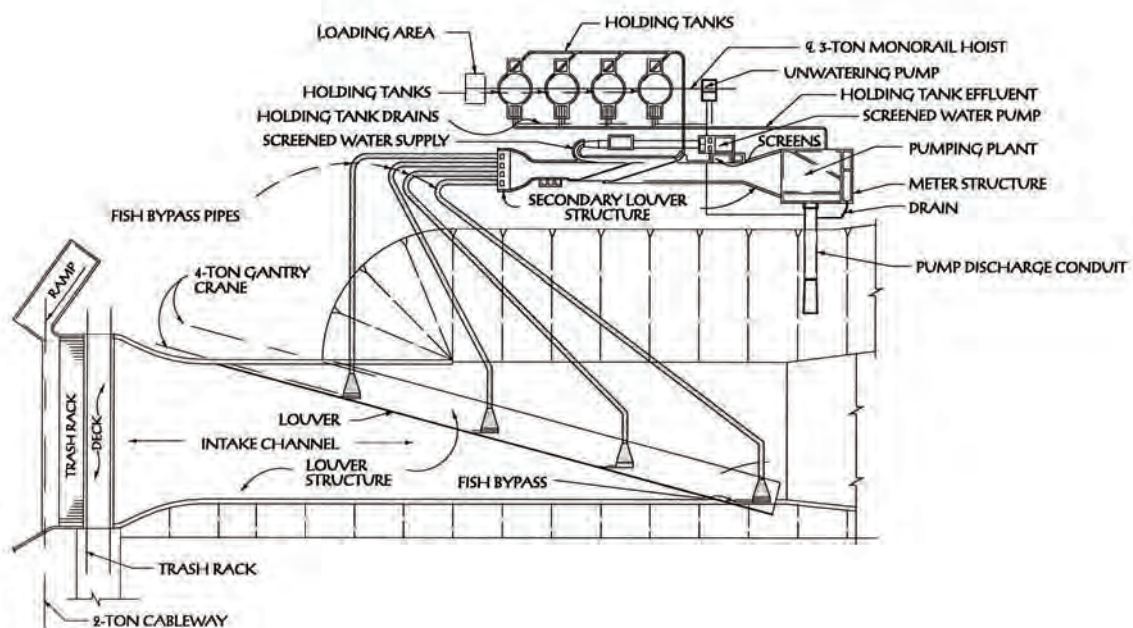
FIGURE 1.—Plan view schematic of Tracy Fish Collection Facility.

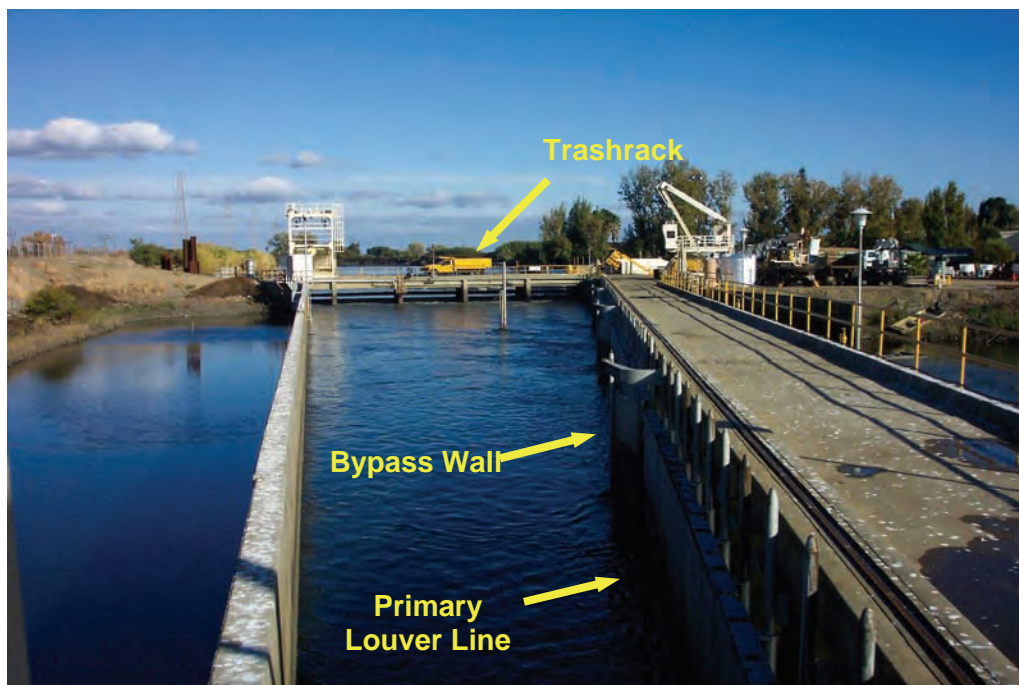
FIGURE 2.—Features in the primary channel looking upstream.

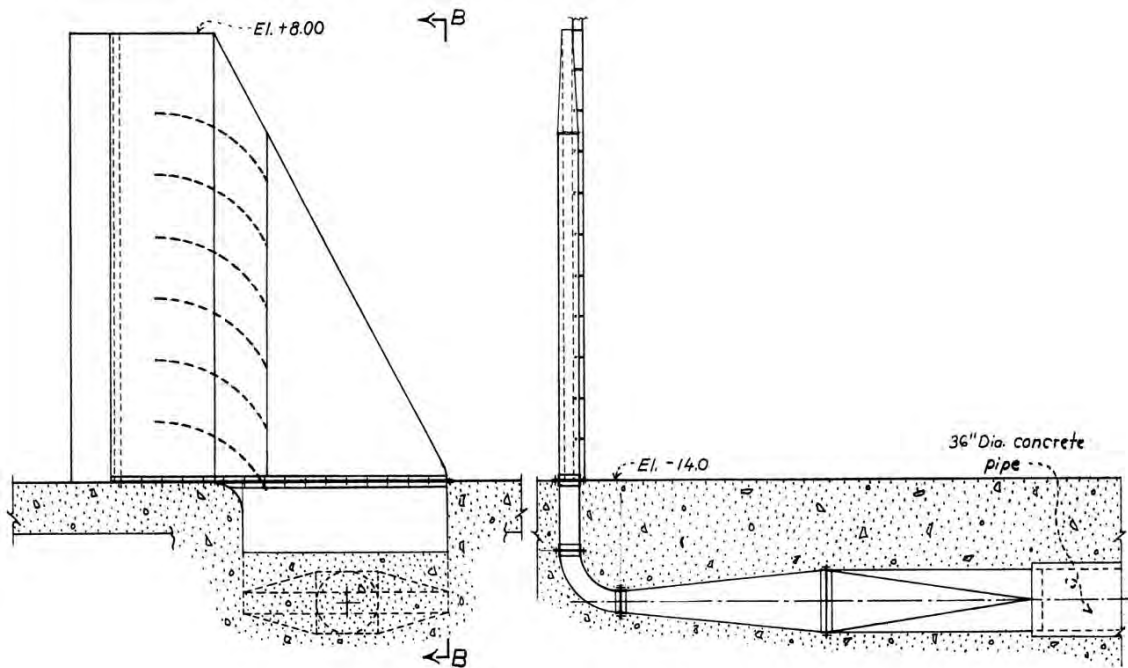
FIGURE 3.—Original bypass intake design using internal curved vanes from 1956.

Although the intakes were designed to generate near-uniform entrance velocity distributions, the vanes were not accessible for maintenance and cleaning. The vanes accumulated debris, causing flow blockages within the intake and degrading

the uniformity of the entrance velocity profiles. As the bypass intakes corroded and deteriorated with time, vane failure reduced velocity distribution control effectiveness and holes in the bypass transition boxes were observed.

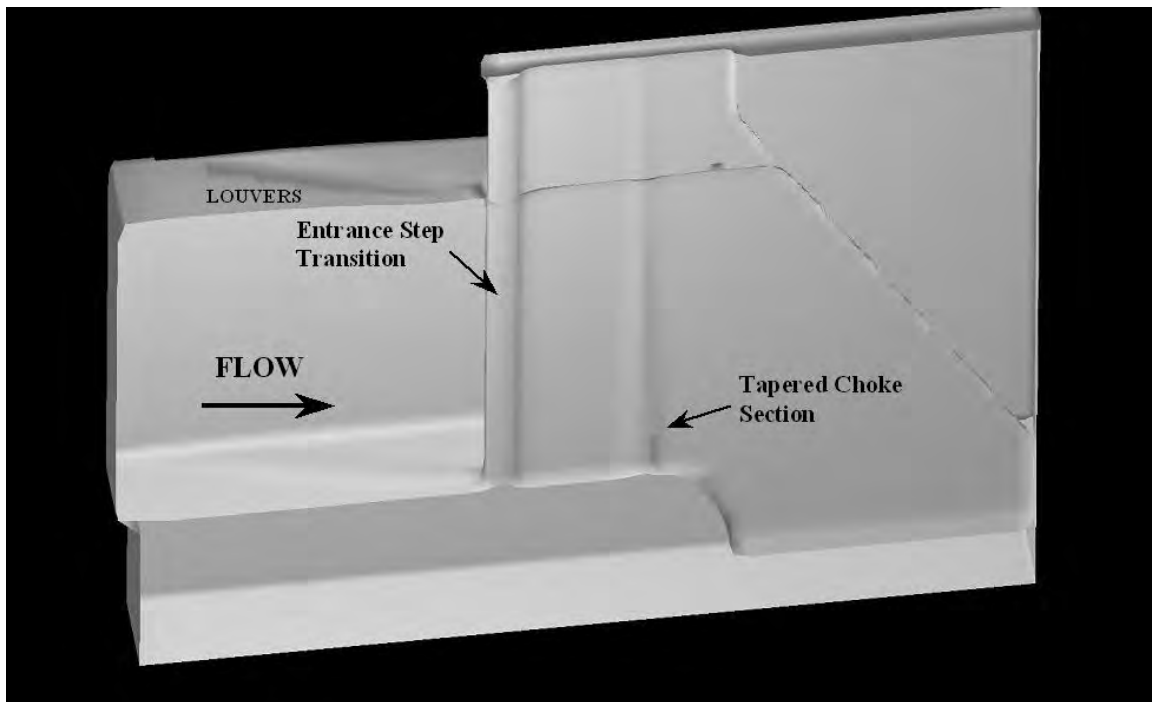
FIGURE 4.—Replacement bypass intake design using a tapered choke section (Kubitschek, 2003).

Because of corrosion and failure of both the vanes and the skin of the transition boxes, an effort was initiated in 2001 to replace the four primary bypass intakes. The bypass intakes were repaired in the spring of 2003 and the replacement bypass intakes were installed at the TFCF in the spring of 2004. The intakes and transition boxes were designed based on physical and computational hydraulic model studies (Kubitschek, 2003). The replacement design used a tapered choke (vertically tapered section) to generate a near-uniform vertical velocity without the need for internal turning vanes (figure 4). This design constricts the intake flow path with a linear expansion from the bottom to the surface, vertically balancing the velocity potential at the intake entrances. The advantage of this design is that debris accumulation may be reduced to sustain effective operation.

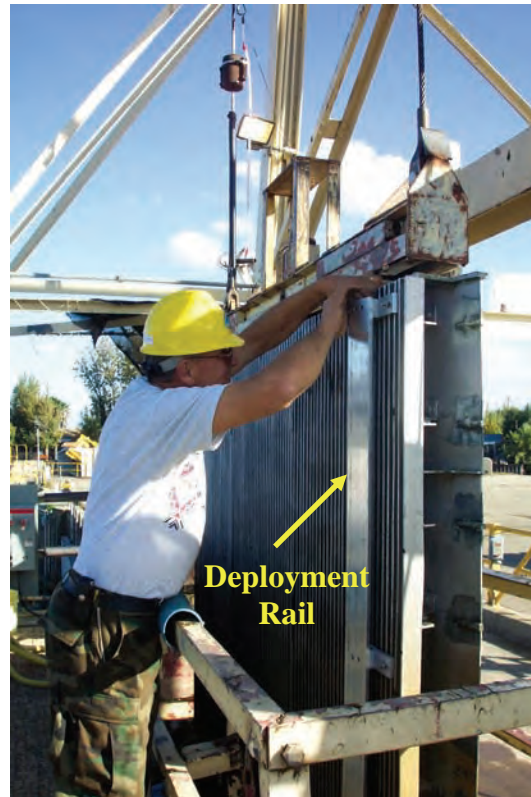
FIGURE 5.—An ADV deployment rail was affixed to the louver panel just upstream from the bypass entrance.

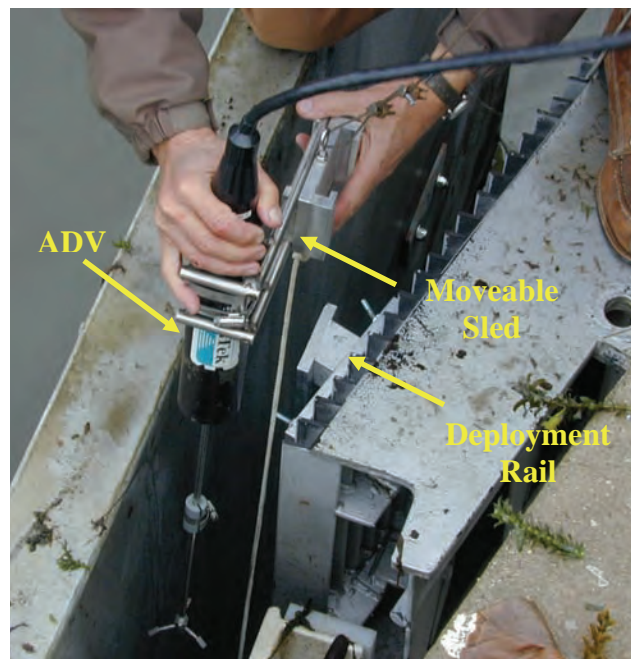
FIGURE 6.—The ADV was attached to a moveable sled to vertically position the instrument along the rail.

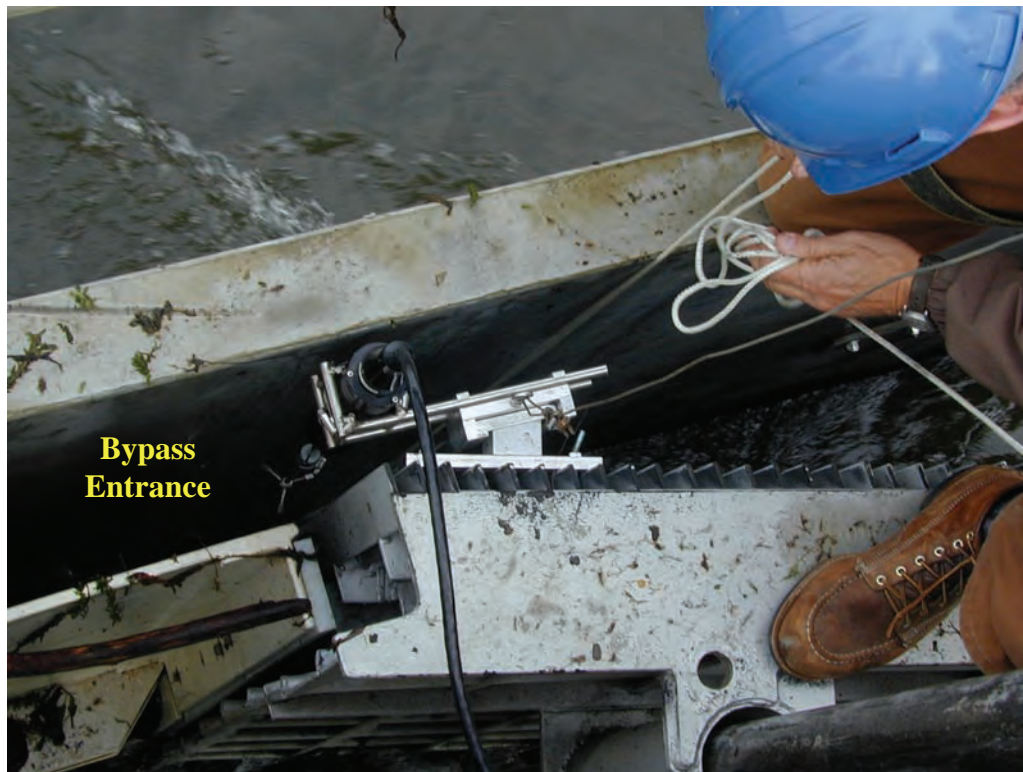
FIGURE 7.—The ADV was lowered down on the deployment rail into the bypass entrance.

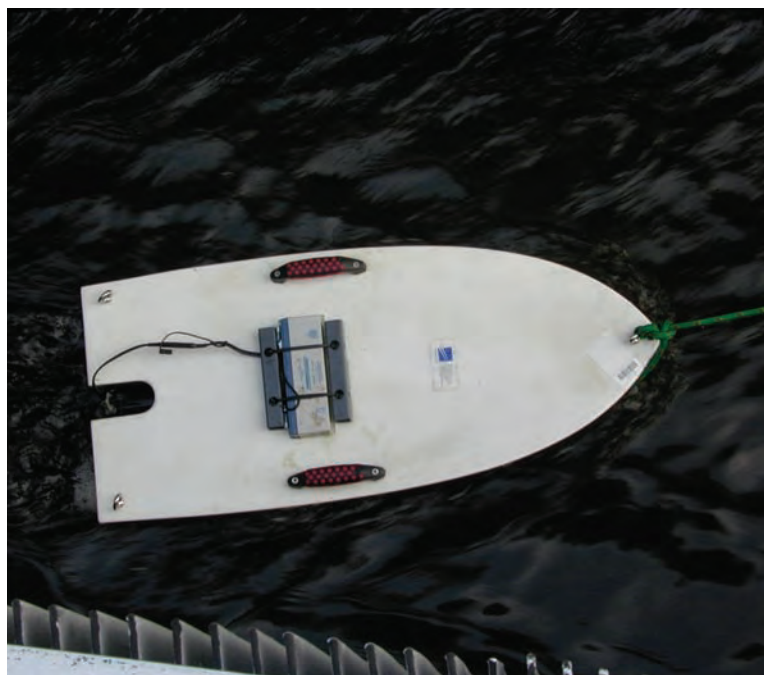
FIGURE 8.—Nortek BoogieDopp velocity profiler.

Near-field approach velocity profiles upstream from the intake were collected with the Nortek BoogieDopp instrument which was replaced by the Qmetrix Qliner in 2004 (figure 8). This instrument utilizes acoustic Doppler technology to measure velocity profiles with an accuracy of 1 percent of the measured value ± 0.016 ft/s (0.5 cm/s). A current profiler is mounted on the bottom of a boogie board. The BoogieDopp is easily deployed from land since it collects data in a Pocket PC through a wireless radio modem. The instrument records velocity values in a series of depth cells throughout the water column. Velocities are averaged over a 5-second period for each 15 cm depth cell during the measurement duration of 60 seconds.

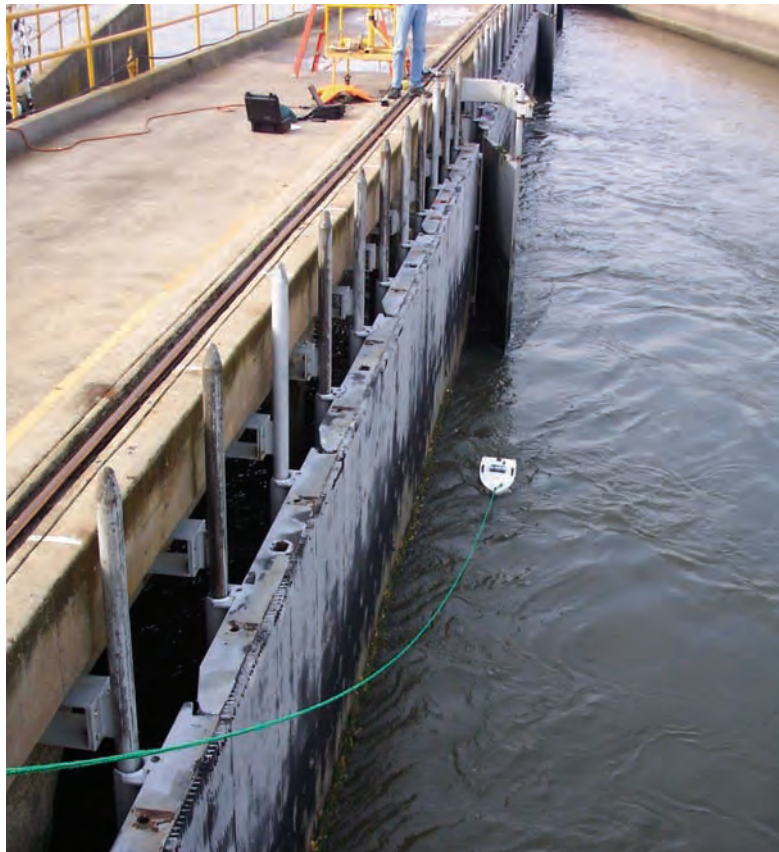
FIGURE 9.—The BoogieDopp was positioned upstream from the intake entrance to document near-field approach velocity conditions.

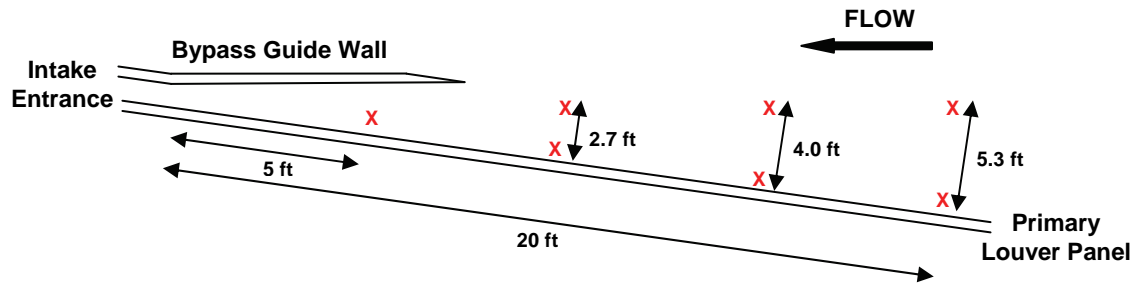
FIGURE 10.—Schematic of velocity profile locations (indicated by X) upstream from the intake entrance. Profiles were measured against the louver panel face and several feet away from the louvers.

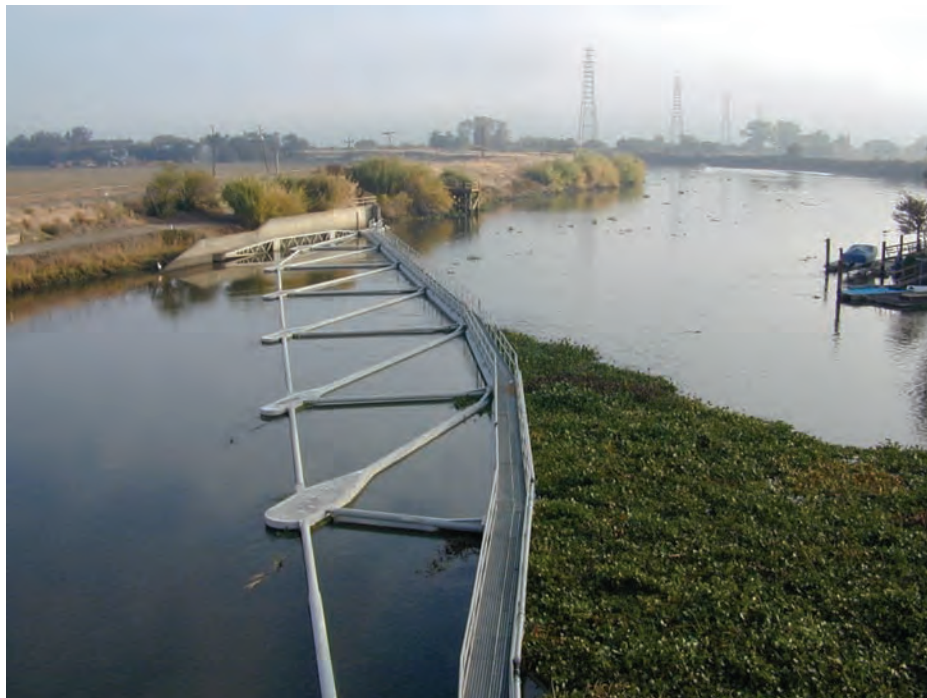
FIGURE 11.—Debris collected upstream from the debris boom. Heavy debris loads clog the facility and affect the performance of the louver system.

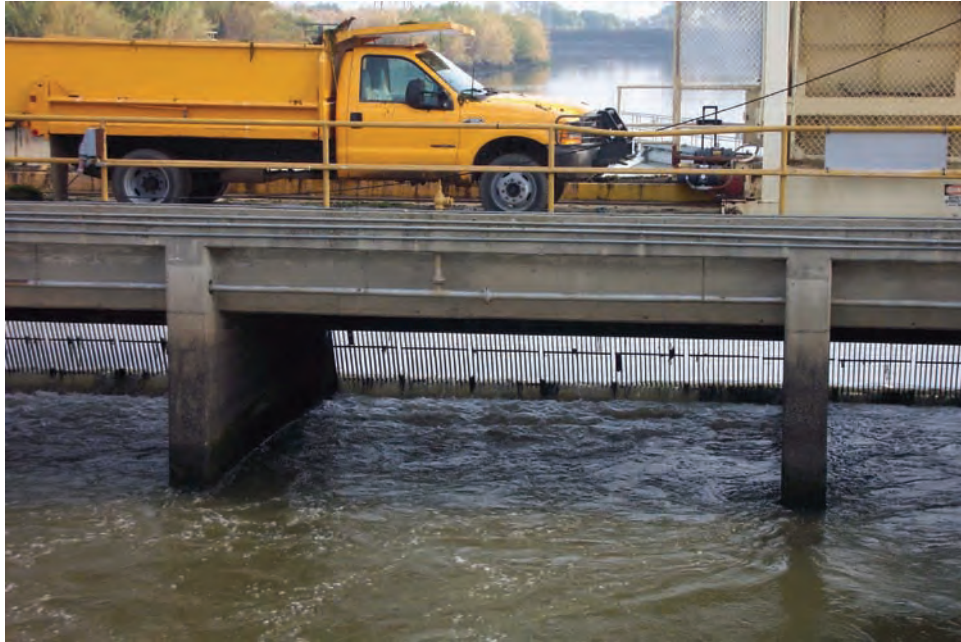
FIGURE 12.—Trashrack fouling was documented during data collection.

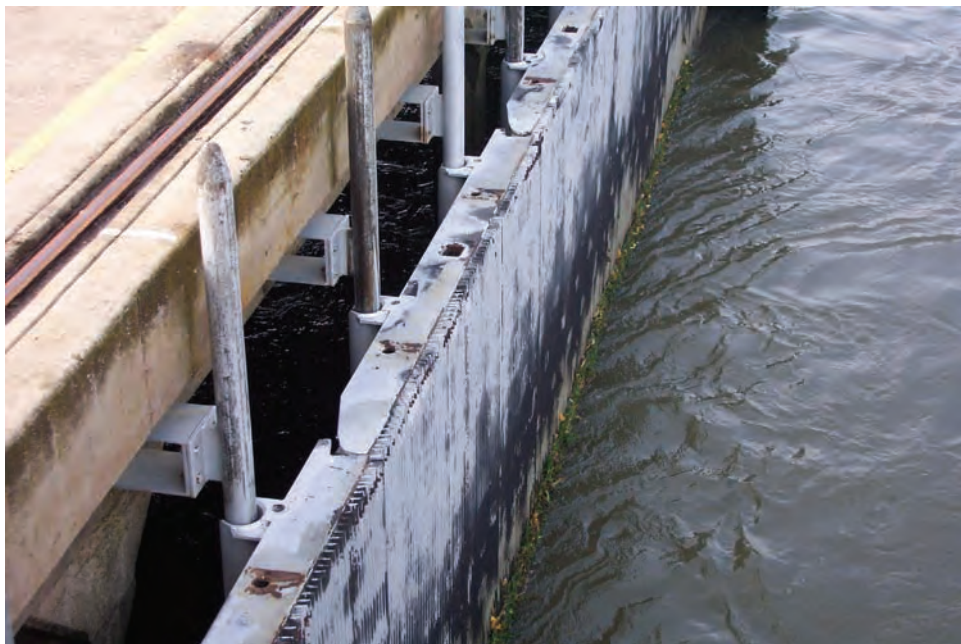
FIGURE 13.—Louver panel fouling was documented during data collection.

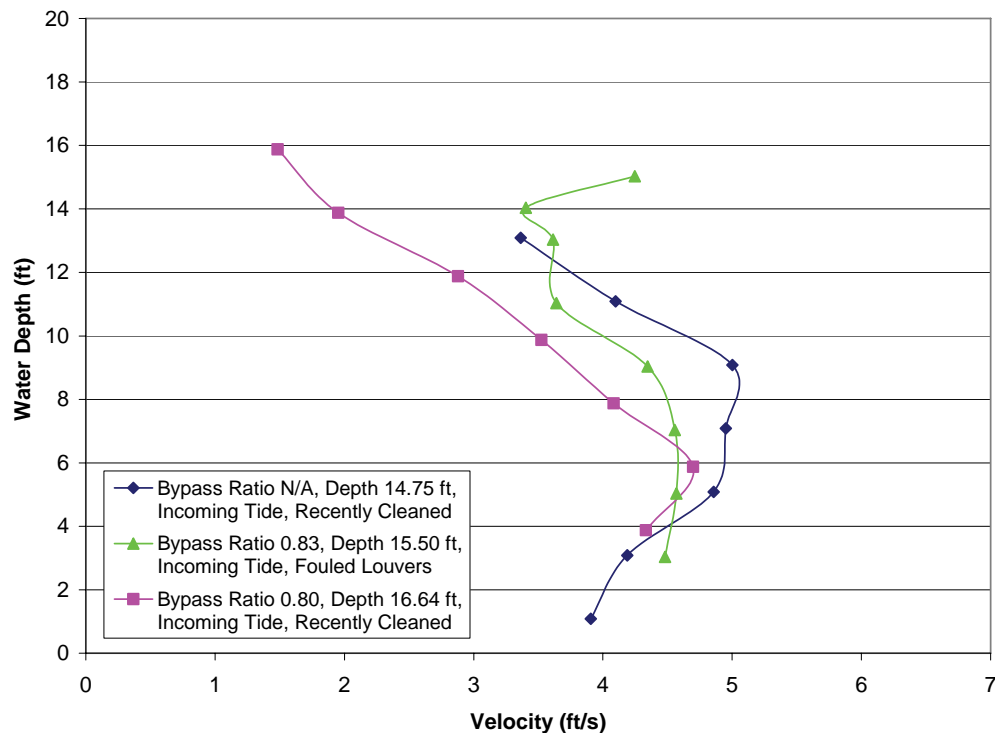
FIGURE 14.—Velocity profiles in the original primary bypass 1 intake entrance.

The downstream velocity components are presented below for various bypass ratios, water depths, and debris conditions. Original intake velocity profiles for bypasses 1 and 2 are shown in figures 14 and 15 and the replacement intake velocity profiles for bypasses 1-4 are shown in figures 16-19, respectively. It is difficult to isolate the effect of intake and transition box condition on nonuniformity since approach velocity distributions, debris fouling, and bypass ratio also affect the entrance velocity profiles. However, for the velocity profiles in bypasses 1 and 4 that have similar operating conditions, the replacement intakes produce a slightly more uniform velocity profile than the existing original intakes. Most importantly, figure 19 shows that the replacement bypasses operate as intended when the standing operating procedure of bypass ratios above 1.0 can be achieved. Bypass ratios less than 1.0 show pronounced vertical nonuniformity.

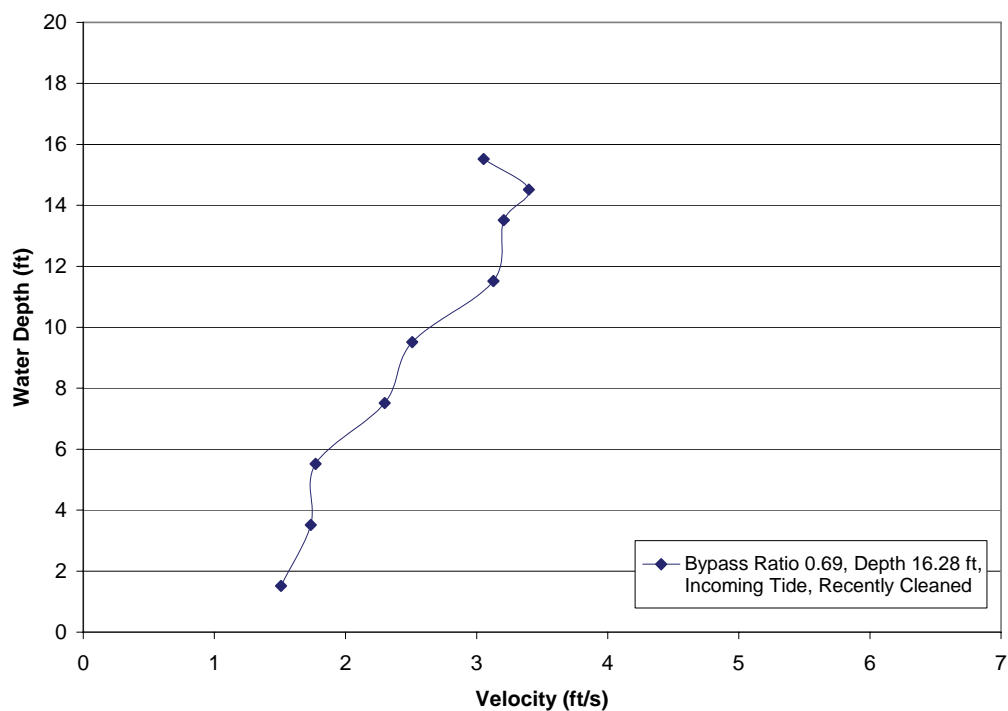
FIGURE 15.—Velocity profiles in the original primary bypass 4 intake entrance.

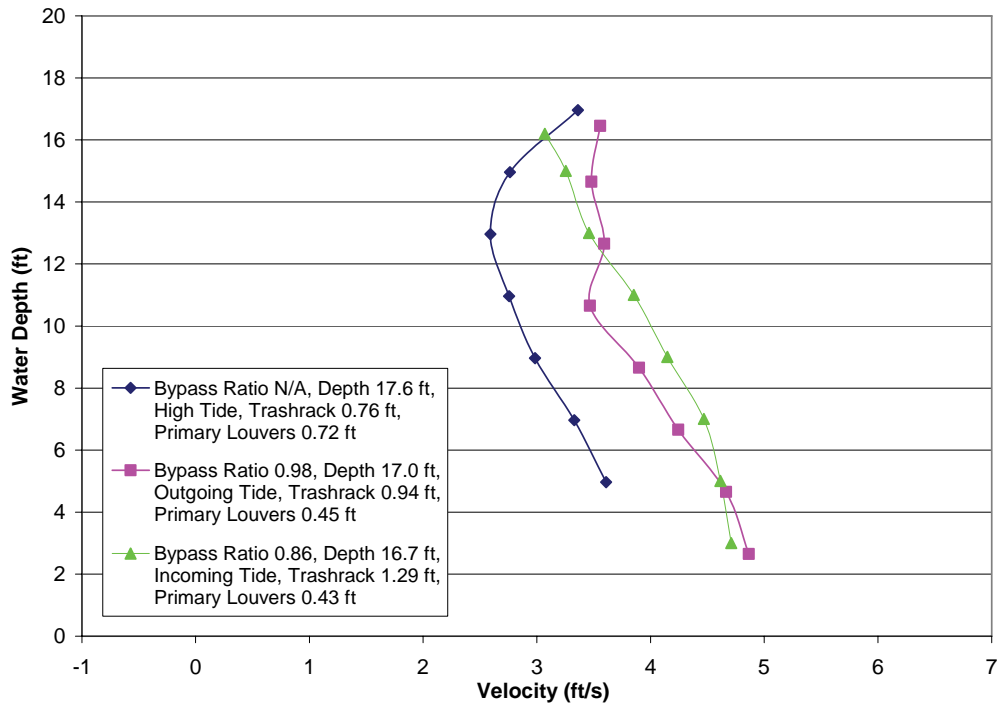
FIGURE 16.—Velocity profiles in the replacement primary bypass 1 intake entrance.

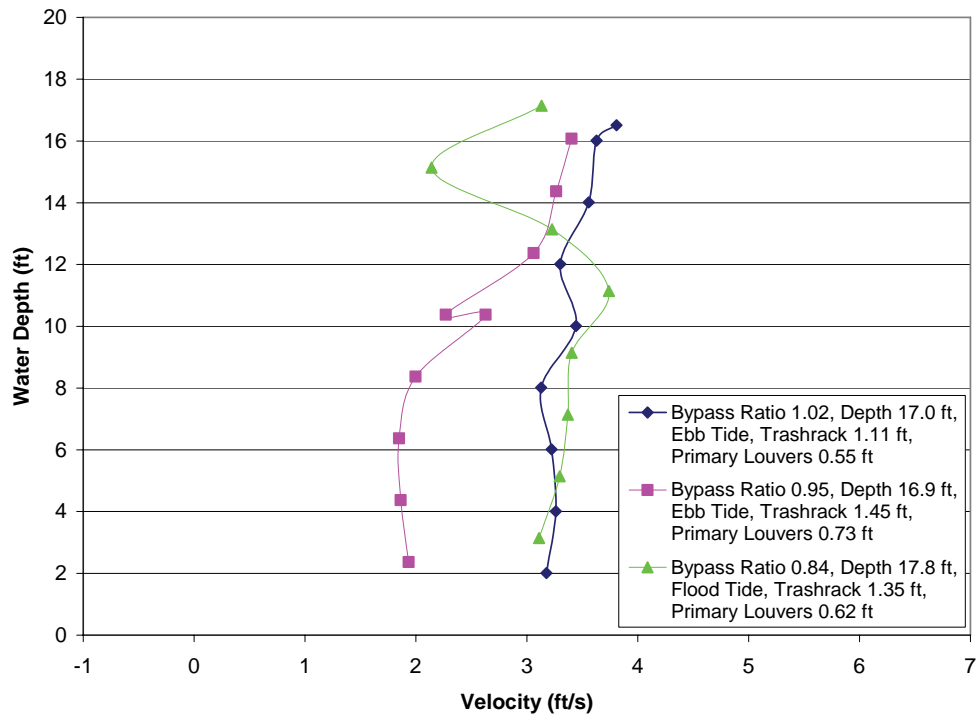
FIGURE 17.—Velocity profiles in the replacement primary bypass 2 intake entrance.

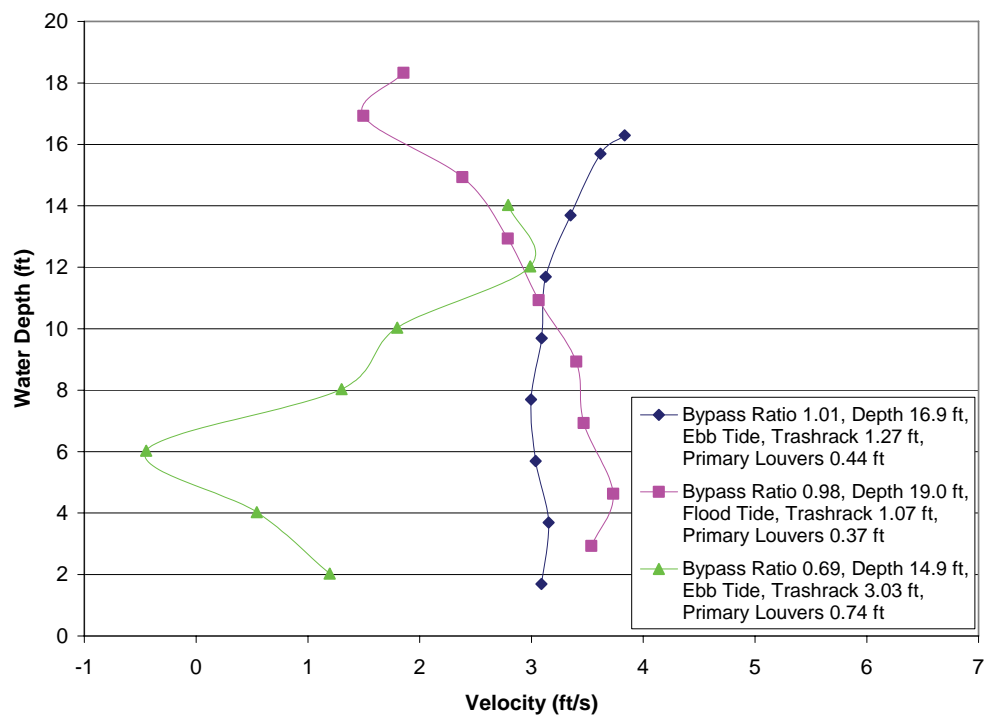
FIGURE 18.—Velocity profiles in the replacement primary bypass 3 intake entrance.

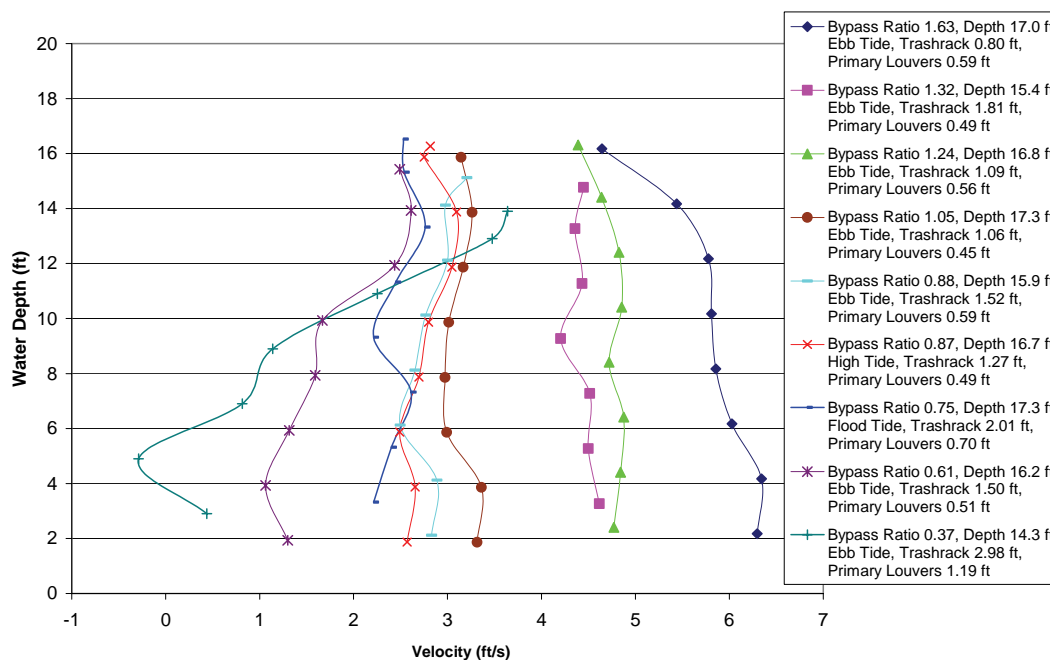
FIGURE 19.—Velocity profiles in the replacement primary bypass 4 intake entrance.

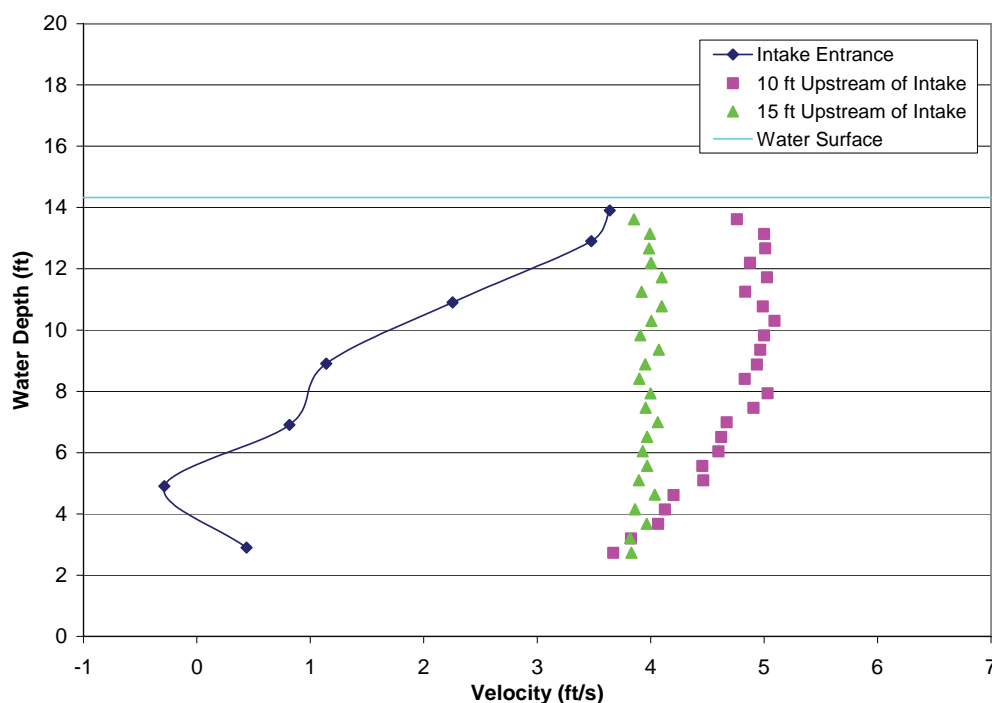
FIGURE 20.—Example of a profile collected with a bypass ratio of less than 1.0. Test 2-4, collected at bypass 4 with a measured bypass ratio of 0.37, shows significant slowing in the approach velocity fields and reverse flows at the intake entrance.

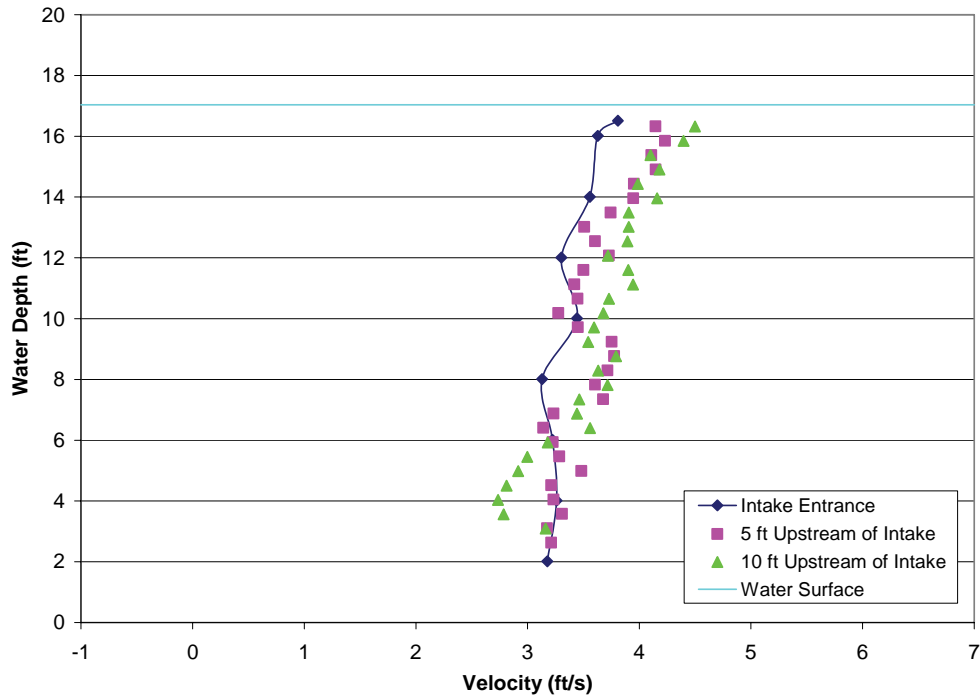
FIGURE 21.—Example of a profile collected with a bypass ratio near 1.0. Test 3-2, collected at bypass 2 with a measured bypass ratio of 1.02, shows similarly shaped approach profiles with a slight deceleration of flow into the intake.

When bypass ratios are near 1.0, profiles measured in the intake are often similar in shape to near-field velocity profiles (figure 21). This similarity in flow distribution is consistent with scale physical model results (Johnson *et al.*, 2004). Flow accelerates or decelerates gradually into the intake with little flow disruption. When bypass ratios are well above 1.0, the flow consistently accelerates into the intake as is recommended for efficient fish collection (figure 22). Since bypass ratios greater than 1.0 are difficult to achieve in the field, one or two of the four bypasses were closed during the field evaluations to force more water to pass through the open bypasses. This alternative operating method raises the bypass ratio of the open bypasses while maintaining an acceptable velocity in the secondary channel.

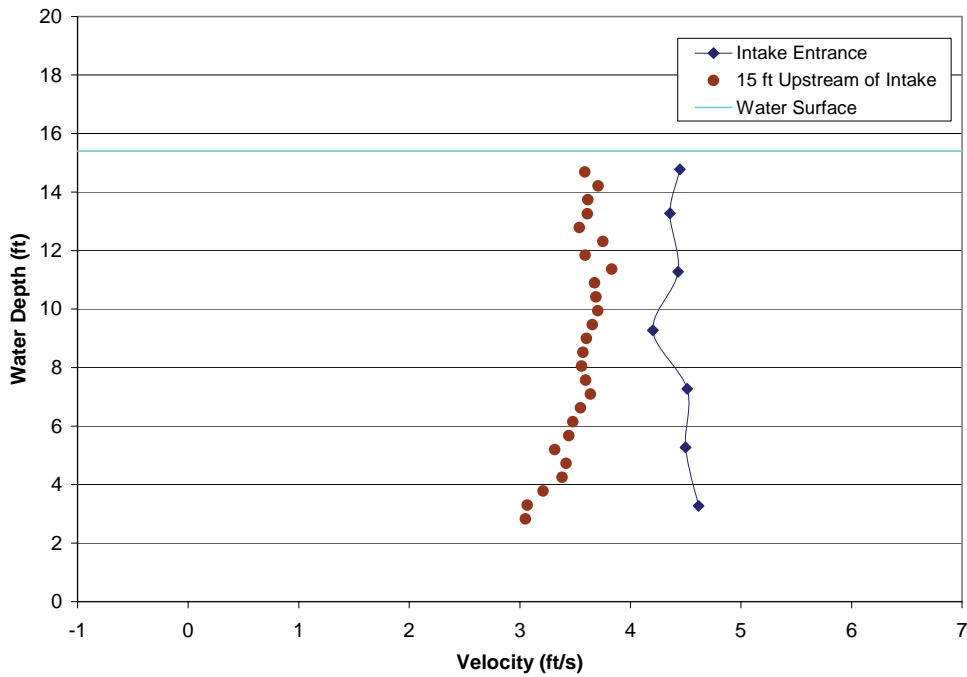
FIGURE 22.—Example of a profile collected with a bypass ratio greater than 1.0. Test 1D, collected at bypass 4 with a measured bypass ratio of 1.32, shows an acceleration of flow into the intake.
