Using Low-Cost Microcontrollers with eTape[®] for Measuring Streamflow

**Water and Sediment Measurement – Internal Applied Science
Water Resource and Planning Office
Final Report No. IAS-2020-016
Hydraulic Laboratory Technical Memorandum, PAP-1223**

**Technical Services Center
Hydraulic Investigations and Laboratory Services Group**

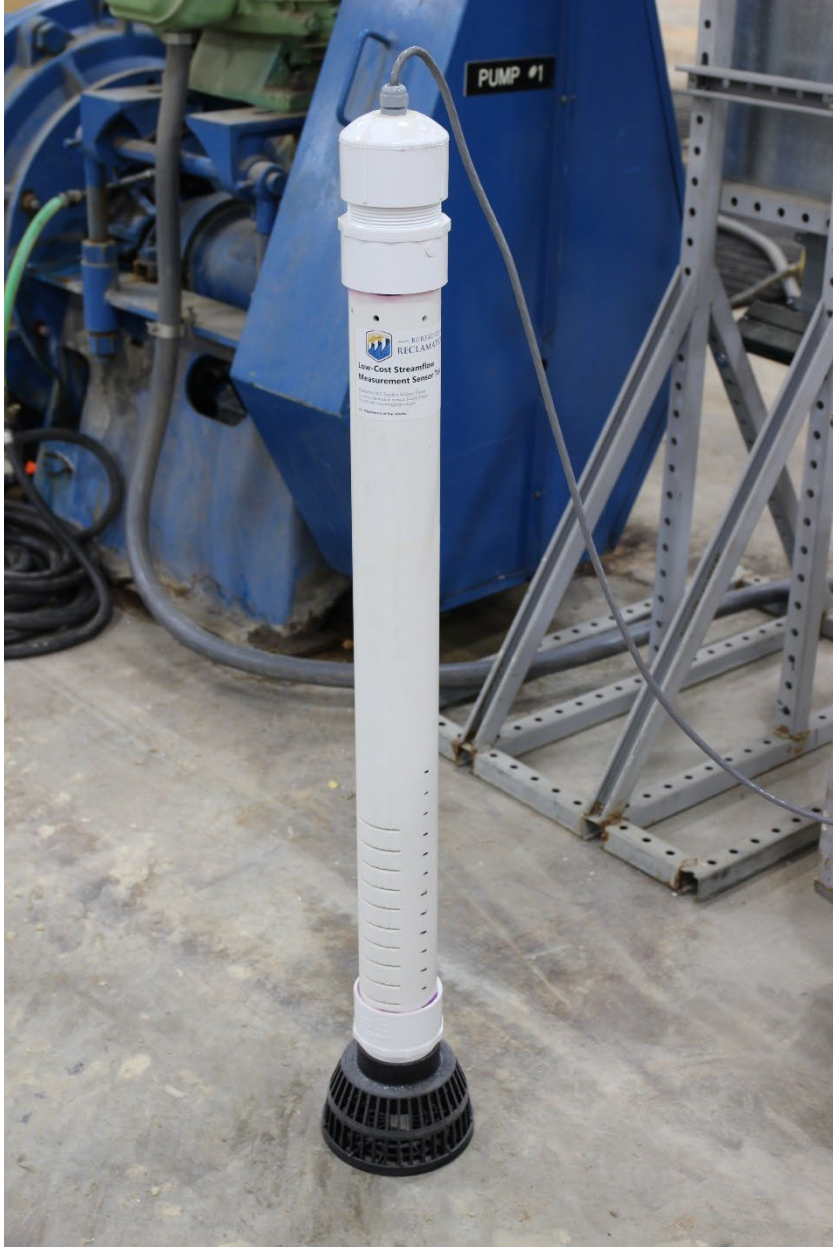
Figure 2 – Photograph of the PVC standpipe housing the eTape®.

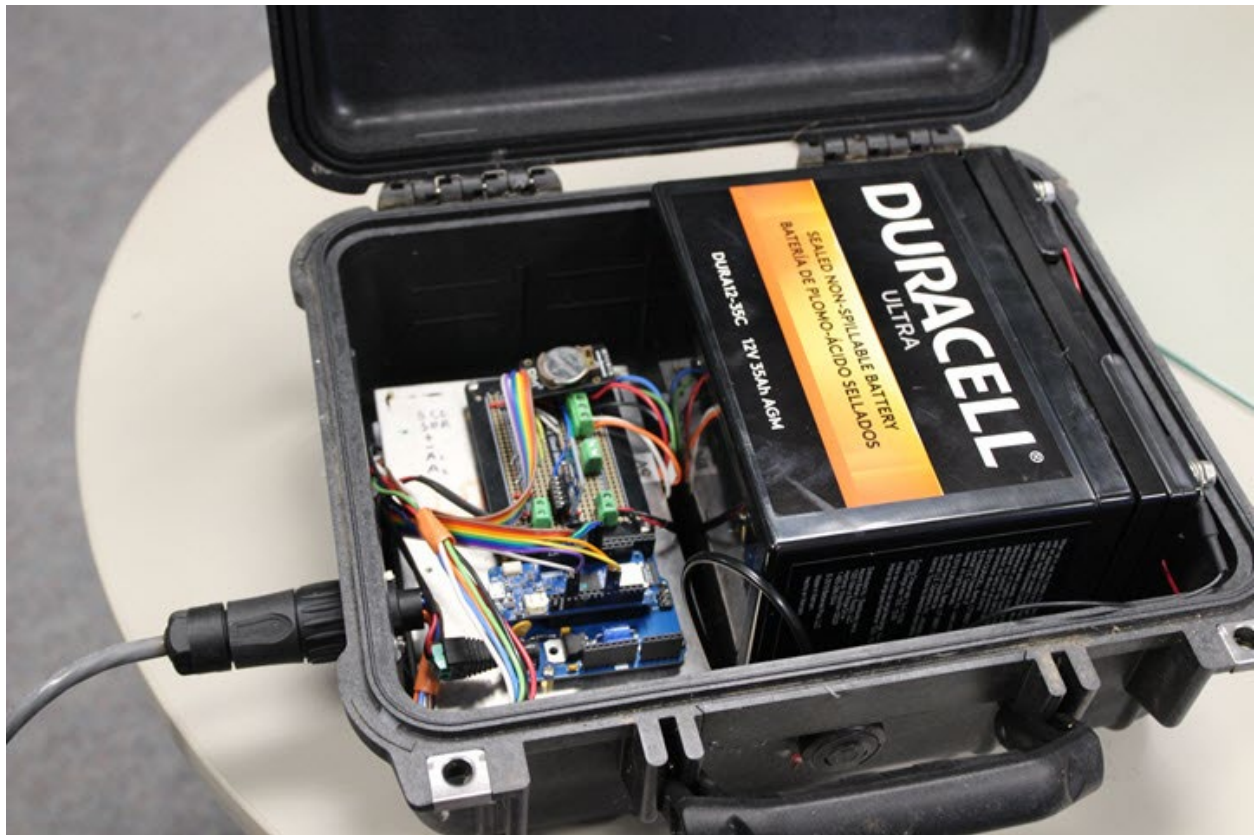
Figure 8 – Photograph of the entire datalogger assembly showing the backplane assembly along with a 12 VDC, 35 amp-hr battery. A water-tight connector (left) was used for connecting the eTape®.

Both the RTC module and the current sensing module were wired into the MKR Zero using a through-hole circuit prototype breadboard. The breadboard allowed each component to share a common power terminal as well as the addition of screw-wire terminals for connecting the 12V battery and eTape® sensor without the need for fabricating a custom circuit board. The MKR Zero was connected to the various components and sensors using a Dupont-style wiring harness. Both the breadboard circuit and the “shielded” MKR Zero were mounted onto an aluminum backplane (Figure 7), which could be housed inside a water-tight Pelican case along with a 35 amp-hr 12VDC battery (Figure 8).

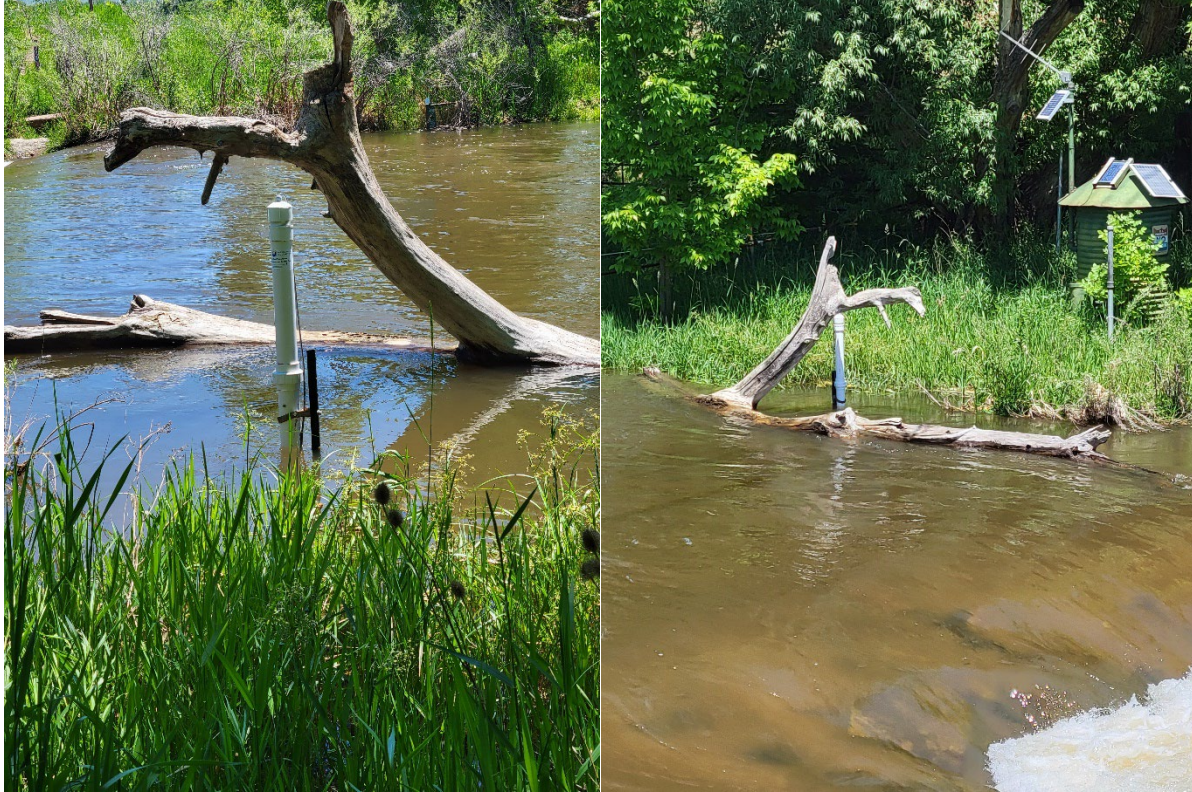
Figure 10 – Photographs showing the eTape® sensor installed at the Boulder Creek location.

An eTape® sensor was located alongside USGS gage #06730200 – Boulder Creek at North 75th Street near Boulder, CO. The sensor was attached to a fencepost in an eddy along the north side of Boulder Creek (Figure 10), behind a large, fallen cottonwood stump. The datalogger was securely located next to the USGS gage housing. The expected depth of Boulder Creek at this location exceeds the height of the eTape® sensor. An extension of PVC pipe above the top of the eTape® was used to visually assess the eTape® sensor during these high flow periods. This sensor remained deployed for approximately two years.

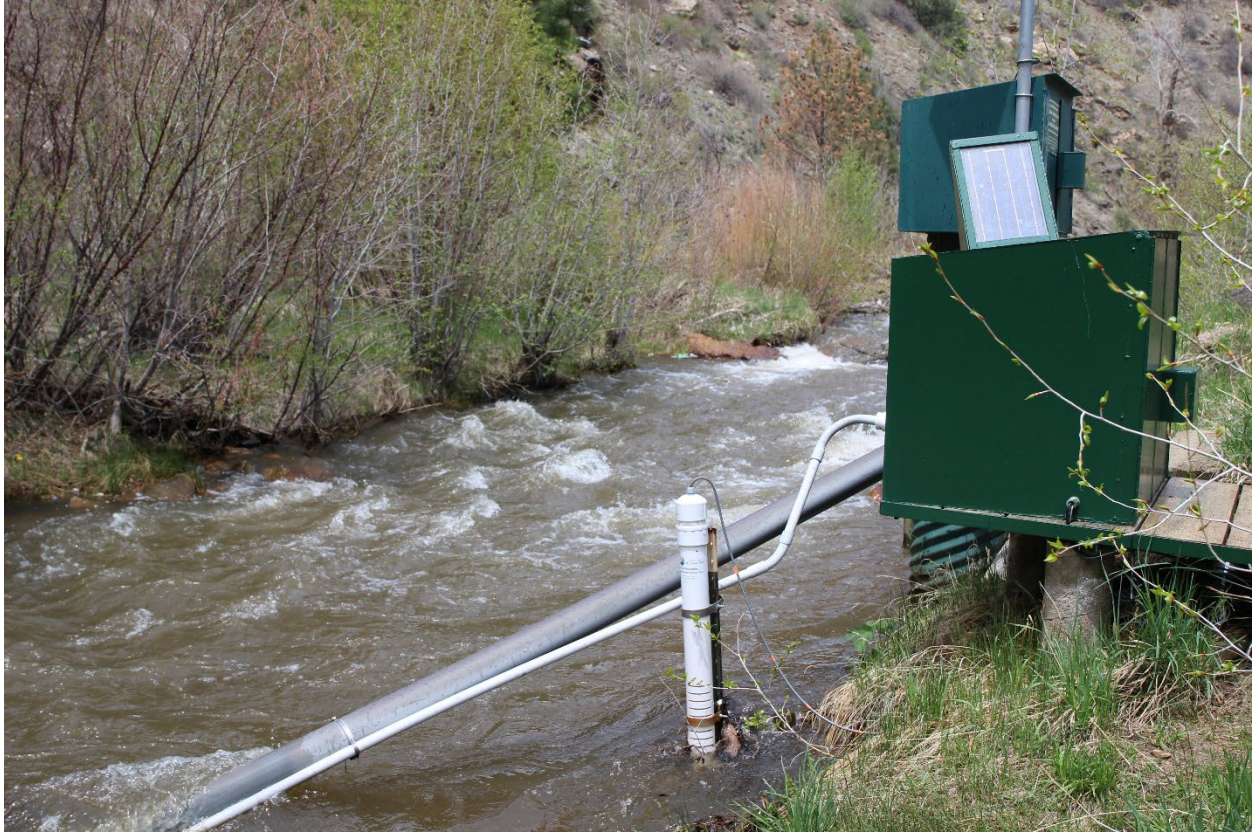
Figure 11 – Photograph showing the eTape® sensor installed at the Clear Creek location.

The second eTape® sensor was located alongside USGS gage #06718550 – North Clear Creek near Blackhawk, CO. The sensor was attached to a well anchored fence post on the downstream side of a conduit used for the USGS gage (Figure 11). The USGS conduit provided protection from the stream’s swift current and floating debris. The datalogger was securely located underneath a wooden platform next to the USGS gage housing. Although the USGS gage was in a deeper location in the stream channel, eTape® sensor depth measurements can still be compared provided it is submerged. This sensor remained deployed for approximately two years.

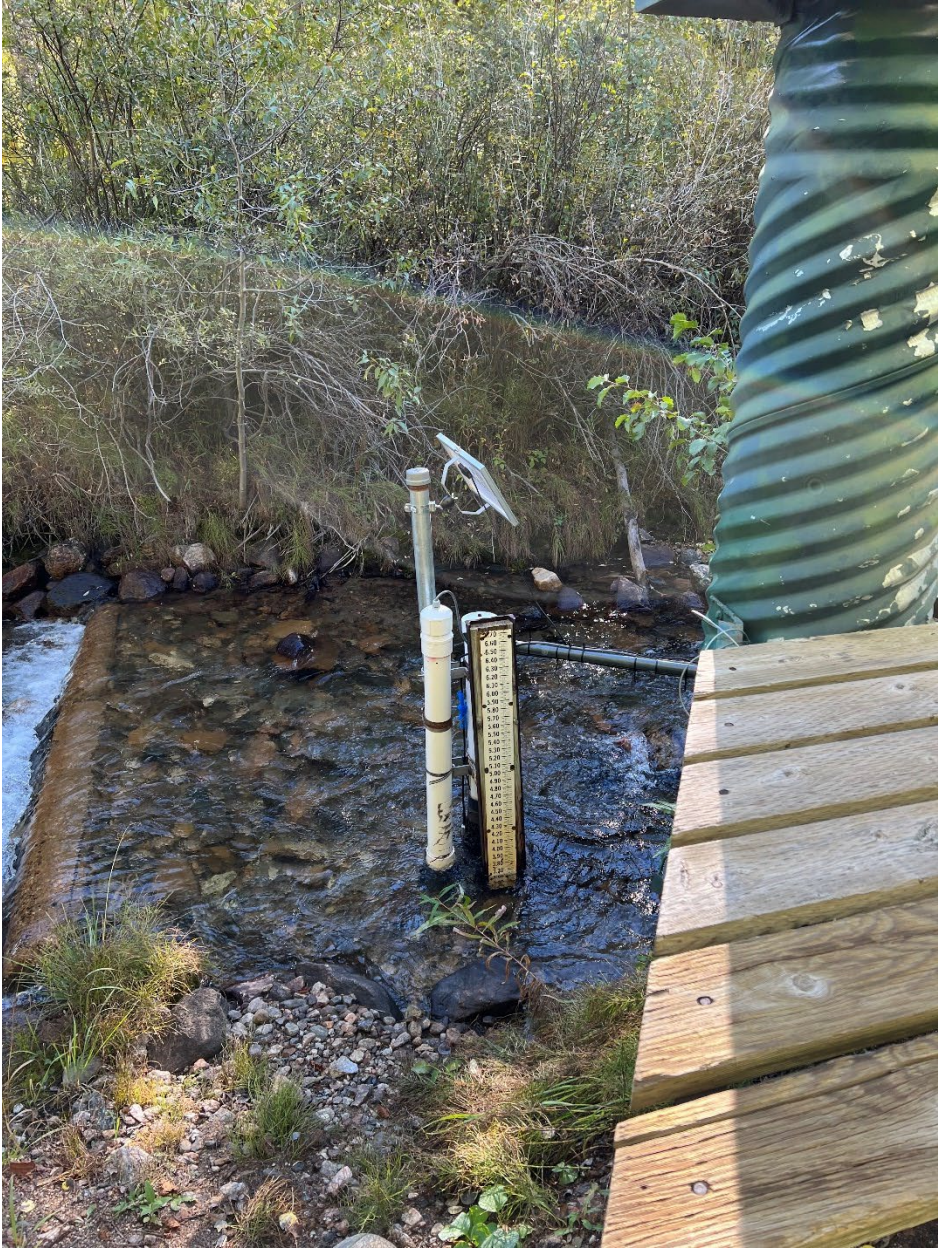
Figure 12 – Photograph showing the eTape® sensor installed at the Leavenworth Creek location.

The third eTape® sensor was located alongside USGS gage #06714800 – Leavenworth Creek near Georgetown, CO. The sensor was attached to a post near the USGS staff gage (Figure 12). The datalogger was secured underneath the wooden platform of the USGS gage housing. A solar panel was added to this gage to extend the battery life of the datalogger. An early November snowfall prevented deployment at this location during the first year of this investigation, resulting in this sensor only being deployed for a year.

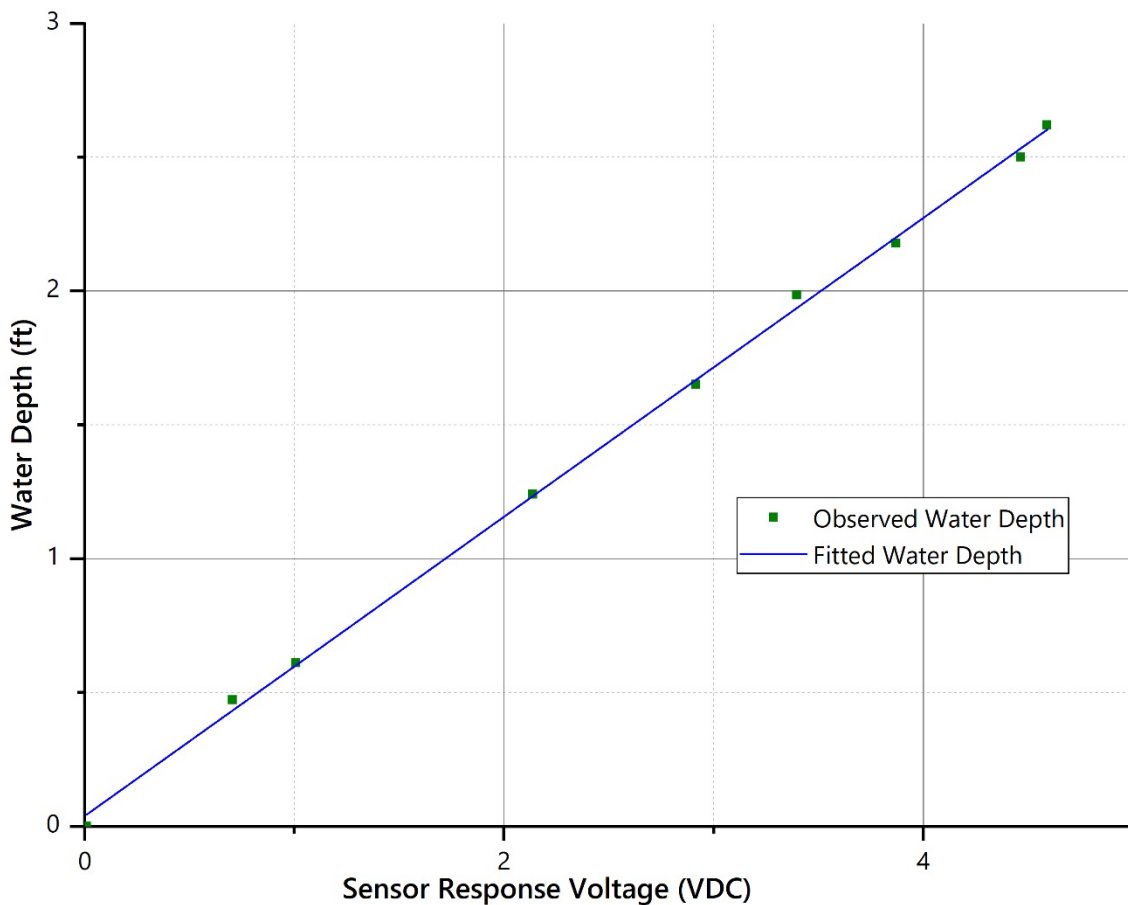
Figure 13 – Laboratory results for eTape® sensor calibration.

2.7 ft, this amounts to an accuracy within ± 0.135 ft. A completely assembled eTape® sensor was tested in the laboratory using a 48-inch acrylic standpipe. The MKR Zero recorded eTape® output voltage for nine water depths. The following linear equation was used for describing the relationship between the eTape® output voltage and water depth:

$$Depth = \beta_0 V_o + \beta_1$$

Where β_0 is the linear relationship between voltage, V_o , and depth (in feet) over the active length of the eTape® sensor (2.7 ft), and β_1 is the sensor offset relative to the depth of water. The laboratory calibration resulted in values for β_0 and β_1 of 0.56 ft/VDC and 0.04 ft, respectively. Results from laboratory calibration are presented in Figure 13. The maximum residual from this fitted equation is 0.048 ft, well within Milone’s reported accuracy of ± 0.135 ft.

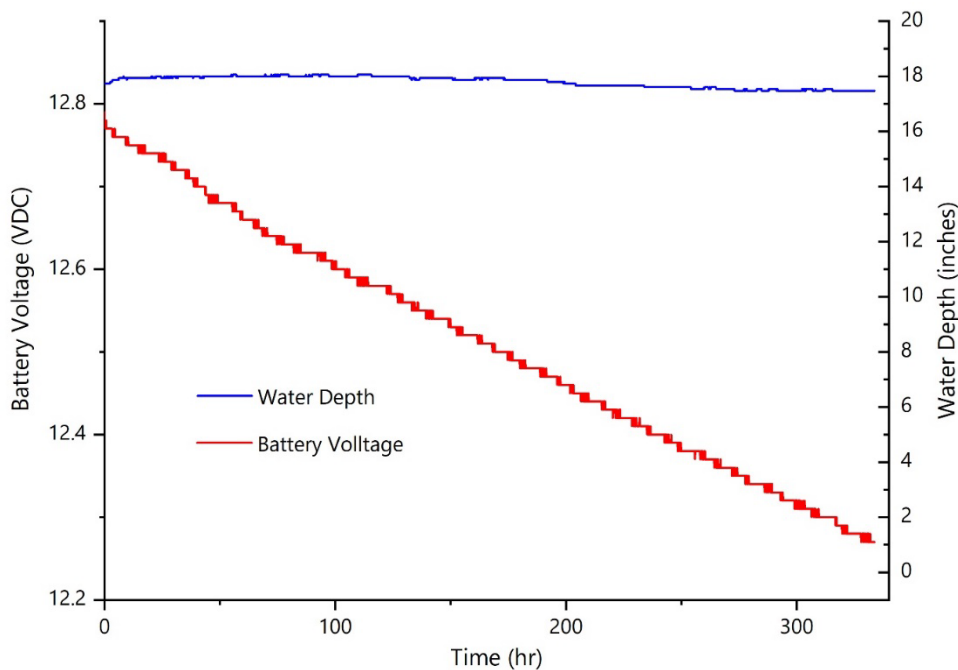
Figure 14 – eTape® sensor data collected during a two-week laboratory test.

The eTape® sensor was subjected to a long-term test in the laboratory. Over a period of two weeks, the eTape® depth sensor remained in a 48-inch standpipe collecting data from the eTape® as well as the current and temperature sensors. The purpose of this test is to assure expected functionality of the sensor assembly and to monitor power drawdown from the battery. Time-stamped sampling occurred every five minutes, as intended for field deployment, recording depth, battery voltage, and temperature. The water depth in the 48-inch standpipe was held constant at around 17.5 inches. Results from this test are presented in Figure 14.

Figure 14 shows the battery voltage dropping only 0.52 volts over a two-week period. The test showed the water level remained constant at approximately 18 inches, lowering only slightly due to evaporation loss in the laboratory. Not shown in Figure 14, the average recorded temperature was 74.1°F with minimum and maximum values of 72.5°F and 77.0°F, respectively, both reasonable for the laboratory environment.

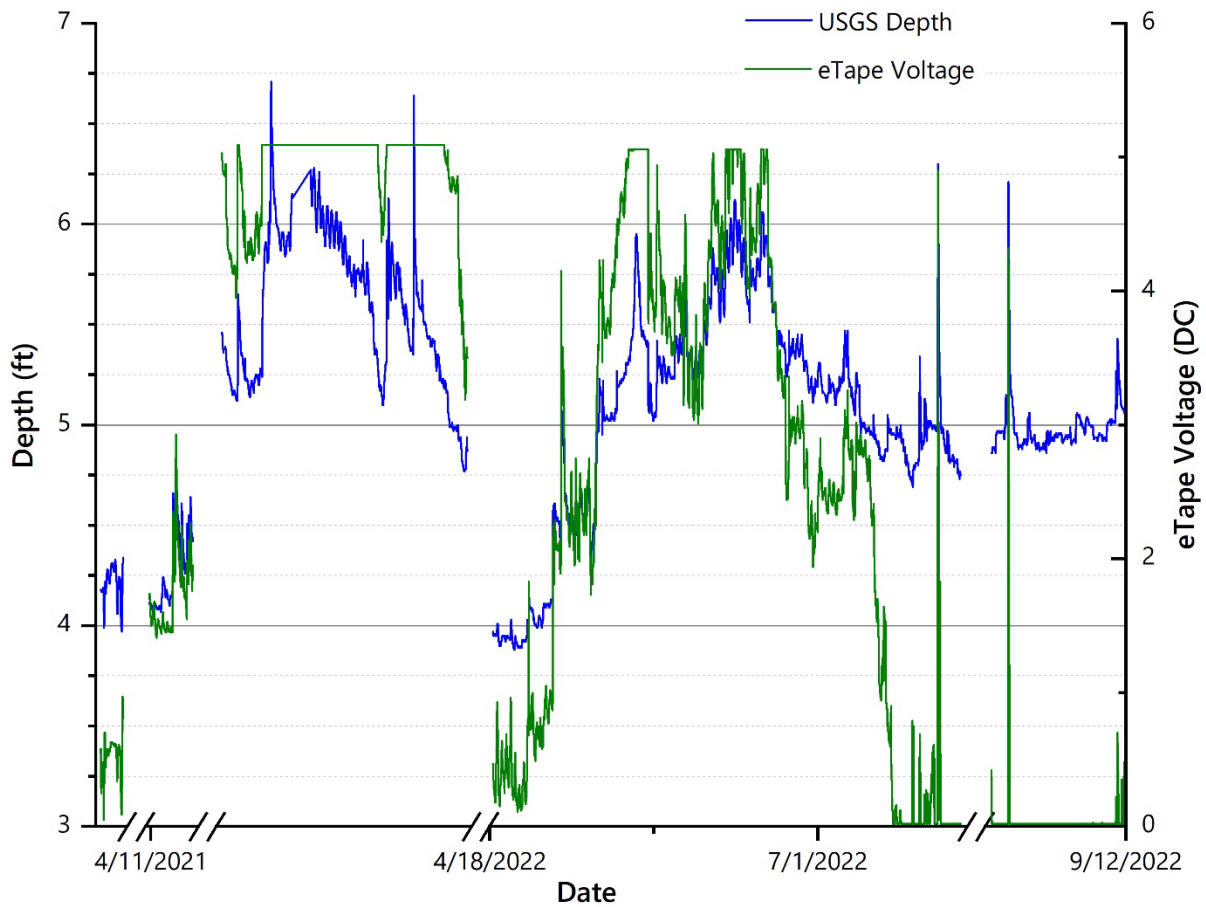
Figure 15 – eTape® sensor data collected at the Boulder Creek site with concurrent USGS depth measurements.

The eTape® sensor located alongside USGS gage #06730200 – Boulder Creek at North 75th Street near Boulder, CO. collected 57,027 samples at 5-minute intervals (79.2 days) from December 8, 2020, through September 11, 2022. Power at this site was not augmented by solar panels, however, this site was accessed often enough for battery charging such that the battery voltage never dropped below 11.75 VDC. The collected data for this site are presented in Figure 15.

The data presented in Figure 15 illustrates problems encountered with the eTape® sensor. One such problem occurs when the water depth exceeds the range of the eTape®. When this happens, the eTape® inside the PVC housing is submerged and its voltage response is at a maximum of 5.1 VDC. Ideally, the voltage response continues to function when the submergence subsides, however, data collected during May and June of 2021 show this did not happen (Figure 16). The eTape® response remained constant. One possible reason for this malfunction could be that sediment clogged the suction strainer attached to the PVC housing preventing the standpipe to drain below the eTape®. Figure 17 presents a photograph taken on June 8, 2021, show high flows in Boulder Creek. The annual peak discharge for Boulder Creek at this location occurred on May 30th. The same problem occurred again in 2022, however, the eTape® recovered from the high water quicker than the previous year.

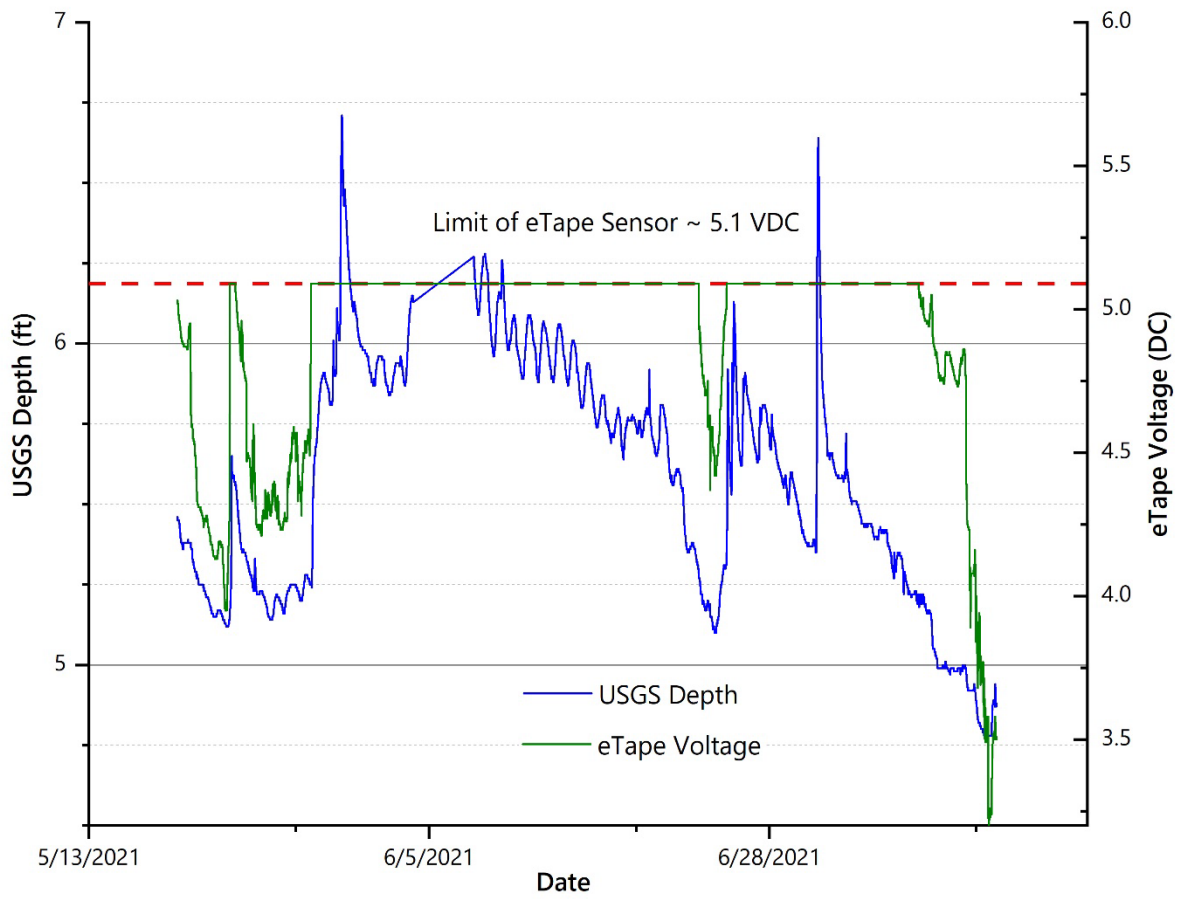
Figure 16 – An excerpt of the data collected at the Boulder Creek site showing high flow depths exceeding the range of the eTape® sensor.

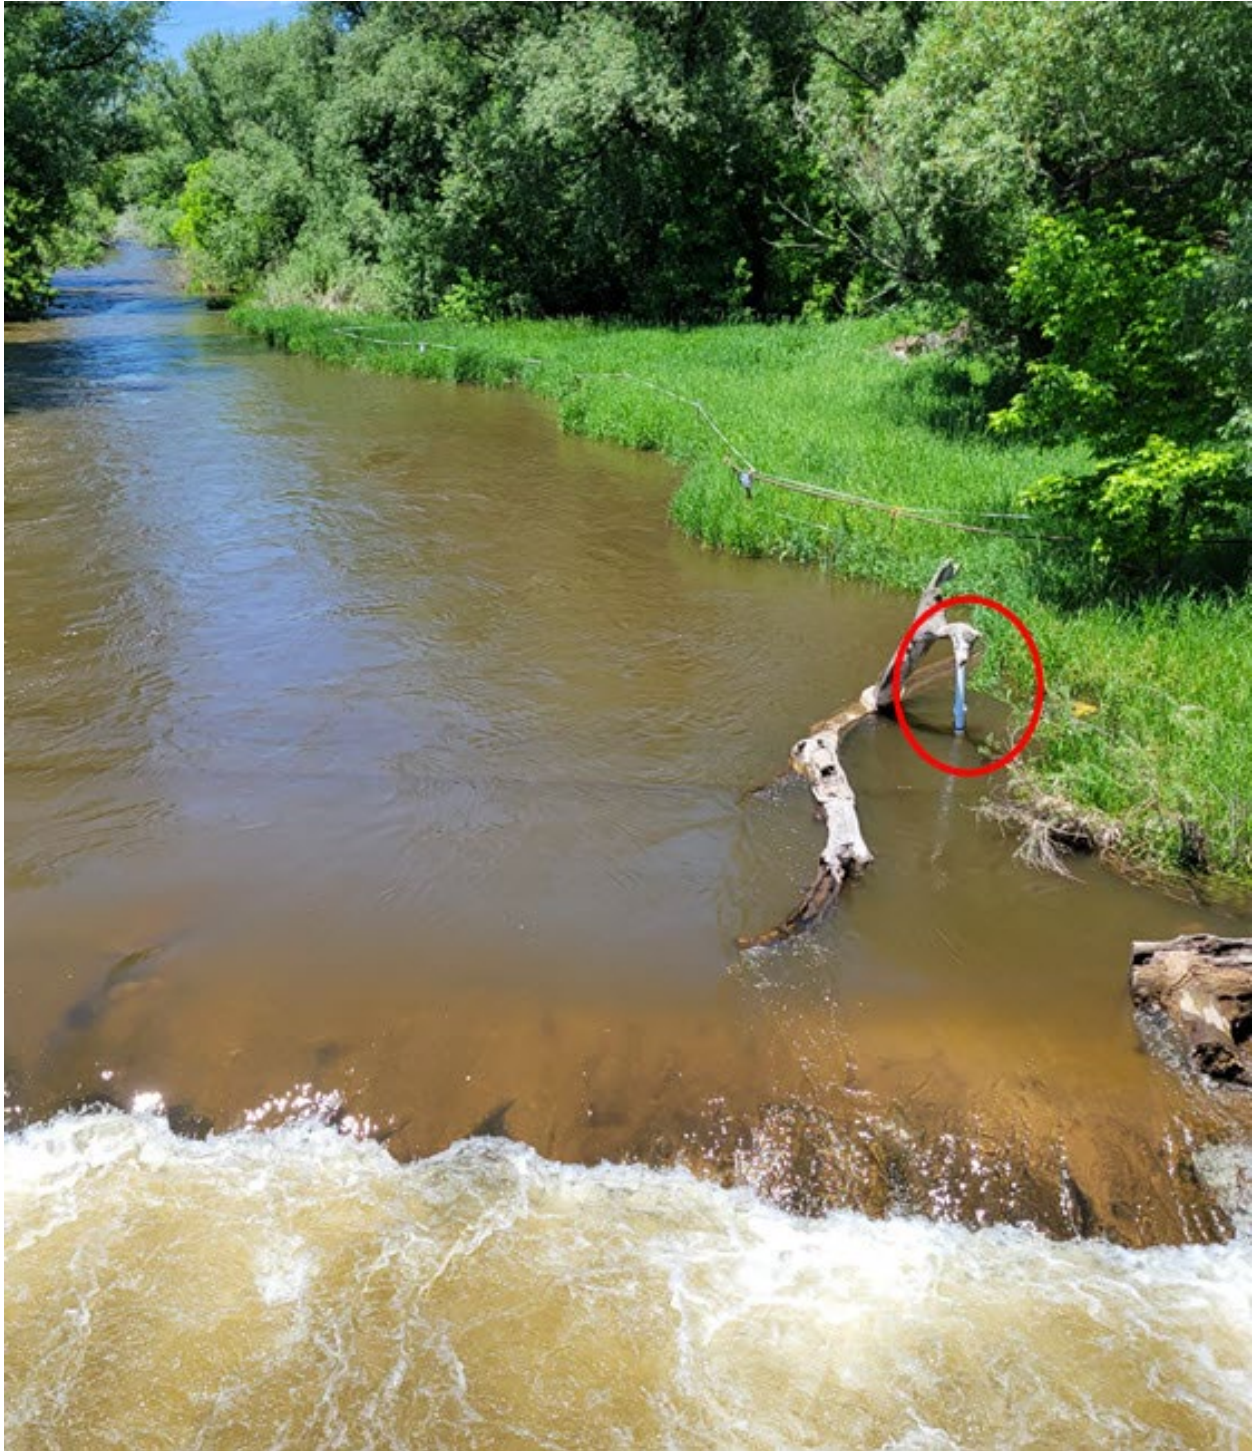
Figure 17 – Photograph of the Boulder Creek site taken shortly after the occurrence of the peak annual flow. The eTape® sensor is circled in red.

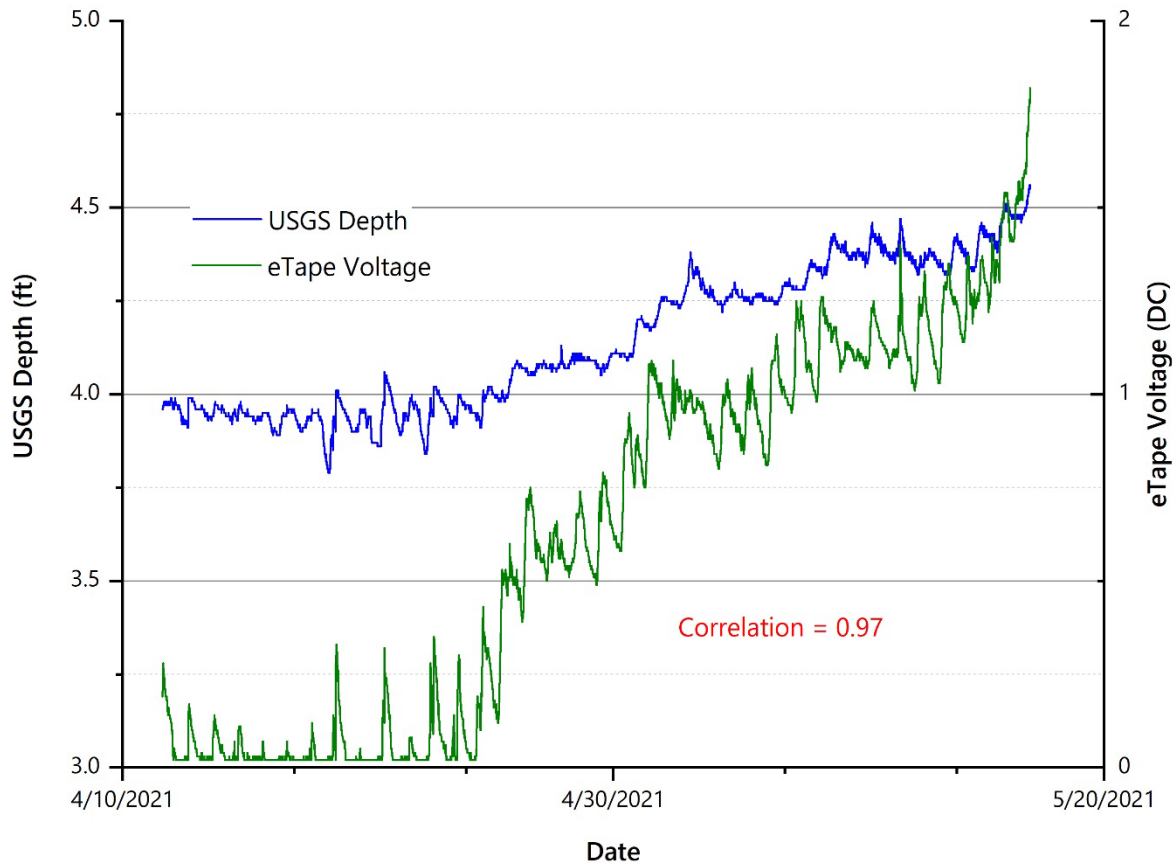
Figure 19 – 2021 eTape® sensor data collected at the Clear Creek site with concurrent USGS depth measurements.

As seen in Figure 18, the data collected at Clear Creek in June 2022 seemed erroneous with a lot of noise. An investigation into this problem revealed the noise came from the eTape® itself, the datalogger appeared to function correctly. The circuit embedded in the eTape® sensor is sealed in a potting solution by Milone Technologies and could not be inspected without damaging the sensor. The exact cause of the failure is unknown. Data collect at Clear Creek during April and May of 2021 did, however, have a strong Pearson Correlation of 0.97 (Figure 19).

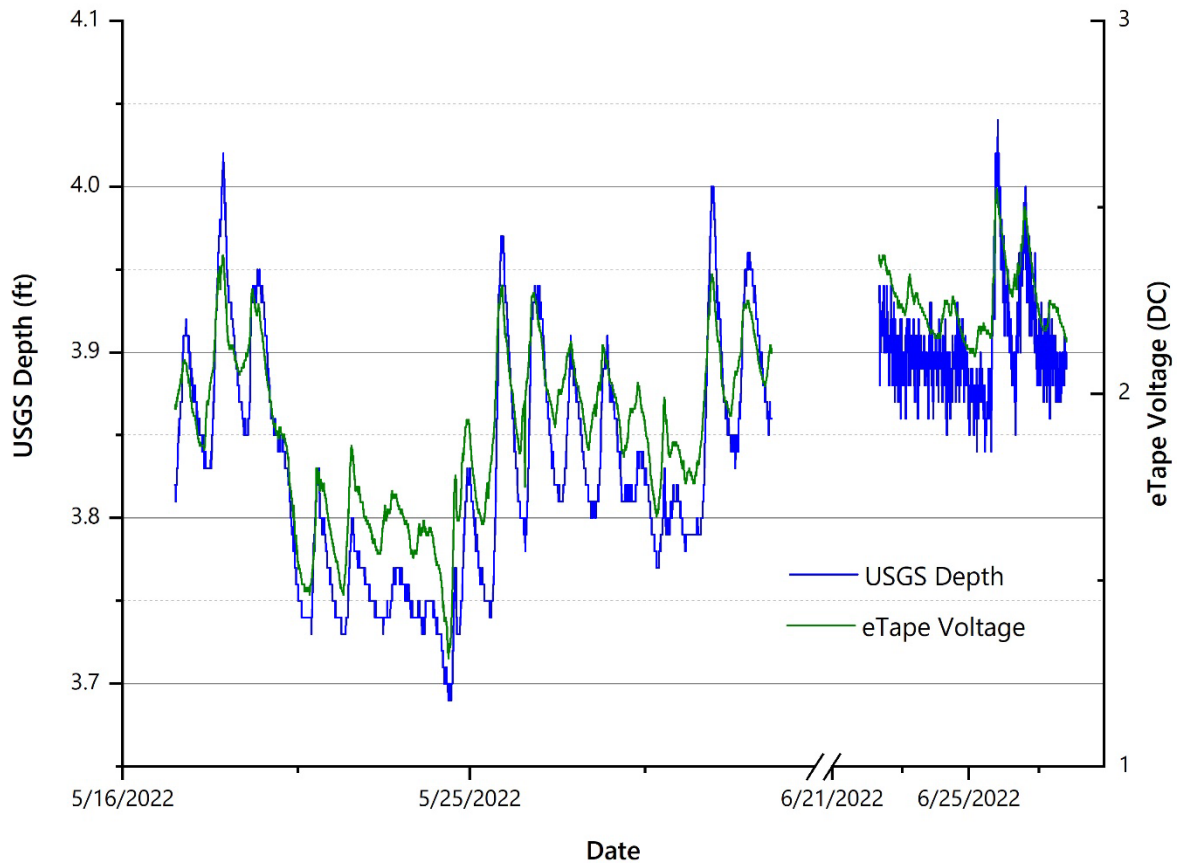
Figure 20 – eTape® sensor data collected at the Leavenworth Creek site with concurrent USGS depth measurements.

The eTape® sensor located alongside USGS gage #06714800 – Leavenworth Creek near Georgetown, CO collected 6,309 samples at 5-minute intervals (8.76 days) from May 17, 2022, through June 27, 2022. Power at this site was augmented with a 10-watt solar panel. Although a relatively smaller amount of data was collected at Leavenworth Creek, the data show a strong correlation between the eTape® sensor voltage response and the USGS depth, having a Pearson correlation of 0.94. June 2022 USGS depth measurements appear to have some noise, slightly lowering the Pearson correlation (Figure 20).
