BUREAU OF RECLAMATION
Technical Service Center
Denver, Colorado

TRAVEL REPORT

Code : D-8560 Date: December 13, 2005
To : Manager, Water Resources Research Laboratory
From : Tony Wahl
Subject: Travel to Altus, Oklahoma to Visit Flow Measurement Sites and Check Structures on the W.C. Austin Project

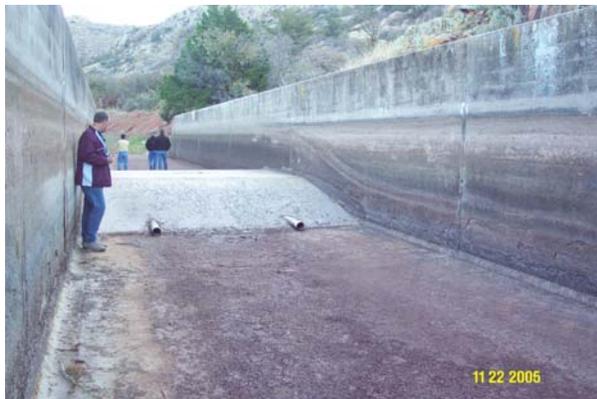
Altus Main Canal bench flume – This long-throated flume was installed into a rectangular concrete-lined section. The flume performed well during the first season of operation in 2005. To allow for accurate measurement at maximum possible flow rates, a downstream diverging ramp was included in the design. This ramp produces an energetic hydraulic jump below the structure at lower flow rates (i.e., at lower tailwater levels) that surprised some District and Area Office staff. The ITRC report expressed concern over the possible scouring potential of the flow and potential increased loading on the channel walls due to the raised water surface created by the flume. There was no evidence of scour during our visit, but there is a joint in the floor (probably an old repair) just downstream from the flume that could potentially experience a high uplift pressure. This joint should be repaired so that there is no offset into the flow. Regarding the issue of the increased loading on the flume walls, the ITRC report stated that water levels had increased several feet following installation of the flume. This is true only at very low flows. The water level increase at maximum design discharge (1000 ft³/s) is only about 4 inches, and at more typical high flow rates (up to 750 ft³/s), the water level in the canal never exceeds the original design maximum water surface.

Figure 1. — Altus Main Canal bench flume.

James Allard and Matthew Warren shared results of the past summer's comparison of the measurements from this flume with measurements made at the Altus Dam outlet gates. The agreement between the two sets of data is quite good, with a systematic difference between them that is generally less than 3% of the flow. Preliminary work has shown that a minor adjustment to the gate rating equations can bring them into agreement with the flume measurements. When this adjustment is performed, it should take into account the estimated flow through the drainage pipes installed through the flume, even though that flow is very small compared to the total flow.

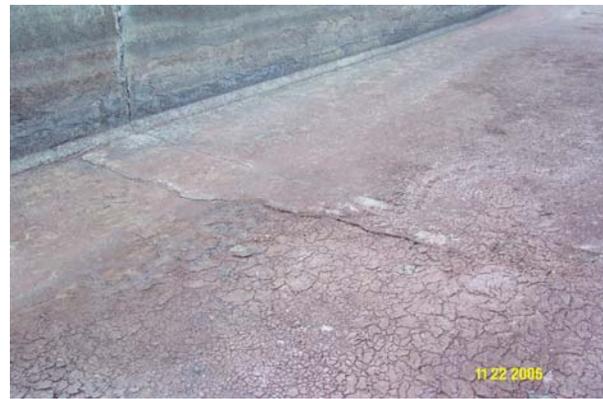
Figure 2. — Joint in concrete about 8 ft downstream from measurement flume.

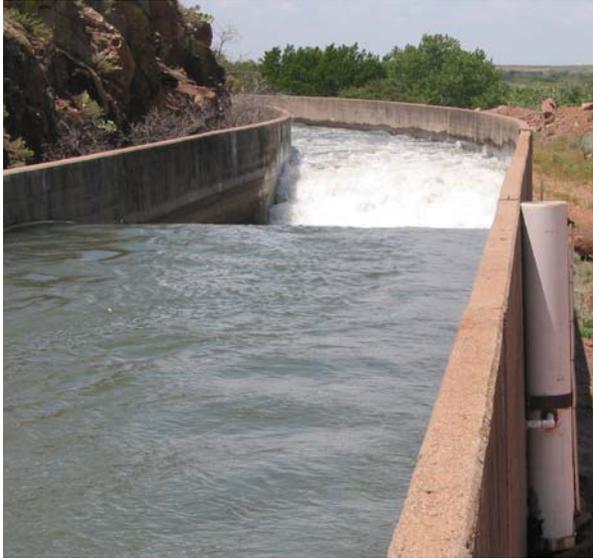
Figure 3. — Altus Main Canal bench flume in operation during the summer of 2005.

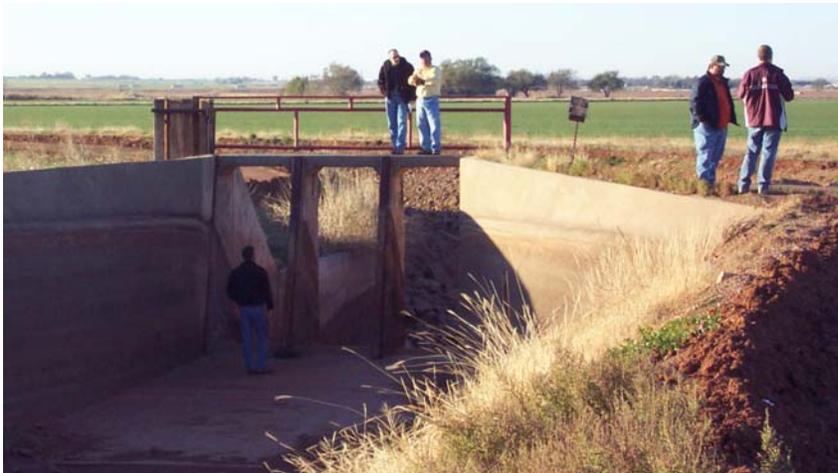
A4.8 Check and Drop Structure – This is one of the sites being considered for improvement with a long-crested weir. We discussed some issues related to determining the design height and length for the weir. The general plan for modifying these structures is to construct the long-crested weir on one half of the 2-bay structures, or two-thirds of the 3-bay structures, and leave one bay available to be operated as a traditional stoplog check.

Figure 4. — A4.8 Check Structure.

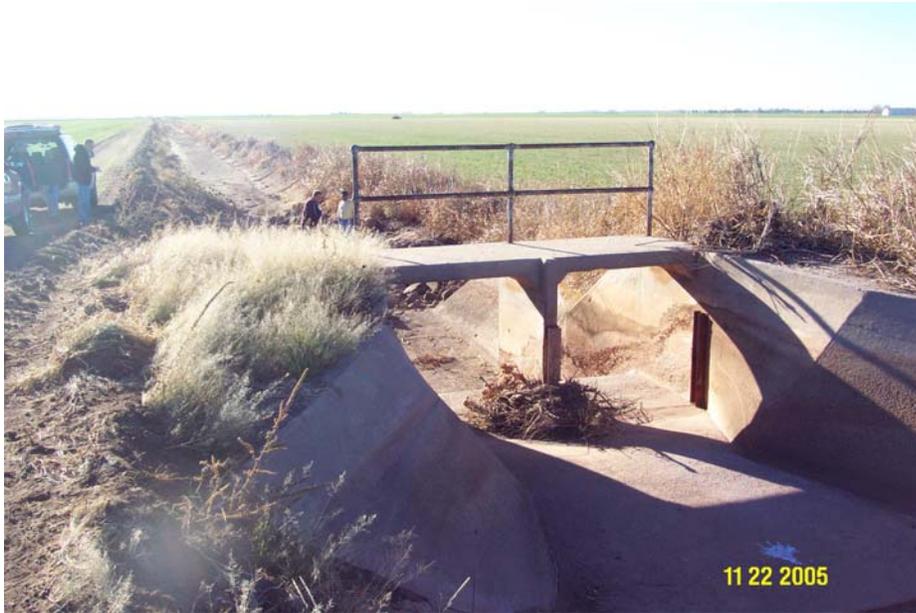
W10.6 Check Structure – The district would like to add flow measurement capability here in the West Canal just below the check structure. This is a 10-ft base width trapezoidal earthen channel with 1.5:1 side slopes. A structure with a rectangular-shaped throat and vertical side walls would probably be easiest to construct. I will develop a design for the district.

Figure 5. — W10.6 check structure, looking downstream toward the planned site for the new long-throated flume.

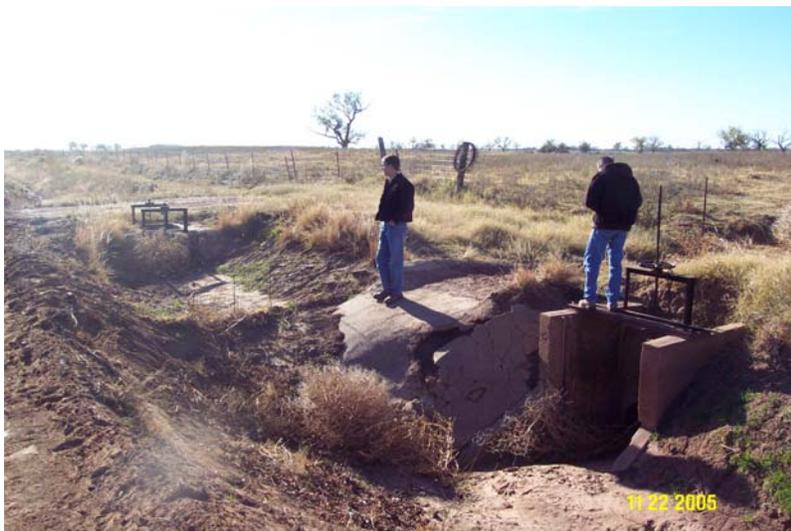
West Canal Wasteway – This site is the tail end of the West Canal. A delivery is made through a CHO (Constant-Head Orifice turnout) and additional flow is spilled over a roughly constructed concrete sill and through a gate-controlled turnout structure leading to the same spill channel. The majority of the spilled flow goes through the gated turnout. A large culvert about 75 yards downstream presently establishes the water level in the spill channel. This culvert is installed on a slope, and drops about 1 to 1.5 ft over its length.

Figure 6. — End of the West Canal. The last turnout is the CHO at left. Water not delivered is spilled over the rough concrete section at center, or through the gate-controlled turnout at left. To operate the CHO, a water level is maintained in the West Canal that is approximately equal to the crest elevation of the rough concrete sill.

While at the site we discussed measurement alternatives for this site. We concluded that the best approach was probably to modify the culvert either by replacing it or adding a second parallel culvert at a lower elevation, to reduce the water level in the spill channel, and then construct a long-throated flume about halfway between the head of the spill channel and the culvert.

Later, while visiting the Ozark Canal wasteway we came to a different conclusion about measuring waste flows. Rather than measuring the actual spill, we could measure the total of the spill and the tail-end delivery in the canal itself. Knowing the amount of water billed for and the amount measured, the district would know that the difference was either wasted water or water that was used but not billed for. In either case, that water would represent an opportunity for the district. The same logic could be applied to this site, and a flow measurement structure would then be constructed in the West Canal itself, just upstream from the tail end structures. This approach would depend on there being additional channel freeboard available above the water level normally maintained to supply water into the CHO, since a measurement structure would require some head.

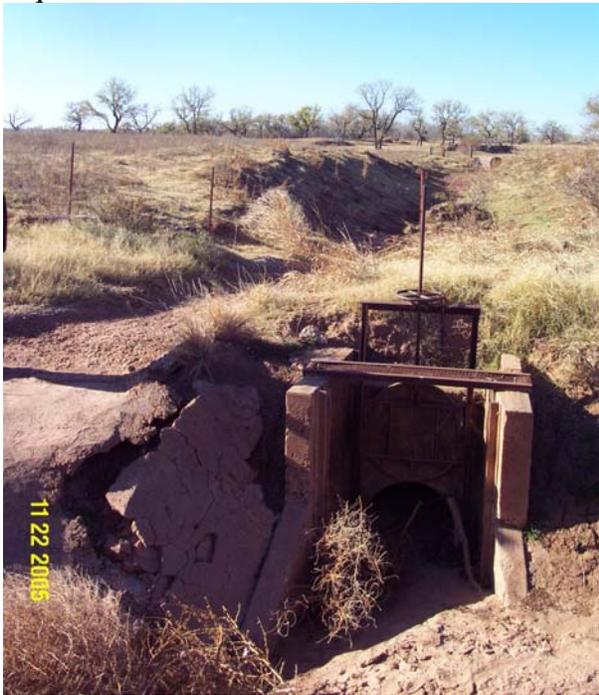
Figure 7. — Spill channel at tail end of West Canal. Culvert in spill channel is visible in far right of photo.

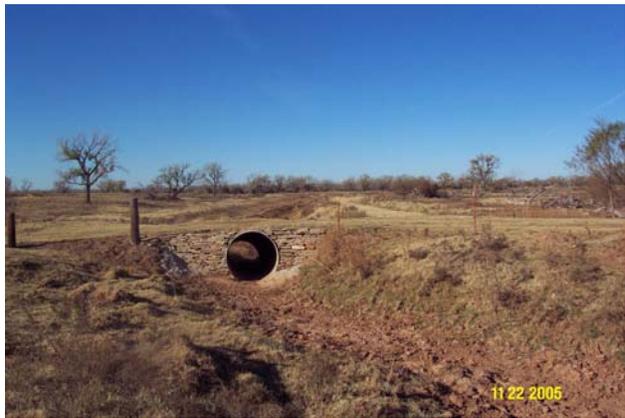
Figure 8. — Close-up of culvert in spill channel at end of West Canal.

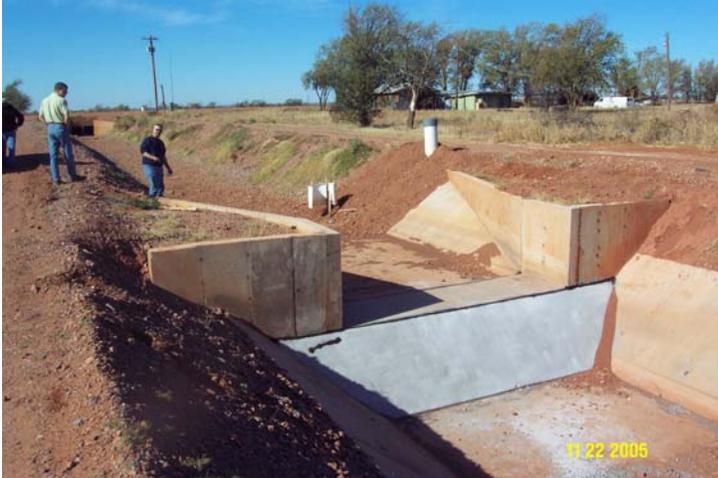
Ozark Canal Check – This turnout from the Altus Canal is the head of the Ozark Canal. We briefly visited a flow measurement structure constructed last year. A similar design may be used at the A17.6 lateral (discussed below).

Figure 9. — Flow measurement structure near head of Ozark Canal. The wedge of fresh concrete on the downstream side was added recently to minimize accumulation and recirculation of abrasive material at the base of the drop.

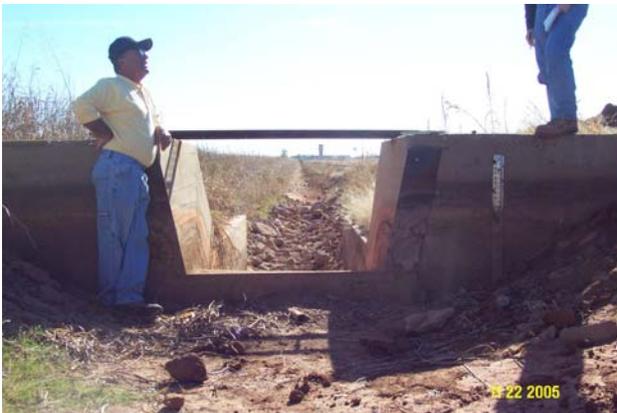
Ozark 4.6 Lateral – This lateral receiving water from the Ozark Canal is located just upstream from Altus Air Force Base. Flow measurement is desired in the lateral itself. A drop structure about 900 ft downstream from the head gates was modified many years ago by addition of a Cipoletti weir blade. The weir is inaccurate because there is a lack of approach depth (the blade is only about 9 inches above the approach channel floor), causing the weir to operate with partial contraction. Also, the time required for the pool to stabilize between the head gate and the weir is quite long. The ITRC recommended a Doppler-type flow meter for this site, due to the lack of available head. The head required for the Cipoletti weir means that the Ozark Canal must be operated at a very high depth to make the delivery into the O4.6 lateral.

Figure 10. — 5-ft wide drop structure on the Ozark 4.6 lateral, retrofitted in the past with a 4-ft wide Cipoletti weir.

I suggested a two-phase approach to this site. For the upcoming season the district could remove the Cipoletti weir blade and install two rounded approaches (vertical half-sections of large-diameter PVC pipe) on the upstream corners of the existing concrete structure. With this modification, the structure could be rated as a long-throated flume using WinFlume. This would provide workable flow measurement and would reduce the water levels in the lateral, presumably also allowing the district to operate the Ozark Canal at a lower level. This would not significantly change the time required for the measurement to stabilize following a flow change.

If, after a year of operation, the district still wanted to reduce the lag time between making a flow change and obtaining a stable measurement, a long-throated flume could be designed for installation just downstream from the O4.6 lateral head gates. With the removal of the Cipoletti weir, enough head should be available to allow for a functional structure. This would raise water levels back up somewhat, but the level could probably still be kept lower than the present condition.

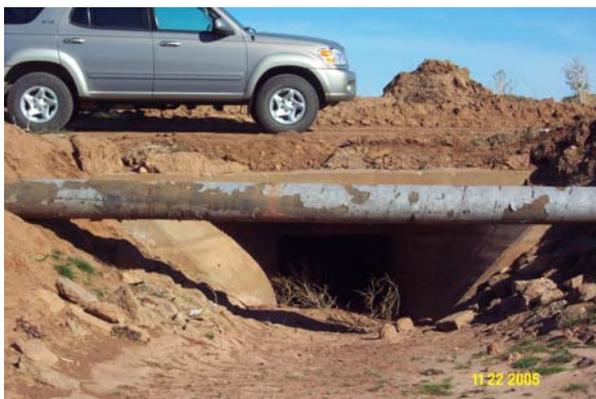
Ozark 15.2 Lateral – This diversion from the Ozark canal is controlled by two gates that discharge into a box culvert passing beneath the canal maintenance road. A 4-ft Parshall flume is located about 50 yards downstream, but appears to operate fully submerged based on high-water stains. The ITRC recommended making measurements at this site by a stream gaging technique using a FlowTracker positioned at the box culvert outlet. Gradually, a gate calibration might be developed. I suggested the possibility of modifying the Parshall flume to create a long-throated flume that operates in free flow. This would depend on whether additional head could be consumed. If some head is being dropped at the gate now, it may be possible to transfer some of that head loss to a modified flume and open the gates further to make the delivery. I asked Glen Barker to survey the high water marks in the lateral and in the Ozark Canal to determine how much head loss might be occurring across the turnout gates with the present arrangement. This site was originally designed for a flow of 50 ft³/s, but the district reportedly never delivers more than 40 ft³/s. The head gates consist of two 24-inch by 24-inch rectangular slide gates. Glen Barker later related that the ditchrider typically operates these gates about three quarters open. Survey data collected by Glen Barker following the site visit showed that the head loss from the Ozark canal into the lateral is about 1.38 ft.

Figure 11. — Downstream end of box culvert at head of Ozark 15.2 lateral.

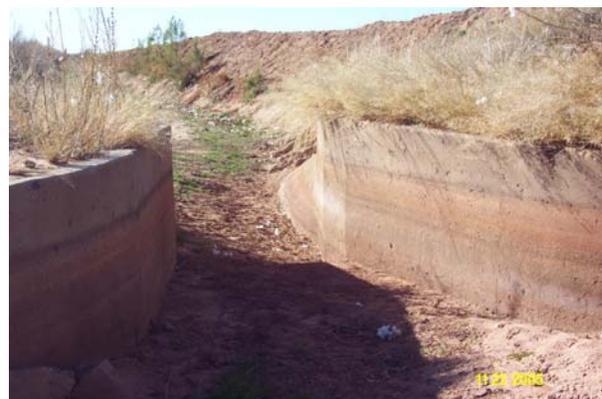
Figure 12. — 4-ft Parshall flume in Ozark 15.2 lateral.

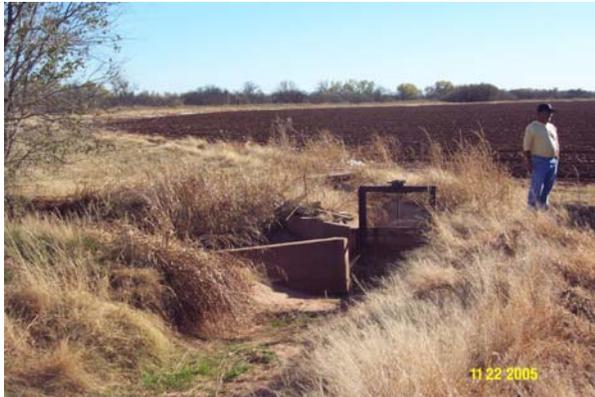
Ozark Wasteway – This site was surveyed extensively early in the summer by Bob Einhellig during his visit to the Altus area to present a ditchrider training short course. At its tail end, the Ozark canal enters a division box from which a final delivery is made and excess flow enters the wasteway channel. The Ozark canal itself offers a good location for installation of a long-throated flume. Such a measurement would tell the district the total flow being supplied to the division box. Comparing that measurement to the amount of water billed to the last delivery would tell the district how much total water is lost to spillage and overdelivery. The survey data collected by Bob Einhellig should be sufficient for design purposes.

Figure 13. — Division box at end of Ozark Canal. The canal enters from the bottom of the photo. The wasteway proceeds to the left, and the final delivery goes out the far side of the box.

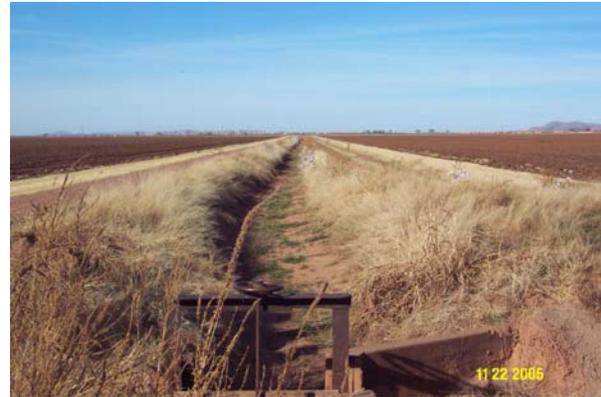
Figure 14. — Ozark Canal looking upstream from the tail end division box. A long-throated flume could be installed in this reach.

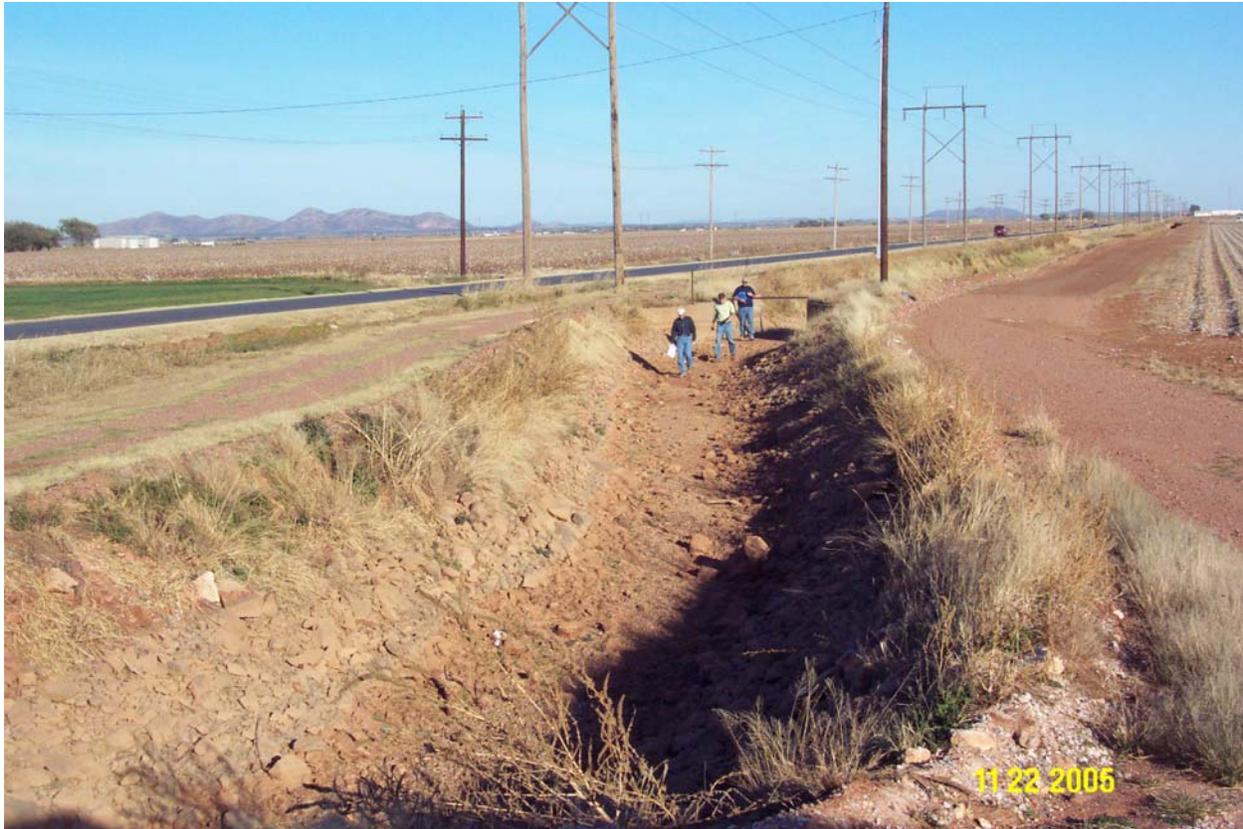
A17.6 Check Structure and Lateral – This site was also surveyed by Bob Einhellig during the summer of 2005. The plan for this site is to remove an existing 8-ft Parshall flume and transfer flow measurement to a drop structure located a short distance downstream (or possibly relocate the drop to approximately the existing flume location). This will lower the water level in the head of the A17.6 lateral, allowing the district to reduce the operating level of the Altus Canal, thereby increasing system capacity by reducing the tailwater below an upstream inverted siphon. We asked the district to recheck some of the survey data before we proceed with developing a design.

Figure 15. — Looking downstream from the head of the A17.6 lateral. The first structure is the Parshall flume. A drop structure is located in the distance, to the right of the car on the highway.
