TR-2011-05

## **Travel to Visit Central Arizona Project, Parker Dam, and Hoover Dam**

**Dates of Travel: August 2-4, 2011**

TRAVEL REPORT

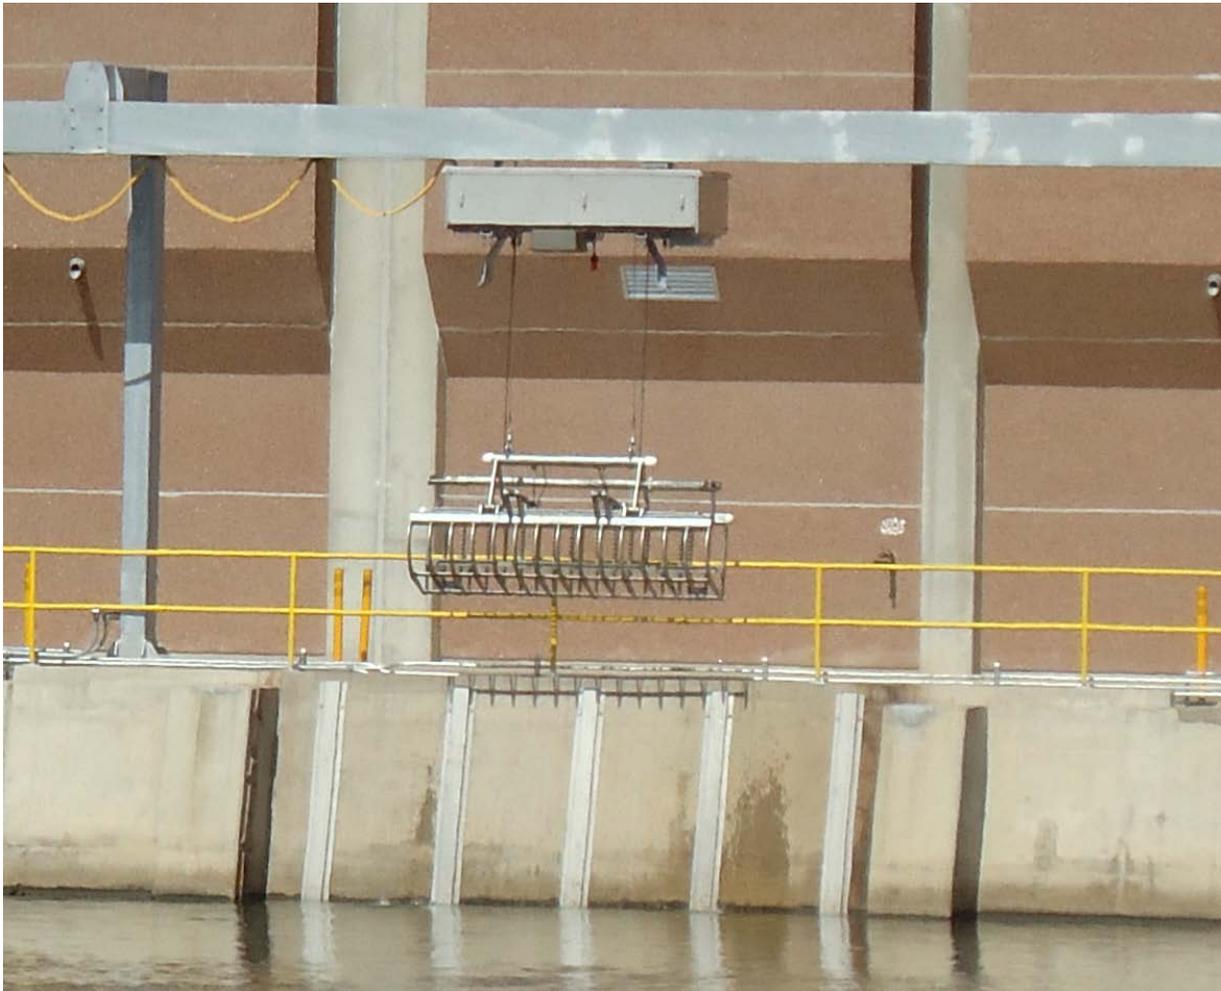
Figure 1 – Trash rake being raised by cable at the Little Harquahala pumping plant on the CAP. Trash racks and raking systems are of similar design for all of CAP pumping facilities.

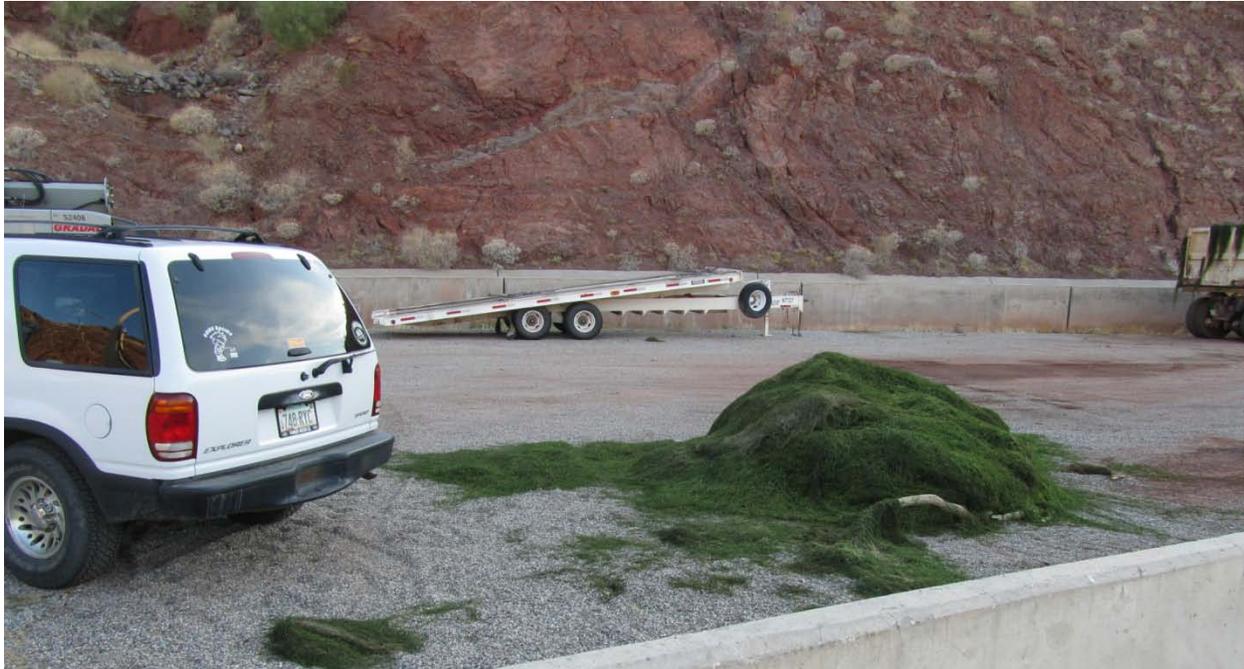
The Mark Wilmer intake pumping plant was the last stop on the CAP. While an abundance of Quagga mussels are found at this facility, aquatic debris loading continues to be the biggest challenge (Figure 2). To date, mussels have not created noticeable head loss through the trash rack until aquatic debris is present. Aquatic weeds from Lake Havasu come into the forebay in large quantities and adhere to the mussel covered trash rack which causes head differential across the trash racks. It is believed that without the presence of mussels many of the weeds would pass through the trash rack and head loss would not accumulate as quickly. A boat style weed harvester is manned twenty-four hours a day to gather the weeds upstream of the forebay. For the cooling system, strainers are used to capture mussel debris. So far colonization within the cooling lines and other small piping systems has not caused problems. Following the visit to Mark Wilmer, Josh and Bryan stayed the night in Lake Havasu City.

Figure 2 - A small pile of aquatic debris removed from the trash rack structure at the inlet to Mark Wilmer Pumping Plant.

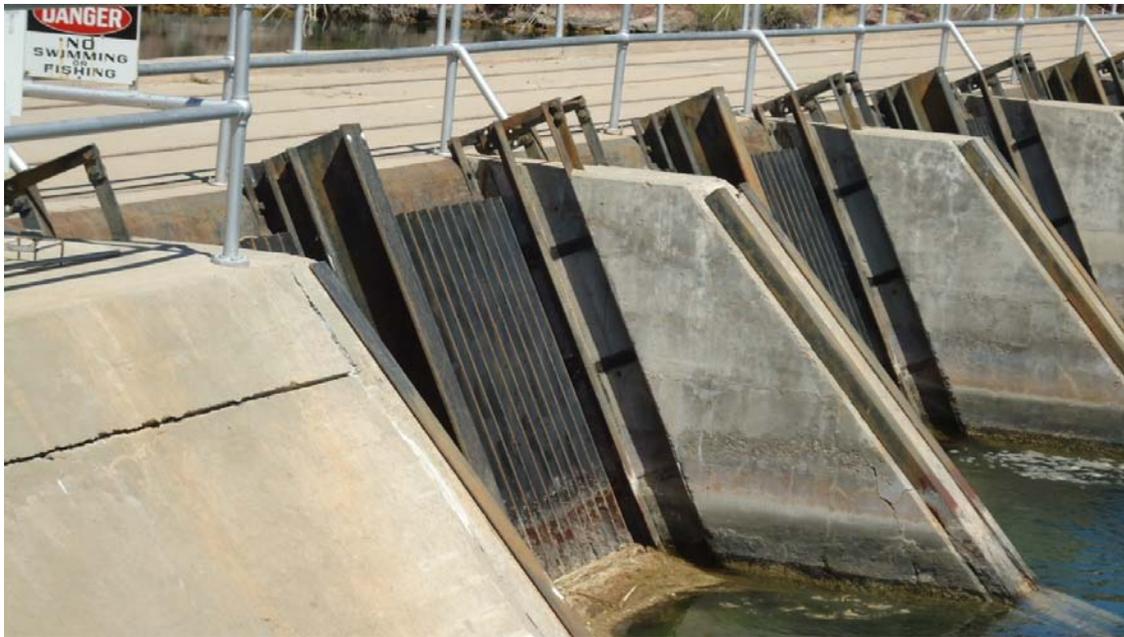
**Parker Dam:** The morning of August 3<sup>rd</sup> Josh and Bryan met Leonard Willett in Lake Havasu City and traveled together to Parker Dam. First, they looked at the trash racks upstream of the forebay which are about 60 feet deep (Figure 3). A raking system is being investigated for future installation on this trash rack since heavy aquatic debris loads are a concern. The design and installation of a trash raking system may be challenging for this site due to the large depths and high velocities seen through the trash racks.

Figure 3 – Section of trash rack on the forebay of Parker Dam. A trash raking system is currently being planned for this trash rack in the near future.

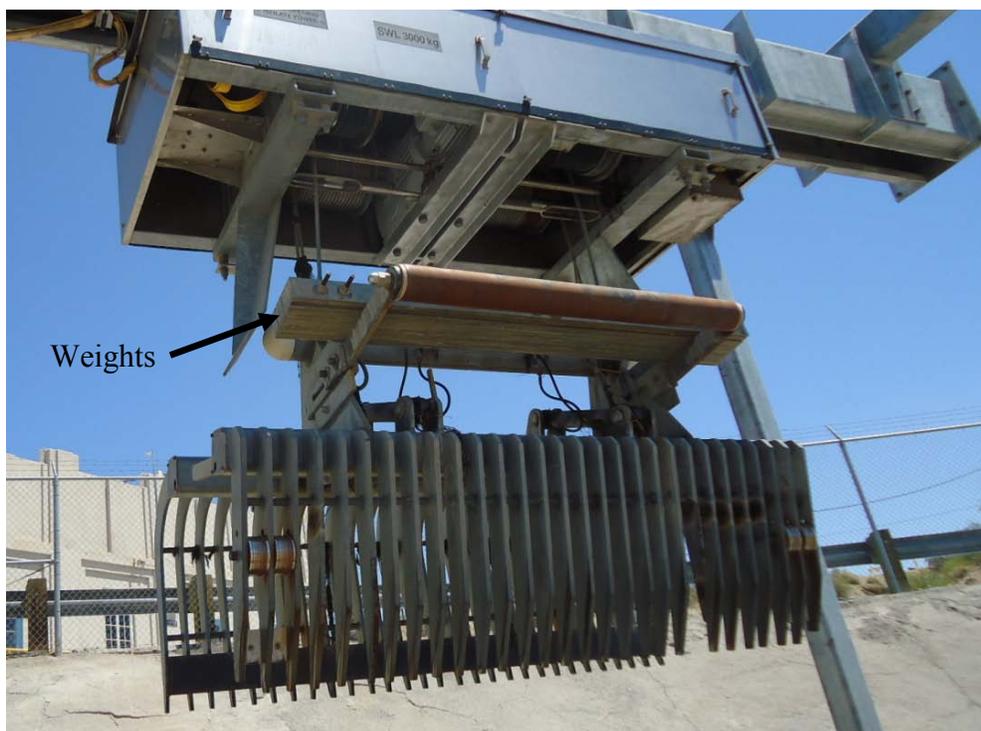
**Headgate Rock Dam:** Josh, Bryan, and Leonard then traveled downstream to look at the trash rake used at Headgate Rock Dam. Again, Quagga mussels were present on the trash racks but aquatic weed debris has been the main challenge. Due to high velocities through the trash rack, weights were mounted on the backside of the rake to keep it balanced in the flow (Figure 4). Operators commented that once balanced the rake seemed to work well.

Figure 4 – Trash rake at Headgate Rock Dam. Weights were added to the back side of the rake to keep it balanced against high velocities through the trash racks.

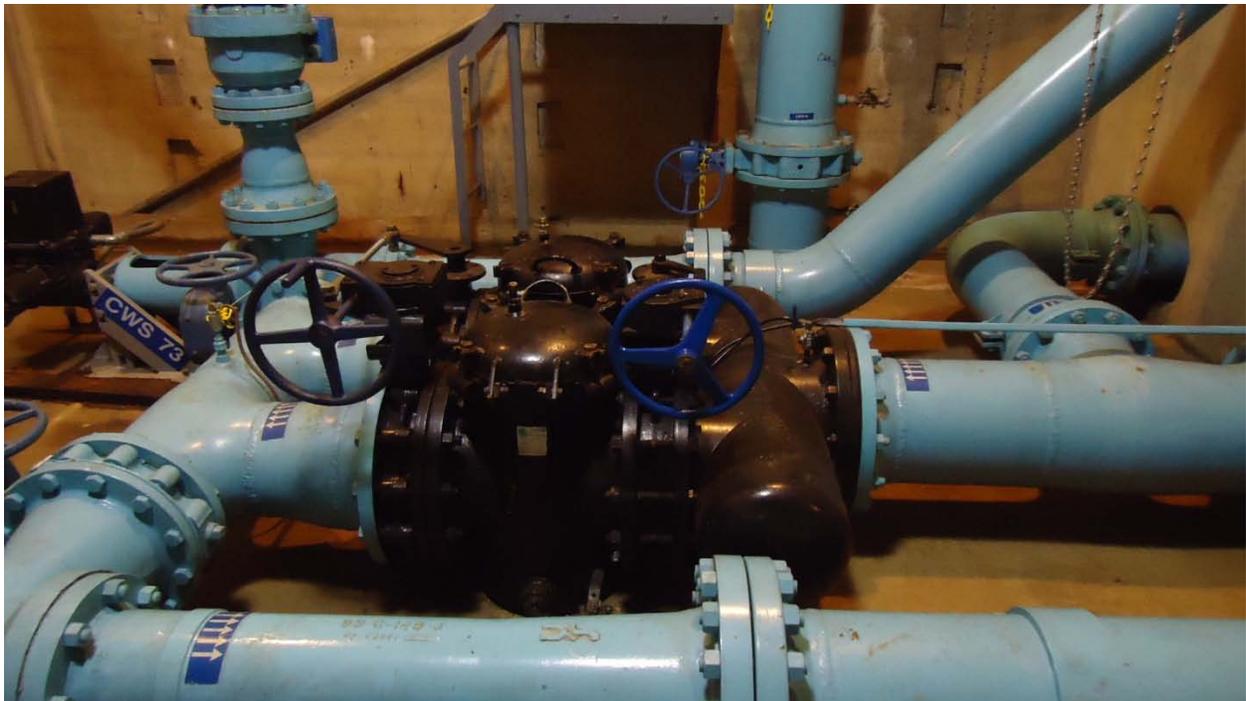
**Hoover Dam:** After staying the night in Henderson, Nevada, Josh and Bryan met Leonard at Hoover Dam at about 9:00 the morning of Thursday, August 4<sup>th</sup>. Leonard showed them various components of the facility including the 30 ft diameter penstocks, the cooling system (Figure 4) of the turbines, generators, and transformers, and sections of the fire suppression system. Hoover's complex cooling system draws water from upstream off the penstocks as well as the tailbay downstream. Mussel debris that breaks off of the upstream trash racks and penstocks clog many portions of the cooling system, especially as pipe size is reduced. One unit's cooling system was set up to temporarily pump all the water from the tailbay through a strainer which is showing promising results for reducing debris clogging, allowing operating temperatures to remain within the acceptable range. Fire system pipes are at risk as they are easily clogged with mussel debris and colonization. While reducing colonization of mussels within the piping systems would help, it appeared that Hoover's greatest challenge is dealing with debris from dead mussel shells.

Figure 5 – Part of the cooling water system coming off the penstocks at Hoover Dam. A portion of the cooling water is also drawn from the tailbay.
