RECLAMATION

TR-2014-02

Travel to Roza Canal & Powerplant

TRAVEL REPORT

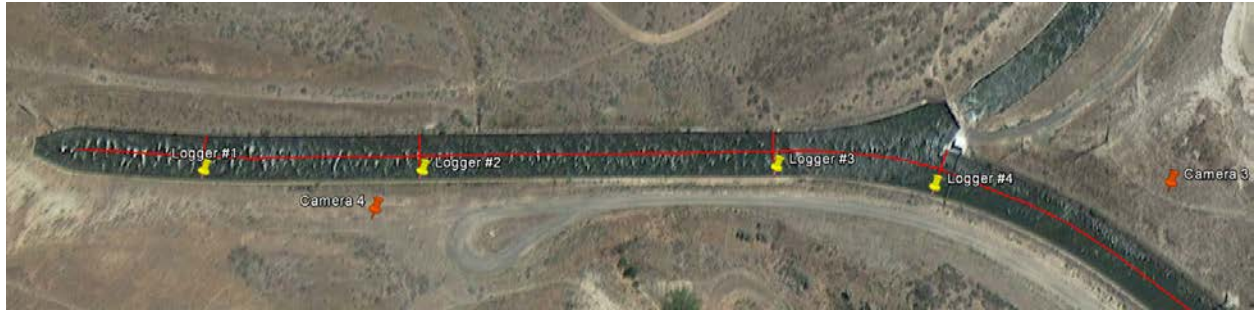
Figure 1 Upper forebay canal locations of water-level loggers and video cameras for the rejection test. Loggers are shown in yellow and video cameras in red.

Wednesday, March 12th – Josh, Bryan, and Kylie began surveying, installing and/or modifying deployment sites near the Instream HK site. This work continued along the main section of the canal throughout the morning and was completed by noon. The afternoon consisted of surveying and deploying water level loggers at various locations along the forebay in preparation for the load rejection test. Figures 1 and 2 show logger locations for the rejection test.

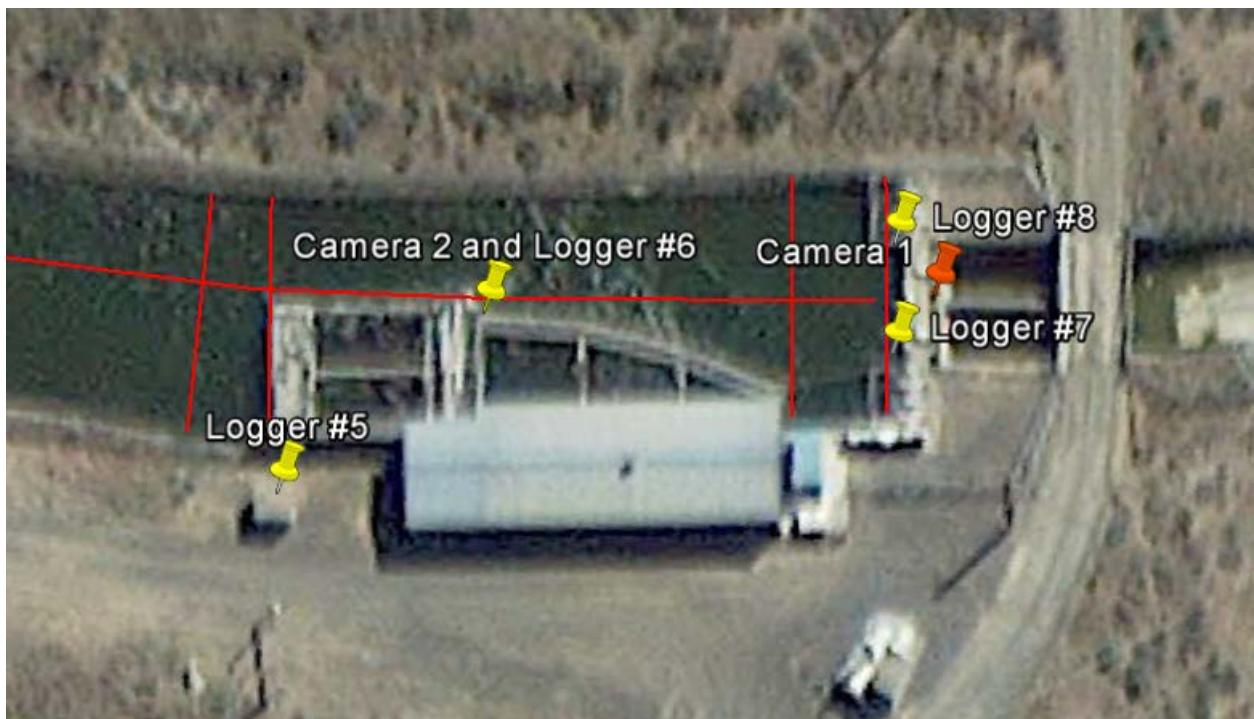
Figure 2 Locations of water-level loggers and video cameras placed near the penstock intake and spillway for the rejection test. Loggers are shown in yellow and video cameras in red.

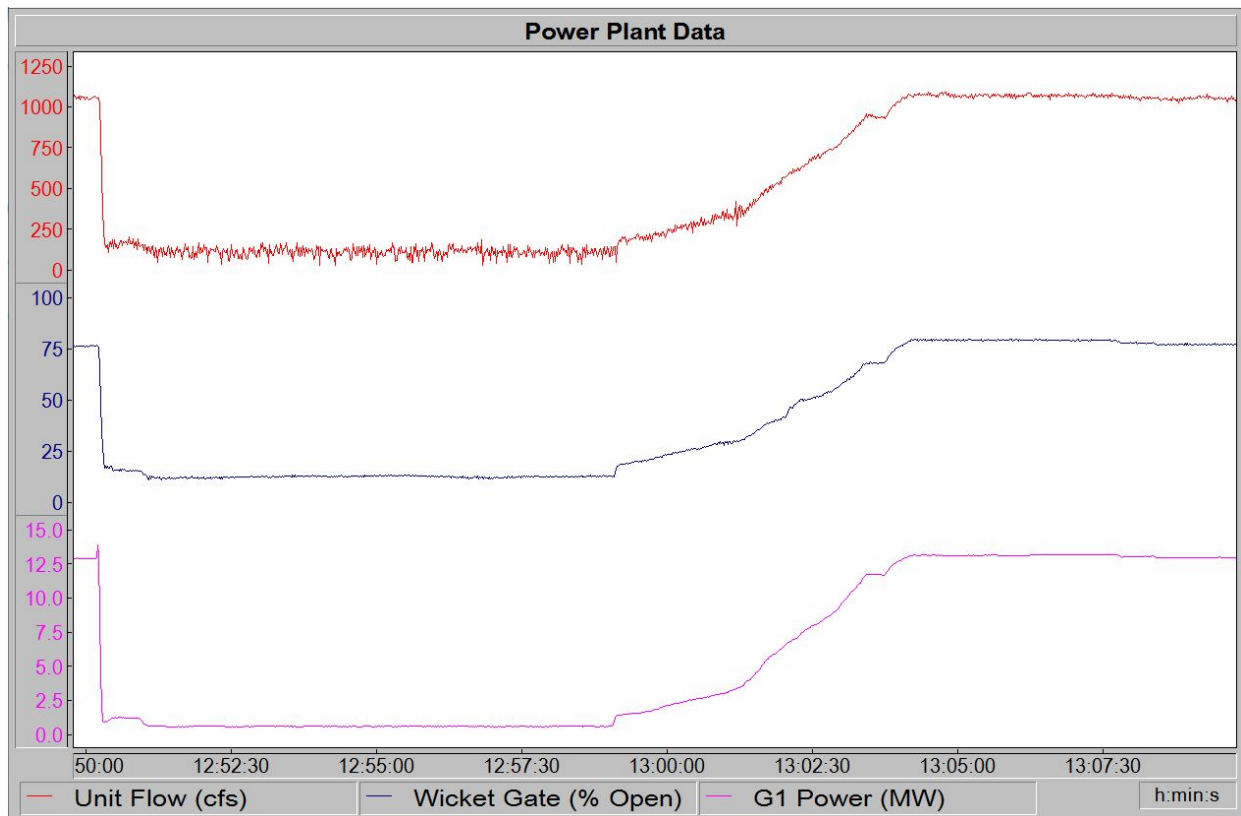
Figure 3 Penstock flow, wicket gate opening, and generator measurements during the load rejection test.

Rejection Impact Study – A load rejection was simulated by taking the unit down from 13 to 1 MW (1,050 to 150 cfs) by closing the wicket gates at the same speed as an emergency closure. This caused a transient water surface in the forebay which overtopped the radial gates and activated the siphons on the spillway. Visual observations and water level measurements indicated that the water level came near the top of the canal lining but did not overtop the canal (Figures 5 & 6). Preliminary data from field measurements are shown in Figures 3 – 6. Data and video collected during the test will be used in an analysis using a numerical model of the forebay to determine spillway and forebay performance in the event of a full load rejection. A full report of that analysis will be available around the beginning of May.

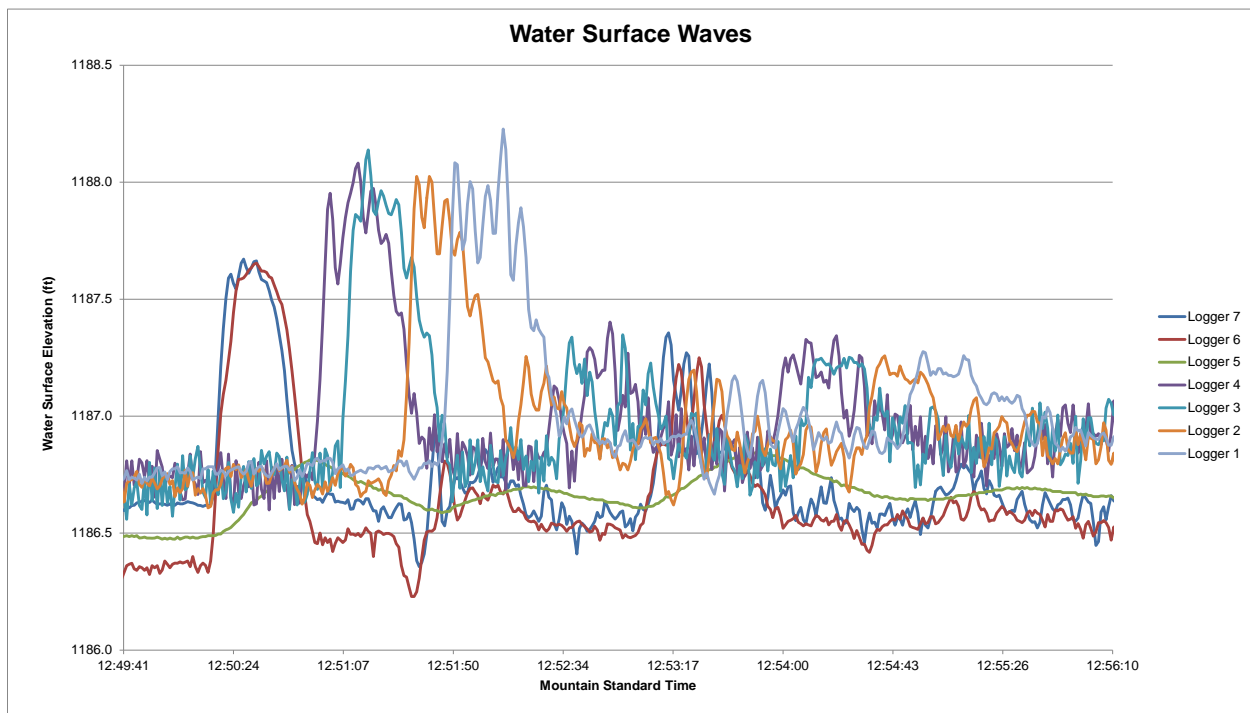
Figure 4 Transient wave at the various logger locations along the canal forebay. Logger 7 is at the siphons and logger 1 is closest to the tunnel outlet. Preliminary analysis shows the wave speed was about 12 ft/s.

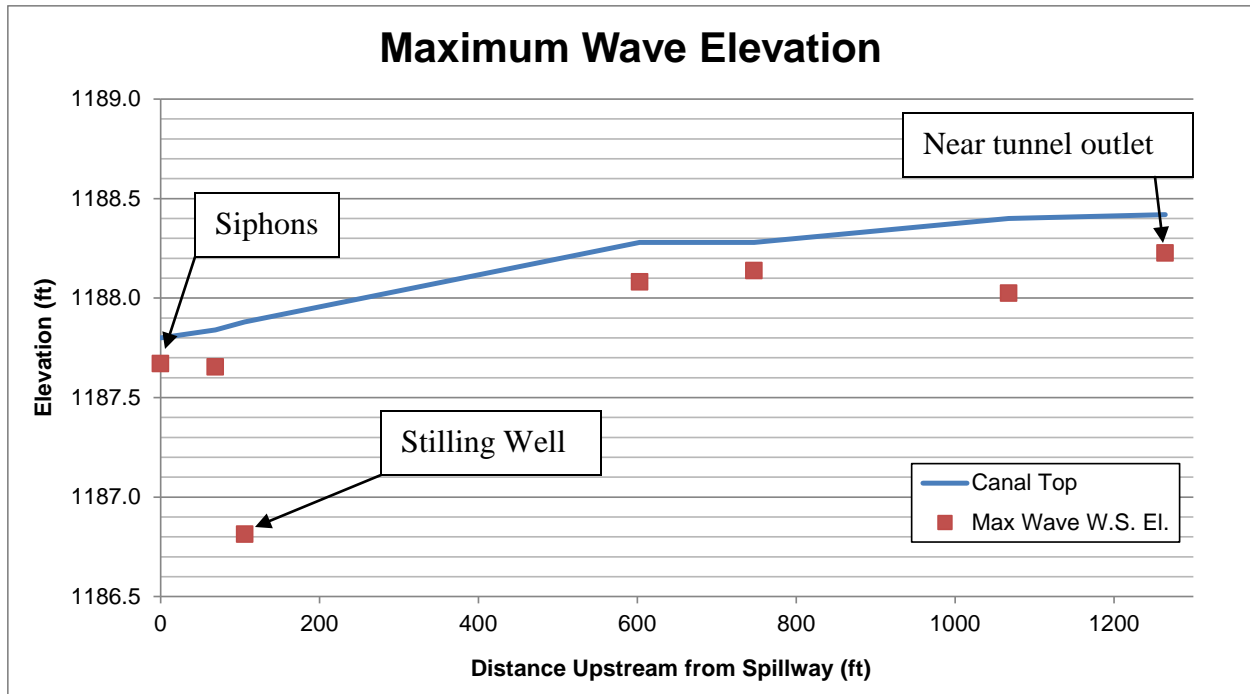
Figure 5 Maximum water surface elevations relative to the top of the canal forebay lining.

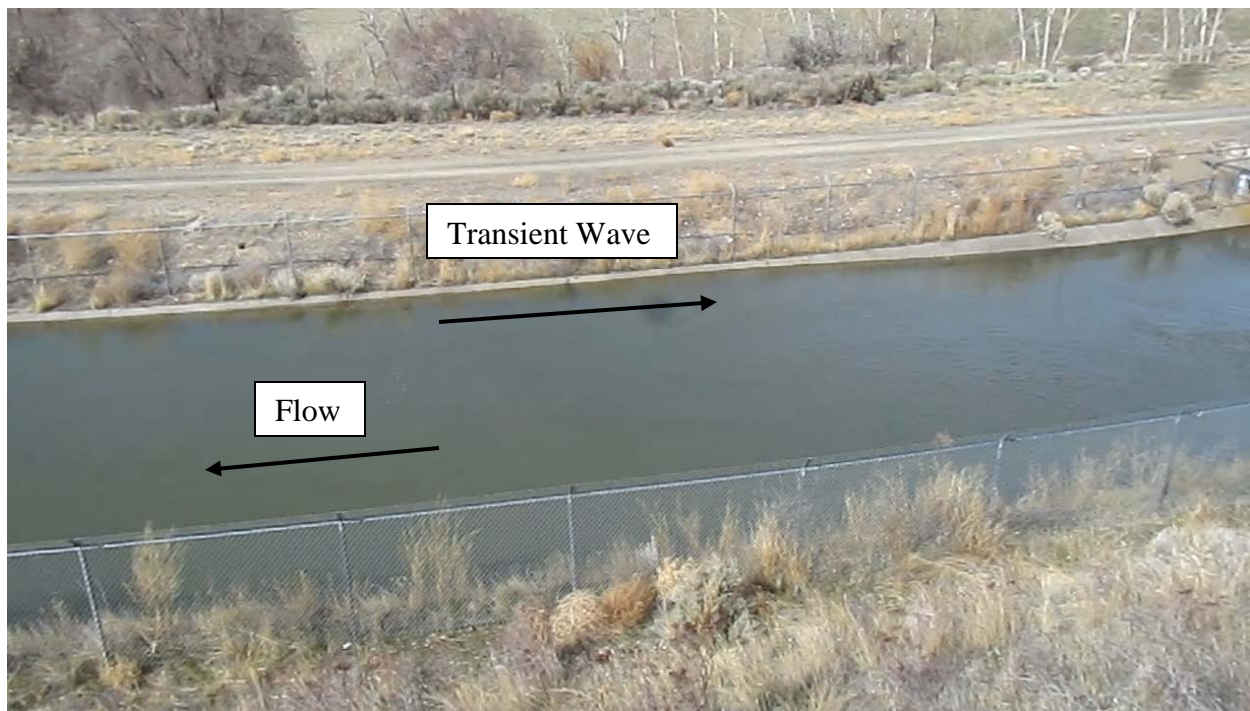
Figure 6 Transient wave near the top of the lining in the canal just upstream of the RID Y junction, near logger #4 (about 600 ft upstream from siphons). Video observations seem to confirm water levels recorded by the loggers.
