RECLAMATION

TR-2014-05

Travel to Roza Canal and Powerplant

Travel to Roza Canal and Powerplant for field testing of hydrokinetic characterization and impacts to existing canal hydraulic operation (S&T project 7317).

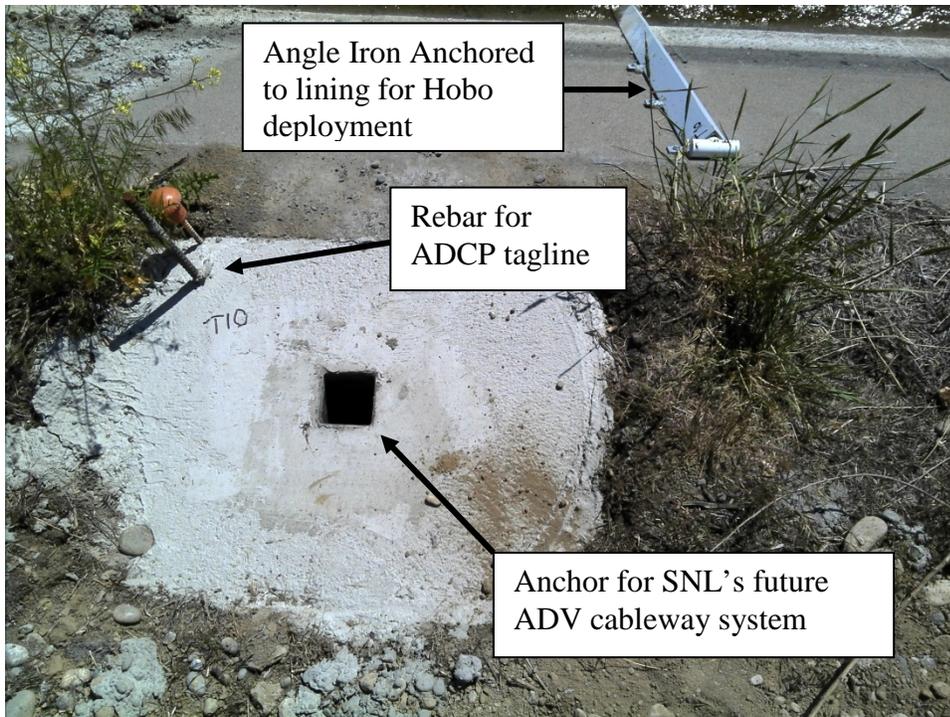
Figure 1 Typical setup for water level and ADCP instrumentation deployment at 12 measurement cross-sections.

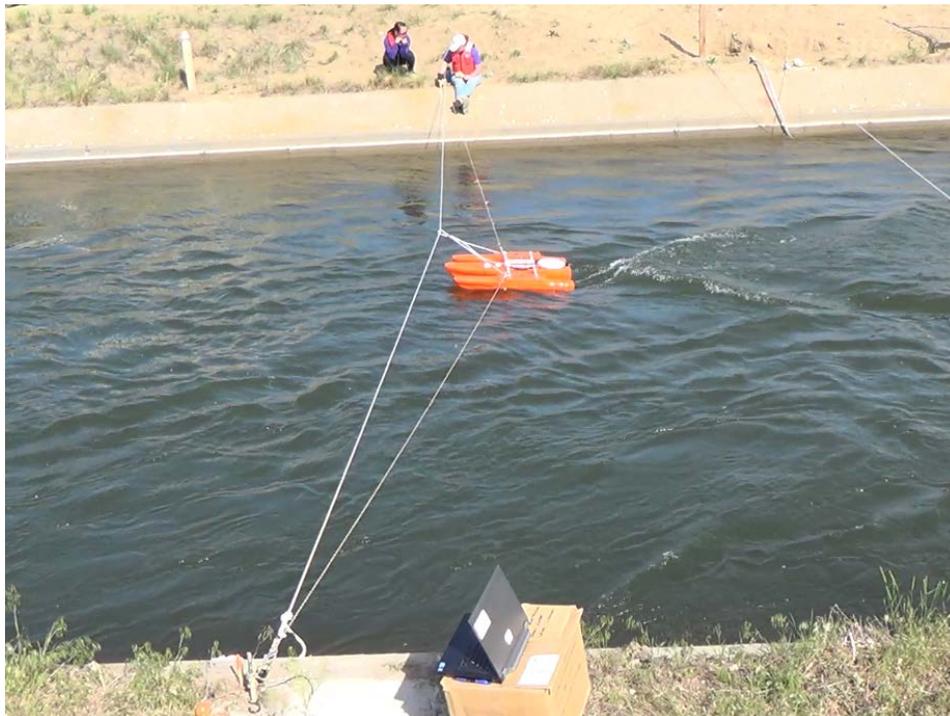
Figure 2 Reclamation's Rio Grande ADCP with the Ocean Science River Boat. Location is 32 ft upstream of the HK unit.

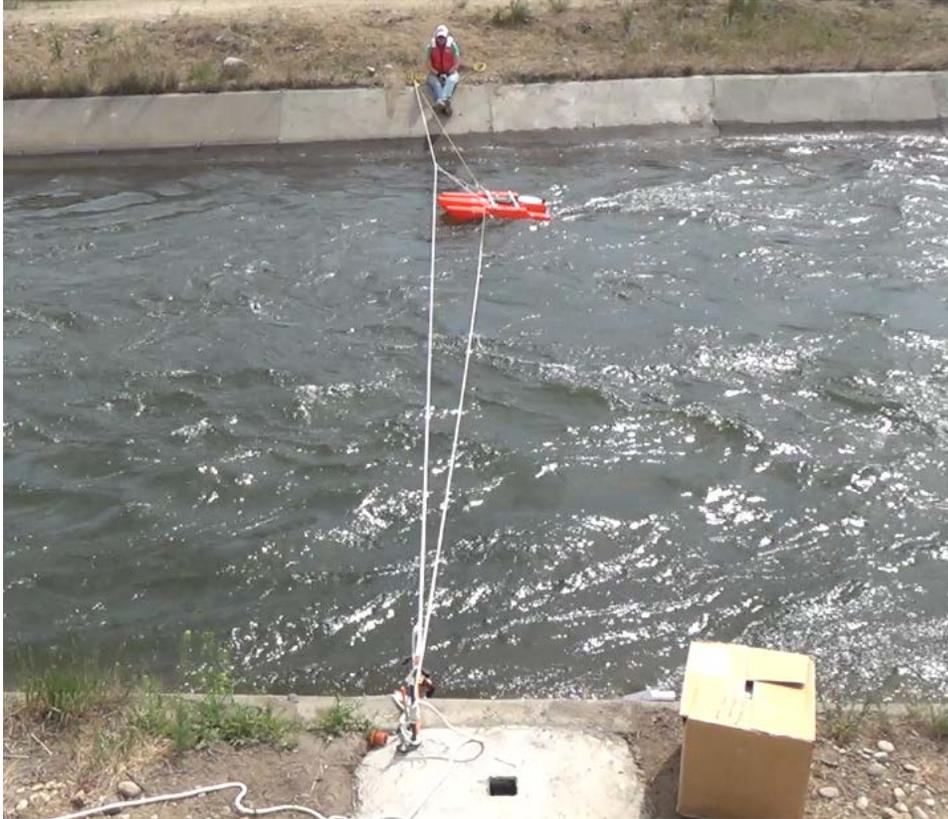
Figure 3 Reclamation's Rio Grande ADCP with the Ocean Science River Boat. Location is 32 ft downstream of the HK unit in the wake caused by the rotor.

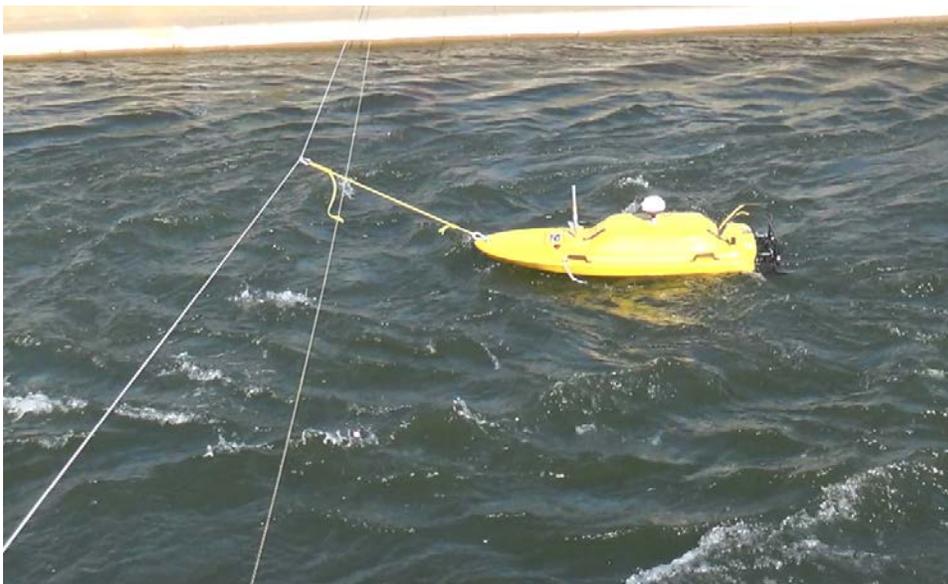
Figure 4 SNL's Rio Grande ADCP with the Z-Boat. Location is 32 ft downstream of the HK unit in the wake caused by the rotor.

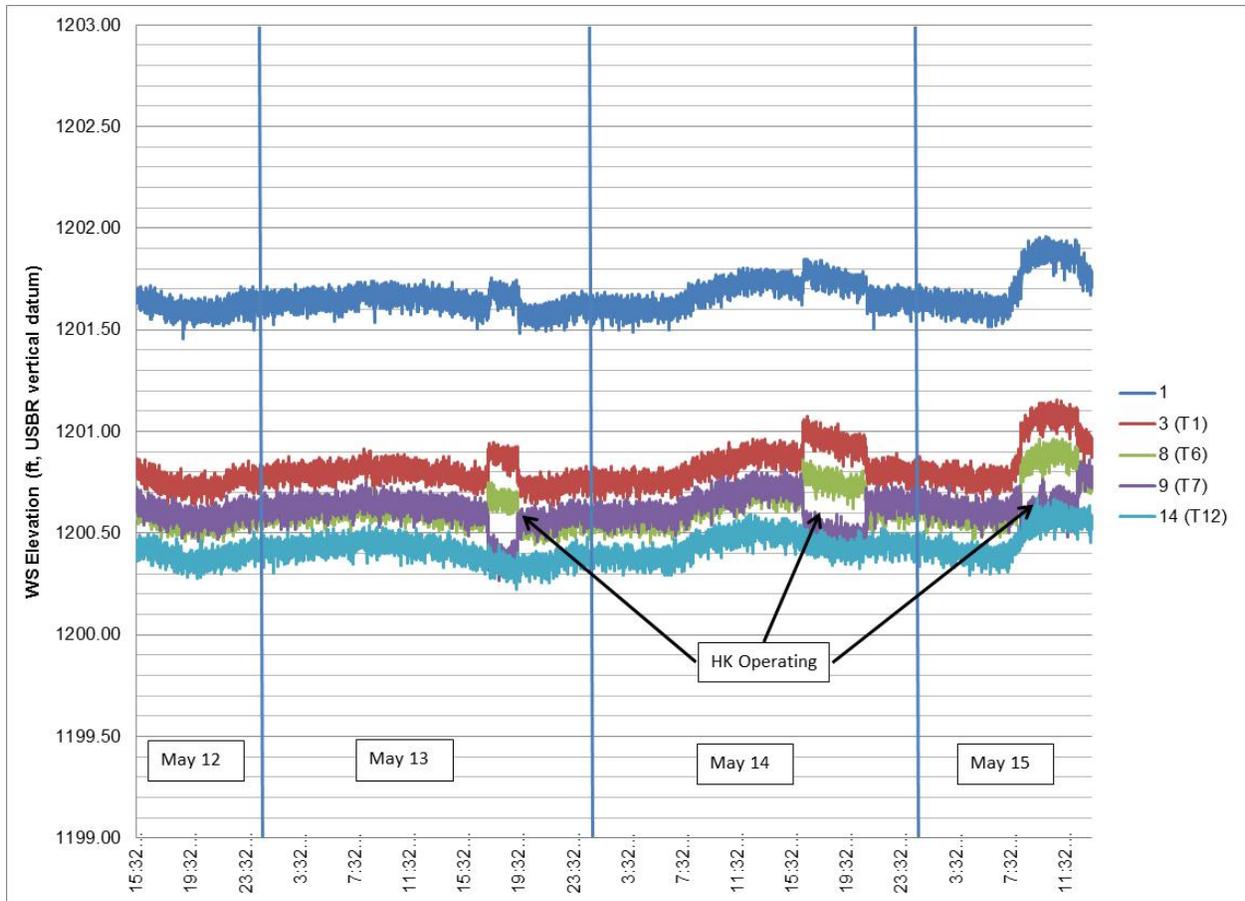
Figure 5 Water level data throughout the test week. Data are from logger locations 1, T1, and T6, (2400 ft, 165 ft, and 16 ft upstream of the HK unit respectively) as well as T7 and T12 (16 ft, and 165 ft downstream of HK unit respectively).

Thursday afternoon was spent taking down test equipment and preparing to return home. With the exception of the ratchets, tagline ropes were left in place for testing in August. The Hobo loggers were removed from the canal to download water level data throughout the week. Two loggers were missing as they had vibrated loose from their end caps in the flow (T8 and #18). Powerplant data were recorded throughout the week and will continue to be logged over the summer. Powerplant data will be downloaded at the conclusion of the August test.

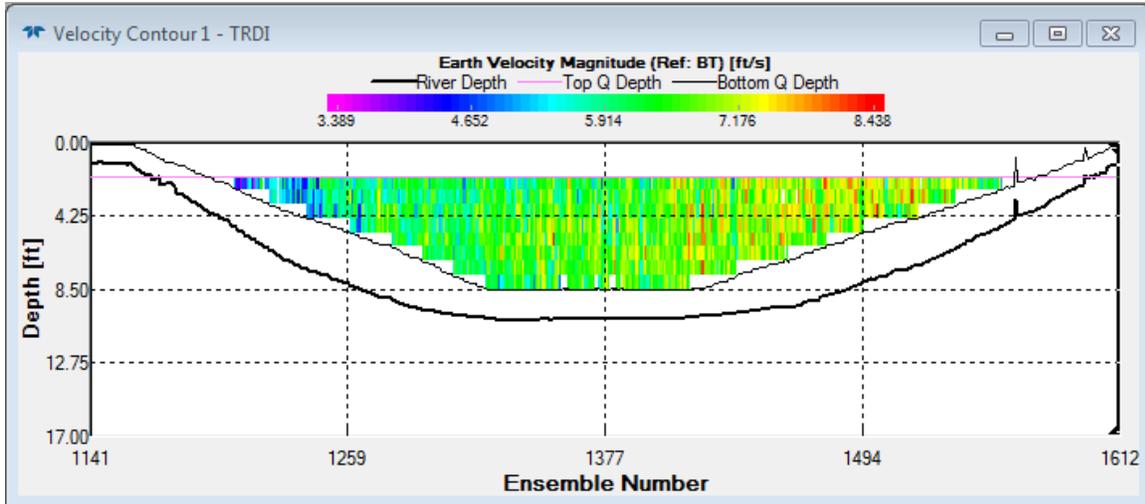
Figure 6 Baseline ADCP data at T1 (165 ft upstream of HK unit) looking downstream.

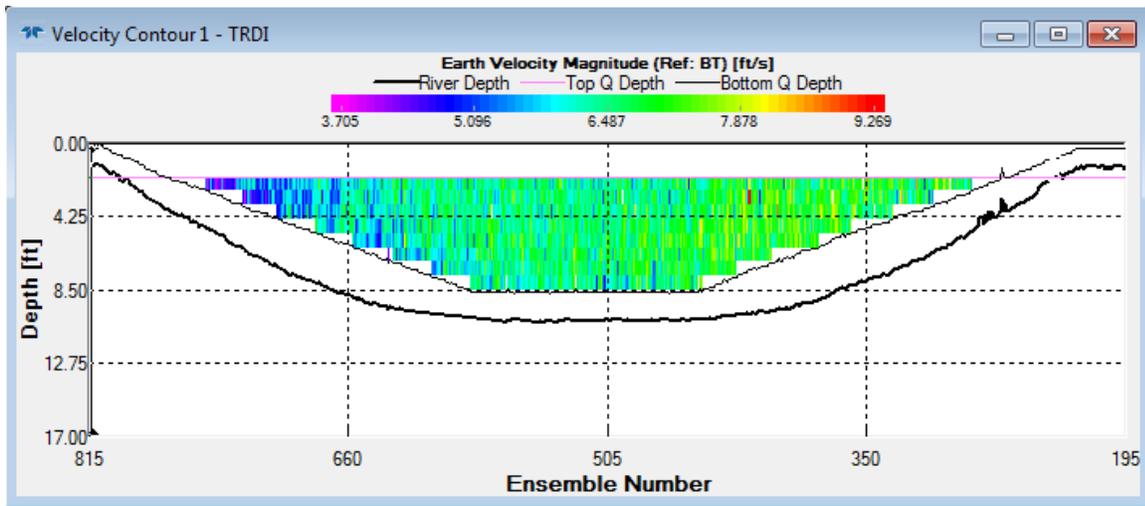
Figure 7 Baseline ADCP data at T5 (32ft upstream of HK unit) looking downstream.

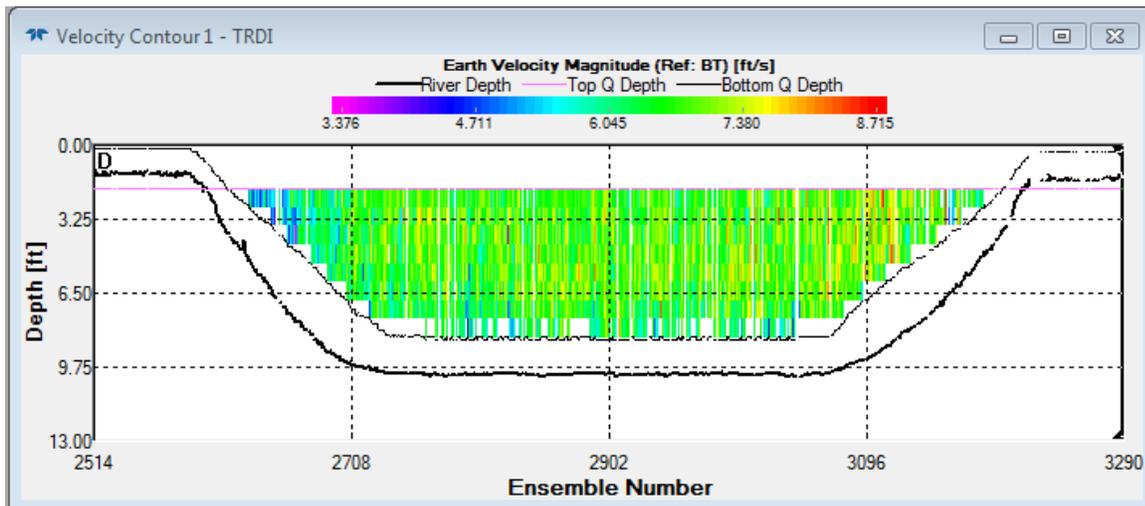
Figure 8 Baseline ADCP data at T8 (32 ft downstream of HK unit) looking downstream.

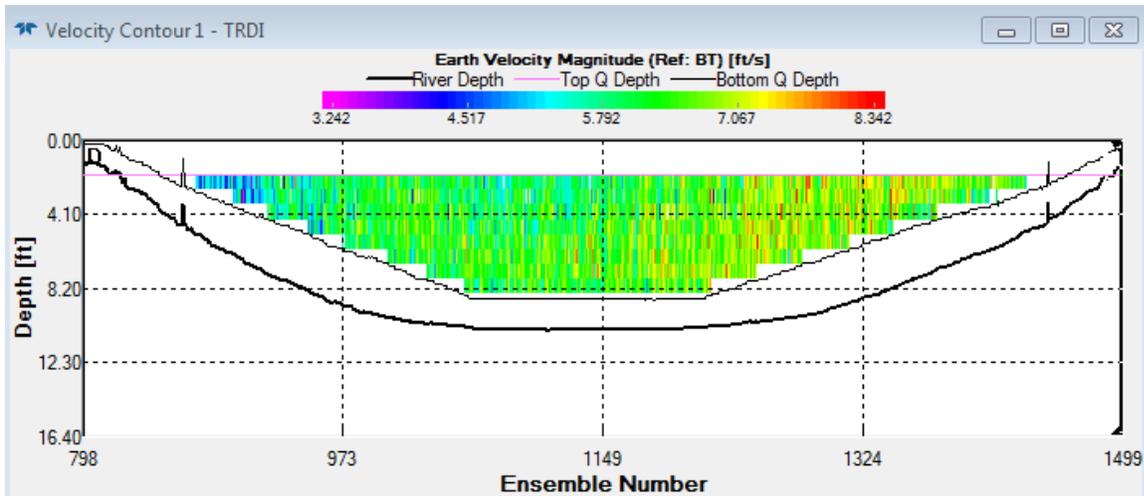
Figure 9 ADCP data with HK unit operating at location T1 (165 ft upstream) looking downstream.

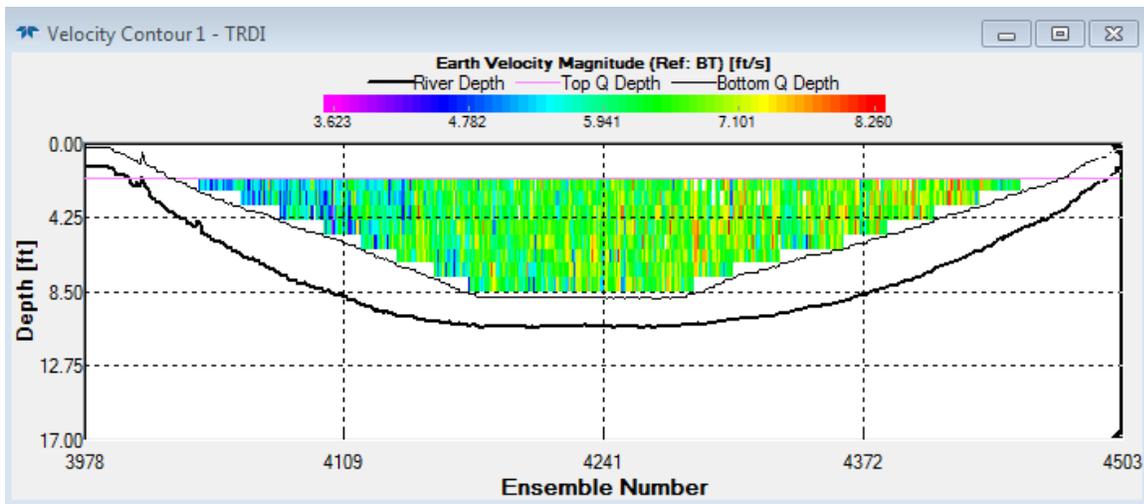
Figure 10 ADCP data with HK unit operating at location T5 (32 ft upstream) looking downstream.

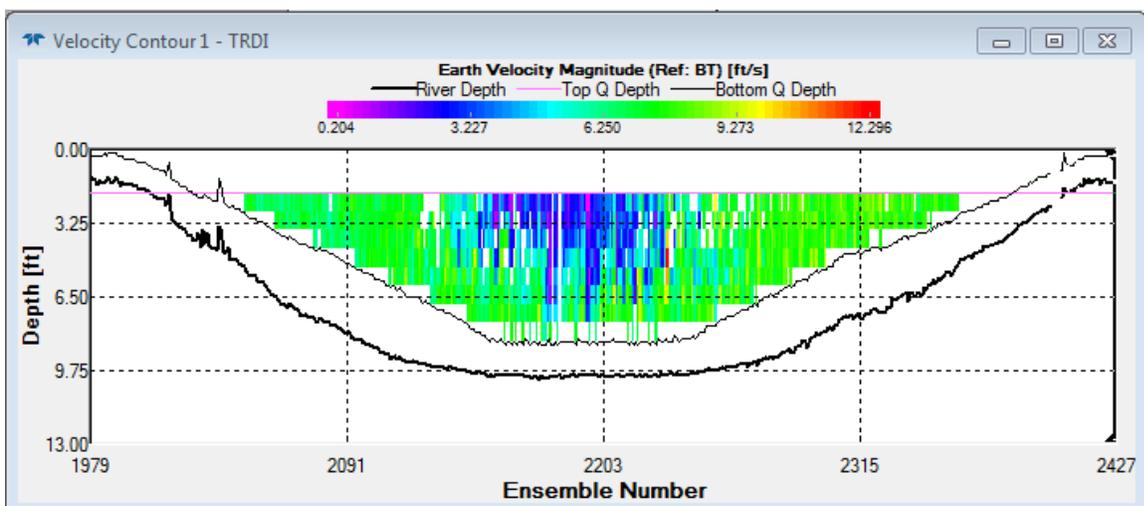
Figure 11 ADCP data with HK unit operating at location T8 (32 ft downstream) looking downstream. The wake is evident on both sides of the canal with lower velocities near the center line downstream of the rotor.
