**EVALUATION OF TECHNIQUES FOR  
DETECTION OF CAVITATION ON THE  
RUNNER OF A MODEL HYDRAULIC TURBINE**

December 1991

**U.S. DEPARTMENT OF THE INTERIOR  
Bureau of Reclamation  
Denver Office  
Research and Laboratory Services Division  
Hydraulics Branch**

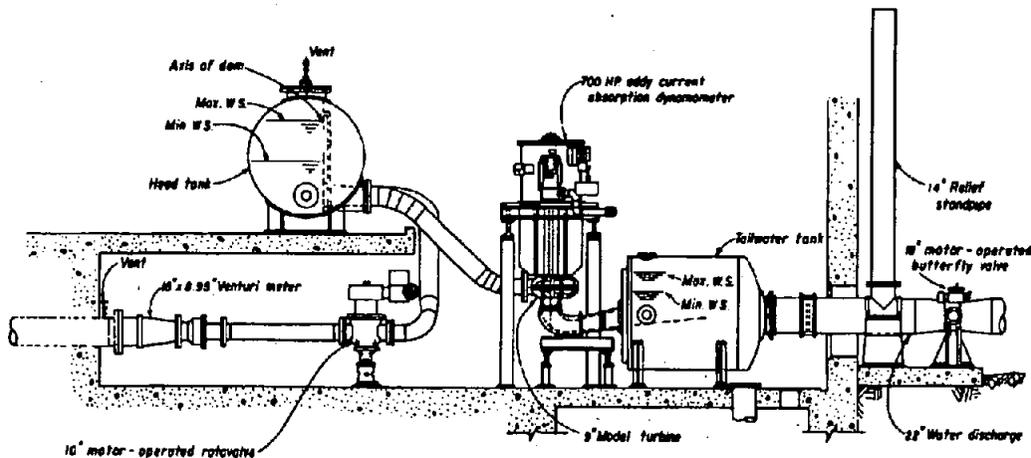
Figure 1. - Elevation view of the test stand, as it was installed at Estes Powerplant. The standpipe was moved about 60 ft downstream when the test stand was installed at CSU.

Reclamation (the Bureau of Reclamation) and CSU (Colorado State University) have agreed to collaborate on cavitation research with a model hydraulic turbine. The turbine is a 1:40.33 scale model of the 700-MW turbine units G22, G23, and G24, at Grand Coulee Third Powerplant, Columbia Basin Project, WA. Allis Chalmers Corporation, York, PA, fabricated the model turbine, which was originally installed in the turbine test stand at Estes Powerplant, near Estes Park, CO, in 1974. The model is designed to operate in the prototype head range and provides complete geometric similarity with the prototype from the penstock intake through the downstream tailrace. Major components of the turbine model are shown in figures 1 and 2.

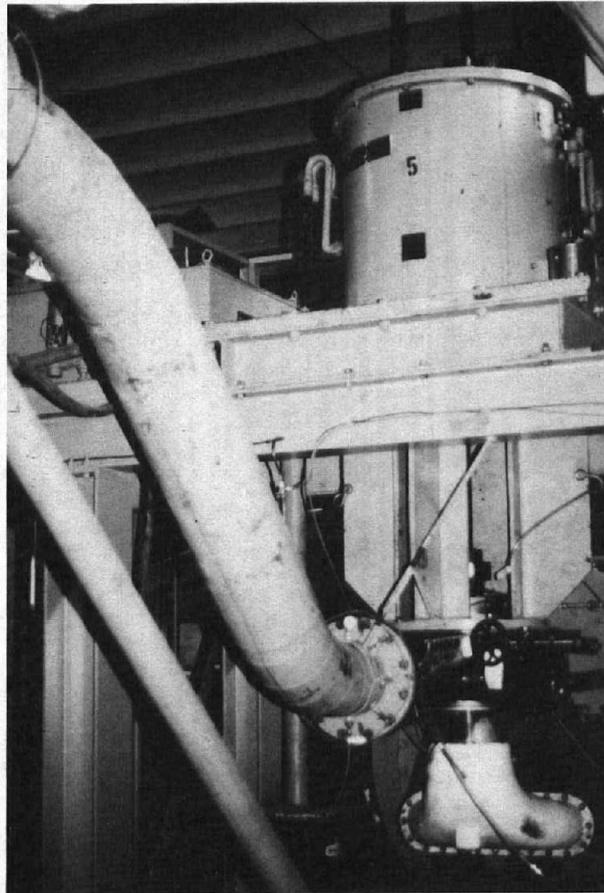
Figure 2. - The penstock and model turbine area. Main components shown include the penstock (left), spiral case, draft tube, and dynamometer (top).

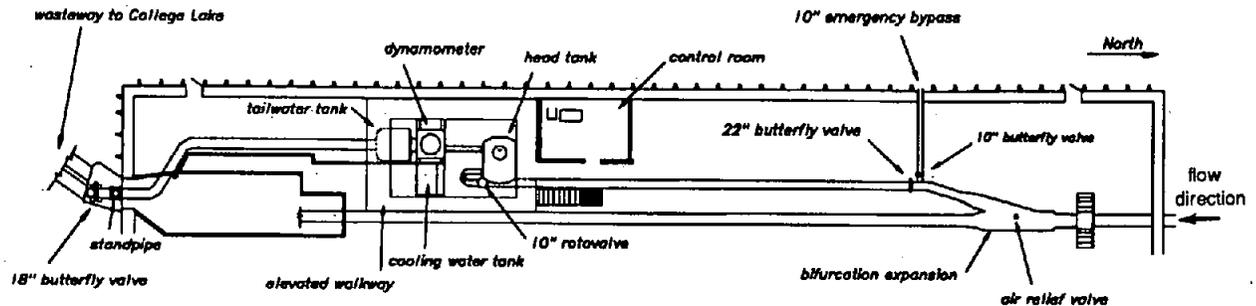
Figure 3. - Plan view of turbine test facility arrangement. The turbine test stand is installed on the west side of the hydromachinery laboratory at the ERC.

Following the guard valve, the pipeline enters the north end of the hydromachinery laboratory; the arrangement inside the laboratory is shown in figure 3. Just inside, the 24-in (61.0-cm) line enters a bifurcation, where the flow is diverted into the 18-in (45.7-cm) line supplying water to the test facility. An air-release, vacuum-break valve is mounted on the top of the bifurcation. Blowoff valves upstream of the bifurcation permit dewatering. Immediately downstream of the bifurcation a hand-operated 22-in (55.9-cm) butterfly valve is installed for emergency shutdown. A hand-operated 10-in (25.4-cm) butterfly valve controls a 10-in (25.4-cm) emergency bypass line, discharging through the west wall of the laboratory. The turbine test stand is located about 75 ft (22.9 m) downstream of this bypass. The facility from the venturi meter through the head tank, penstock, turbine, draft tube, and tailwater tank is essentially the same as it was at Estes Powerplant. The head tank rests on a steel frame structure about 8.5 ft (2.59 m) above the floor of the laboratory (fig. 4). The turbine, dynamometer, and cooling water tank are installed on the same steel structure used at Estes Powerplant (fig. 5). Discharge piping from the tailwater tank proceeds about 60 ft (12.2 m) downstream, through two 60° bends that align the flow for discharge past the standpipe, through an 18-in (45.7-cm) motor-operated butterfly valve, and into the wasteway. The wasteway conveys the discharge into an open channel leading to College Lake, about one-fourth of a mile downstream.

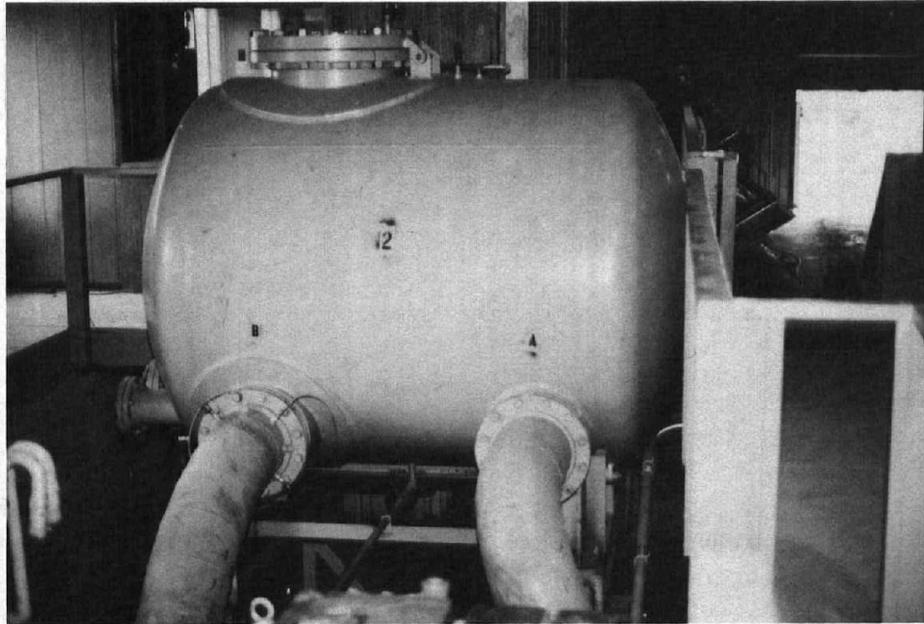
Figure 4. - Head tank for the model turbine. Flow from the Rotovalve enters the head tank on the right and exits through the model penstock on the left. The control room is located through the window on the left.

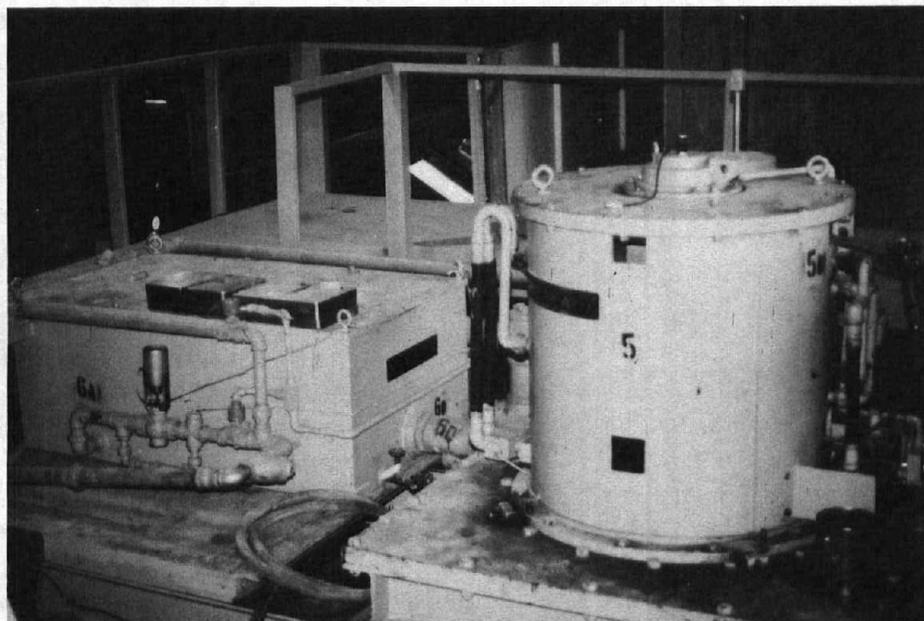
Figure 5. - Dynamometer (right) and the dynamometer cooling water tank installed on top of the test stand frame.

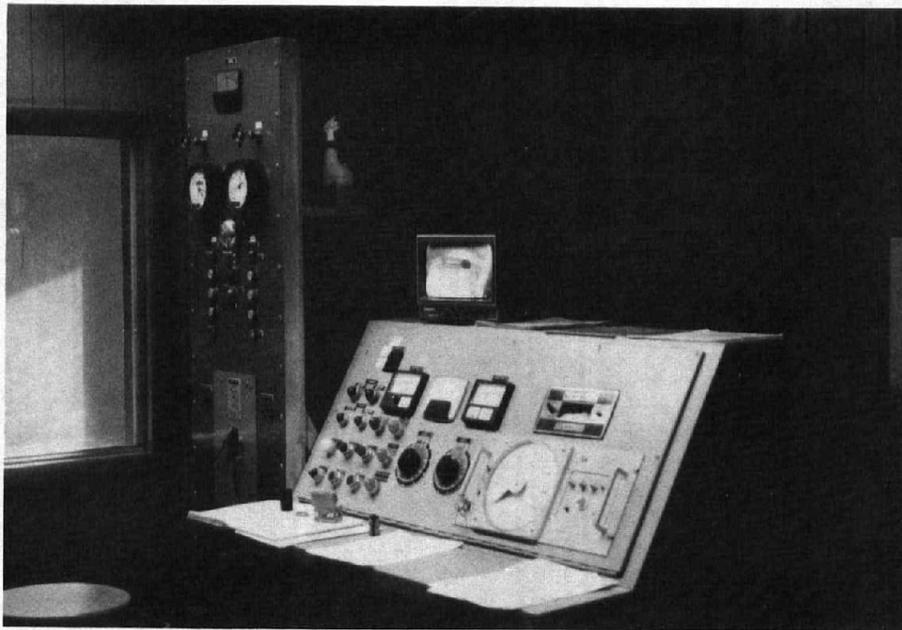
Figure 6. - Test facility control room showing the valve control panel (left) and dynamometer control console (right).

The test facility is operated from a control room located on the second floor of the laboratory, immediately upstream of the turbine test stand (fig. 6). The dynamometer control console, valve control panel, and major items of instrumentation are located in the control room. Signals from pressure transducers, thermocouples, and other sensors are relayed through an input panel near the model turbine to an output panel mounted in the control room. These signals are continuously monitored by a Hewlett Packard HP85 computer and a 3421A Data Acquisition and Control Unit. This system provides the operator with the current operating status of the turbine model. Large viewing windows allow the operator to see most areas of the test facility, and a closed circuit TV monitor in the control room permits viewing of the turbine runner through the plexiglas draft tube.

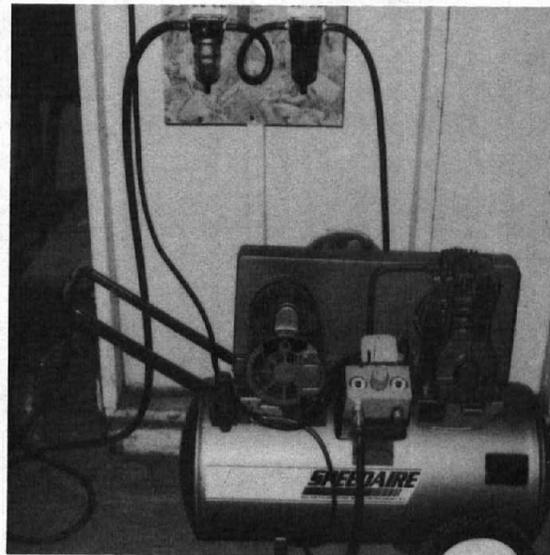
Figure 7. - Three-hp, 20-gal air compressor with oil/water and particulate filters. The compressor supplies air to the oil mist lubrication units.

Three precision bearings are lubricated by oil mist supplied by three oil mist units. Compressed air was originally supplied to the misters by a 1-1/2-hp air compressor already present in the laboratory. Following initial runs, a buildup of oil shellac within the air regulators on the misters caused the regulators to stick open at the start of each run. It was suspected that the oil supplied with the oil mist units when they arrived from Estes Powerplant had deteriorated due to age, causing the shellac buildup. The air regulators were cleaned, and the oil mist reservoirs were drained, cleaned, and refilled with a new oil recommended by the dynamometer manufacturer. After several hours of operation, the shellac buildup returned. Following the failure of the 1-1/2-hp air compressor, a new 3-hp (2.24-kW), 20-gal (75.7-L) air compressor was purchased. This compressor is equipped with water, oil, and particulate filters, and an automatic condensate blowoff valve. Since the installation of the new compressor, the shellac buildup has ceased and the misters have worked well.

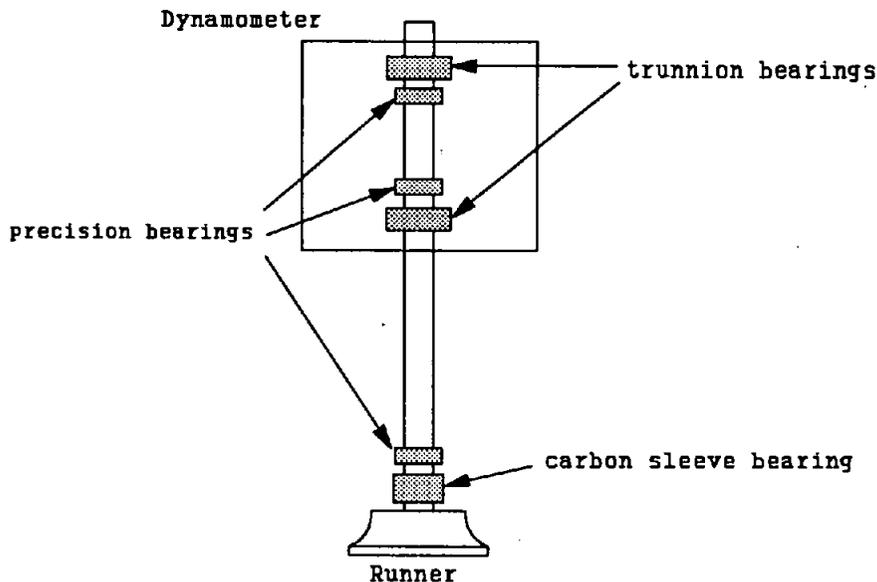
Figure 8. - Location of dynamometer and turbine bearings.

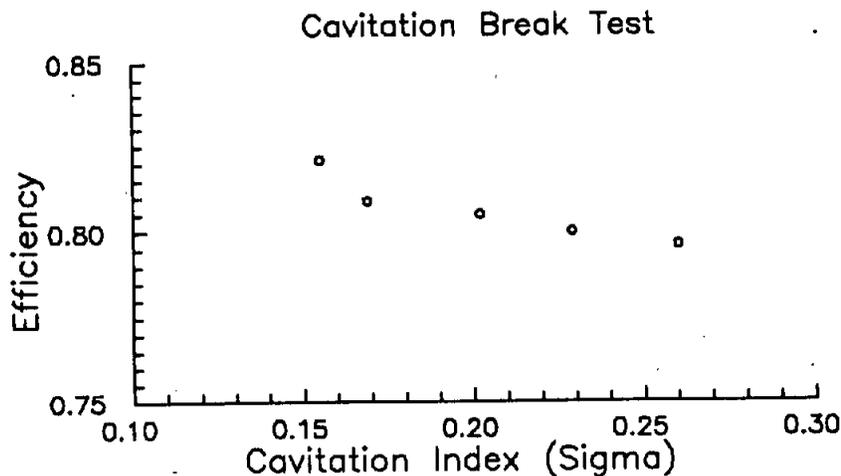
Figure 9. - Results of attempted cavitation break test at 17° gate opening and speed ratio = 0.70.

The shortened length of the standpipe noted previously has limited the maximum NPSH available to about 50 ft (15.2 m). Any higher NPSH causes discharge of water through the top of the standpipe, with resulting local erosion near the wasteway. At maximum head this limits the maximum  $\sigma$  to about 0.2, but at lower heads,  $\sigma$  values of 0.3 to 0.4 can easily be obtained. This is sufficient to eliminate cavitation on the turbine runner under most operating conditions.

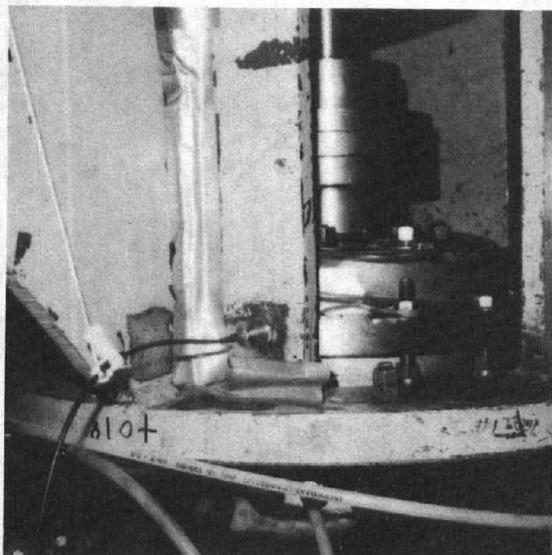
Figure 10. - Accelerometer, stud-mounted on the turbine test stand.

used for tailrace measurements at Flatiron and other C-BT powerplant sites. The B&K Type 4370 accelerometer was stud-mounted to the turbine test stand frame (fig. 10). This location is in direct structural contact with the spiral case, stay ring, and distributor assemblies. An Endevco Model 8530-100 piezoresistive absolute pressure transducer was flush-mounted at the draft tube throat, directly below the runner (fig. 11).

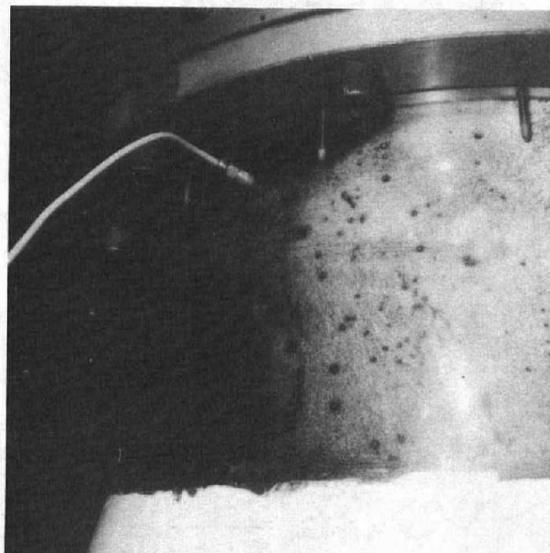
Figure 11. - Piezometric pressure transducer flush-mounted at the draft tube throat.

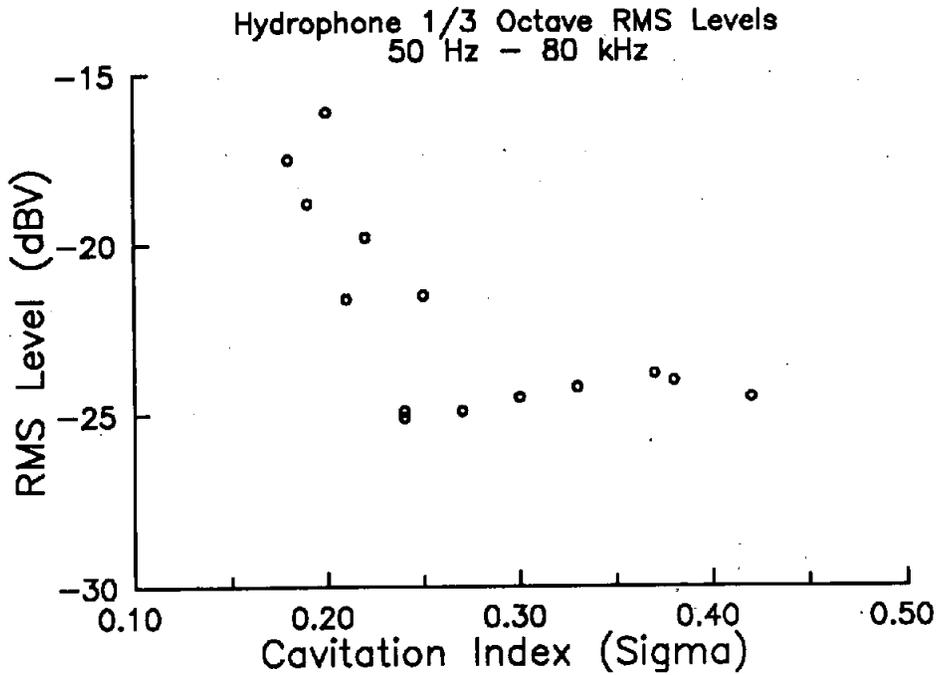
Figure 12. - Hydrophone one-third octave rms levels vs.  $\sigma$ .  
These data were collected at full gate opening and a speed ratio of 1.02.

overall, one-third octave rms levels for the hydrophone, pressure transducer, and accelerometer are plotted against the cavitation coefficient,  $\sigma$ , in figures 12, 13, and 14. A pronounced increase in rms level corresponded to the onset of cavitation, which was visually evaluated to be about  $\sigma = 0.25$  for operation at full gate.

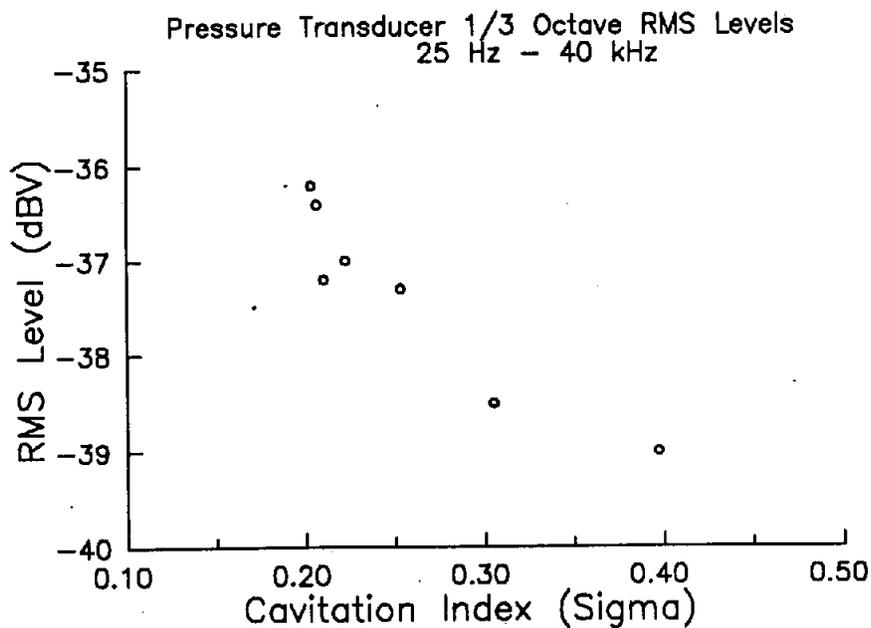
Figure 13. - Pressure transducer one-third octave rms levels vs.  $\sigma$ .  
These data were collected at full gate opening and a speed ratio of 1.03.

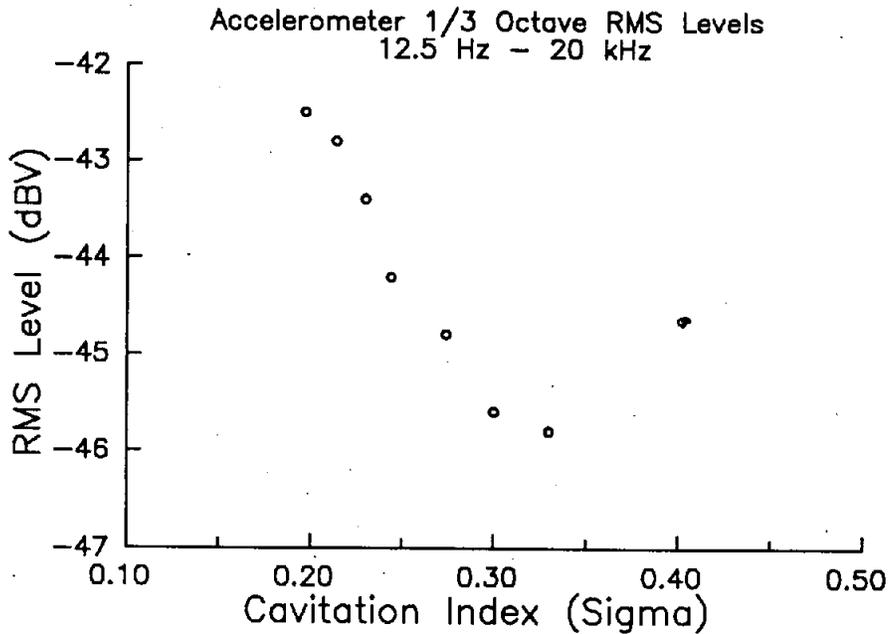
Figure 14. - Accelerometer one-third octave rms levels vs.  $\sigma$ . These data were collected at full gate opening with the speed ratio held constant at 1.03.

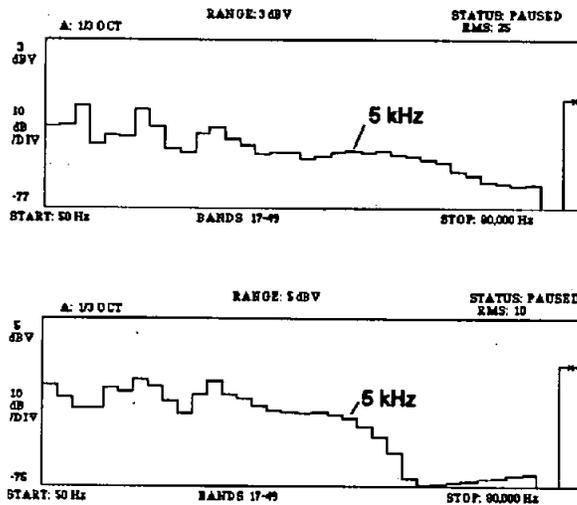
Figure 15. - Hydrophone one-third octave analyses. The top plot is at  $\sigma = 0.27$ , while the lower plot is at  $\sigma = 0.18$ . As cavitation activity increases, components above about 5 kHz drop out.

In addition to the variation in rms levels, one-third octave and narrow band analyses of the hydrophone output showed a definite drop in the signal level above about 5 kHz as cavitation activity increased. Figures 15 and 16 show examples.

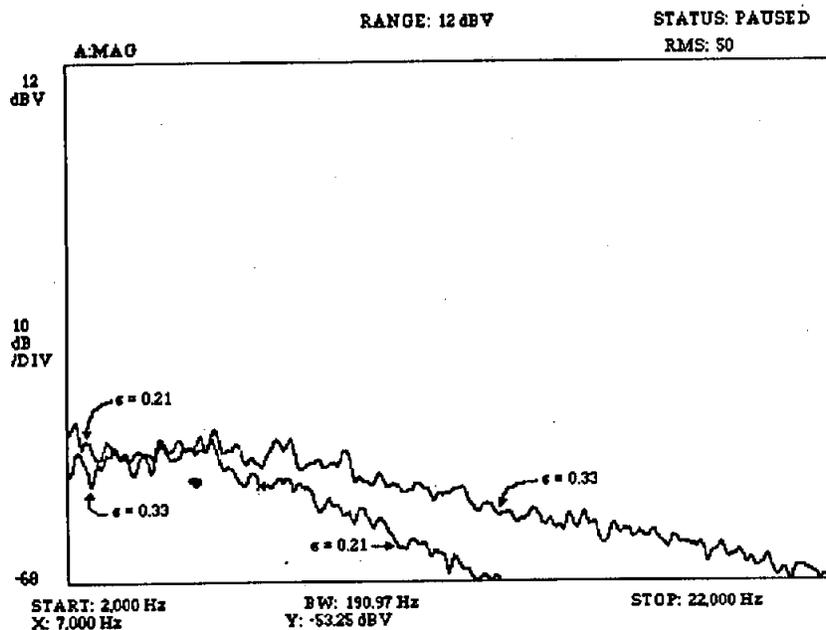
Figure 16. - Hydrophone narrow band analyses. Note the loss of high frequency signal as cavitation activity increases.

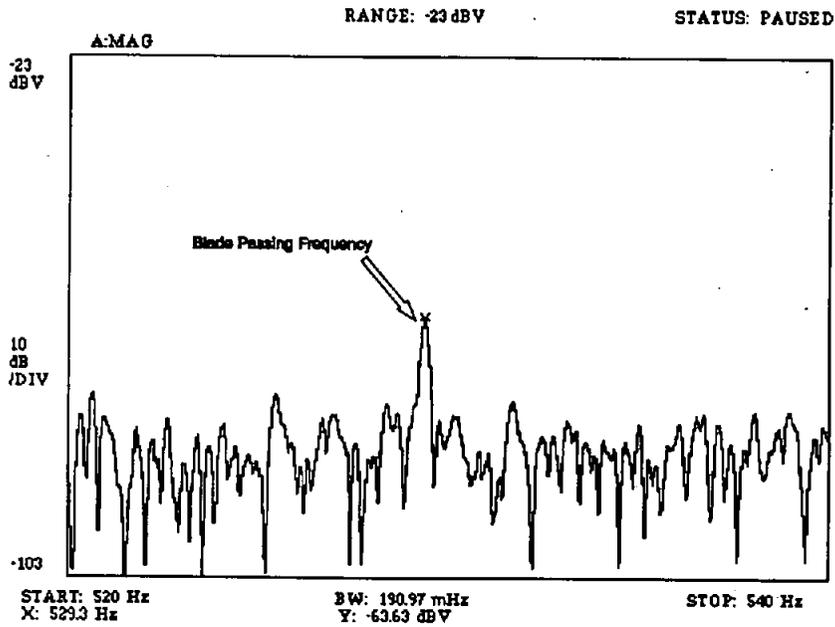
Figure 17. - Pressure transducer narrow band analysis with no cavitation. Note the strong signal at the blade passing frequency (approx. 530 Hz).

Narrow band analyses of the pressure transducer output also gave some indication of cavitation. Under noncavitating conditions, the blade passing frequency dominated the signal. However, as the tailwater level was lowered and cavitation increased, the blade passing frequency became less dominant. This behavior is shown in figures 17 and 18. Note that the blade passing frequency itself is different in the two figures because the shaft speed was varied to maintain the same speed ratio and unit power as the tailwater level was changed.

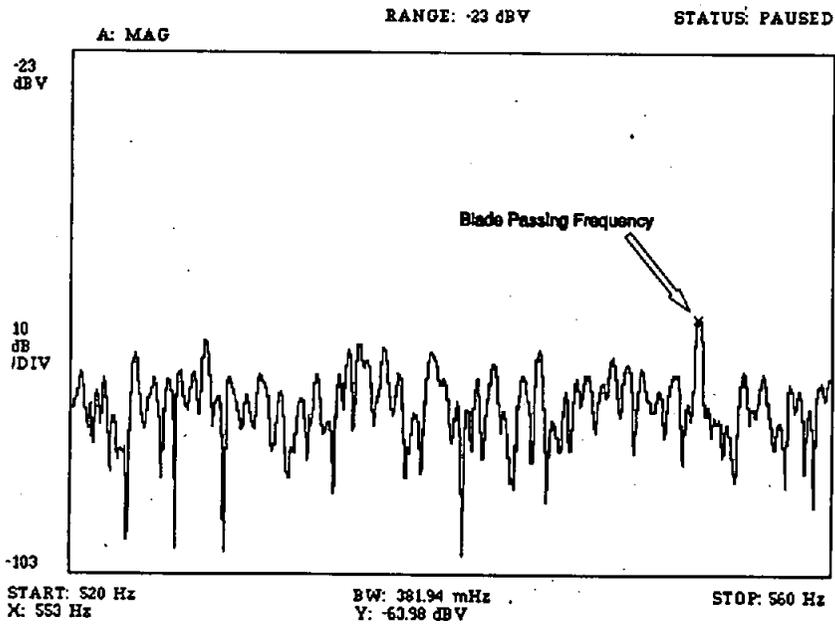
Figure 18. - Pressure transducer narrow band analysis with cavitation. The blade passing frequency (approx. 554 Hz) becomes less dominant as cavitation intensity increases.

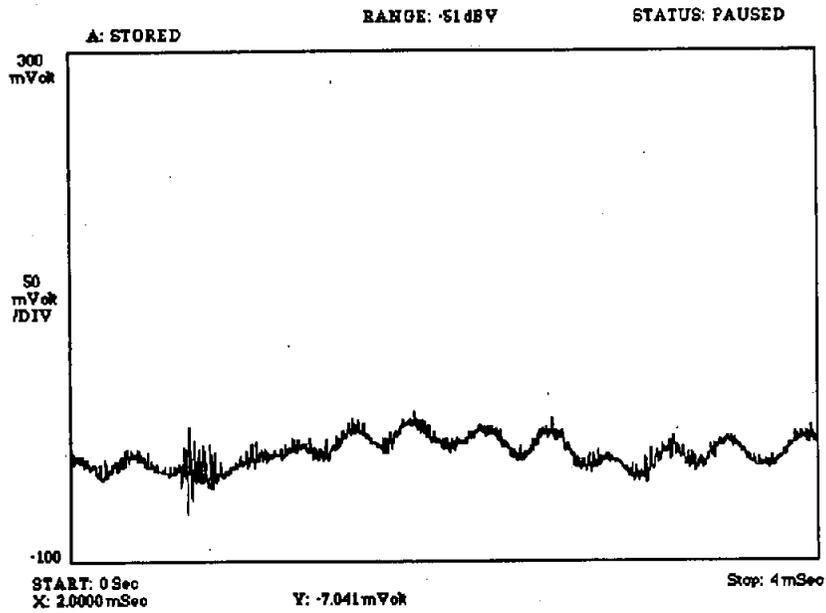
Figure 19. - Time domain output from pressure transducer. Note the burst signal at the lower left. The frequency of this burst is about 36 kHz.

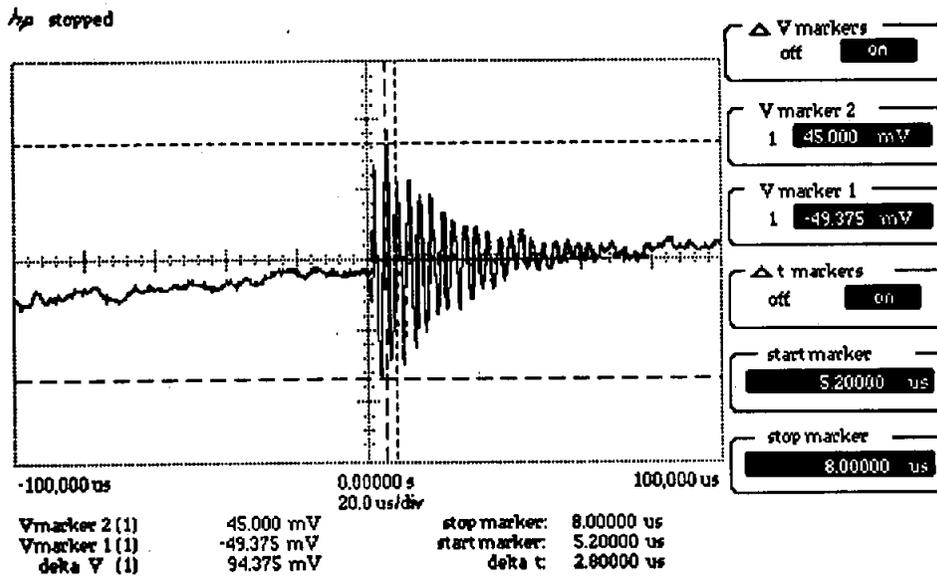
Figure 20. - Time domain output from accelerometer. Note the extremely high frequency of 357 kHz.

The accelerometer also provided some indication of cavitation when signals were monitored in the time domain. During runs at cavitating conditions, time traces recorded with the digitizing oscilloscope indicated very high frequency signals, between 350 to 500 kHz. Figure 20 shows one such trace. These short-duration, high-frequency signals are far beyond the range of the accelerometer, which has a resonant frequency of about 25 kHz. Although the amplitude of these signals is unreliable, their presence during cavitating conditions indicates that high-frequency sensors such as AE transducers may be useful for cavitation detection.

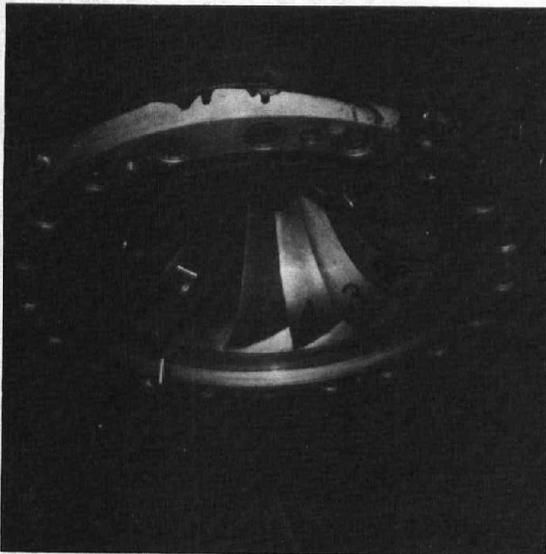
Figure 21. - AE transducer configured as a sending unit mounted on the turbine runner.

Testing was done using a calibrated AE signal generator to try to determine portions of the turbine structure that would be sensitive to cavitation occurring on the runner. The draft tube was removed and an AE transducer configured as an exciter was placed on the runner (fig. 21). An AE sensor was then located at various points around the structure and output signal levels were recorded. The best coupling with the least interference from random excitation impacts of a small hammer on other parts of the turbine assembly was found between the runner and the shaft just below the lower coupling flange (fig. 22). Other locations that were sensitive to signals originating on the runner were the head cover/stay vane ring and the uppermost bearing cap. The bearing cap seemed to be well isolated from signals originating on other portions of the model and test stand structure. Although the shaft was sensitive at the bottom side of the coupling, no signal could be detected above the coupling. Table 2 summarizes the results of the measurements.

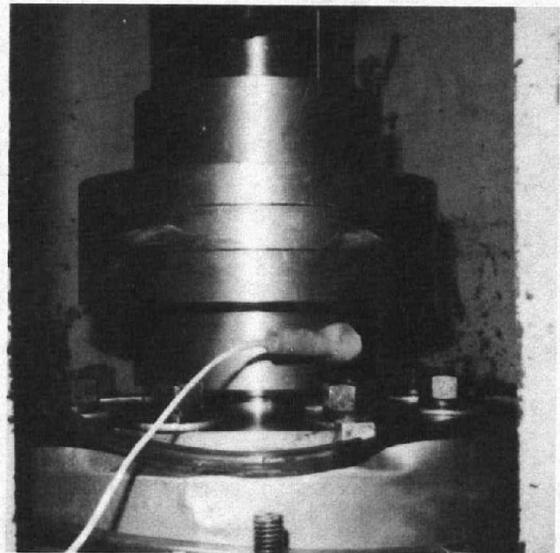
Figure 22. - AE transducer mounted on the lower shaft coupling just above the turbine runner. This transducer was used to receive signals transmitted through the transducer in figure 21.

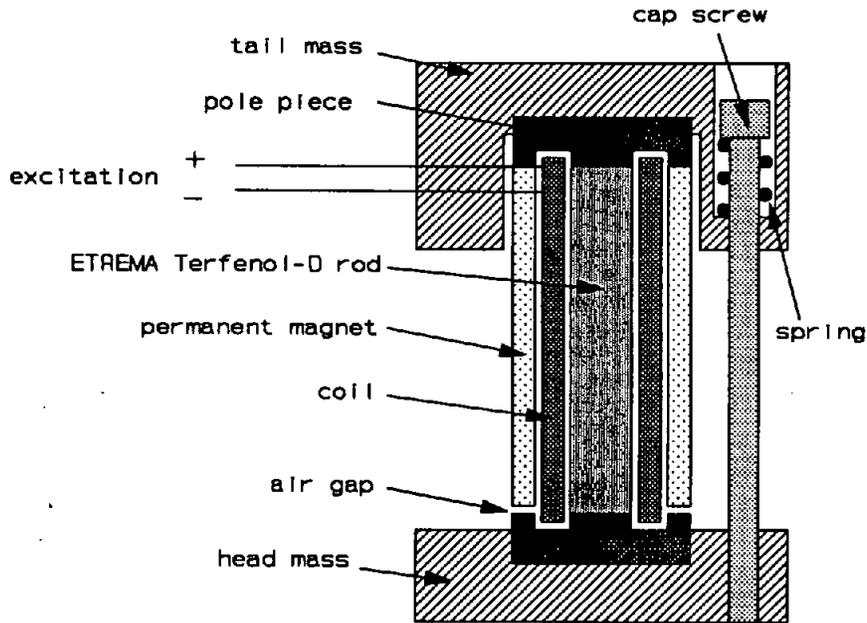
Figure 23. - Schematic diagram of magnetostrictive actuator. The actuator utilizes the magnetostrictive material ETREMA Terfenol-D.

Initial experience with magnetostrictive materials was gained in tests conducted with a magnetostrictive actuator incorporating a Terfenol-D rod. A schematic diagram of the actuator appears in figure 23. The actuator is made up of the Terfenol-D rod, surrounded by a coil for excitation or output, a permanent magnet to apply the magnetic bias, and a prestressing assembly.

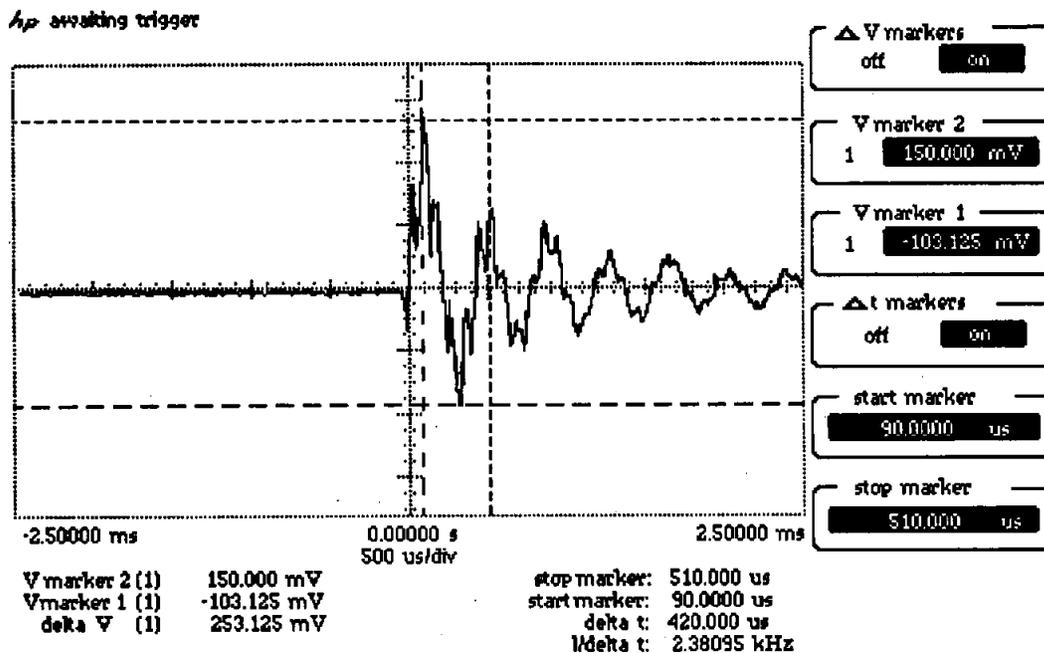
Figure 24. - Pencil test output from magnetostrictive actuator.

To test the sensitivity of the actuator a "pencil test" was performed. The pencil test is a qualitative test commonly used in the AE field for testing of very sensitive transducers. A medium hardness (HB), 0.5-mm-diameter pencil lead was extended about 0.25 in (6.4 mm) out of the pencil and placed in contact with the surface of the actuator at a 75° angle. A force was then applied perpendicular to the axis of the pencil lead, causing the lead to break. Care was taken so that the pencil did not strike the actuator after the lead broke. An oscilloscope trace of the resulting output for the actuator is shown in figure 24.

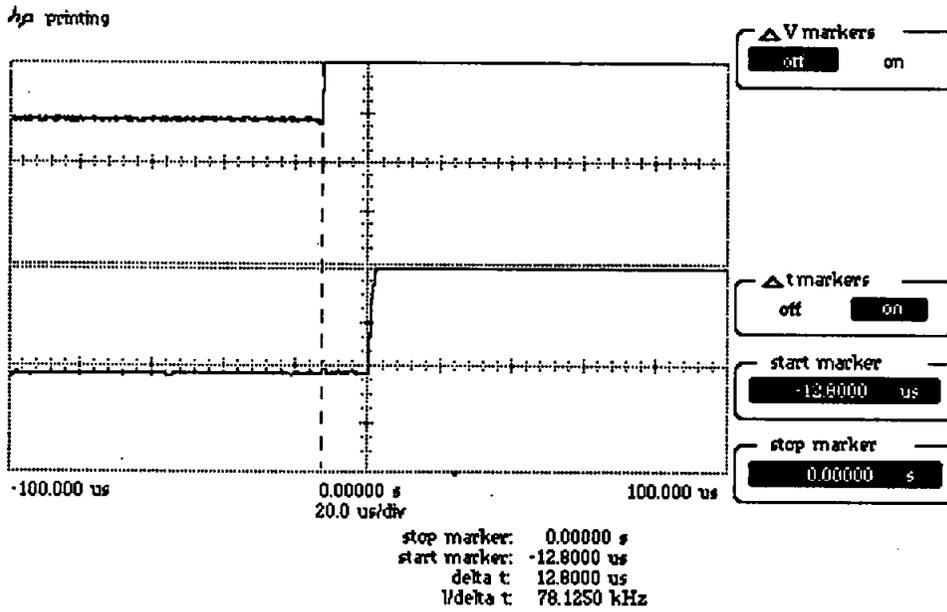
Figure 25. - Torque sensor time shift displayed on the oscilloscope.

Figure 25 shows the signals generated by the two optical triggers and the elapsed time  $\Delta t$  displayed on the oscilloscope. Figure 26 shows a narrow band analysis of the analog  $\Delta t$  output. The shaft does appear to oscillate in an angular vibration mode. Two dominant oscillations at 12.5 Hz and 31.75 Hz appear. Thus far in this research, use of this sensor for cavitation detection has been unsuccessful.

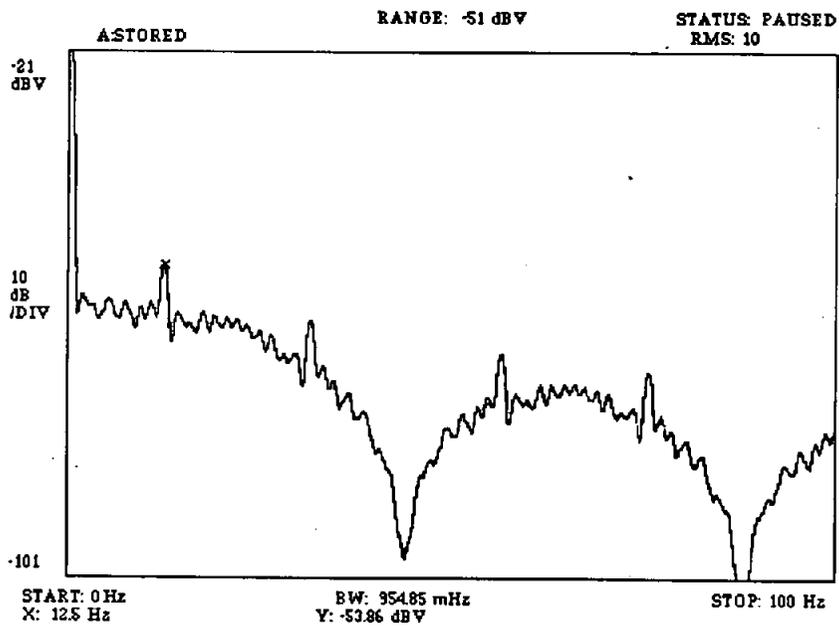
Figure 26. - Narrow band analysis of analog  $\Delta t$  output from the torque sensor.

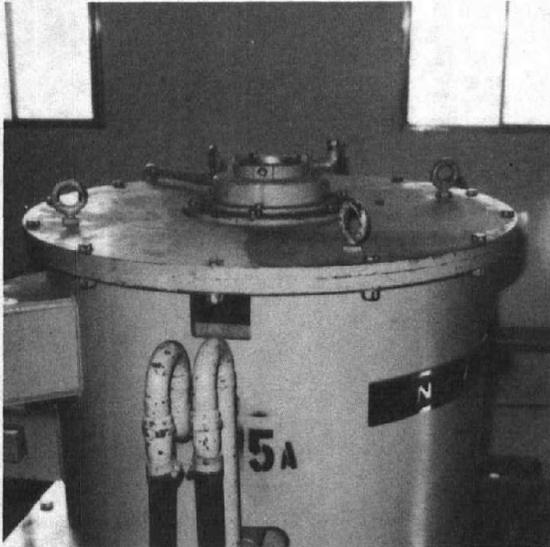
Figure E-1. - Dynamometer prior to disassembly.

Disassembly began by removing the Servo-tech tachometer generator and cover plate. Next, the collar surrounding the permanent magnet generator was removed, and the permanent magnet generator was removed from the shaft. The top cover of the dynamometer housing was then unbolted and removed using a crane. The trunnion bearing was then removed from the shaft. Two cover plates were removed to expose the precision rotor bearing. Removal of the rotor bearings requires the use of a specially built gear puller. This gear puller was fabricated, but the excellent condition of the bearing prompted the decision to reassemble the dynamometer at this point. A series of photos is included at the end of this appendix showing the disassembly procedure.

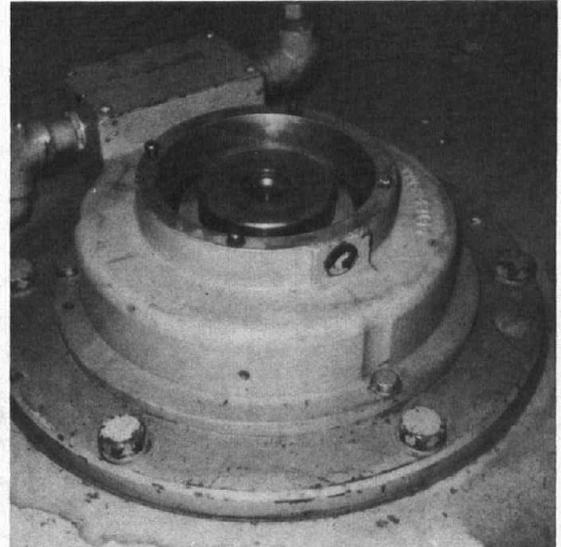
Figure E-2. - Cover plate removed to reveal tachometer generator.

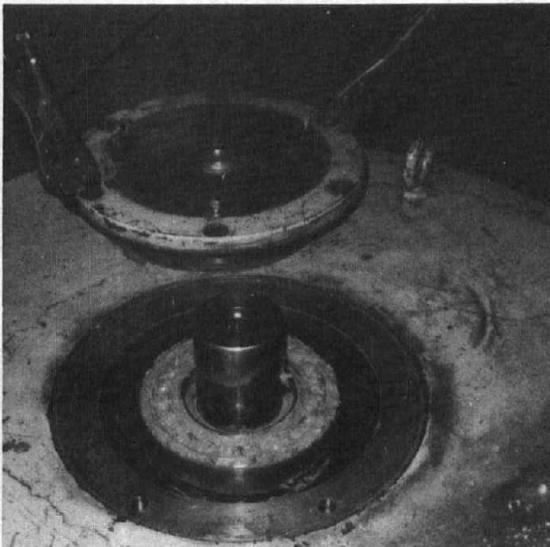
Figure E-3. - Cover removed to expose upper trunnion bearing

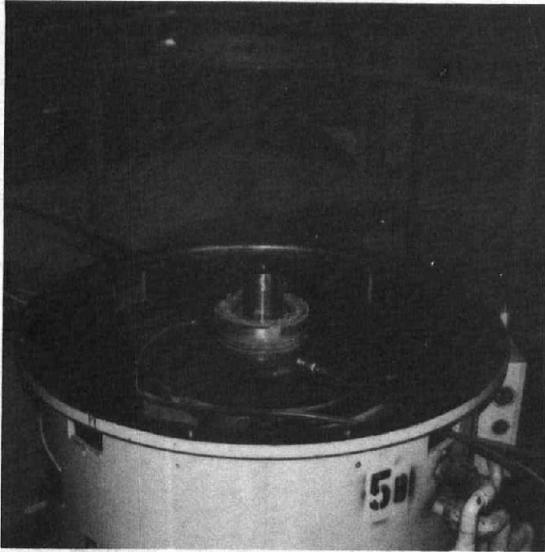
Figure E-5. - Top plate of the dynamometer removed. Oil mist is supplied to the top precision bearing through the copper tubing on the right. Oil mist exhaust from the bearing is drained through the flexible plastic tubing on the left.

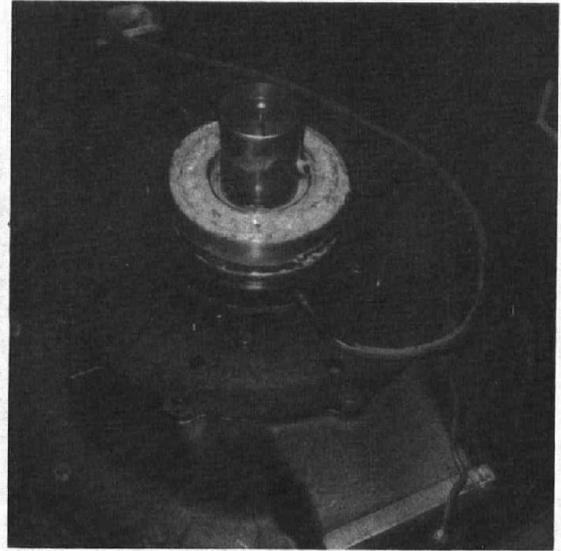
Figure E-6. - Closeup view of the trunnion bearing and oil mist lines.

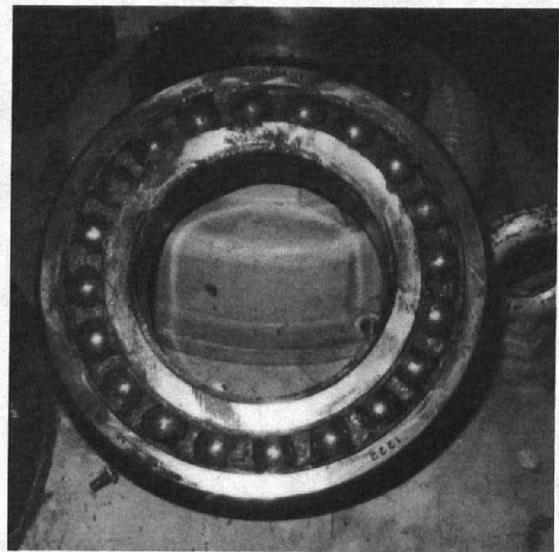
Figure E-8. - Dynamometer upper trunnion bearing following removal from the dynamometer.

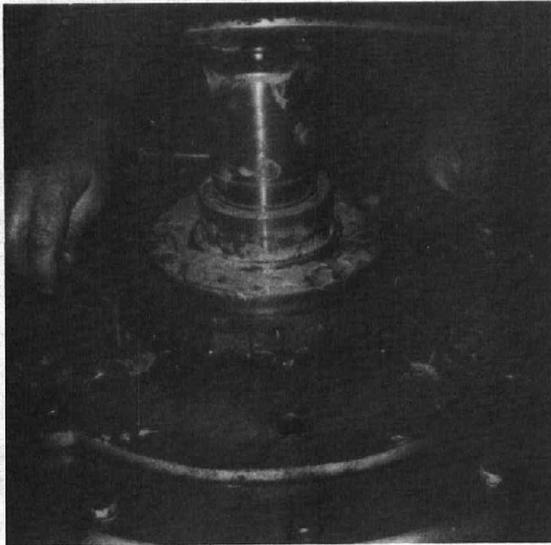
Figure E-9. - Using supplied bolt jacks to lift the cap that covers the precision bearing.

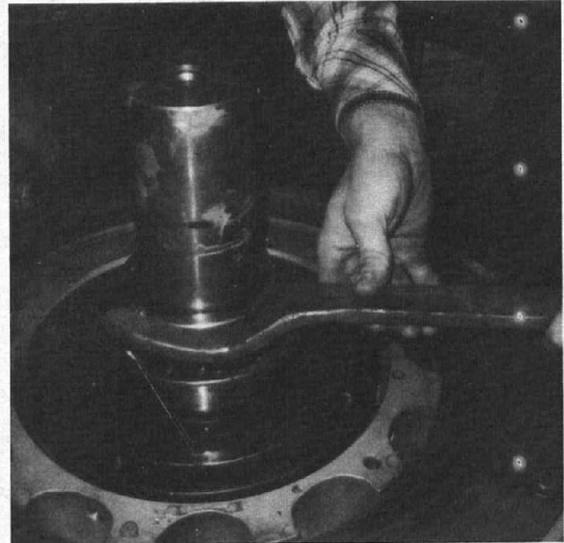
Figure E-10. - Using a spanner wrench to remove the precision bearing retainer ring and nut.

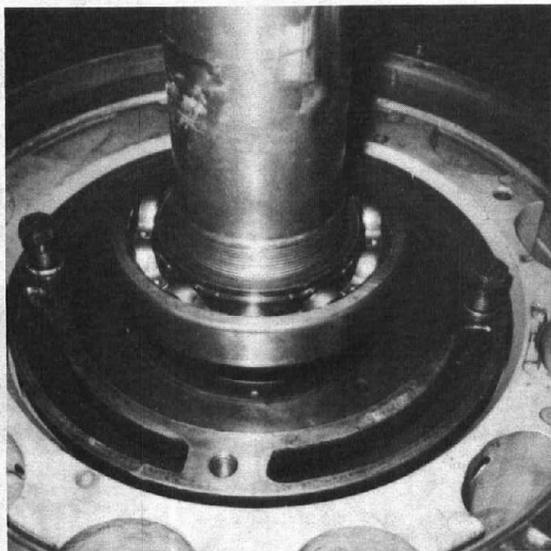
Figure E-11. - Dynamometer top precision bearing in place following removal of the retainer ring and nut.

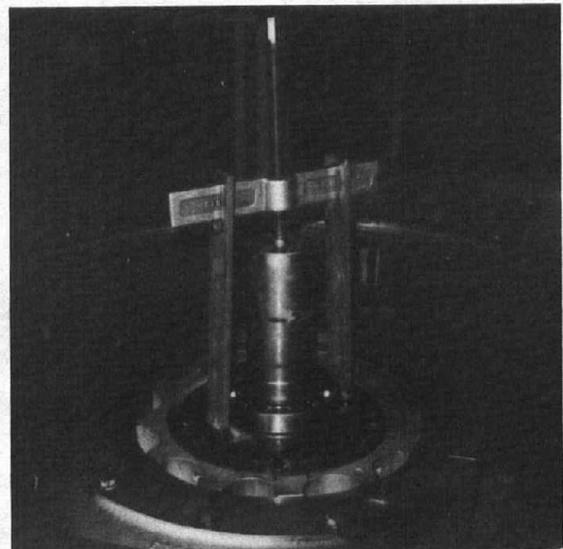
Figure E-12. - Bearing puller in place for removal of the precision bearing. The precision bearing was not removed.

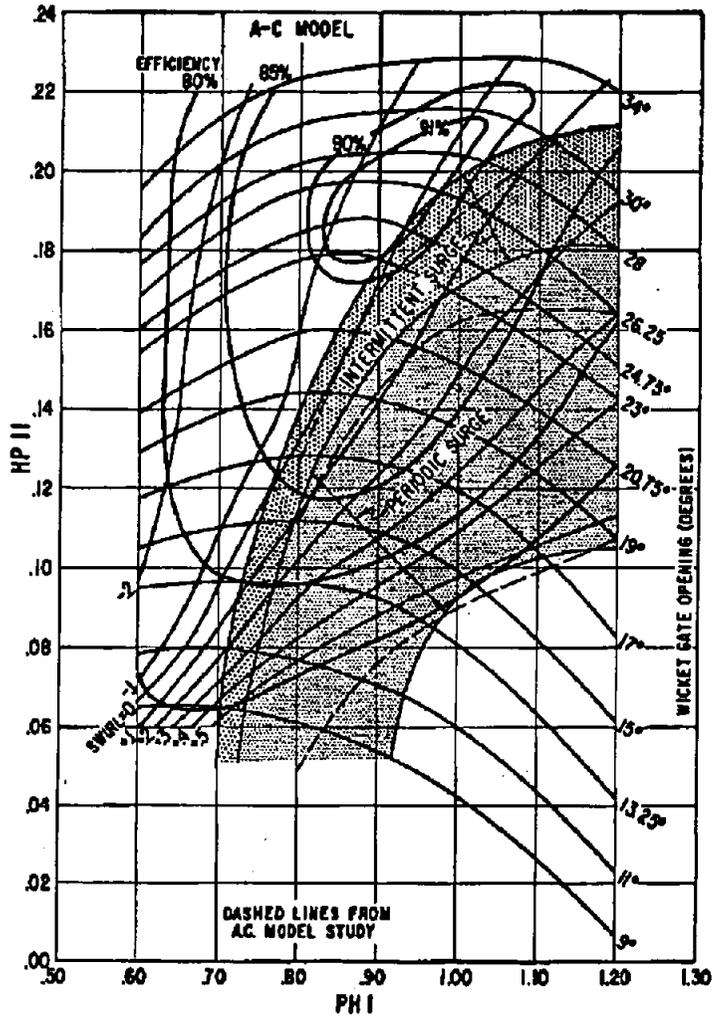
Figure F-1. - Allis Chalmers 9-in model efficiency-hill curve, as determined from tests conducted with the model installed at Estes Powerplant.
