GLEN CANYON 230-KV SHUNT CAPACITOR AND 345-KV AUTOTRANSFORMER SWITCHING TRANSIENT FIELD TESTS

U.S. DEPARTMENT OF THE INTERIOR
Bureau of Reclamation
Denver Office
Research and Laboratory Services Division
Electric Power Branch

**GLEN CANYON SWITCHYARD 230-KV SHUNT
CAPACITOR AND 345-KV AUTOTRANSFORMER
SWITCHING TRANSIENT FIELD TESTS**

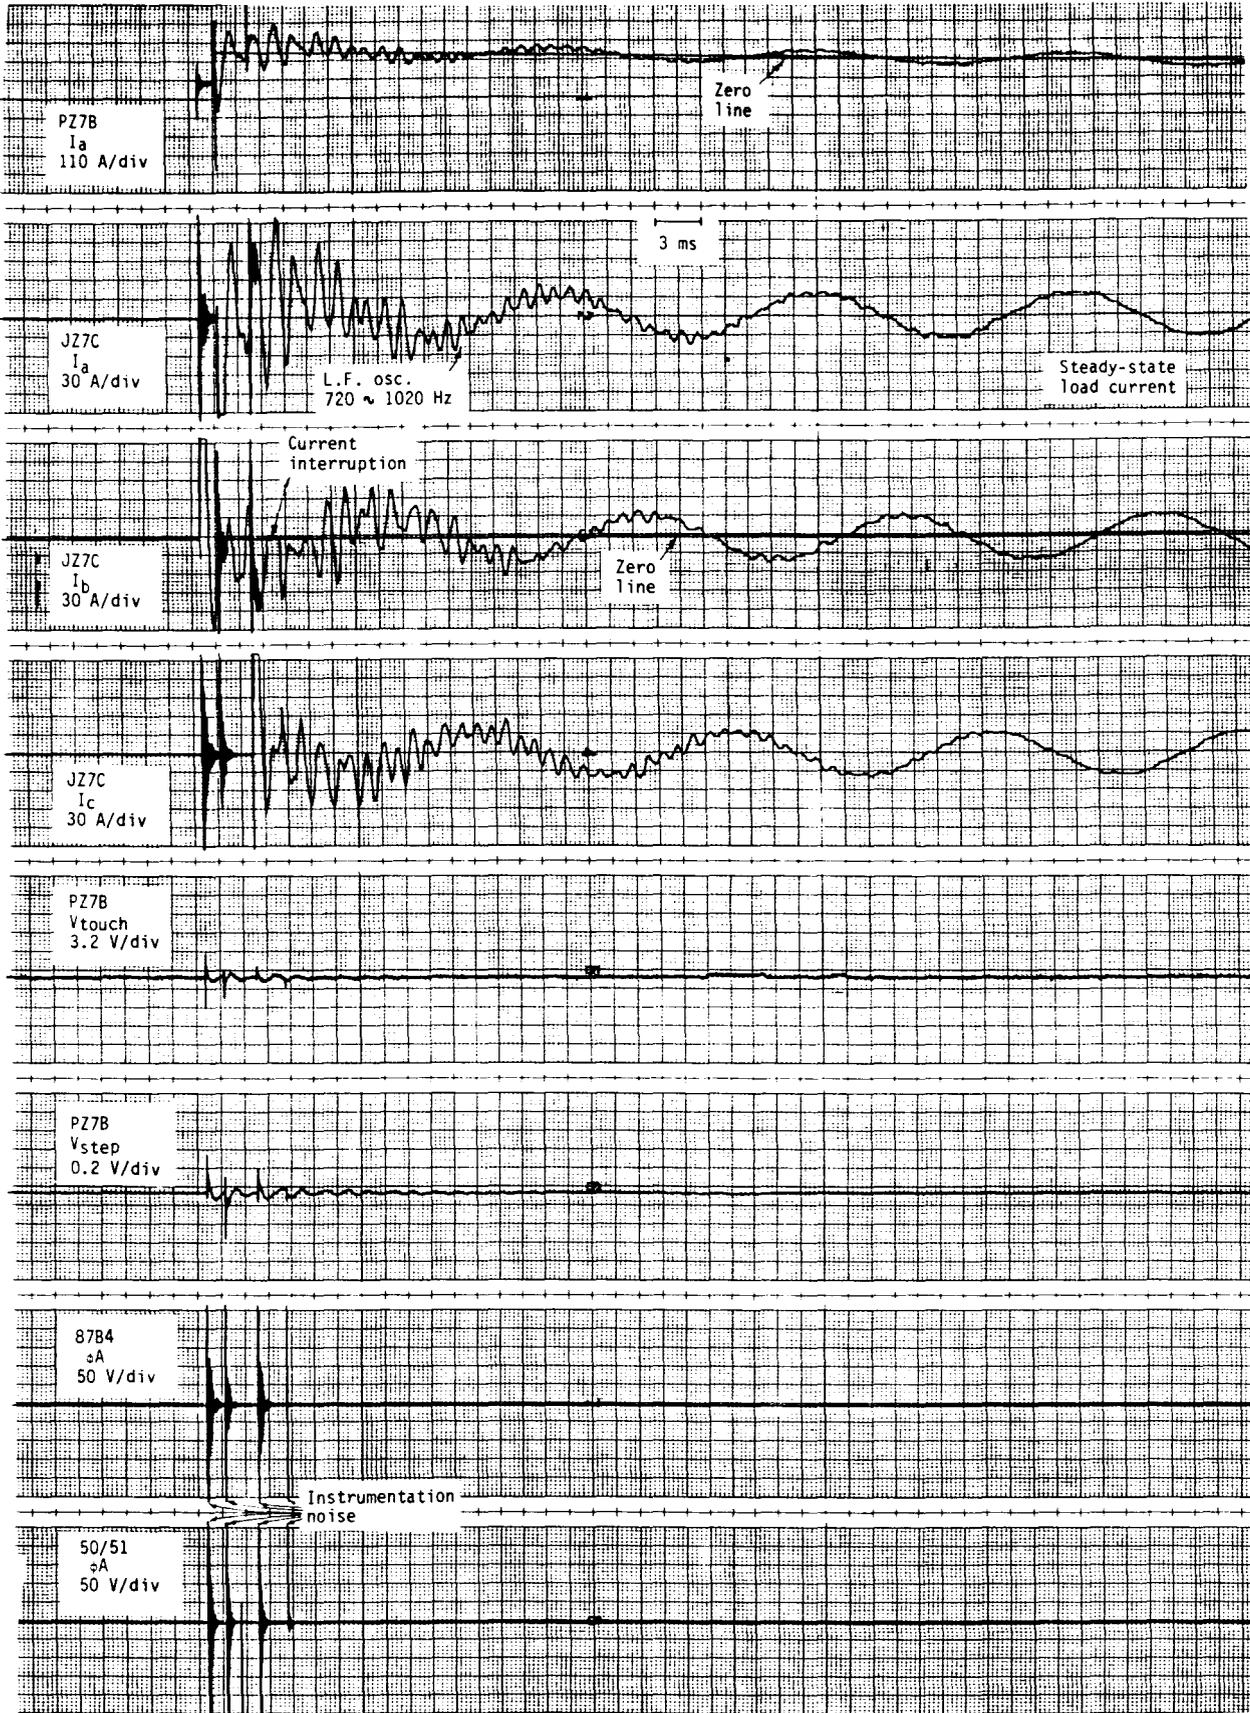
Figure 2. - Series I, test 1: digital electronic strip chart traces of switching transient currents and voltages produced when 230-kV capacitor bank PZ7B energized. No other banks on-line.

- The circuit breaker pole current conduction process can be clearly observed during the closing operation of PCB JZ7C, as evident in figures 2 and 4 for tests 1 and 2, series I. As the breaker contacts traveled to close the gap, an arc established in the individual poles as the power system phase-to-neutral voltage (voltage across the gap) in each phase approached a crest. Each pole, therefore, began to conduct at a different time

Figure 2 shows traces of switching transient currents and voltages produced when 230-kilovolt capacitor bank PZ7B was energized with no other banks on-line (series I, test 1). The highest capacitor bank transient current occurred in phase B, reaching about 1600 amperes peak. The resulting peak transient overvoltage on that phase was 133 percent rated peak phase-to-neutral voltage. Note that the highest transient overvoltage occurred in phase A at 138 percent. A pole restrike occurred on phase B of circuit breaker JZ7C, resulting in a voltage discontinuity of approximately 25 kilovolts. Capacitor switching transient currents ranged in frequencies from 720 to 1020 hertz for the phase currents and 660 to 720 hertz for the neutral current. Figure 3 shows the corresponding phase and neutral current traces for autotransformer KU5A. It also shows the 230-kilovolt bus voltage of phase A taken at east bus capacitor voltage transformer VZ7A. Notice

that the amplitude response of this device has a significant attenuation at high frequencies when compared to the 230-kilovolt bushing tap potential traces in figure 2.

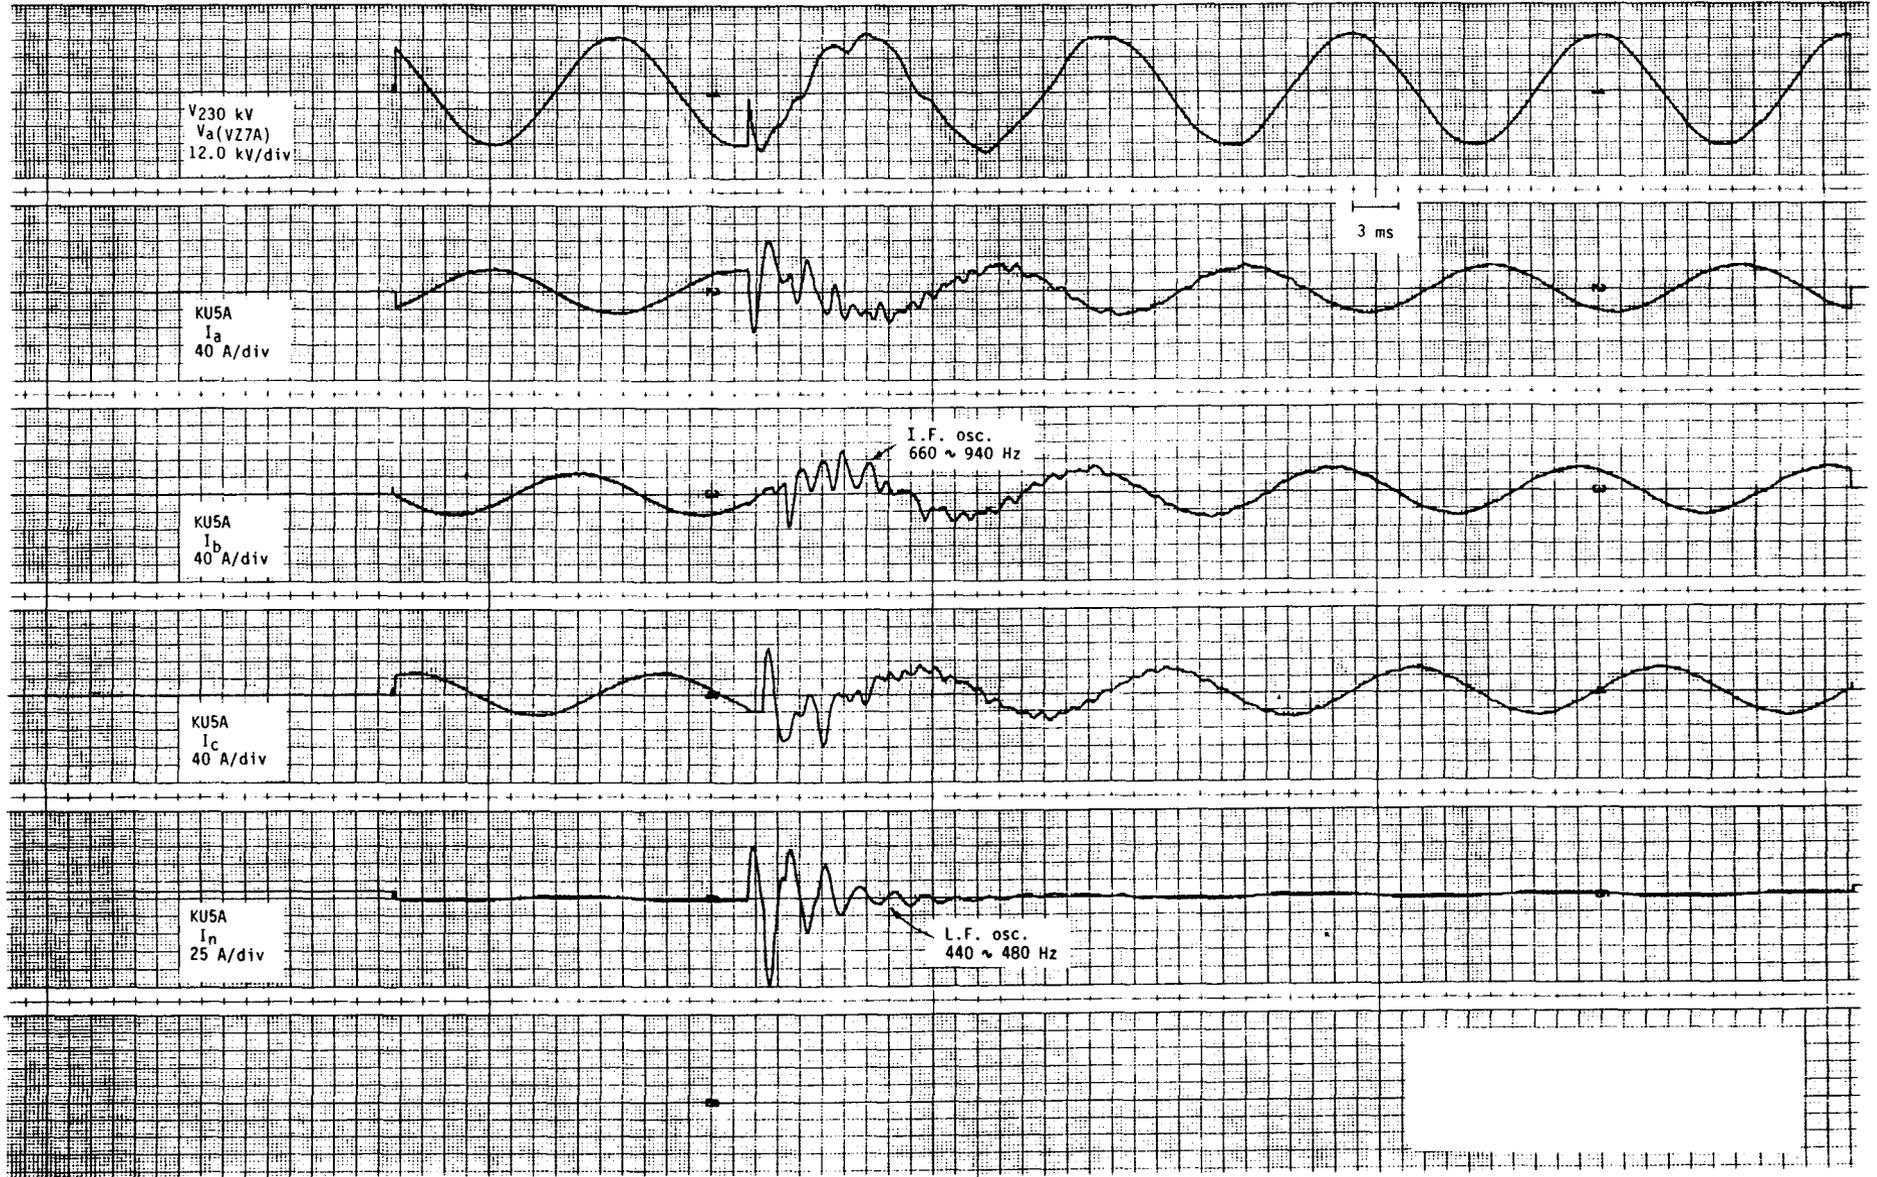
Figure 3. - Series I, test 1: digital electronic strip chart traces of transformer KU5A 230-kV side voltage and currents when capacitor bank PZ7B energized. No other banks on-line.

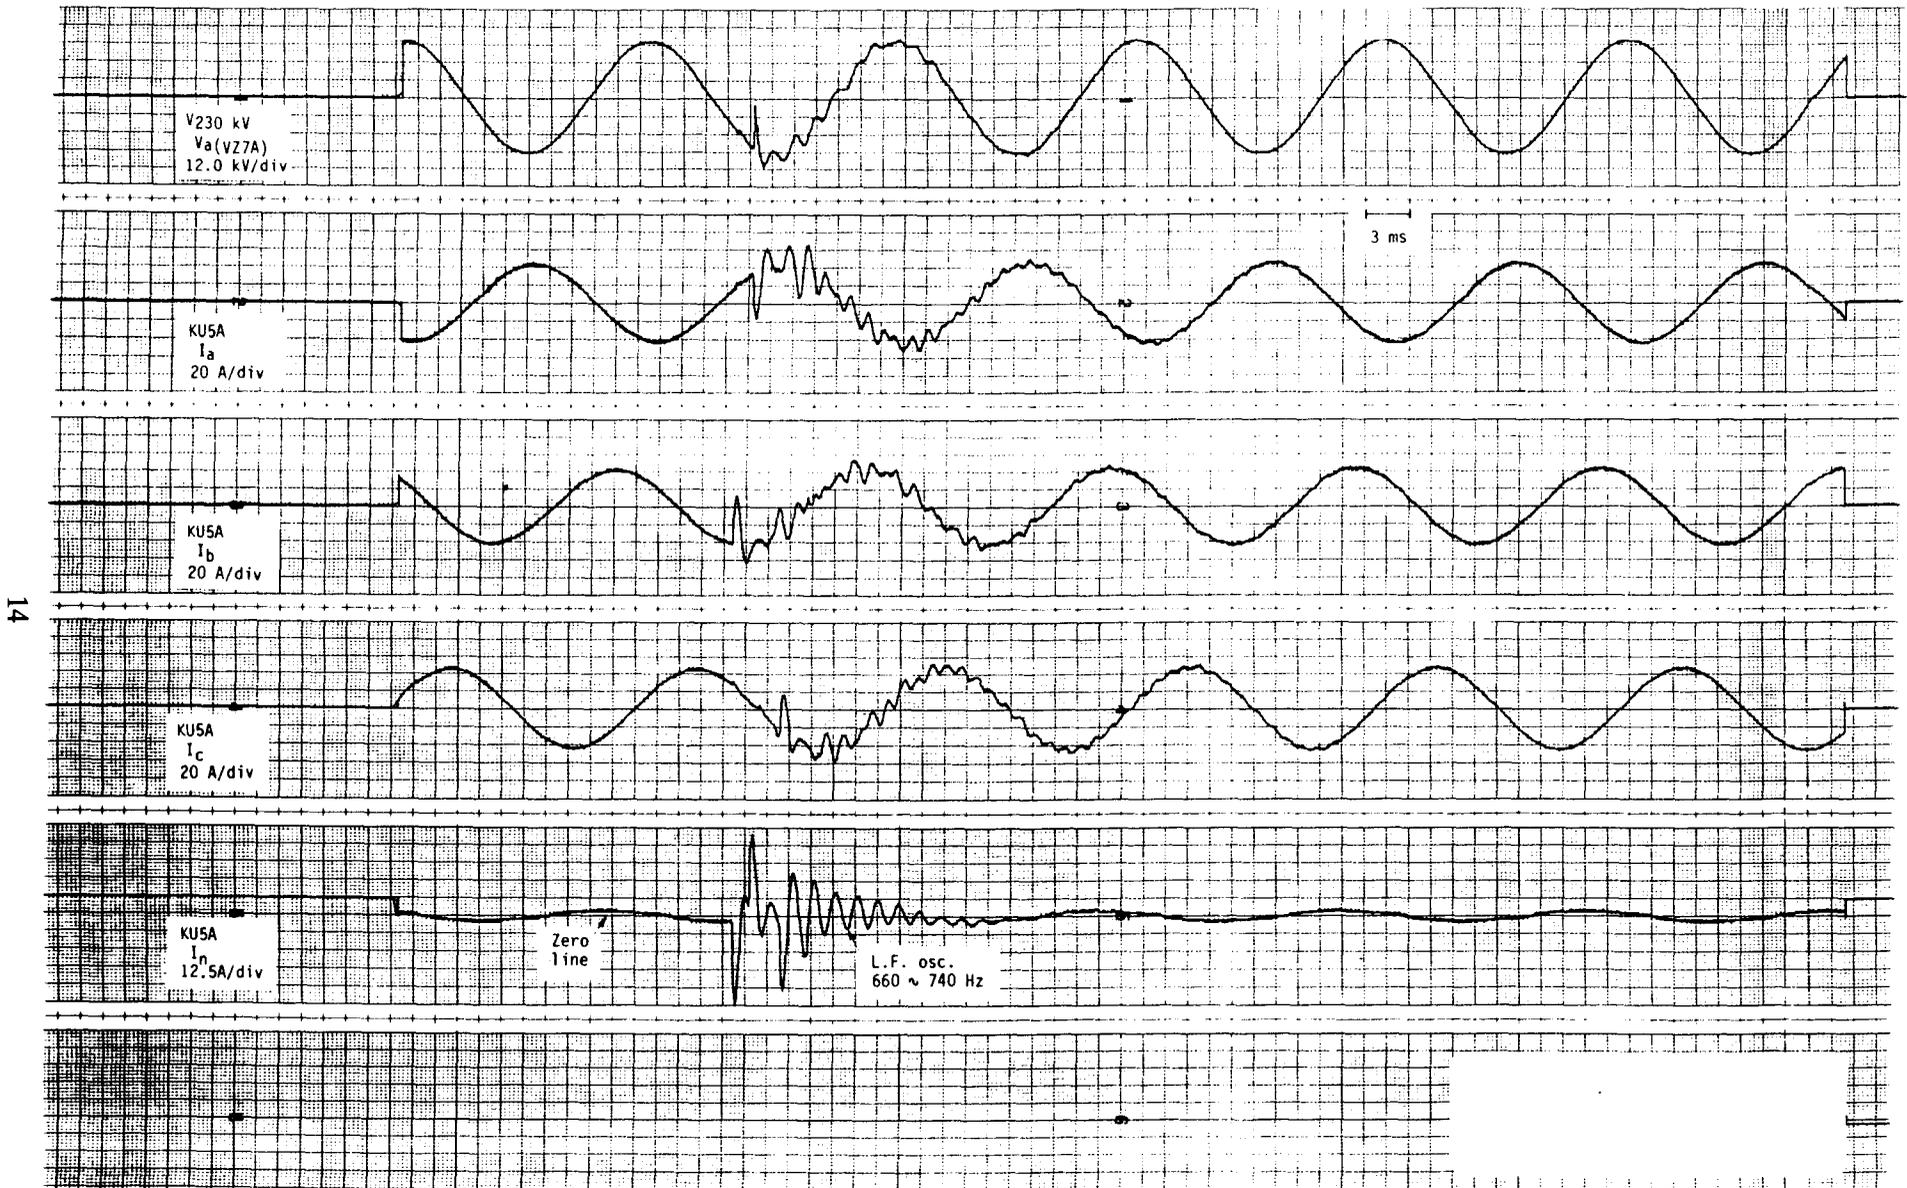
Figure 5. - Series I, test 2: digital electronic strip chart traces of transformer KU5A 230-kV side voltage and currents when capacitor bank PZ7A and PZ7B energized. No other banks on-line.

Energization of two capacitor banks (PZ7A and PZ7B) with no other banks on-line (series I, test 2) yielded similar magnitude transient phase currents but a larger neutral current as shown in figure 4. Overvoltages on the 230-kilovolt bus were also slightly larger than the previous test, reaching 144 percent rated peak phase-to-neutral voltage. Current interruption and restrike of the phase C pole of circuit breaker JZ7C is clearly evident in the current traces. As predicted in electromagnetic transient program studies performed by WAPA, the capacitor transient currents consisted of a low-order oscillation at 600 hertz and a high order of oscillation at 5.5 kilohertz, as can be seen in these traces. The higher frequency is superimposed on the lower frequency. Figure 4A is a time-expanded version of figure 4 that clearly shows the high frequency component. Autotransformer KU5A phase and neutral current traces are given in figure 5.
