# **CHEMICAL STABILIZATION OF SOILS**

**Laboratory and field evaluation of several  
petrochemical liquids for soil stabilization**

**W. R. Morrison  
Engineering and Research Center  
Bureau of Reclamation**

**June 1971**

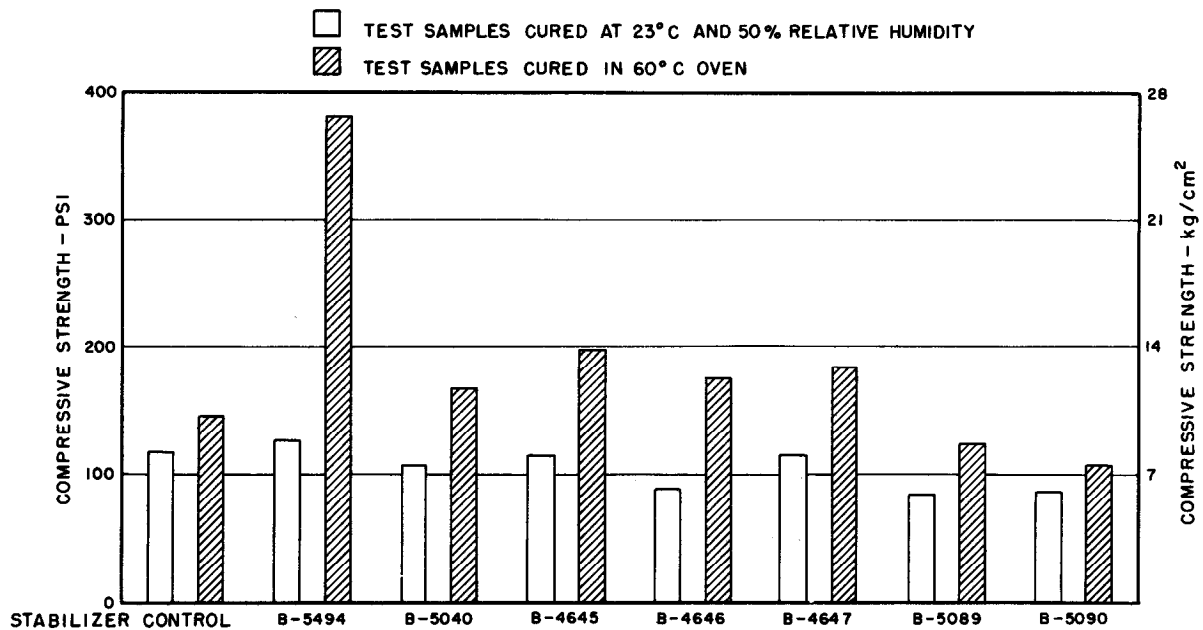
Figure 3. Compressive strength development after 28 days for sandy soil B-4433 treated with various solvent-base stabilizers. Application rate of stabilizer was 1 gsy (4.6 l/m<sup>2</sup>)

b. Solvent-base stabilizers.—Compressive strength test results are summarized in Table 3, and comparison of relative binding strength between the stabilizers is shown graphically in Figure 3. No significant increase in compressive strength was noted for the treated soil samples cured at 73.4° F (23° C) and 50 percent relative humidity. In some cases the values were lower than those obtained for the untreated soil samples. This was true for the soil samples treated with conventional cutback asphalt B-5040; asphalt prime material B-4646; and the two petroleum resins B-5089 and B-5090. For soil samples treated with asphaltic materials and cured at 140° F (60° C), an increase in strength development was noted. Within these data liquid asphalt B-5494 produced the highest values; they

were nearly twice that obtainable with the other liquid asphalt prime materials.

The test results indicated that the petroleum resins were slow curing and produced compressive strengths lower than the asphalt prime materials. The slow curing was most evident for the 140° F (60° C) oven-cured test cylinders. Examination of the treated soil samples after 28 days' curing showed the residues of both petroleum resins were still tacky. Because of the slow-curing properties, these materials would not be too satisfactory for use in soil stabilization. Treated areas would be susceptible to weathering or mechanical damage during the long curing period.

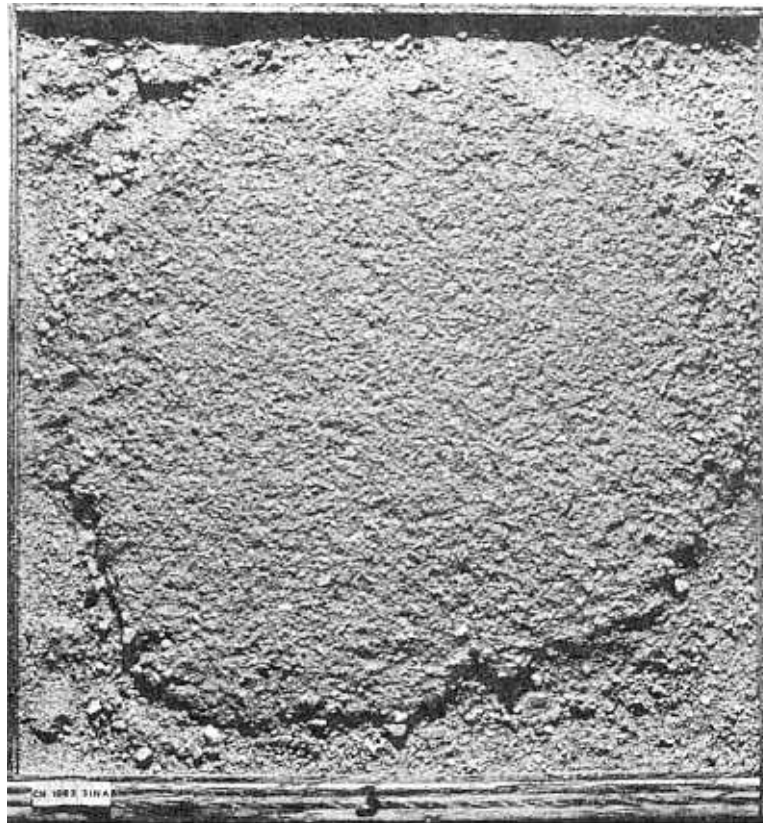
a. Date: 2/17/70 (original condition). Photo PX-D-69222

b. Date: 2/25/71 (1-year exposure). Photo PX-D-69223

Photograph 9. Outdoor exposure test results for sandy soil treated with a water mixture containing 2.5 percent vinyl polymer material B-5800. Application rate of mixture was 1 gsy ( $4.6 \text{ l/m}^2$ ). Sample shows considerable wearing at edges after 1 year's weathering.

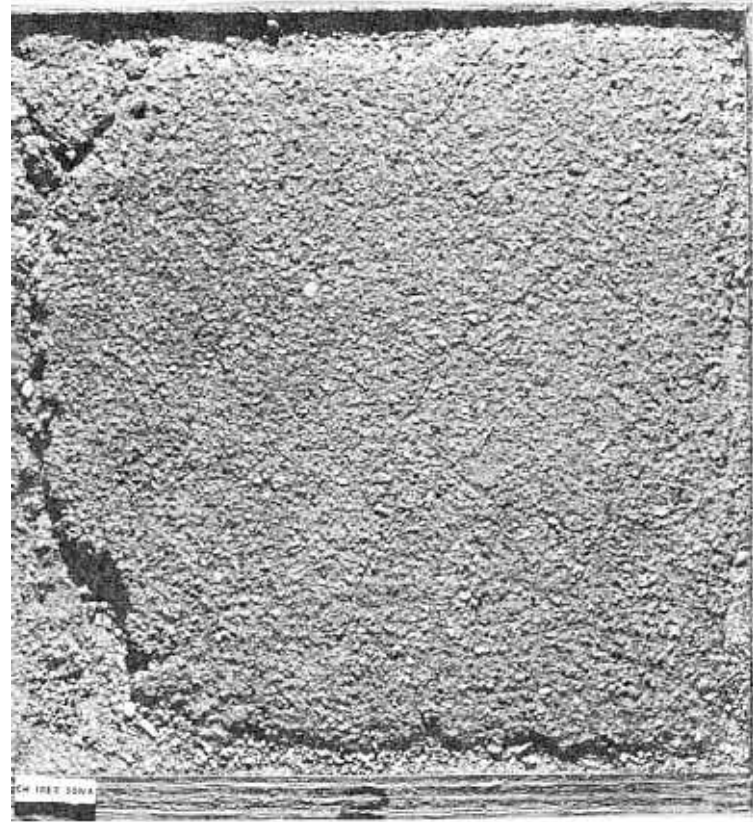
a. Date: 2/17/70 (original condition). Photo PX-D-69228

b. Date: 2/25/71 (1-year exposure). Photo PX-D-69229

Photograph 12. Outdoor exposure test results for sandy soil treated with a water mixture containing 10 percent elastomeric material B-5856. Application rate of mixture was 1 gsy ( $4.6 \text{ l/m}^2$ ). Sample showed some erosion at edges after 1 year's weathering.

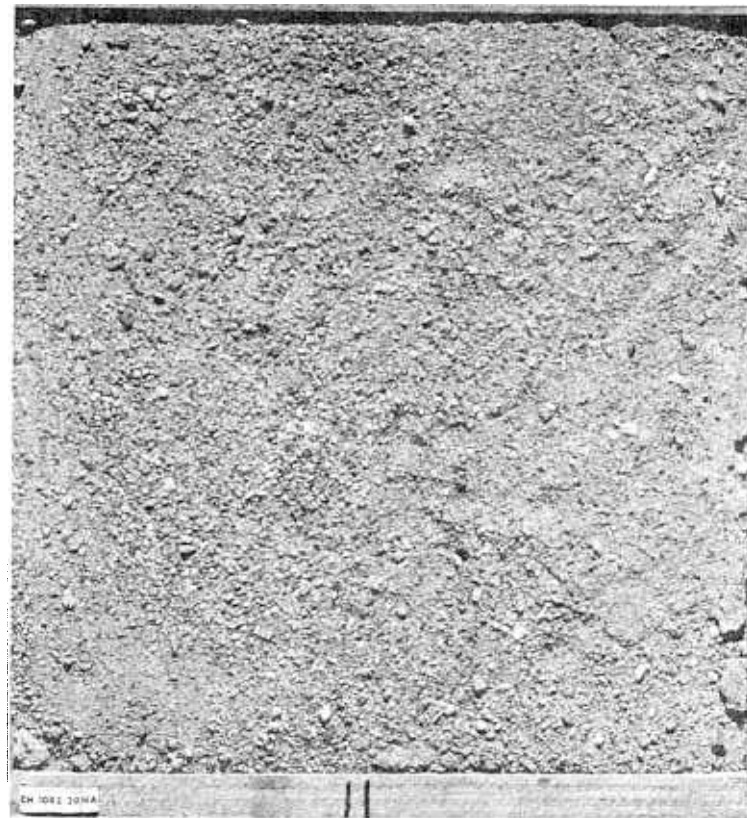
a. Date: 2/17/70 (original condition). Photo PX-D-69236

b. Date: 4/27/70 (2-month exposure). Photo PX-D-69237

**Photograph 16. Outdoor exposure test results for untreated (control) sandy soil. Test was discontinued after 2 month's weathering with sample showing extensive erosion.**

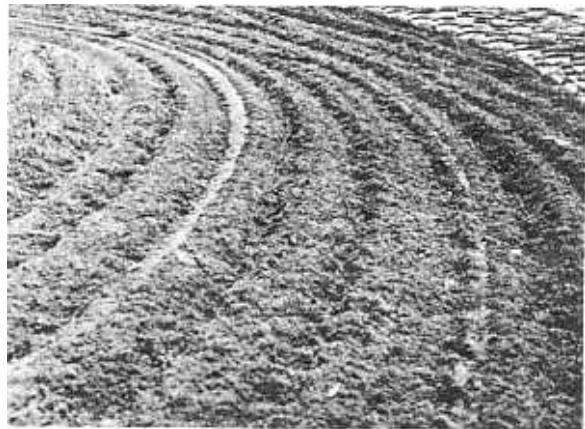
Photograph 19. Fort Thompson-Grand Island 345-kv Transmission Line—A close-up view showing the condition after the first coat of liquid asphalt had been harrowed at USBR Tower No. 174/2. Photo P-466-602-6627

2. Scarify and loosen the sand with a harrow.
3. Apply a one-coat coverage of liquid asphalt at the rate of 1 gsy (4.6 l/m<sup>2</sup>).
4. Rescarify the area with a harrow.
5. Apply a second coat of liquid asphalt at the rate of 1 gsy (4.6 l/m<sup>2</sup>).

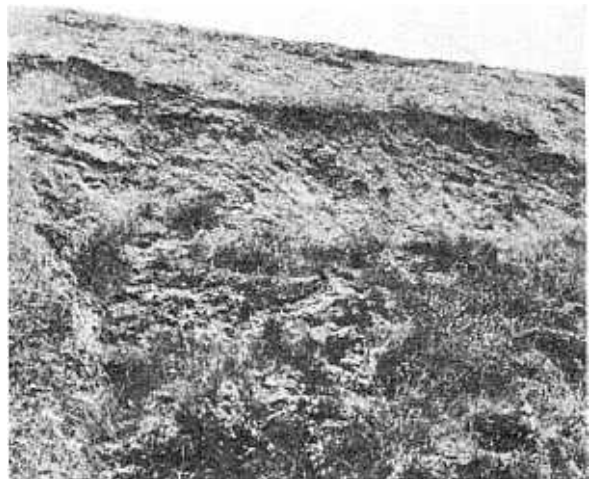
Photograph 23. View of spoil bank opposite Mile 25.0 on the Tehama-Colusa Canal, Central Valley Project, California. This area has a history of sloughing which required rebuilding the fence, shown in Photograph 24, numerous times. Photo P602-D-69238

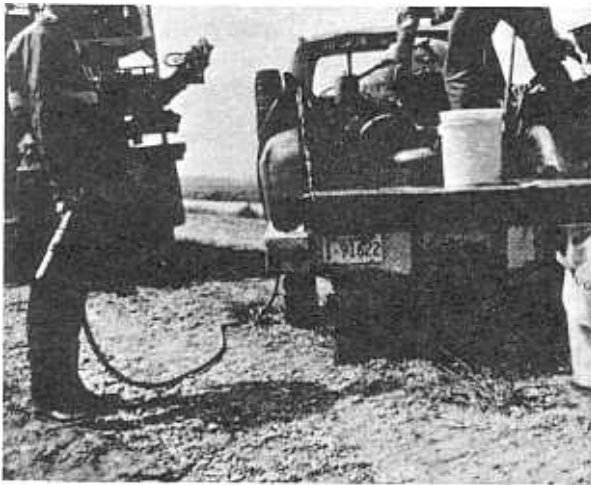
Photograph 24. Treatment of spoil bank for erosion control. A water-base acrylic copolymer was used for the stabilization application. View at left shows spray rig used in application. Left Photo P602-D-69239, right Photo P602-D-69240

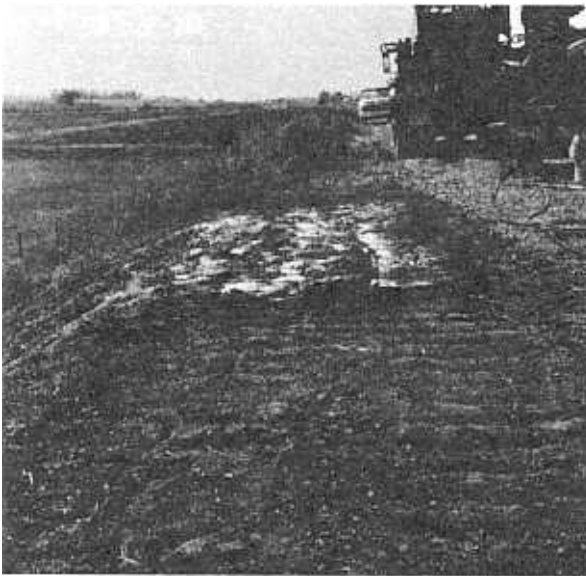
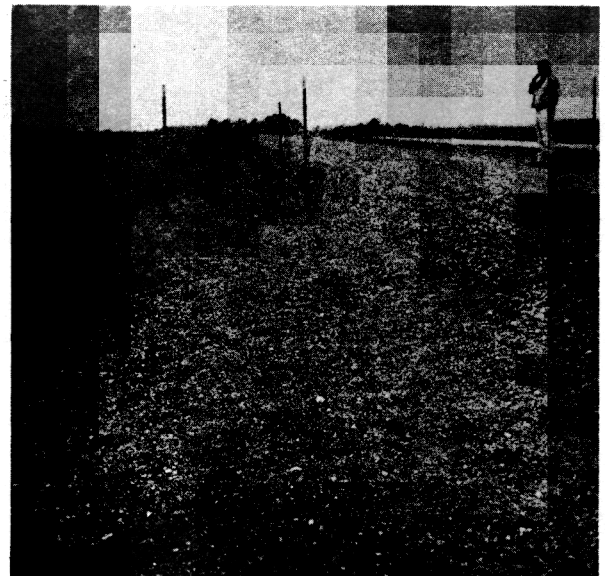
**Photograph 26.** View at left shows top of left slope immediately after treatment. Condition after 1 year is shown at right. Only a portion of the top slope was treated which resulted in the erosion shown in Photograph 25. This would indicate the need for treating the top of the slope. Left Photo P602-D-69243, right Photo P602-D-69244

shown in Photographs 25 to 27. A well defined crust was noted and the only erosion occurring was in that portion of the Tehama-Colusa Canal opposite Mile 25.0, below the top of the slope that was not treated. The eroded area is shown in Photograph 25, and the results of this test indicate the need for also treating the top of the slope.

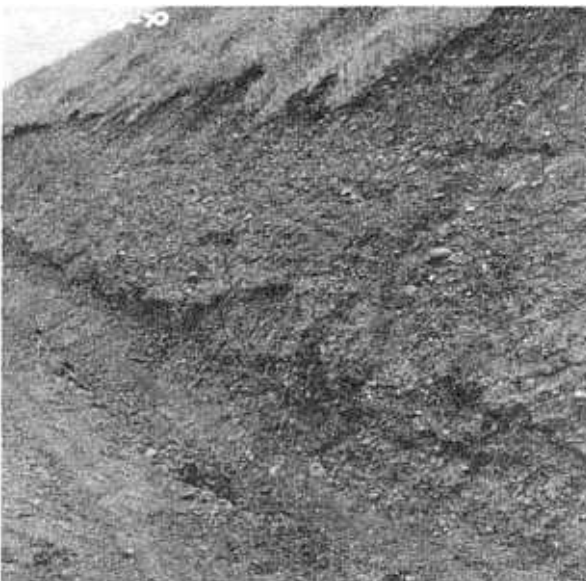
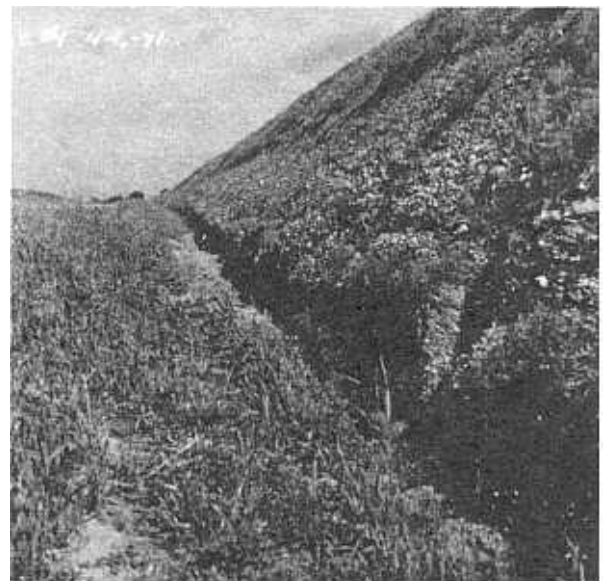
**Photograph 27.** View at left looking downstream at area to be treated on right bank of the O&M road opposite Mile 0.09, Putah South Canal. Condition after 1 year is shown at right. Slope was stable with a well-defined crust, and the material appeared to penetrate very well in the sandy-gravel deposit. Left Photo P413-D-69245, right Photo P413-D-69246
