REC-ERC-74-27

# HYDRAULIC MODEL STUDIES OF CANYON FERRY DAM SPILLWAY STILLING BASIN

December 1974

Engineering and Research Center  
Bureau of Reclamation

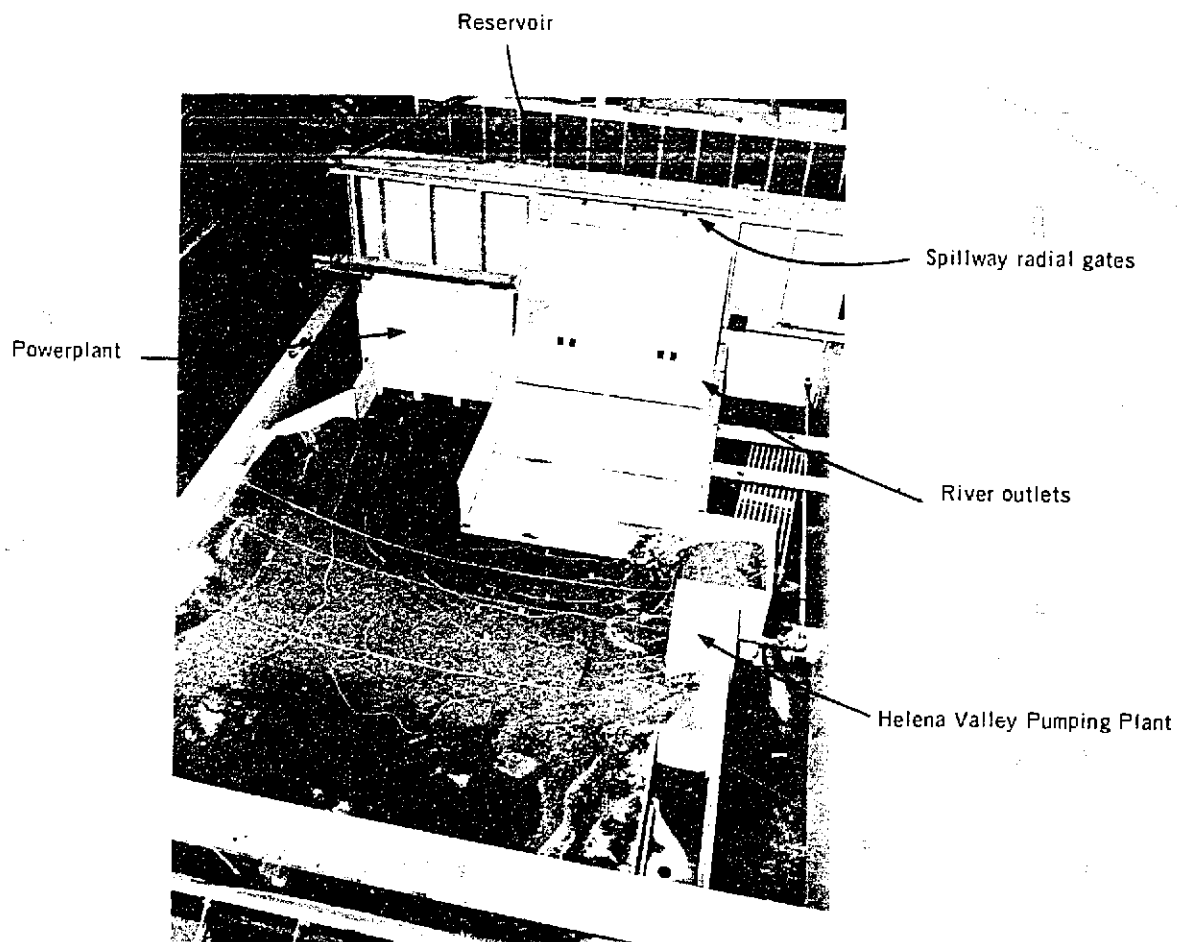
Figure 1. 1:48 Scale model layout of Canyon Ferry Dam. Photo P296-D-75729

The model, constructed to a scale of 1:48, included 190 feet (58 m) of the upstream reservoir, the dam, powerplant, Helena Valley Pumping Plant, and 450 feet (137 m) of the downstream river channel, figure 1. To properly model the various releases from the reservoir, provision for controlled releases from the spillway, river outlets, powerplant, and pumping plant were included in the model. Each control was calibrated before the test program started. A tailgate assembly and sand trap were used to control the downstream tailwater elevation and collect eroded sand and gravel. Water was supplied to the model through the permanent laboratory system. Discharges were measured by one of a bank of venturi meters installed in the laboratory.

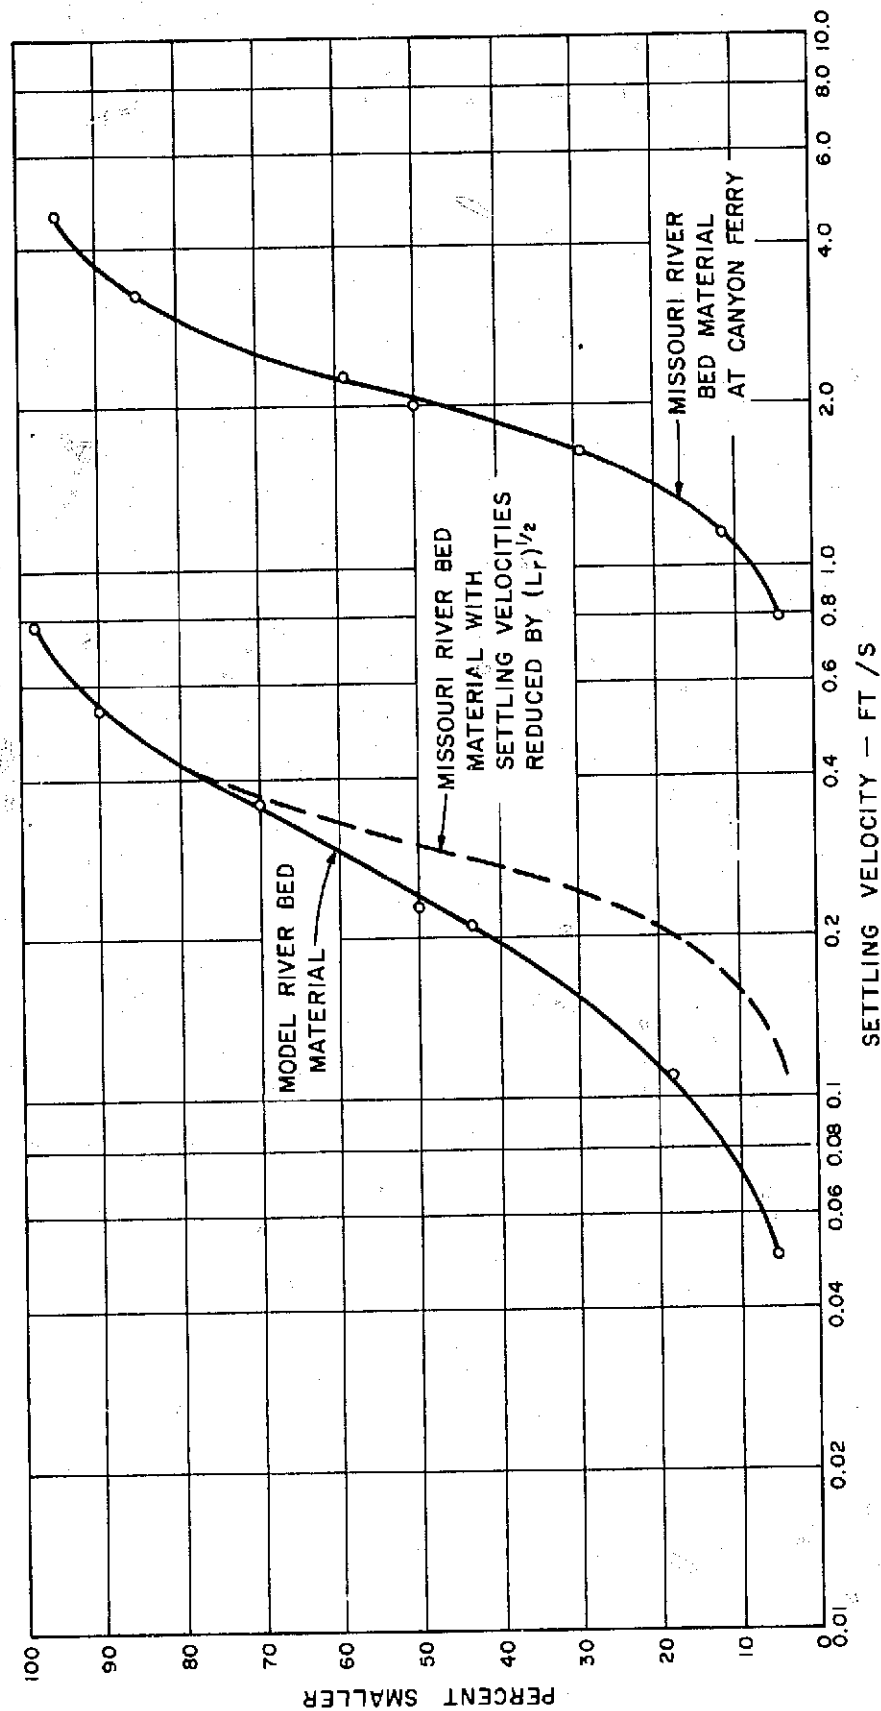
Figure 2. Comparison of settling velocities, Canyon Ferry model study.

Using the Froude Model Law, the settling velocity ratio of the model to prototype riverbed material was  $(L_r)^{1/2}$  or 1:6.93. Figure 2 relates the settling velocity of the model and prototype riverbed material. The top 30 percent of the model material is very close to the scaled settling velocity of the prototype material. The lower 70 percent of the model material is lighter than the prototype material.

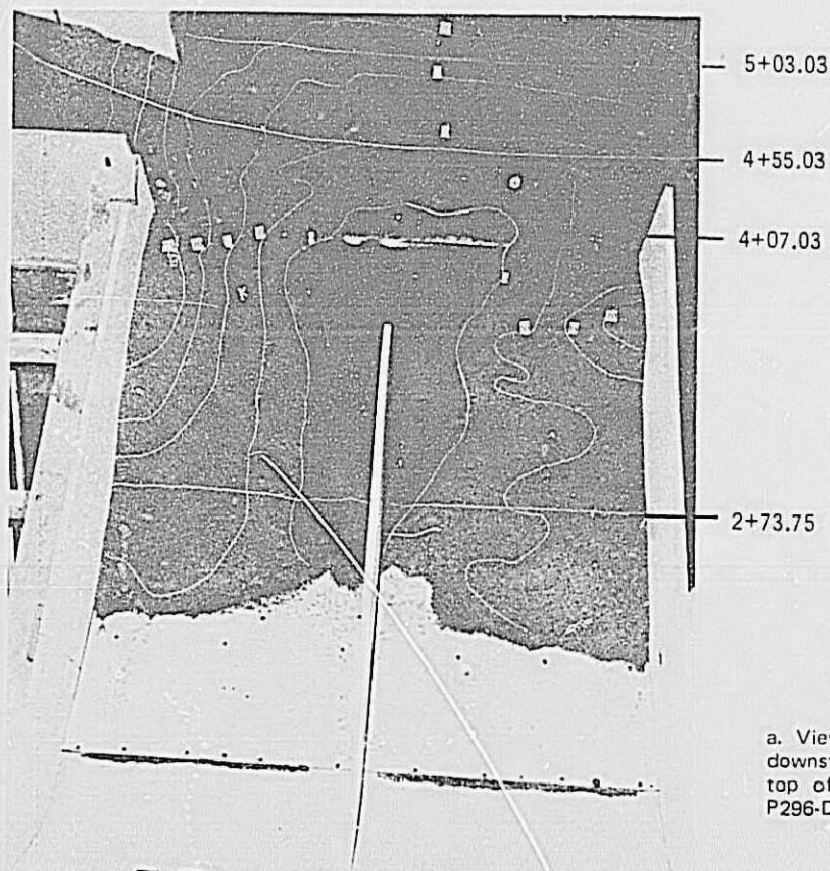
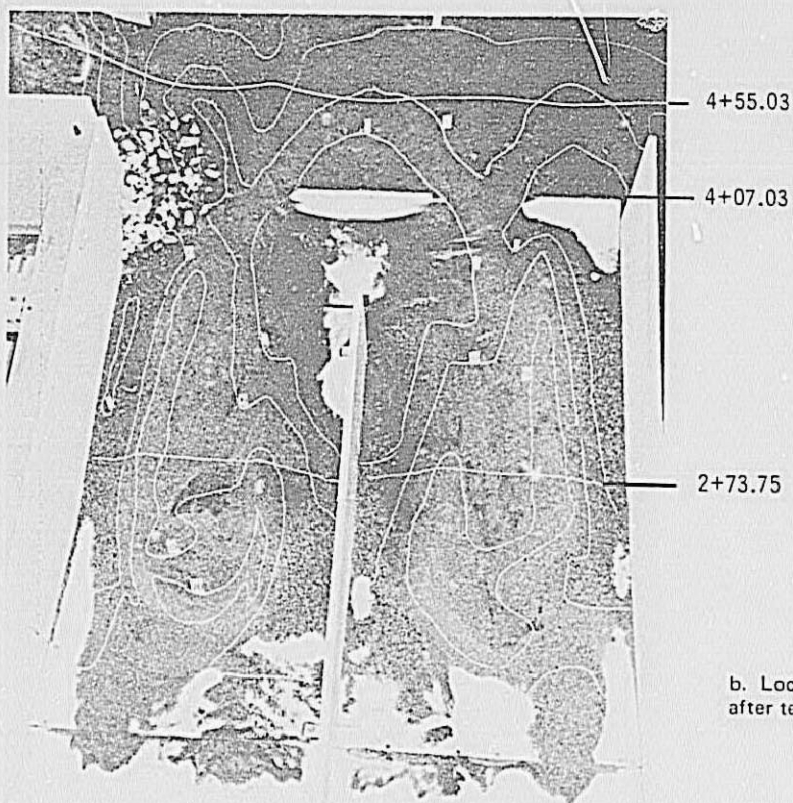
Figure 4. Model verification, test 5.

a. View of the stilling basin and downstream river channel from the top of the dam before test. Photo P296-D-75713

b. Location of riverbed material after test. Photo P296-D-75714

To verify the Canyon Ferry model, the August 1970 sounding of the prototype stilling basin and downstream river channel (fig. 3), was modeled (fig. 4a). The significant river outlet and spillway releases were applied to the model on a compressed time scale representing the 1971 releases from the prototype, test 5. (See Appendix for test conditions.) A major portion of the 1971 releases involved the river outlet works.

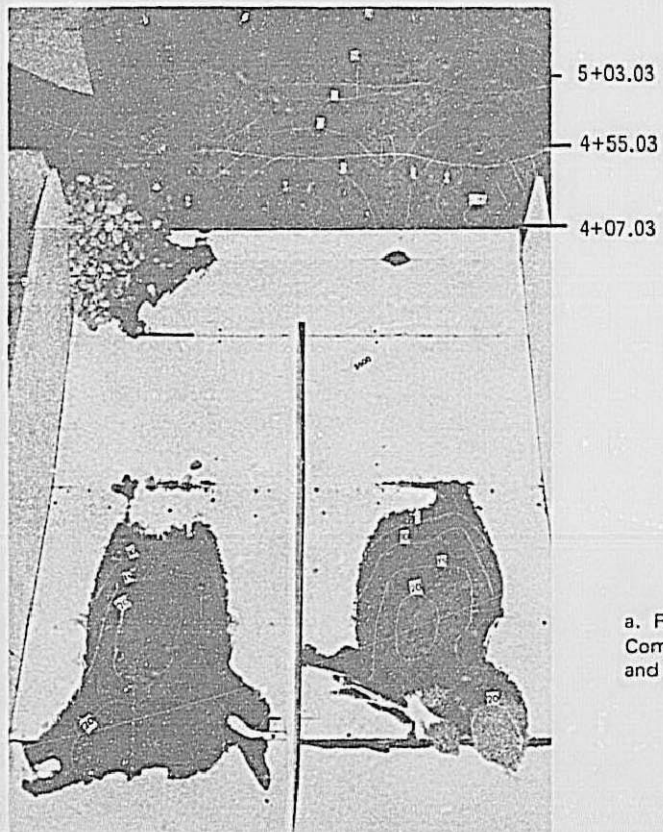
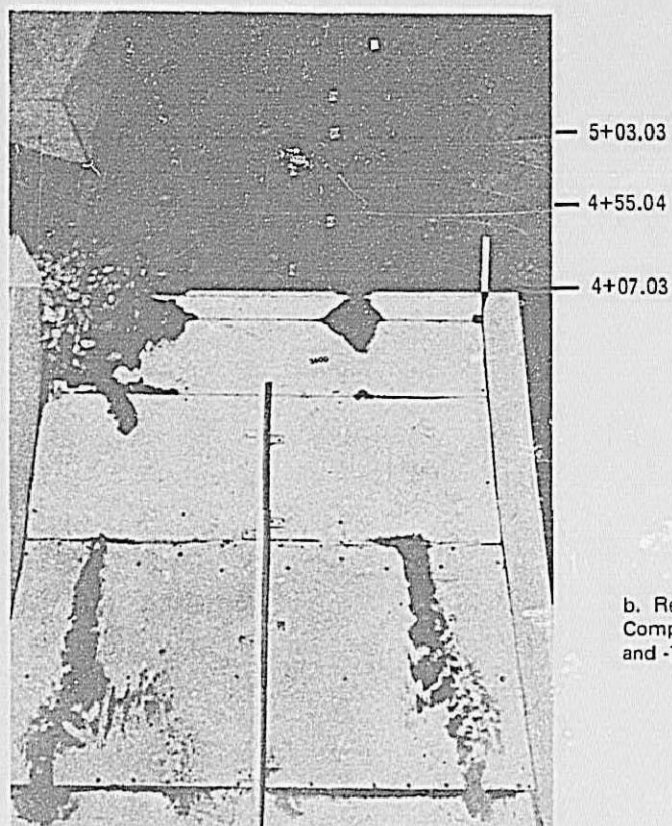
Figure 6. Results of river outlet  
releases, tests 1 and 7.

a. Results of test 1,  $Q = 9,500 \text{ ft}^3/\text{s}$ .  
Composite of photos P296-D-75707  
and -75708

b. Results of test 7,  $Q = 4,000 \text{ ft}^3/\text{s}$ .  
Composite of photos P296-D-75716  
and -75717

Initial conditions for tests 8 and 9 were the conditions resulting from tests 7 and 8, figures 6b and 7a, respectively.

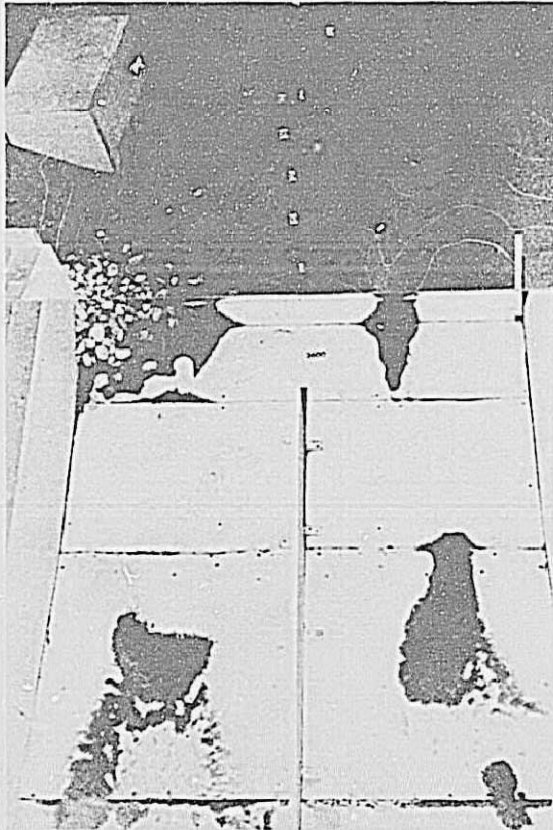
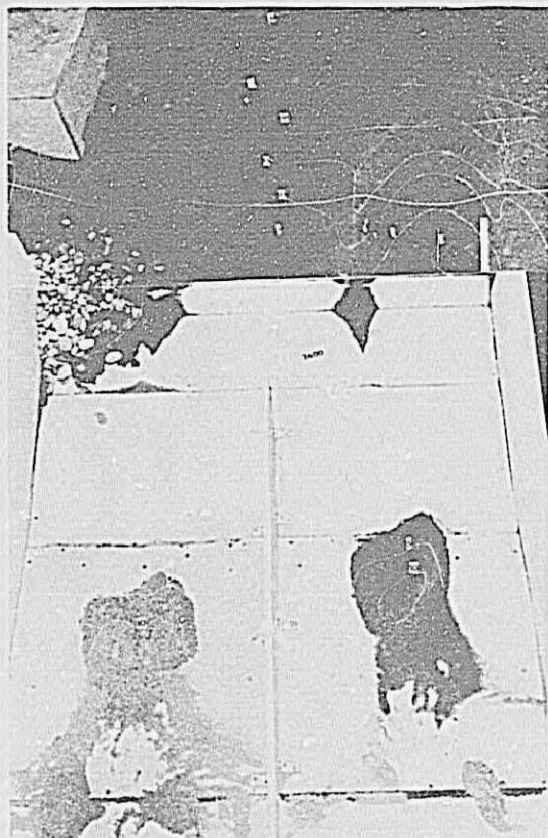
Figure 7. Results of river outlet  
releases, tests 8 and 9.

a. Results of test 8,  $Q = 5,000 \text{ ft}^3/\text{s}$ .  
Composite of photos P296-D-75718  
and -75719

b. Results of test 9,  $Q = 6,000 \text{ ft}^3/\text{s}$ .  
Composite of photos P296-D-75720  
and -75721

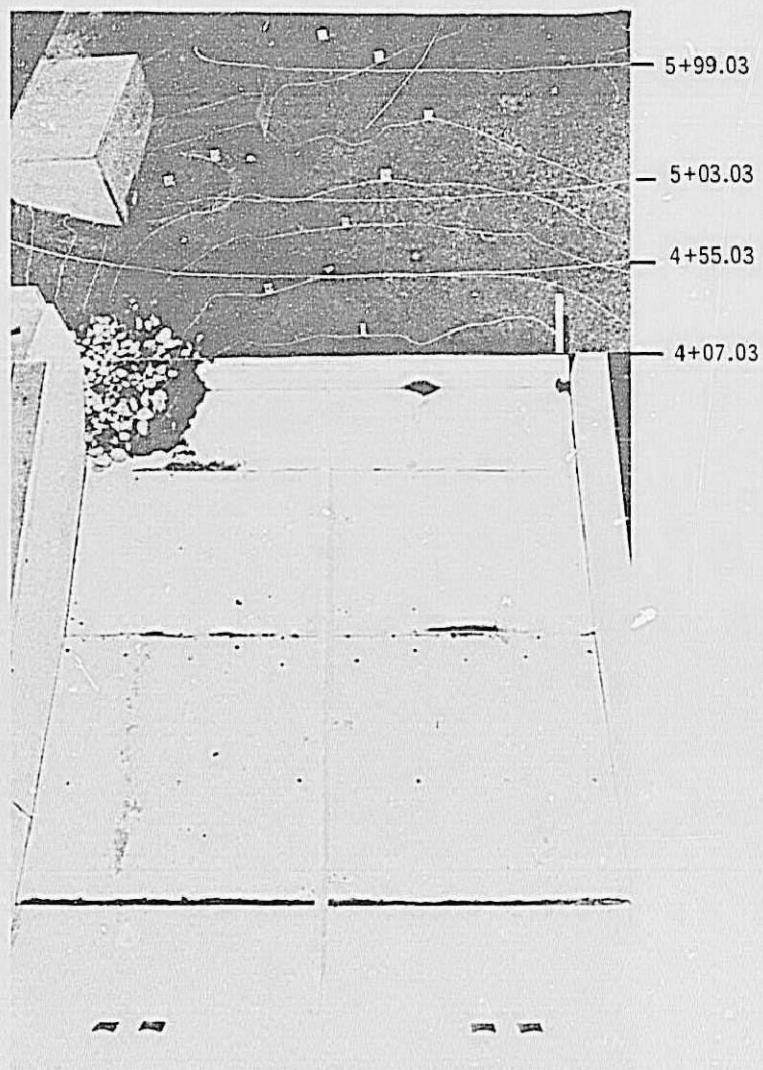
Figure 8. Result of river outlet release, test 14.  
Composite of photos P296-D-75727 and -75728

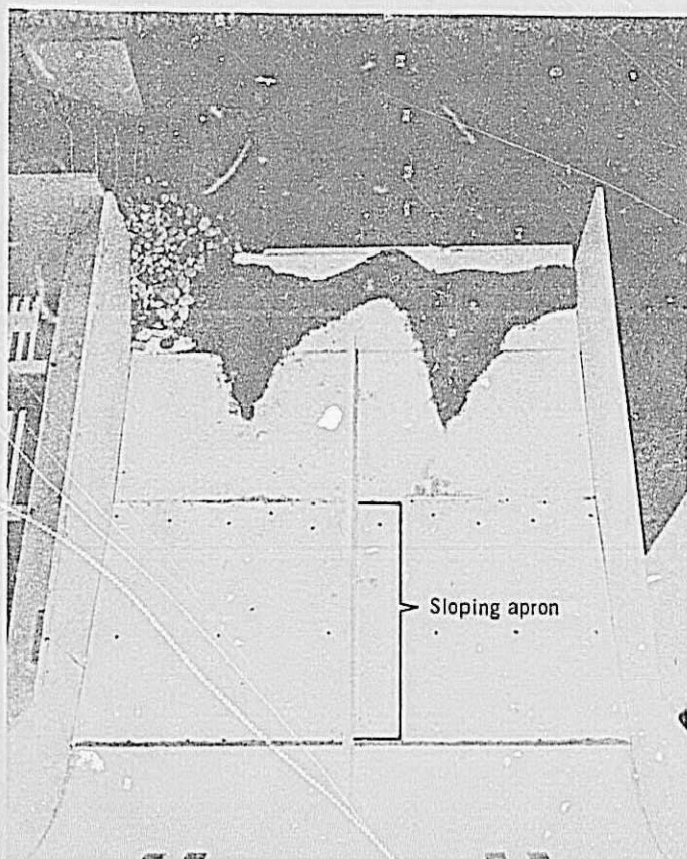
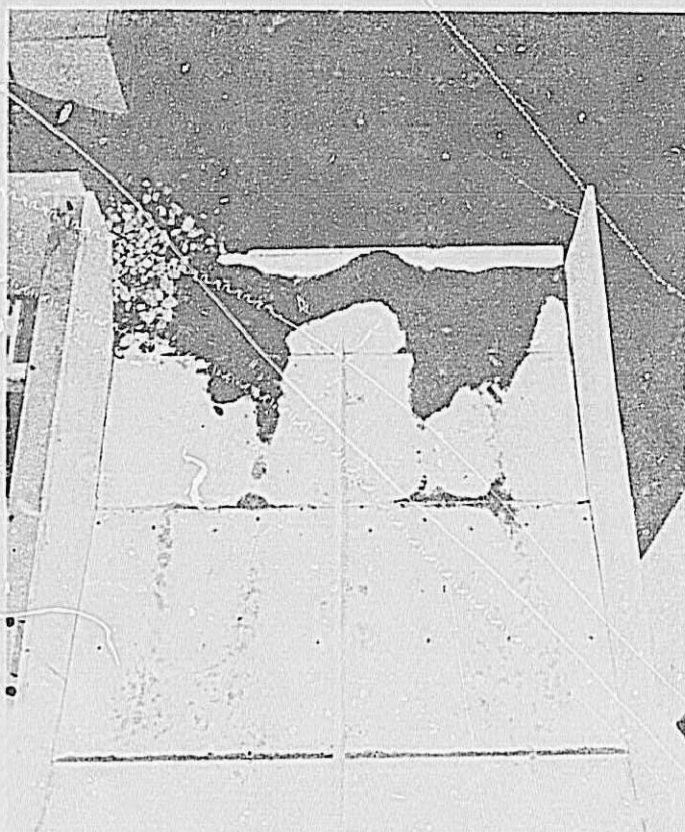
Figure 9. Result of river outlet release with debris initially in the basin, test 16.

a. Riverbed material deposited in lower half of the basin after 15,000  $\text{ft}^3/\text{s}$  spillway discharge. Photo P296-D-75732

b. View of basin after operation of river outlets at 3,000  $\text{ft}^3/\text{s}$ . Note riverbed material deposited on sloping apron. Photo P296-D-75733

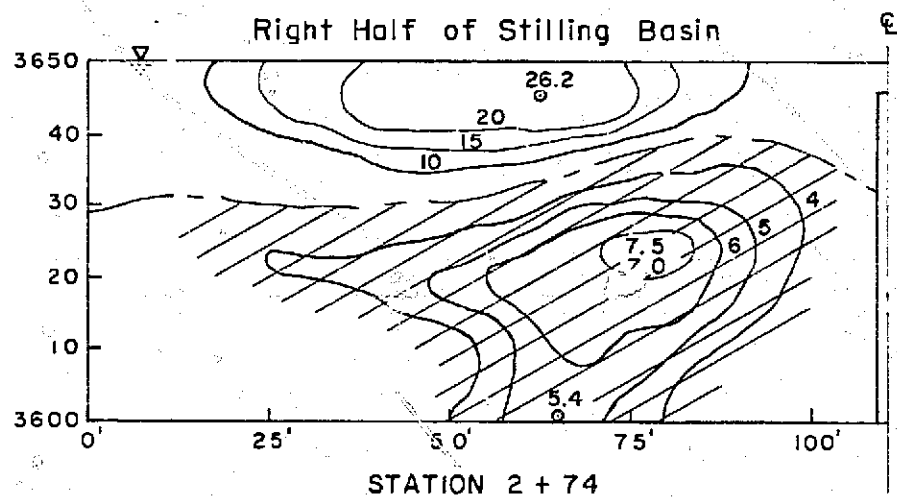
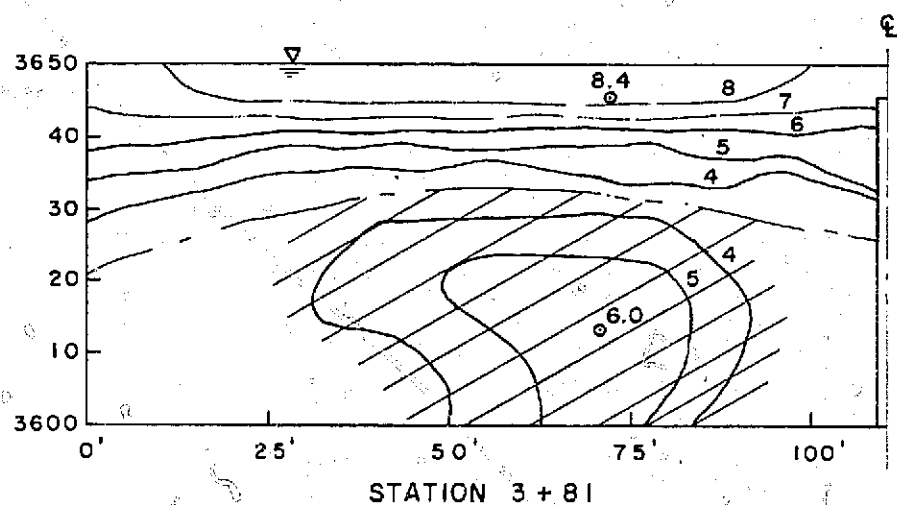
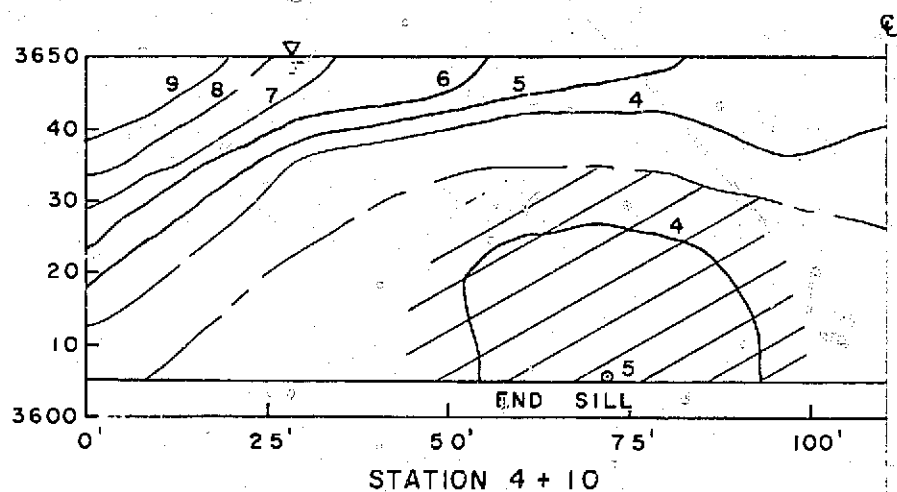
Figure 10. Isovels—river outlets  $Q = 9,500 \text{ ft}^3/\text{s}$ .

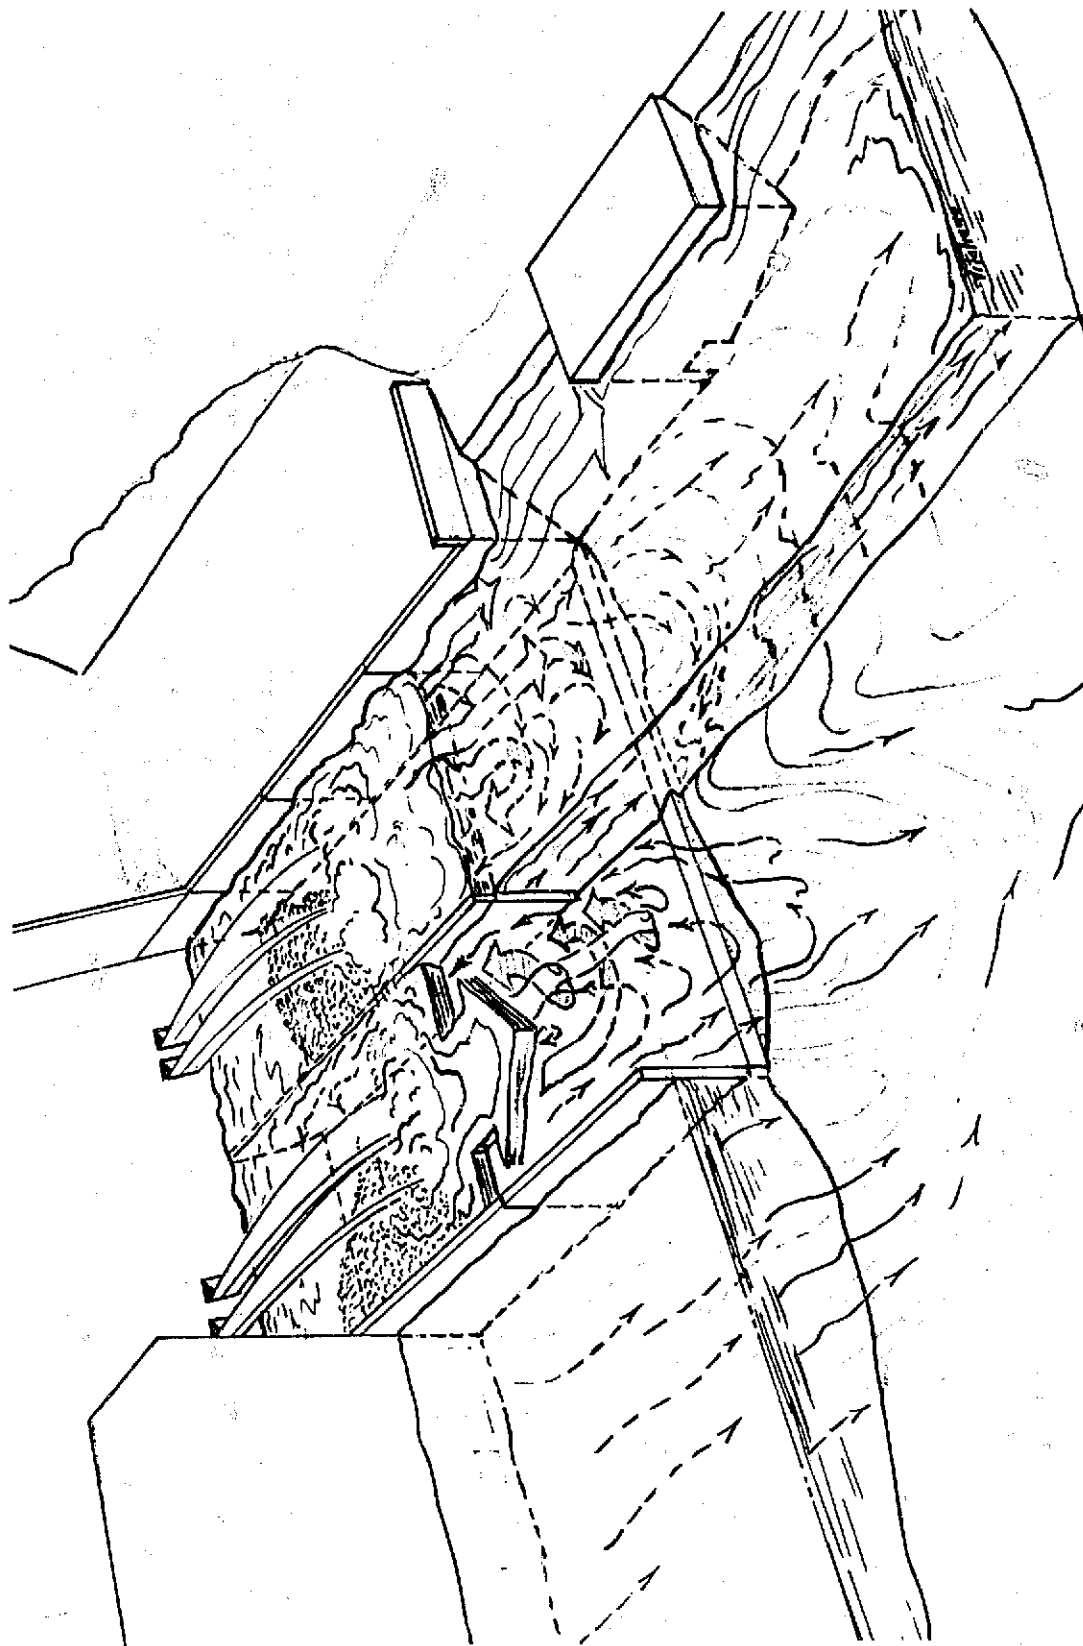
Figure 11. Flow patterns resulting from river outlet releases. Photo P296-D-75745

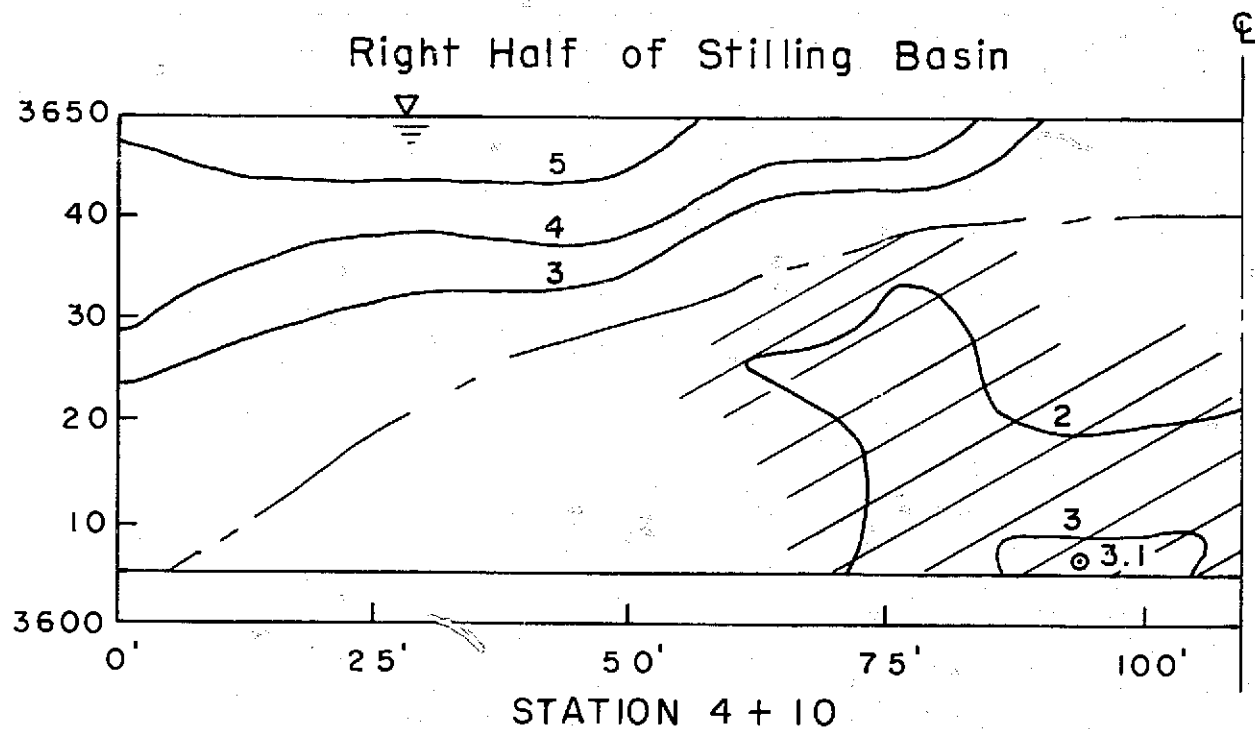
Figure 12. Isovels—river outlets  $Q = 3,000 \text{ ft}^3/\text{s}$ .

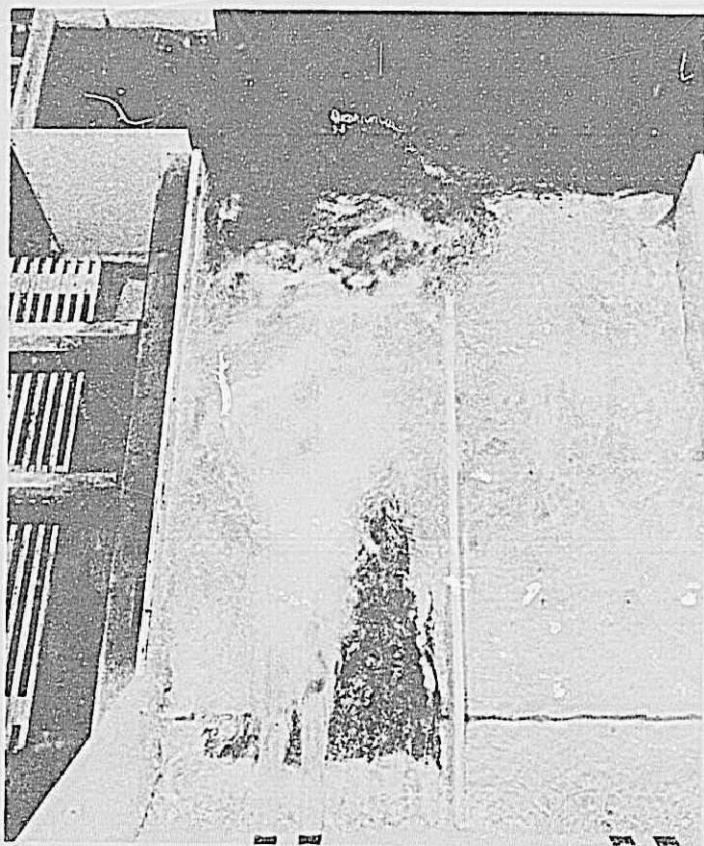
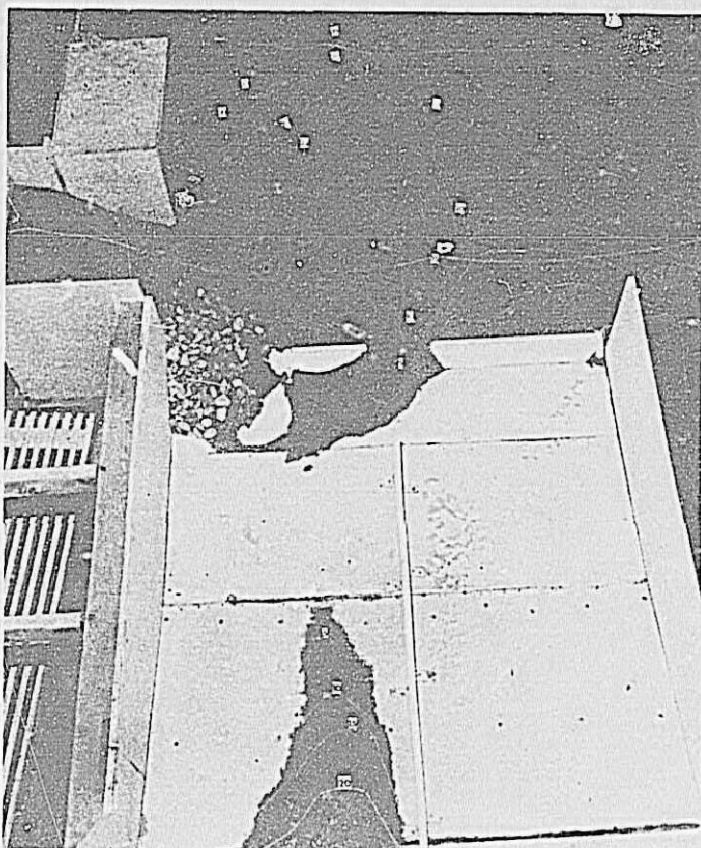
Figure 13. Asymmetrical operation of two river outlets, test 13.

a. Outlets No. 3 and 4, total  $Q = 4,750 \text{ ft}^3/\text{s}$ . Photo P296-D-75725

b. Results of test 13. Photo P296-D-75726

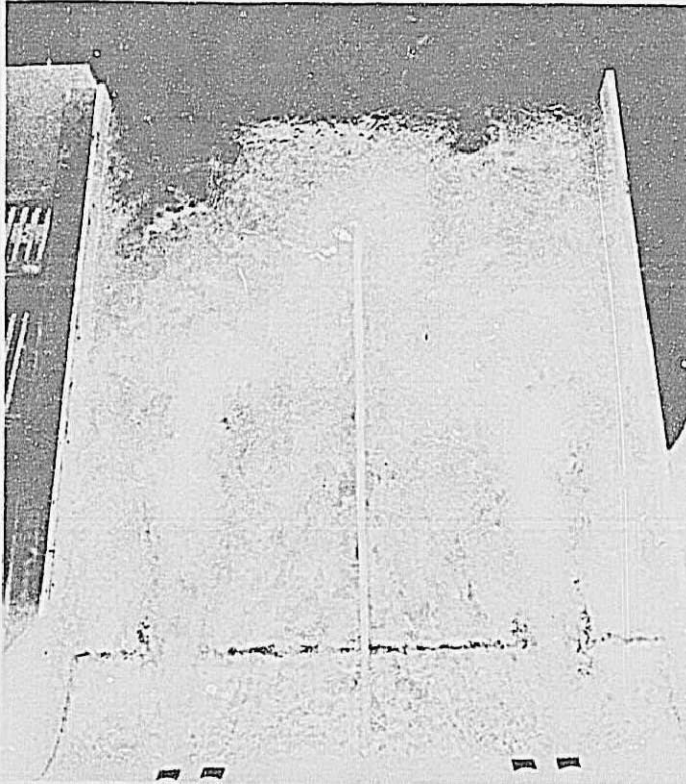
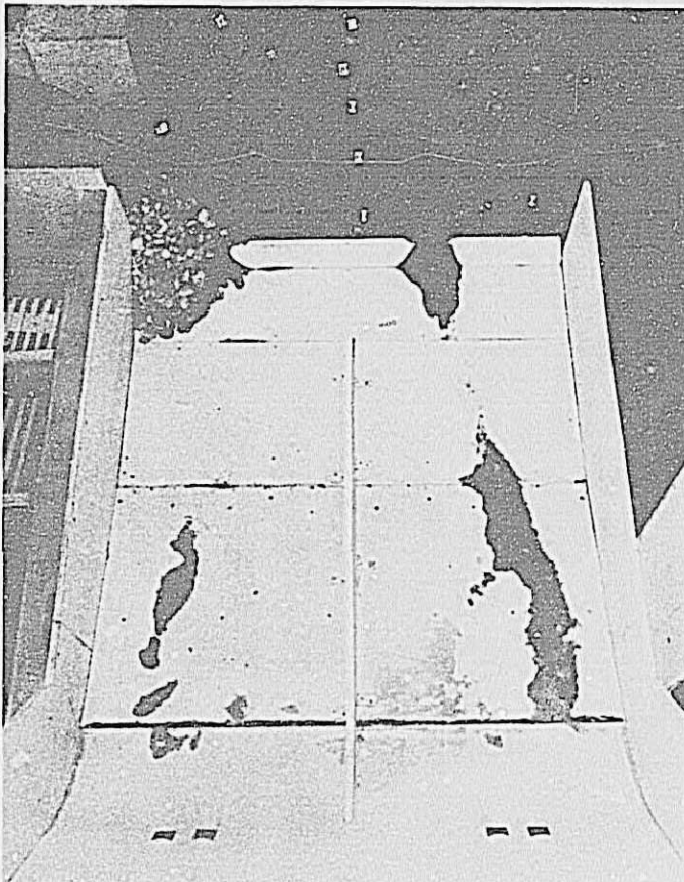
Figure 14. Symmetrical operation of  
 two river outlets, test 15.

a. Outlets No. 1 and 4, total  
 $Q = 4,750 \text{ ft}^3/\text{s}$ . Photo  
 P296-D-75730

b. Results of test 15. Photo  
 P296-D-75731

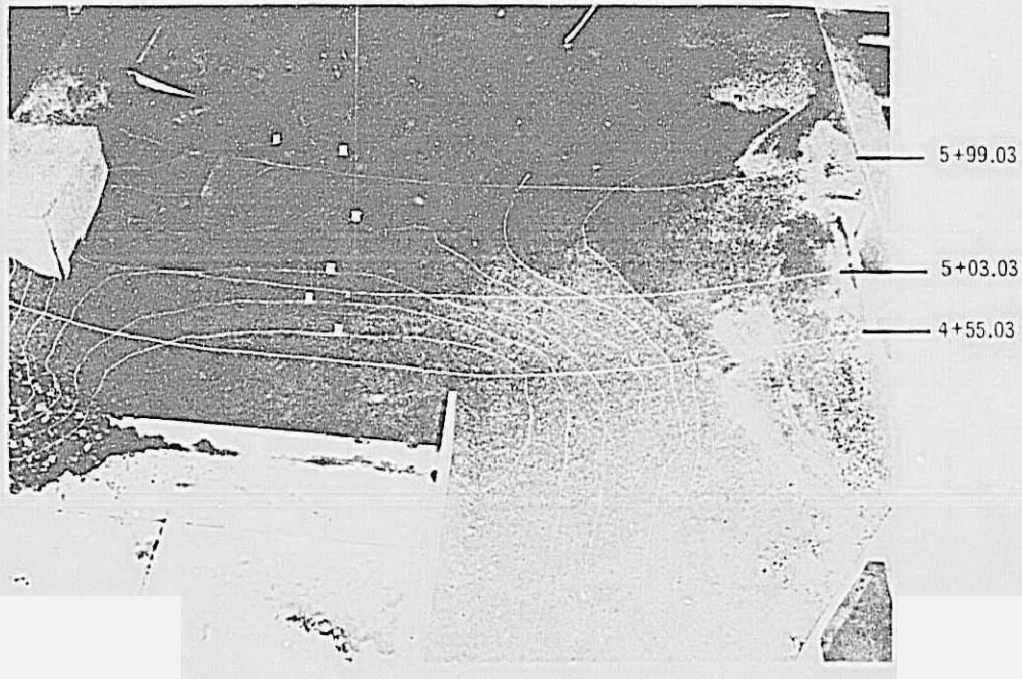
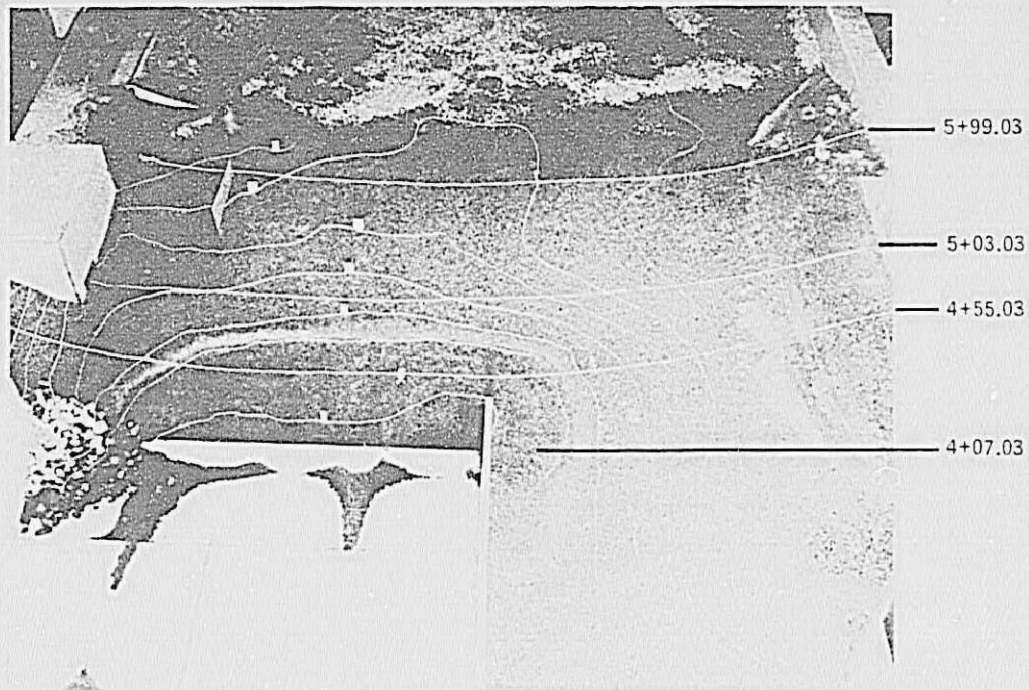
Figure 15. Result of spillway release, test 2.

a. View of basin and downstream river channel before test 2. Photo P296-D-75709

b. View of basin and downstream river channel after test 2. Photo P296-D-75710

**Spillway**—It was noted early in the testing program that small spillway releases would not sweep the basin floor clean. Test 2, with a spillway release of 9,400 ft<sup>3</sup>/s (266 m<sup>3</sup>/s), did not clear the riverbed material initially in the basin, figure 15.

Test 3 (fig. 17) was conducted with a spillway release of 24,000 ft<sup>3</sup>/s (680 m<sup>3</sup>/s) using the results of test 2 (fig. 15) as the initial condition. As figure 17 illustrates, the basin was swept clear of riverbed material. Minor erosion occurred in the channel immediately downstream from the stilling basin end sill. The spill required to clean various amounts of material from the basin, will be covered in a later section of this report.

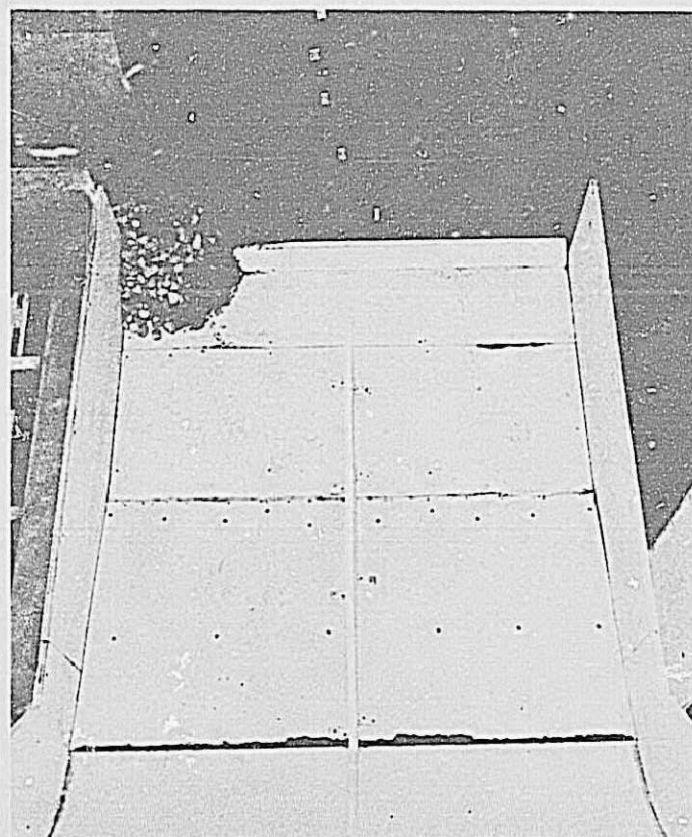
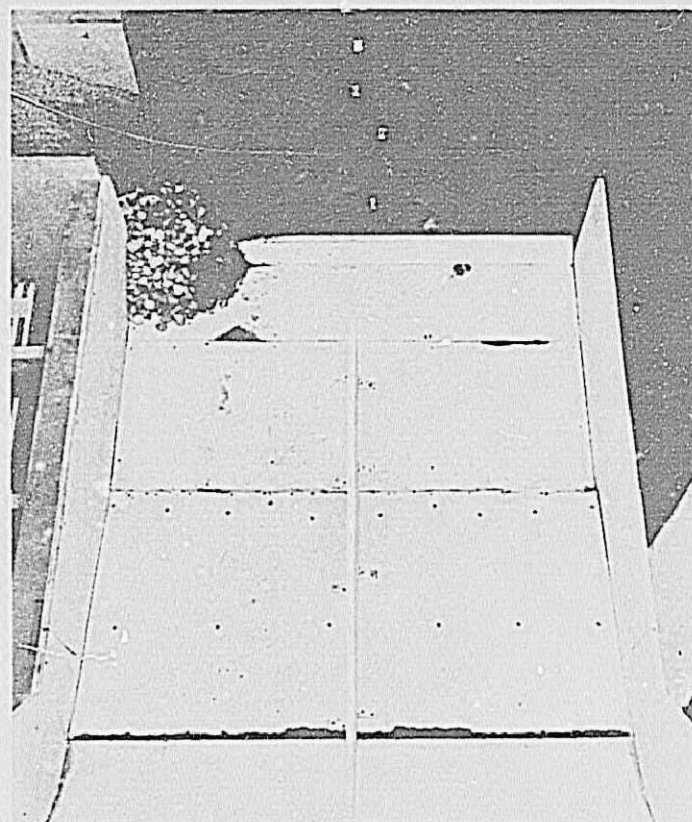
Figure 16. Result of small spillway releases, tests 24 and 25.

a. Results of test 24,  $Q = 4,100$   
 $\text{ft}^3/\text{s}$ . Photo P296-D-75738

b. Results of test 25,  $Q = 6,600$   
 $\text{ft}^3/\text{s}$ . Photo P296-D-75739

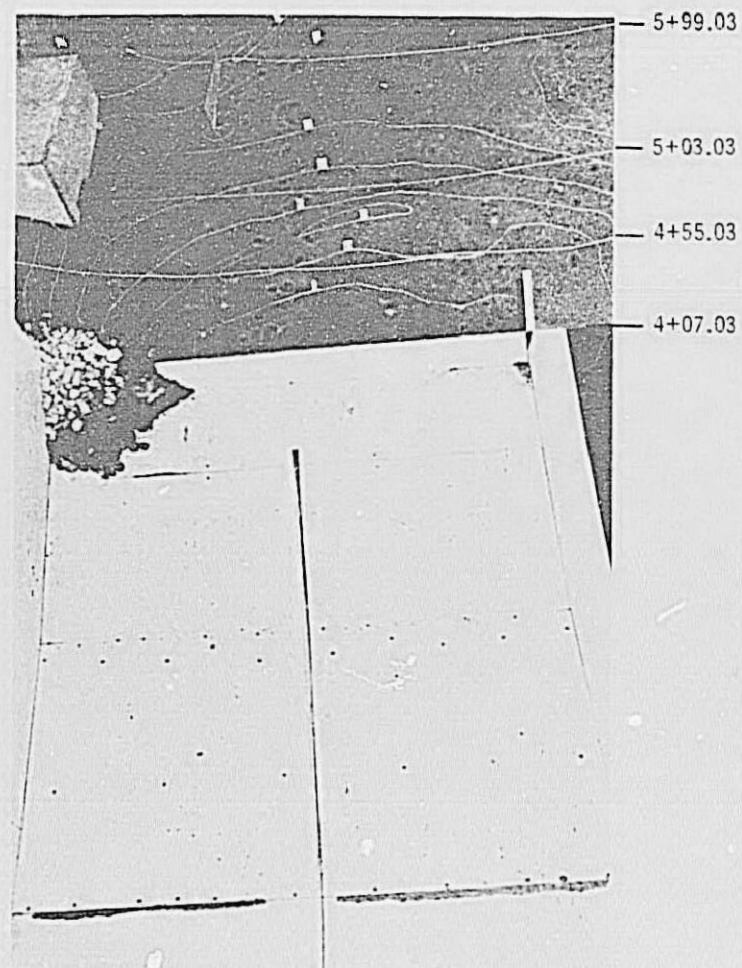
Figure 17. Result of large spillway release, test 3.

View of basin after test 3, basin swept clean with minor erosion downstream of end sill.  $Q = 24,000$   $\text{ft}^3/\text{s}$ . Composite of photos P296-D-75711 and -75712

Test 3 (fig. 17) was conducted with a spillway release of  $24,000 \text{ ft}^3/\text{s}$  ( $680 \text{ m}^3/\text{s}$ ) using the results of test 2 (fig. 15) as the initial condition. As figure 17 illustrates, the basin was swept clear of riverbed material. Minor erosion occurred in the channel immediately downstream from the stilling basin end sill. The spill required to clean various amounts of material from the basin, will be covered in a later section of this report.

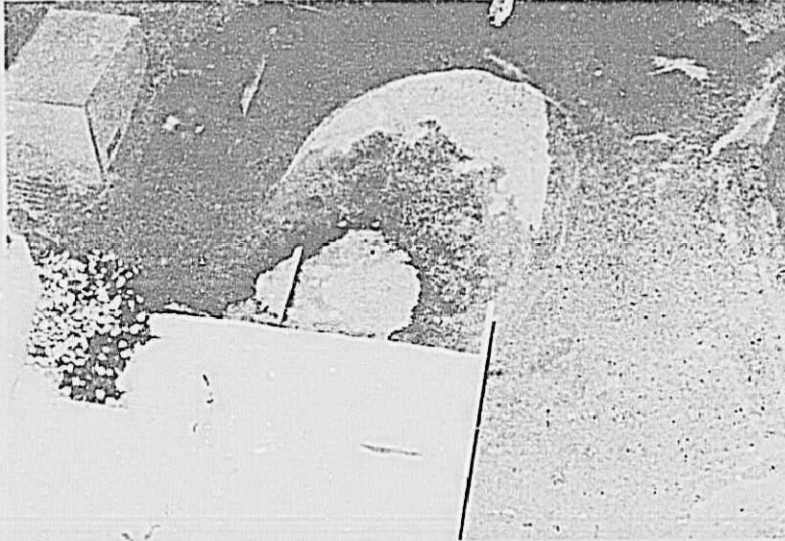
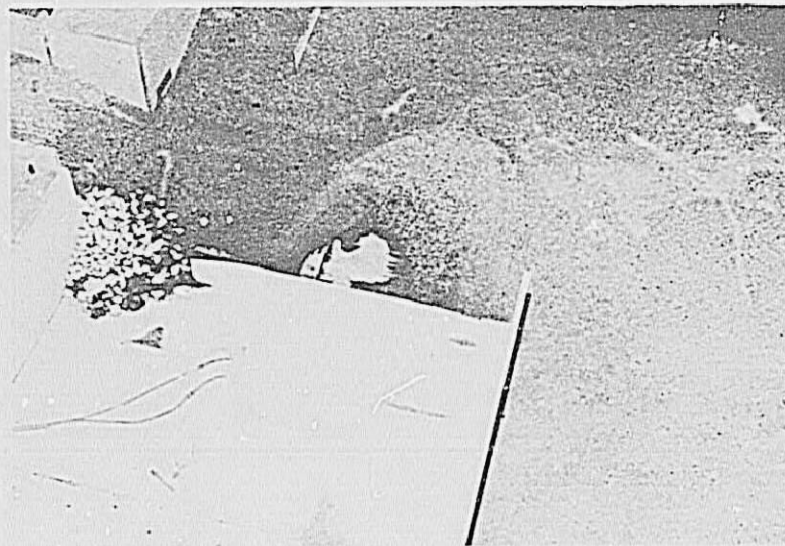
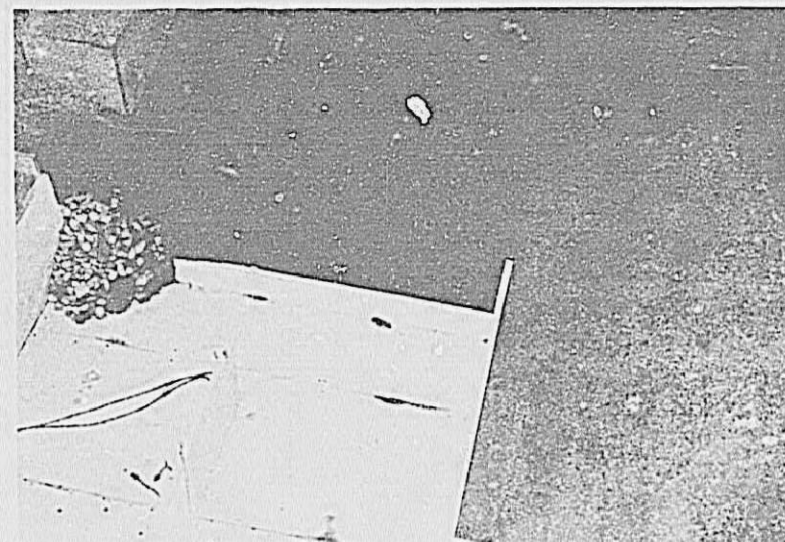
Figure 18. Results of asymmetrical spillway operations, tests 26, 27, and 28.

a. Results of test 26, gates 2, 3, and 4, total  $Q = 14,500 \text{ ft}^3/\text{s}$ . Photo P296-D-75740

b. Results of test 27, gates 2, 3, and 4, total  $Q = 8,300 \text{ ft}^3/\text{s}$ . Note some riverbed material moved into right bay of basin. Photo P296-D-75741

c. Results of test 28, gates 2, 3, and 4, total  $Q = 3,900 \text{ ft}^3/\text{s}$ . Photo P296-D-75742

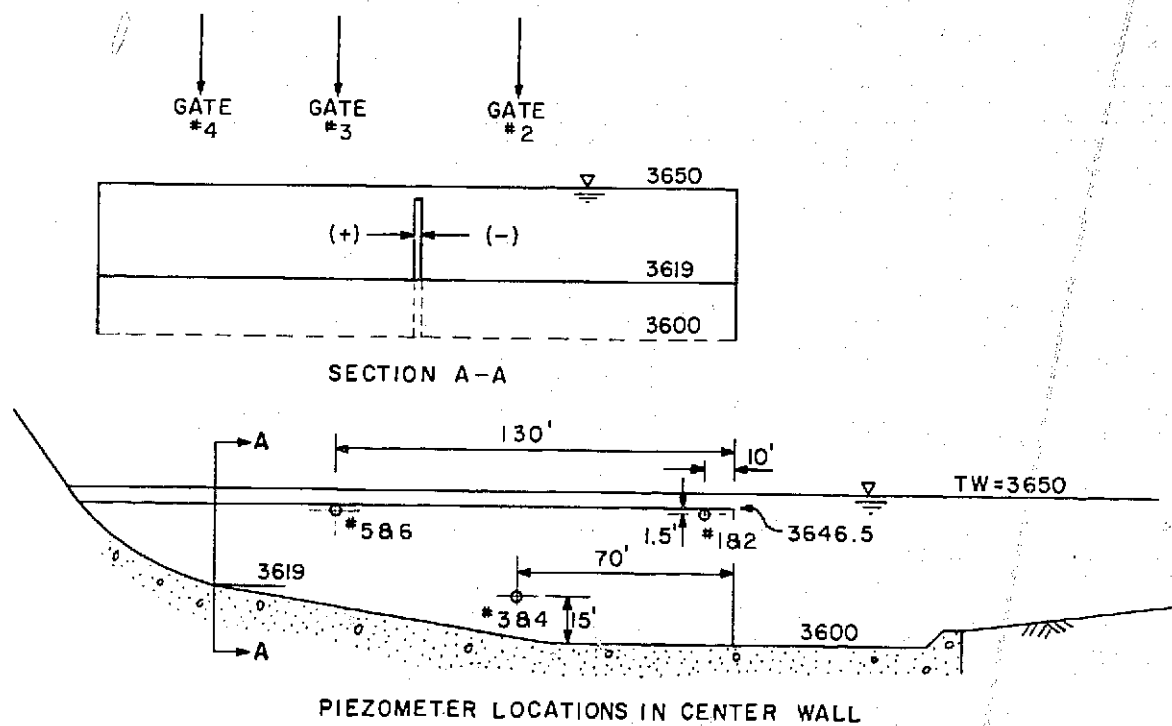
TEST #	PIEZ. # 1 & 2			PIEZ. # 3 & 4			PIEZ. # 5 & 6		
	MAX. HEAD	AVG.	MAX. HEAD	MAX. HEAD	AVG.	MAX. HEAD	MAX. HEAD	AVG.	MAX. HEAD
26 $Q=14,500\text{ft}^3/\text{s}$ ( $4,833\text{ft}^3/\text{s}$ ) GATE	+		-	+		-	+		-
	2.5 ft.	0	1.6 ft.	4.5 ft.	0	4.5 ft.	1.2 ft.	-1.5 ft.	6.0 ft.
27 $Q=8,300\text{ft}^3/\text{s}$ ( $2,767\text{ft}^3/\text{s}$ ) GATE	2.0 ft.	+0.5 ft.	0.8 ft.	2.8 ft.	+0.4 ft.	2.4 ft.	0.8 ft.	-0.5 ft.	2.0 ft.
28 $Q=3,900\text{ft}^3/\text{s}$ ( $1,300\text{ft}^3/\text{s}$ ) GATE	0.3 ft.	-0.05 ft.	0.5 ft.	0.4 ft.	-0.05 ft.	0.7 ft.	0.3 ft.	-0.2 ft.	0.6 ft.

Figure 19. Basin center wall pressures with asymmetrical spillway operation.

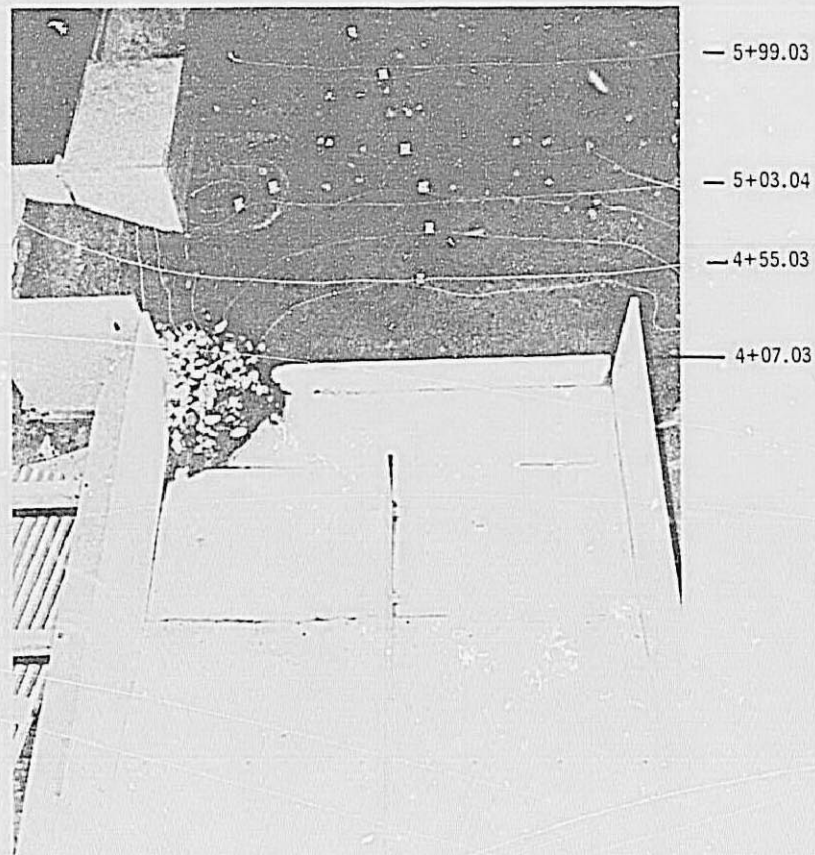
Figure 20. Results of powerplant and Helena Valley Pumping Plant operations, tests 6A and 6B. Photo P296-D-75715

**Powerplant and Helena Valley Pumping Plant.**—Test 6A determined the effect of the powerplant operation on the movement of riverbed material near and in the stilling basin. Before the start of the test some very fine material was observed on the stilling basin floor. The powerplant discharged 6,000 ft<sup>3</sup>/s for approximately 31 hours (prototype time scale). There was no movement of the fine material initially present on the floor of the basin over this time span. Test 6B was an extension of test 6A with the powerplant discharging 6,000 ft<sup>3</sup>/s and the Helena Valley Pumping Plant turbines releasing 463 ft<sup>3</sup>/s (13 m<sup>3</sup>/s) into the downstream channel for a time span representing 10 hours in the prototype. Again, there was no indication of any movement of the fine material on the stilling basin floor. A local scour hole and buildup occurred in

**Powerplant and Helena Valley Pumping Plant.**—Test 6A determined the effect of the powerplant operation on the movement of riverbed material near and in the stilling basin. Before the start of the test some very fine material was observed on the stilling basin floor. The powerplant discharged  $6,000 \text{ ft}^3/\text{s}$  for approximately 31 hours (prototype time scale). There was no movement of the fine material initially present on the floor of the basin over this time span. Test 6B was an extension of test 6A with the powerplant discharging  $6,000 \text{ ft}^3/\text{s}$  and the Helena Valley Pumping Plant turbines releasing  $463 \text{ ft}^3/\text{s}$  ( $13 \text{ m}^3/\text{s}$ ) into the downstream channel for a time span representing 10 hours in the prototype. Again, there was no indication of any movement of the fine material on the stilling basin floor. A local scour hole and buildup occurred in
