REC-ERC-74-27

# HYDRAULIC MODEL STUDIES OF CANYON FERRY DAM SPILLWAY STILLING BASIN

December 1974

Engineering and Research Center  
Bureau of Reclamation

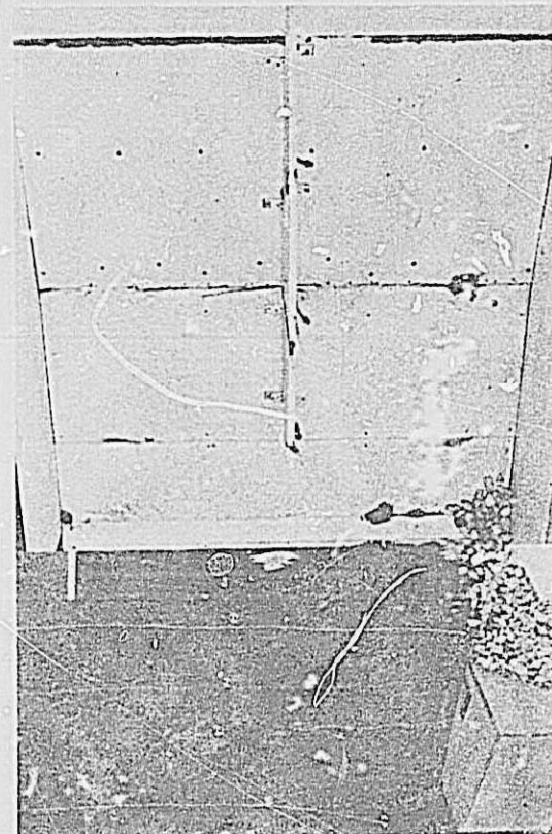
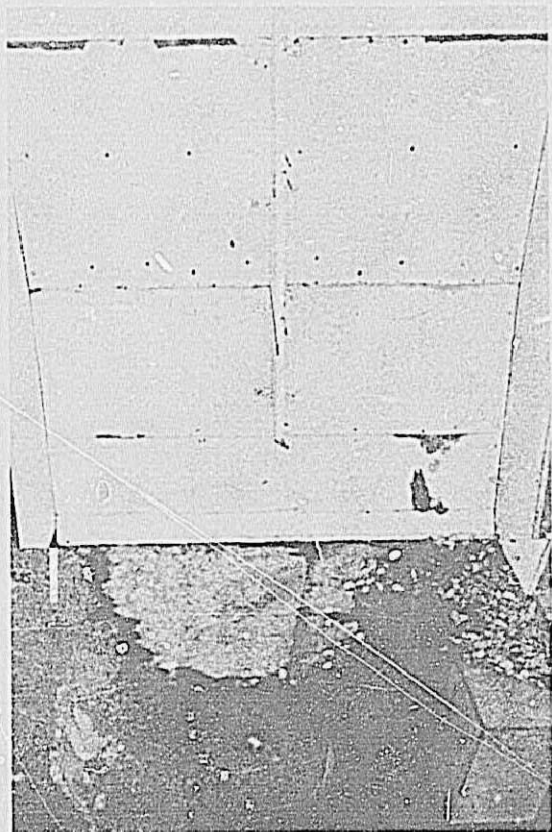
Figure 21. Results of simultaneous  
spillway and river outlet operations,  
tests 34 and 38.

a. View of stilling basin after test 34.  
Spillway  $Q = 4,750 \text{ ft}^3/\text{s}$ , river outlet  
 $Q = 4,750 \text{ ft}^3/\text{s}$ . Composite of photos  
P296-D-75752 and -75753

b. View of stilling basin after test 38.  
Spillway  $Q = 10,000 \text{ ft}^3/\text{s}$ , river  
outlet  $Q = 4,750 \text{ ft}^3/\text{s}$ . Composite of  
photos P296-D-75755 and -75756

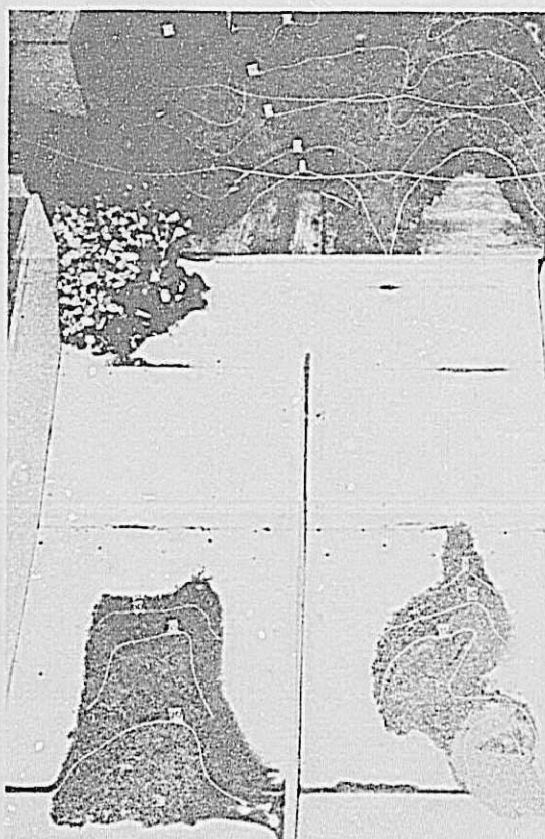
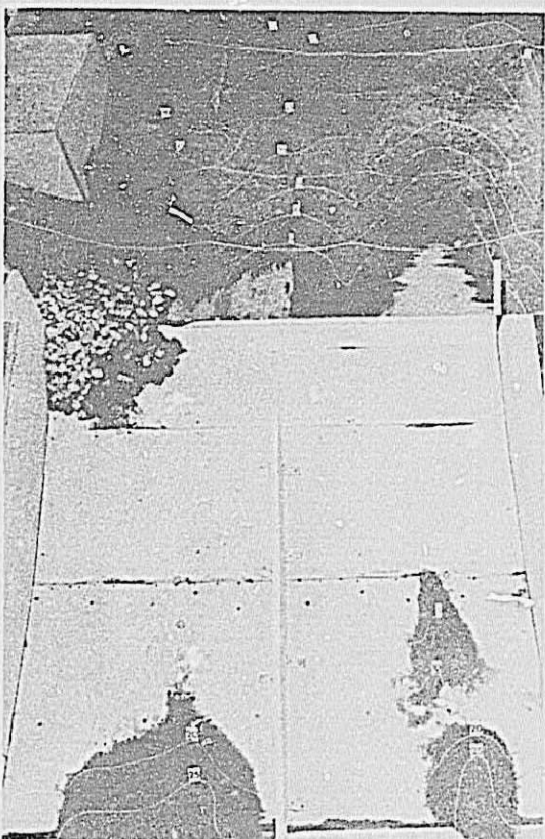
Figure 22. Stability of downstream river channel, tests 20 and 21.

a. Results of test 20, river outlet  $Q = 9,500 \text{ ft}^3/\text{s}$ . Composite of photos P296-D-75734 and -75735

b. Results of test 21, river outlet  $Q = 9,500 \text{ ft}^3/\text{s}$ . Composite of photos P296-D-75736 and -75737

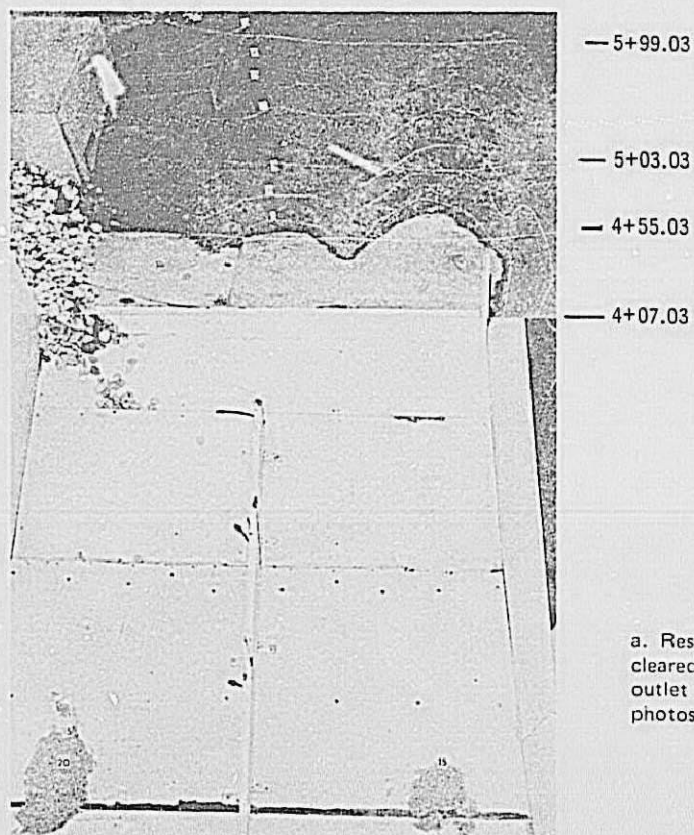
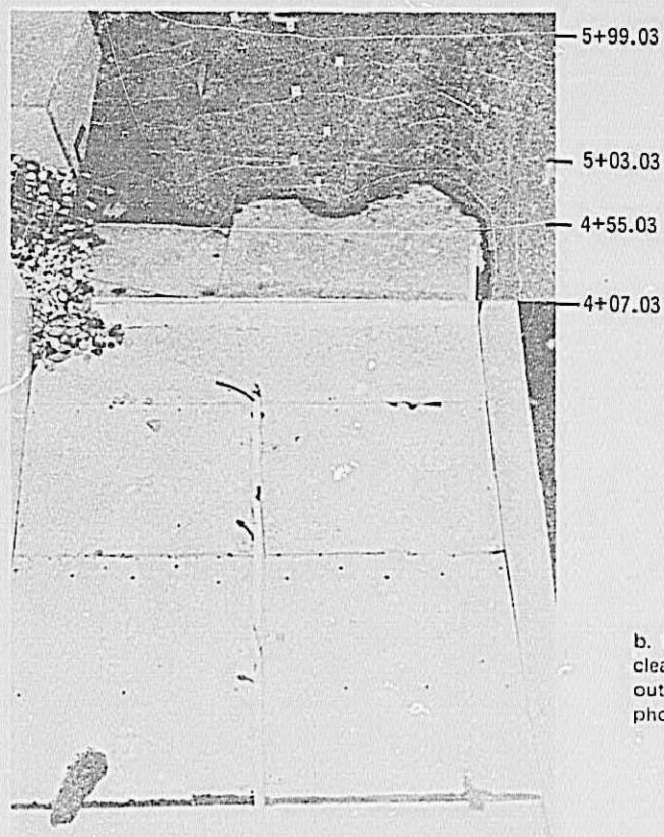
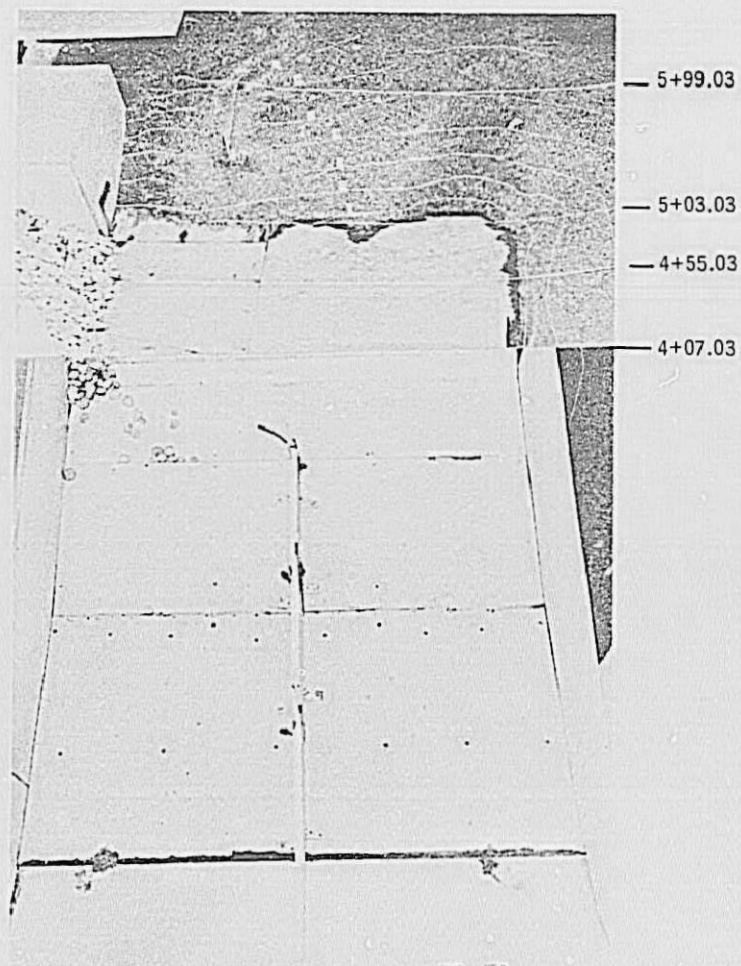
Figure 24. Downstream river channel cleared to bedrock, tests 29, 30, and 31.

a. Results of test 29. Riverbed cleared to bedrock for 50 feet, river outlet  $Q = 9,500 \text{ ft}^3/\text{s}$ . Composite of photos P296-D-75743 and -75744

b. Results of test 30. Riverbed cleared to bedrock for 75 feet, river outlets  $Q = 9,500 \text{ ft}^3/\text{s}$ . Composite of photos P296-D-75746 and -75747

c. Results of test 31. Riverbed cleared to bedrock for 100 ft, river outlet  $Q = 9,500 \text{ ft}^3/\text{s}$ . Composite of photos P296-D-75748 and -75749

5. Clearing the river bottom of loose riverbed material down to bedrock for a distance of 100 feet (30 m) downstream from the end sill will prevent the movement of riverbed material into the basin for river outlet releases up to the design discharge of  $9,500 \text{ ft}^3/\text{s}$  ( $269 \text{ m}^3/\text{s}$ ).

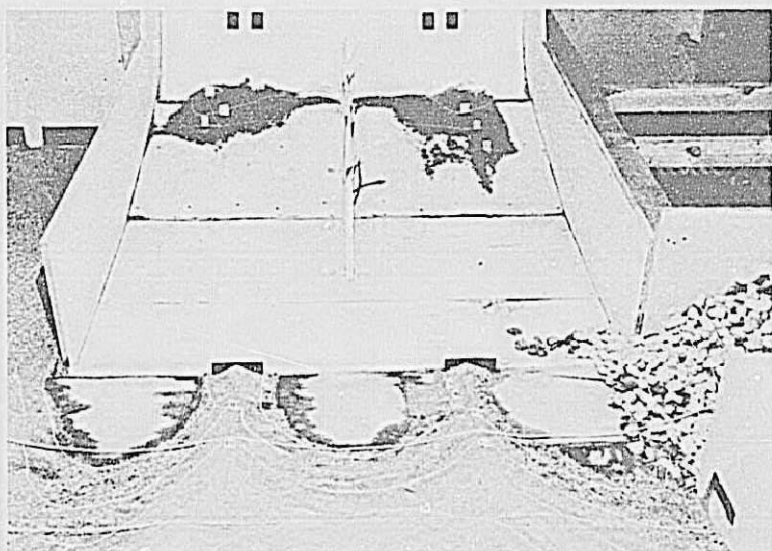
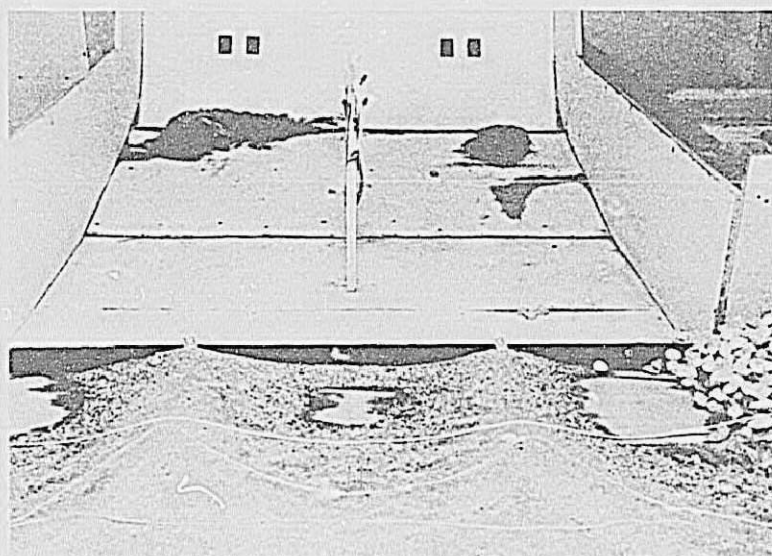
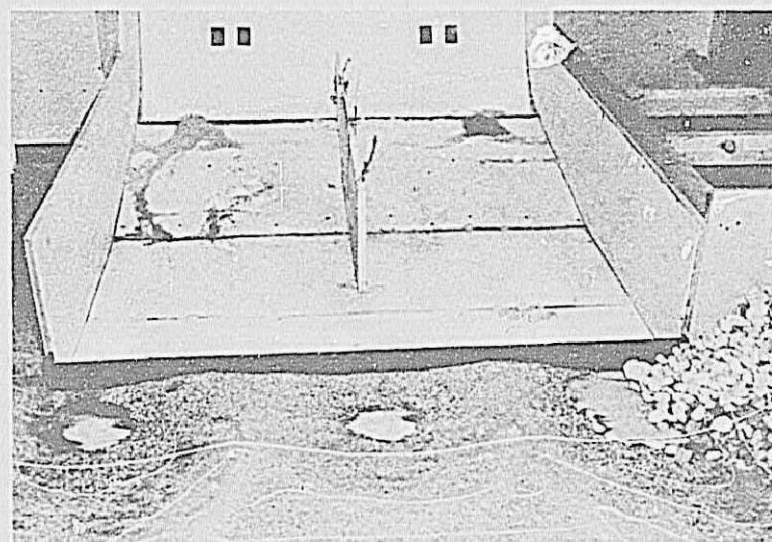
Figure 25. End sill wall studies, tests 32, 33, and 36.

a. Results of test 32. Two, 5-foot-high, 20-foot-long walls. Note material on sloping apron. Photo P296-D-75750

b. Results of test 33. One, 8-foot-high wall extending full width of basin. Note downstream riverbed material overtopped the end sill wall. Photo P296-D-75751

c. Results of test 36. One, 12-foot-high wall extending full width of basin. Photo P296-D-75754

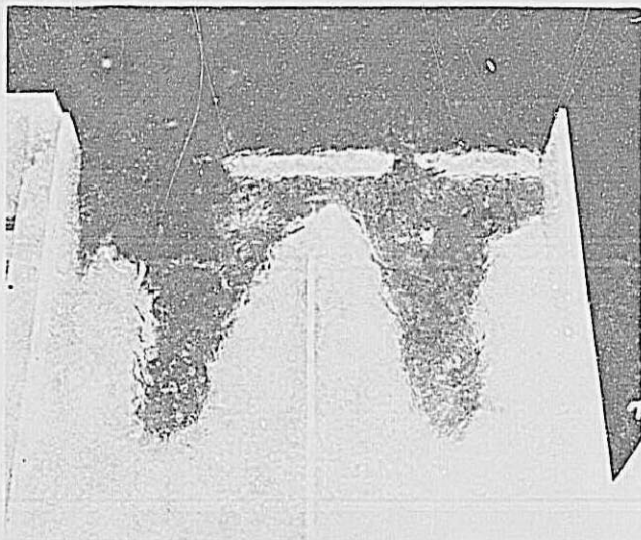
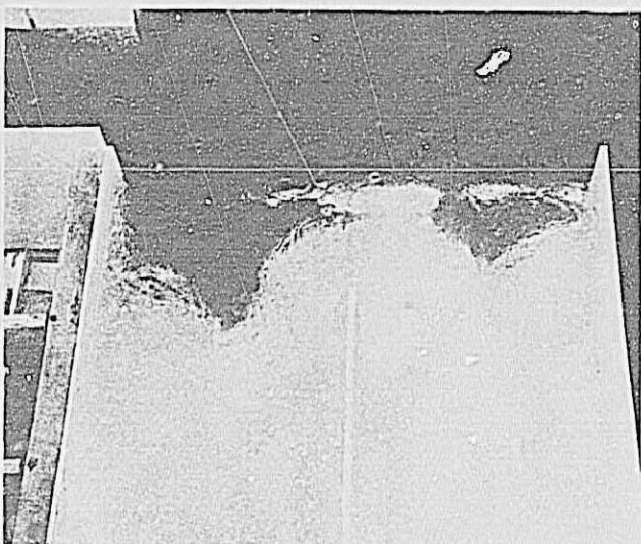
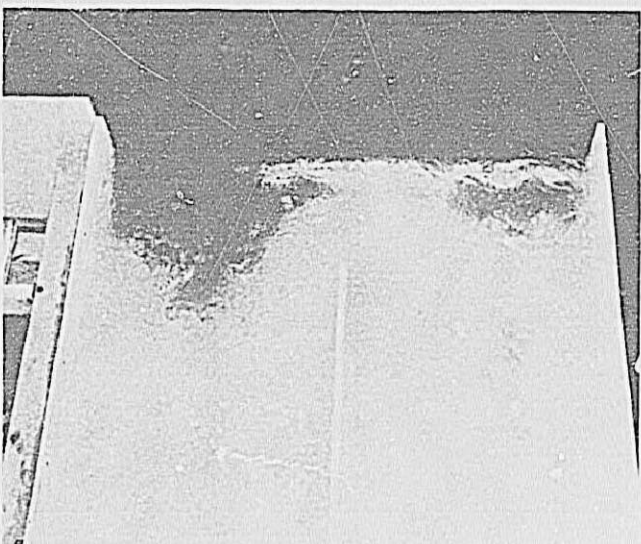
Figure 26. Spill required to clean stilling basin of  $400 \text{ yd}^3$ , tests 10, 11, and 12.

a. Test 10, basin after 6 hours,  $Q = 11,000 \text{ ft}^3/\text{s}$ . Photo P296-D-75722

b. Test 11, basin essentially cleaned after 6 hours,  $Q = 20,800 \text{ ft}^3/\text{s}$ . Photo P296-D-75723

c. Test 12, basin essentially cleaned after 2 hours.  $Q = 24,400 \text{ ft}^3/\text{s}$ . Photo P296-D-75724

Since spillway or river outlet releases are necessary approximately 6 out of every 7 years at Canyon Ferry Dam, the idea of sweeping future deposits of material out of the basin by spillway releases was considered. Tests 10, 11, and 12 were conducted to determine the minimum spillway release required to sweep the basin clean with approximately 400 yd<sup>3</sup> (306 m<sup>3</sup>) of material deposited on the sloping apron. Figure 7b illustrates the approximate initial condition for these tests. Figure 26 illustrates locations of the deposited riverbed material after spillway operation at discharges of 11,000, 20,800, and 24,400 ft<sup>3</sup>/s (312, 589, and 691 m<sup>3</sup>/s), tests 10, 11, and 12, respectively. The 24,400 ft<sup>3</sup>/s spill essentially cleaned the basin in 2 hours as compared to 6 hours for the 20,800 ft<sup>3</sup>/s.

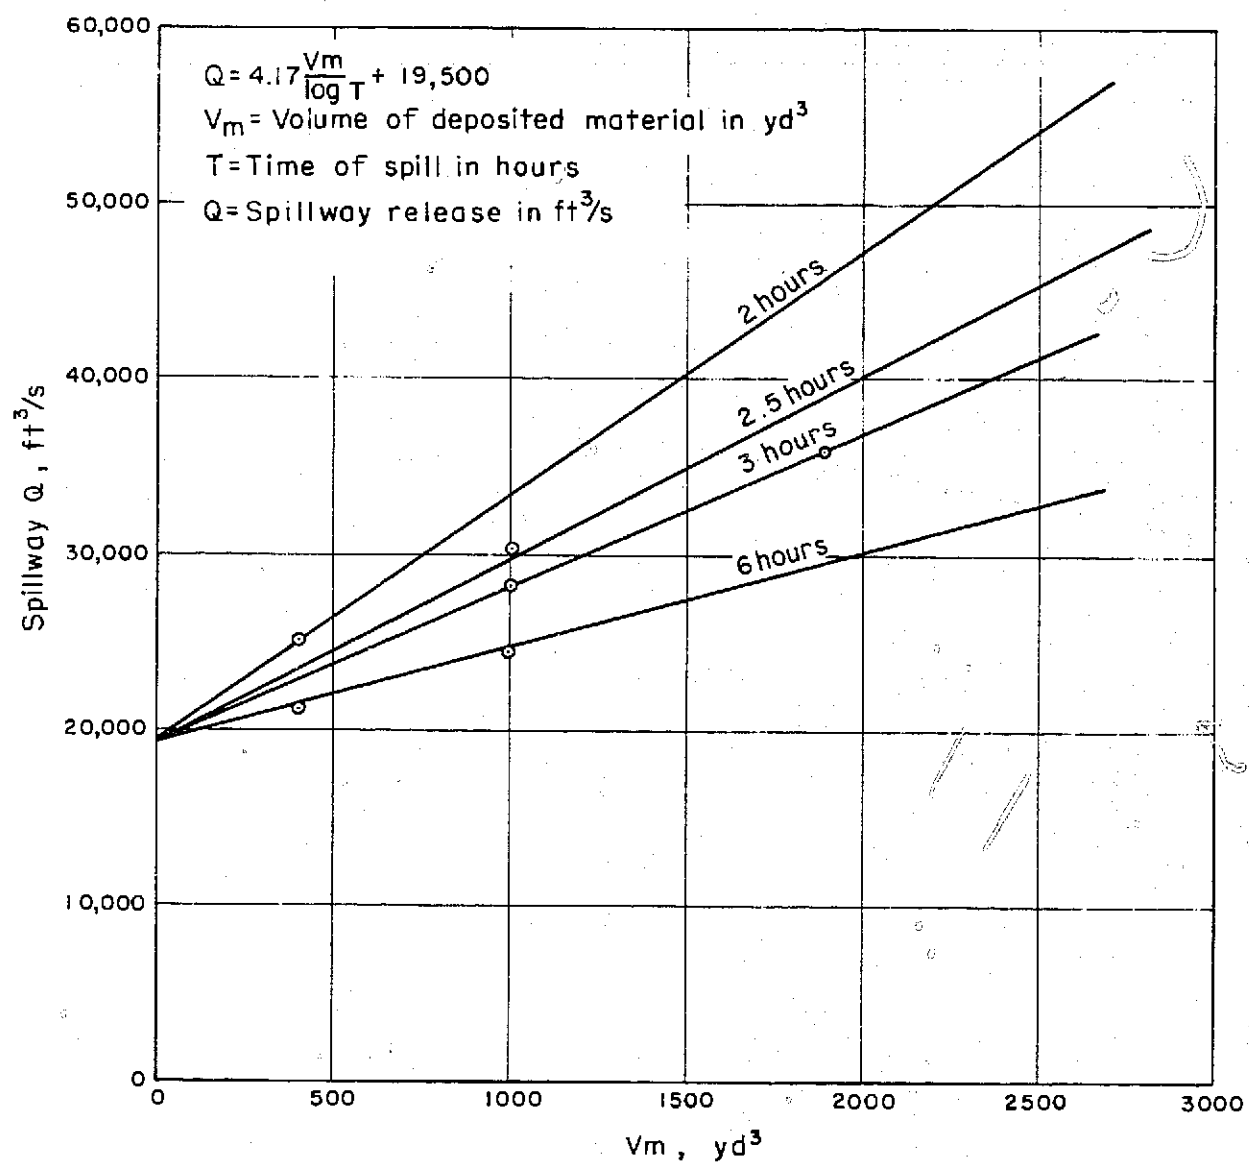
Figure 27. Removal of riverbed material from stilling basin.

2. Releases from the spillway, powerplant, or the Helena Valley Pumping Plant do not carry riverbed material into the stilling basin.
3. Model tests indicated that the deposited riverbed material could be cleared from the stilling basin with adequate spillway releases. The time and amount of spill required to clear this material from the stilling basin can be determined from figure 27.

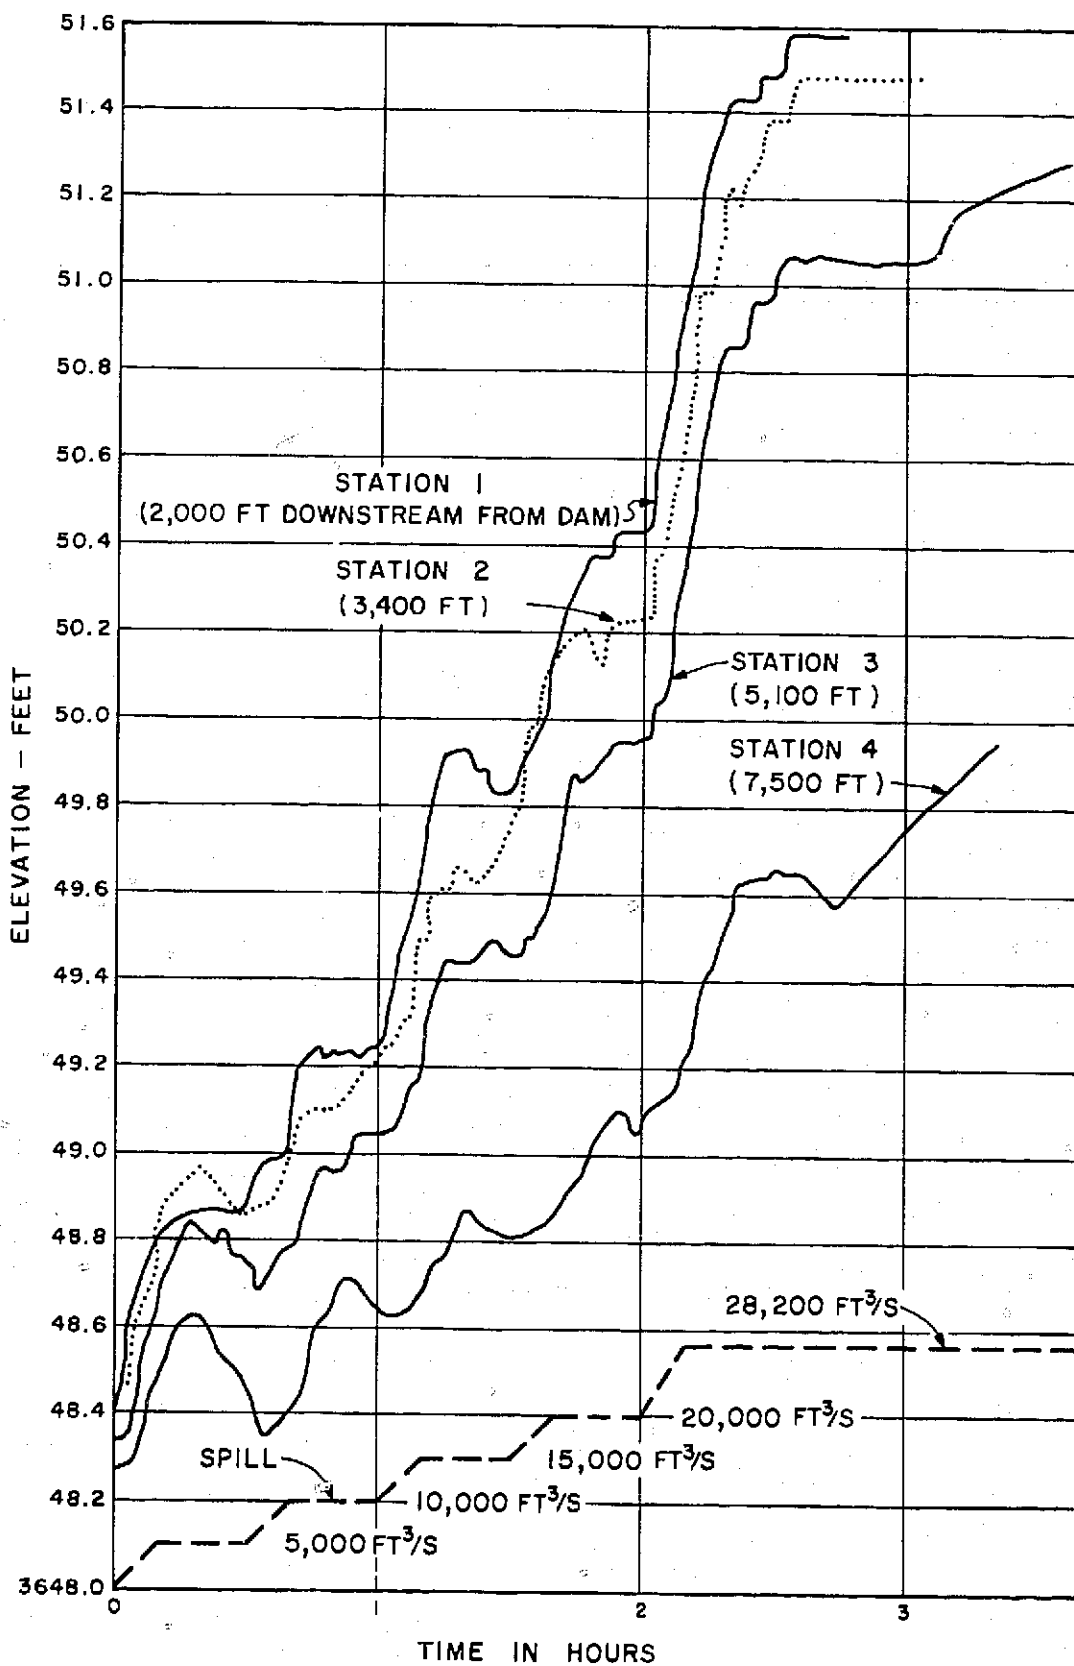
Figure 28. Water surface elevations below dam during spill.
