**REC-ERC-79-2**

# TETON DAM—FOUNDATION GROUT TESTING PROGRAM

Engineering and Research Center Water and Power Resources Service

December 1979

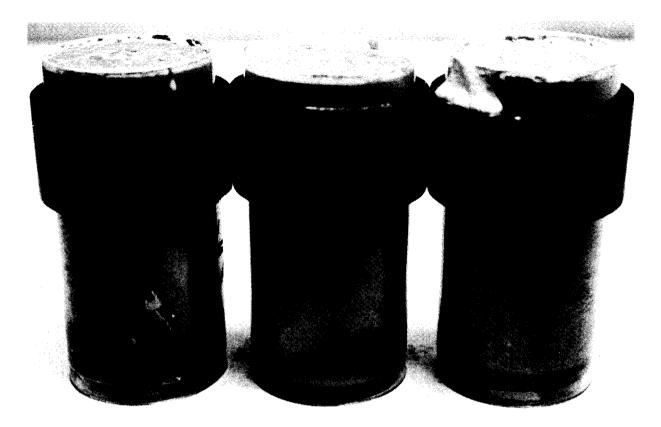
- Figure 1.-Cylinders, 50 by 100 mm (2 by 4 in), cast for unconfined compressive strength testing. W:C:S = 1:1:1, 0 percent calcium chloride 27 to 32 °C (80 to 90 °F). Note loss of bleed water and settling of solid particles. Some laitance can be seen as white spots on tops of specimens. Photograph C-8481-70.

Less bleeding occurred in grouts with a lower proportion of water to solids. Figure 1, which shows a

1:1:1 grout at 27 to 32 °C (80 to 90 °F), demonstrates the bleeding characteristic typical of neat-cement and sanded grouts with no calcium chloride. Bleeding in these cylinders caused a reduction in volume of 3 percent. Grouts with a 0.8:1 W:C ratio showed more bleeding and grouts with higher sand contents showed slightly less bleeding than figure 1.

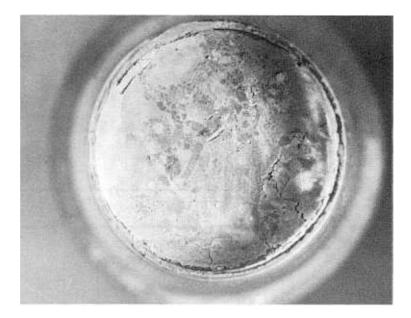
Figure 6.-Top of 30-mm (1<sup> $\frac{1}{4}$ -in) diameter cylinder cast for erodibility testing. W:C = 5:1, 0 percent calcium chloride, 13 to 21 °C (55 to 70 °F). Note laitance on surface. Photograph C-8481-155.</sup>

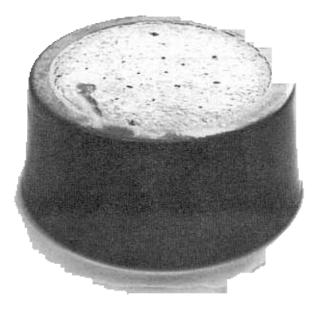
Figure 13.-Typical time of setting specimen cast 7 hours prior to photographing and had reached final set. W:C = 0.8:1, 5 percent calcium chloride, 13 to 21 °C (55 to 70 °F). Note laitance on top. Photograph C-8481-74.

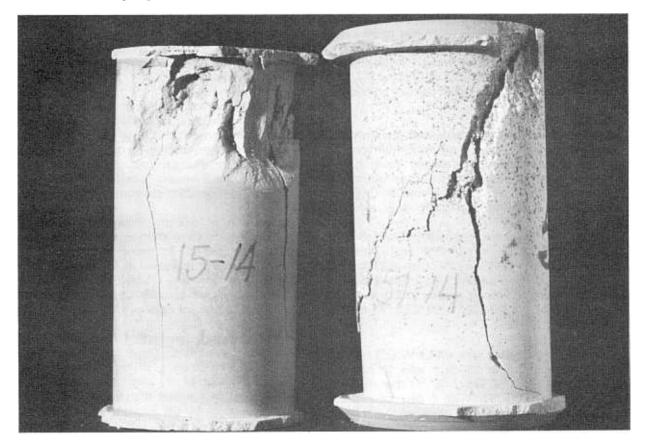
Figure 25.-Cylinders 50 by 100 mm (2 by 4 in), tested for unconfined compressive strength at an age of 90 days. Left: W:C = 0.8:1, 8 percent calcium chloride, 2 to 4 °C (35 to 40 °F). Right: W:C:S = 1:1:1.4, 6 percent calcium chloride, 2 to 4 °C (35 to 40 °F). Left cylinder shows splitting failure. Right cylinder shows shear failure on diagonal plane (roughly 1 o'clock to 7 o'clock). Photograph C-8481-116.

Two modes of failure were observed in unconfined compressive strength testing (fig. 25). Stronger grouts, mainly 0.8:1 W:C ratio, displayed a splitting-type failure. A shear-type failure, similar to concrete, was demonstrated by sanded grouts which were usually weaker.
