REC-ERC-81-1

CLOSED-SYSTEM FREEZING OF SOILS IN LININGS AND EARTH EMBANKMENT DAMS

**Engineering and Research Center
Water and Power Resources Service**

March 1981

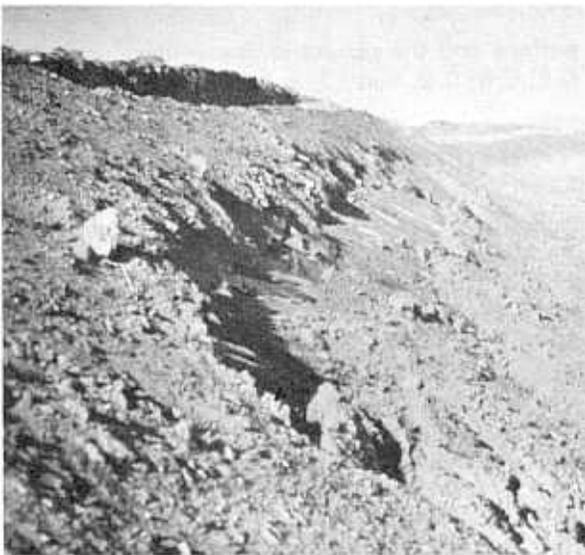
Figure 15. — Slippage of polyvinyl chloride membrane lining due to closed-system freezing. Photo P801-D-79452

There was no water table under the lining sufficiently near the canal surface to have caused open-system freezing. Apparently, as frost penetrated into the subgrade, moisture migrated upward and froze at and in thin lenses immediately below the plastic lining barrier. The record of

daily temperatures in the general area showed an unseasonable warming trend for a few days prior to the slide, with the maximum temperatures up to 13 °C (55 °F). This probably caused thawing to depths immediately below the plastic membrane. Melting water would be trapped between the plastic membrane and frozen material below and lubrication under the lining seems to be a plausible explanation for the cause of the slide.

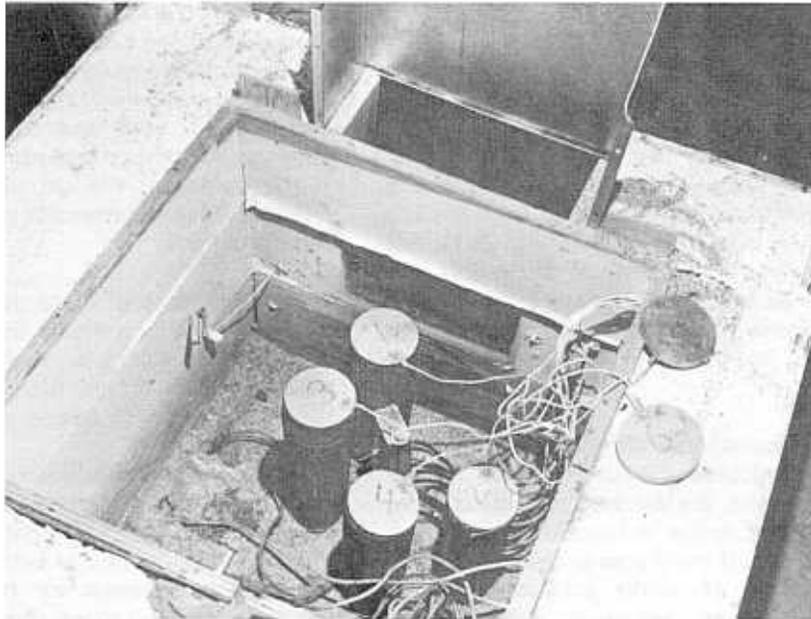
Figure B-2. — Soil specimens in insulated housing being prepared for freezing test. The center bank of thermocouples on the wooden post can be seen. Photo E-2343-2
