REC-ERC-84-5

# **STEWART MOUNTAIN DAM CONCRETE CORE ANALYSIS-1983**

**May 1984**

**Engineering and Research Center**

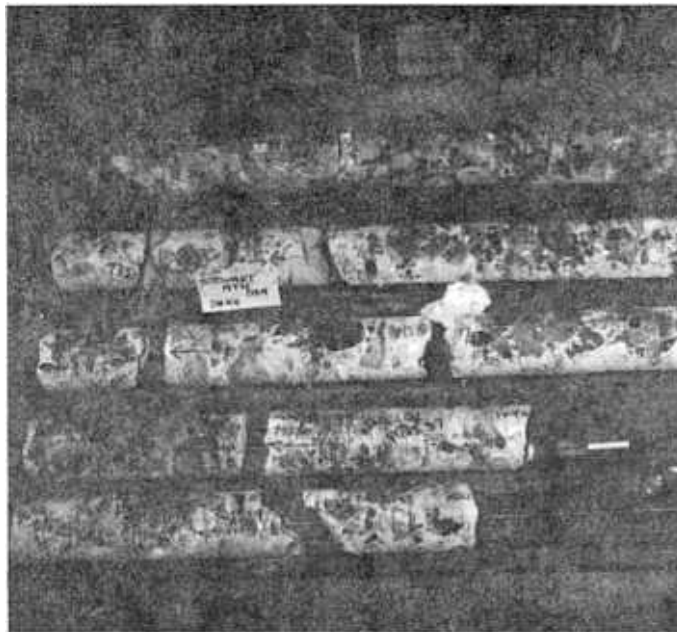
Figure 2.-Typical core sections before being cut into specimens,  
Stewart Mountain Dam. P801-D-80458

The cores were extracted in sections and packed in wooden boxes with damp sawdust. They were then marked with drill hole number and depth, and shipped to the Bureau of Reclamation, Engineering and Research Center, Denver, Colorado (fig. 2). After arrival, the cores were examined, logged, photographed, and marked for cutting into test specimens. The cores received had a large percentage of disbonded joints. All specimens, other than those set aside for direct shear tests, were sawed to 12-inch lengths. Direct shear specimens averaged about 4 inches in length.

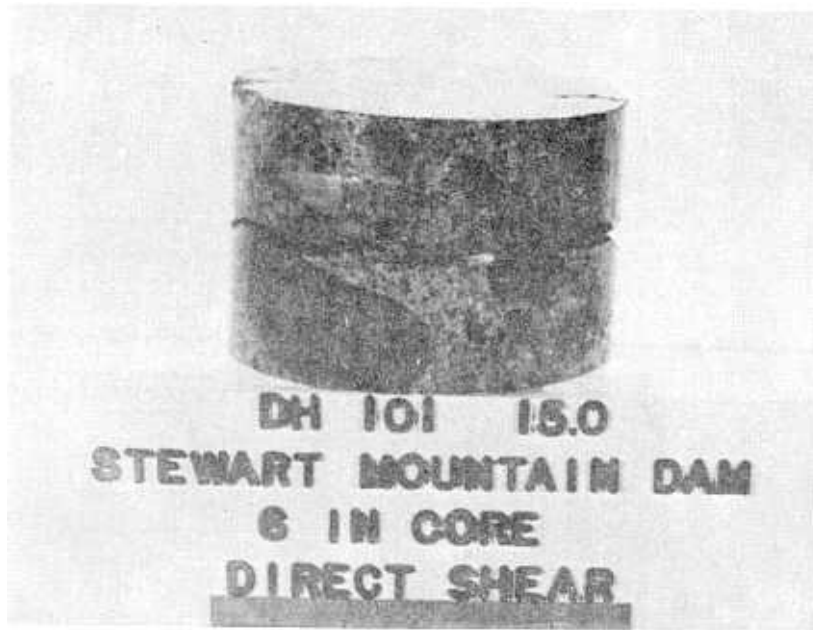
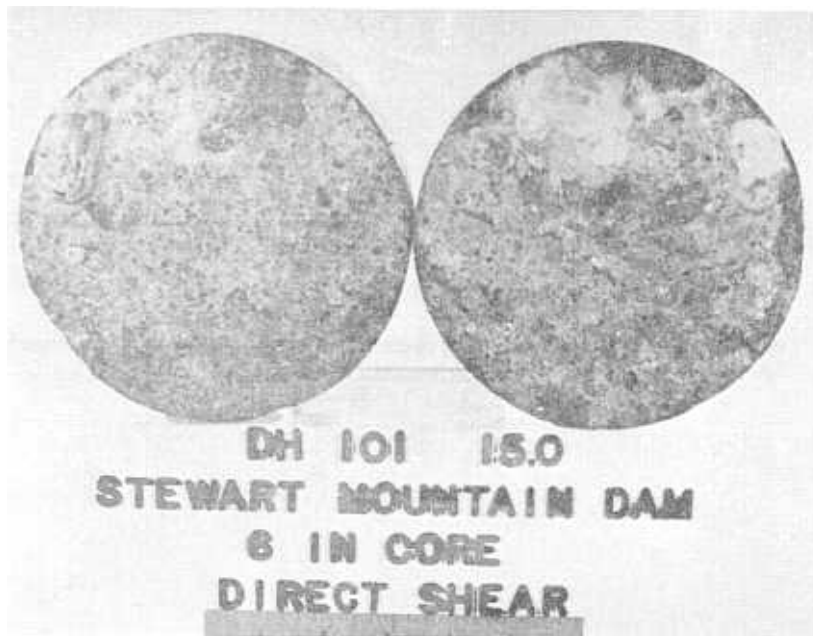
Figure 10.—Typical direct shear specimen, Stewart Mountain Dam.  
P801-D-80466 and P801-D-80467

Selected intact specimens were subjected to break-bond tests, followed by sliding friction tests. Most specimens were unbonded and these were tested using only the sliding friction test. Several of the specimens contained construction joints. The cores were cut into about 4-inch lengths with the joints as close as possible to midlength. Break-bond data were obtained by subjecting each specimen to a constant standard load while simultaneously increasing the horizontal shearing load until the specimen failed or broke bond (fig. 10). The maximum horizontal shear and constant standard loads were recorded. The failed surfaces were then subjected to a series of tests with increasing standard loads, where the shear loads required to displace the surface at each standard load were determined. The results of the break-bond and sliding friction tests are shown in table 3. Values for cohesion and the tangent of the angle of friction ( $\tan \phi$ ) are also shown in table 3. These direct shear test results showed no significant difference between drill holes or between upper and lower portions of the dam. Thirty-three specimens were tested, and the results were varied. Many of the samples were of poor quality with considerable amounts of material missing. Also, a large number of fracture and joint surfaces were coated with alkali silica gel.
