REC-ERC-87-1

LONG-TERM CHANGES IN THE PROPERTIES OF SOIL LININGS FOR CANAL SEEPAGE CONTROL

Engineering and Research Center

**U. S. Department of the Interior
Bureau of Reclamation**

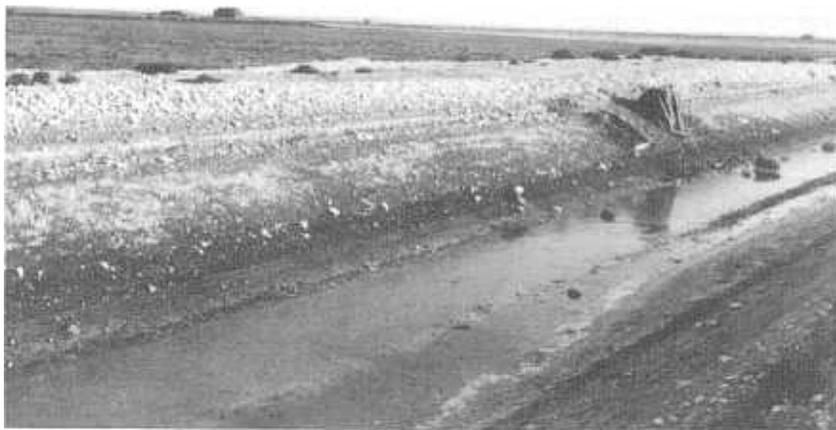
Figure A-1. – Lateral EL-68 near station 211+00. General view of soil lining showing trench excavated to conduct unit weight tests. A permeability test is in progress on the canal slope under a tarpaulin to protect against freezing. November 1957. R-222-116-39930.

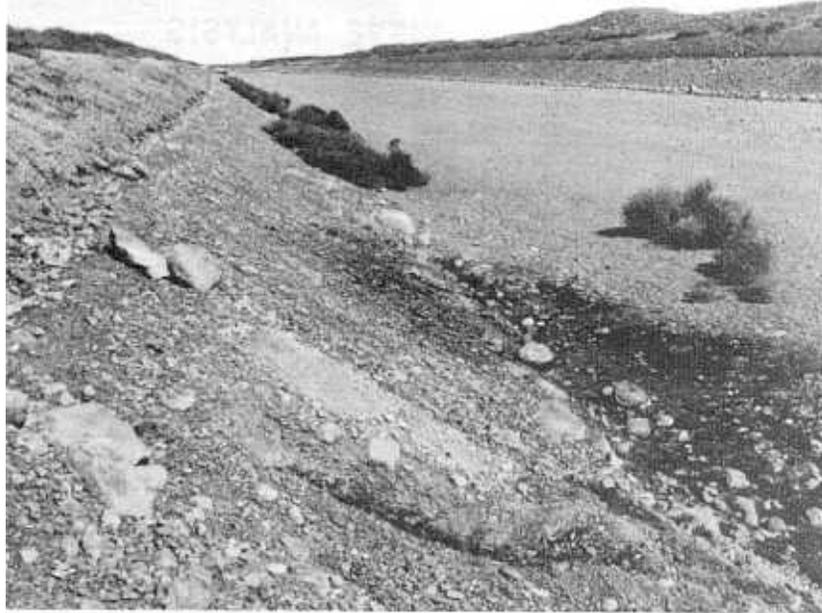
Figure A-3. – Potholes East Canal looking upstream from right bank near station 881+00. Gravel cover varies in thickness from 6 to 15 inches. Lining has experienced two operating seasons. Excavation in low center is for unit weight tests. March 1955. P-222-117-36308.

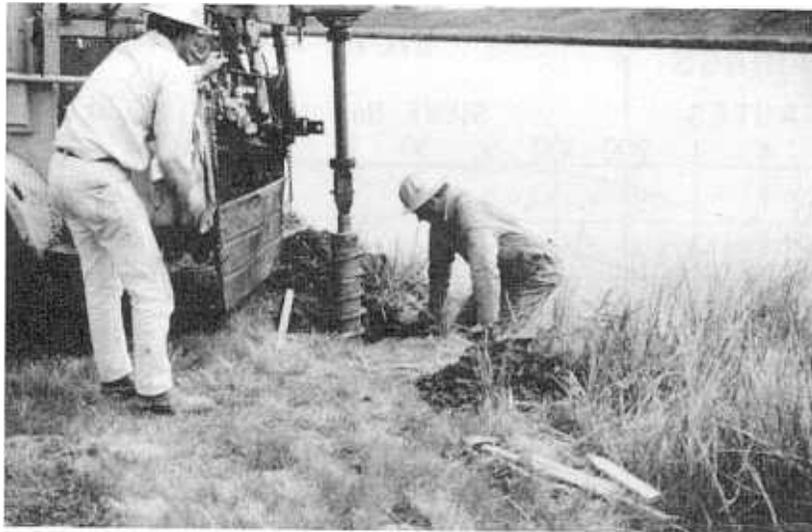
Figure A-7. – Delta-Mendota Canal at station 5049+50 after 14 years of service. Drillers are obtaining undisturbed, hollow-stem auger samples from the top of the lining for unit weight measurements. March 1965. P214-D-63660.

Unit weight tests were performed by Bureau personnel using the sand cone method (des. E-24 of [4]). Although the same test procedure was used, minor variations (± 2 lbf/ft³ (0.3kN/m³)) in unit weight of a soil are expected from different technicians and even from the same technician under different soil conditions. A hollow-stem auger sampler was used for unit weight tests in the side slope lining of the water-filled Delta-Mendota Canal (fig. A-7).

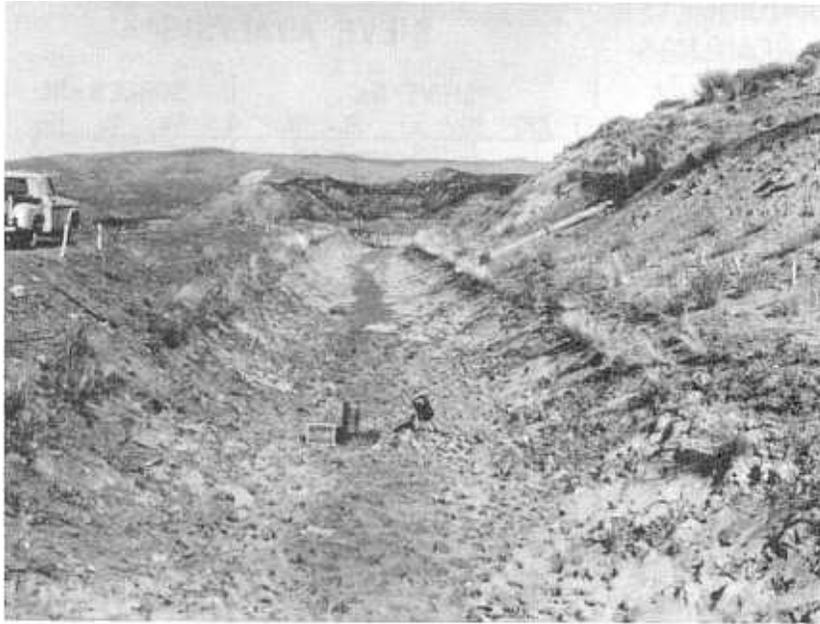
Figure A-9. – Southside Canal at station 635+65. Unit weight test being performed in canal bottom. Note the numerous cattle tracks.

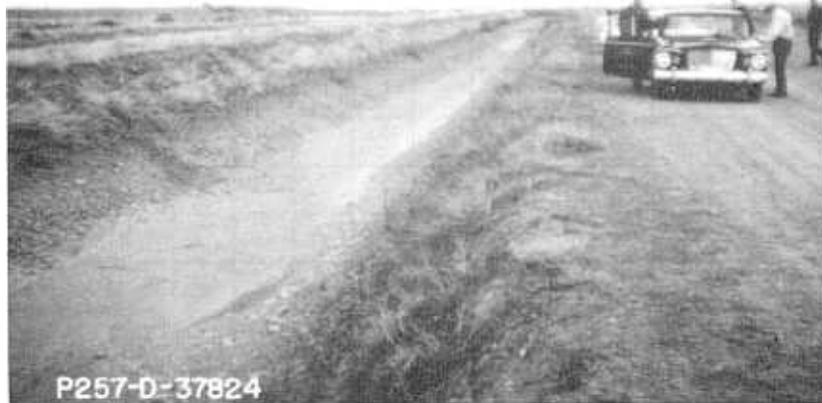
Figure A-12. – Hudson Canal near stations 470+00 to 485+00. Seepage through the lining has damaged adjacent farmland. March 1963. CTP 257-D-37824.

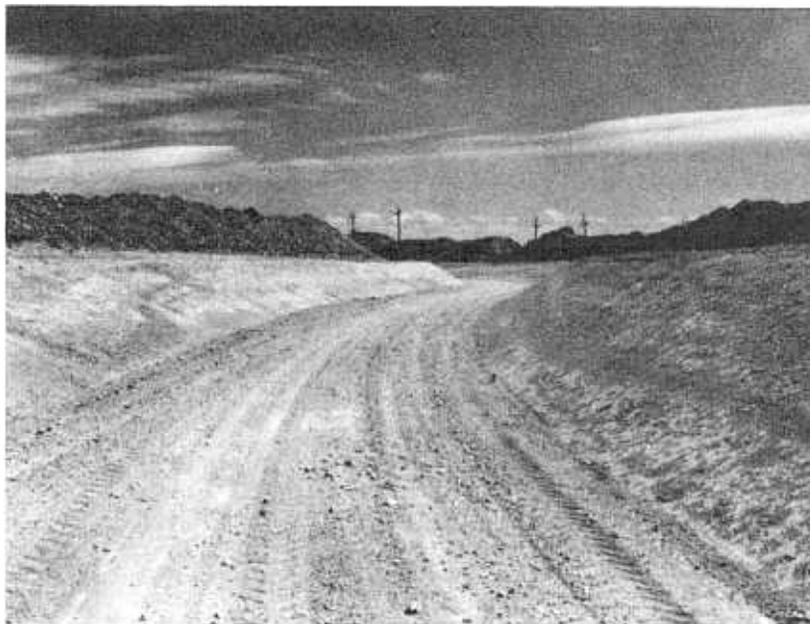
Figure A-17. — Newly-constructed soil lining at station 763+00 in the Helena Valley Canal. August 1958. P596-600-810.

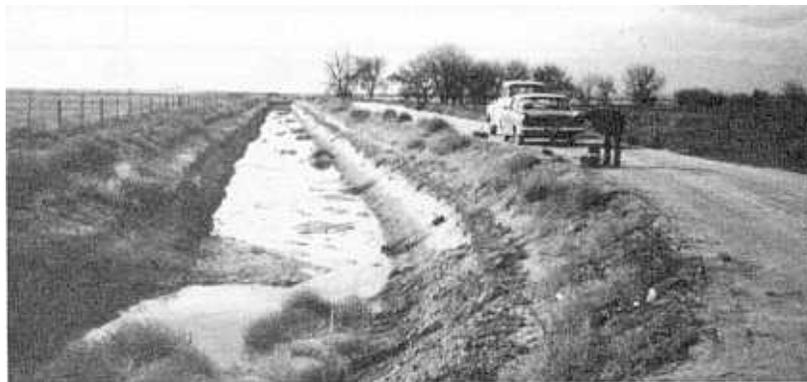
Figure A-22. – Lining test site between stations 1474+98 and 1477+48 on the South Platte Supply Canal after 6 years of canal operation. November 1962. CTX-D-36555.

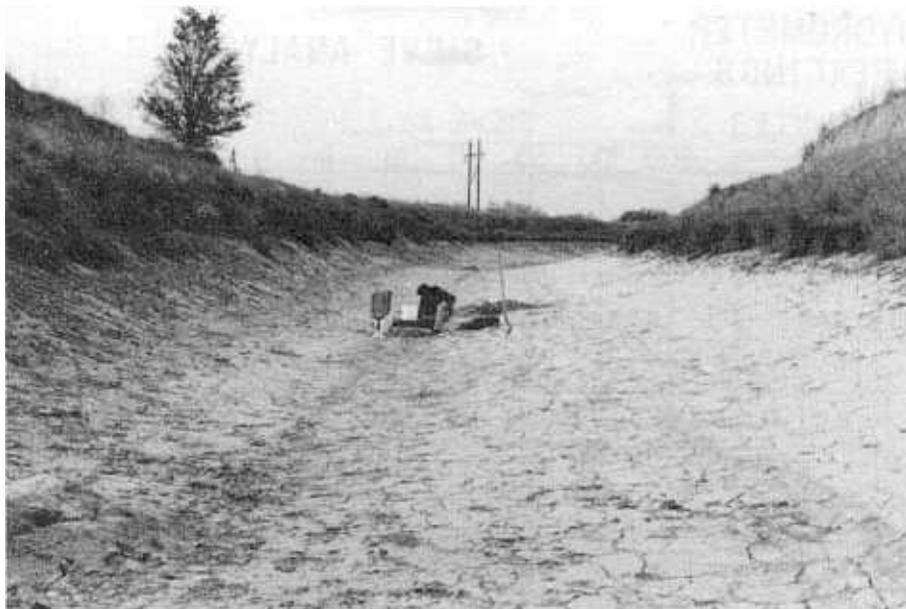
Figure A-26. – Sand cone unit weight test at station 383+20 on Culbertson Canal. The cracks in the soil surface are in sediment. October 1981.

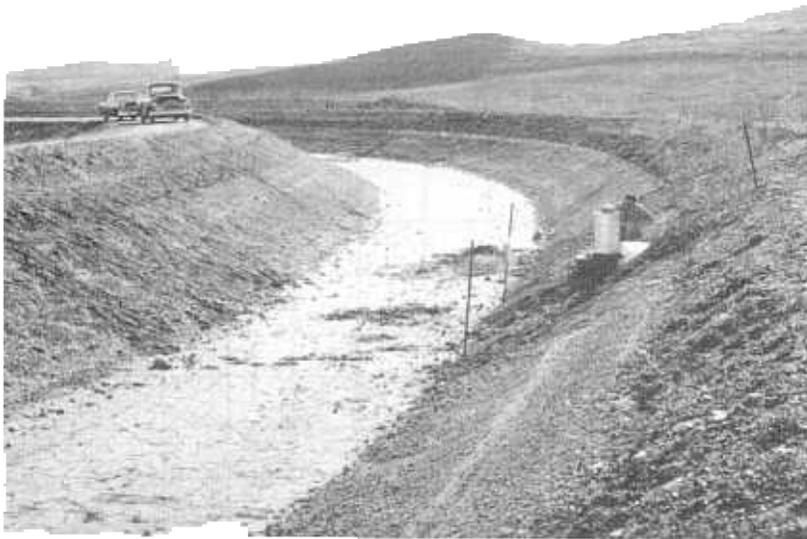
Figure A-30. – Field permeability test in side slope lining of Upper Meeker Canal at station 723+70. November 1958. P328-701-7491.

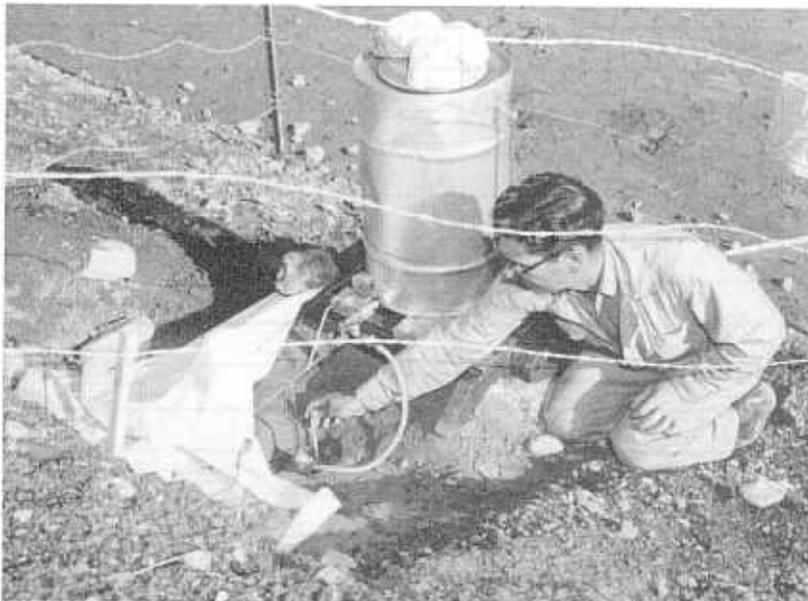
Figure A-31. – Closeup of shallow-well test in Upper Meeker Canal. See Figure A-30. November 1958. Technician is measuring water temperature in the well. The barbed wire fence is to prevent possible disturbance of the equipment by cattle. P328-701-7492.
