CONCRETE PERFORMANCE IN GRAND COULEE FOREBAY DAM, WASHINGTON: 1-YEAR CORE REPORT

*Concrete and Structural Branch
Division of General Research
Engineering and Research Center
Bureau of Reclamation*

*December 1977
GR-13-77*

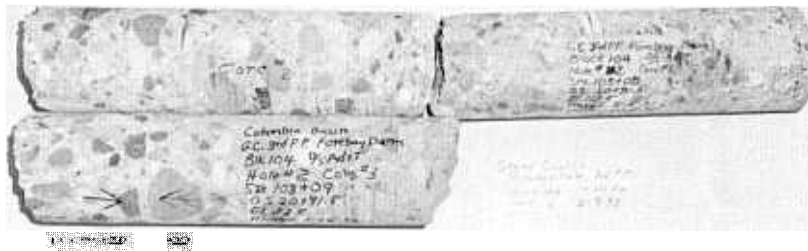
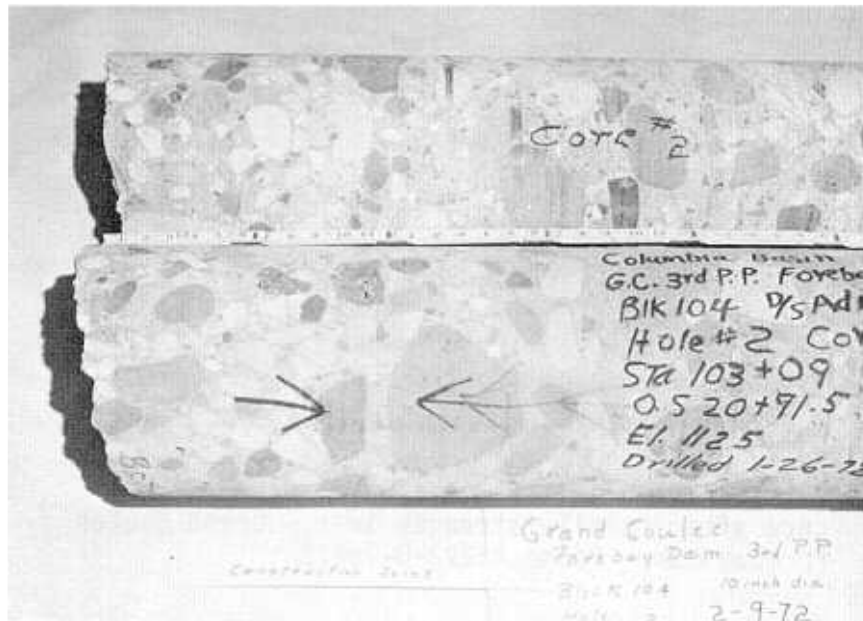
Figure 2. - Typical 255-mm (10-in) diameter cores showing a construction joint - Grand Coulee Forebay Dam.
Photos P1222-D-78276 and P1222-D-78277

In the Denver laboratories, the cores were first logged to provide a record of specimen lengths and unusual characteristics such as embedded reinforcing steel, rock pockets, construction joints, etc. The cores were then marked for the type of test to be conducted. Photographs were taken of the cores in groups and individually as needed to show detail. Figures 2, 3, and 4 are photographs of some typical specimens.

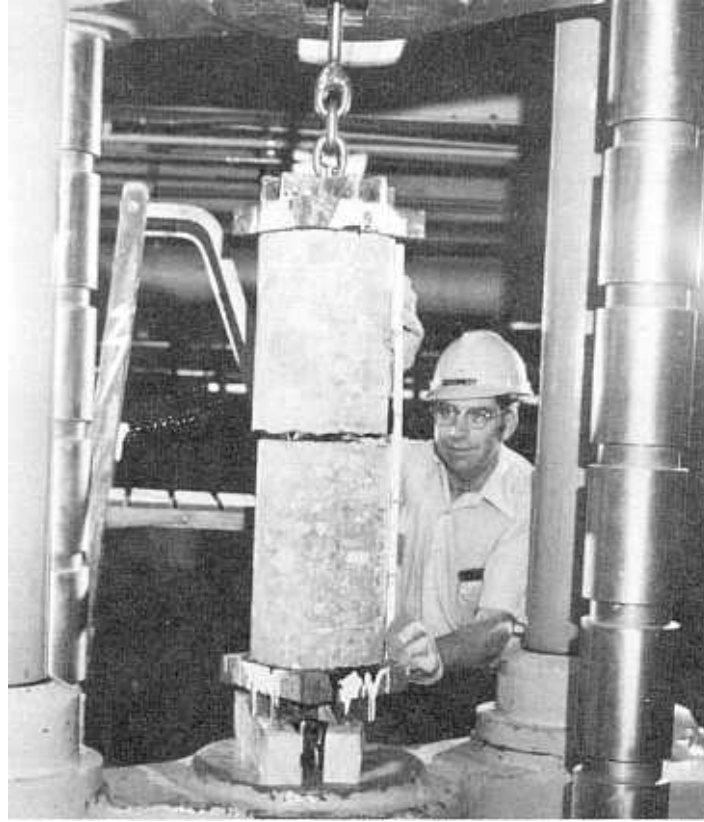
Figure 3. - Typical 255-mm (10-in) diameter core after tensile strength test - Grand Coulee Forebay Dam. Photo P1222-D-78273

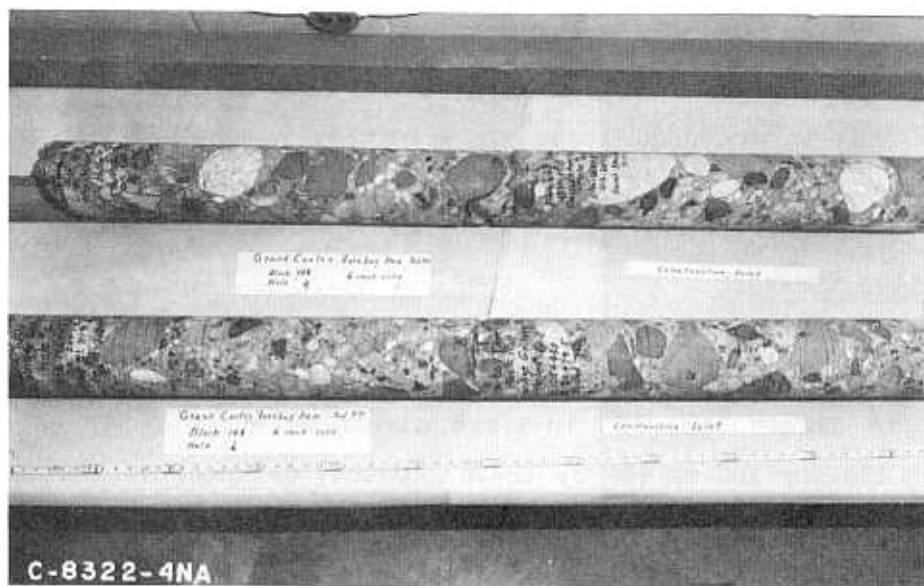
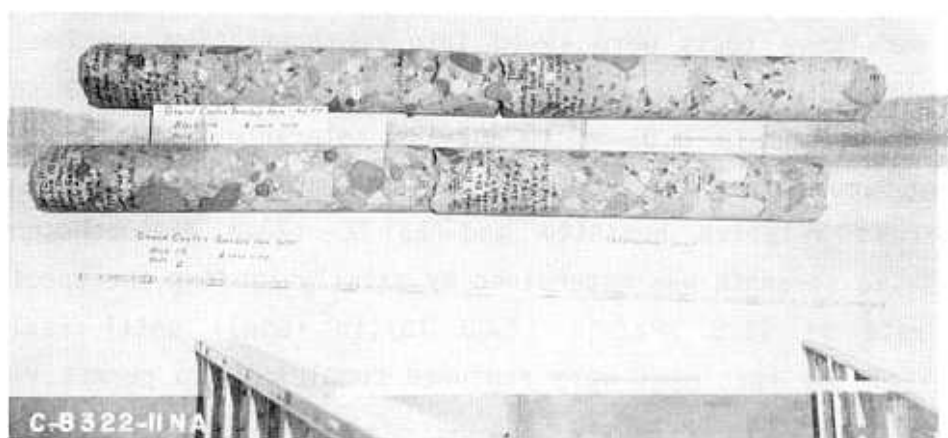
Figure 4. - Typical 150-mm (6-in) diameter cores showing construction joints - Grand Coulee Forebay Dam. Photos P1222-D-78274 and P1222-D-78275

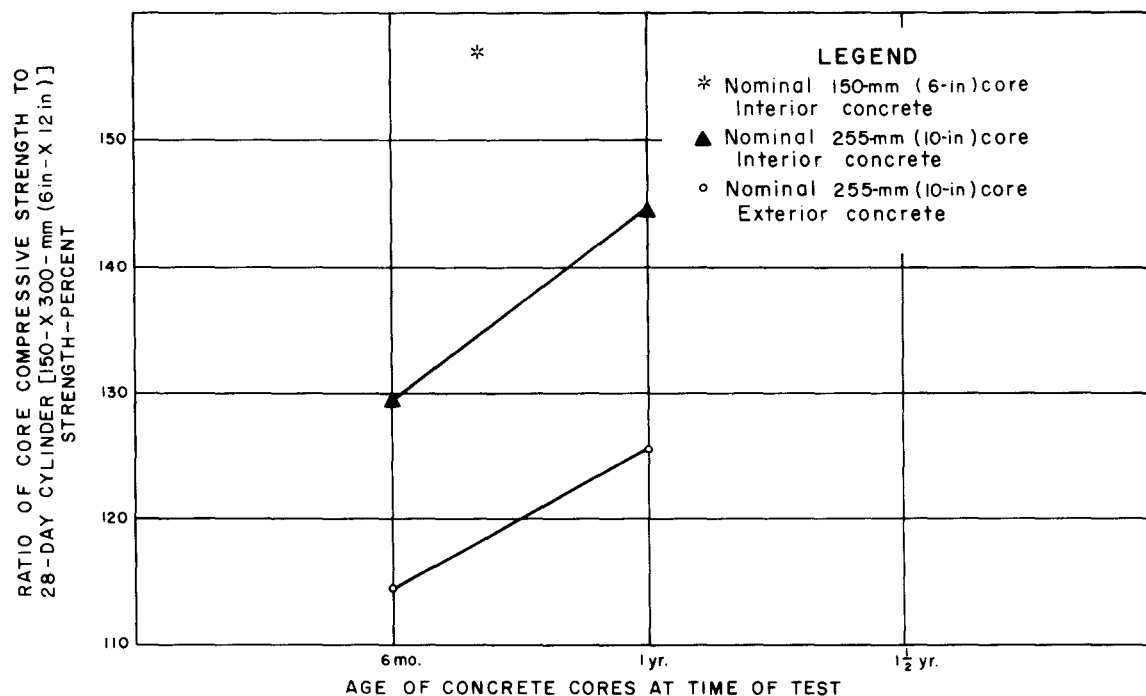
Figure 5. - Comparison of compressive strength of concrete cores and control cylinders, Grand Coulee Forebay Dam.

In general, compressive strength development of the cores was in direct correlation with that of the 28-day control cylinders, with an overall ratio of core strength to 28-day control cylinder strength of 121 percent at 6 months' age and 135 percent at 1 year's age. The strength ratio was higher for interior concrete than for exterior concrete at both 6 months' and 1 year's age. For several of the core specimens there were no 28-day control cylinder strengths available for comparison. For some reason, 6 of the 13 cores extracted from exterior concrete and tested at 6 months' age had compressive strengths below the control cylinder strengths. However, cores extracted from approximately the same locations and tested at 1 year's age did not reflect this trend. The comparisons between core strengths and the 150- by 300-mm (6- by 12-in) control cylinders are shown graphically on figure 5.

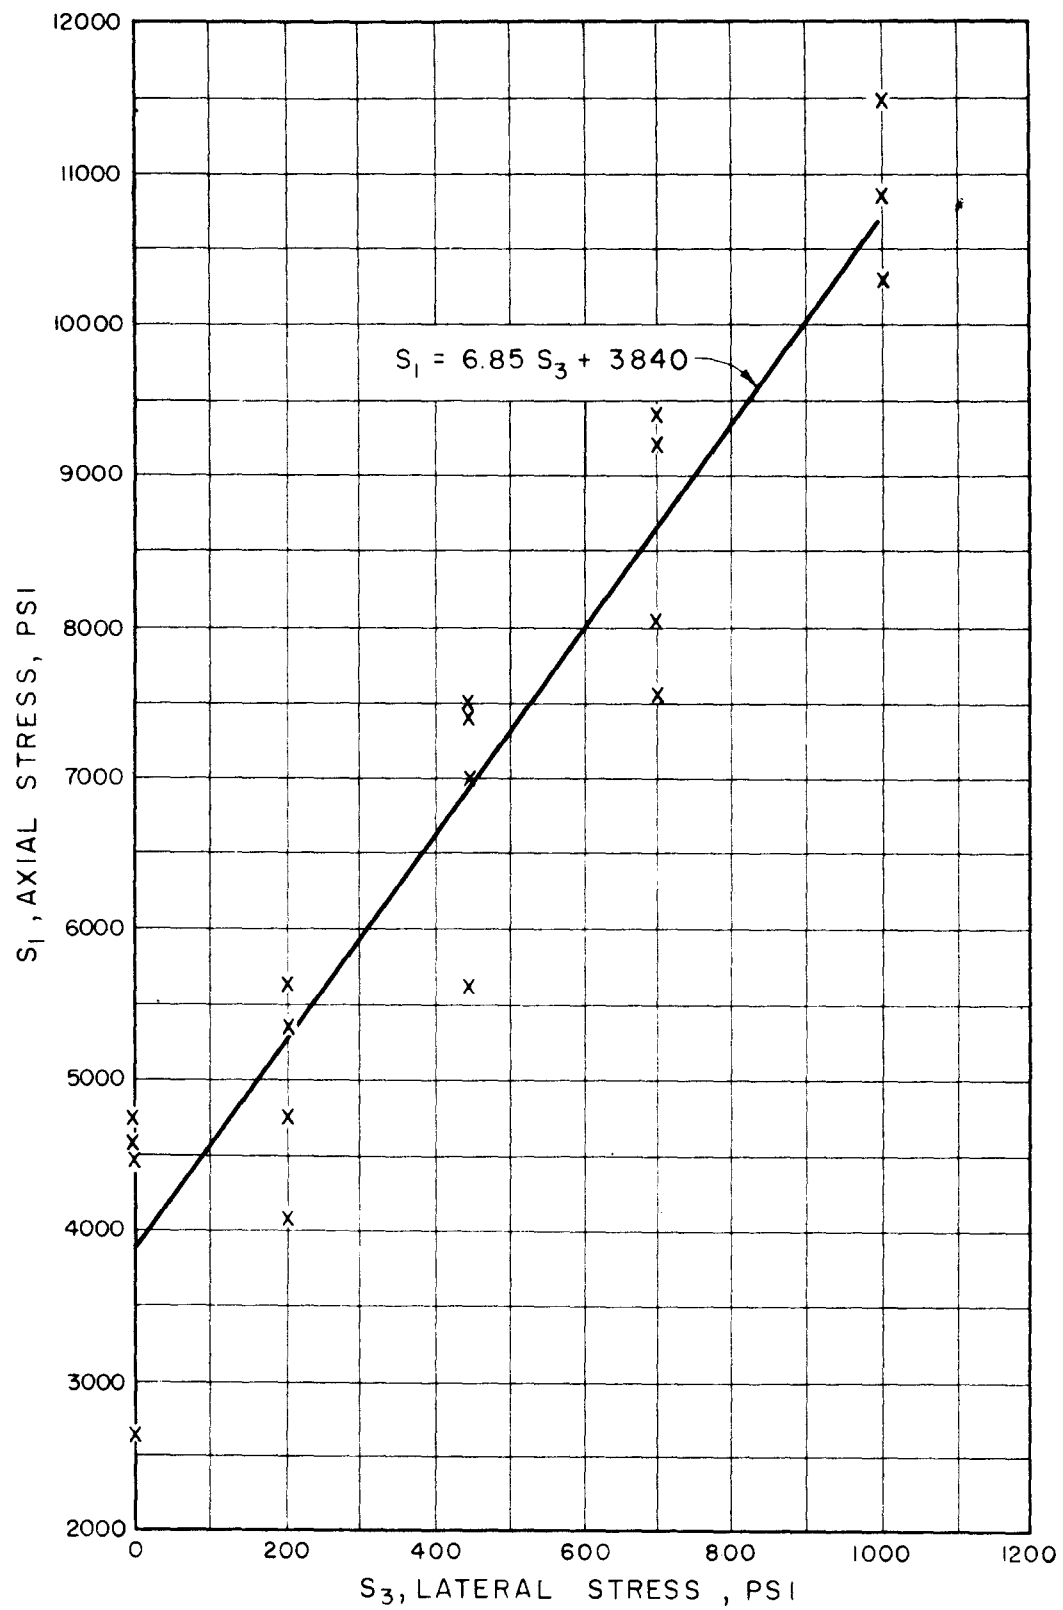
PRINCIPAL STRESS RELATIONSHIP
FOR GRAND COULEE FOREBAY DAM CONCRETE
JOINTED CORES - AIR DRY

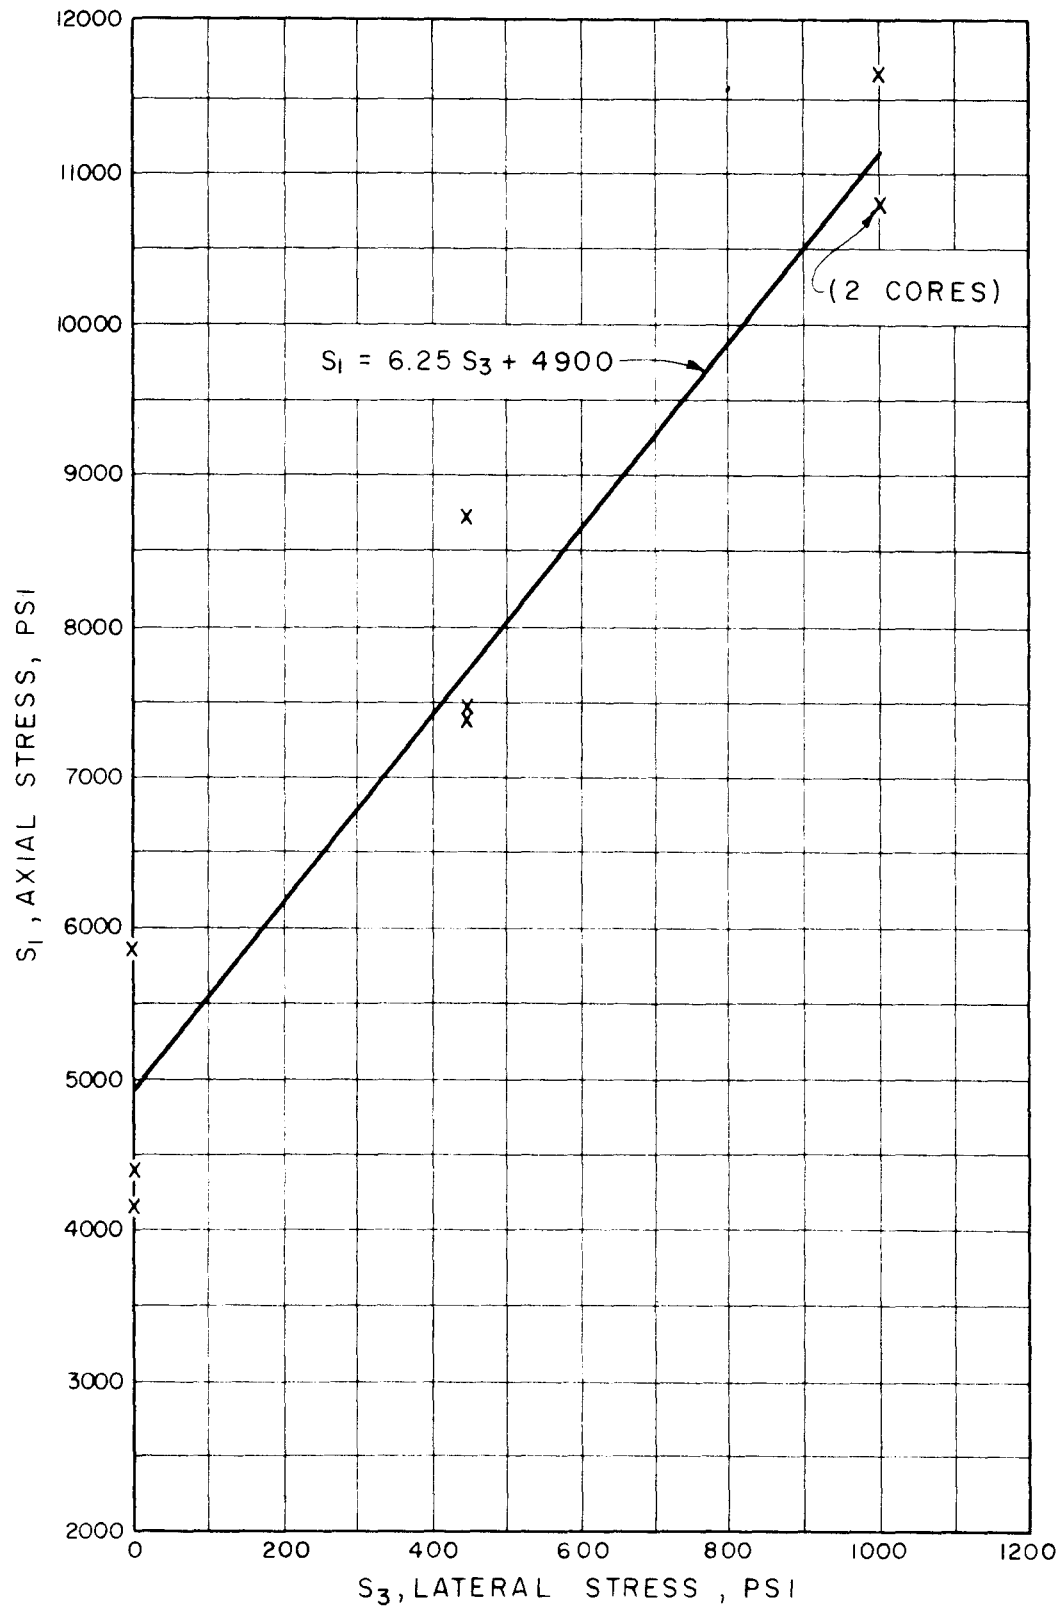
PRINCIPAL STRESS RELATIONSHIP
FOR GRAND COULEE FOREBAY DAM CONCRETE
UNJOINTED CORES - AIR DRY

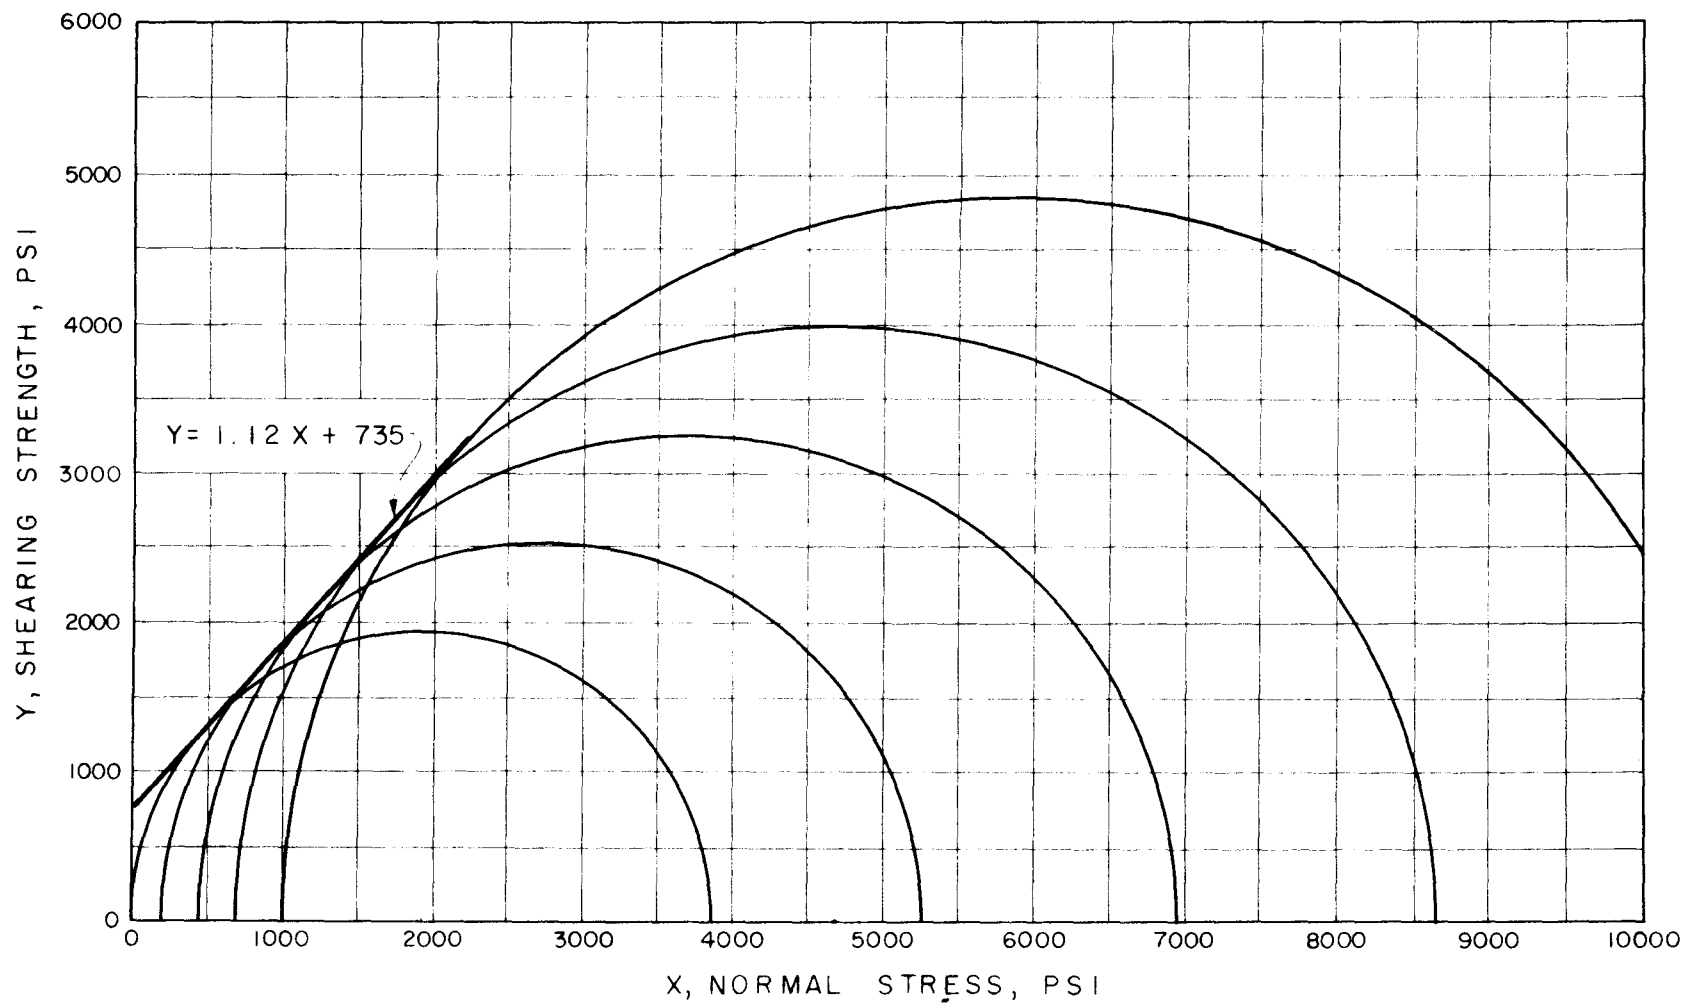
MOHR'S DIAGRAM FOR GRAND COULEE FORBAY DAM CONCRETE
JOINTED CORES - AIR DRY

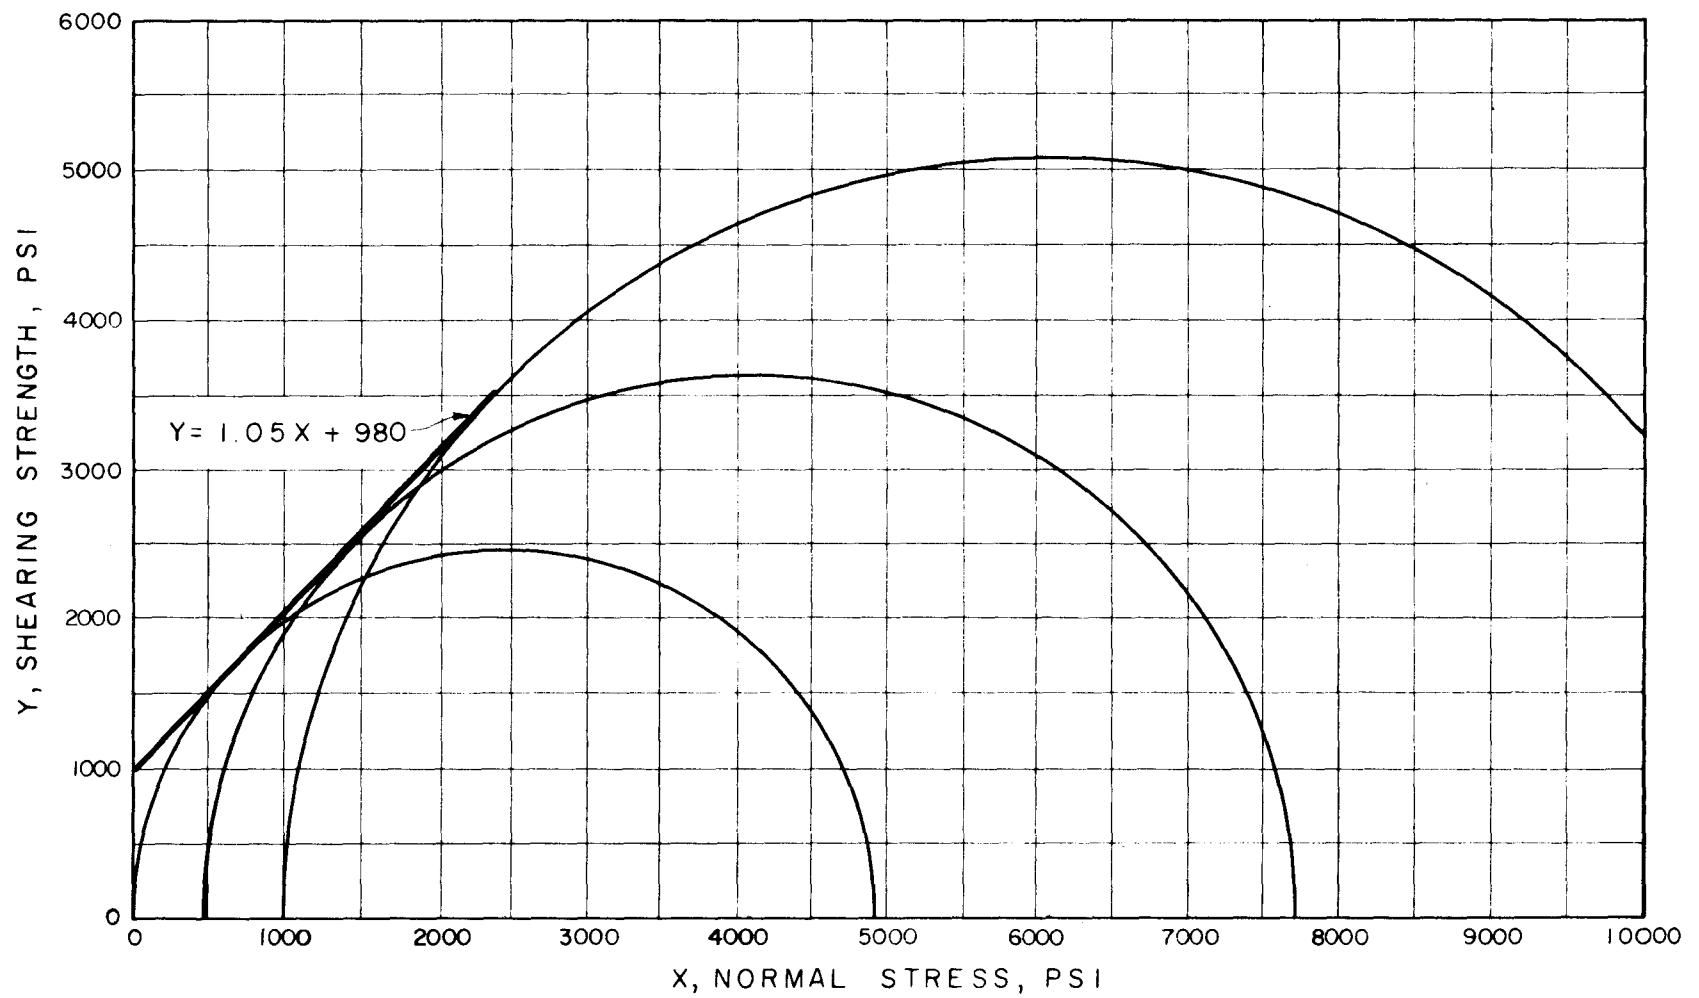
MOHR'S DIAGRAM FOR GRAND COULEE FORBAY DAM CONCRETE
UNJOINTED CORES - AIR DRY

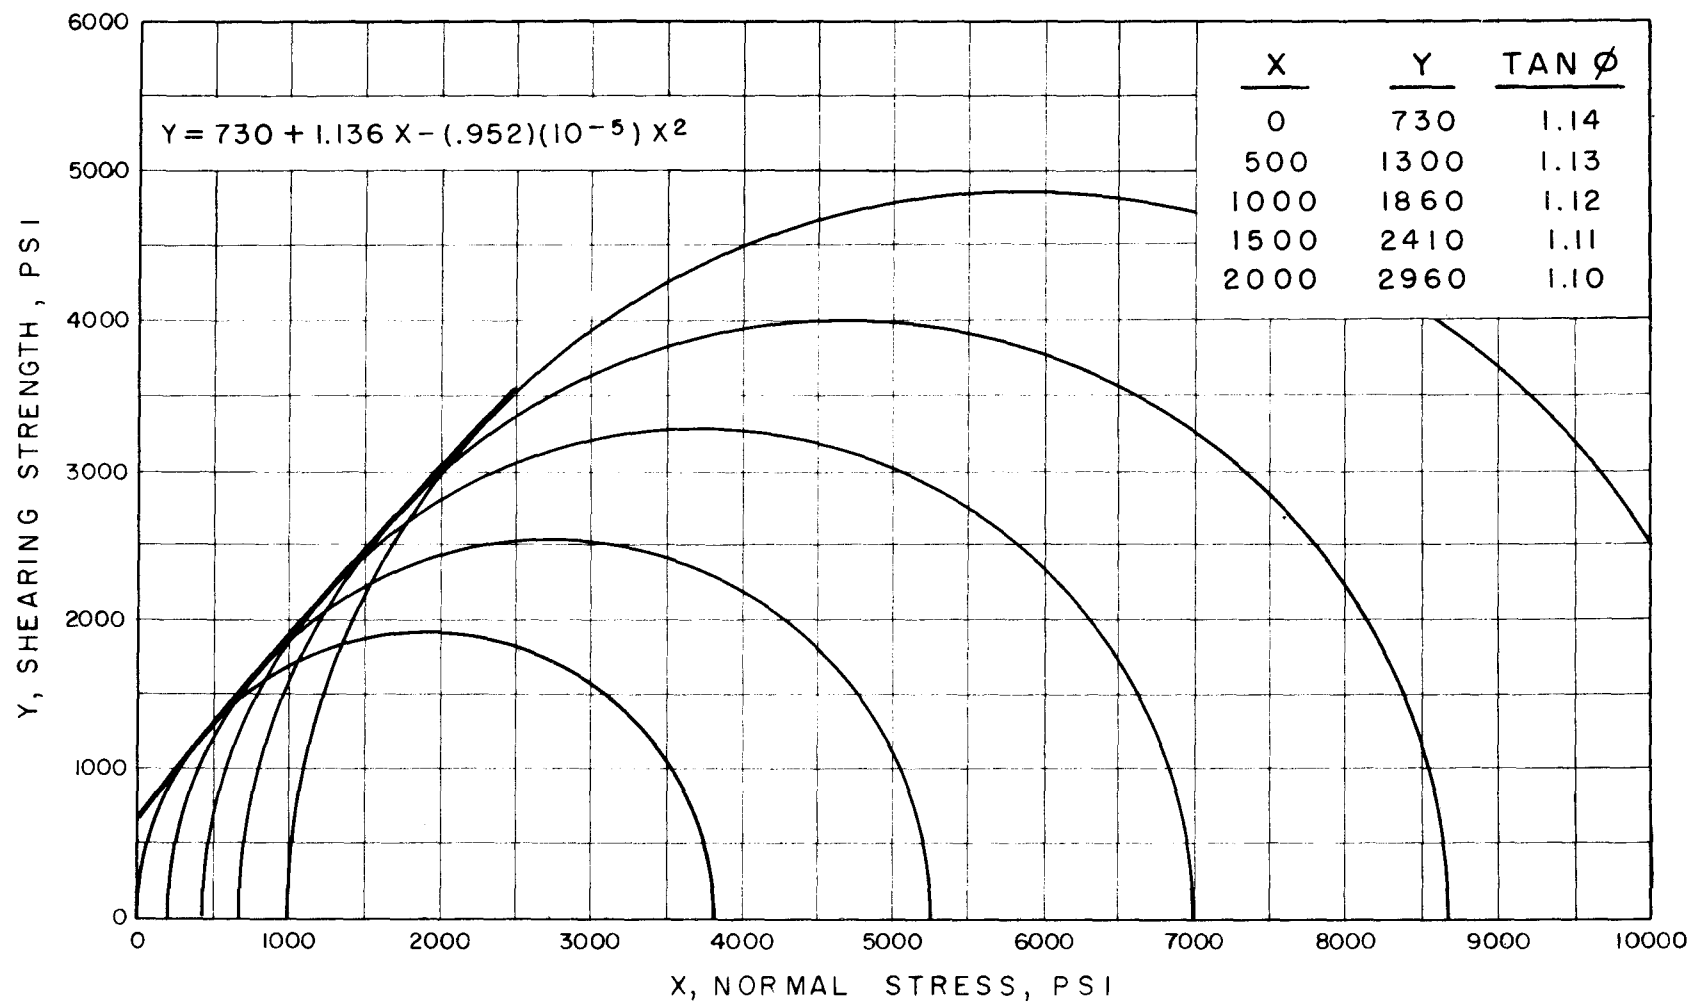
MOHR'S DIAGRAM FOR GRAND COULEE FORBAY DAM CONCRETE
JOINTED CORES - AIR DRY
(CURVED SOLUTION)

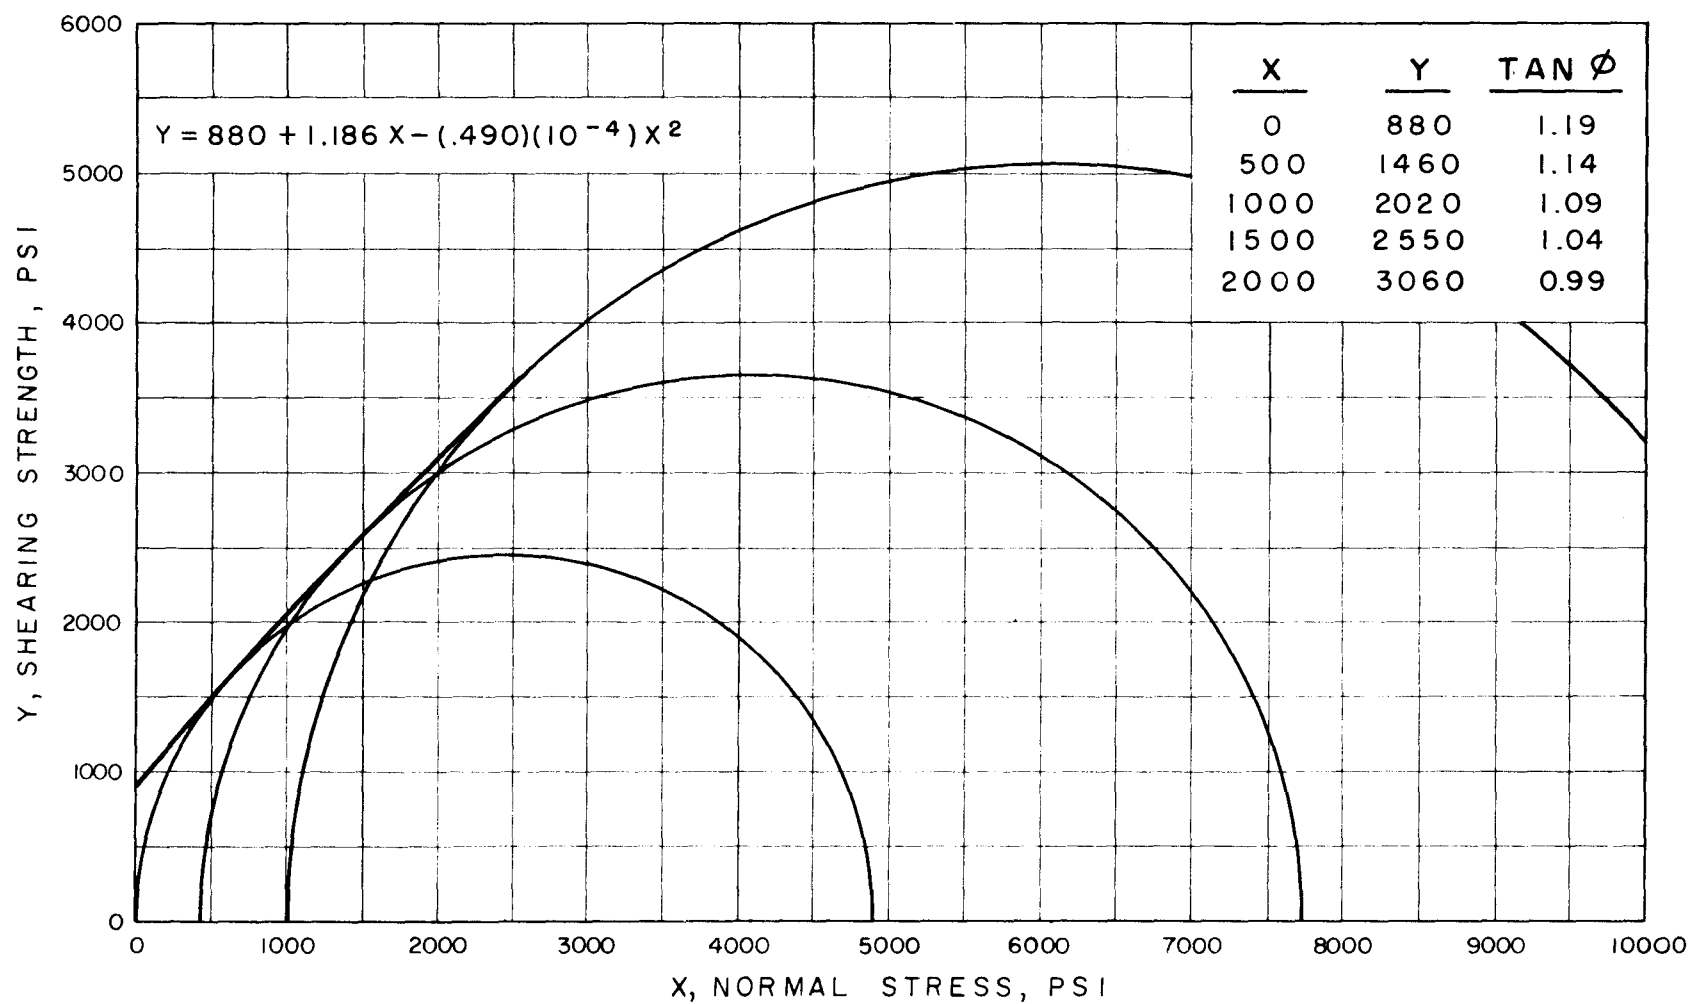
MOHR'S DIAGRAM FOR GRAND COULEE FORBAY DAM CONCRETE
UNJOINTED CORES - AIR DRY
(CURVED SOLUTION)

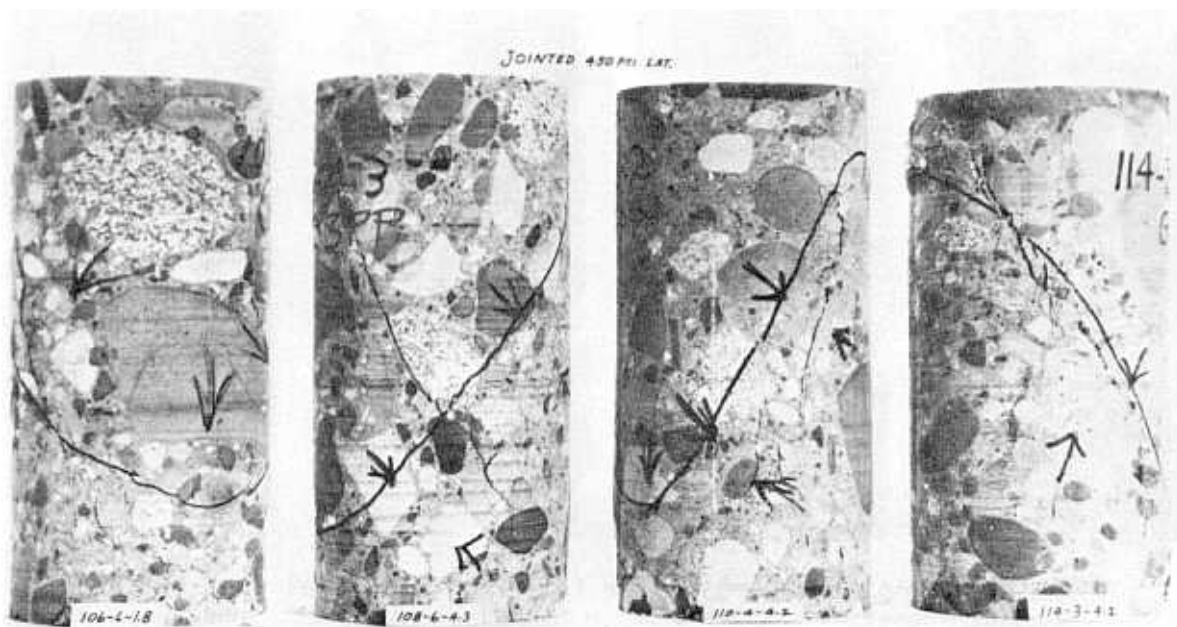
Figure 9. - Jointed cores after failure in triaxial test at 450-lb/in^2 lateral pressure.

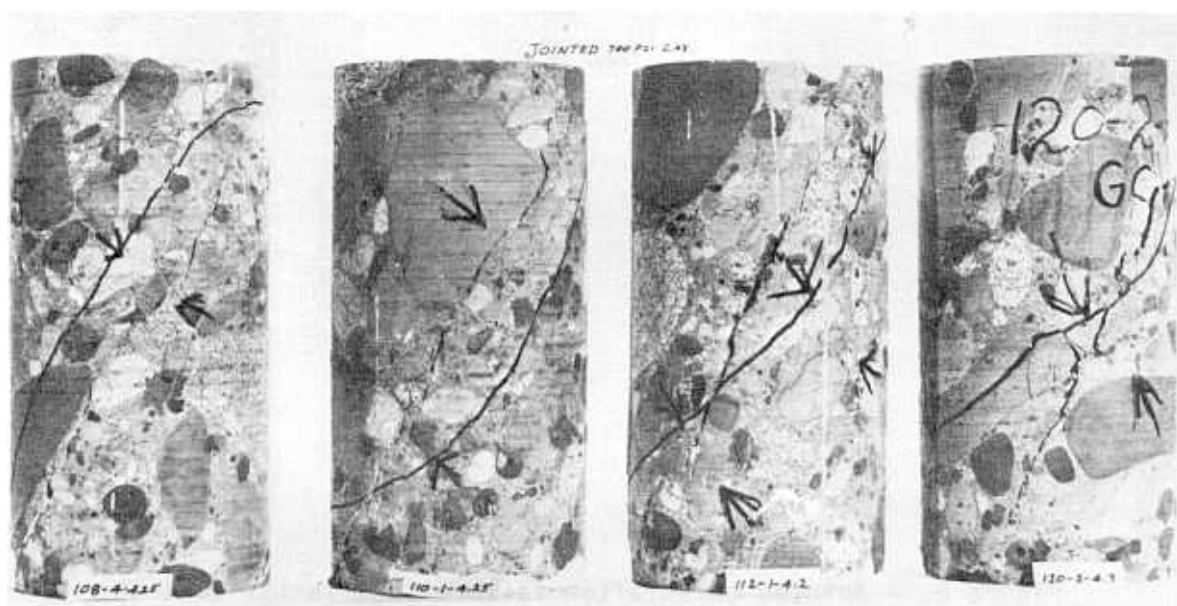
Figure 10. - Jointed cores after failure in triaxial test at 700-lb/in^2 lateral pressure.

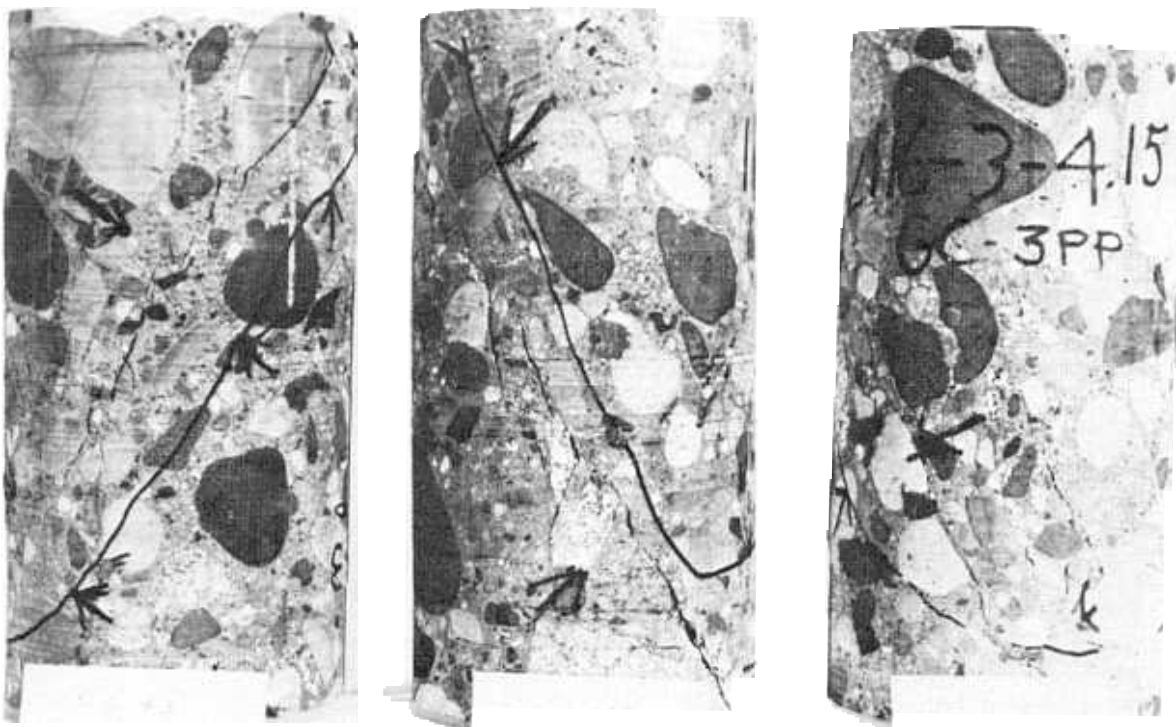
Figure 11. - Jointed cores after failure in triaxial test at 1,000 lb/in² lateral pressure.

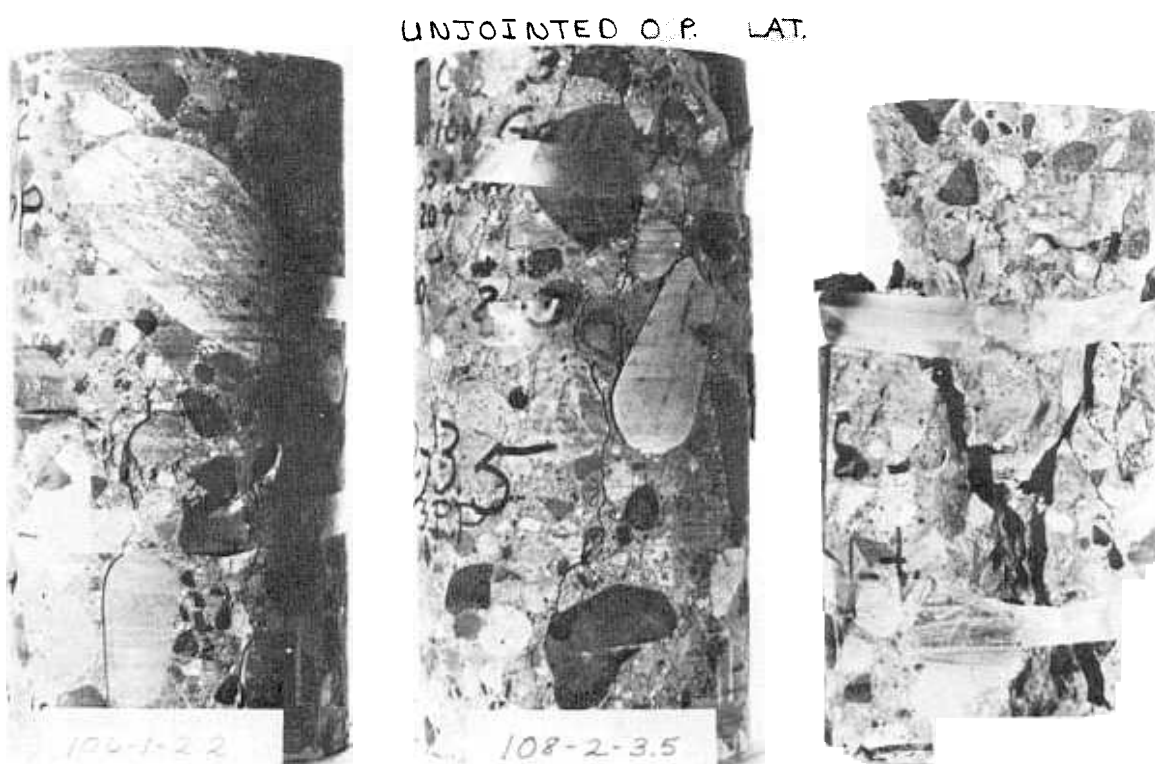
Figure 12. - Unjointed cores after failure in uniaxial compression test.

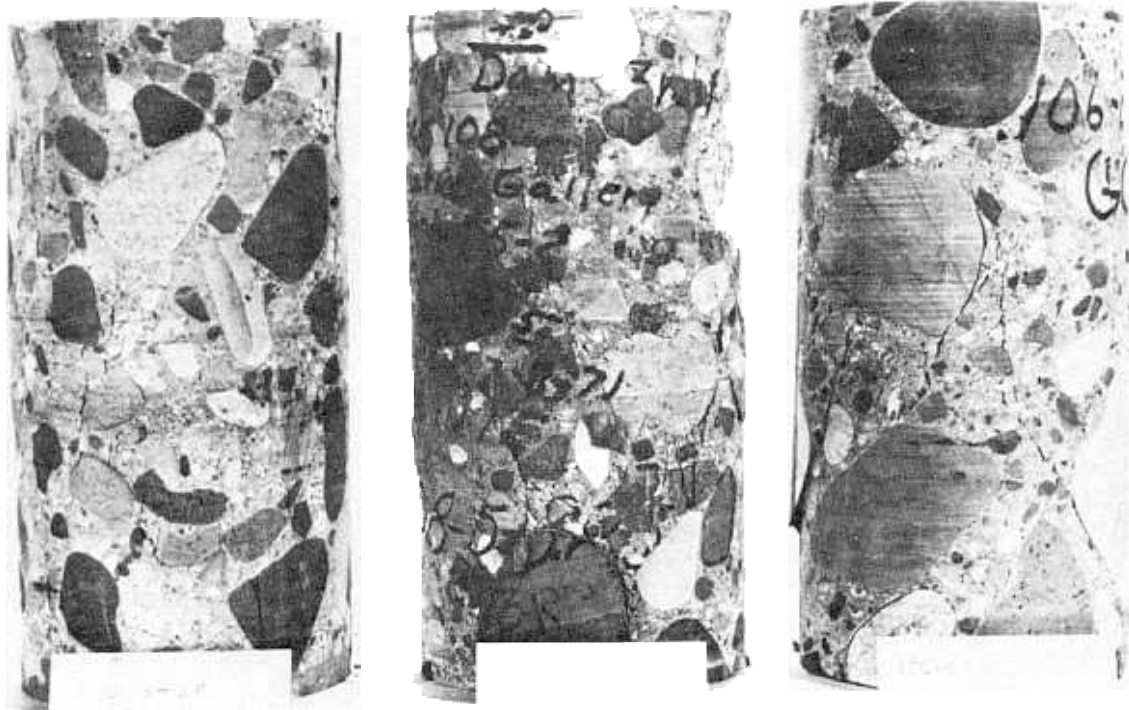
Figure 13. - Unjointed cores after failure in triaxial test at 450-lb/in² lateral pressure.

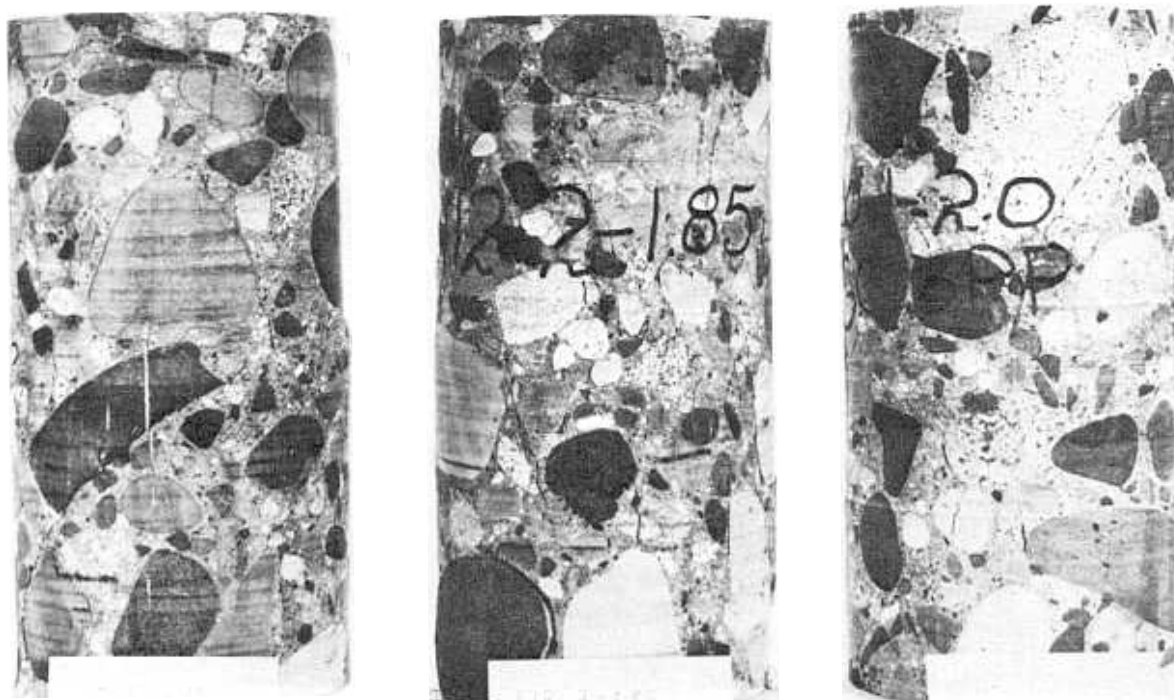
Figure 14. - Unjointed cores after failure in triaxial test at 1,000-lb/in² lateral pressure.

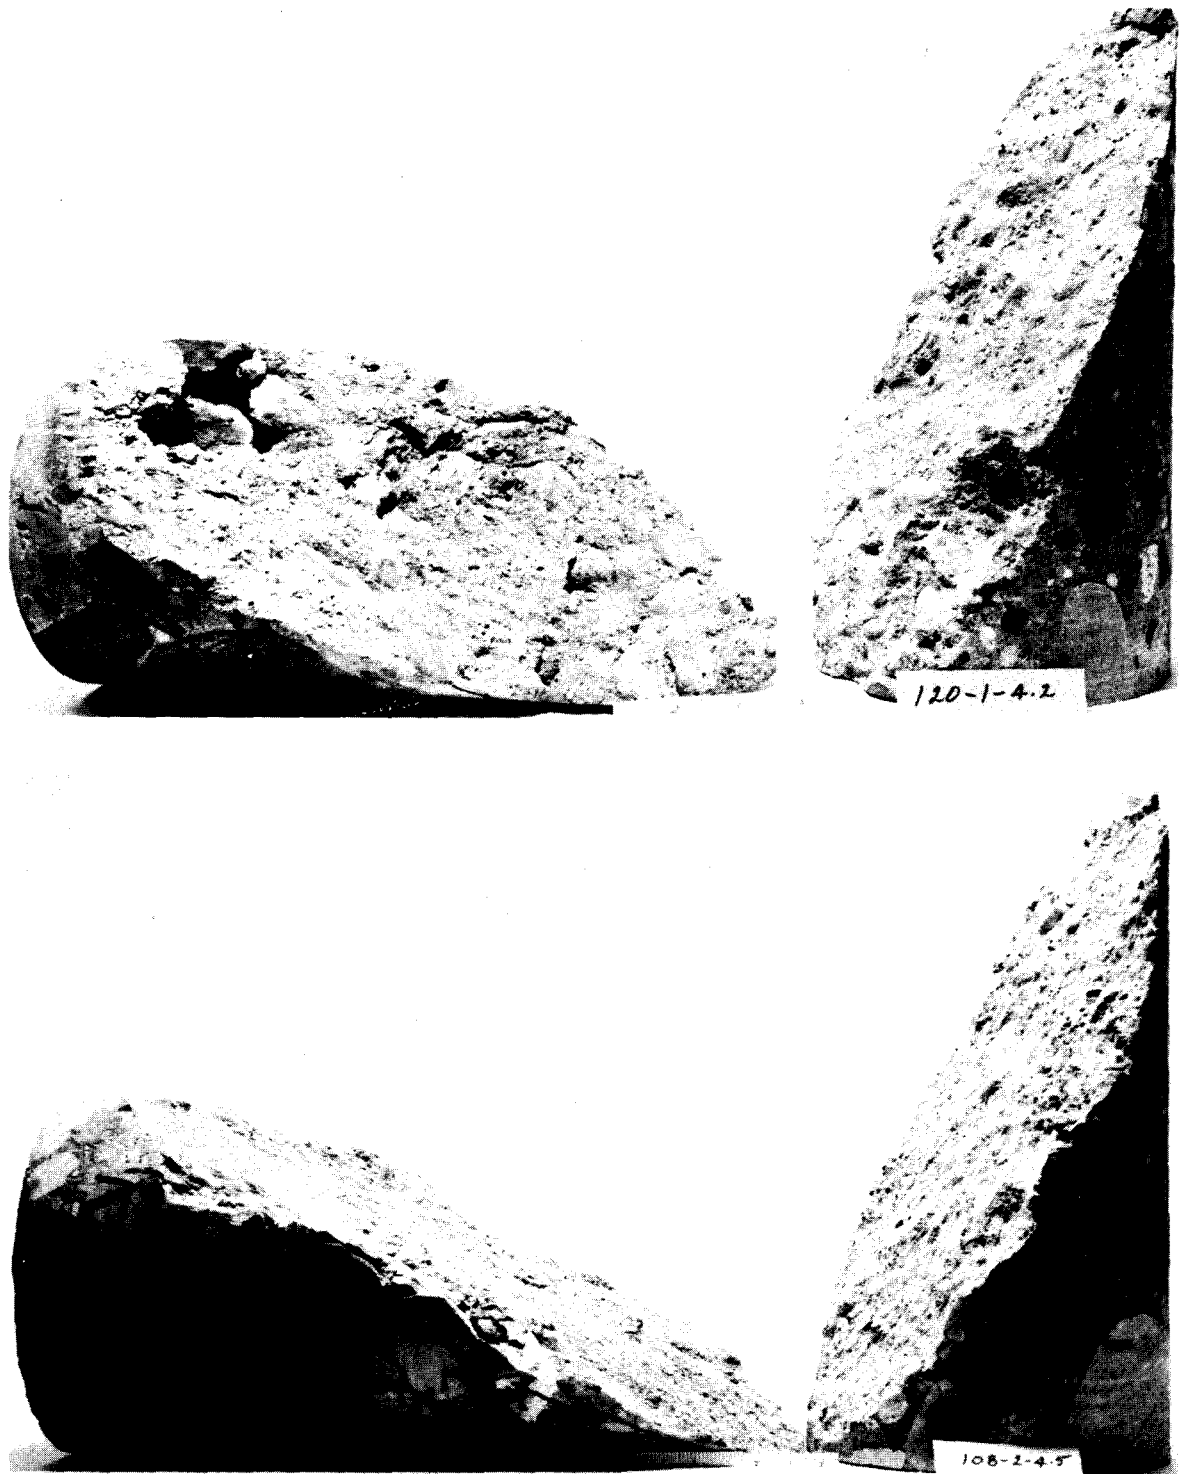
Figure 1. - Photograph of jointed concrete showing failure surface
 Top - at "0" lateral load (note hole in horizontal piece and smooth plane indicating poor bond)
 Bottom at 200 lb/in² lateral load (note smooth plane)
 C-8322-49 C-8322-54

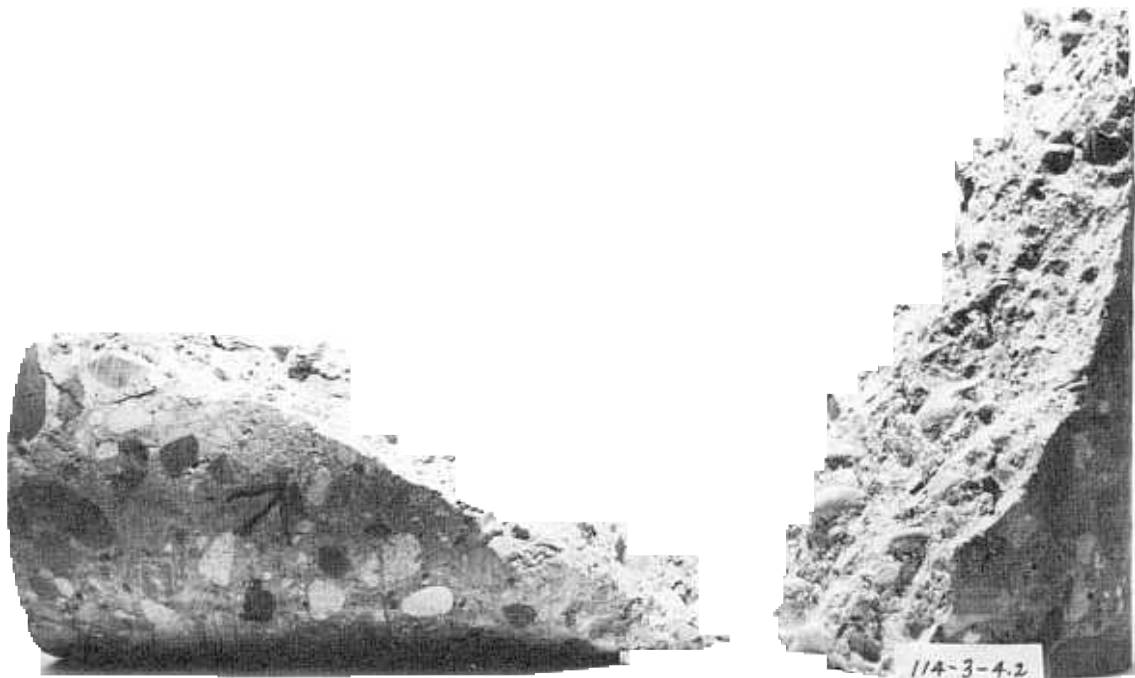
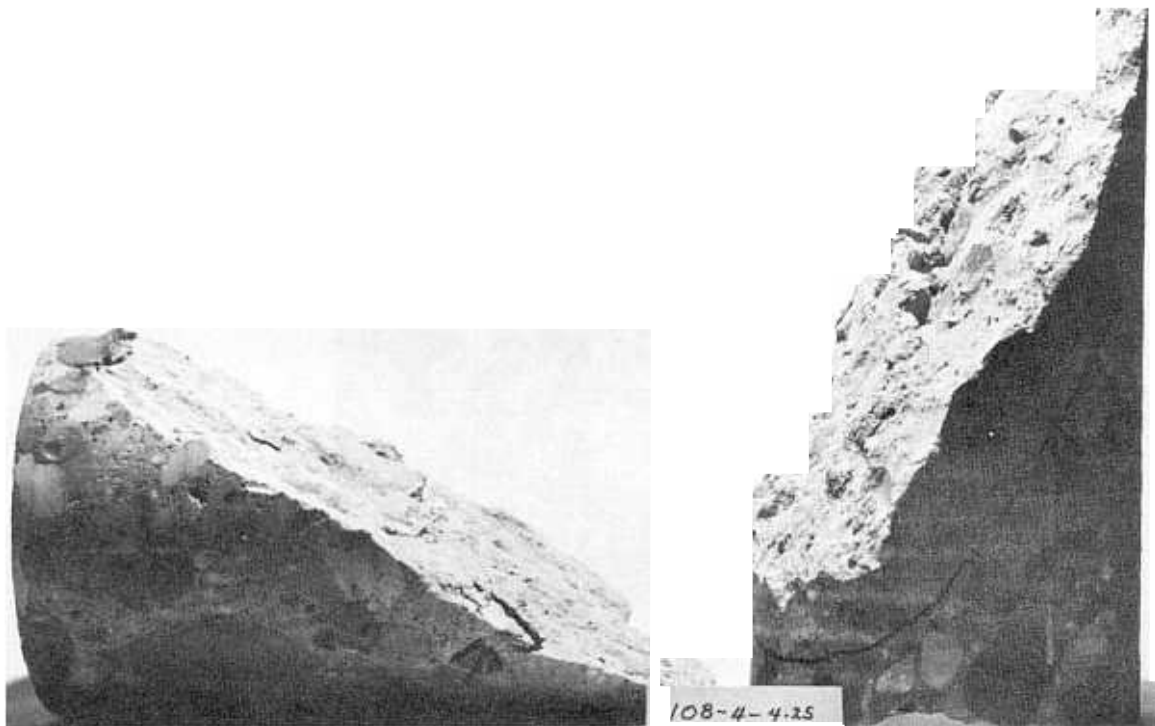
Figure 2. - Photograph of jointed concrete showing failure surface
 Top - at 450 lb/in² load (note jagged type of break)
 Bottom at 700 lb/in² load (note jagged break and hole)
 C-8322-51 C-8322-62
