CONCRETE PERFORMANCE IN GRAND COULEE FOREBAY DAM, WASHINGTON: 1-YEAR CORE REPORT

*Concrete and Structural Branch
Division of General Research
Engineering and Research Center
Bureau of Reclamation*

*December 1977
GR-13-77*

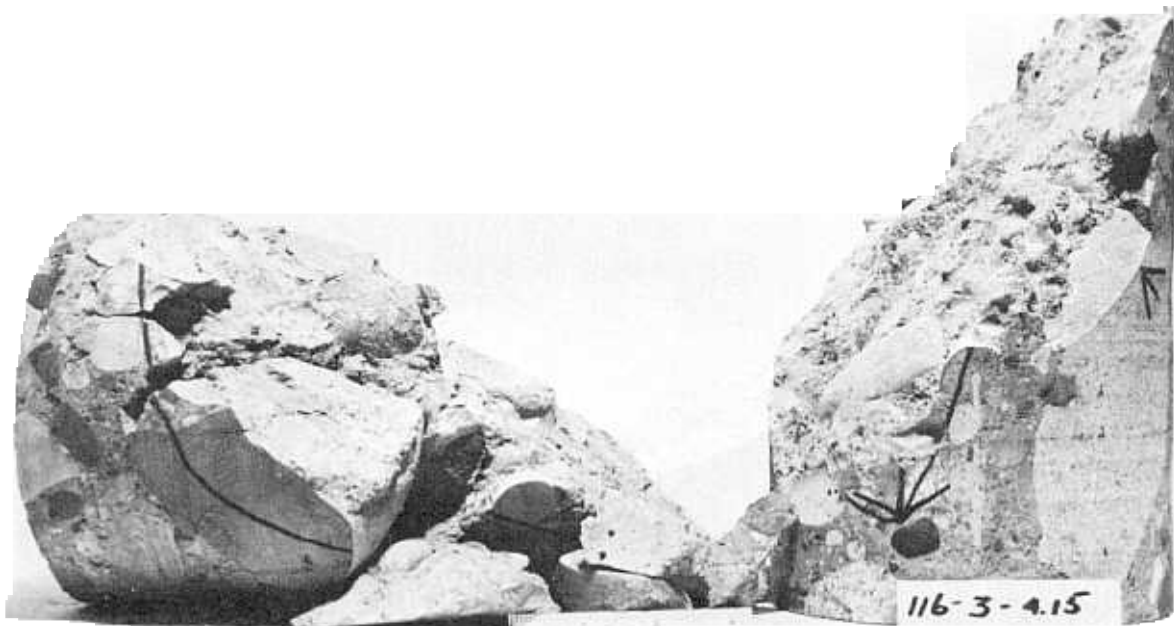
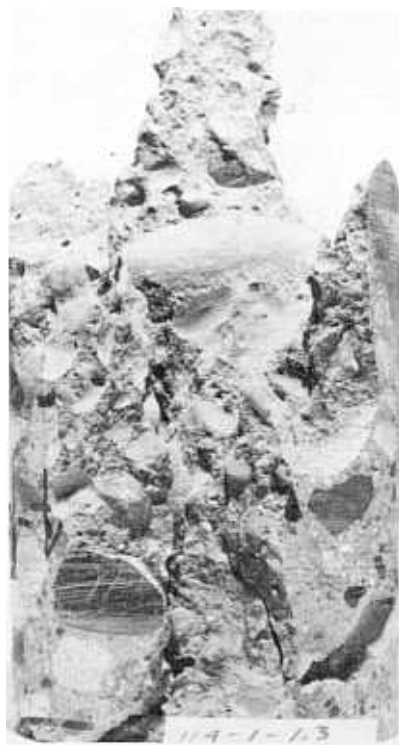
Figure 3 - Photograph of concrete showing failure surface
 Top - jointed concrete 1,000 psi lateral load (note jagged break)
 Bottom - unjointed concrete "0" lateral load (cone shaped break)
 C-8322-57 C-8322-56

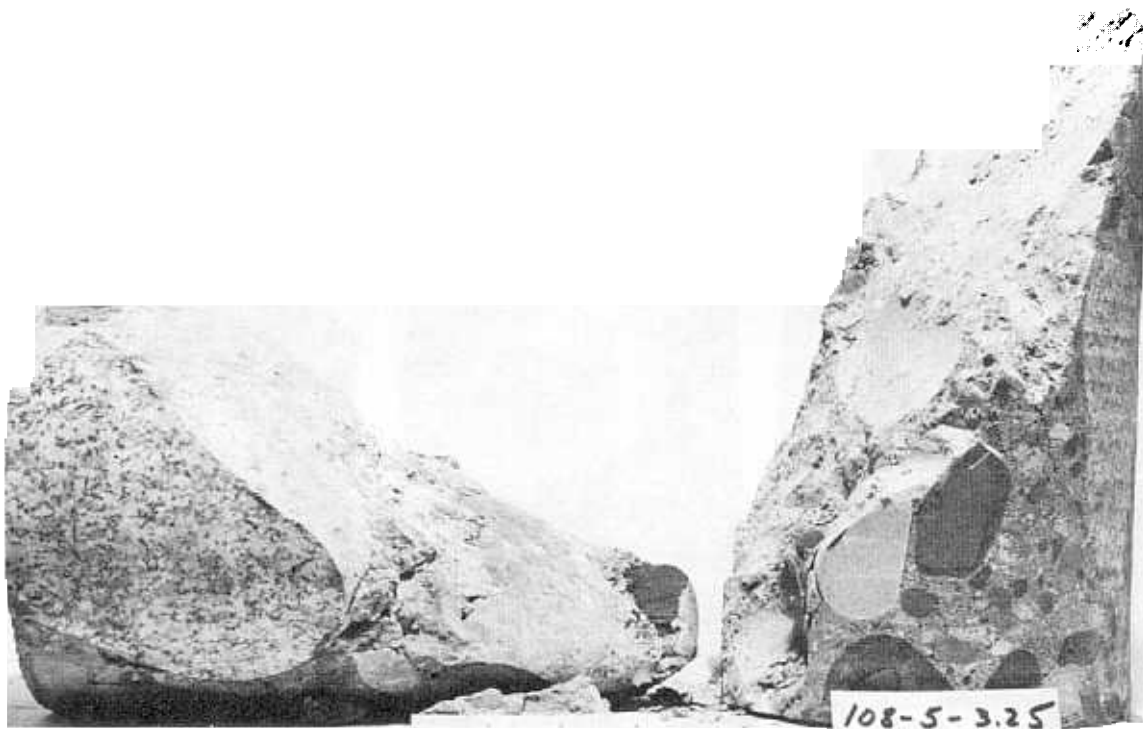
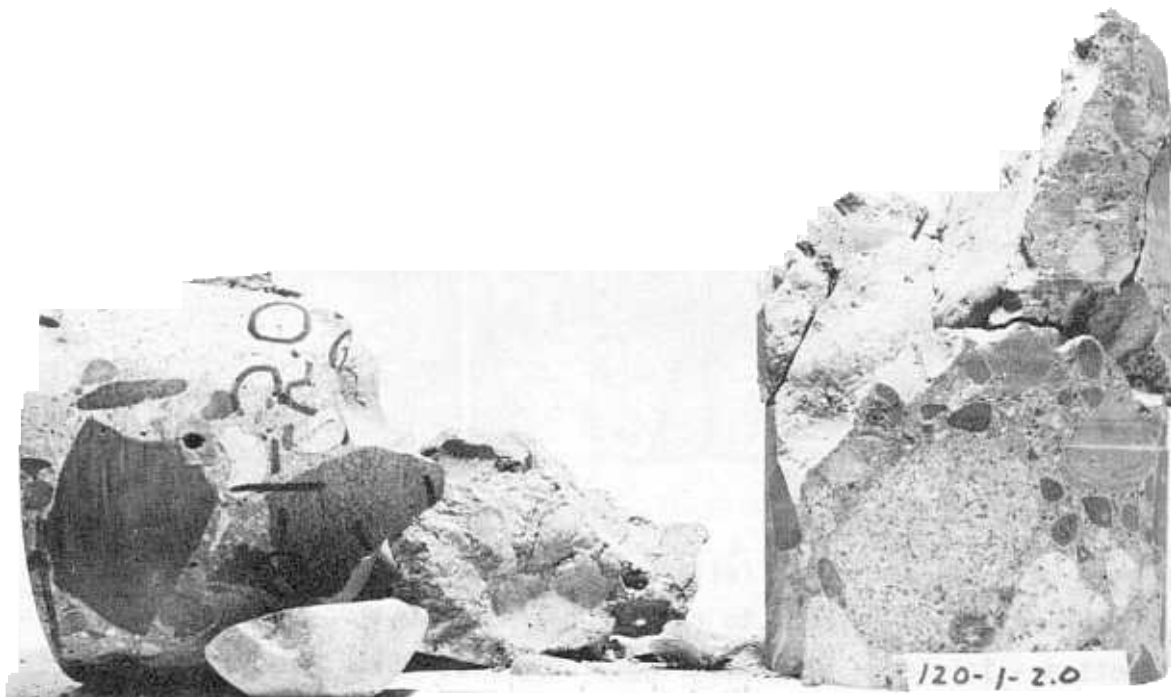
Figure 4. - Photograph of unjointed concrete showing failure surface
 Top - at 450 lb/in² lateral load (note splitting tangent to large aggregate)
 Bottom at 1,000 lb/in² lateral load (irregular break)
 C-8322-58 C-8322-59

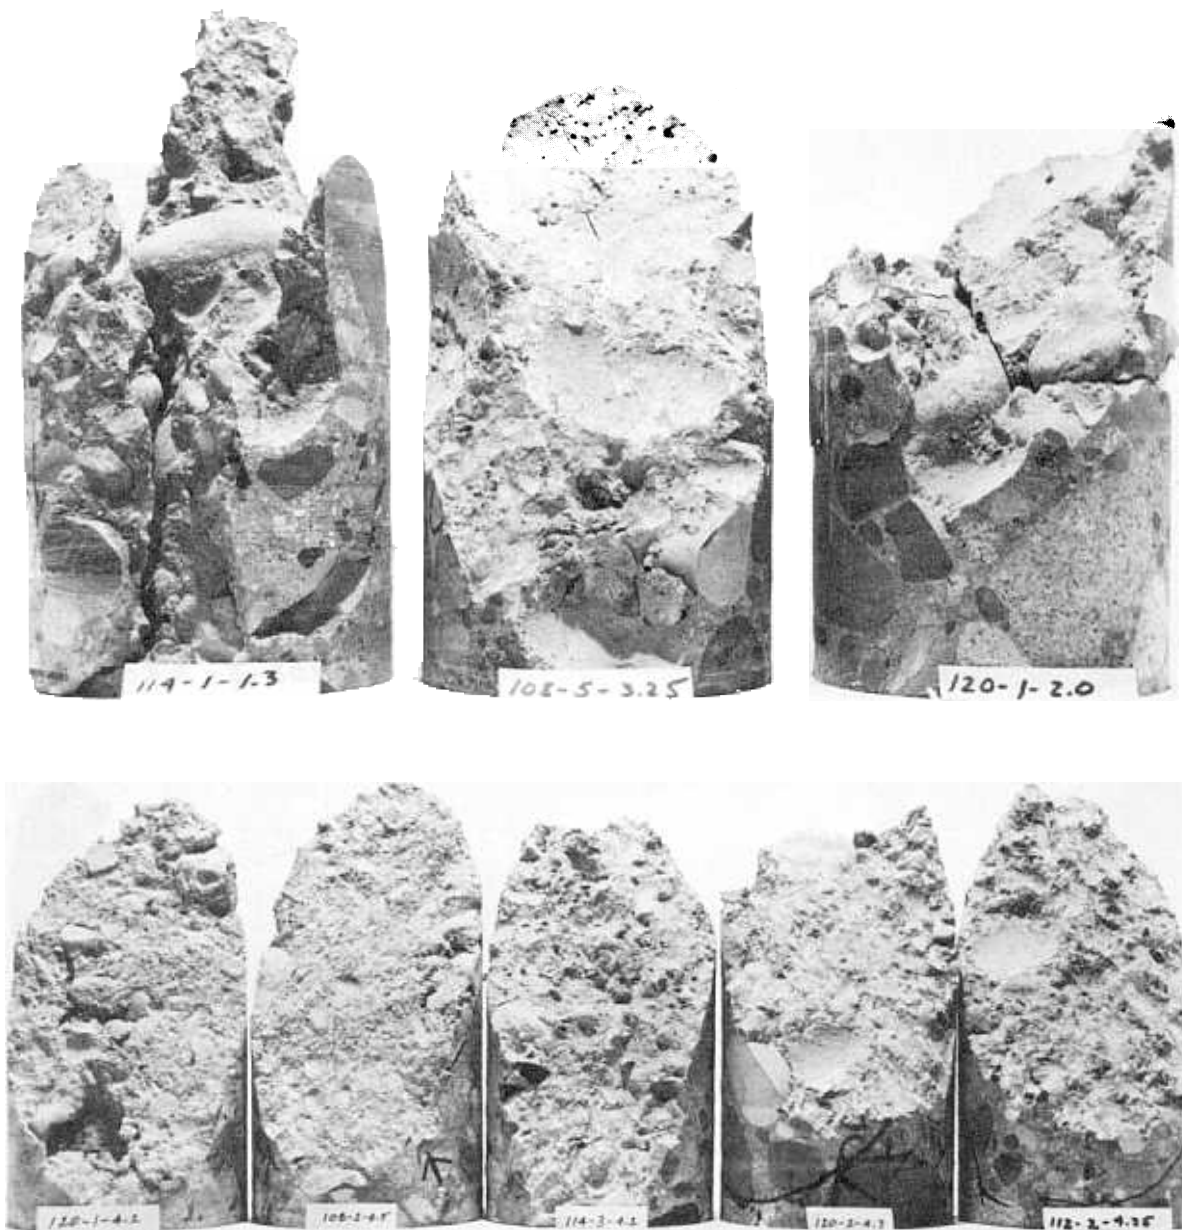
Figure 5. - Comparison of failure of unjointed and jointed concrete
 Top - unjointed - (left to right) "0", 450 and 1,000 lb/in² lateral load
 Bottom - jointed - (left to right) "0", 200, 450, 700, and 1,000 lb/in² lateral load
 C-8322-47 C-8322-48

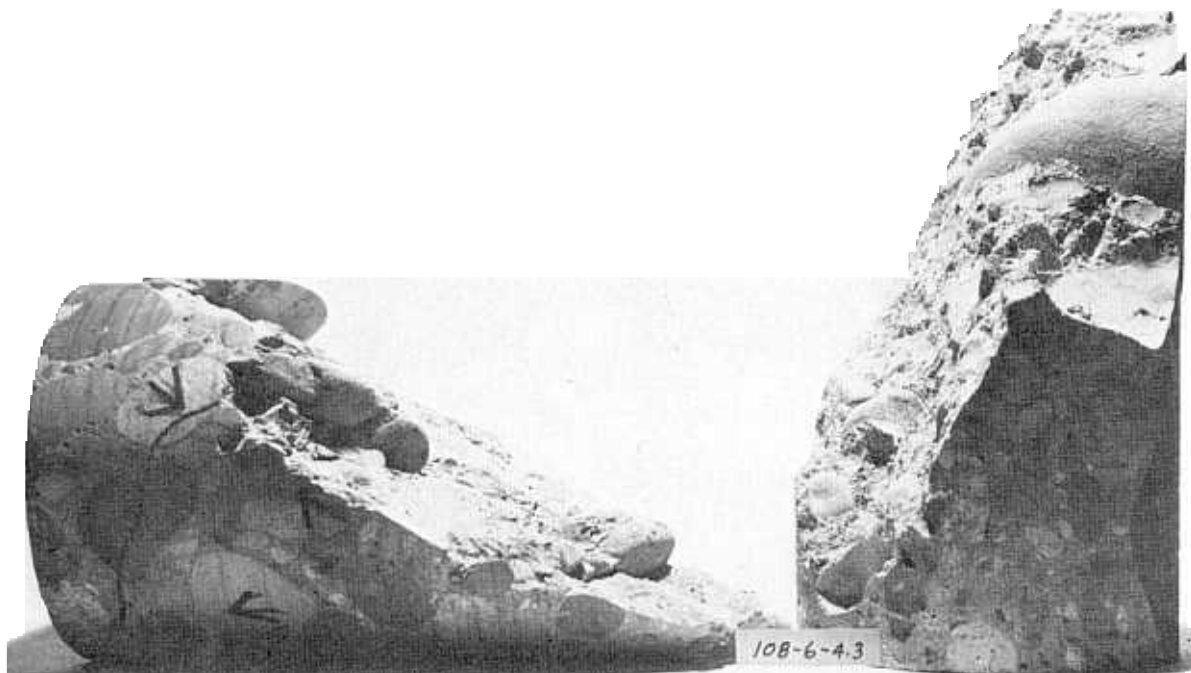
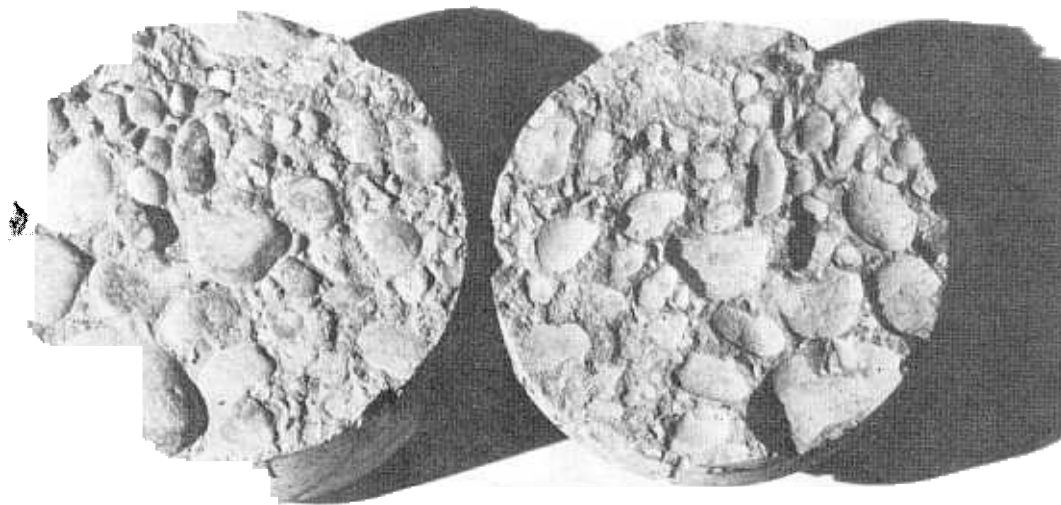
Figure 6. - Photograph of jointed concrete failure surface
Top - split at right angles to approximate joint (shown by arrows)
Bottom - showing separation at right angles to the axis of the core
(not subjected to triaxial test)
C-8322-63 C-8322-25

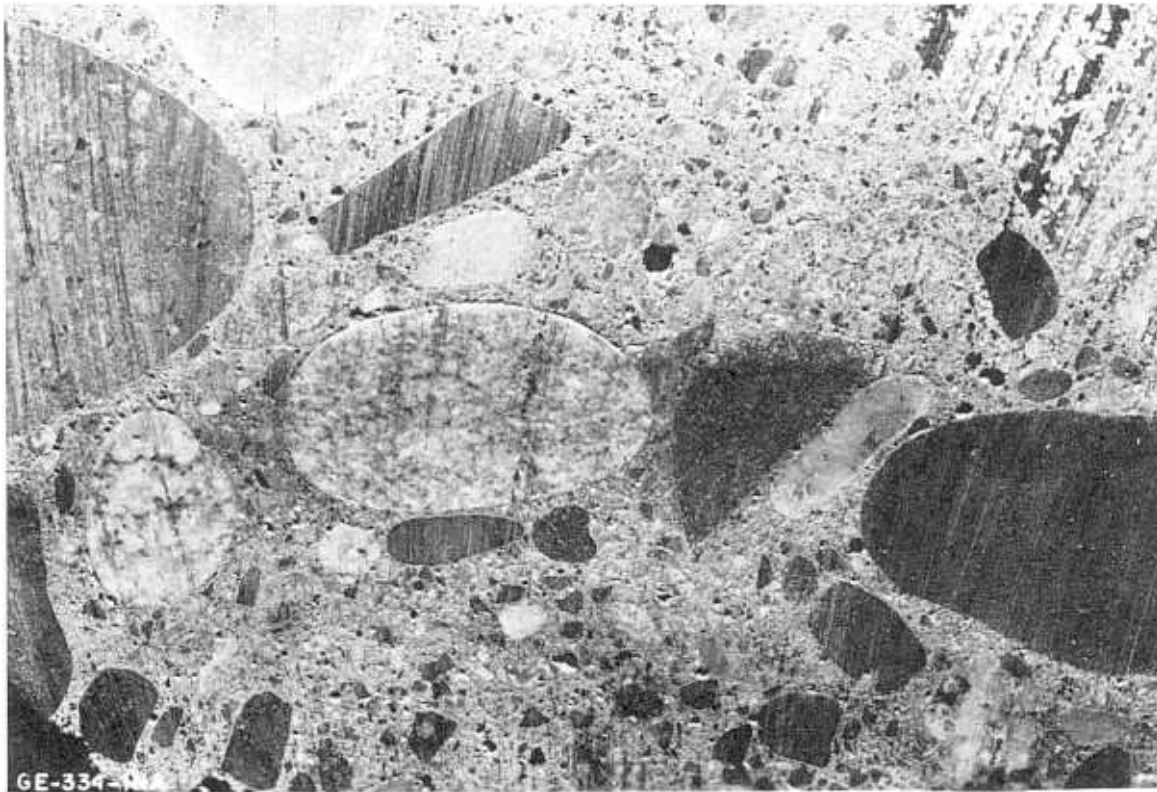
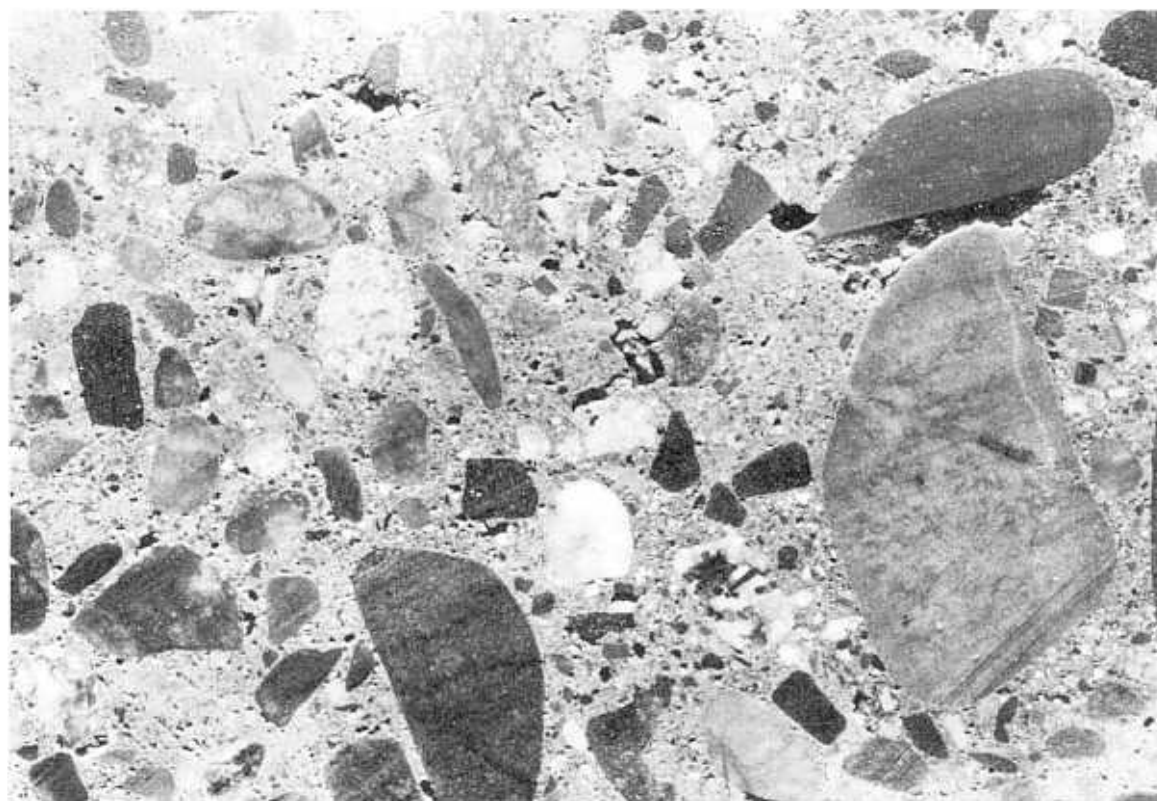
Figure 7. - Photograph of concrete showing size of aggregate and distribution indicating possible joint planes

Top - sample 106-3-4

Bottom - sample 106-1

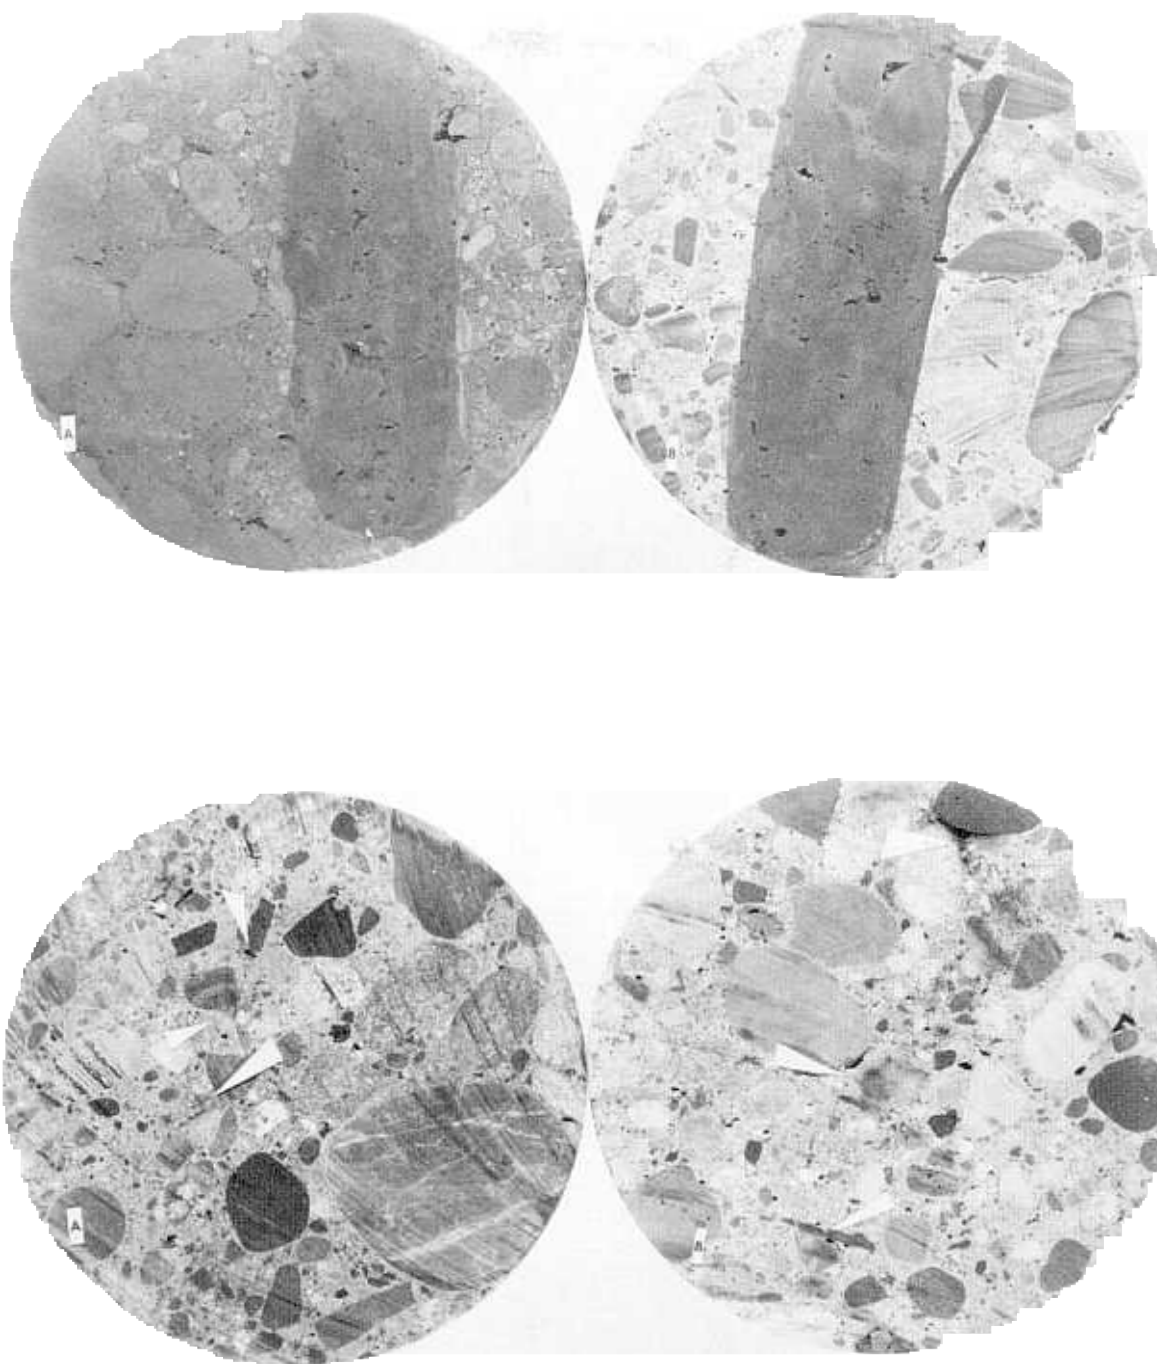
Figure 8. - Photograph of results of staining test to delineate unbroken joint
 (sample 106-3-4)
 Top - stained top of concrete
 Bottom - underside penetration of stain (white arrows) in voids subparallel
 to joint plane
 C-8322-64 C-8322-65
