GR-81-8

# CONCRETE PERFORMANCE IN CRYSTAL DAM, COLORADO: 1-YEAR CORE REPORT

June 1981 Engineering and Research Center

U.S. Department of the Interior Bureau of Reclamation Division of Research Concrete and Structural Branch

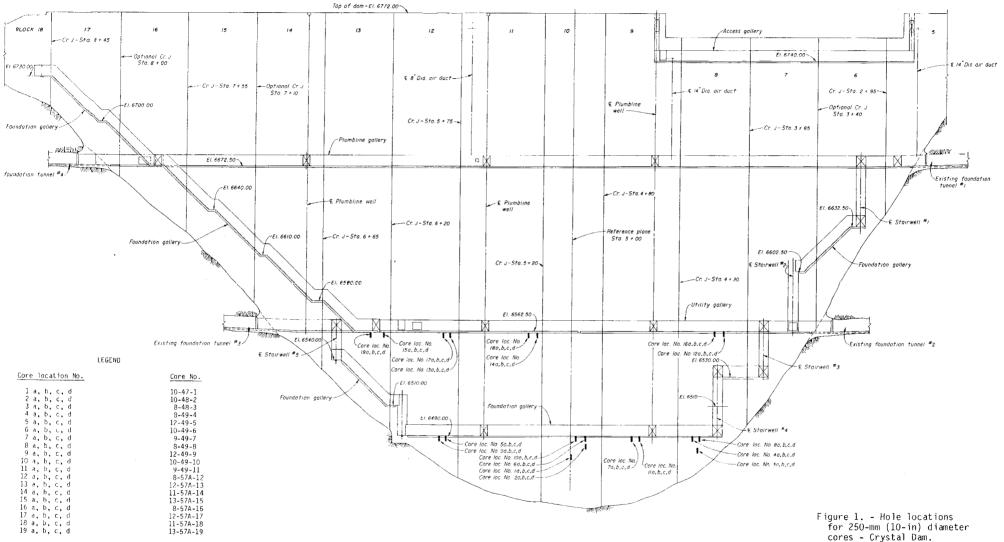
s – cryscar bair.

The construction specifications (No. DC-7000) for Crystal Dam required extraction of 250-mm (10-in) diameter cores at locations stipulated by Bureau of Reclamation. Nineteen cores were taken: three at approximately 70 days', eight at 6 months', and eight at 1 year's age. All except the three 70-day cores were taken from foundation and utility gallery floors. The three early cores were extracted from the downstream face of the dam. Core locations are shown on figure 1.

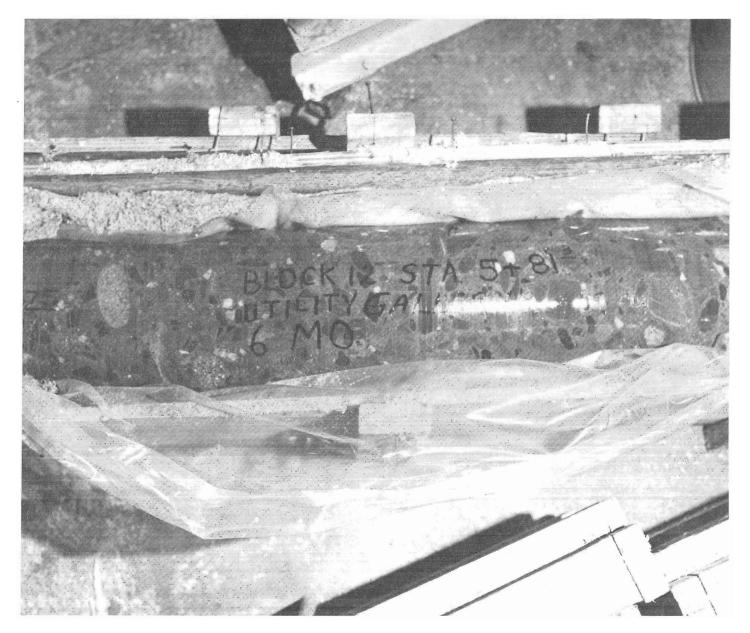
Figure 2. - Typical "as-received" condition of 250-mm (10-in) diameter cores - Crystal Dam. Photo P622C-427-7363.

When the cores arrived in Denver, they were unpacked and inspected (fig. 2). All cores were damp, and no shipping damage was evident. Only one construction joint was disbonded when received. Cores were then logged to provide a record of specimen lengths and any unusual characteristics, such as embedded reinforcing steel, rock pockets, construction joints, etc. Each core was marked for the type of test to be conducted. Photographs of the cores were taken to record details (fig. 3).

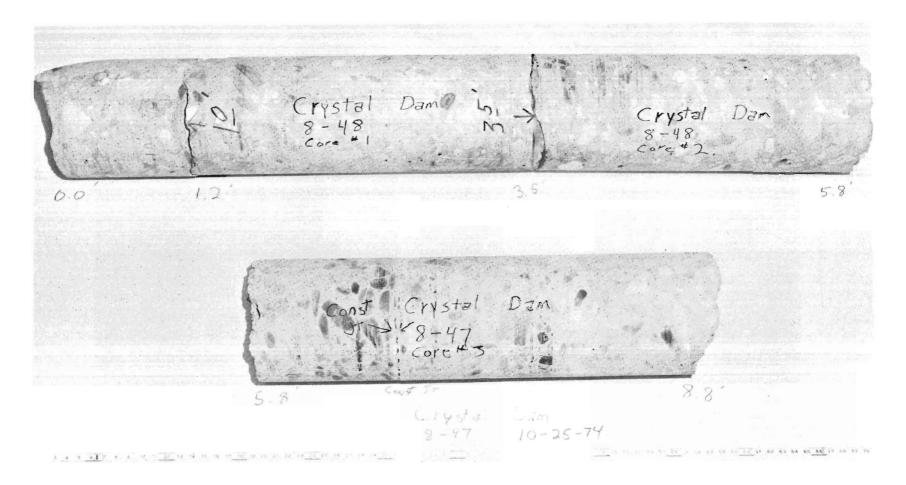
Figure 3. - Typical 250-mm (10-in) diameter cores showing a construction joint - Crystal Dam. Photo C-8426-2.

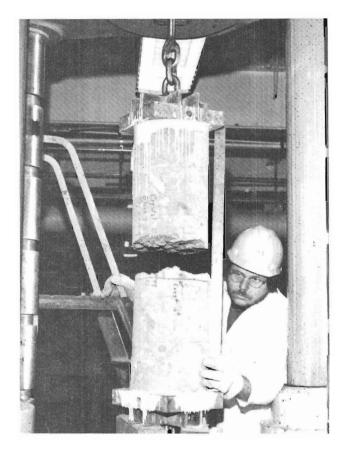
Figure 4. - Typical 250-mm (10-in) diameter core after tensile strength test - Crystal Dam. Photo C-8448-1.

Thirty-eight cores were used for tension tests. Twenty-three of these cores intersected horizontal construction joints. Steel plates, 50 mm (2 in) thick, were cemented with epoxy to the ends of each test specimen. Following a 24-hour cure of the epoxy at room temperature, the cores were placed in the testing machine with the end plates connected to the upper and lower platens through chain linkages. All specimens were loaded axially at a rate of 1.4 MPa (200 lb/in<sup>2</sup>) per minute until failure occurred (fig. 4).

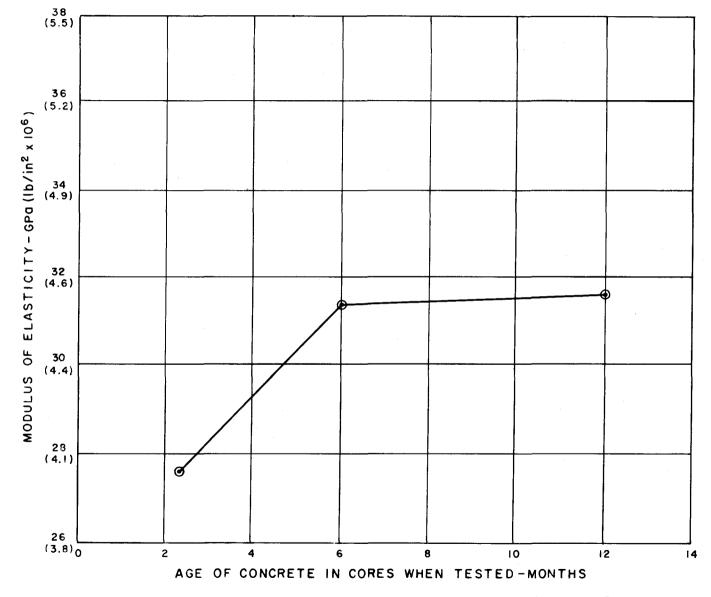
Figure 5. - Average moduli of elasticity of mass concrete in Crystal Dam.

Results of elastic properties tests are summarized in tables 1, 1A, and 2. The moduli of elasticity averaged 31.7 GPa (4.60 x  $10^6$  lb/in<sup>2</sup>) at 1 year's age. As expected, there was some increase in the moduli from 70 days to 1 year (fig. 5).

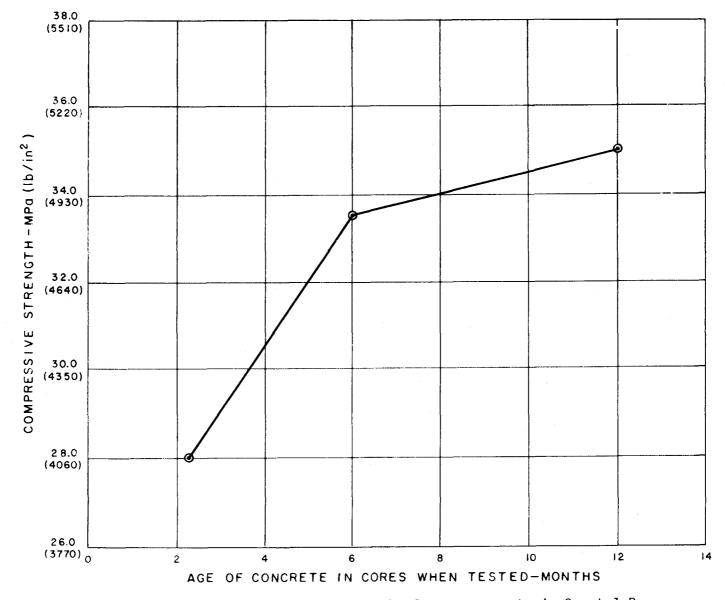
Figure 6. - Average compressive strength of mass concrete in Crystal Dam.

The results of the individual tests are shown in tables 1 and 1A. Summaries of results are shown in table 2 and figures 6 and 7. The average compressive strength for the concrete was 33.7 MPa (4890  $1b/in^2$ ) at 6 months' age and 35.0 MPa (5080  $1b/in^2$ ) at 1 year's age. This shows a 3.9-percent increase in strenth from 6 months' age to 1 year's age, which is slightly below average for typical strength development in mass concrete.

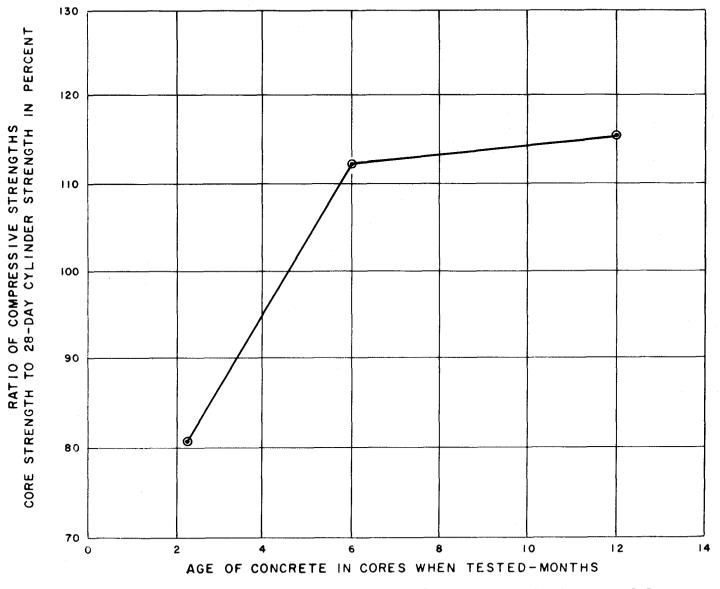
Figure 7. - Ratio of core to companion 28-day cylinder strengths in Crystal Dam.

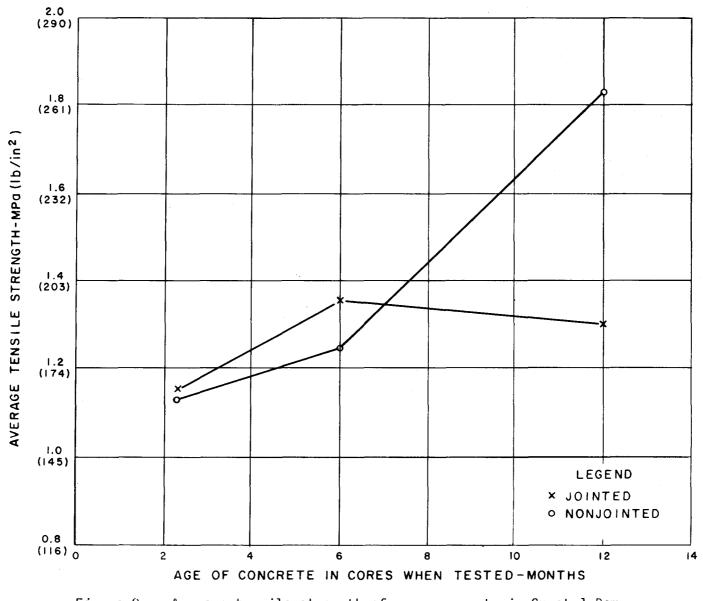
Figure 8. - Average tensile strength of mass concrete in Crystal Dam.

The bond strength of the horizontal construction joints appears to be slightly less than the tensile strength of the adjoining concrete (table 3 and figs. 8 and 9). The tensile strength of specimens with construction joints was about 94 percent of the tensile strength of specimens without construction joints. Of 23 specimens which contained construction joints, 14 failed in the joint during testing. The apparent and slight reduction in the tensile strength of jointed specimens from 6 to 12 months' age is not considered significant and likely results from variability of test specimens.

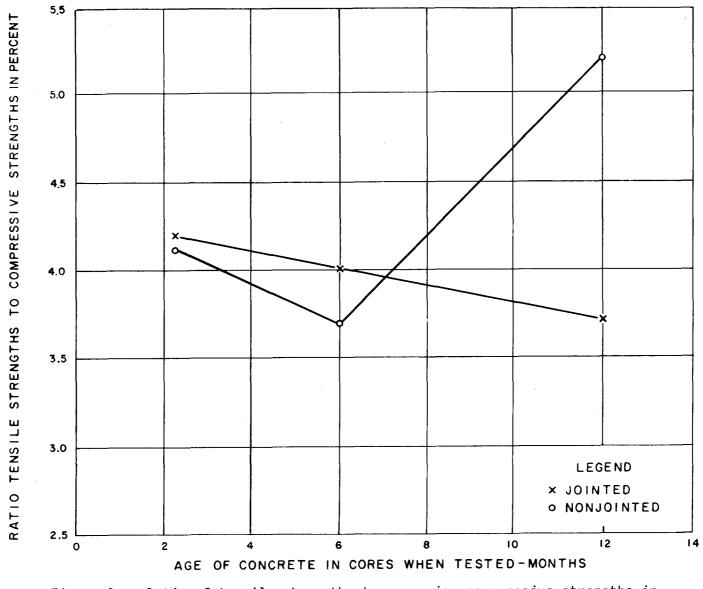
Figure 9. - Ratio of tensile strengths to companion compressive strengths in Crystal Dam.
