GR-82-11

OWYHEE DAM — 1982

Concrete Core Investigation

August 1982
Engineering and Research Center

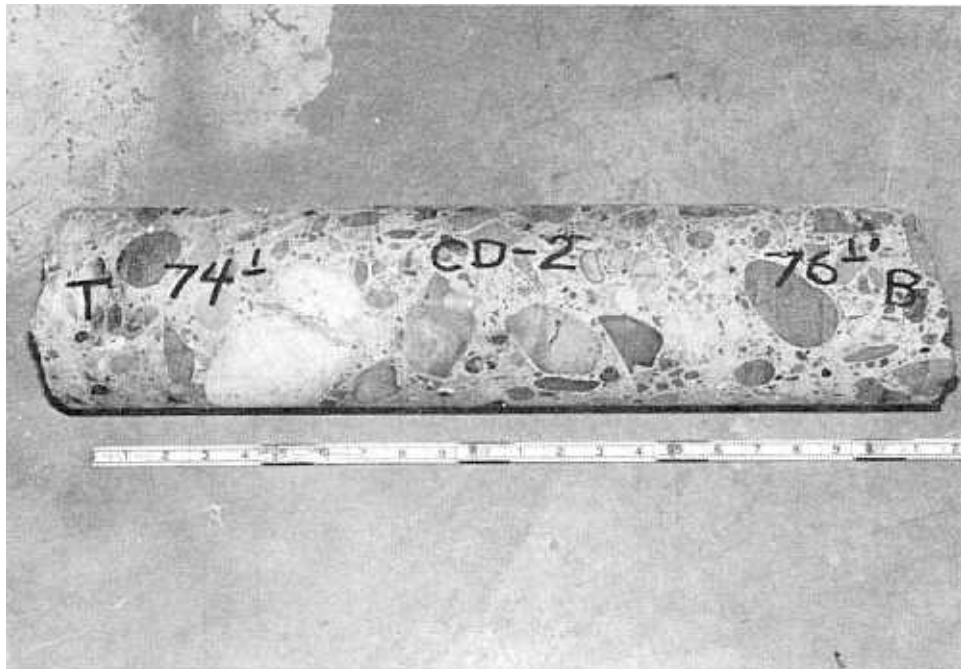
Figure 2. — Typical concrete core test specimen. Owyhee Dam. P801-D-80038

reference. The cores were then shipped to the Bureau's Engineering and Research Center in Denver, Colo. After arrival, the cores were examined, logged, and marked for cutting into test specimens (fig. 2).

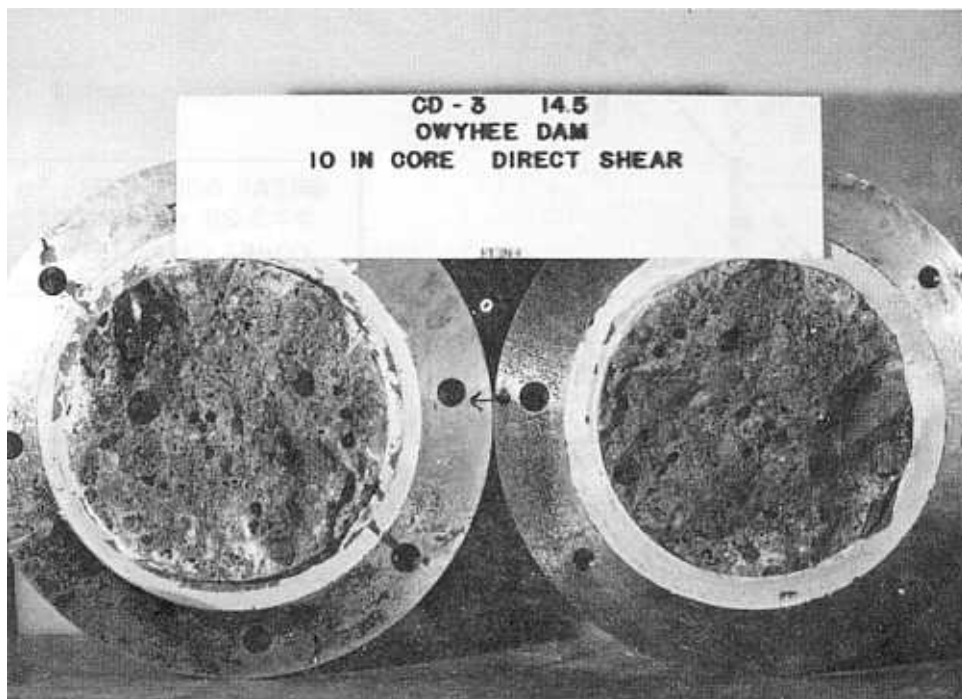
Figure 10. — Typical direct shear test specimen after test. Owyhee Dam.
P801-D-80040

Selected intact specimens were subjected to a loading condition generally referred to as a break bond test, and followed by sliding friction tests. A few unbonded specimens were tested using only the sliding friction test (figs. 9 and 10); all of these specimens contained a construction joint. The cores were cut into about 100-mm (4-in) lengths with the joints as close as possible to midlength. Break bond data were obtained by subjecting each specimen to a constant normal load while simultaneously increasing the horizontal shearing load until the specimen failed (broke bond). The maximum horizontal and constant normal loads were recorded. The failed surfaces were then subjected to a series of increasing normal loads, and the shear loads required to displace the surface at each normal load were determined. The results of the break bond and sliding friction tests are shown in table 2 and plotted on figures 11 and 12. Values for cohesion and the tangent of the angle of friction ($\tan \phi$) are also shown in table 2. The least squares line (fig. 12) for sliding friction has a correlation coefficient of 0.89 for 71 points.
