TREATMENT OF EXPANSIVE CLAY CANAL LINING

*March 1984
Engineering and Research Center*

***U.S. Department of the Interior
Bureau of Reclamation
Division of Research
and Laboratory Services
Geotechnical Branch***

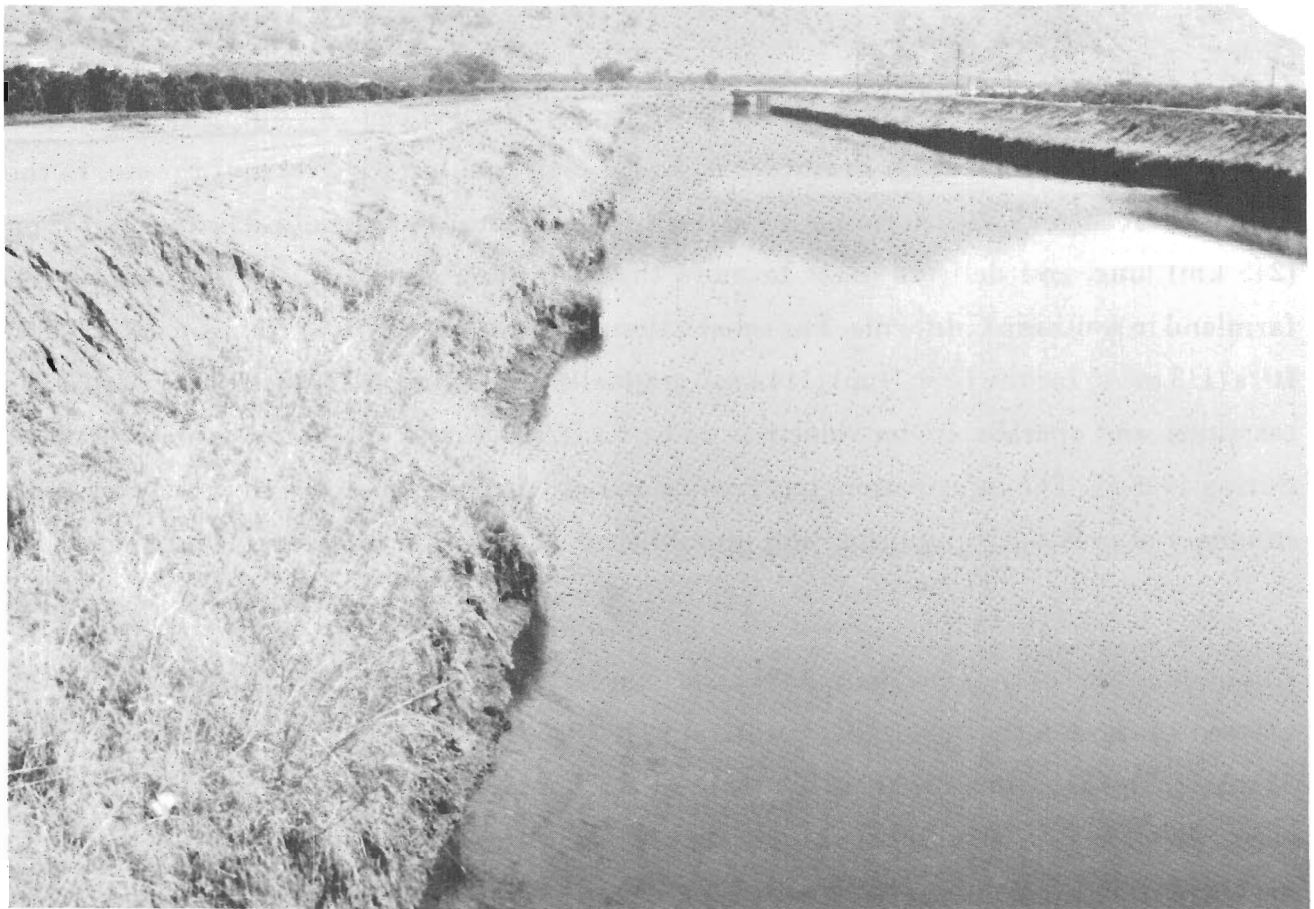
Figure 1. — Friant-Kern Canal prior to lime stabilization. Note slope failure along linings, P801-D-80750

About one-third of the canal length, 54 mi (87 km), from mile 34 to mile 88 (km 55 to km 142), traverses an area of the Porterville Formation. Of this 54 mi, 23 mi (37 km) are earth lined, and 31 mi (50 km) are concrete lined. The soils of the Porterville Formation contain expansive clays, which exhibit significant volume change, shrink-age, and expansion with changes in moisture content. Volume change can be a serious problem for canal linings in that lower densities and strengths occur below the waterline due to absorption of water by the soil. Above the waterline, shrinkage occurs with cracks forming several feet deep, resulting in a loss of shear strength. As a result, the canal slopes become unstable and slides occur. The photograph on figure 1 shows the condition of the canal prior to stabilization, note the slope failures along the canal.

After the first 3 years of operation, the canal developed several lining failures. The concrete lining of the canal cracked and buckled from the earth pressures of the expansive clay. The earth-lined canal slopes sloughed and failed excessively. The failures were a continual maintenance problem. Several methods of stabilizing the slopes were tried without success including electrochemical treatment, flattening the slopes, and the dumping of riprap on the canal slope. The maintenance of the canal slope became an expensive problem and, in the early 1970's, the Bureau decided to remove several sections of the canal lining, flatten the canal slopes, and reline the canal using a compacted soil-lime mixture in an attempt to stabilize the slopes.

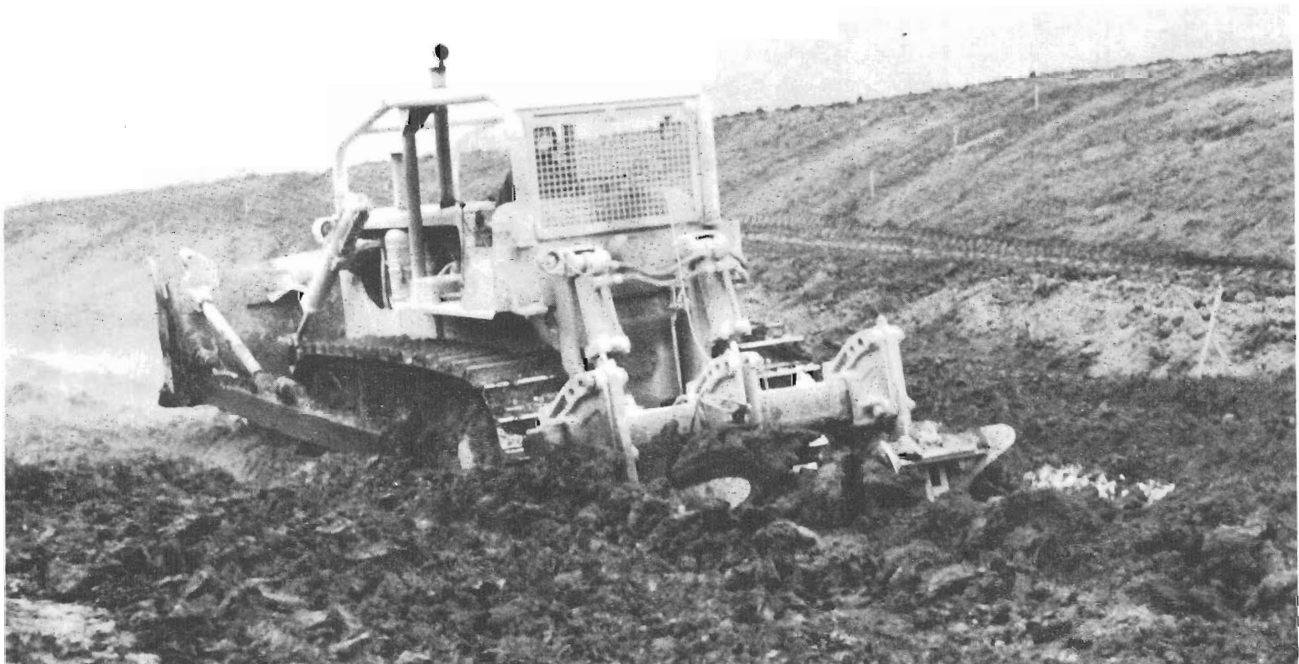
Figure 6. — Mixing quicklime with expansive clay. P801-D-80752

Prior to the third phase of reconstructing the canal side slopes, the rock riprap that had been dumped into slide areas for slope stabilization had to be removed. The material that was to be stabilized with lime and recompacted was then removed by a benching operation. A series of long, sloping benches or ramps were cut from the top of the bank down to the canal bottom with the cut extending far enough into the slope to remove the entire depth of material required for rehabilitation. The 2 percent quicklime was spread over the bench surface, 1 ft (0.3 m) of material from the bench was mixed with the quicklime, and the lime-clay mixture was pushed into the canal bottom where the remaining riprap material had been removed. The long ramp cuts overlapped for a considerable distance, which created problems of construction control. If this method had continued, some areas of canal lining would have been removed twice and some areas not mixed at all. To alleviate the situation, a similar method of slope stripping was performed. The side slopes were worked from top to bottom along 800-ft (244-m) long benches sloped into the side slope to provide the 3.6-ft (1.1-m) thick lining required. The material was spread on the canal bottom and 2 percent additional lime added. Water was added to at least 2 percent over optimum moisture, and then about 1-ft (0.3-m) depth of material was mixed with dozers and graders with the rock being continually removed. When about 6.6 ft (2 m) of the material had been mixed and cured for 24 hours, bulldozers started spreading the material on the slopes, which were then compacted with a self-cleaning sheepsfoot roller moving up and down the slope. A cable winch on a crane “yo-yoed” the roller up and down the slope. The side slopes were constructed in three 1.2-ft (0.4-m) compacted lifts normal to the slope to give the specified 3.6-ft (1.1-m) compacted depth. Photographs of the construction sequences are shown on figures 5 through 8.

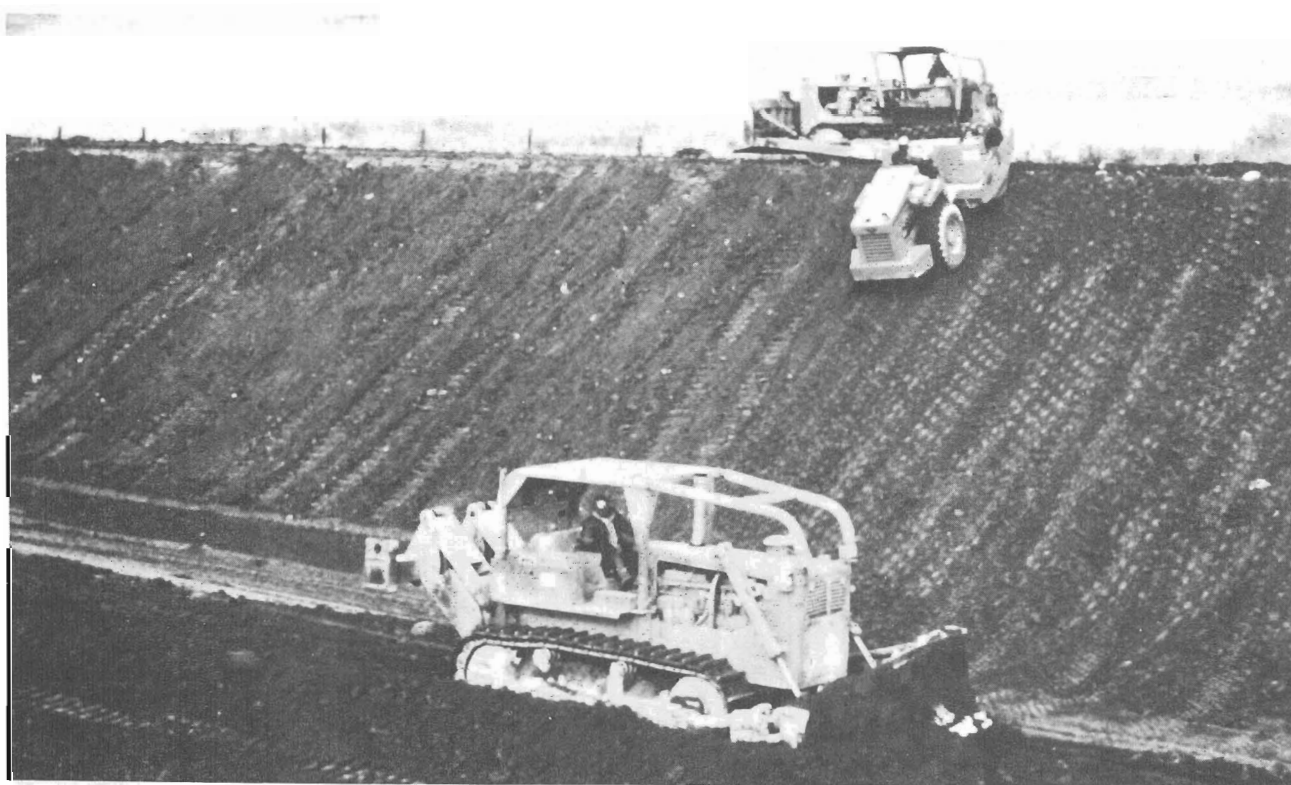
Figure 8. — Compaction of soil-lime canal lining. P801-D-80754

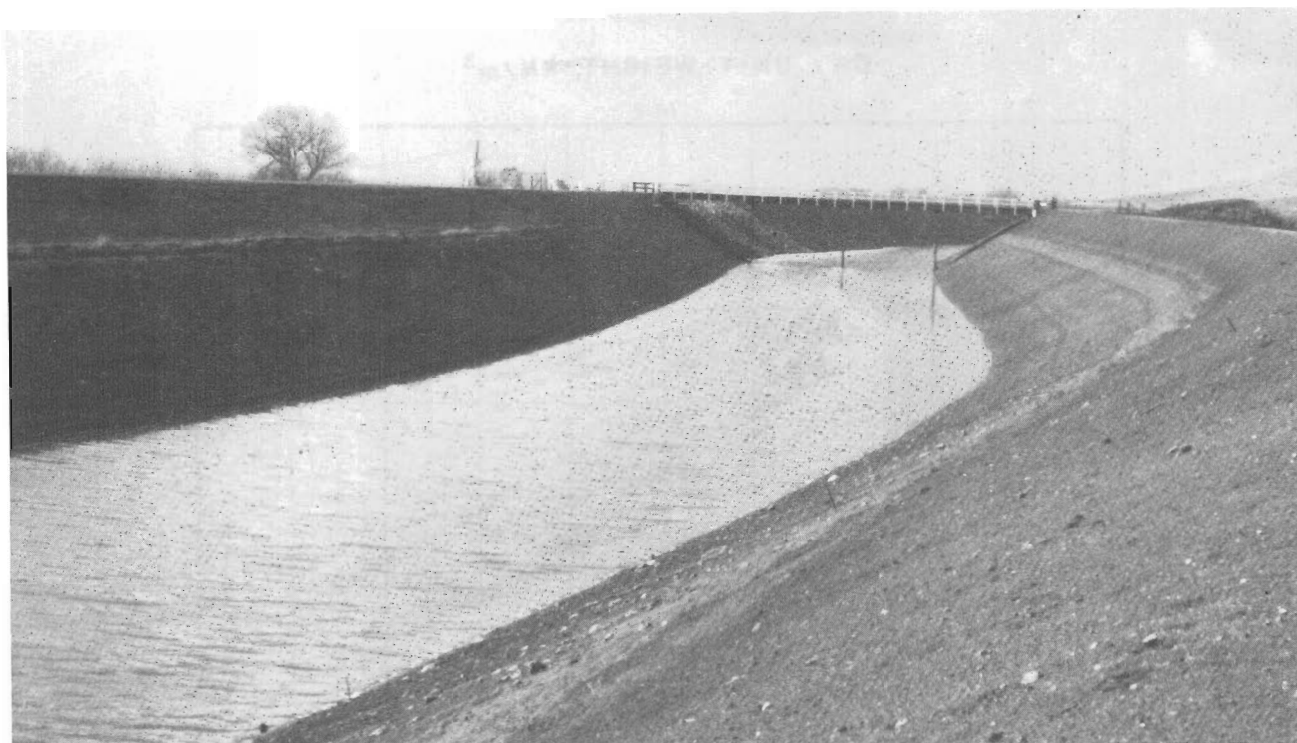
In many places, the marks of the sheepsfoot roller used for compacting the lining are currently (1984) clearly visible on both the canal sides and the invert. A photograph of the canal lining showing its present condition is shown on figure 13.

Figure 13. — Soil-lime lining on Friant-Kern Canal after 5 years of operation. P801-D-80755
