Technical Report No. SRH-2013-23

Brantley Reservoir 2013 Bathymetric Survey

**Brantley Dam
New Mexico**

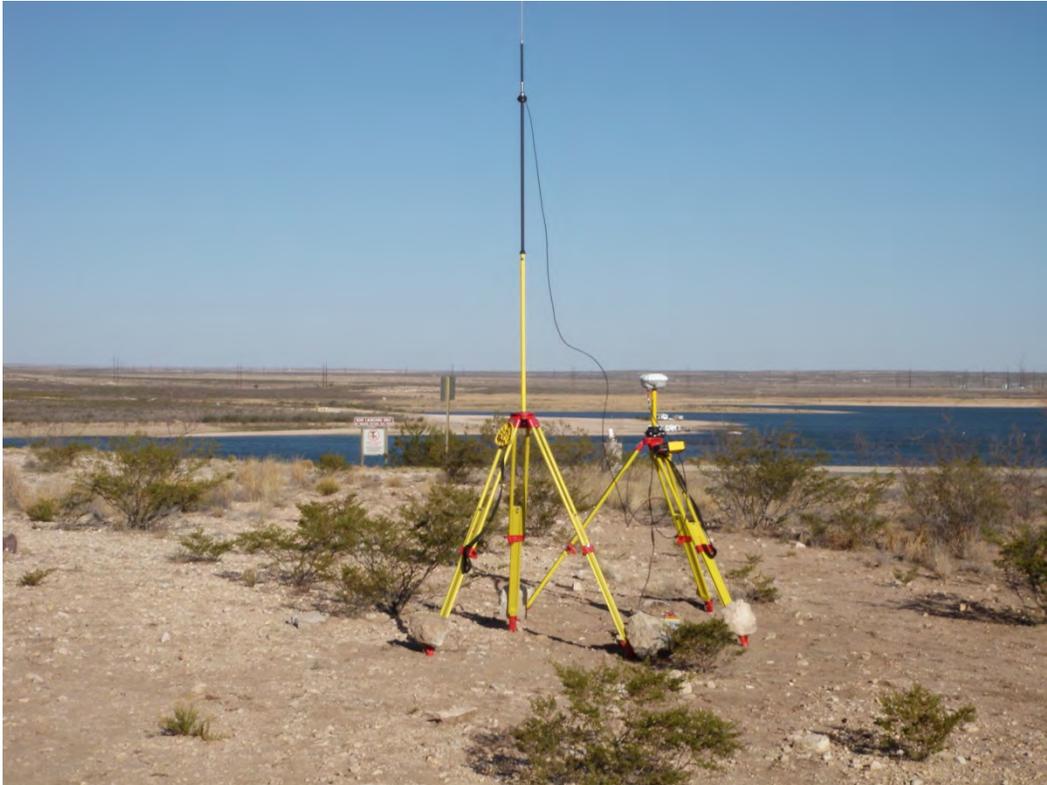
Figure 3 - Temporary control point used as base station for the 2013 hydrographic survey.

Prior to the 2013 bathymetric survey the area near the east boat ramp was searched for a control point established during the 2001 survey. The monument was not located and appeared to have been destroyed by the construction of a walkway path in the recreation area. The west boat ramp area was closed at beginning of the 2013 survey so an attempt to locate a 2001 control point was not conducted. The 2013 survey established a temporary control point between the parking lot and east boat ramp area, Figure 3. The point is a labeled aluminum cap mounted on rebar driven into the ground, but is considered temporary because it is located in open recreational area near a highly traveled path where it could be easily disturbed. The on-line positioning user service (OPUS) was used to establish horizontal and vertical control on the temporary point that was used for the entire 2013 survey. OPUS is operated by the National Geodetic Survey (NGS) and allows users to submit GPS data files that are processed with known point data to determine positions relative to the national control network. The OPUS generated coordinates were used to measure position and the vertical difference between NGVD29, NAVD88, and recorded water surface elevations at the dam. Water surface measurements were collected on the first day of the survey during very calm water surface conditions with no wind or wave action from boat activities. The horizontal control was established in New Mexico state plane east coordinates, NAD83, in feet. Following are the computed OPUS coordinates for the temporary point labeled, SRH1-2013:

As part of the 2013 reservoir survey Brantley Dam piezometer well locations were measured using RTK GPS with the base station set on SRH1-2013 (Figure 3). During the piezometer survey, several Reclamation brass cap monuments and elevations were measured along the top of the concrete portion of the dam, Figures 4, 5, and 6. Except for the one monument labeled “Spill” (Figure 4) located on the left abutment of the concrete portion of the dam, the monuments had no identification labels. The 2013 measured caps were plotted with the 2001 survey data revealing that two of the Reclamation monuments were measured by both studies. The common points were labeled “999” and “1000” in the 2001 survey. The 2013 elevations were within +/- 0.02 feet of the 2001 survey elevations, confirming both surveys were tied to the same vertical datum,

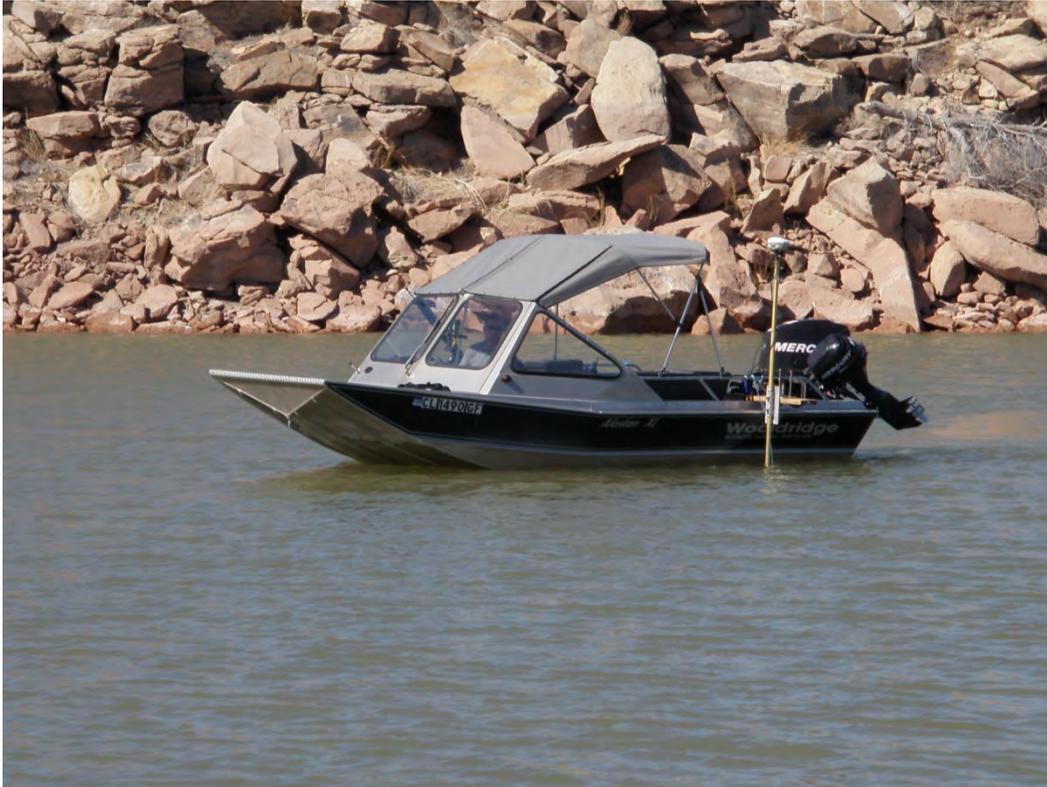
Figure 7 - Survey vessel for reservoir mapping with mounted transducer on side (Lake Sumner-New Mexico, March 2013)

The bathymetric survey equipment was mounted on an aluminum vessel with the transducer and GPS unit located over the side, Figure 7. The hydrographic system included a GPS receiver with a built-in radio, a depth sounder, a helmsman display for navigation, a computer, and hydrographic system software for collecting the underwater data. On-board batteries powered all the equipment. The shore equipment included a second GPS receiver with an external radio. The

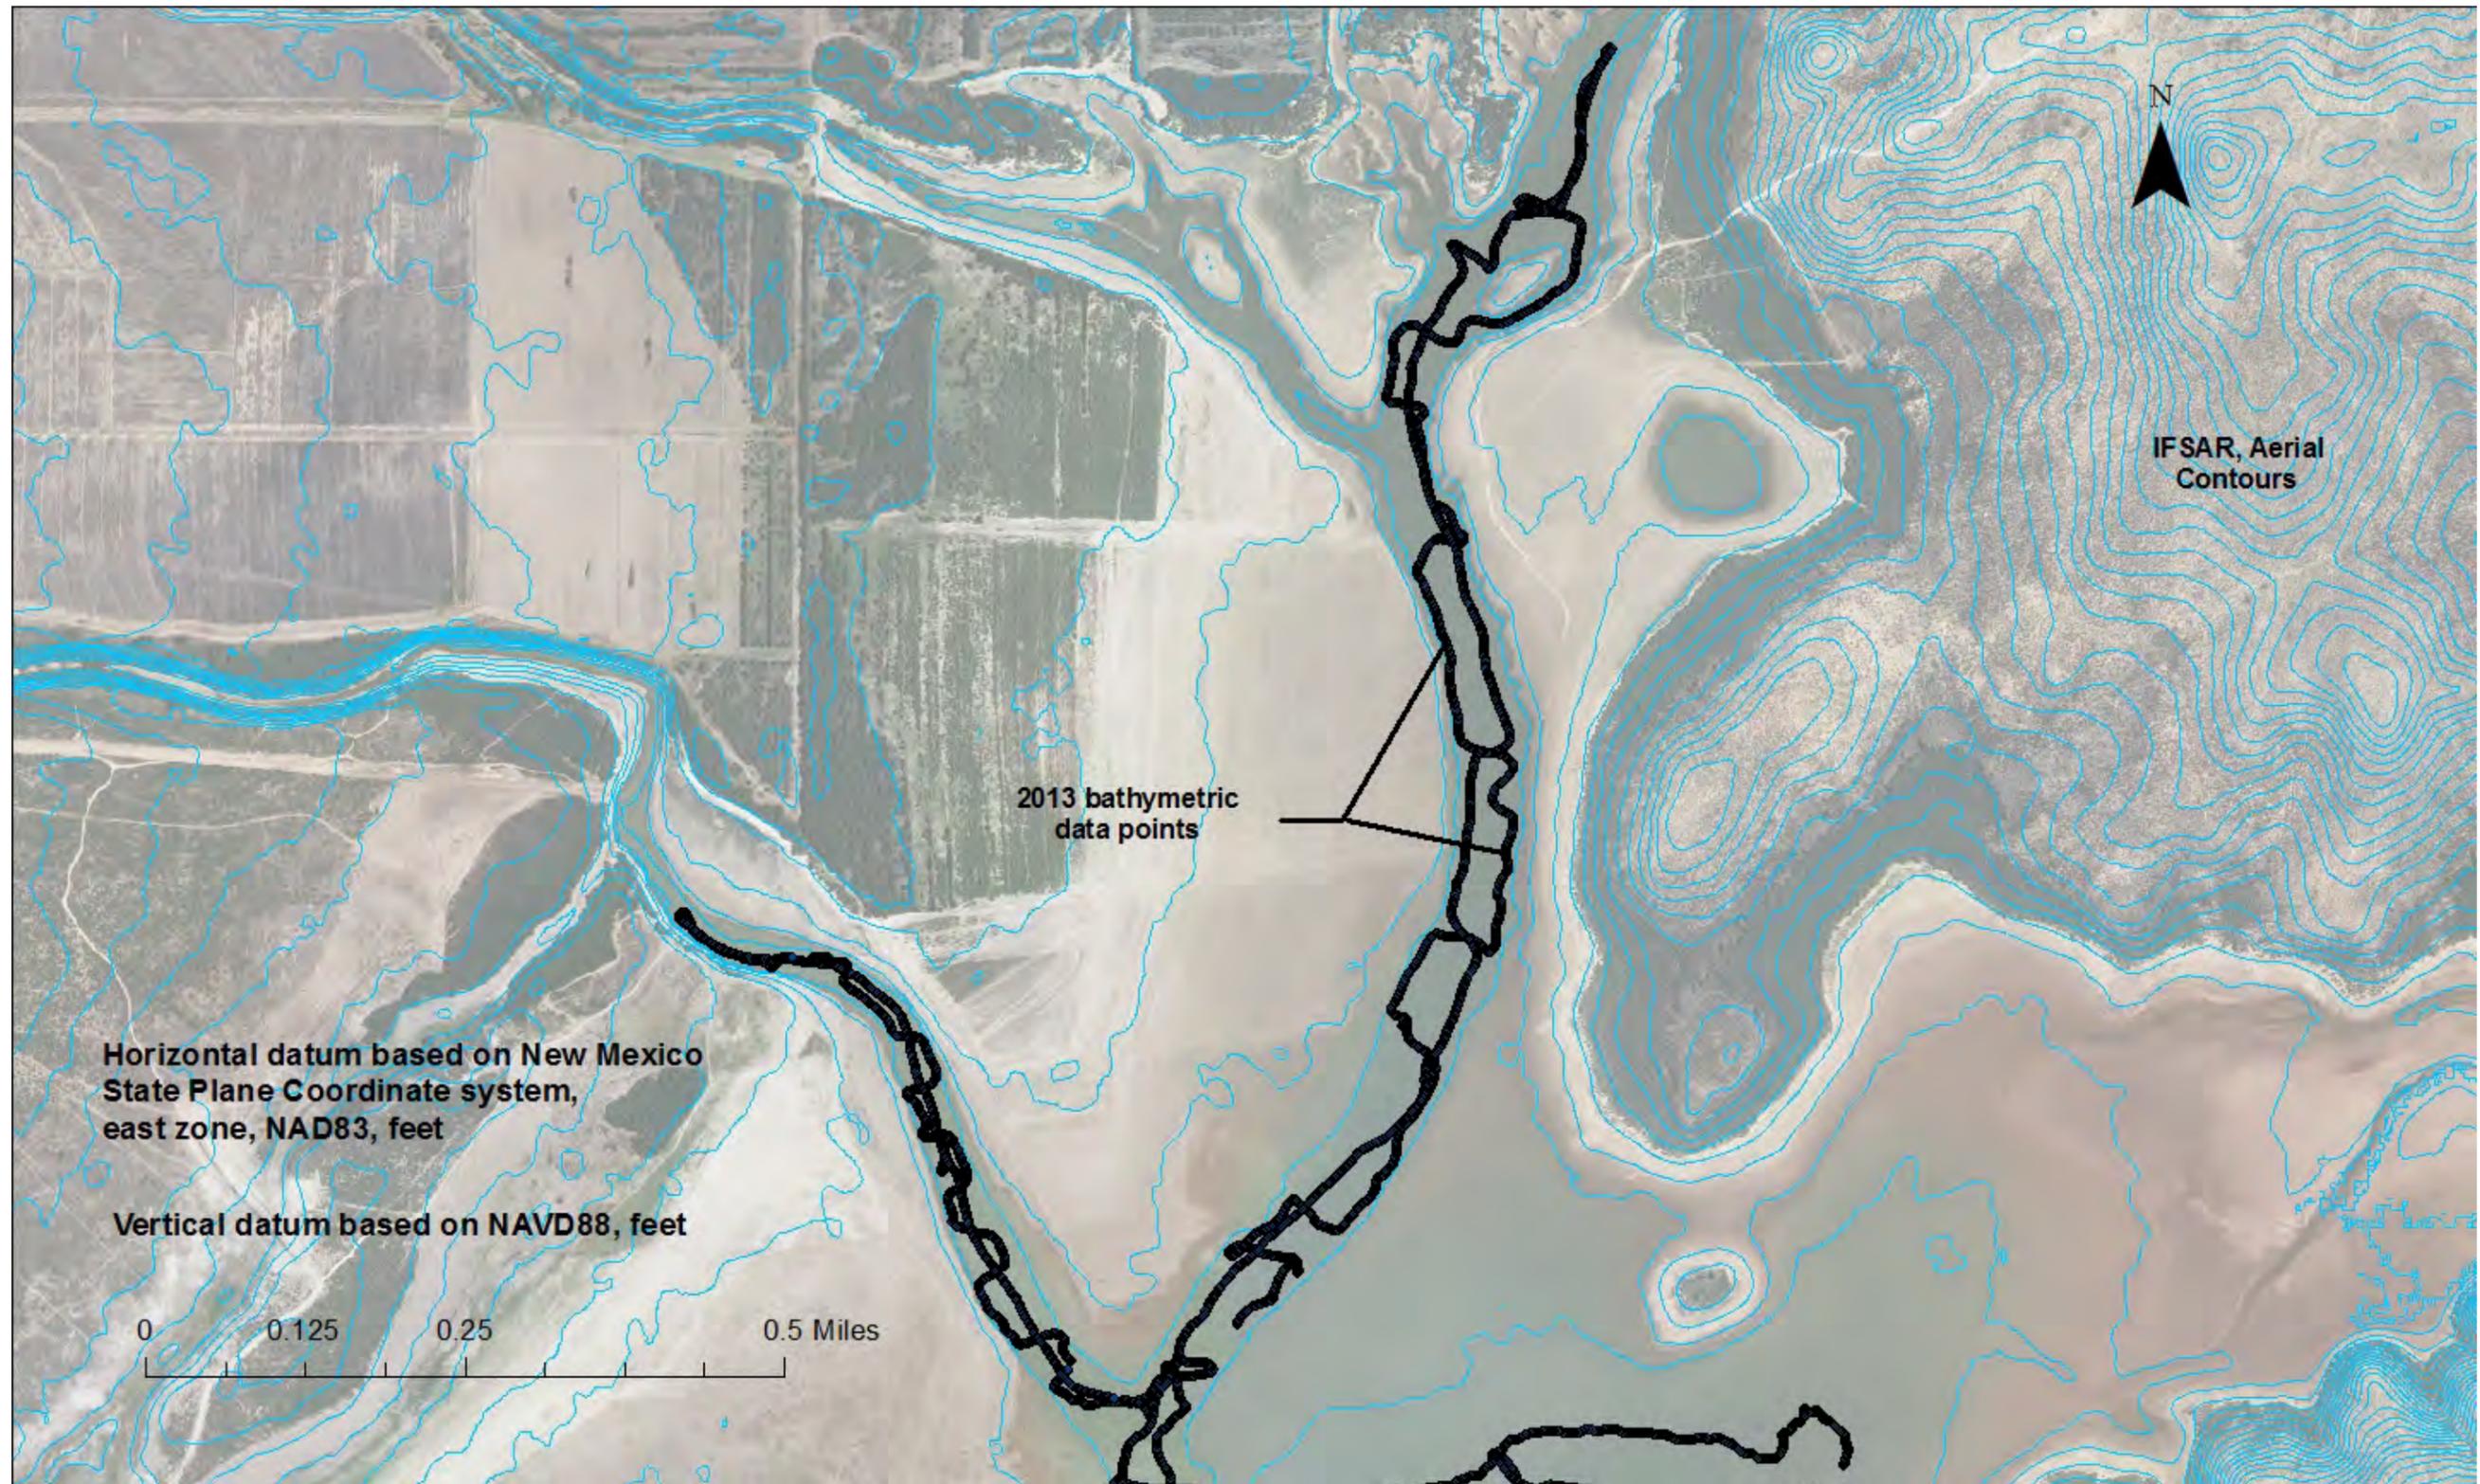
Figure 8 - Brantley Reservoir 2013 data sets (NAVD88).

Figure 9 - Brantley Reservoir 2013 data sets (NAVD88).

Figure 10 - Brantley Reservoir 2013 data sets (NAVD88).

Figure 11 - Brantley Reservoir 2013 data sets (NAVD88).

guidance system provided directions to the boat operator to assist in maintaining a course along the predetermined lines. As each line was traversed, the depth and position data were recorded on the laptop computer hard drive for subsequent processing, resulting in point data at one second intervals. The water surface elevations at the dam from Reclamation gage records and RTK GPS measurements were used to convert the sonic depth measurements to lake-bottom elevations tied to NAVD88 (measured 1.6 feet higher NGVD29). Final processing of the April 2013 bathymetric data resulted in around 37,500 points, Figures 8 through 11.

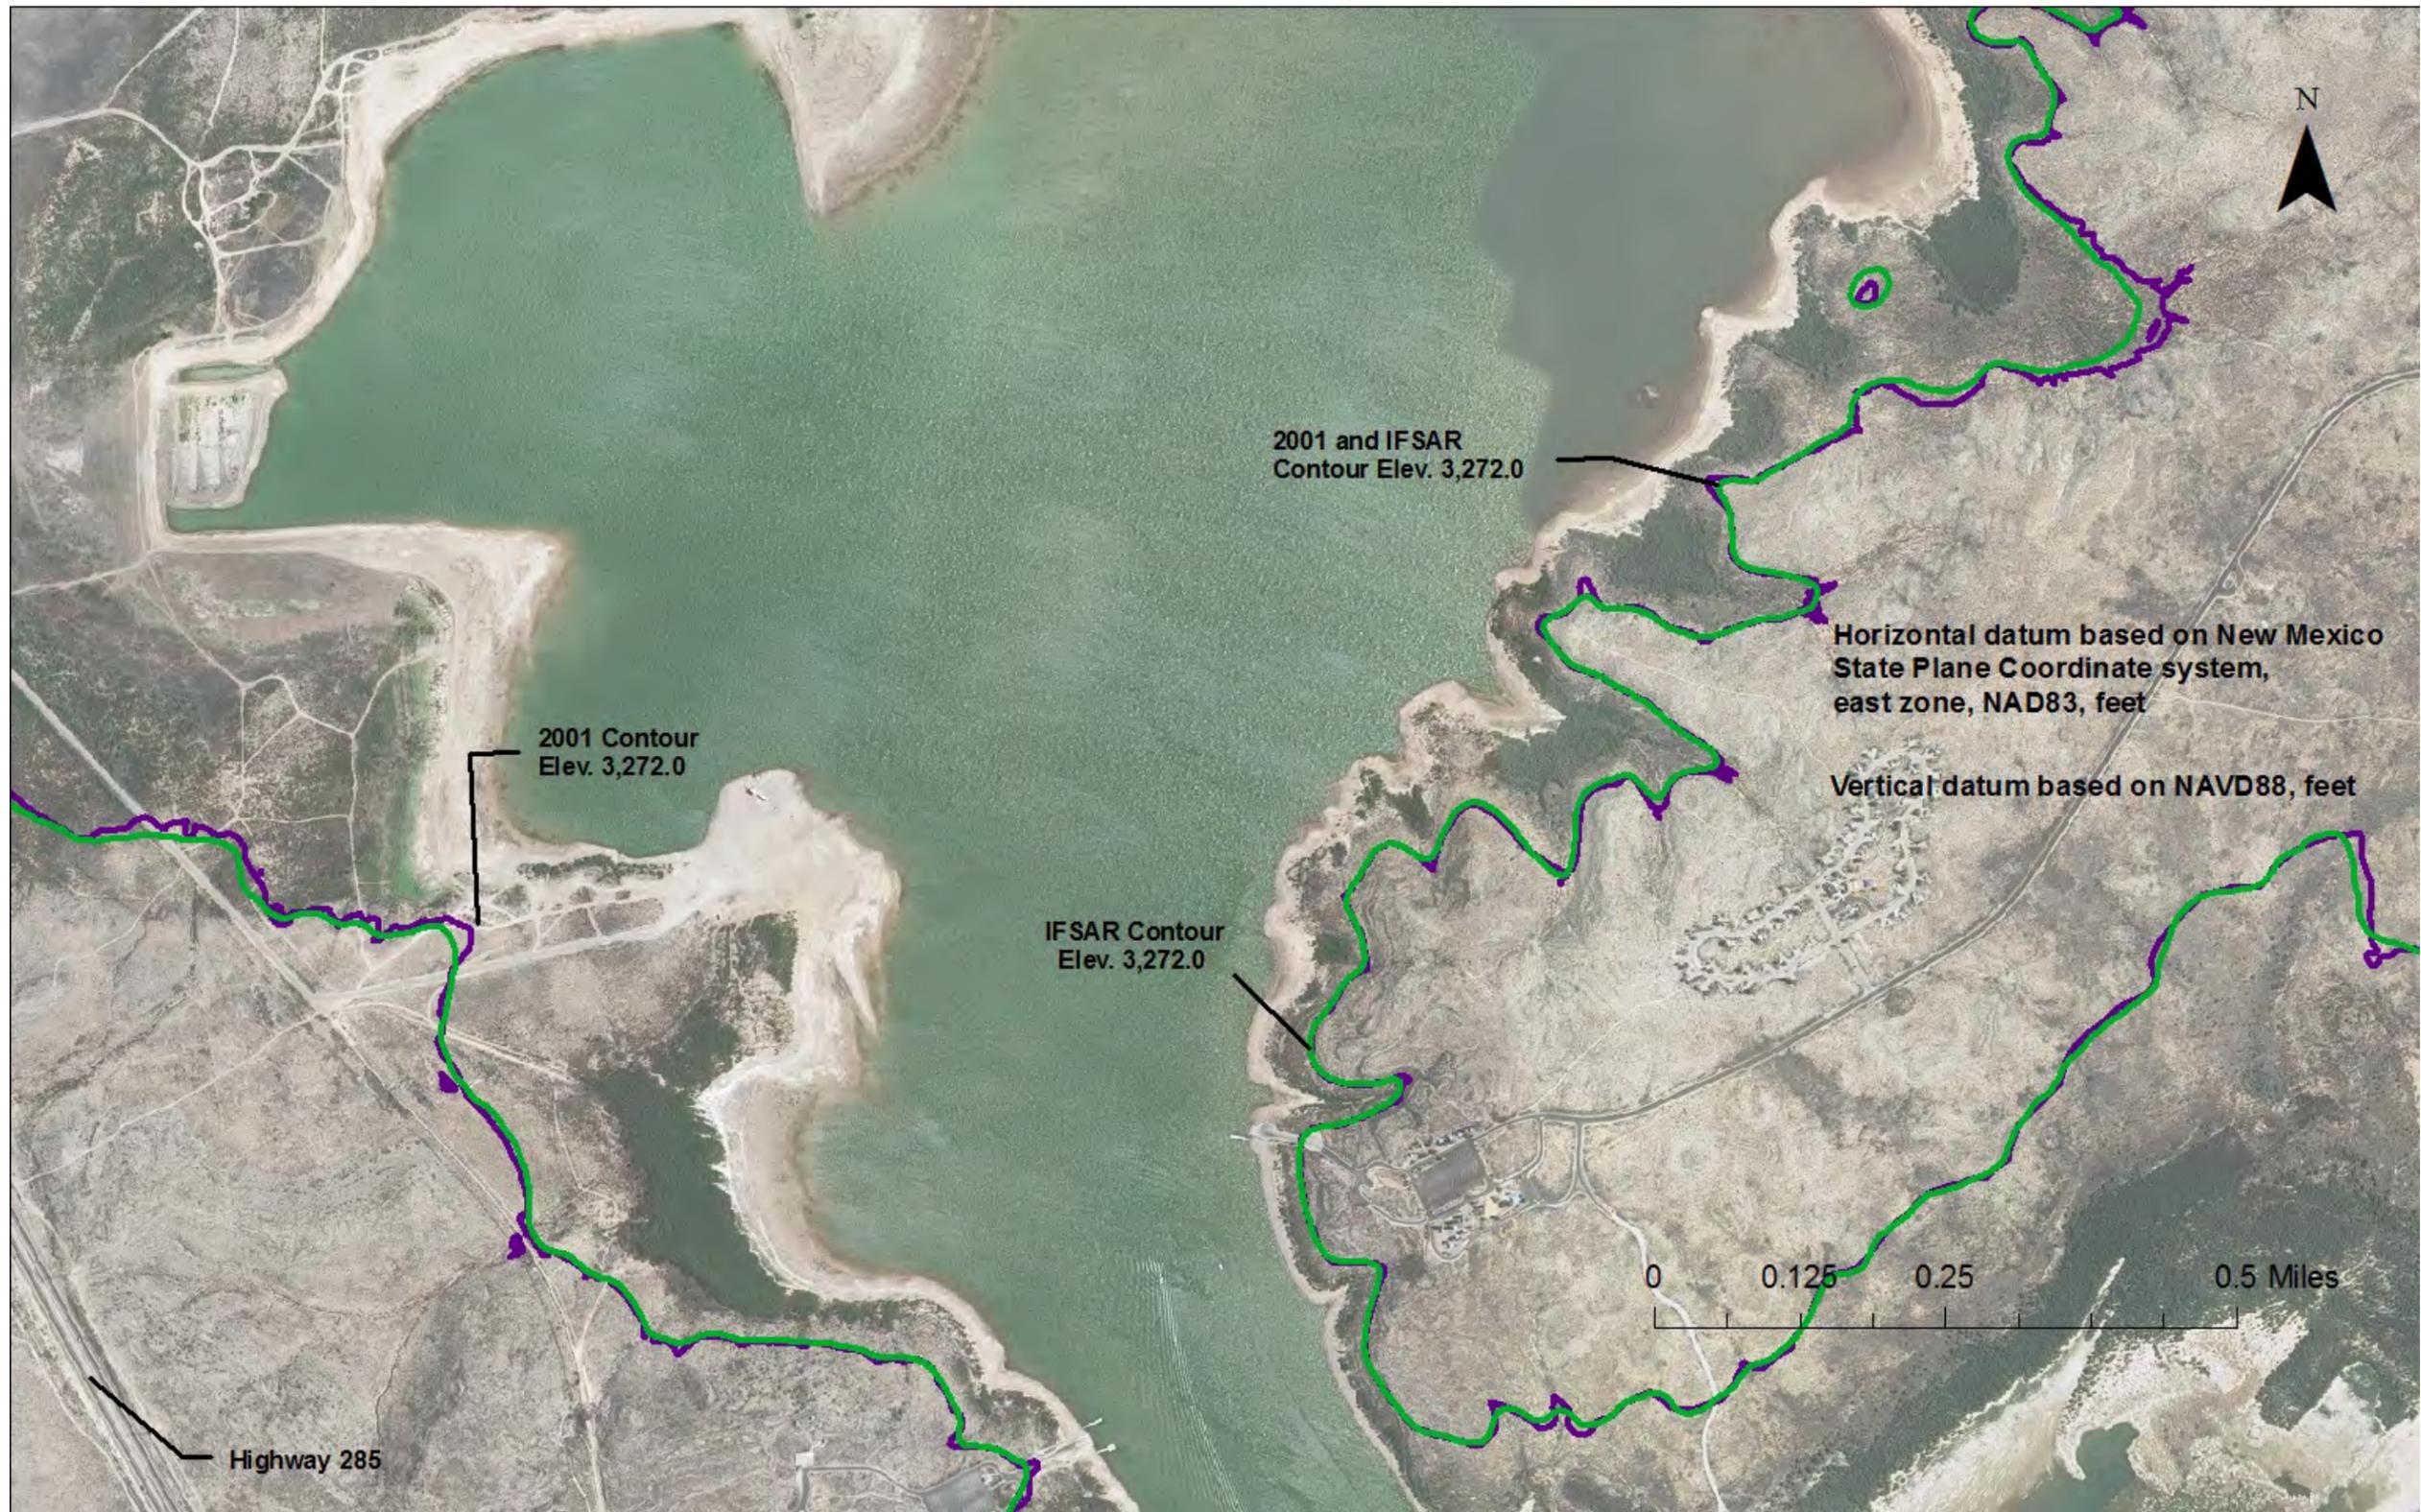
Figures 14 through 16 provide a comparison of the 2001 aerial developed contours at elevations 3,268 and 3,272 with the 2013 developed contours at the same elevations that used the 2008 IFSAR data. As can be seen on the figures, the two developed upper elevation contours lined up very well for the reservoir areas shown. The close agreement also indicates there has been a minimum

Figure 14 - Brantley Reservoir 2001 and 2013 contour comparison, elevation 3,268.0 (NAVD88).

Figure 15 - Brantley Reservoir 2001 and 2013 contour comparison, elevation 3,272.0 (NAVD88).

Figure 16 - Brantley Reservoir 2001 and 2013 contour comparison, elevations 3,268.0 and 3,272.0 (NAVD88).

change between 2001 and 2008. The reservoir water level since dam closure has been below elevation 3,260, so minimum change in the topography at these higher elevations due to reservoir operations would be expected. Due to the similarity of the elevations with the other data sets and since it was the most recent above water data information available, the IFSAR data was used for the 2013 reservoir analysis.
