**Technical Report No. ENV-2020-010**

# **Turquoise Lake 2017 Sedimentation Survey**

**Fryingpan-Arkansas Project, Colorado  
Great Plains Region**

**February 2020**

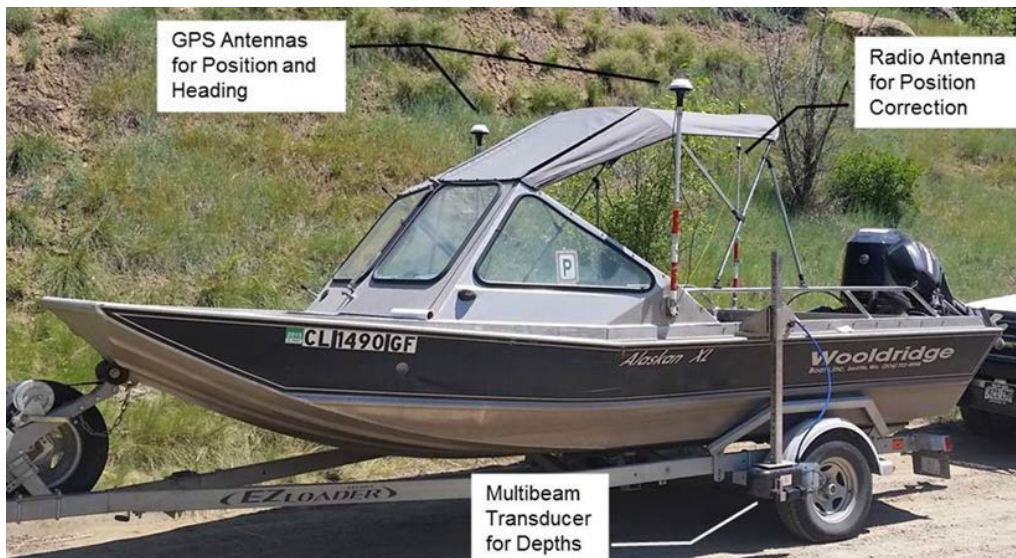
**Figure 17. Wooldridge boat with RTK-GPS and multibeam depth sounder system.**

The survey employed an 18-foot, flat-bottom aluminum Wooldridge boat powered by outboard jet and kicker motors (Figure 17). Reservoir depths were measured using multibeam echo sounder which consisted of the following equipment:

- variable-frequency transducer with integrated motion reference unit,
- near-surface sound velocity probe,
- two GPS receivers to monitor the boat position and heading,
- an external GPS radio, and
- processor box for synchronization of all depth, sound velocity, position, heading, and motion sensor data.

The multibeam transducer emits up to 512 beams (user selectable) capable of projecting a swath width up to 120 degrees in 100 feet (30 meters) of water. Sound velocity profiles were collected
