Technical Memorandum No. ENV-2022-043

Willow Creek Reservoir (CO) 2021 Sedimentation Survey

**Colorado Big Thompson Project, Colorado
Missouri Basin and Arkansas – Rio Grande – Texas Gulf Region**

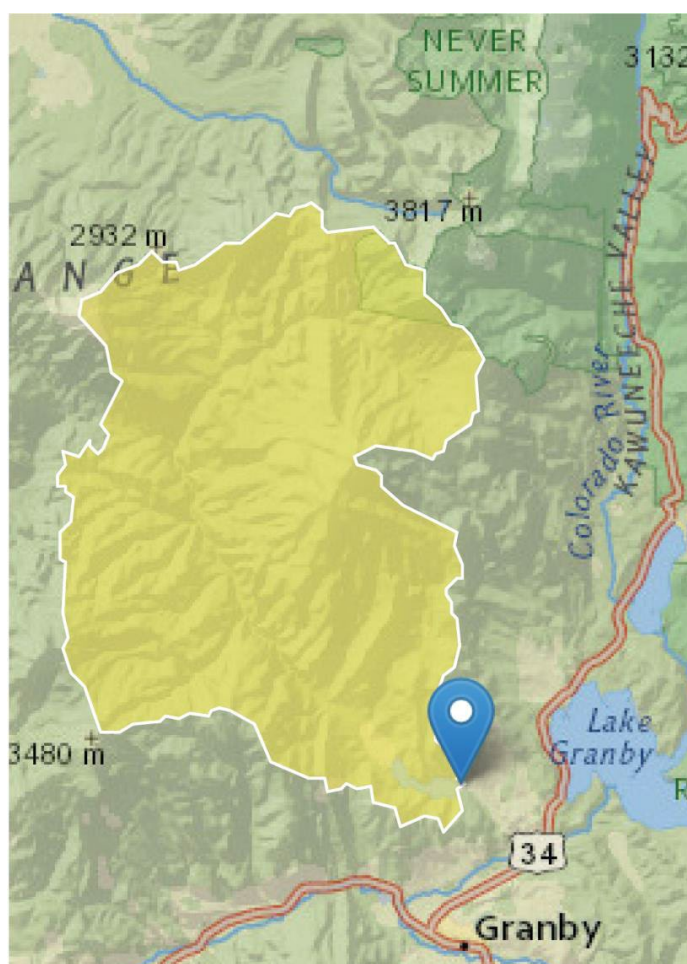
Figure 2.—The watershed above Willow Creek Reservoir has a total drainage area of 133 mi² and a sediment-contributing drainage area of 133 mi² (Hilldale and Bradley 2021).

The watershed upstream of Willow Creek Dam has a total contributing drainage area of 133.4 mi². Basin elevation ranges from 12,300 feet (ft) in the headwaters to 8130 ft Reclamation Project Vertical Datum (RPVD) at the top of the conservation pool. The entire basin contributes sediment to the reservoir, as there do not appear to be any dams upstream of the reservoir, and only about 0.4 percent of the basin is occupied by lakes (table 1; figure 2). All information in this section was taken from Hilldale and Bradley (2021).

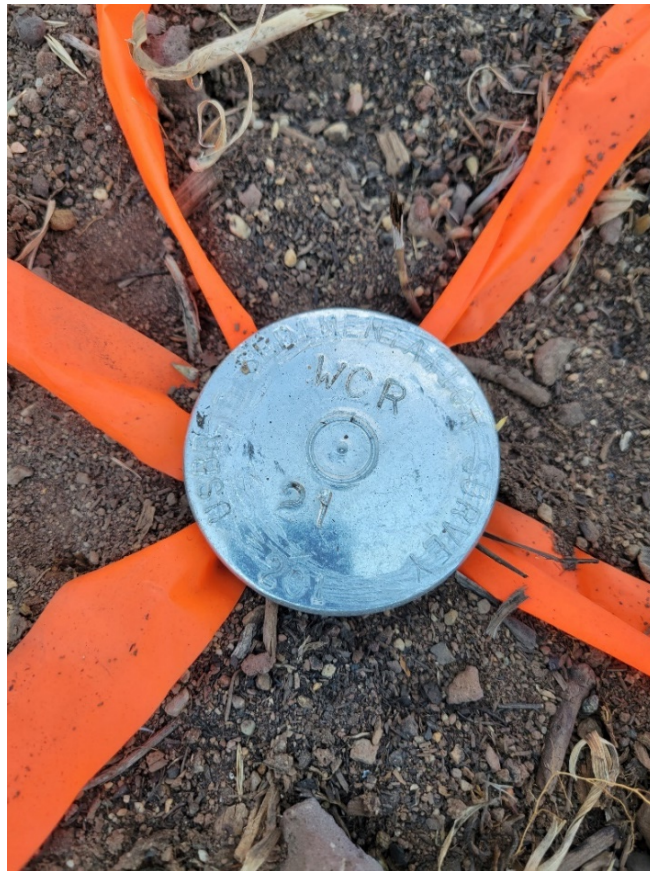
Figure 8.—Image of the cap on the new benchmark.

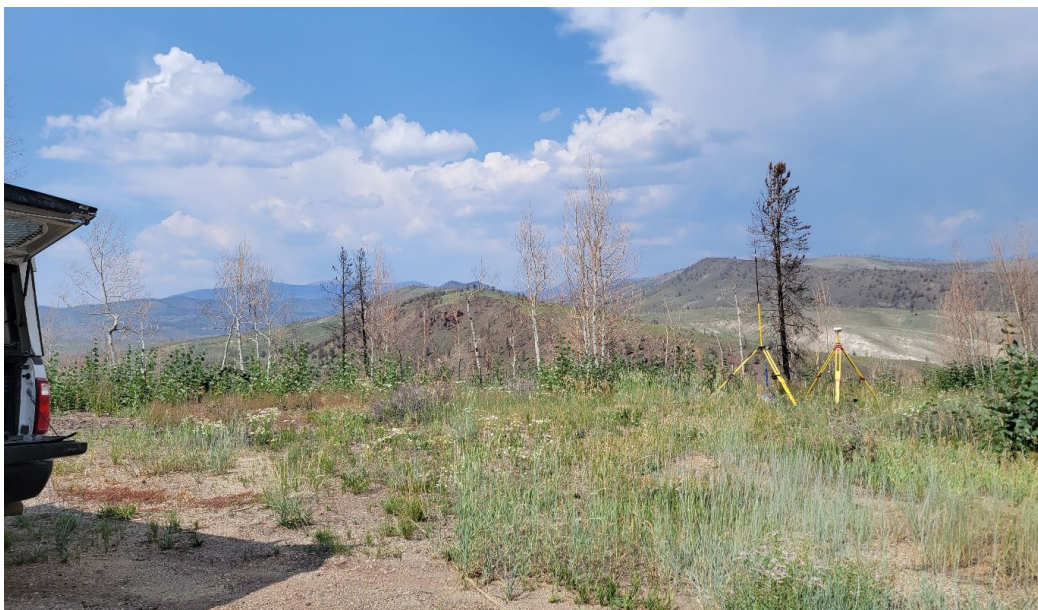
Figure 9.—GPS base station set up over the new benchmark (note burned tree in the background).

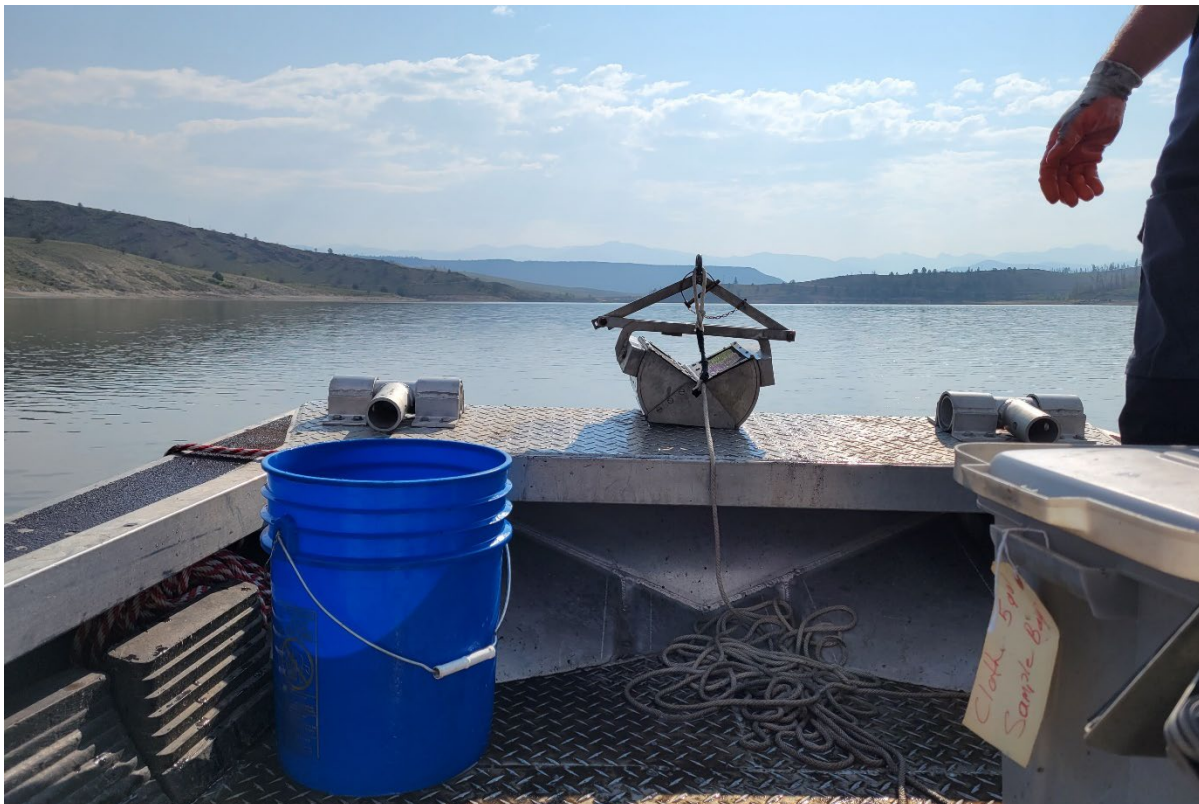
Figure 11.—Photograph of the PONAR sampler (on the bow of the boat) used to collect the reservoir bottom sediment samples.

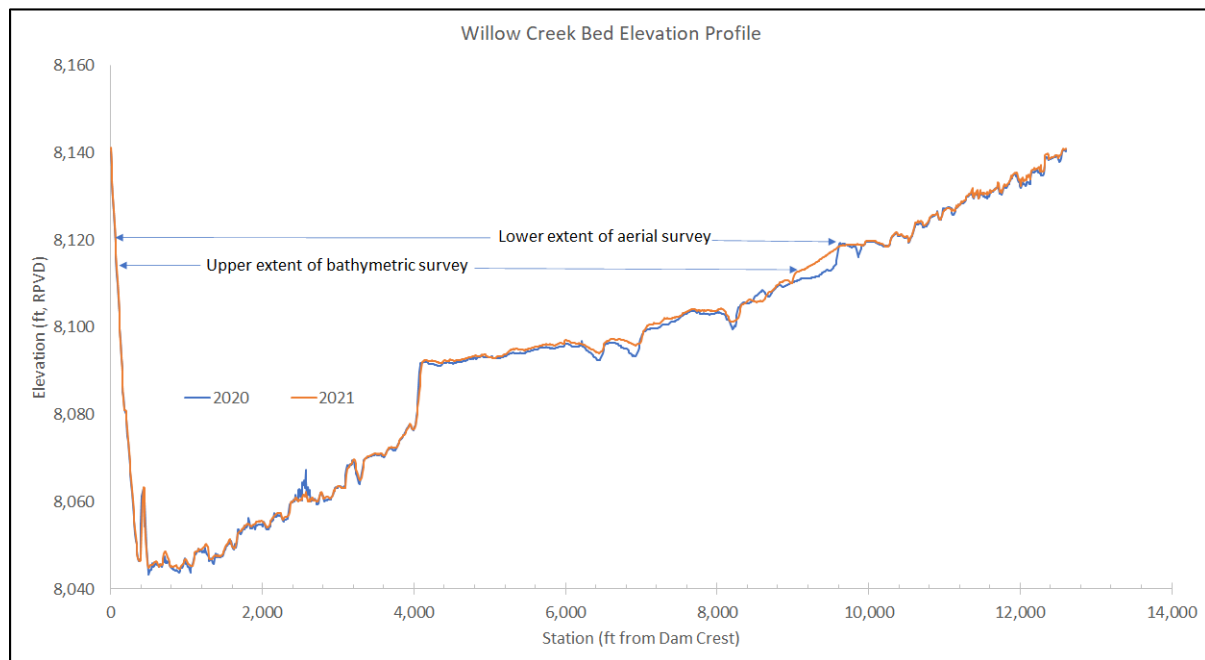
Figure 14.—Longitudinal profile of Willow Creek Reservoir bottom from the dam upstream through the delta.

Note the anomaly in the 2020 profile at station 2,550. Between stations 9,000 and 9,650 it was necessary to interpolate the digital surface between the bathymetry and the above-water topography. This region was surveyed through ice in February 2021 to complete the 2020 survey.

An analysis of reservoir bed elevation change from the 2020 to 2021 surveys has been performed by Javernick (2021). This comparison was difficult due to the two very different coverages of the surveys and the difference in sonar devices used. The most reliable portion of this analysis indicated between 0.5 and 1 ft of increased bed elevation in the delta region of the reservoir (station > 4,000 on figure 14).

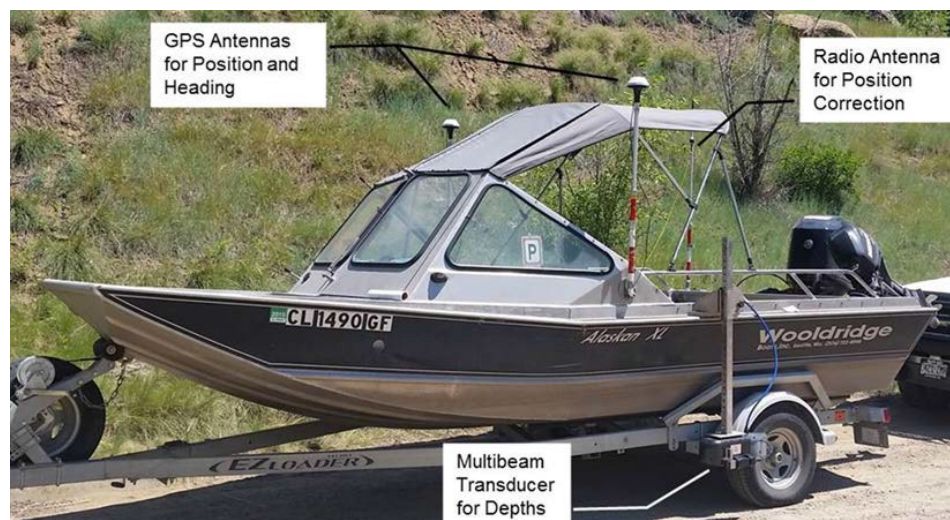
Figure A-1.—Wooldridge boat with real-time kinetic Global Positioning System (RTK-GPS) and multibeam depth sounder system (Odom MB-1 sonar transducer shown).

The survey employed an 18-foot, flat-bottom aluminum Wooldridge boat powered by outboard jet and kicker motors (figure A-1). Reservoir depths were measured using a multibeam echo sounder (Norbit iWBMS_h), which consisted of the following equipment:

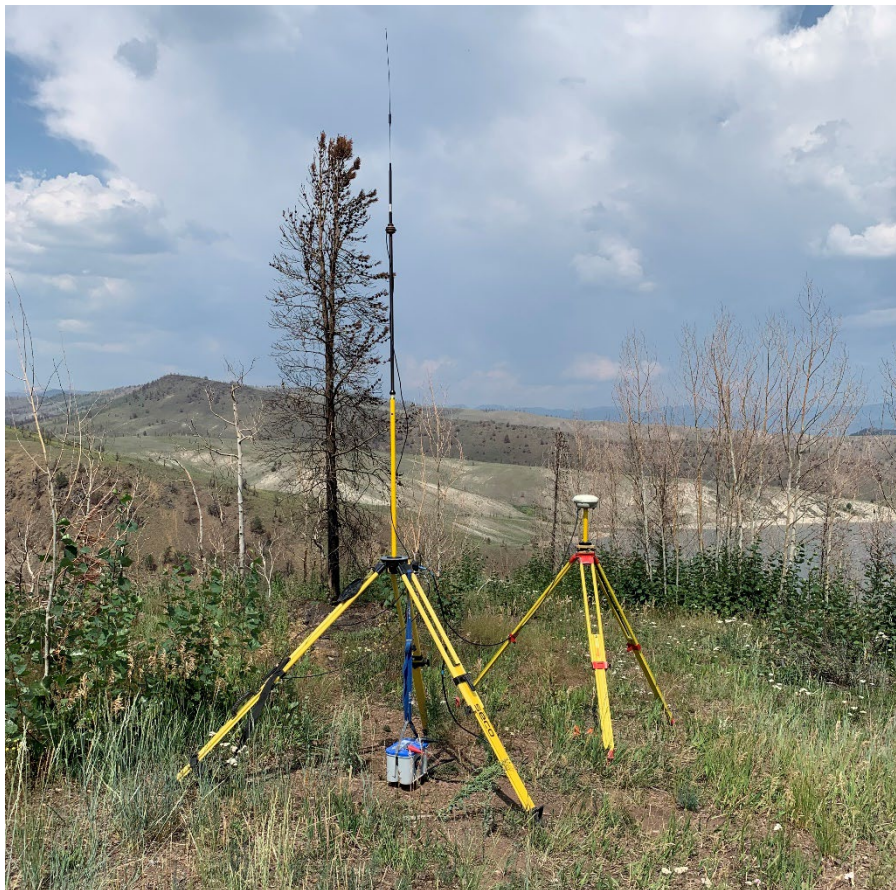
Figure A-2.—The RTK-GPS base station setup used during the survey of Willow Creek Reservoir in Colorado.

Real-time kinetic Global Positioning System (RTK-GPS) survey instruments were used to continuously measure the position of the survey boat and to measure other ground control points and water surface elevation. The GPS base station and receiver were set up on a tripod over a new point overlooking the reservoir (figure 2, main report). The coordinates of this point were computed using the Online Positioning User Service (OPUS) developed by the National Geodetic Survey (NGS) (www.ngs.noaa.gov/OPUS/). During the survey, position corrections were transmitted to the GPS rover receiver using an external GPS radio and ultra high frequency antenna (figure A-2). The base station was powered by a 12-volt battery.

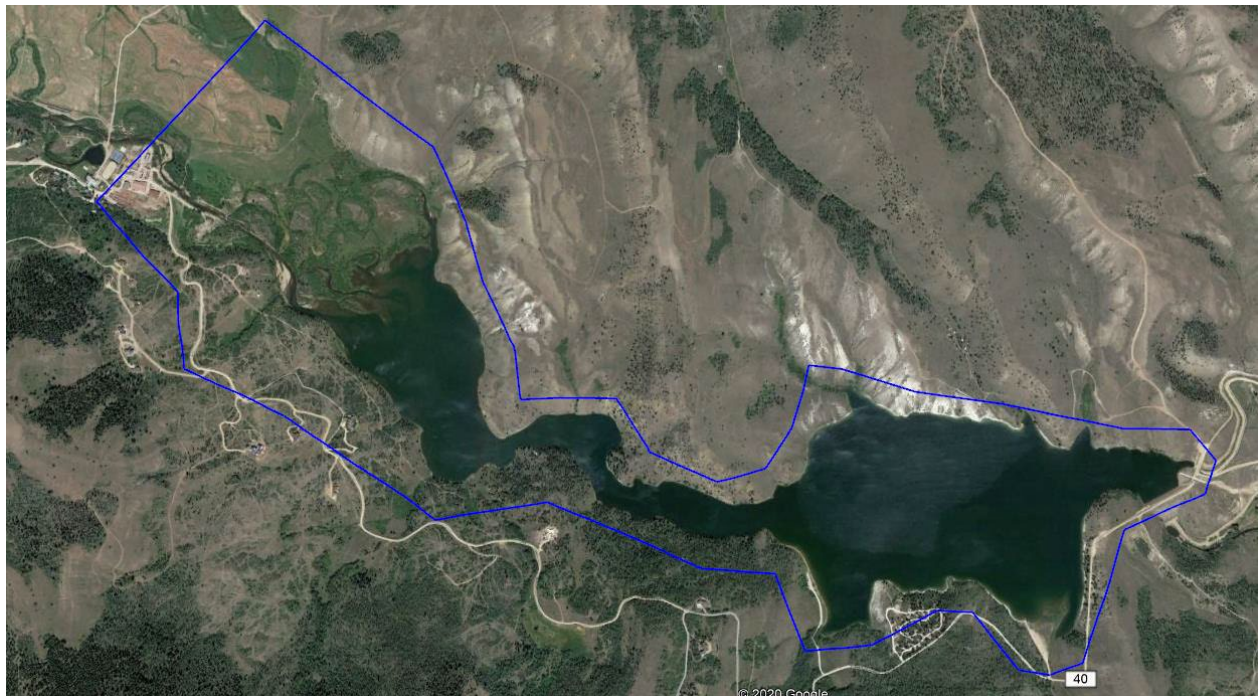
Figure B-1.—Willow Creek Reservoir aerial survey extents for the 2021 topography. This figure is taken from Javernick (2021).

The above-water topography was acquired from August 31 through September 2, 2021, by River Science (Javernick 2021). The data were acquired via drone and captured 3,573 images at a resolution of 1.13 inches per pixel (i.e., ground sample distance) (Javernick 2021). The area covered by the aerial survey, flown September 2, 2021, is shown on figure B-1).
